SITE INSPECTION FORM

SITE NUMBER AND NAME: GP053 Rock Slope North of McIntyre Mine		HIGHWAY & KM: 40:36, 16.295 to 17.161	PREVIOUS INSPECTION DATE: July 21, 2021	INSPECTION DATE: June 14, 2022
LEGAL DESCRIPTION: West SE 15-58-08-W6M East NW-14-58-08-W6M	NAD 83 COORDINATES: UTM Northing Easting 11 5986971 362772 11 5987248 363835		RISK ASSESSMENT: PF: 12 CF: 5 TOTAL: 60	
AVERAGE ANNUAL DAILY TRAFFIC (AADT): 820 (north) & 820 (south) (Reference No. 70000788, 2021)			CONTRACT MAINTENANCE AREA (CMA): 504

PROJECT	PEACE REGION (GRANDE PRAIRIE DISTRICT-SOUTH) GEOHAZARD RISK MANAGEMENT PROGRAM	
TITLE	Site Plan GP053 - Rock Slope North of McIntyre Mine Hwy 40:36, km 16.295 to 17.161	
SCALE	PROJECT No. A05116A01	FIG No. 1

Inspection Photographs

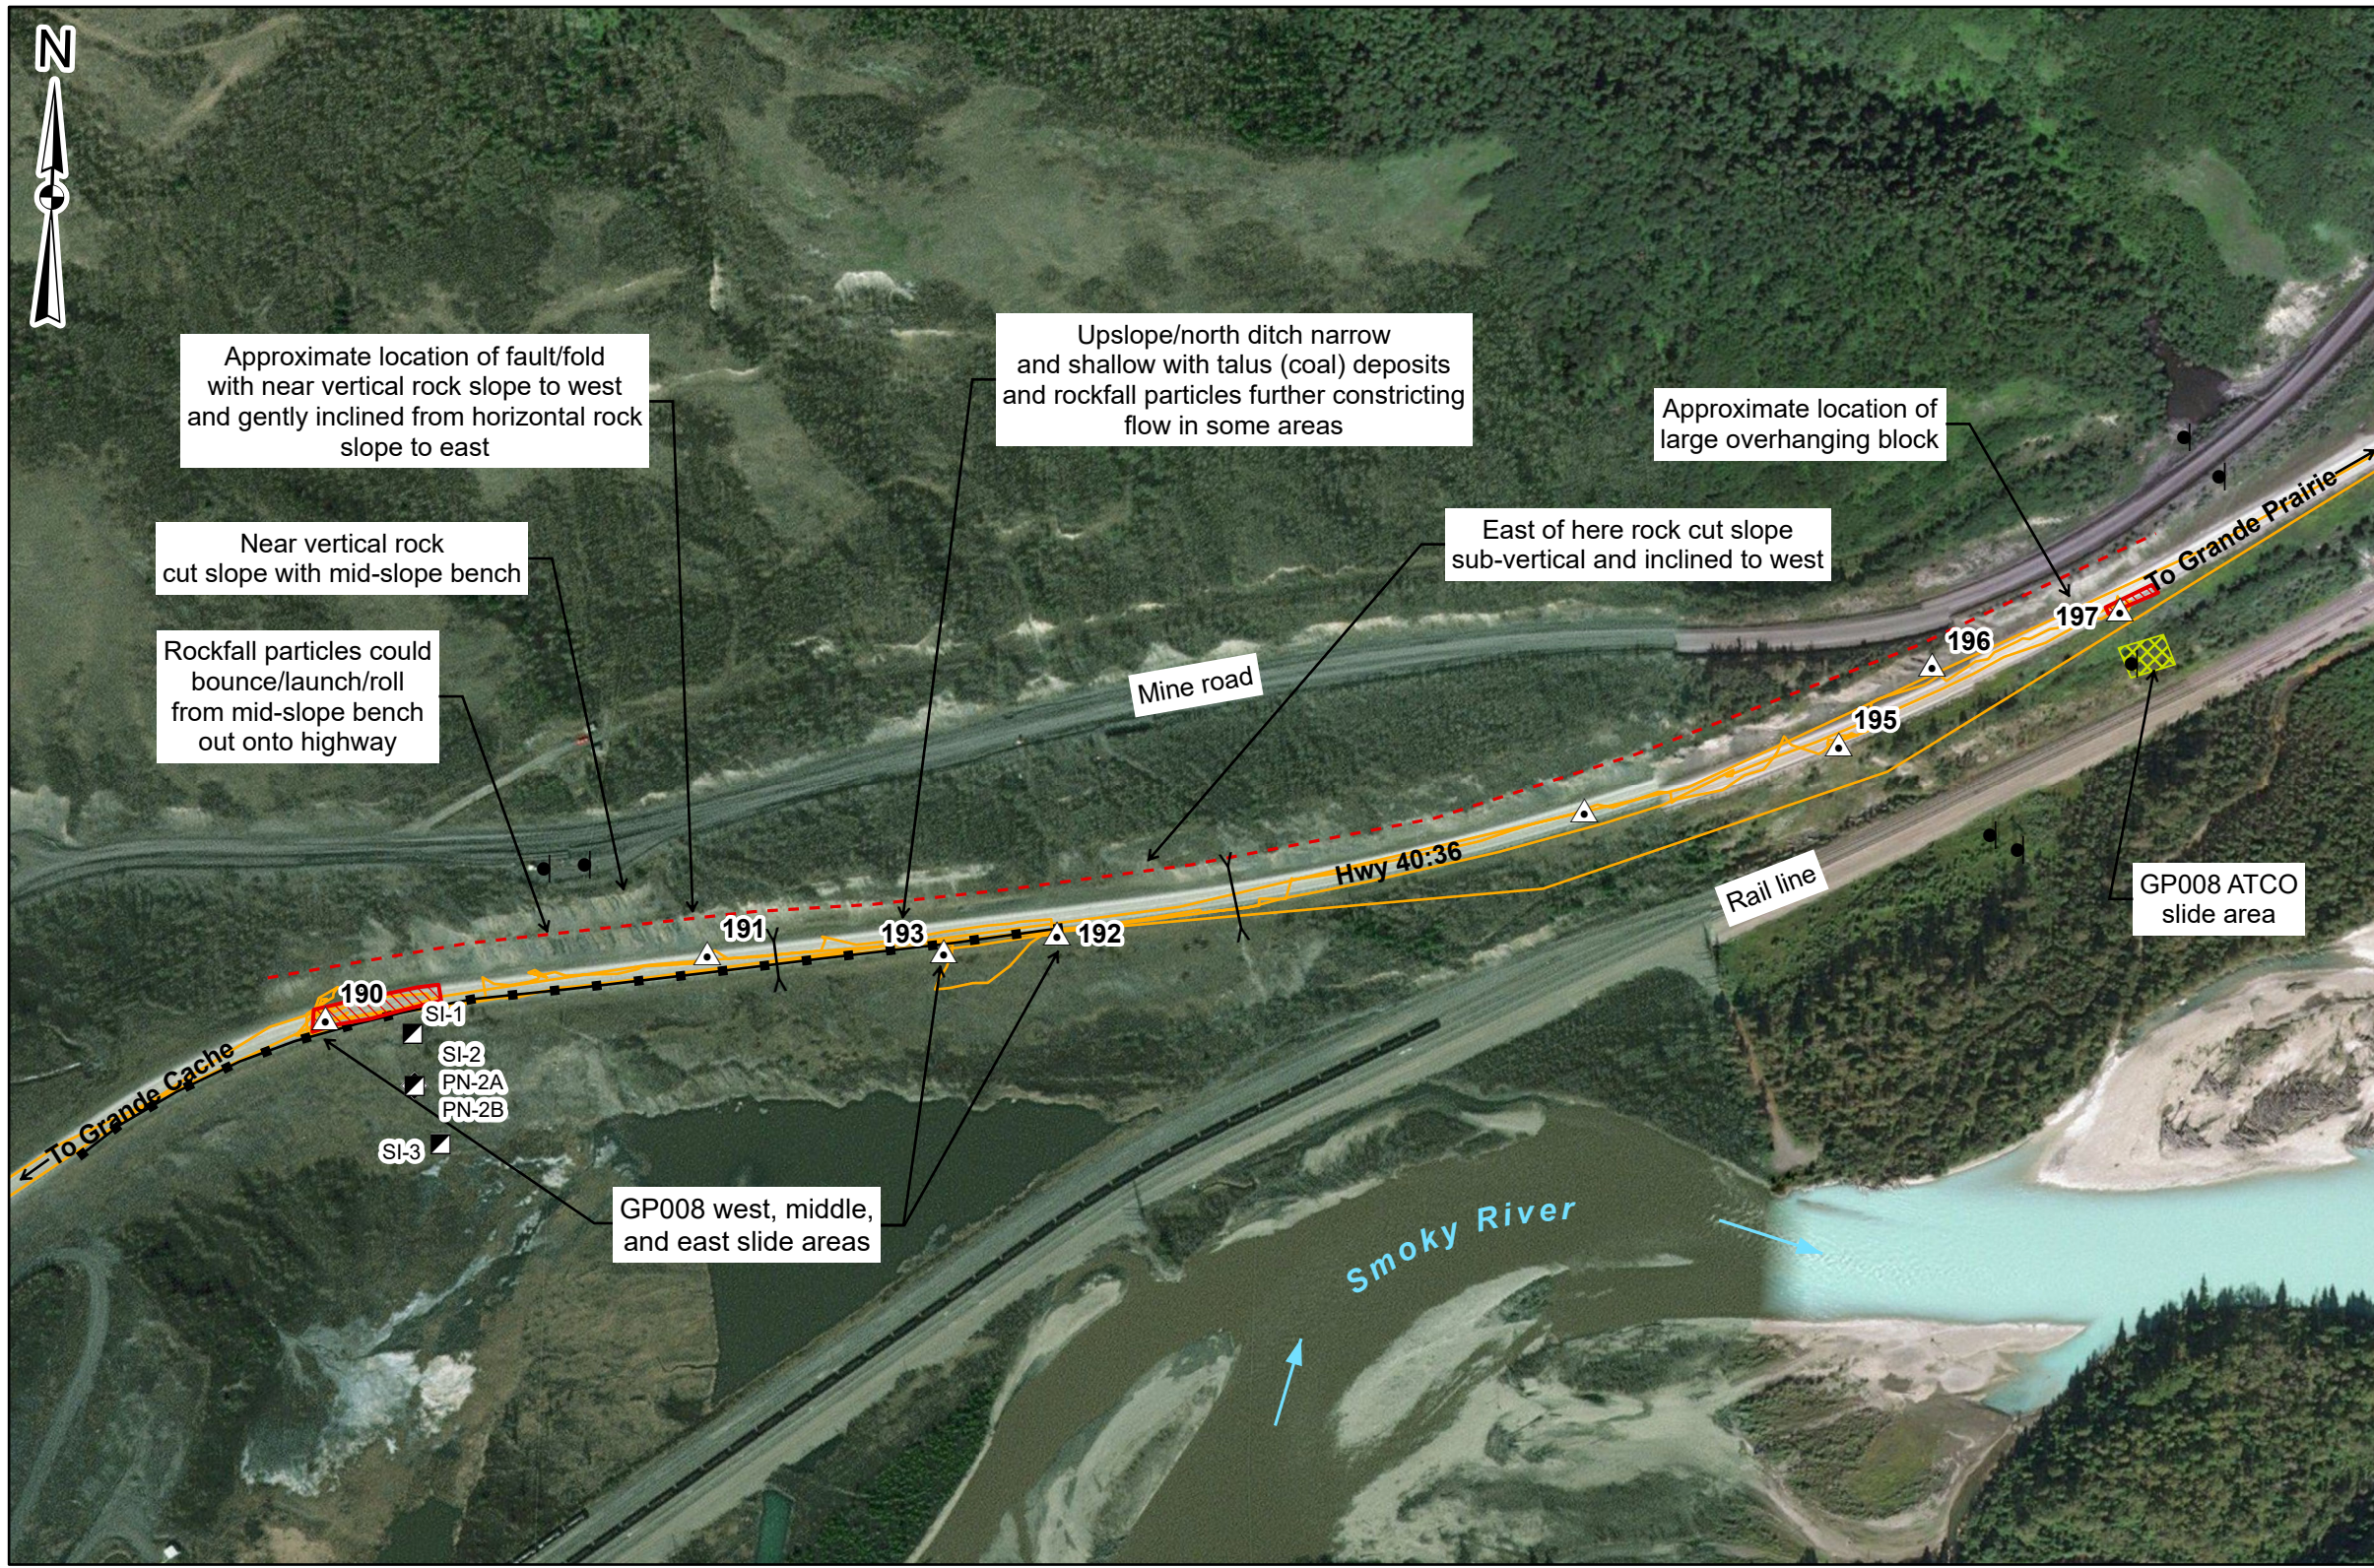
Approximate location of fault/fold with near vertical rock slope to west and gently inclined from horizontal rock slope to east

Upslope/north ditch narrow and shallow with talus (coal) deposits and rockfall particles further constricting flow in some areas

Approximate location of large overhanging block

Near vertical rock cut slope with mid-slope bench

East of here rock cut slope sub-vertical and inclined to west

Rockfall particles could bounce/launch/roll from mid-slope bench out onto highway

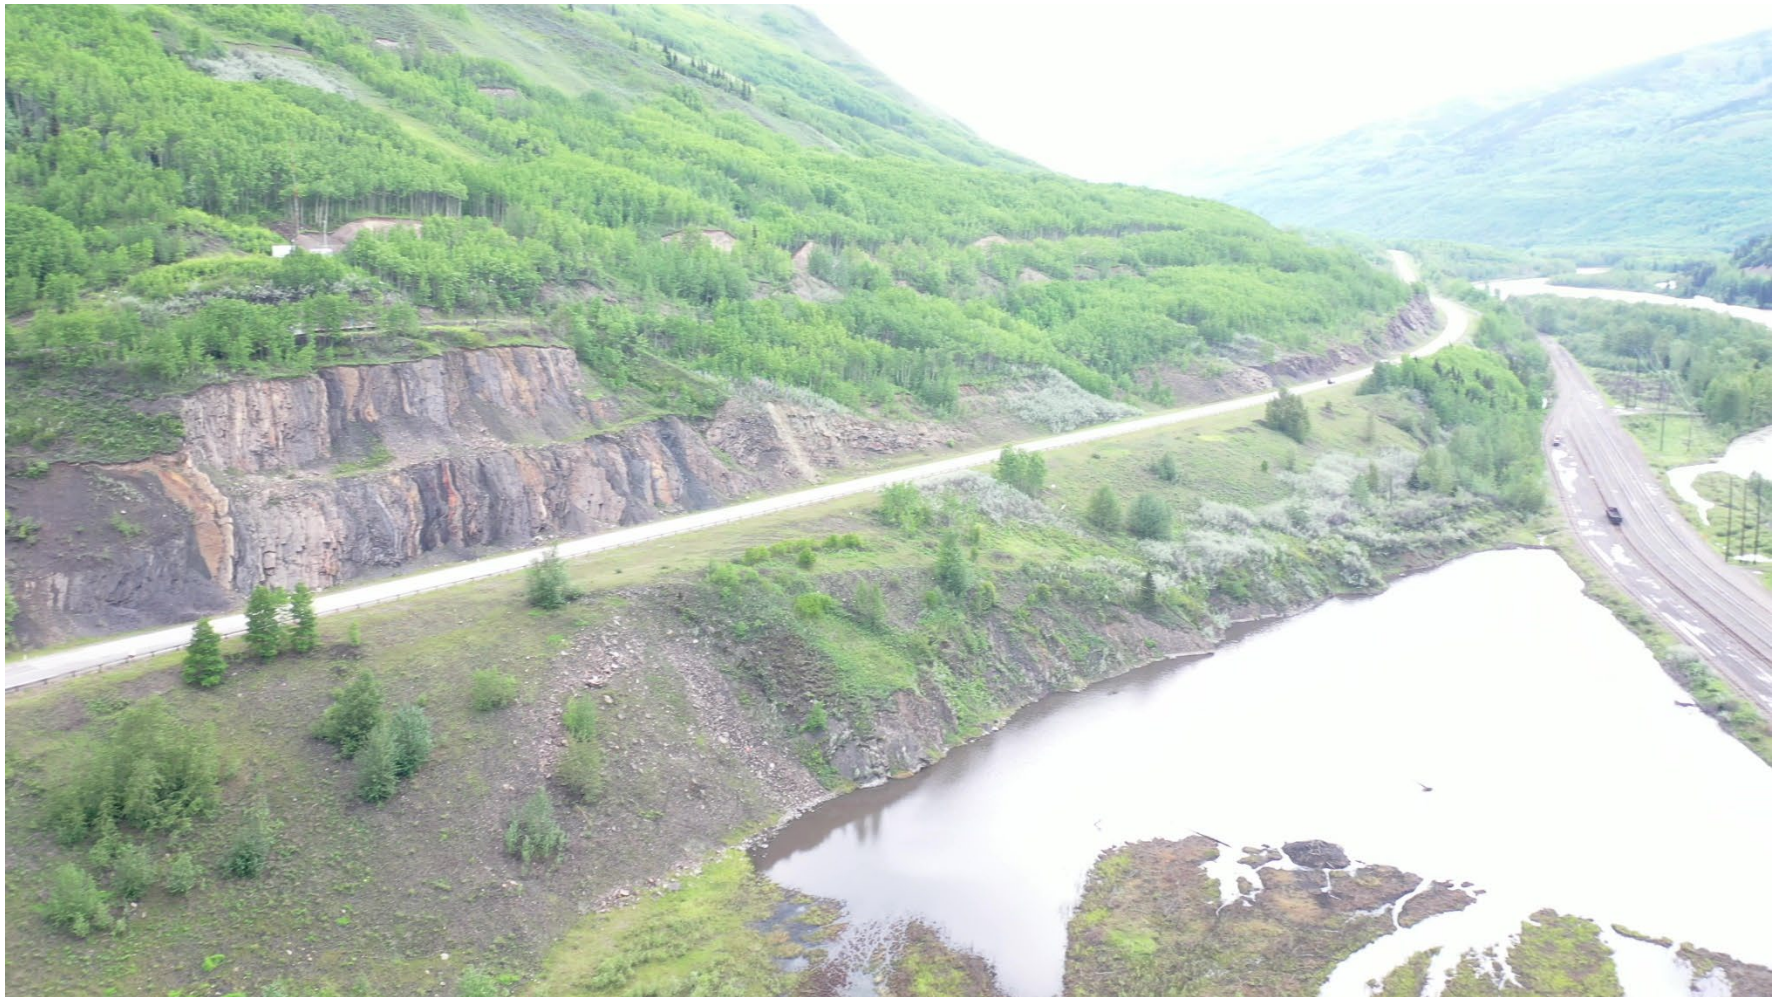
Photo 1 Overview of rockfall corridor along west side of Hwy 40:36 north of McIntyre Mine. Photo taken June 14, 2022, with unmanned aerial vehicle (UAV) facing northeast.

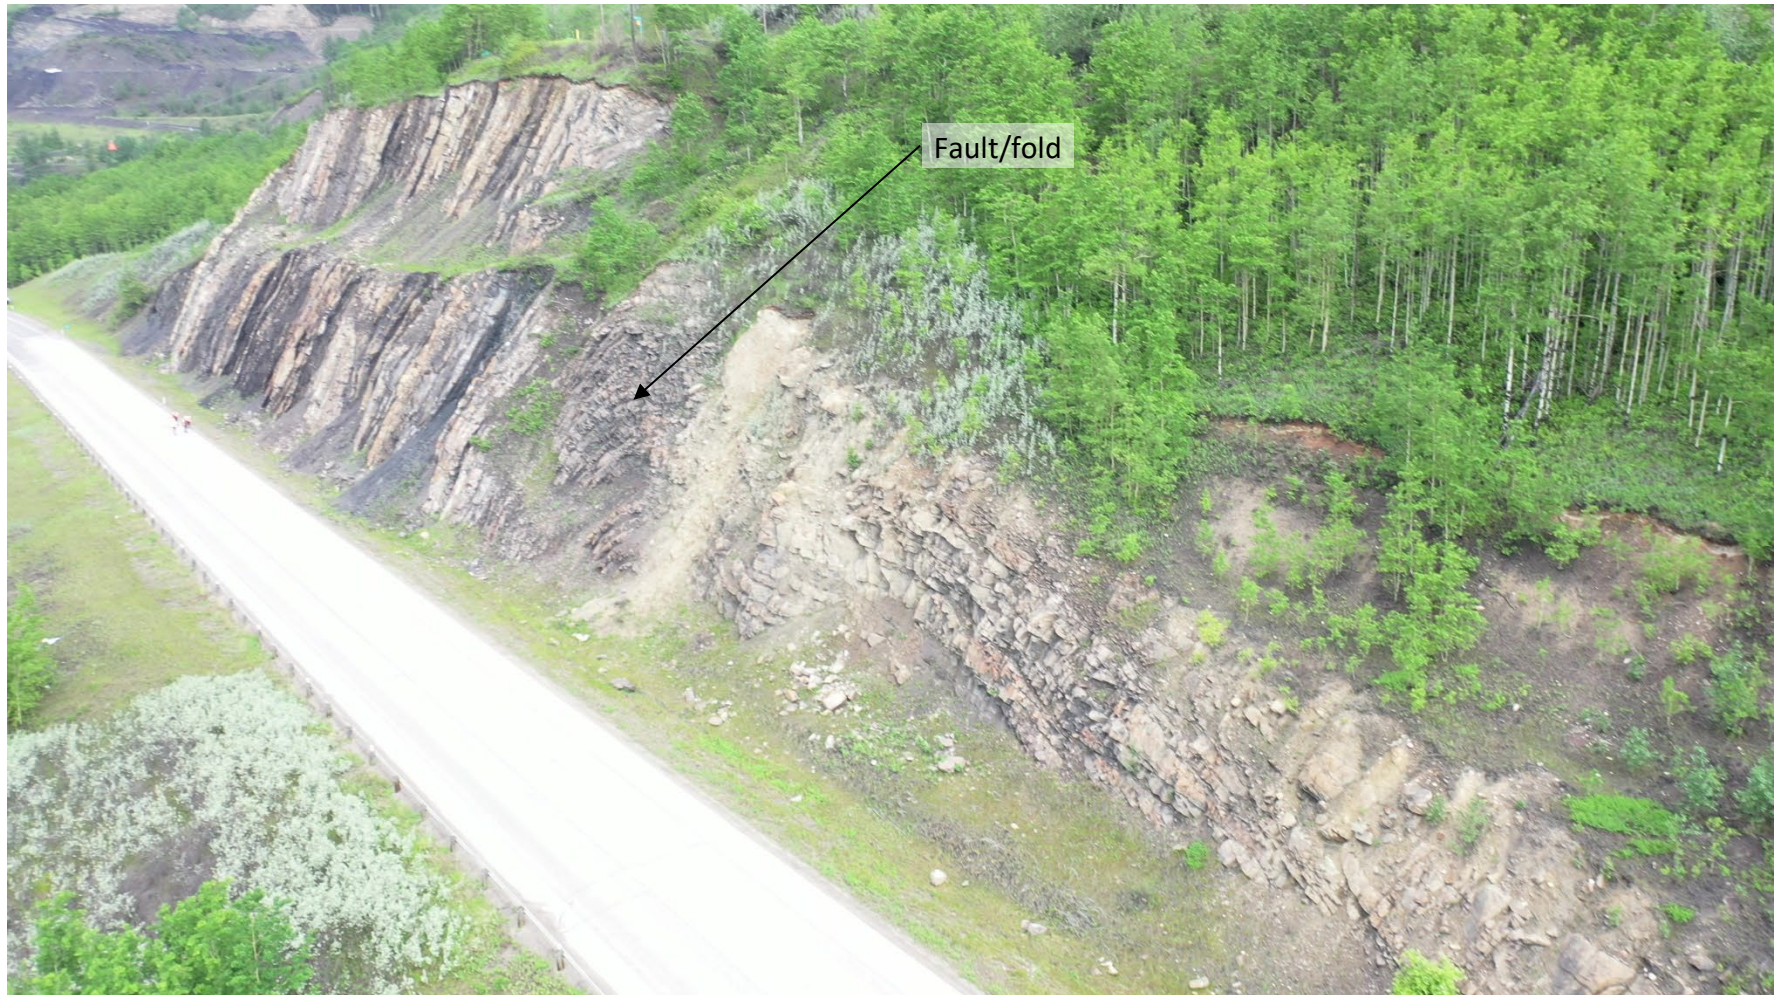
Photo 2 Rock cut slope along west side of Hwy 40:36 between WP190 and WP191 at south/western site limit. Note talus (coal) deposits and rockfall particles in upslope/north highway ditch. As well as change in orientation of bedrock discontinuities mid-photo (near vertical bedding to left/south transitioning at a fault/fold to gently inclined from horizontal on right/north). Photo taken June 14, 2022, with UAV facing northwest.

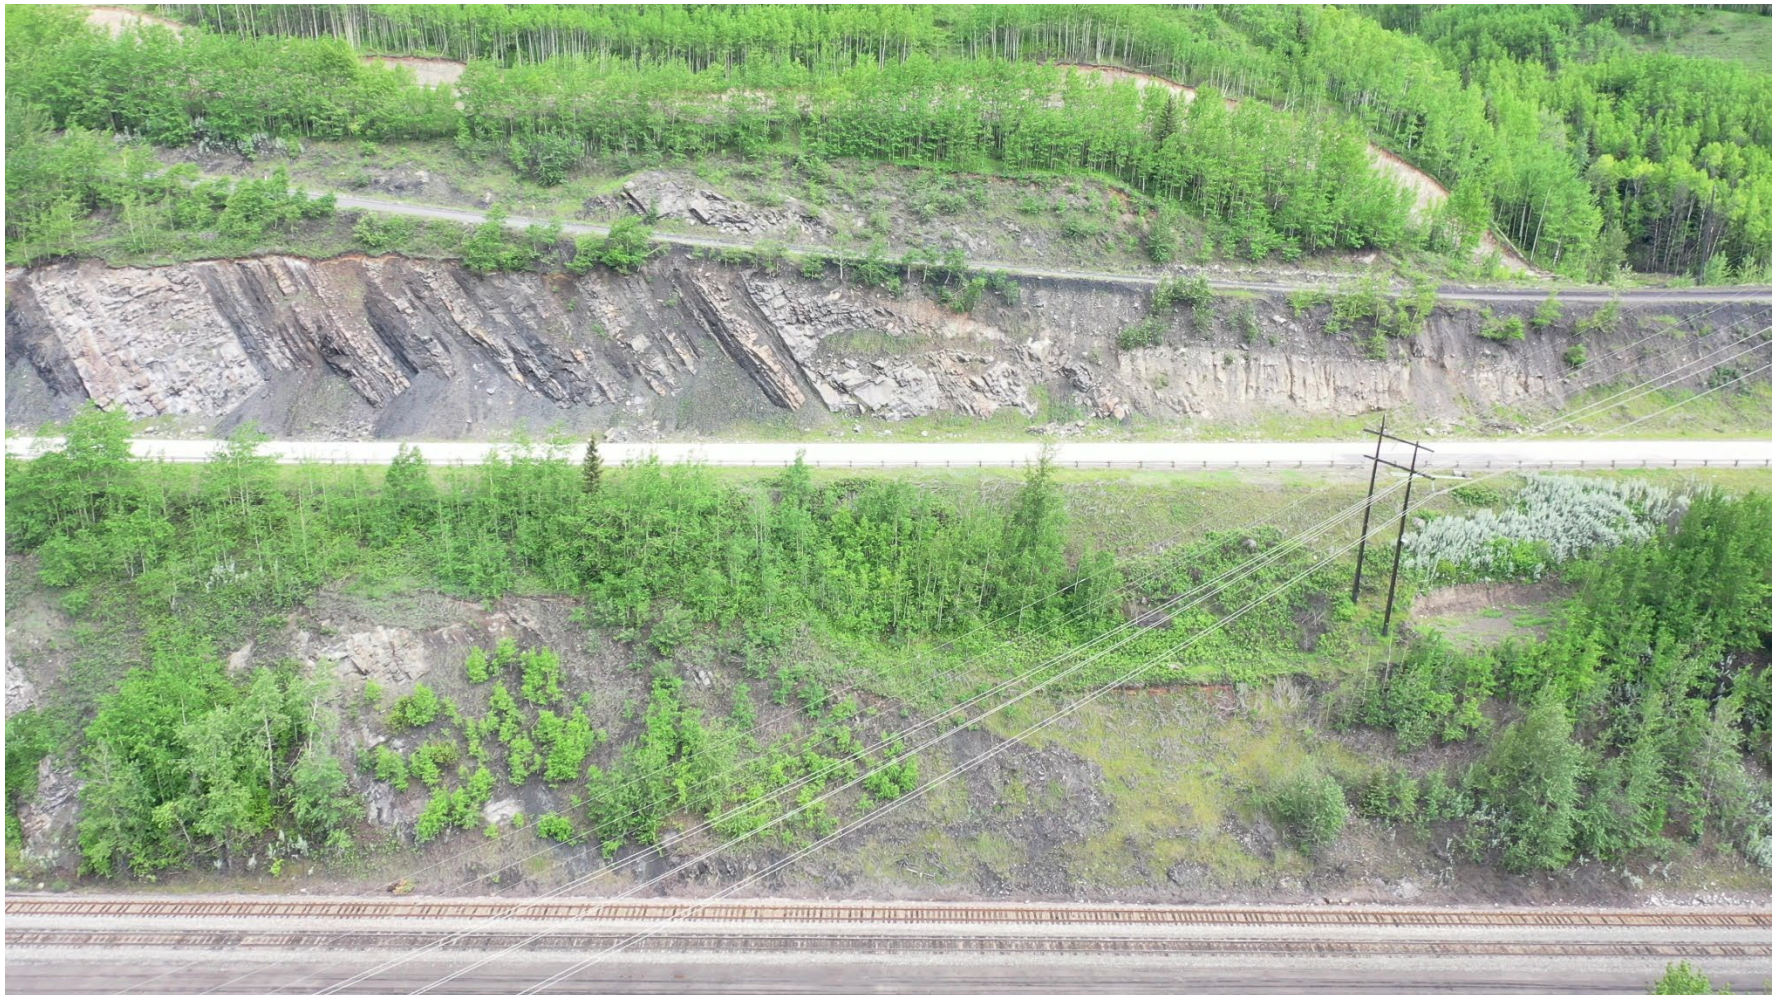
Photo 3 Rock cut slope along west side of Hwy 40:36 at WP 197 at north/eastern site limit. Note talus (coal) deposits and rockfall particles in upslope/north highway ditch. Photo taken June 14, 2022, with UAV facing north.

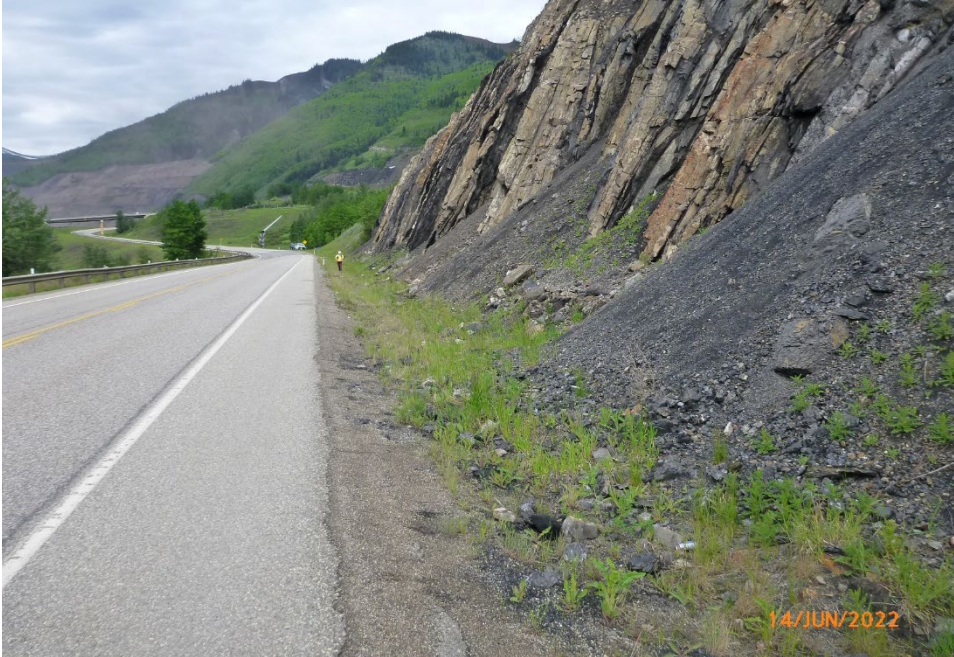
Photo 4 Toe of rock cut slope between WP190 and WP191 at south/western site limit. Note talus (coal) deposits and rockfall particles in upslope/north highway ditch. Photo taken June 14, 2022, facing west.

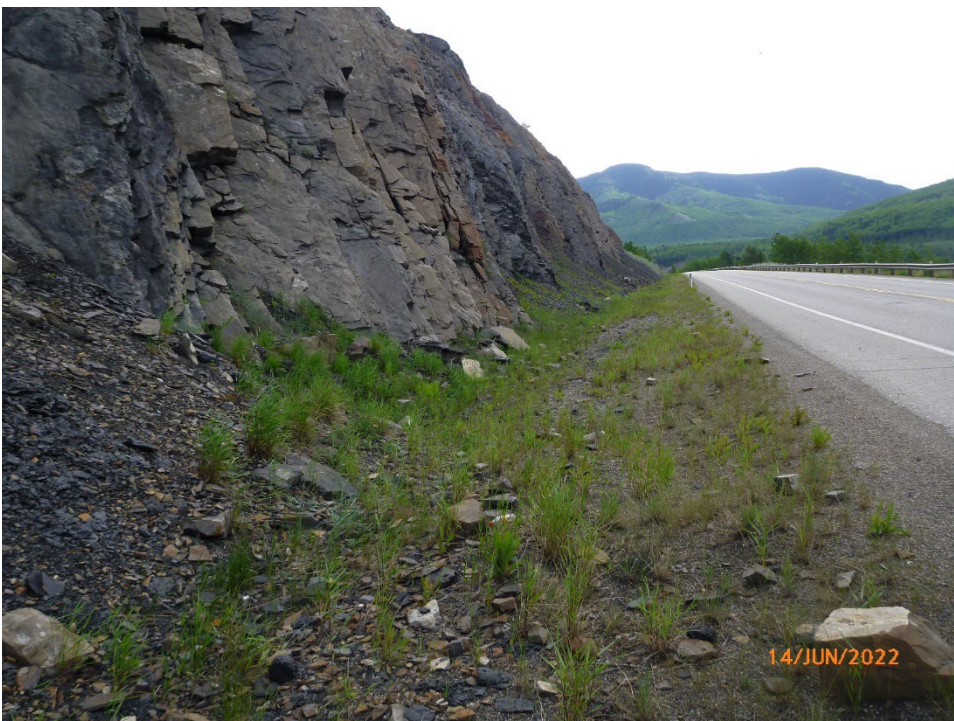
Photo 5 Toe of rock cut slope between WP190 and WP191 at south/western site limit. Note rockfall particles in upslope/north highway ditch. Photo taken June 14, 2022, facing east.

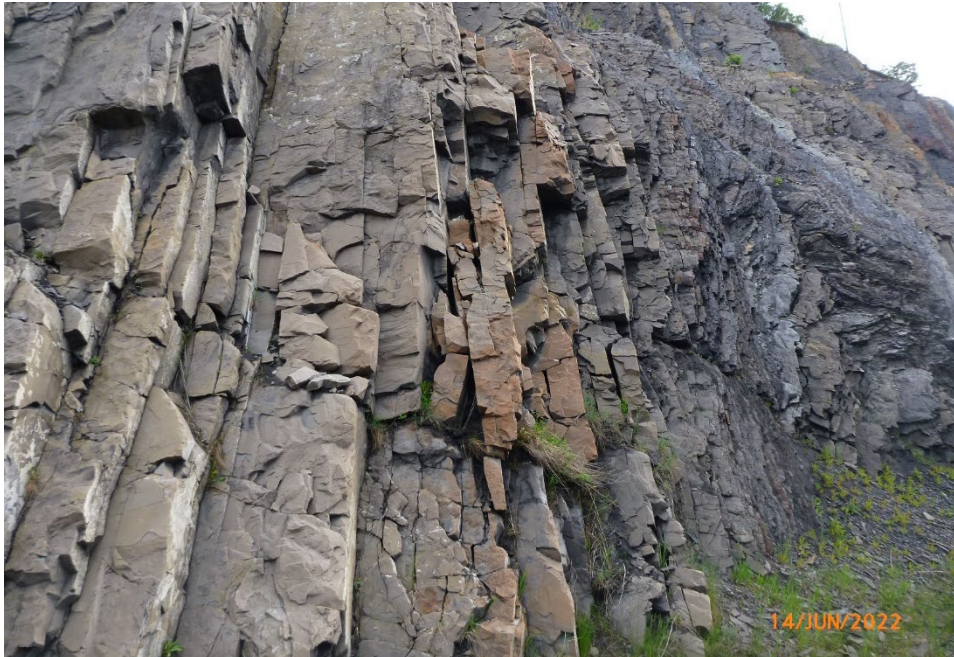
Photo 6 Near vertical bedding of rock cut slope between WP190 and WP191 at south/western site limit. Note hanging rock blocks. Photo taken June 14, 2022, facing north.

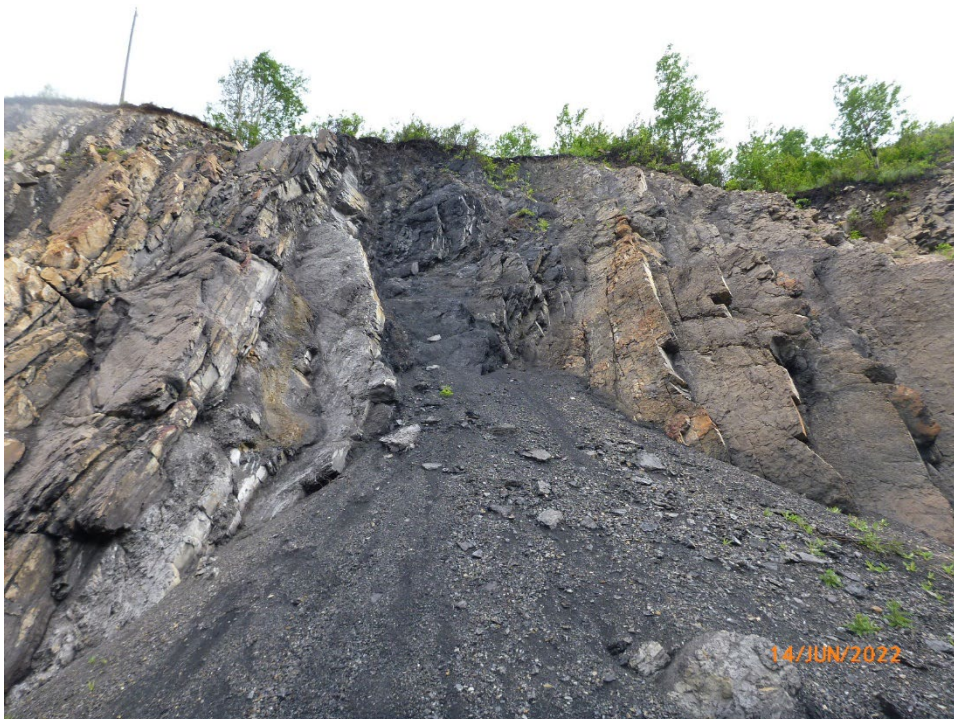
Photo 7 Talus material from coal seam in rock cut slope between WP190 and WP191 at south/western site limit. Photo taken June 14, 2022, facing north.

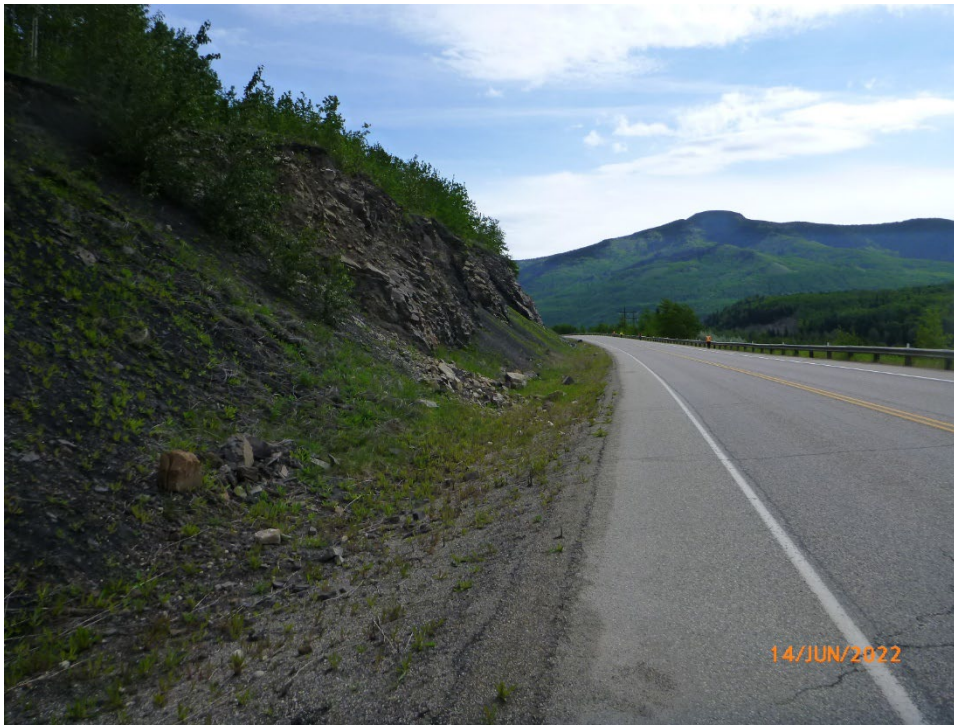
Photo 8 Rock cut slope east of WP192 near middle of site. Photo taken June 14, 2022, facing east.

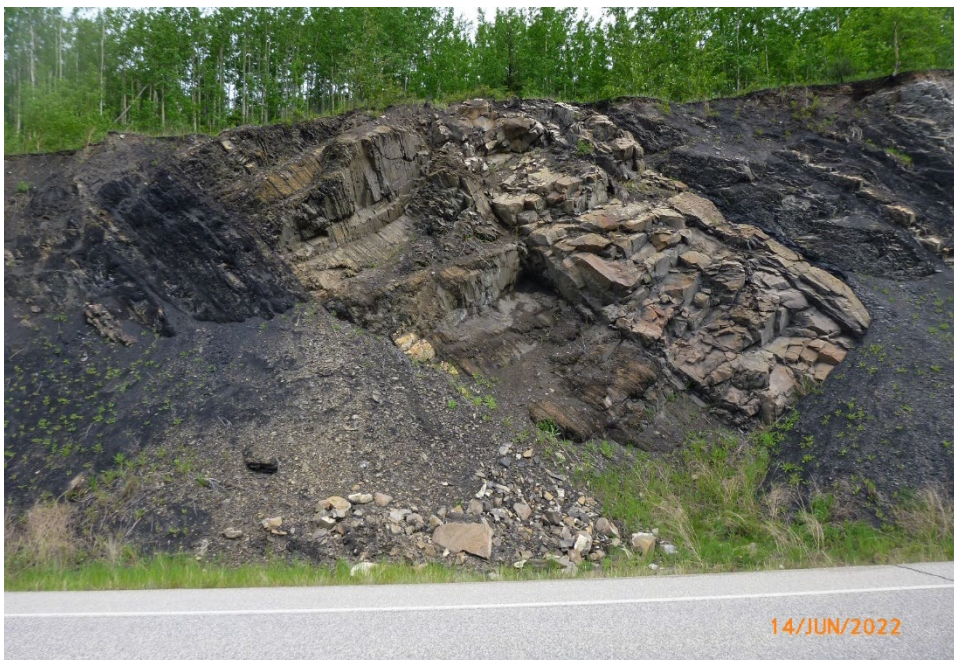
Photo 9 Rock cut slope near WP195 and middle of site. Note talus (coal) materials and rockfall particles in upslope/north highway ditch, which is narrow and shallow, and hanging rock blocks. Photo taken June 14, 2022, facing north.

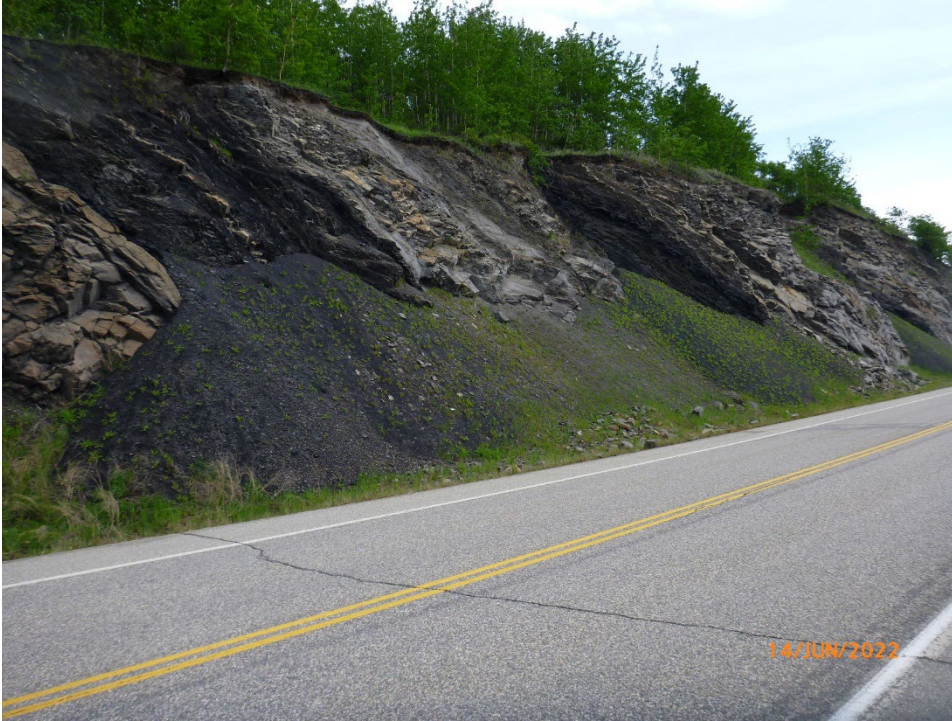
Photo 10 Rock cut slope near WP195 and middle of site. Note talus (coal) materials in upslope/north highway ditch, which is narrow and shallow. Photo taken June 14, 2022, facing north.

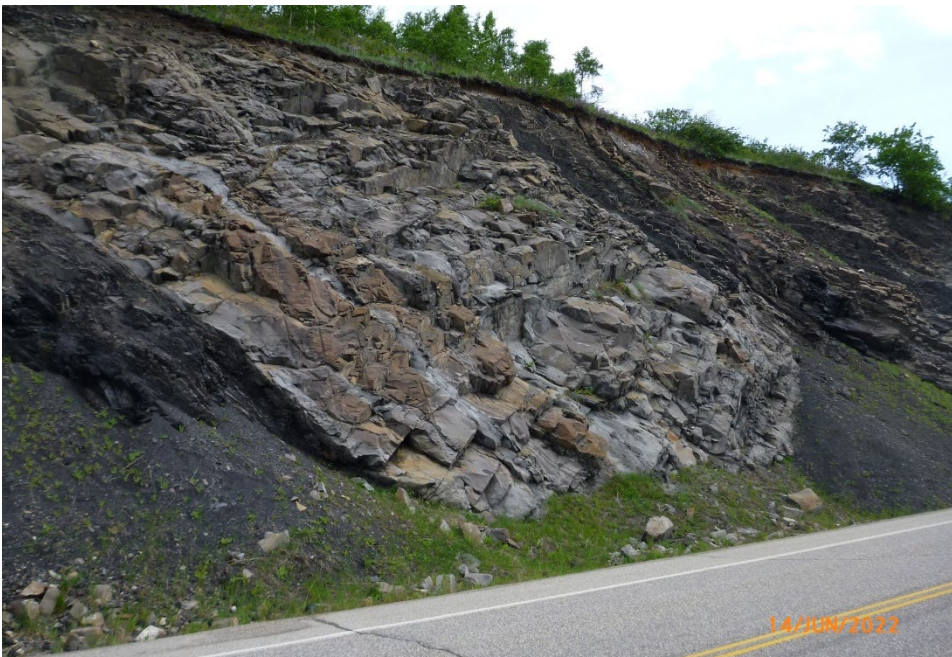
Photo 11 Rock cut slope near WP195 and middle of site. Note rockfall particles in upslope/north highway ditch, which is narrow and shallow. Photo taken June 14, 2022, facing northeast.

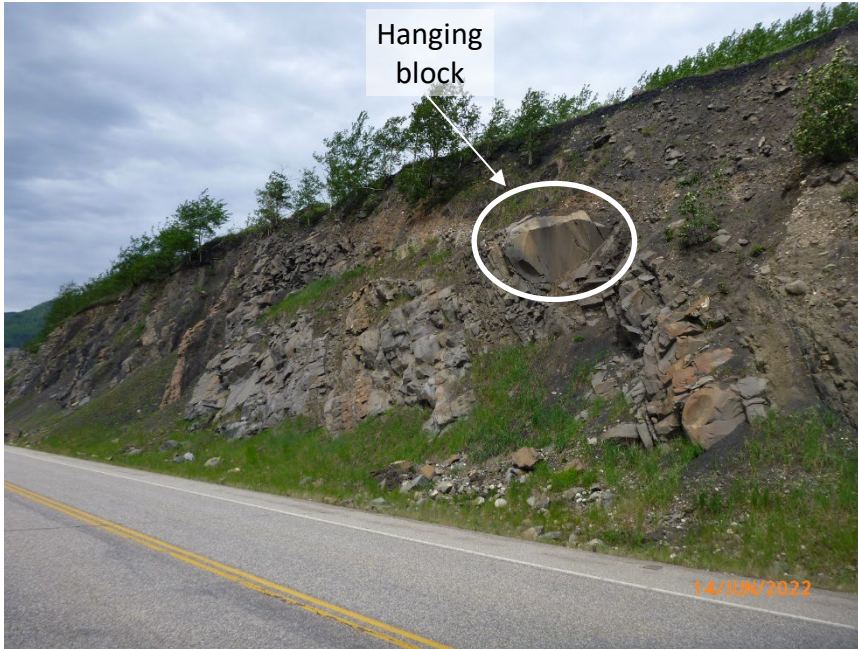
Photo 12 Rock cut slope at WP197 at north/eastern site limit. Note rockfall particles in upslope/north highway ditch, which is narrow and shallow, and hanging rock blocks (see large one circled in white). Photo taken June 14, 2022, facing southwest.

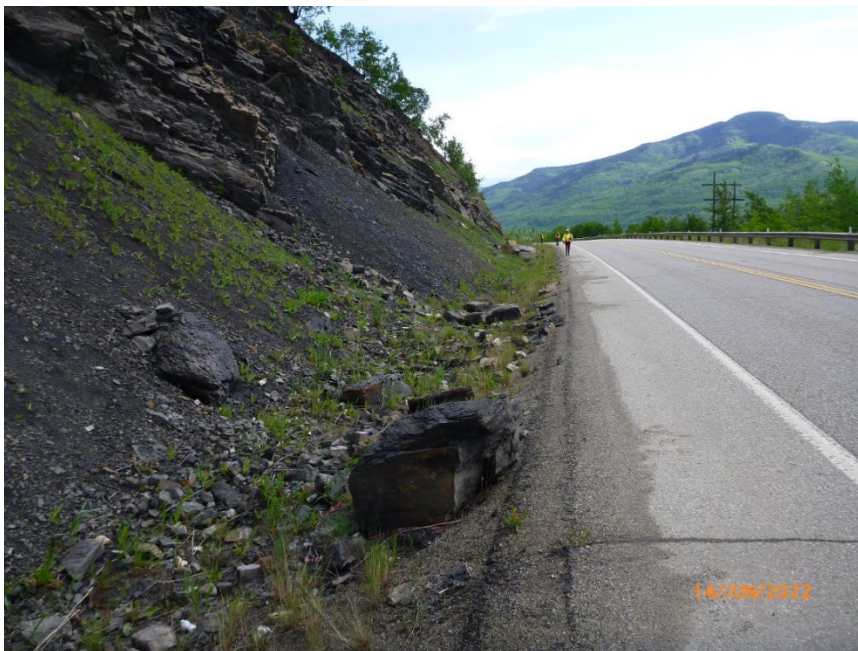
Photo 13 Large rockfall particle in upslope/west ditch between WP195 and WP196 near northern site limit. Photo taken June 14, 2022, facing east.
