SITE NUMBER AND NAME: GP002 Candle Road Slide		HIGHWAY & KM: 40:38, 7.439	PREVIOUS INSPECTION DATE: December 2006	INSPECTION DATE: July 20, 2021
LEGAL DESCRIPTION: NE 20-61-4-W6M	NAD 83 COORDINATES: UTM Northing Easting 11 6017091 398840		RISK ASSESSMENT: PF: 9 CF: 1 TOTAL: 9	
AVERAGE ANNUAL DAILY TRAFFIC (AADT): 780 (north) & 780 (south) (Reference No.: 70000673)			CONTRACT MAINTENANCE AREA (CMA): 504

SUMMARY OF SITE INSTRUMENTATION: There is no instrumentation at the GP002 site. LAST READING DATE: N/A	INSPECTED BY: Chris Gräpel James Lyons Roger Skirrow (AT) Rocky Wang (AT) Ed Szmata (AT) Max Shannon (AT) Chase Milligan (AT) Dwayne Lowen (AT MCI)
PRIMARY SITE ISSUE: Slide in embankment fill and foundation due to high groundwater table. Site is a repeat failure at a previous repair site.	
APPROXIMATE DIMENSIONS: 30 m wide, 25 m high	
DATE OF ANY REMEDIAL ACTION: Repaired in 2004

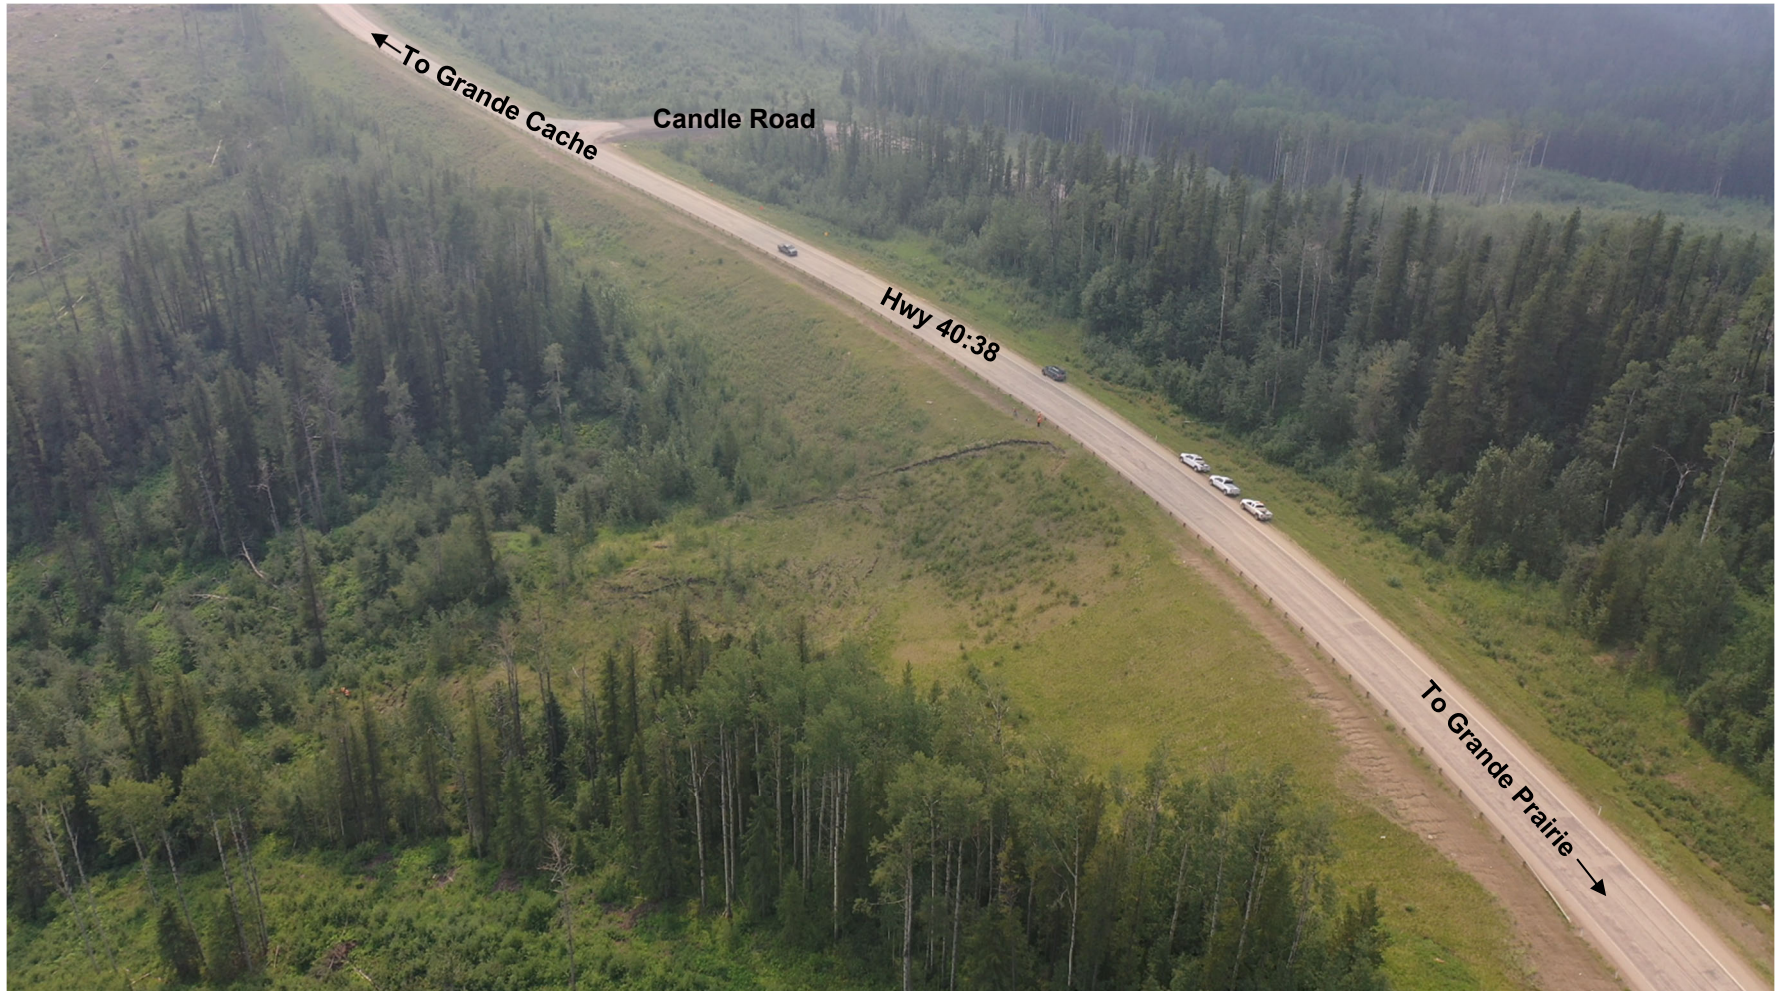
Photo 1 Overview of the GP002 site, indicating Hwy 40, Candle Road. Photo taken July 20, 2021 facing south.

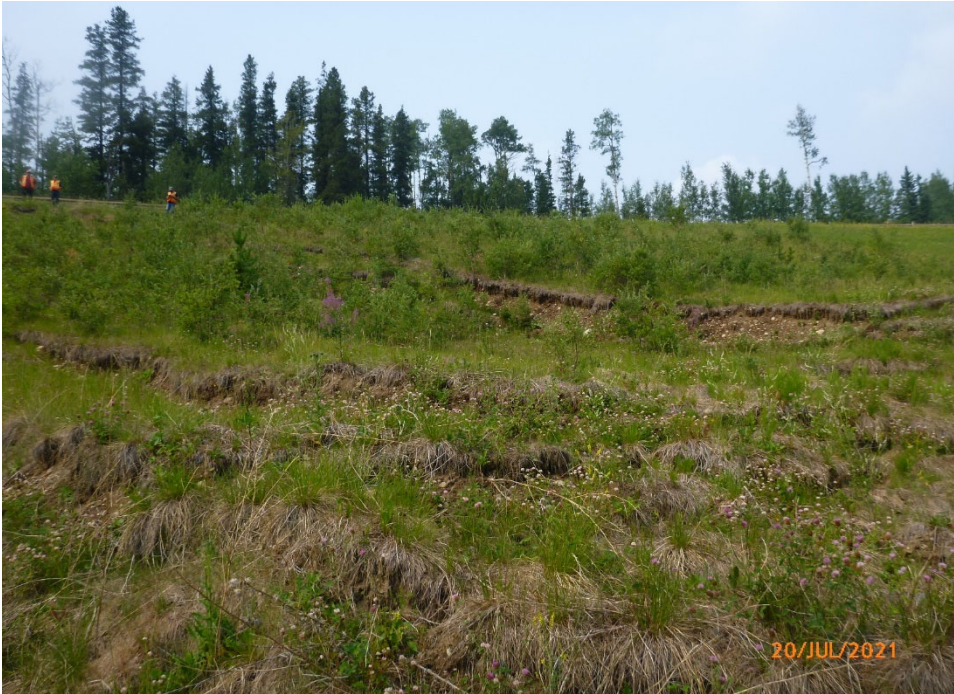
<ul style="list-style-type: none"> - Seems to be more rounded gravel and cobbles visible at upper part of slide than lower part of slide, seems like lower part may have been graded with native material and upper part was reconstructed with gravel. WP098 is at the lower limit of rounded gravel and cobbles. 	
<ul style="list-style-type: none"> - Slope appears to have failed again due to plugged drains resulting in rising water level and saturation of repair fill and/or, shearing through the bedrock ledge 	
<ul style="list-style-type: none"> - WP095, water in cracks about 0.5 m depth in cracks, near zone where cracking is perpendicular to crest of slope, a more active zone where water is located (WP096) 	
<ul style="list-style-type: none"> - WP097, water at surface in a low area 	
<ul style="list-style-type: none"> - Slide repair will likely involve re-excavating the previous repair, assessing if the shear key is intact, re-establishing drainage, with redundant outlets at multiple elevations, and reconstructing the slope with free-draining gravel reinforced with geogrid. Drainage should include filtering so that sediments do not enter the drainage pipes. The work could be done in panels to avoid destabilizing the unsupported steep backscarp, but construction access would have to be considered when assessing panel widths. Estimated cost of repair is in the order of \$600,000 to \$800,000.

Photo 2 Material exposed at the backscarp of the slide appears more granular (cobbles and gravel) than the material near the toe of the slide area. The lower limit of the more granular material is indicated by Waypoint 98. Photo taken July 20, 2021 facing west.

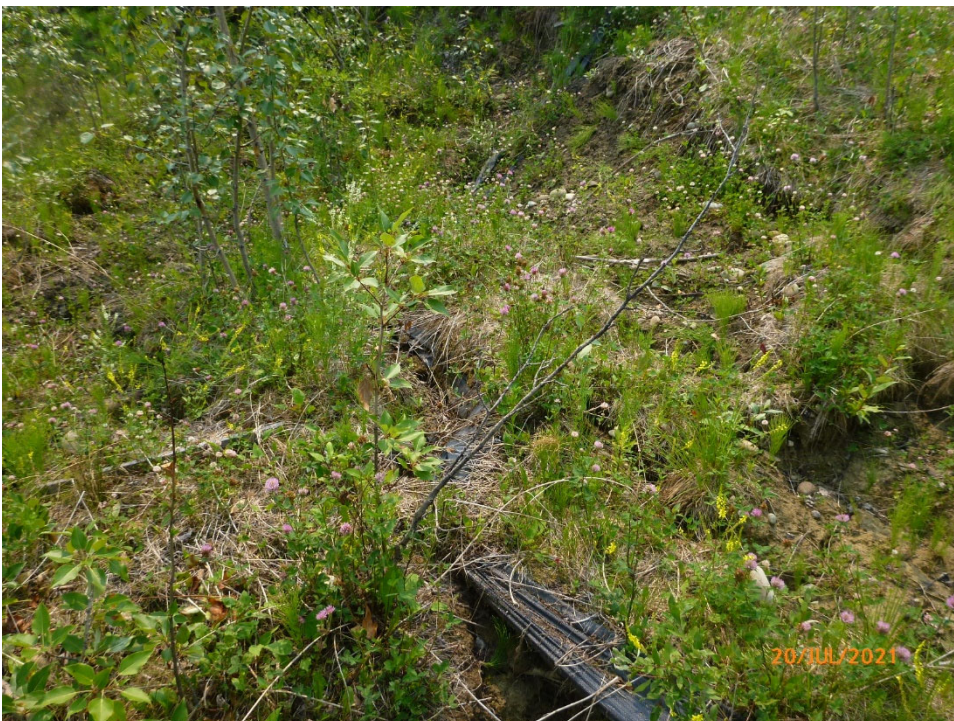
Photo 3 Exposed silt fencing near the toe of the slide (Waypoint 94). Photo taken July 20, 2021 facing north.

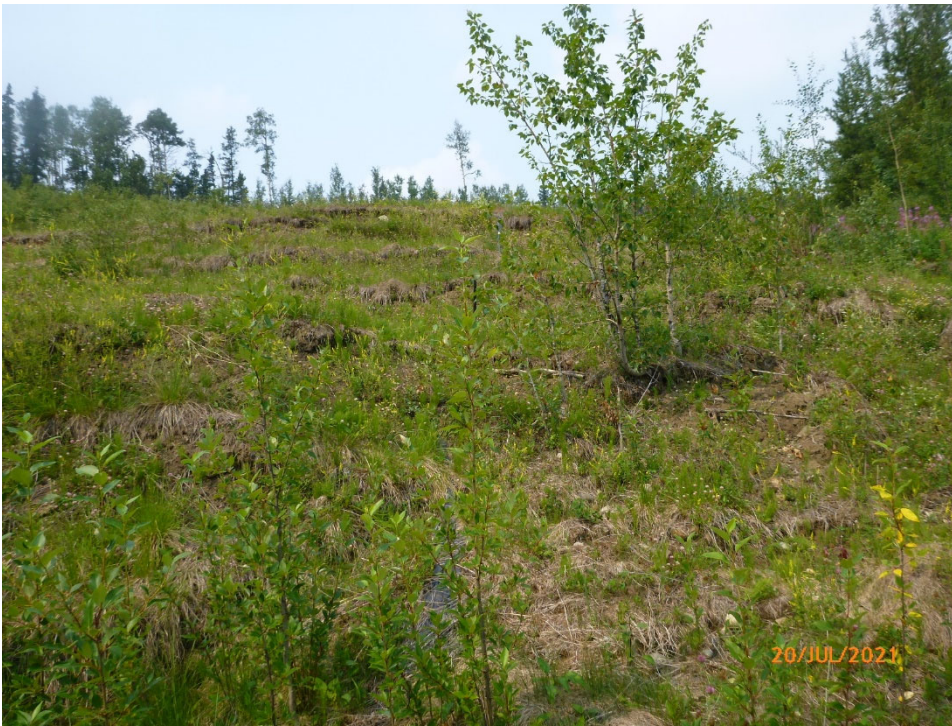
Photo 4 Silt fencing observed near the lower portion of the slide, near the north (left) flank (Waypoint 93). Photo taken July 20, 2021 facing north.

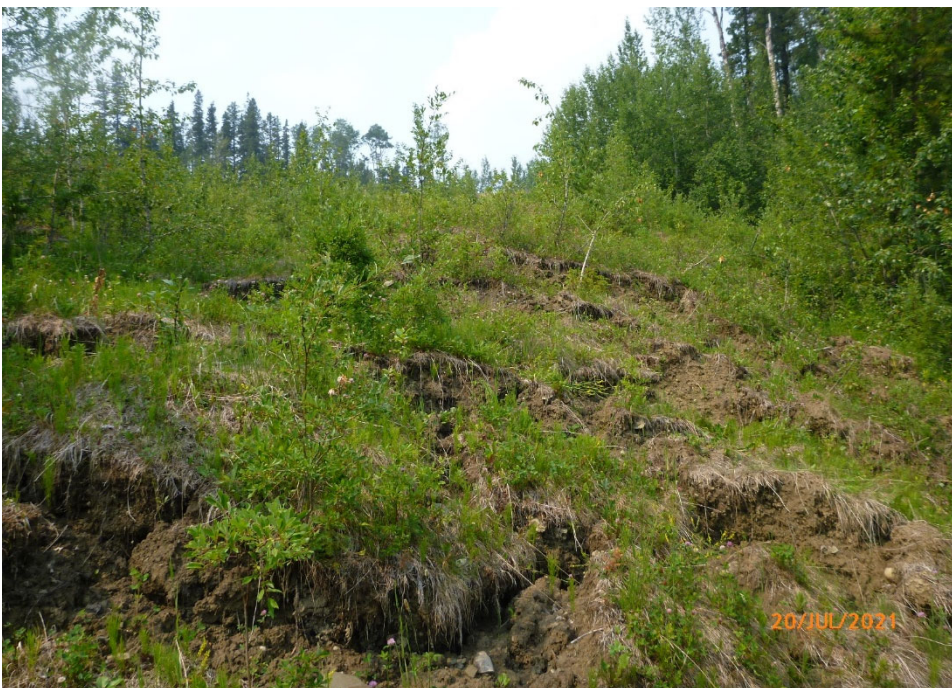
ITEM	CONDITION EXISTS		DESCRIPTION AND LOCATION	NOTICABLE CHANGE FROM LAST INSPECTION	
	YES	NO		YES	NO
Pavement Distress		X			X
Slope Movement	X		Slope movement of approximately 25% to 30% embankment slope extends from 2.9 m behind guardrail down slope to approximately 25 m vertically below the highway		X
Erosion	X				X
Seepage	X		Seepage observed in lower slide area at WP095, 096, and 097		
Culvert Distress		X

Photo 5 Cracking observed near the toe of the slide. Cracks were up to 0.5 m deep and filled with water (Waypoint 95 and 96). The slide appears more active at this area. Photo taken July 20, 2021 facing northwest.
