**SITE INSPECTION FORM**

<b>SITE NUMBER AND NAME:</b> GP002 Candle Road Slide		<b>HIGHWAY &amp; KM:</b> 40:38, 7.457	<b>PREVIOUS INSPECTION DATE:</b> June 13, 2023	<b>INSPECTION DATE:</b> <b>June 3, 2025</b>
<b>LEGAL DESCRIPTION:</b> NE 20-61-04-W6M	<b>NAD 83 COORDINATES:</b> UTM    Northing    Easting 11       6017104    398952		<b>RISK ASSESSMENT:</b> PF: 8    CF: 2    TOTAL: 16	
<b>AVERAGE ANNUAL DAILY TRAFFIC (AADT):</b> 900 (north) & 880 (south) (Reference No. 70000673, 2024)			<b>CONTRACT MAINTENANCE AREA (CMA):</b> 504

PROJECT PEACE REGION (GRANDE PRAIRIE DISTRICT-SOUTH) GEOHAZARD RISK MANAGEMENT PROGRAM		
TITLE Site Plan GP002 - Candle Road Slide Hwy 40:38 km, 7.457		
SCALE 1:2,000	PROJECT No. A05116A01	FIG No. 1

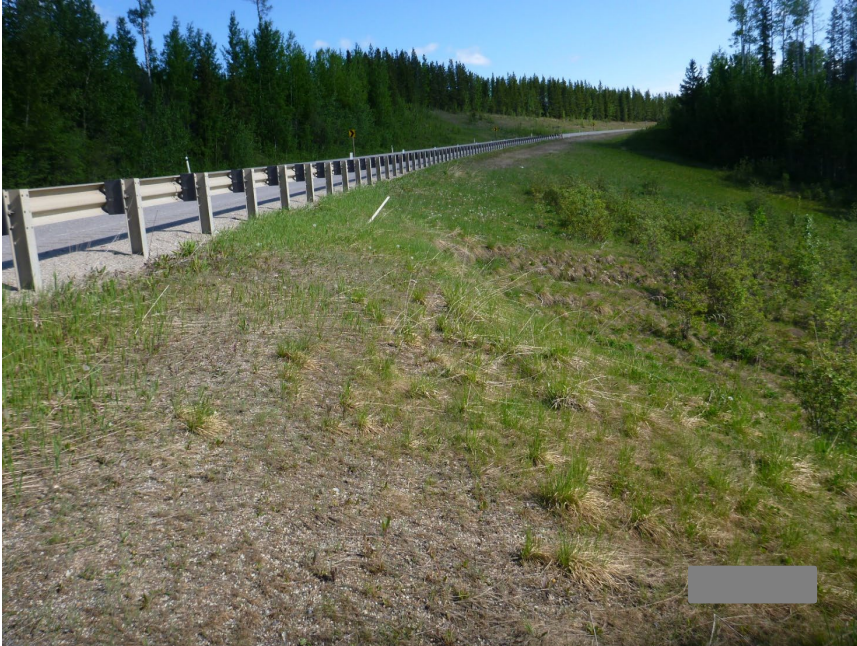
Upper slide area (Photos 1 through 3) has settled, and middle and lower slide areas (Photos 4 through 6) appear more active than upper slide area, especially along the left/north side where several scarps have formed.

**Photo 1** Slide backscarp on east side of Hwy 40:38. Photo taken June 3, 2025, facing north.

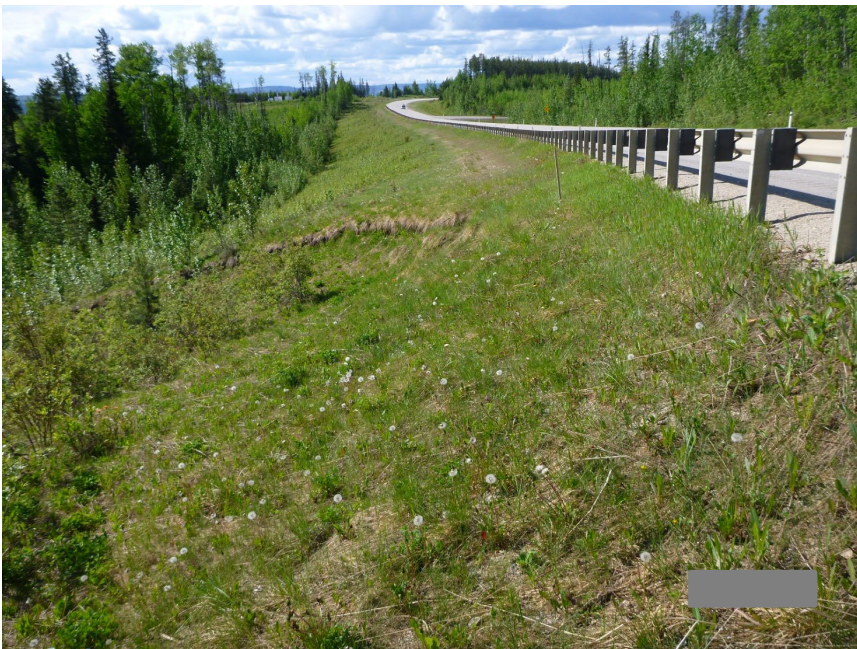
**Photo 2** Slide backscarp on east side of Hwy 40:38. Photo taken June 3, 2025, facing south.

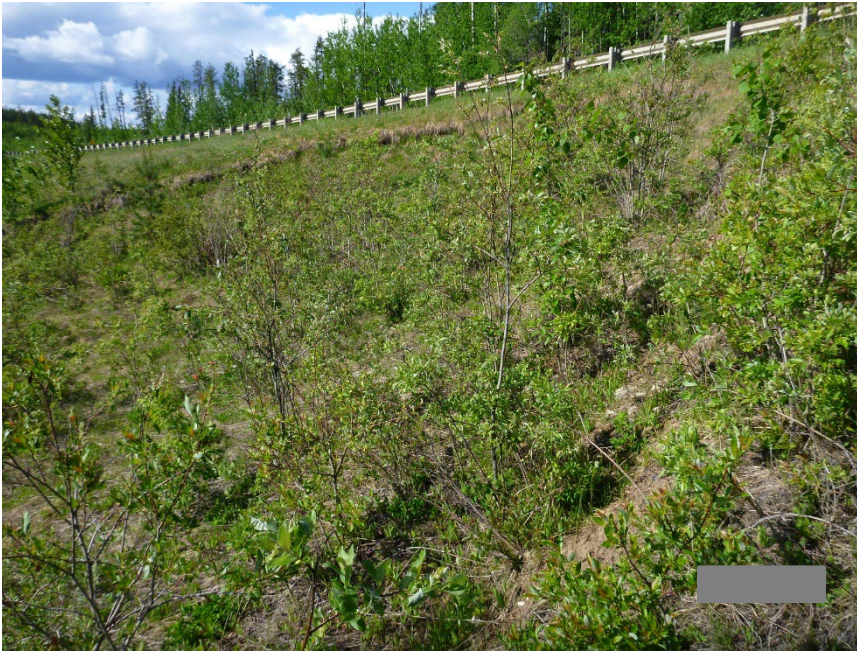
**Photo 3**      **Looking up across top slide area from north/left flank. Photo taken June 3, 2025, facing southwest.**

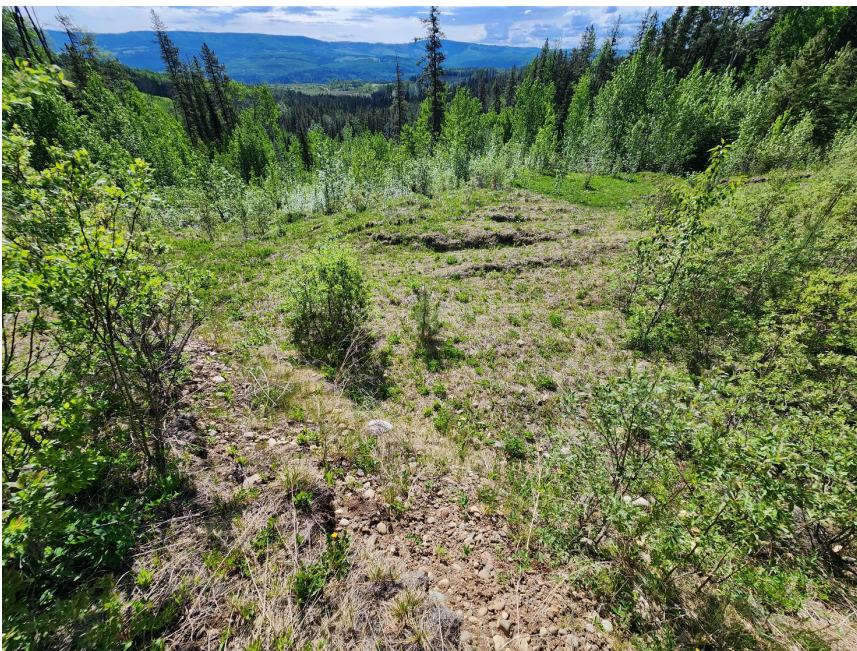
Slope appears to have failed again due to plugged drains resulting in rising water level and saturation of the repair fill and/or shearing through the bedrock ledge.

**Photo 4**      **Looking down across middle slide area from north/left flank. Photo taken June 3, 2025, facing southeast.**

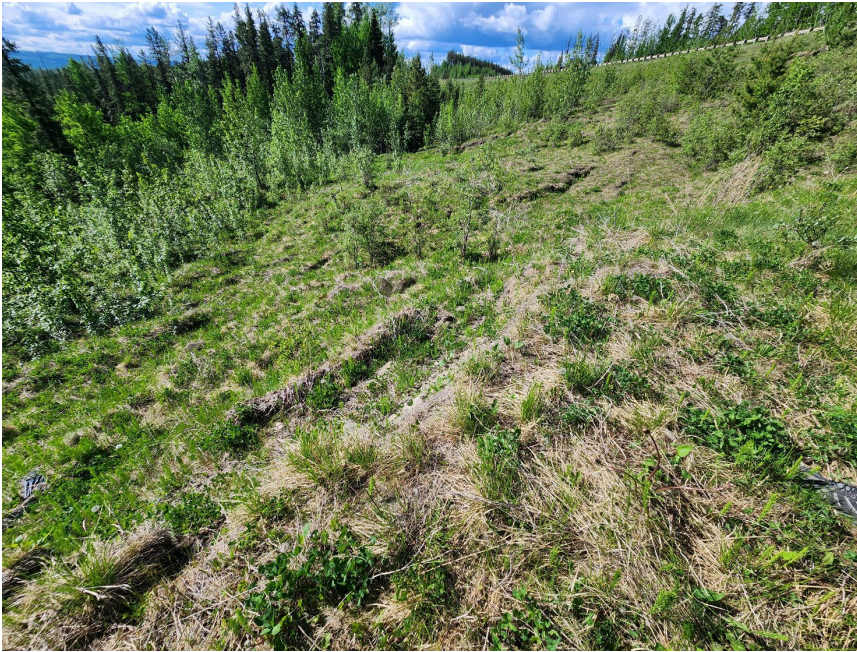
**Photo 5**      **Looking across middle of slide from north/left flank. Photo taken June 3, 2025, facing south.**

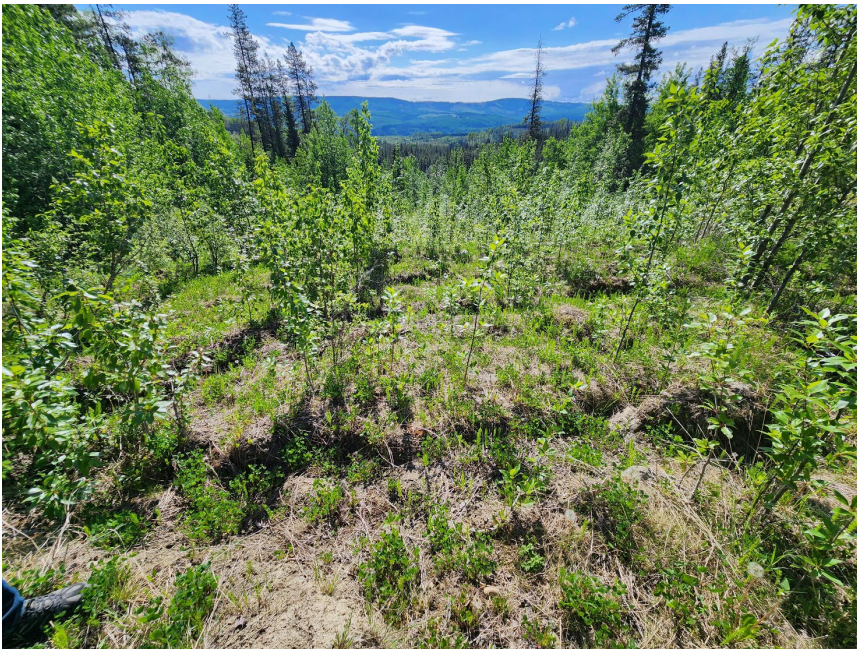
**Photo 6**      **Looking down across lower slide area from middle of slide. Photo taken June 3, 2025, facing southwest.**

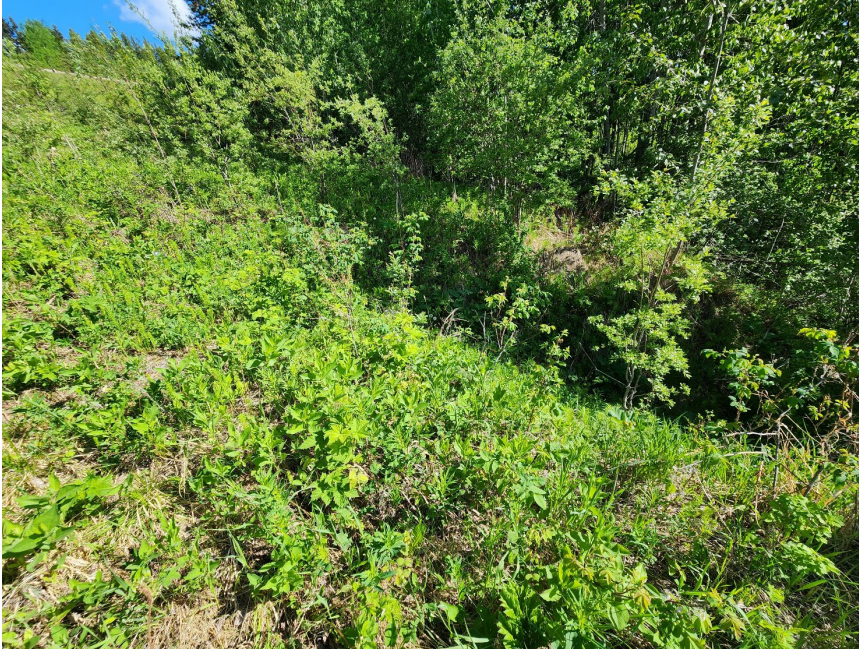
Gully near the north side of the slide.

**Photo 7** Gully near north side of slide. Photo taken June 3, 2025, facing north.

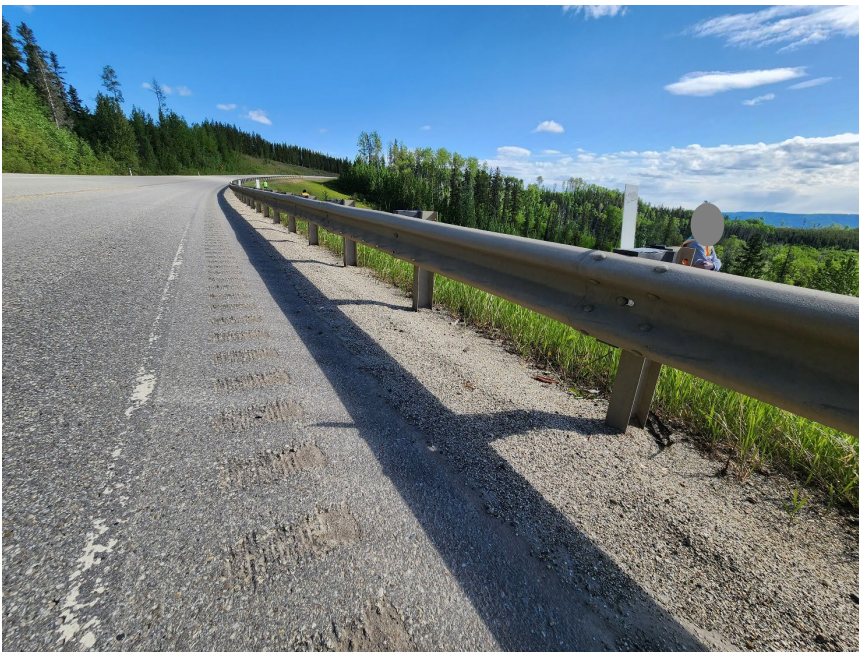
Section of the guardrail along the northbound lane of Hwy 40:38, south of the site, was struck and damaged. Pavement damaged around the posts which were shifted by the impact.

**Photo 8** Section of guardrail damaged south of site. Photo taken June 3, 2025, facing north.
