**ALBERTA TRANSPORTATION  
GEOHAZARD ASSESSMENT PROGRAM  
PEACE REGION – GRANDE PRAIRIE DISTRICT  
2020 INSPECTION**

Site Number	Location	Name	Hwy	km
GP03	NW of Grande Cache	Cutbank River S (Roseham Crk)	40:38	51.8
Legal Description		UTM Co-ordinates (NAD 83)		
NE16-65-5-W6		11U N 6,054,425	E 390,990

**2020 SITE INSPECTION**

**2020 SITE INSPECTION (NORTH HALF)**

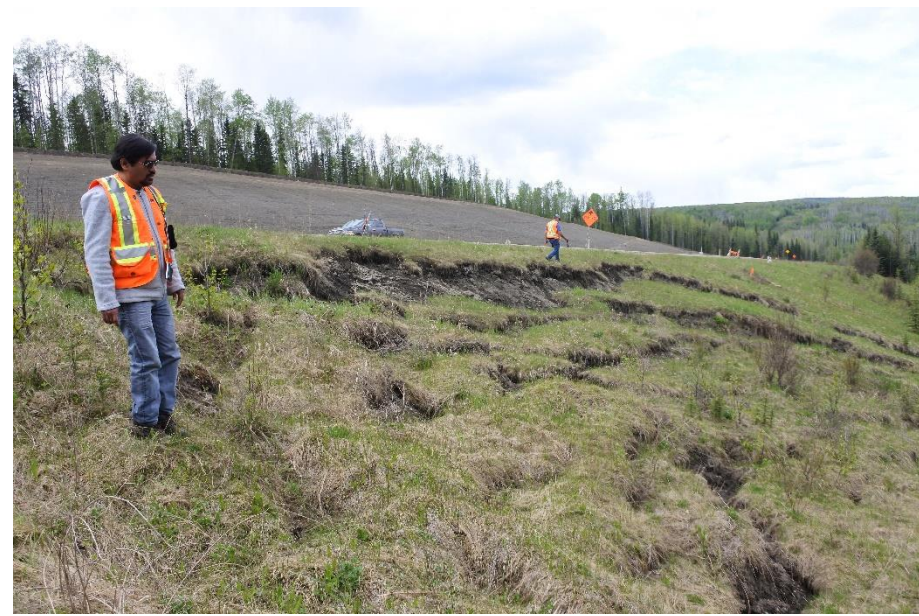
**Photo 1.**  
Looking north at active scarp inside slope of southern portion of the site.

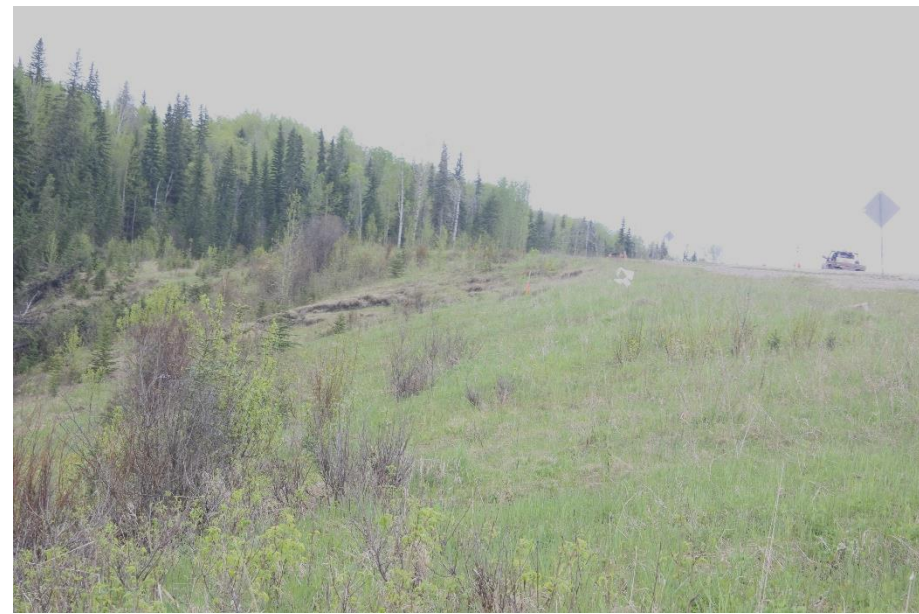
**Photo 2.**  
Looking south at active scarp on side slope of southern portion of the site.

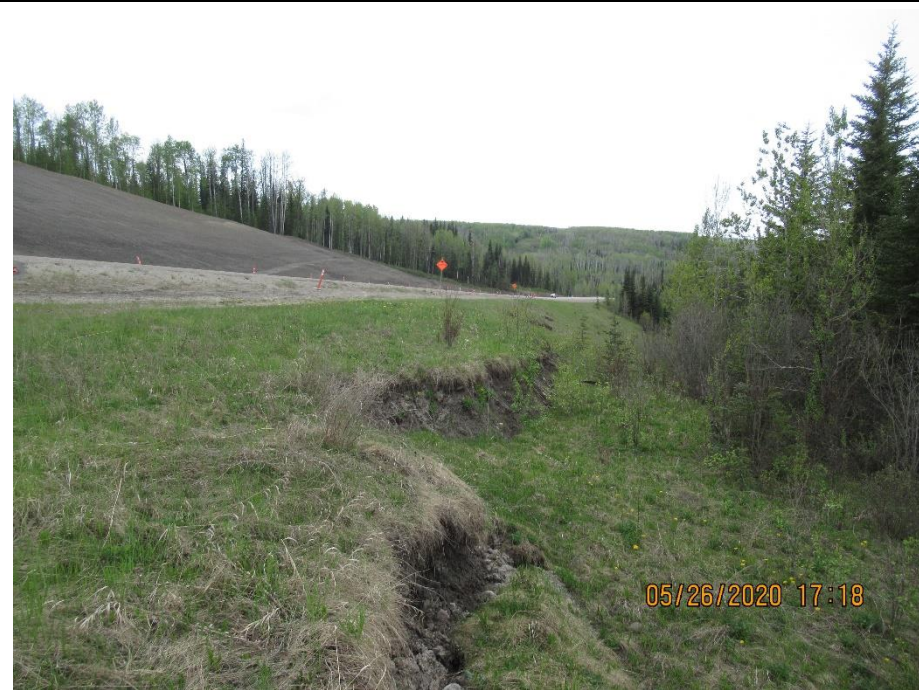
**Photo 3.**  
Looking northwest along the top of the embankment fill where fresh slumping has retrogressed close to the highway.

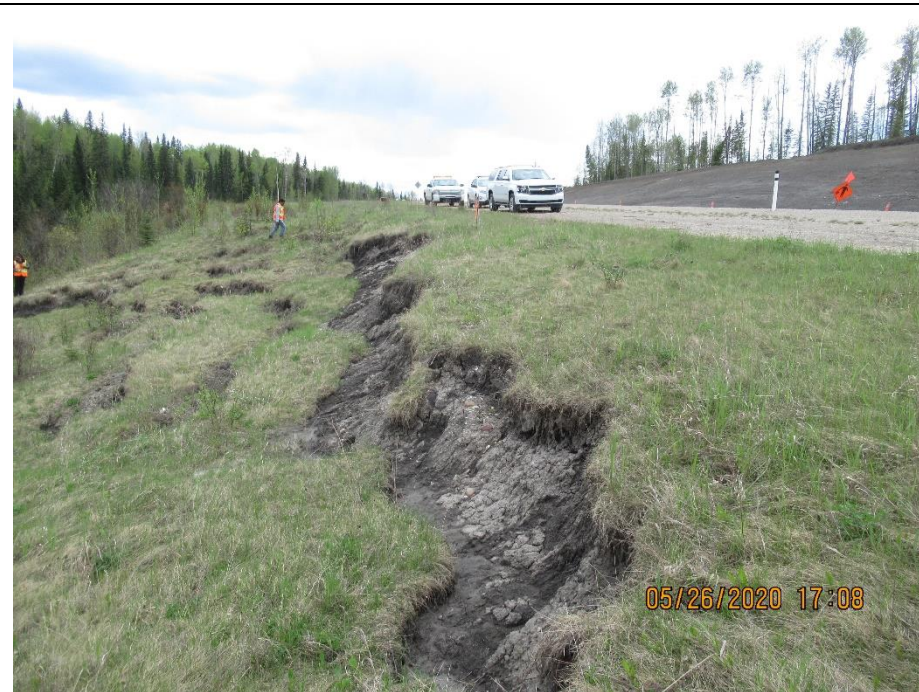
**Photo 4.**  
Looking south at long scarp in sideslope at middle of the site.

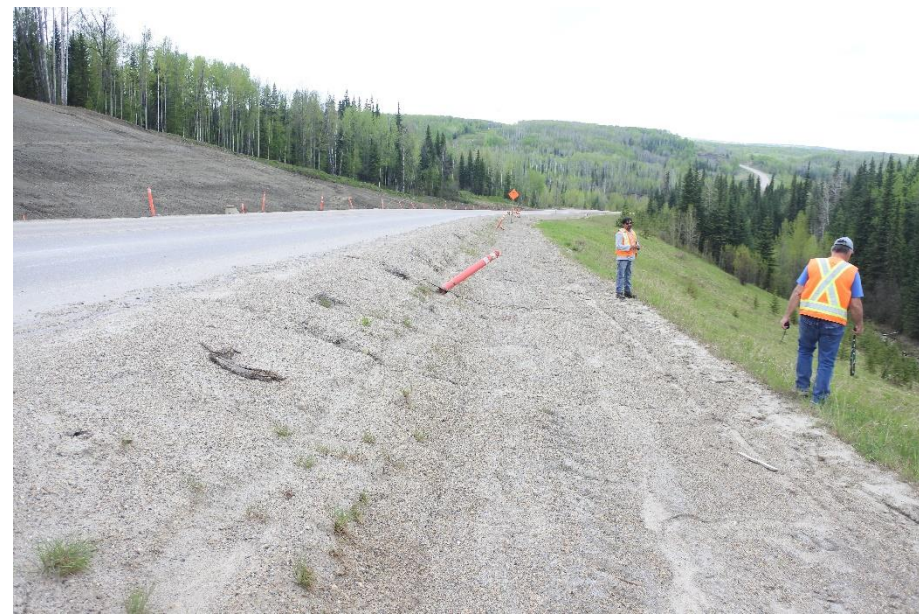
**Photo 5.**  
Looking north at where there was previously some erosion rilling observed at the north end of the site but has been filled in.

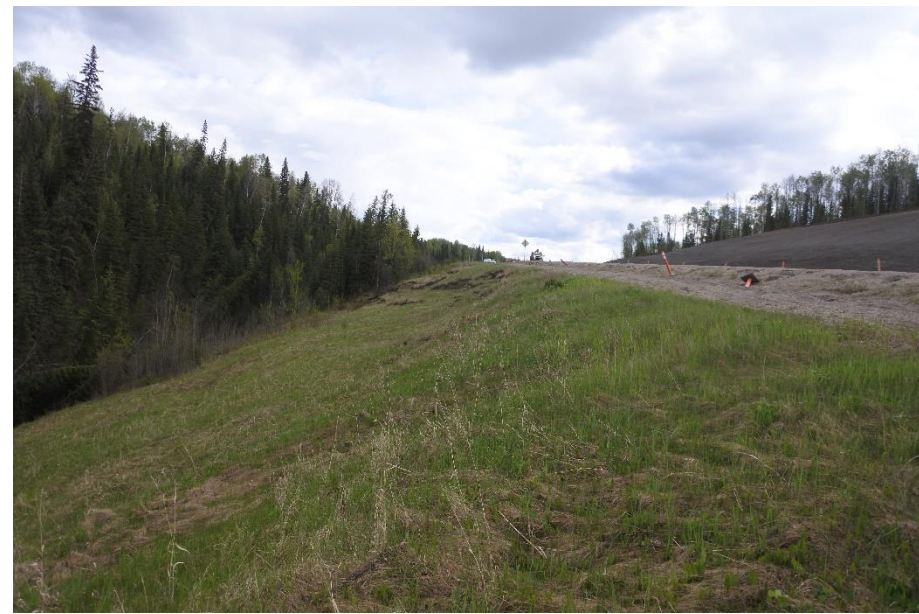
**Photo 6.**  
Looking south towards middle of the site where tilted trees are present.

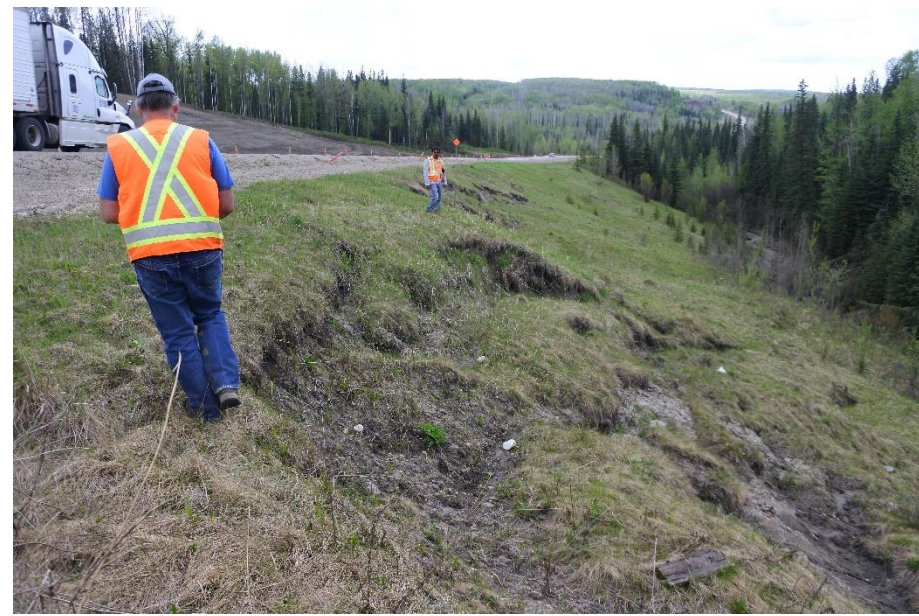
**Photo 7.**  
Looking northwest  
up at the sideslope  
slumping that  
extends close to  
the highway near  
the north end of the  
site.

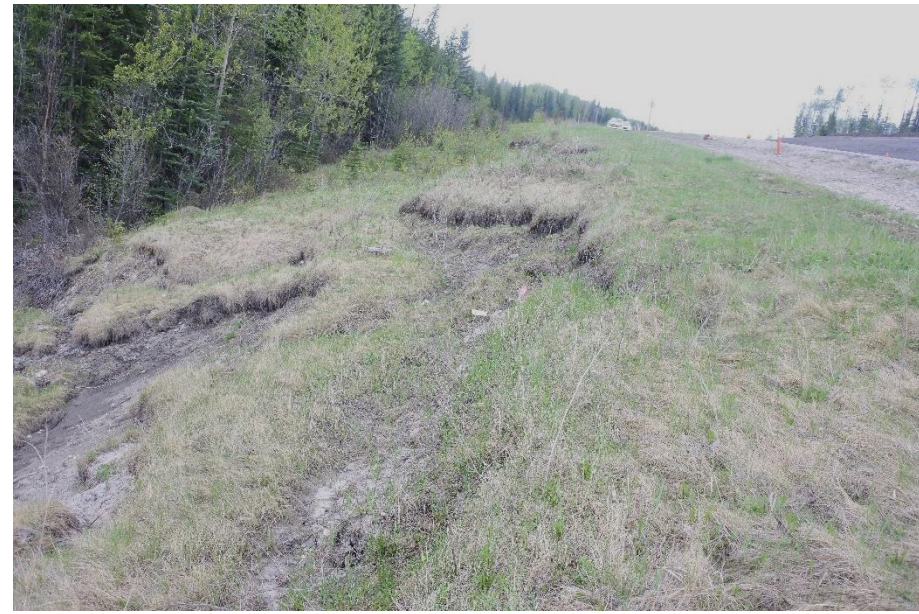
**Photo 8.**  
Looking south at  
the northmost  
scarp on the north  
side.
