Alberta Transportation  
Main Floor, Provincial Building  
9621 96 Avenue  
Peace River, Alberta  
T8S 1T4

**CON0022166 Peace Region (Grande Prairie District – South) GRMP Instrumentation Monitoring Site GP003; H40:38; km 52.134 Cutbank River (South) Section C – 2021 Spring Readings**

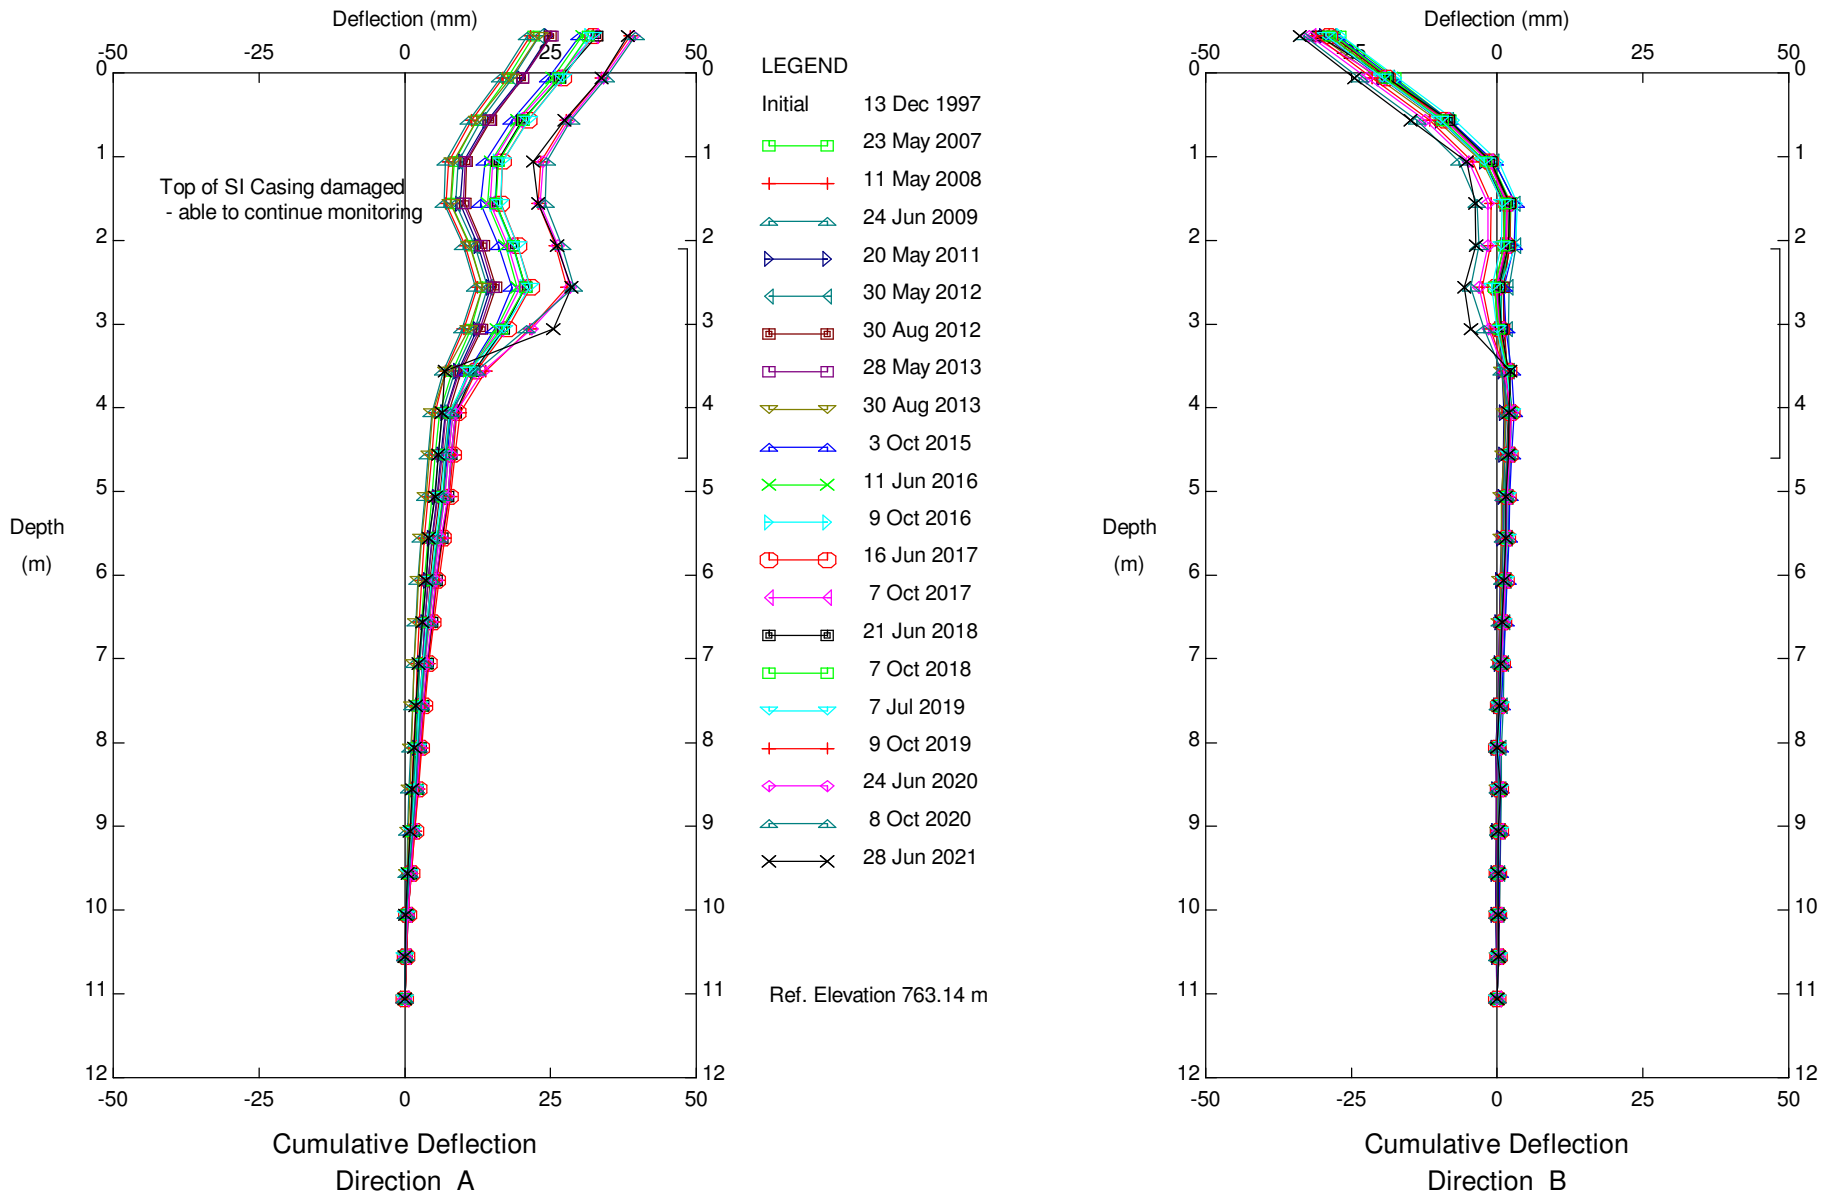
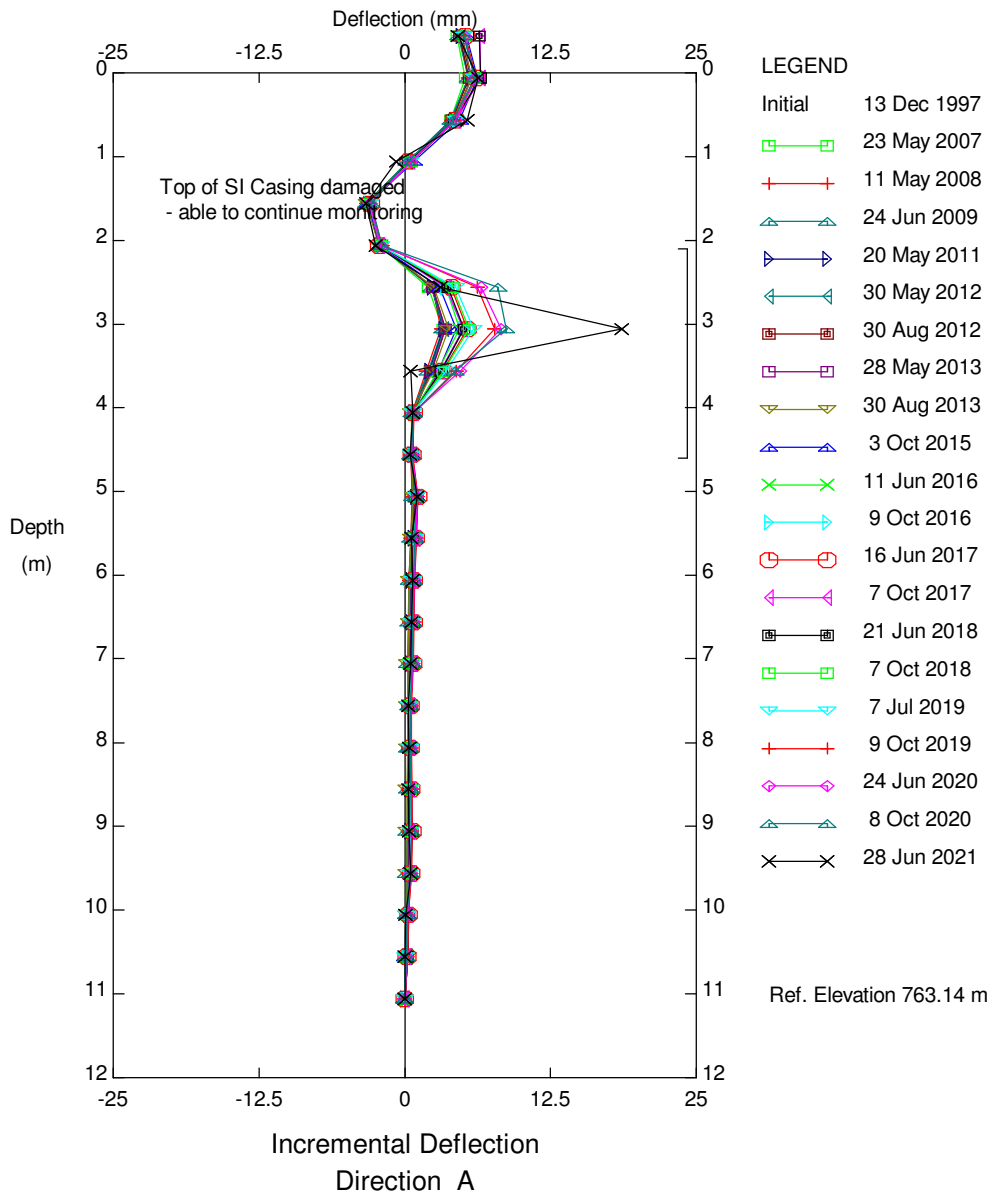
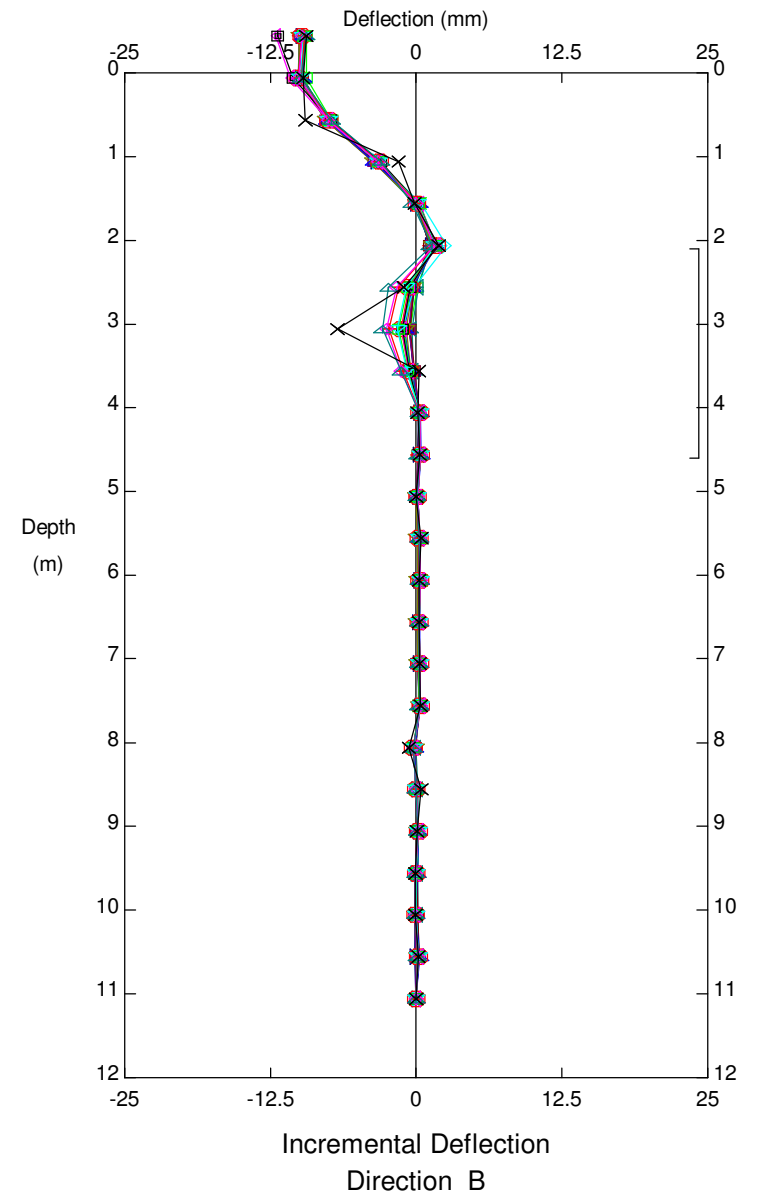
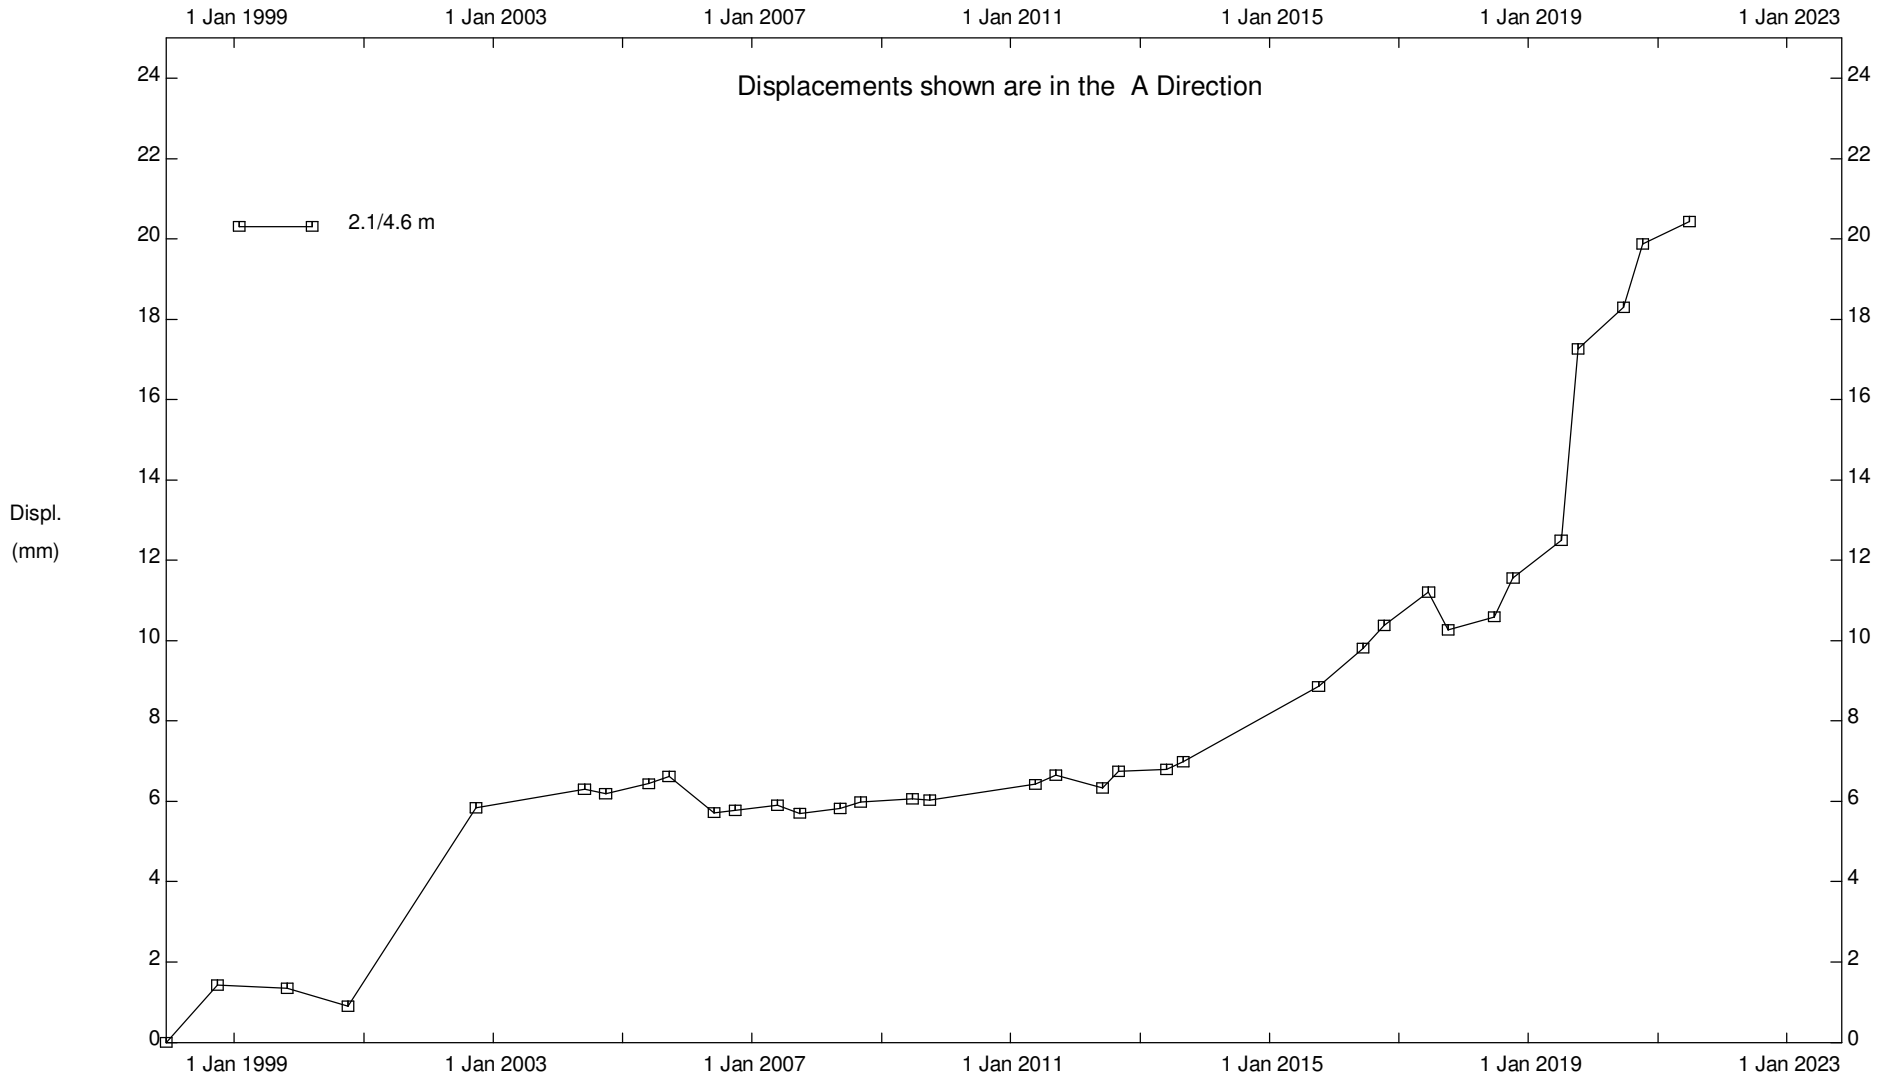
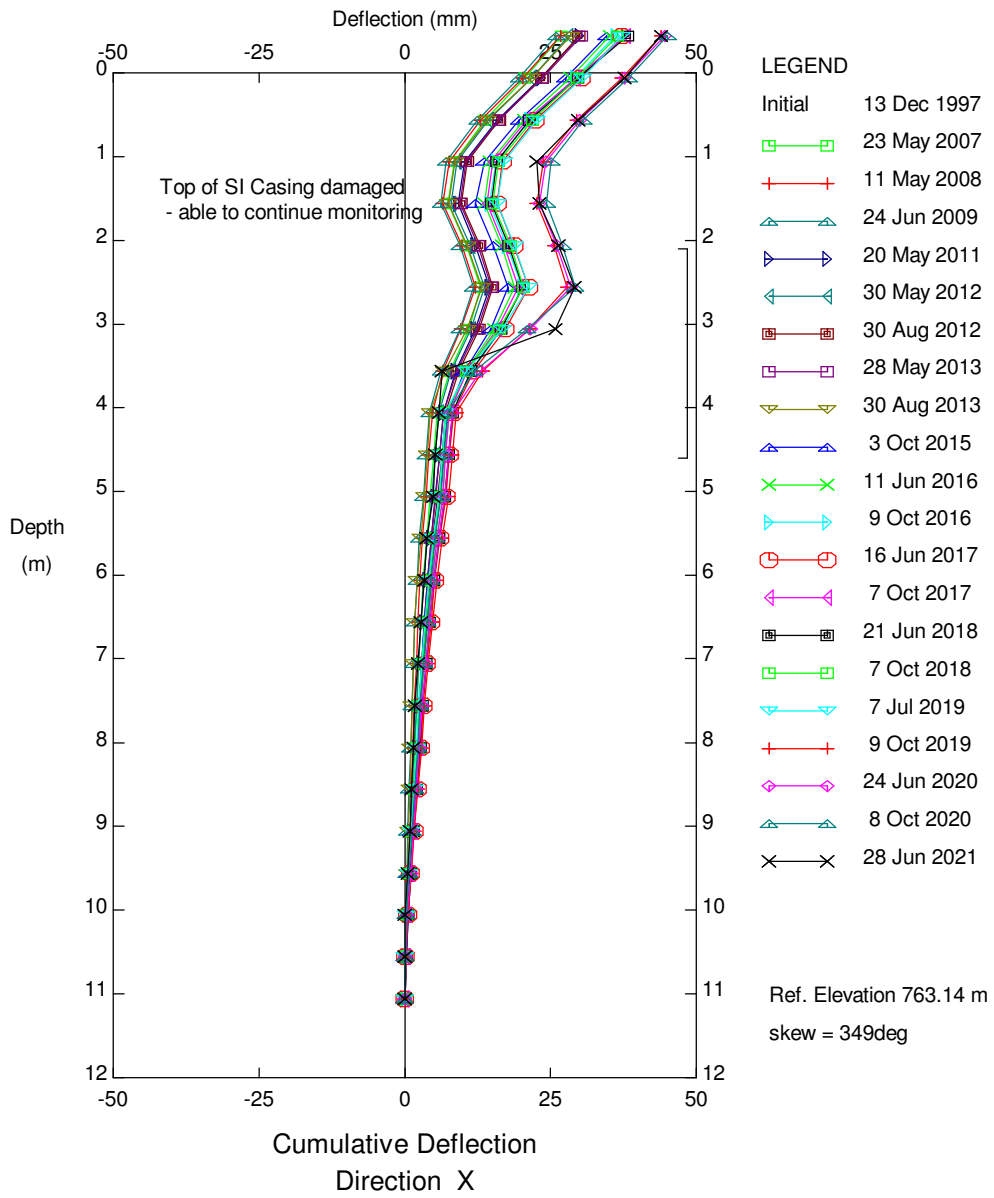
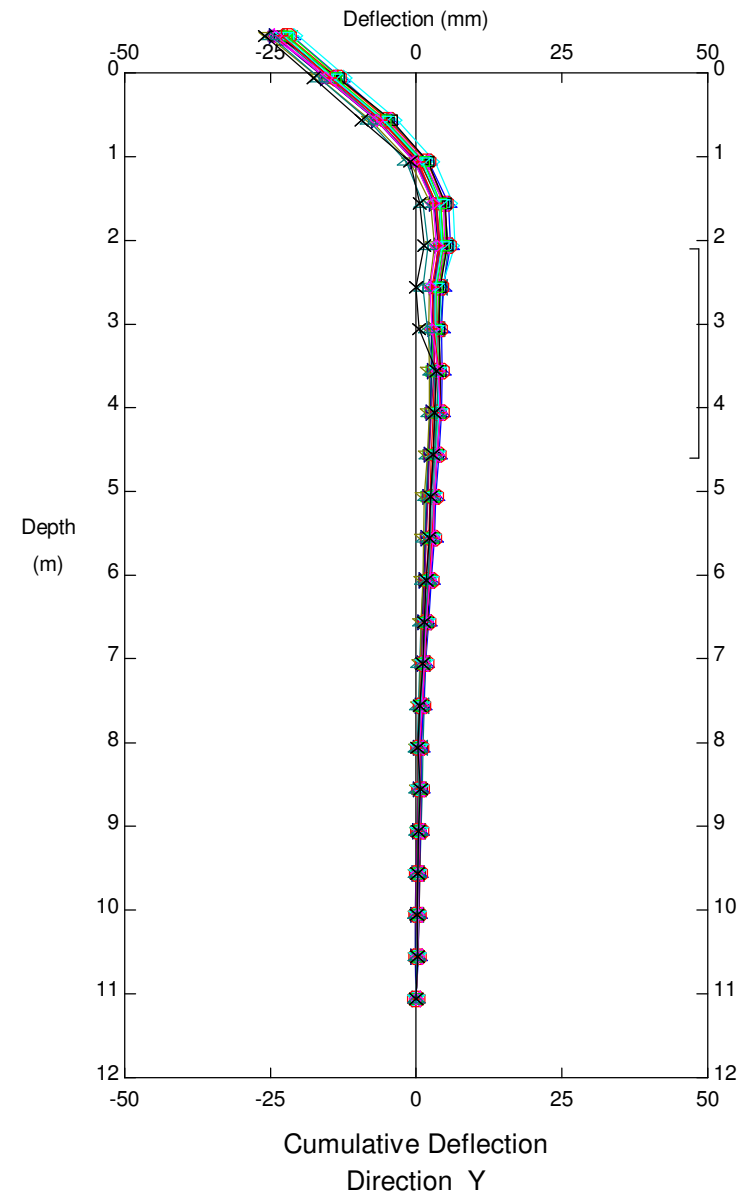
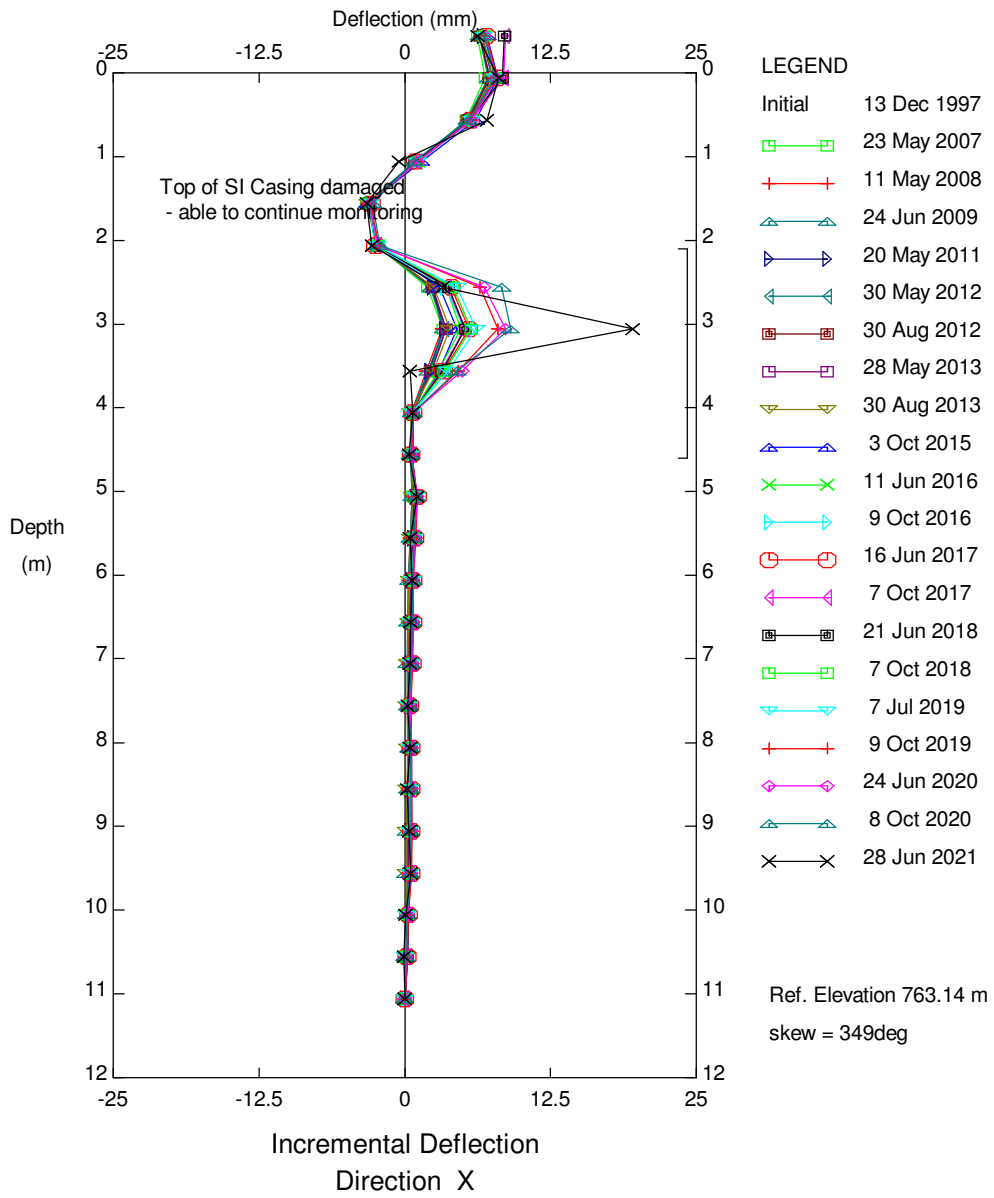
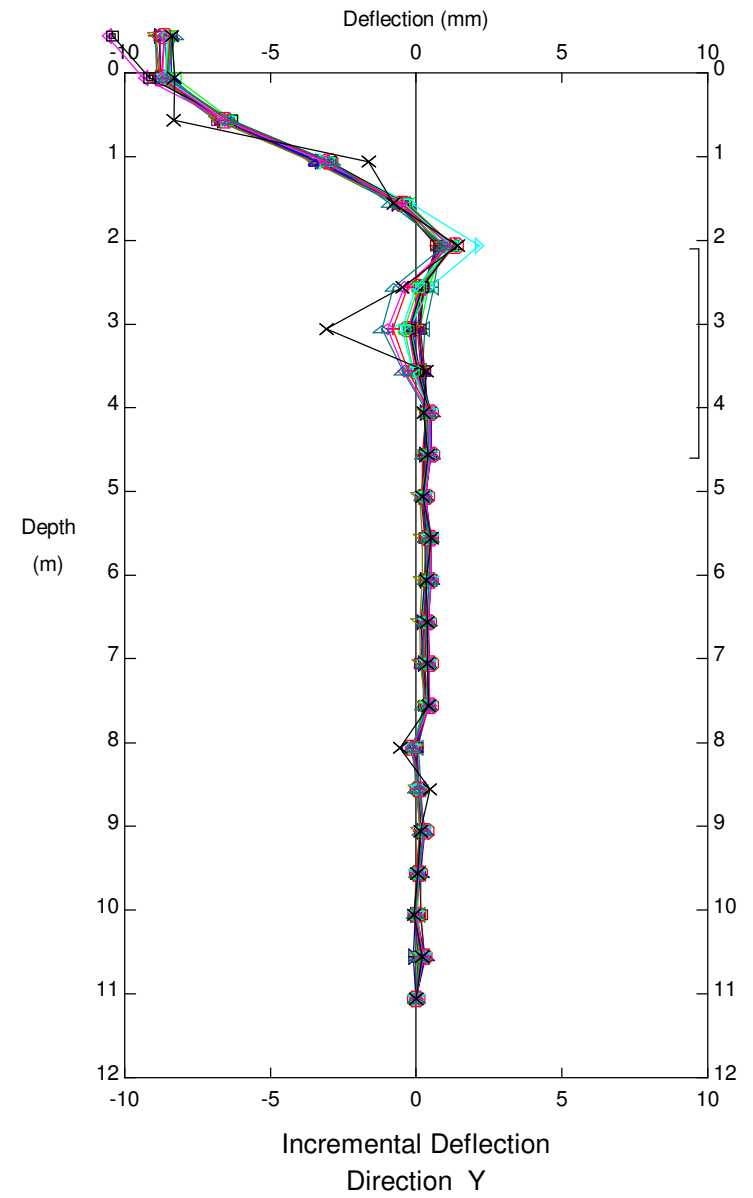
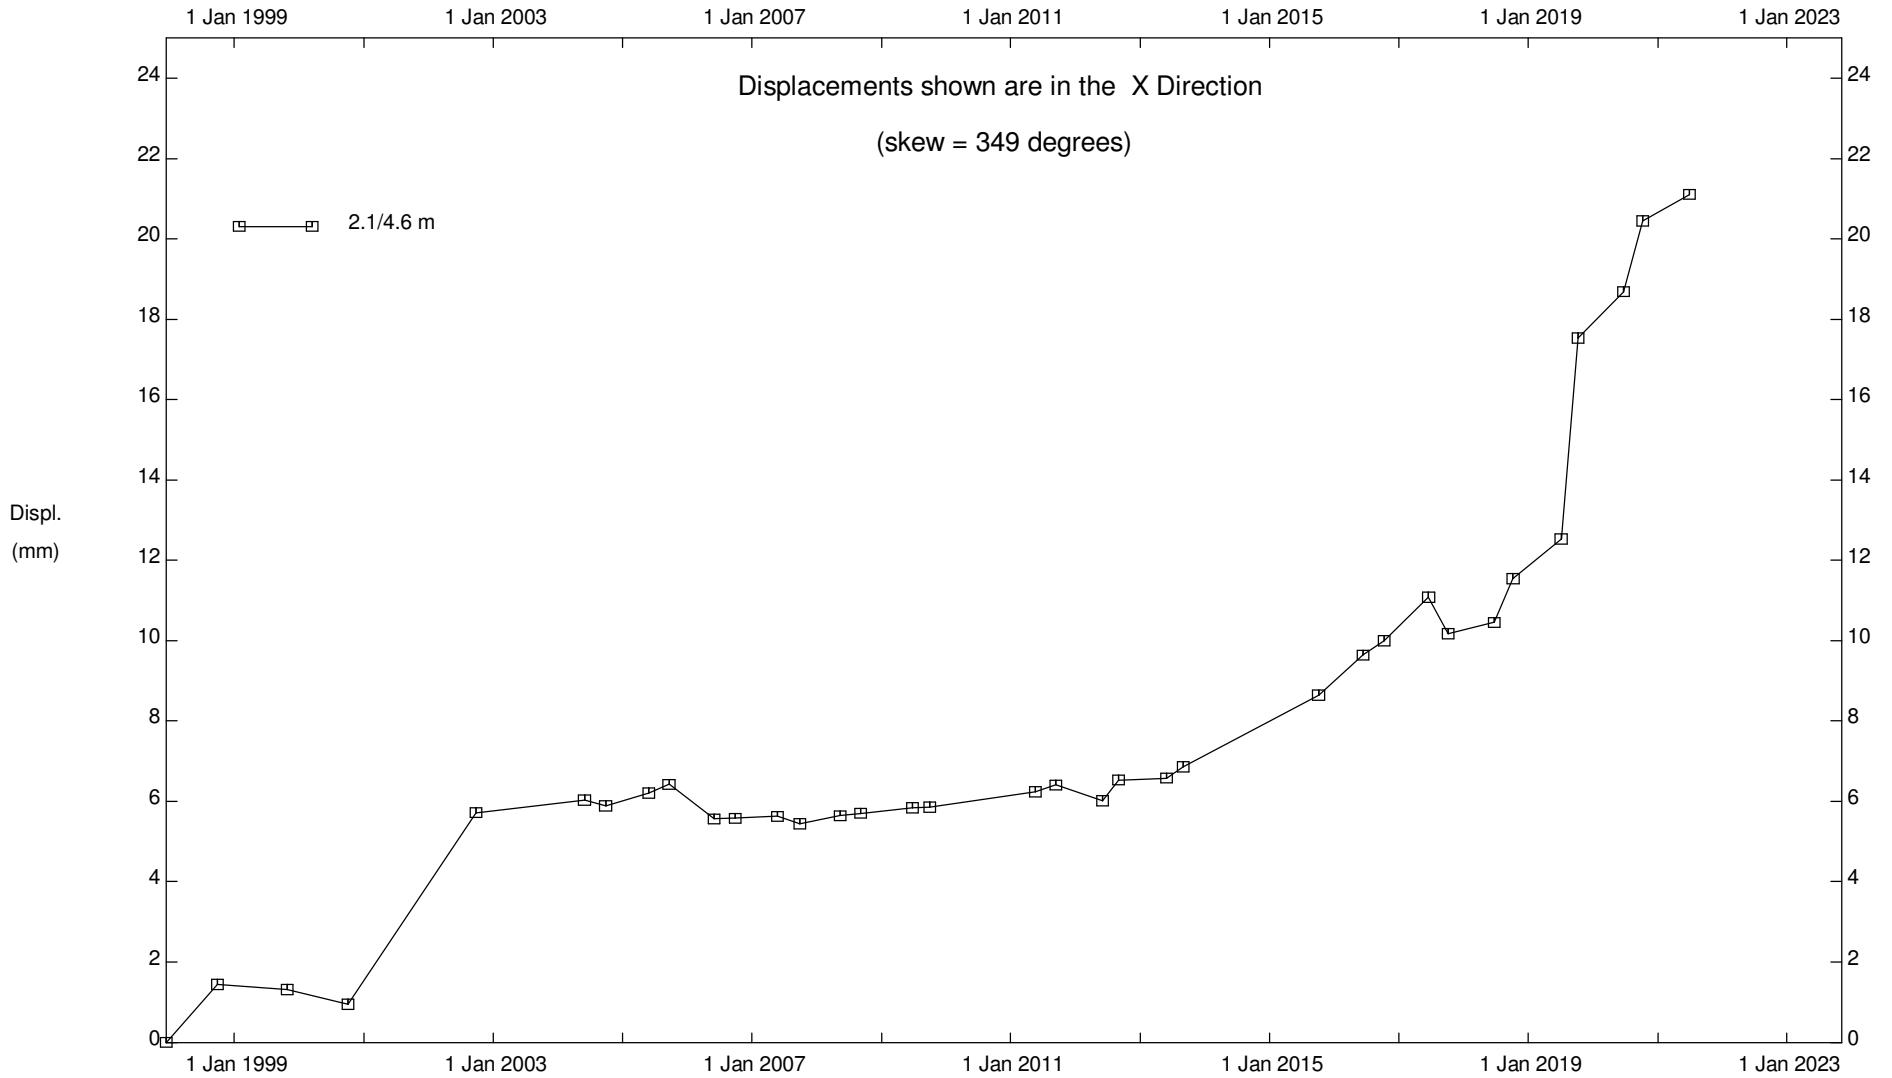
GP003; H40:38, Cutbank River (South), Inclinometer SI-02  
Alberta Transportation

For SI-2, there is a zone of distributed movement from approximately El. 759 m to El. 752 m and a more distinct zone of distributed movement from approximately El. 759 m to El. 760.5 m. There is also some movement from approximately El. 761 m to El. 763 m (i.e., 2 mbgs to ground surface).

SI-2, which is located near the toe of the highway embankment, has been recorded movement at approximately the same elevation as Roseham Creek which is located at the toe of the highway embankment. Movement being recorded by SI-2 was relatively slow and constant between 1997 and 2015. However, between 2015 and 2021, the movement rates have significantly increased (e.g., approximately 1.6 mm/year to 16.8 mm/year, recorded in 2016 and 2019, respectively).

The increased rate of movement was also observed on site, when a larger-than-typical asphalt crack was observed during AT's 2015 annual inspection. The increased rate of movement may be caused by erosion at the toe of the highway embankment and groundwater seeping through the embankment fill.

An increased rate of movement was recorded in the spring 2021 readings. Depending on the fall readings, this may be due to the probe being changed from the one used by the last consultant. KCB may have to re-zero the SI using the spring 2021 readings as baseline.

All operational instruments should continue to be read once per year (spring).

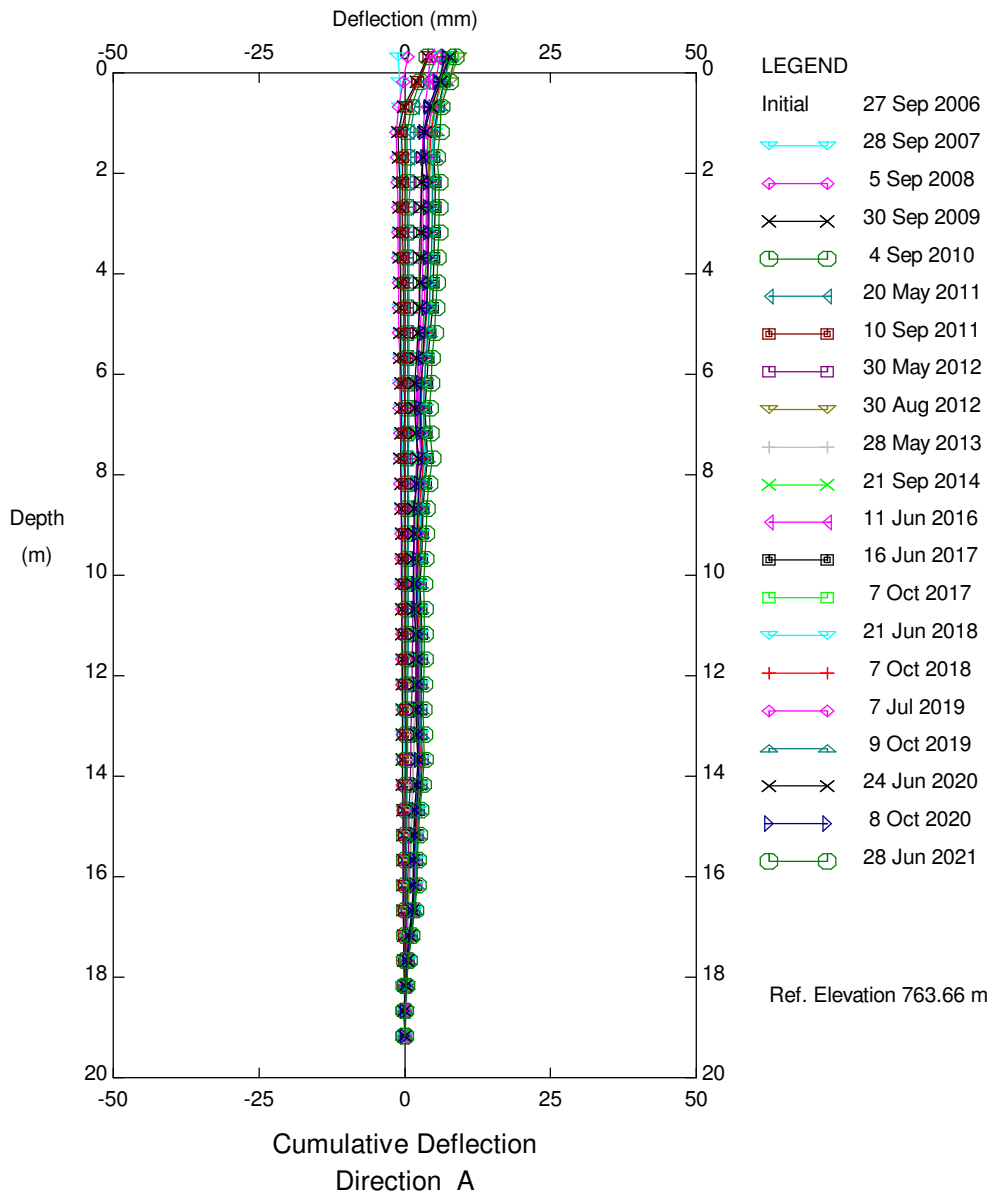
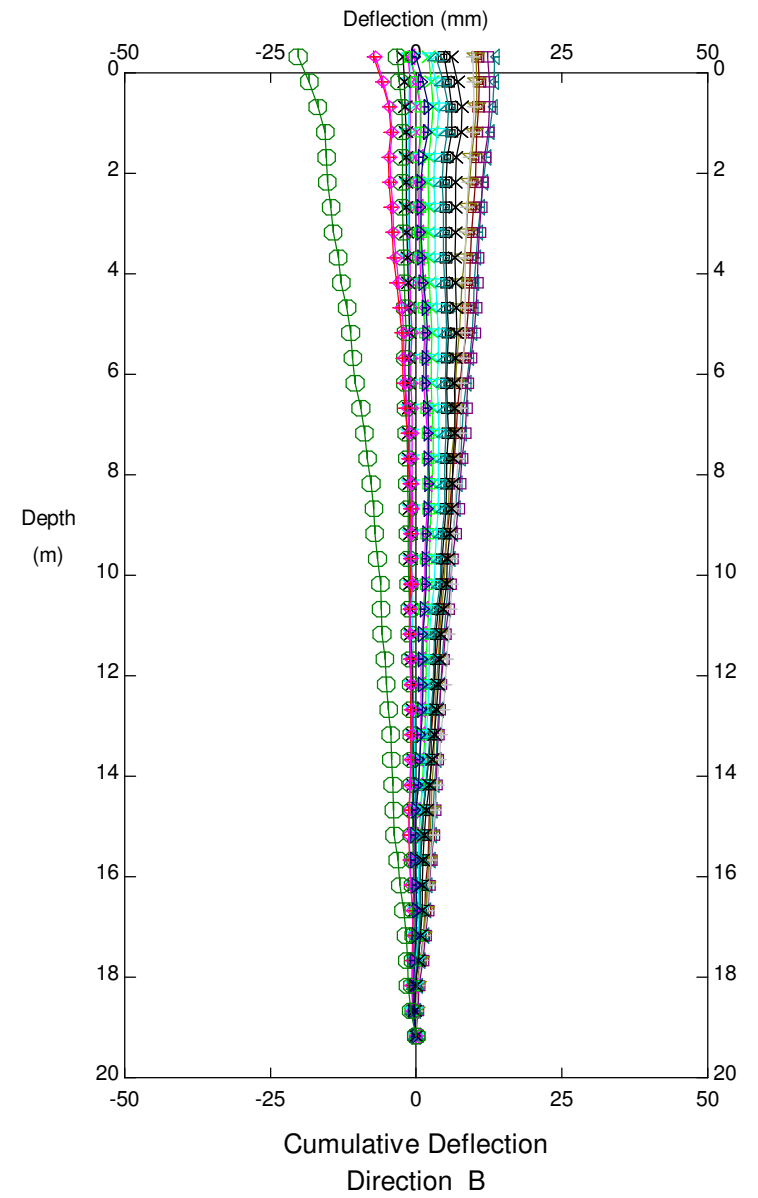
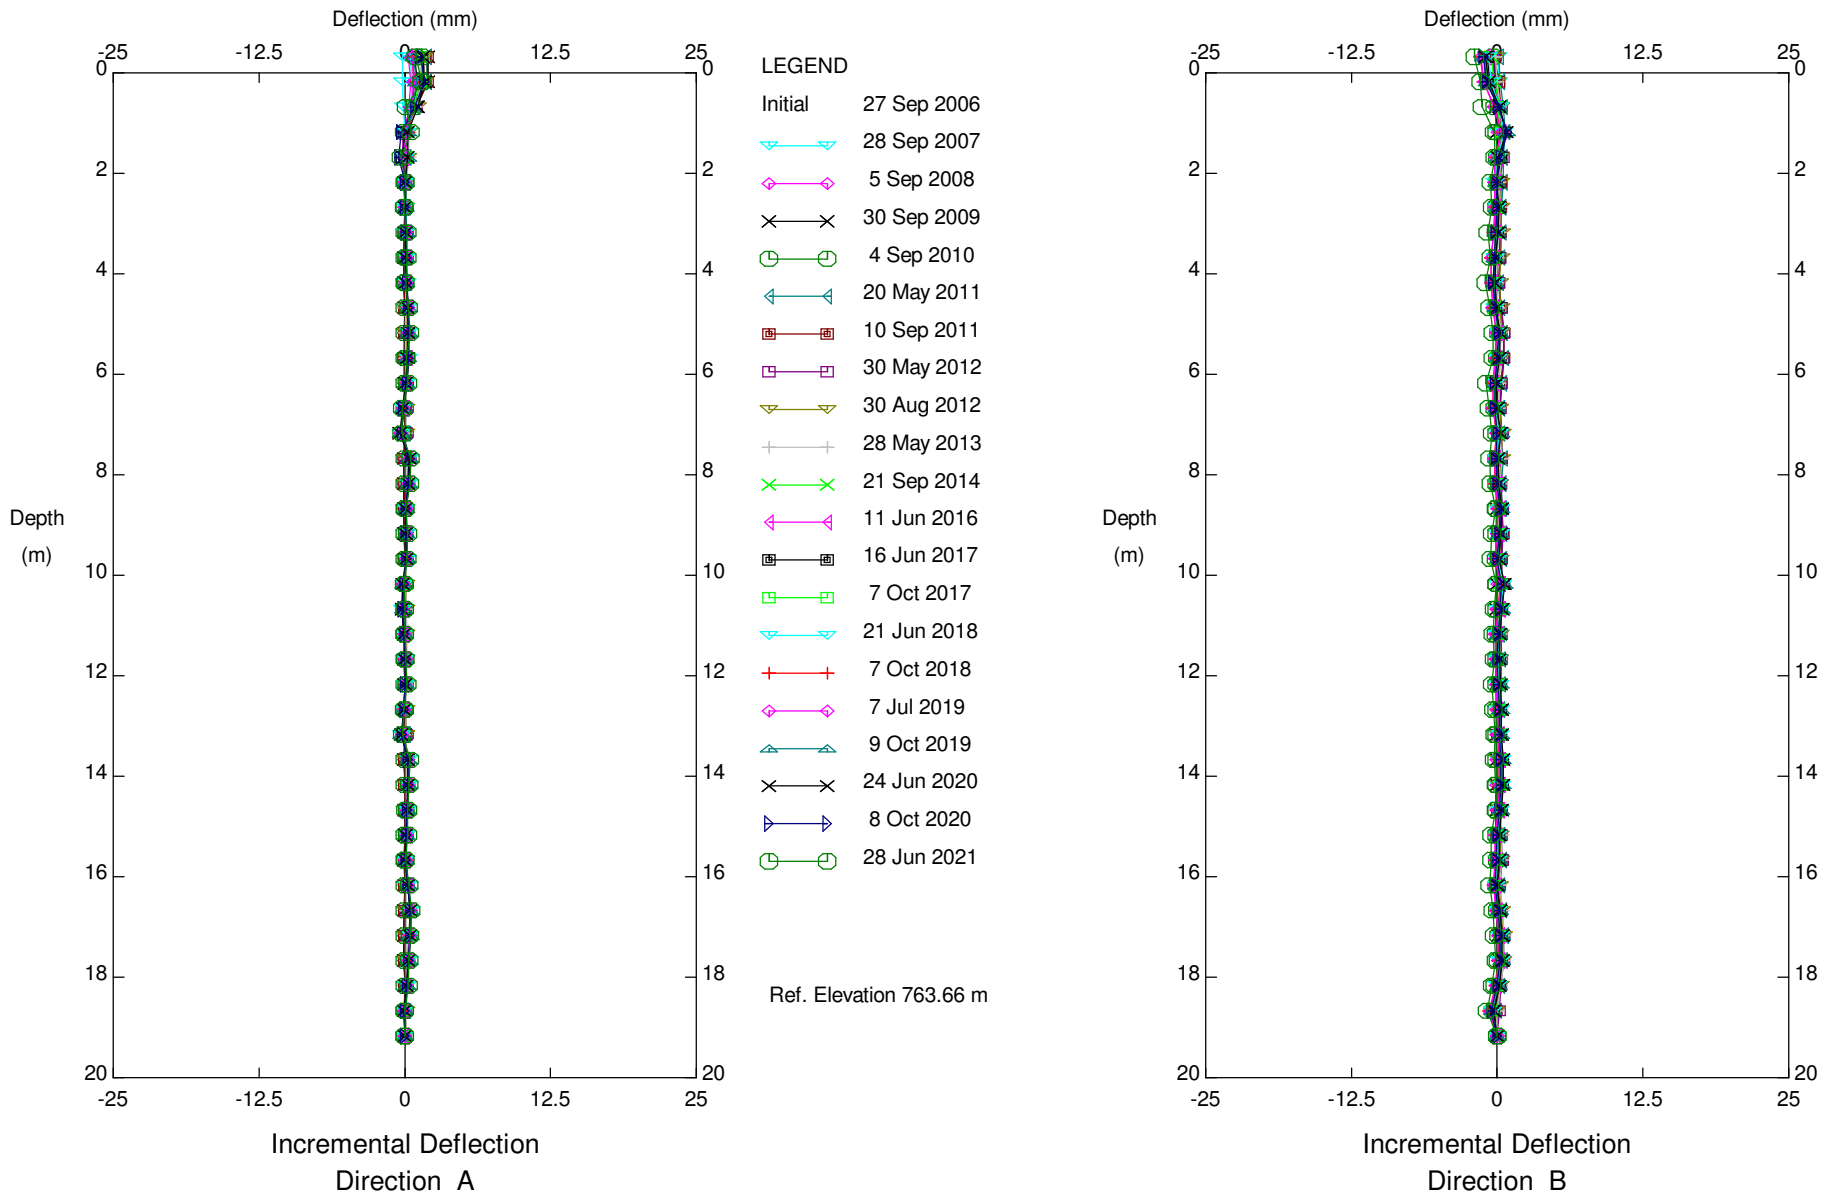
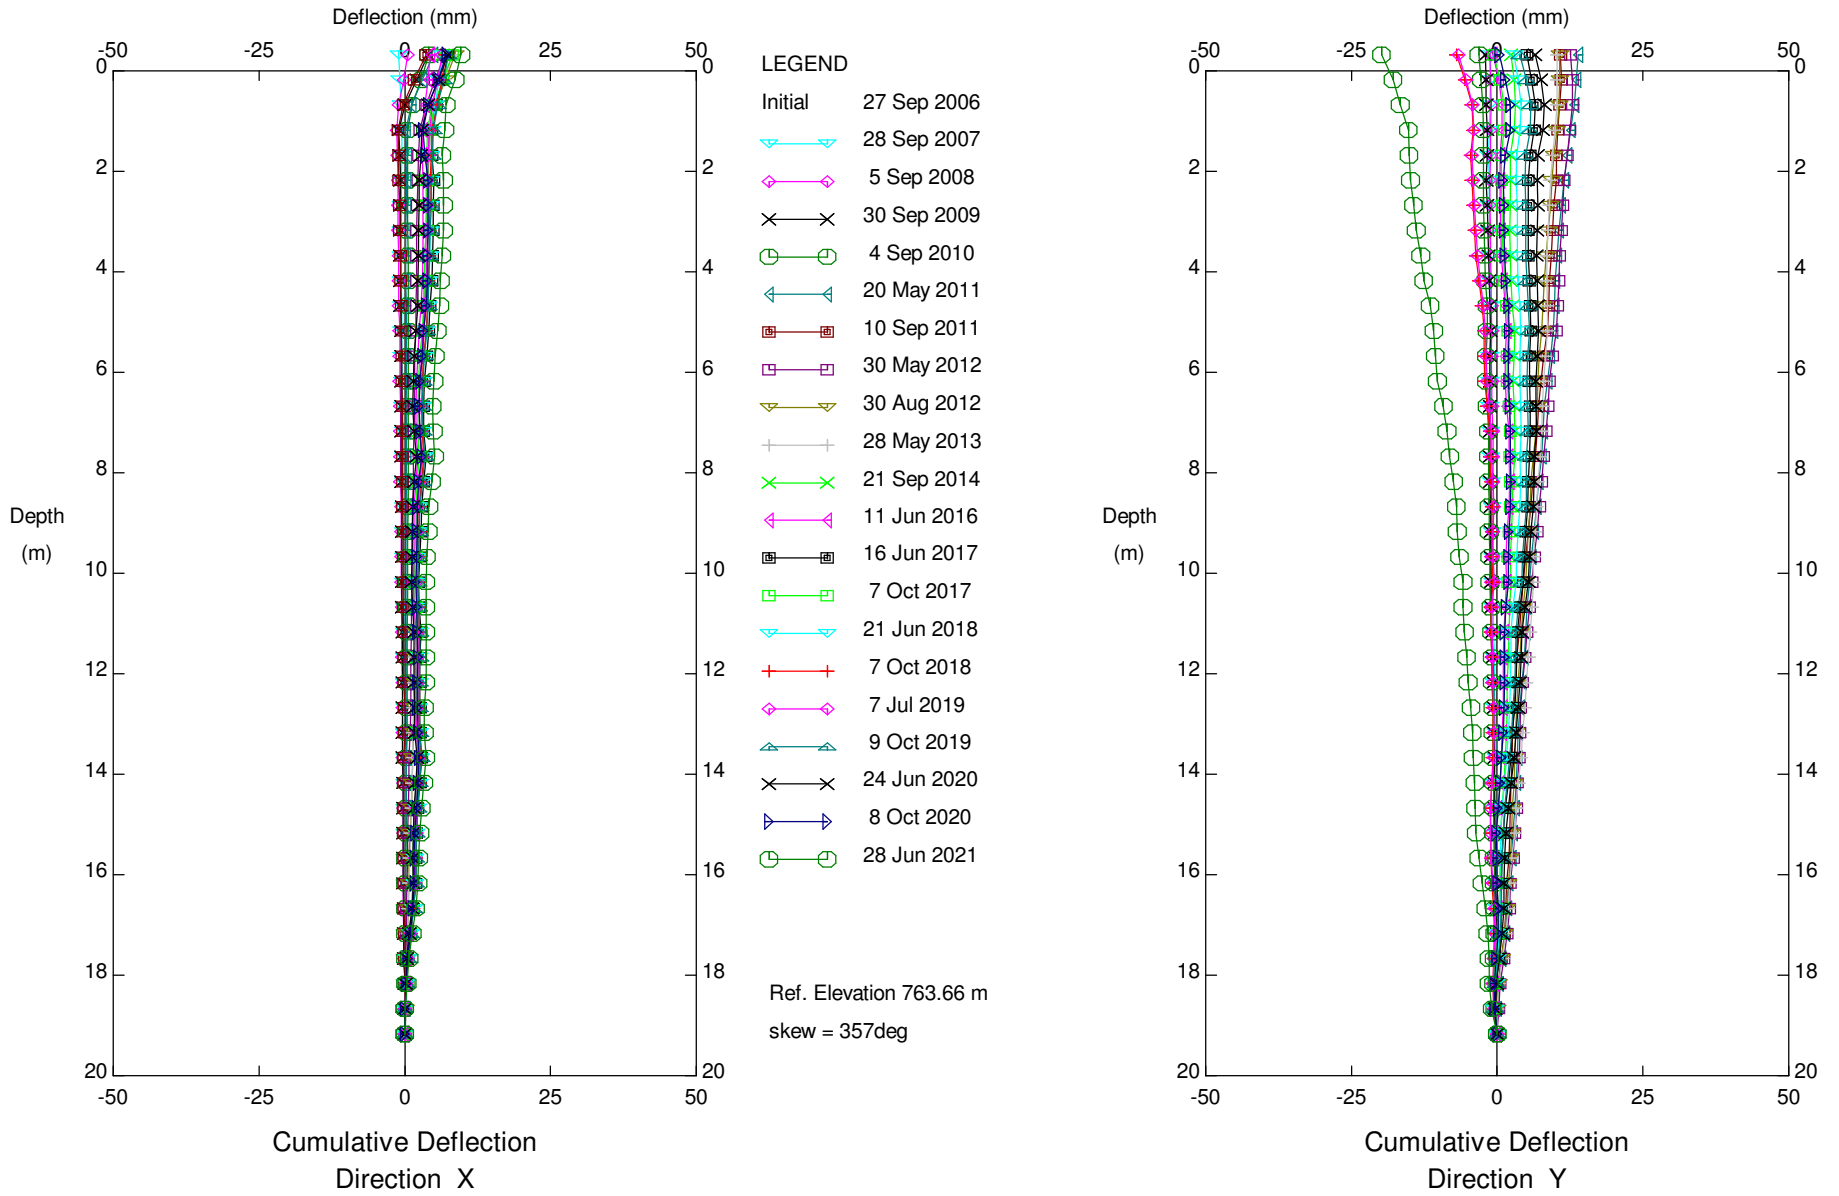
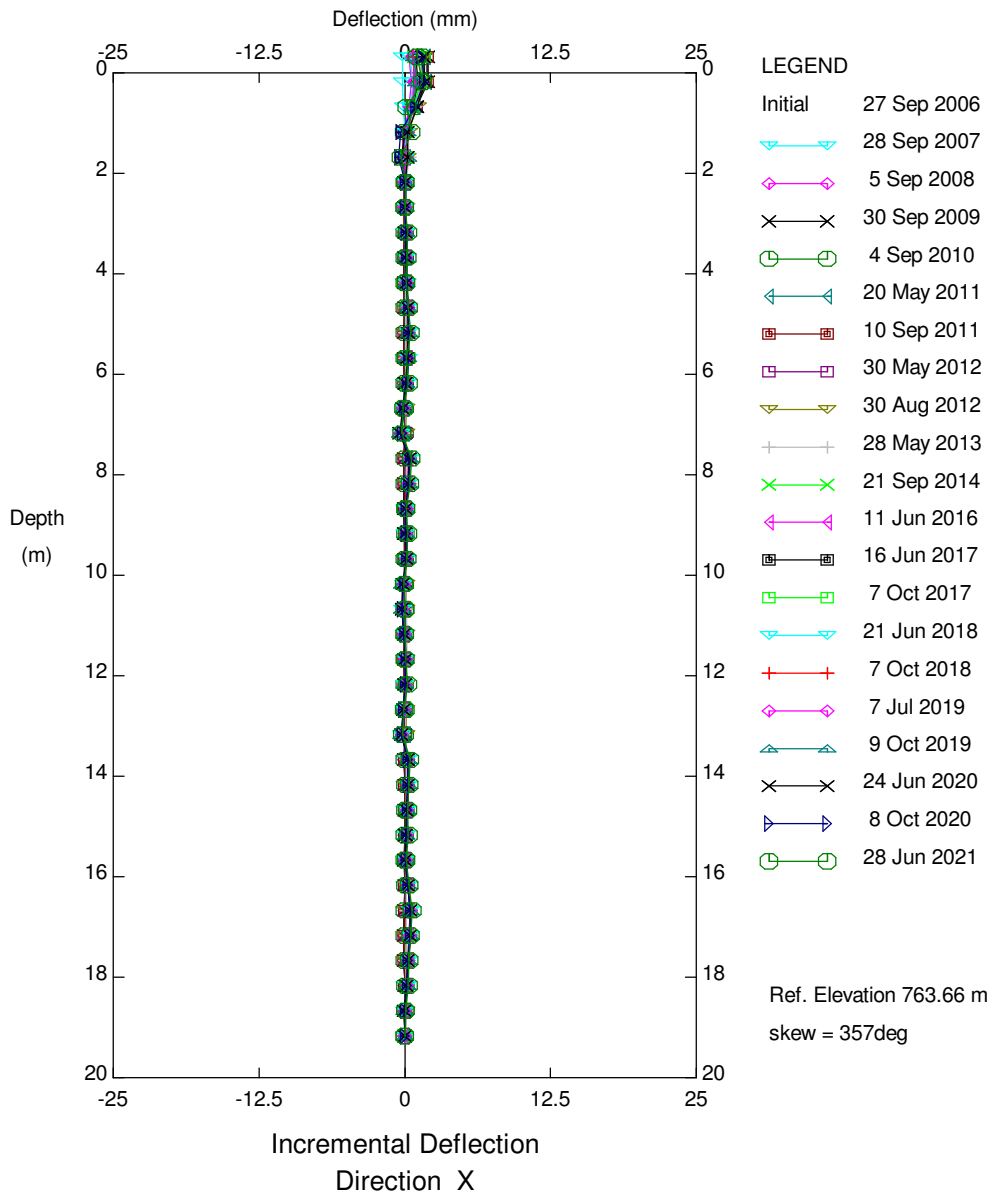
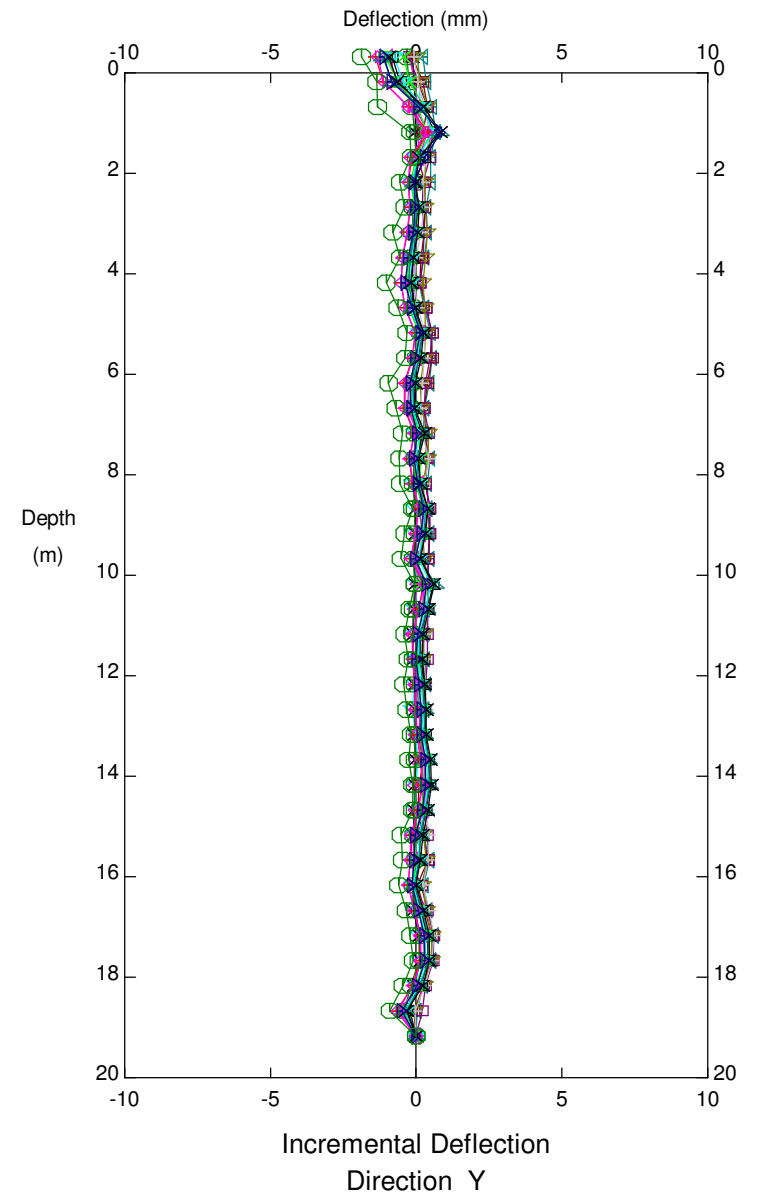
GP003; H40:38, Cutbank River (South), Inclinator SI-03  
Alberta Transportation

For SI-3, there is no discernible zones of movement.
