Alberta Transportation  
Main Floor, Provincial Building  
9621 96 Avenue  
Peace River, Alberta  
T8S 1T4

**CON0022166 Peace Region (Grande Prairie District – South) GRMP Instrumentation Monitoring Site GP003; H40:38; km 52.134 Cutbank River (South) Section C – 2021 Spring Readings**

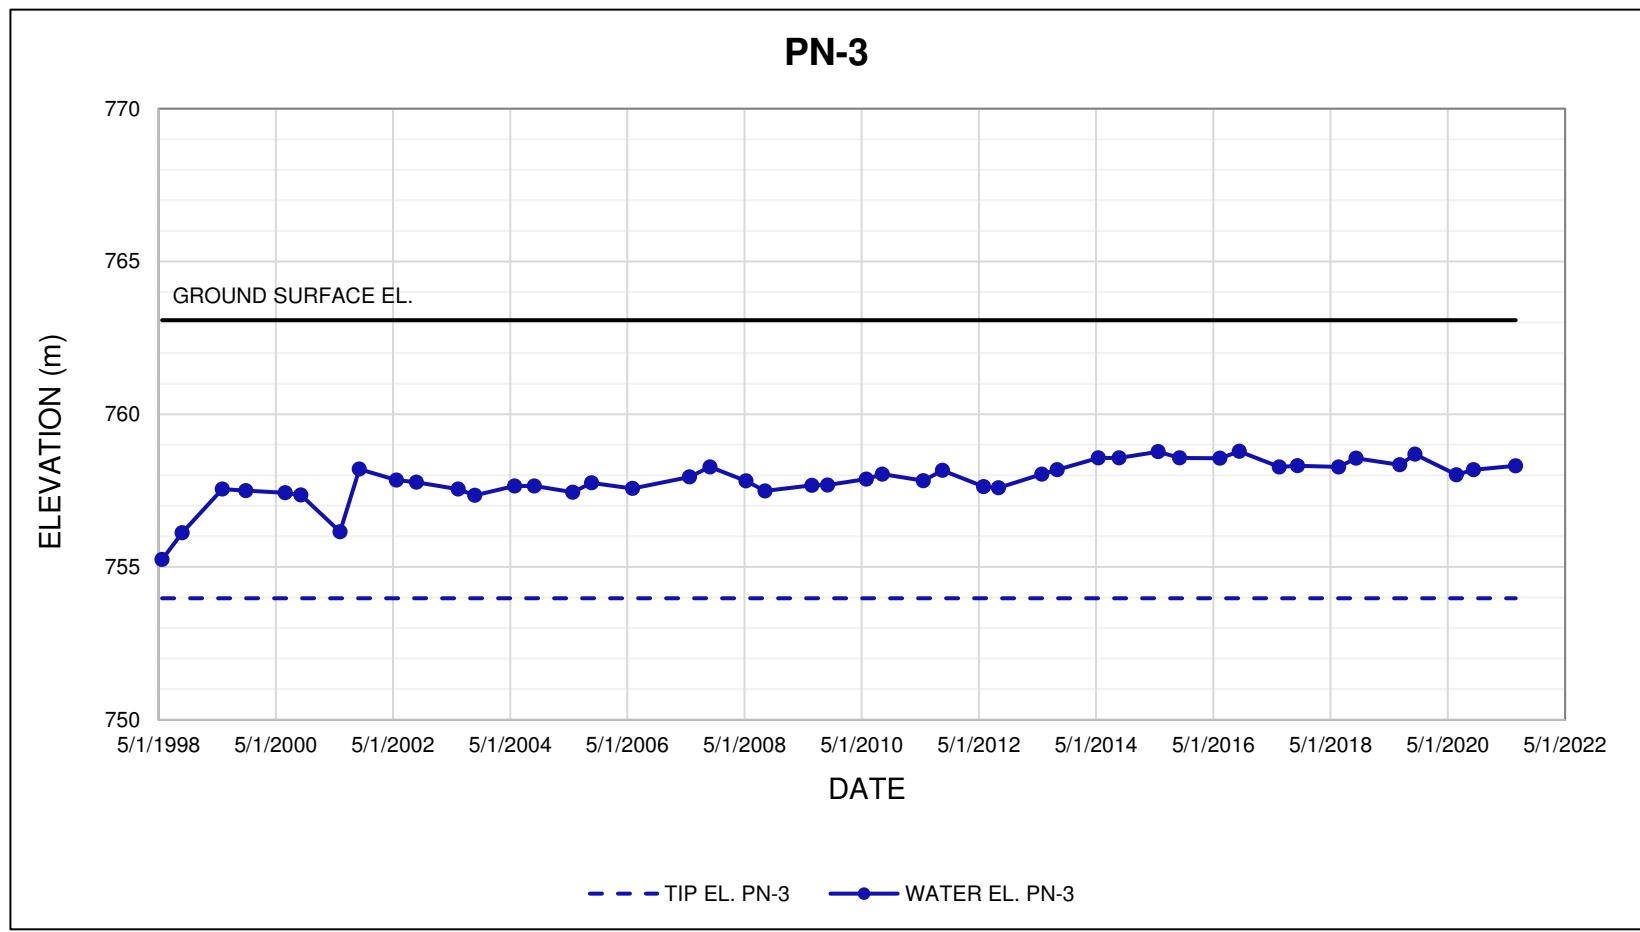
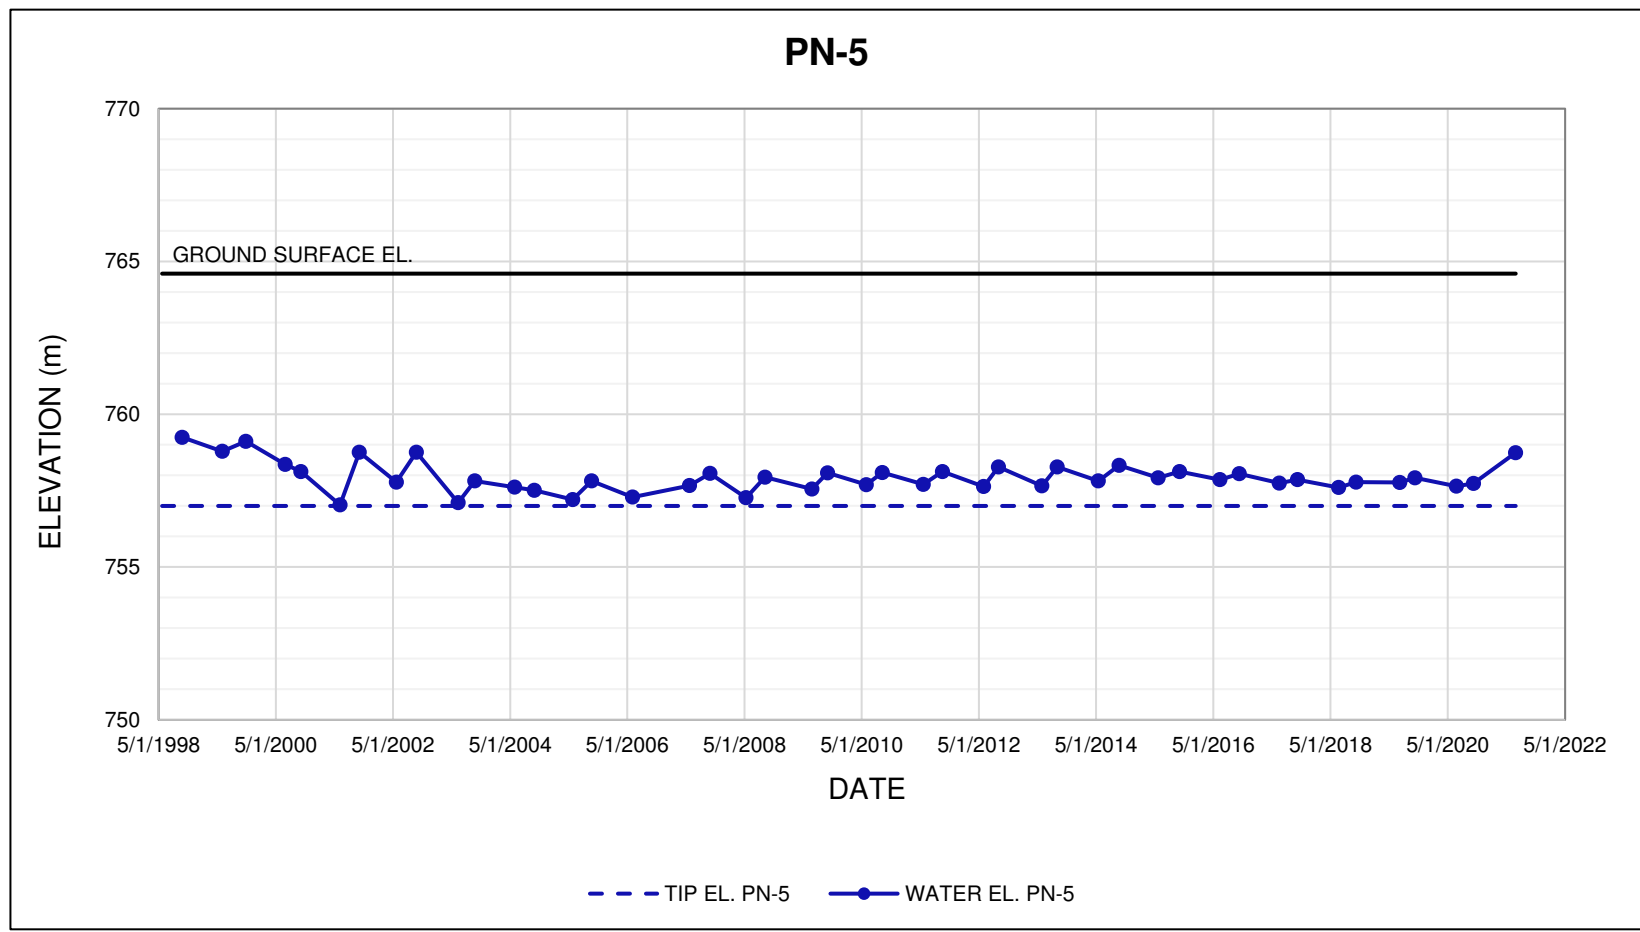
PN-3 recorded a slight increase of 0.1 m since October 2020. PN-5 recorded an increase of 1.0 m in which is more than seasonal variations recorded previously by this instrument. The cause of the increase in PN-5 is unknown but may be due to the instrument ageing and starting to fail (it was installed in 1998). Seasonal variations in water levels doesn't seem likely because PN-3 has not recorded any increase and it was a dry spring and summer. The increase in water level at El. 757 corresponds to the depth at which movement is recorded in SI-02 which would appear to be consistent (higher water level, increased rate of movement). It could be that higher water levels are starting to hydraulically connect to PN-5, though it has taken a while for this to occur since increased movement started in 2015 and an increase in water level was only noted this spring.

If PN-3 starts to indicate variable readings (i.e., increases and decreases), AT may need to replace it.
