SITE INSPECTION FORM

SITE NUMBER AND NAME: GP003-I and II Cutbank River Slides (South) (Roseham Creek)		HIGHWAY & KM: 40:38, 52.134	PREVIOUS INSPECTION DATE: May 26, 2020	INSPECTION DATE: June 15, 2022
LEGAL DESCRIPTION: NE 16-65-05-W6M SE-16-65-05-W6M	NAD 83 COORDINATES: UTM Northing Easting 11 6054593 391085		RISK ASSESSMENT: PF: 9 CF: 3 TOTAL: 27	
AVERAGE ANNUAL DAILY TRAFFIC (AADT): 2170 (north) & 2310 (south) (Reference No. 7000761, 2021)			CONTRACT MAINTENANCE AREA (CMA): 504

PEACE REGION
(GRANDE PRAIRIE DISTRICT – SOUTH) GRMP
SITE INSPECTION FORM

PROJECT	PEACE REGION (GRANDE PRAIRIE DISTRICT-SOUTH) GEOHAZARD RISK MANAGEMENT PROGRAM	
TITLE	Site Plan GP003-I and -II - Cutbank River Slides (South) Hwy 40:38, km 52.134	
SCALE	PROJECT No.	FIG No.
1:3,000	A05116A01	1

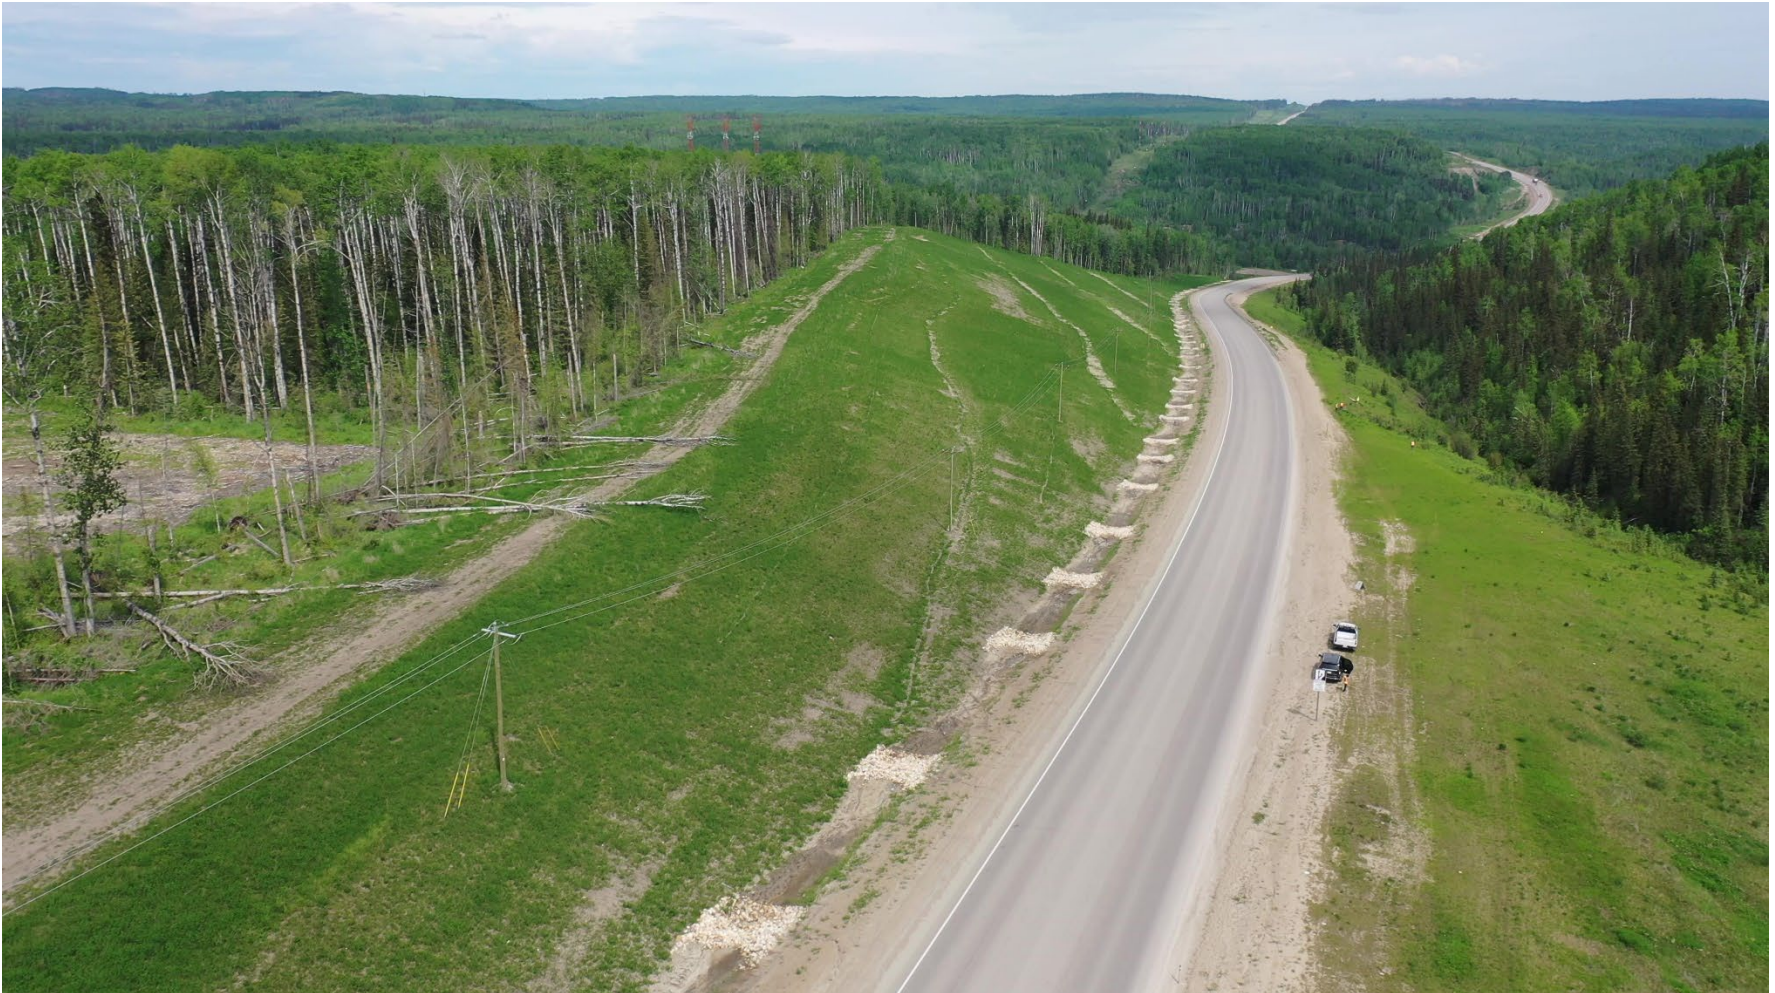
Photo 1 Overview of GP003 site on Hwy 40:38. Photo taken June 15, 2022, with unmanned aerial vehicle (UAV) facing north.

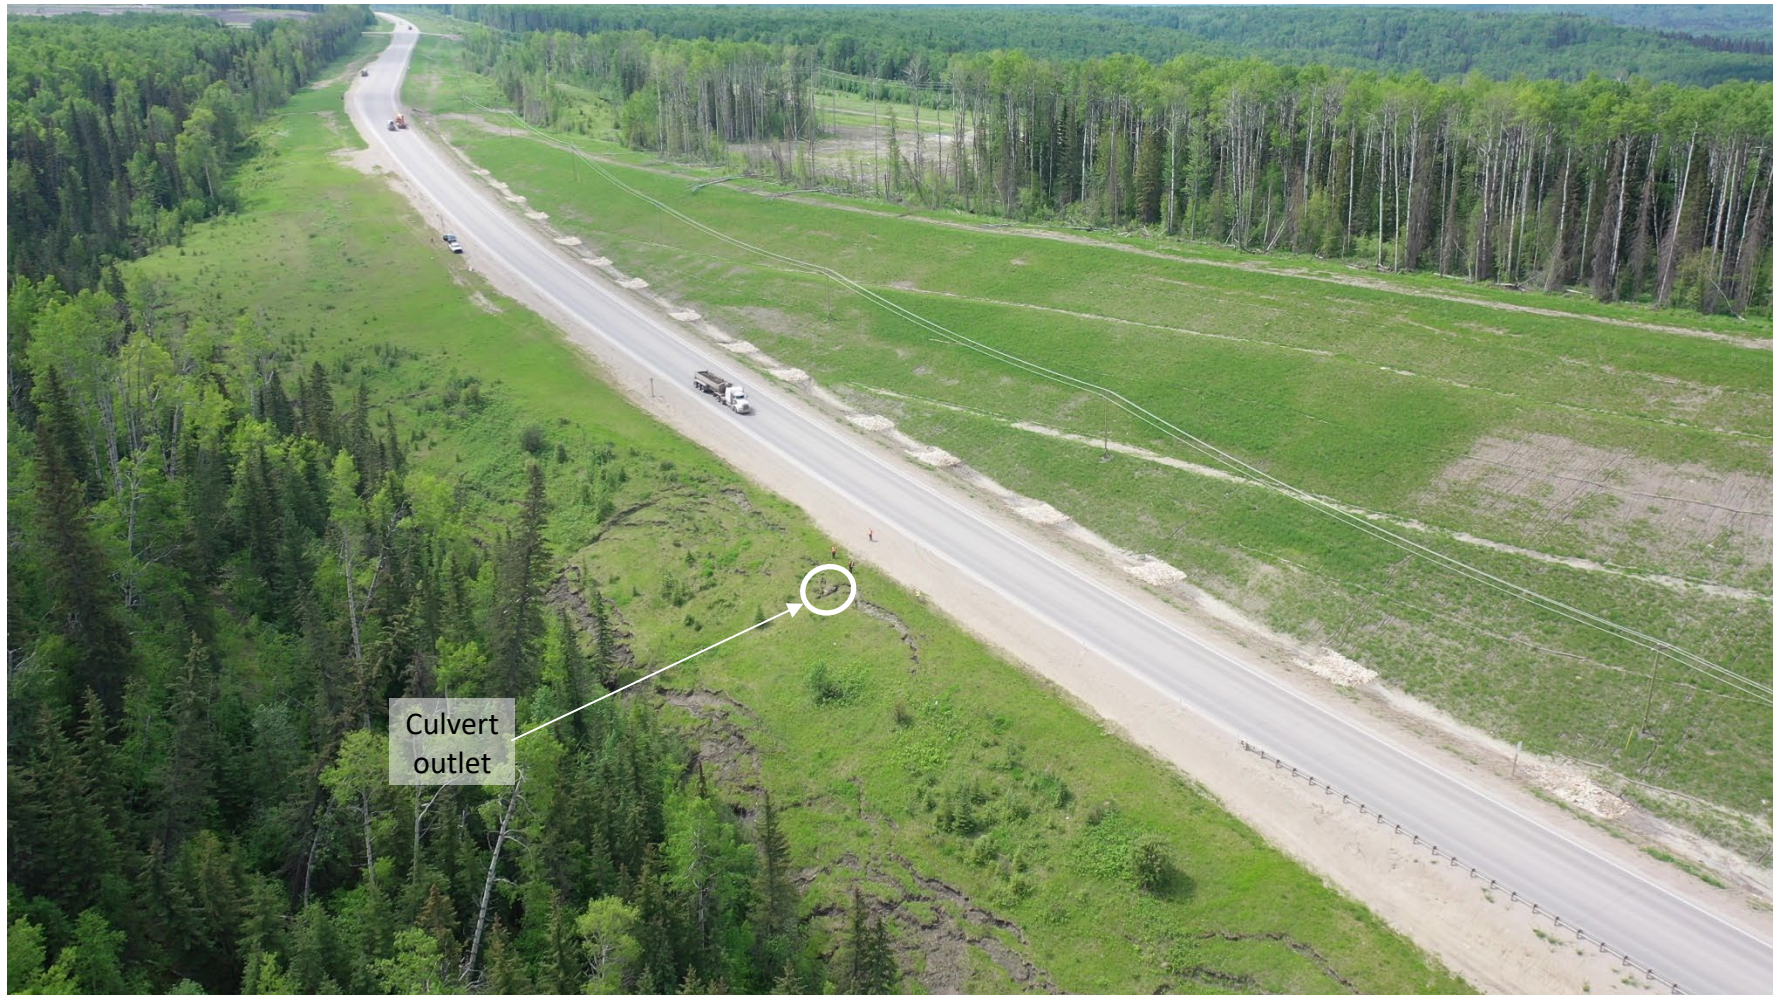
Seepage	X		High groundwater table and seepage previously resulted in wet subgrade leading to alligator cracking in pavement surface.		X
Culvert Distress	X		Culvert outlet on downslope/east side of highway at WP218 blocked with soil, inlet not visible in upslope/west ditch. Some seepage around outlet.	X

Photo 2 Series of slides between Hwy 40:38 and Roseham Creek. Culvert outlet (circled in white) on downslope/east side of highway at WP218 blocked with soil, inlet not visible in upslope/west highway ditch. Photo taken June 15, 2022, with UAV facing southwest.

- Continue to maintain and clean existing subdrain system.
- Monitor seepage around culvert outlet on downslope/east side of highway at WP218. Monitor for signs of sinkhole activity in west ditch where inlet of culvert could be buried.

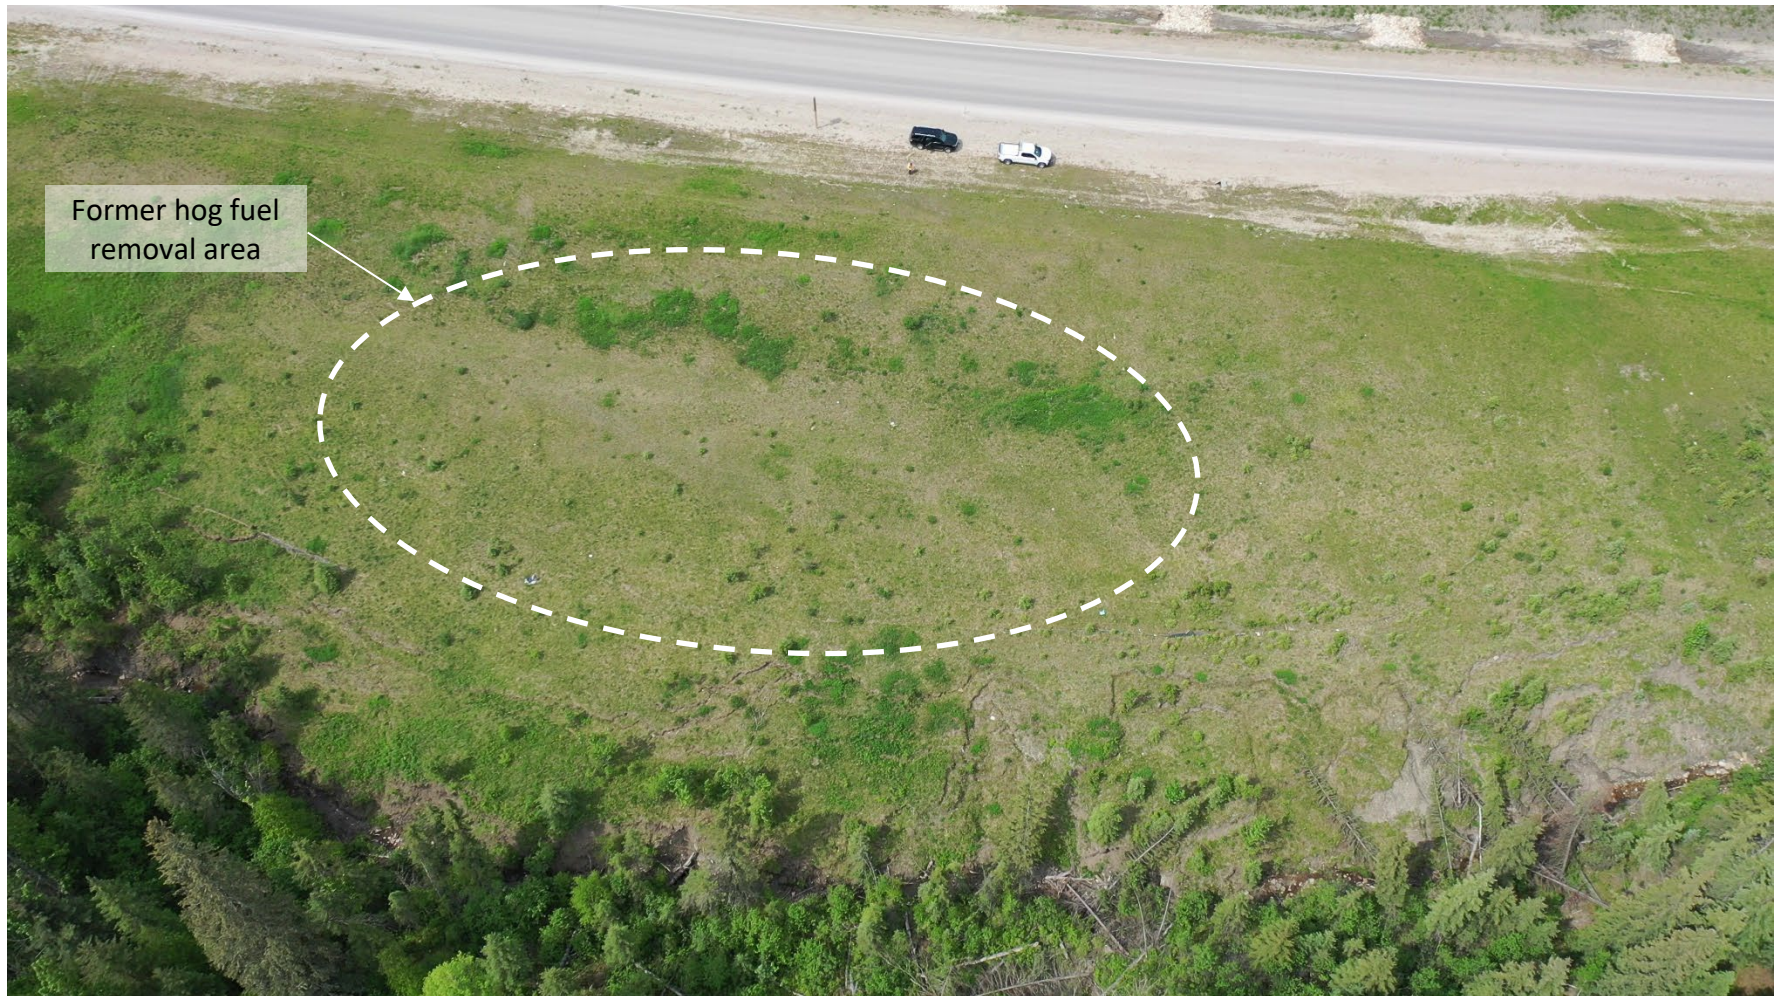
Photo 3 Former hog fuel removal area (circled in white) downslope/east of Hwy 40:38 and WP214. Series of slides along Roseham Creek. Photo taken June 15, 2022, with UAV facing down/west.

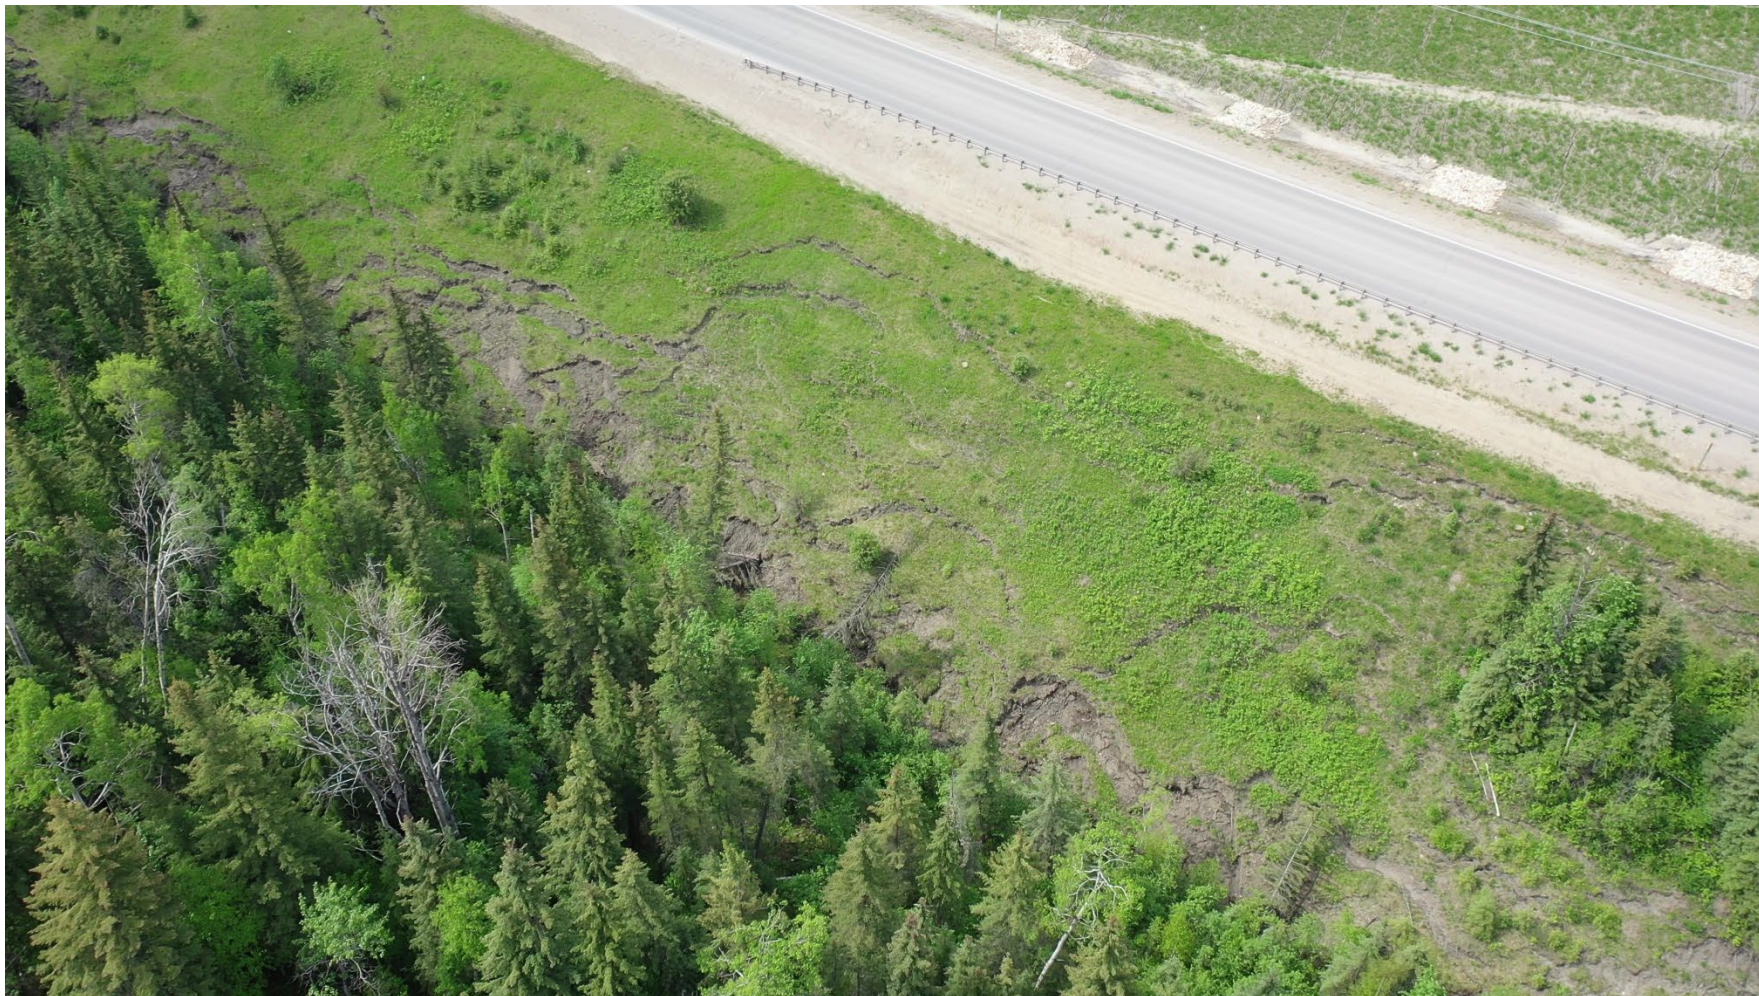
Photo 4 Series of slides between Hwy 40:38 and Roseham Creek. Photo taken June 15, 2022, with UAV facing southwest.

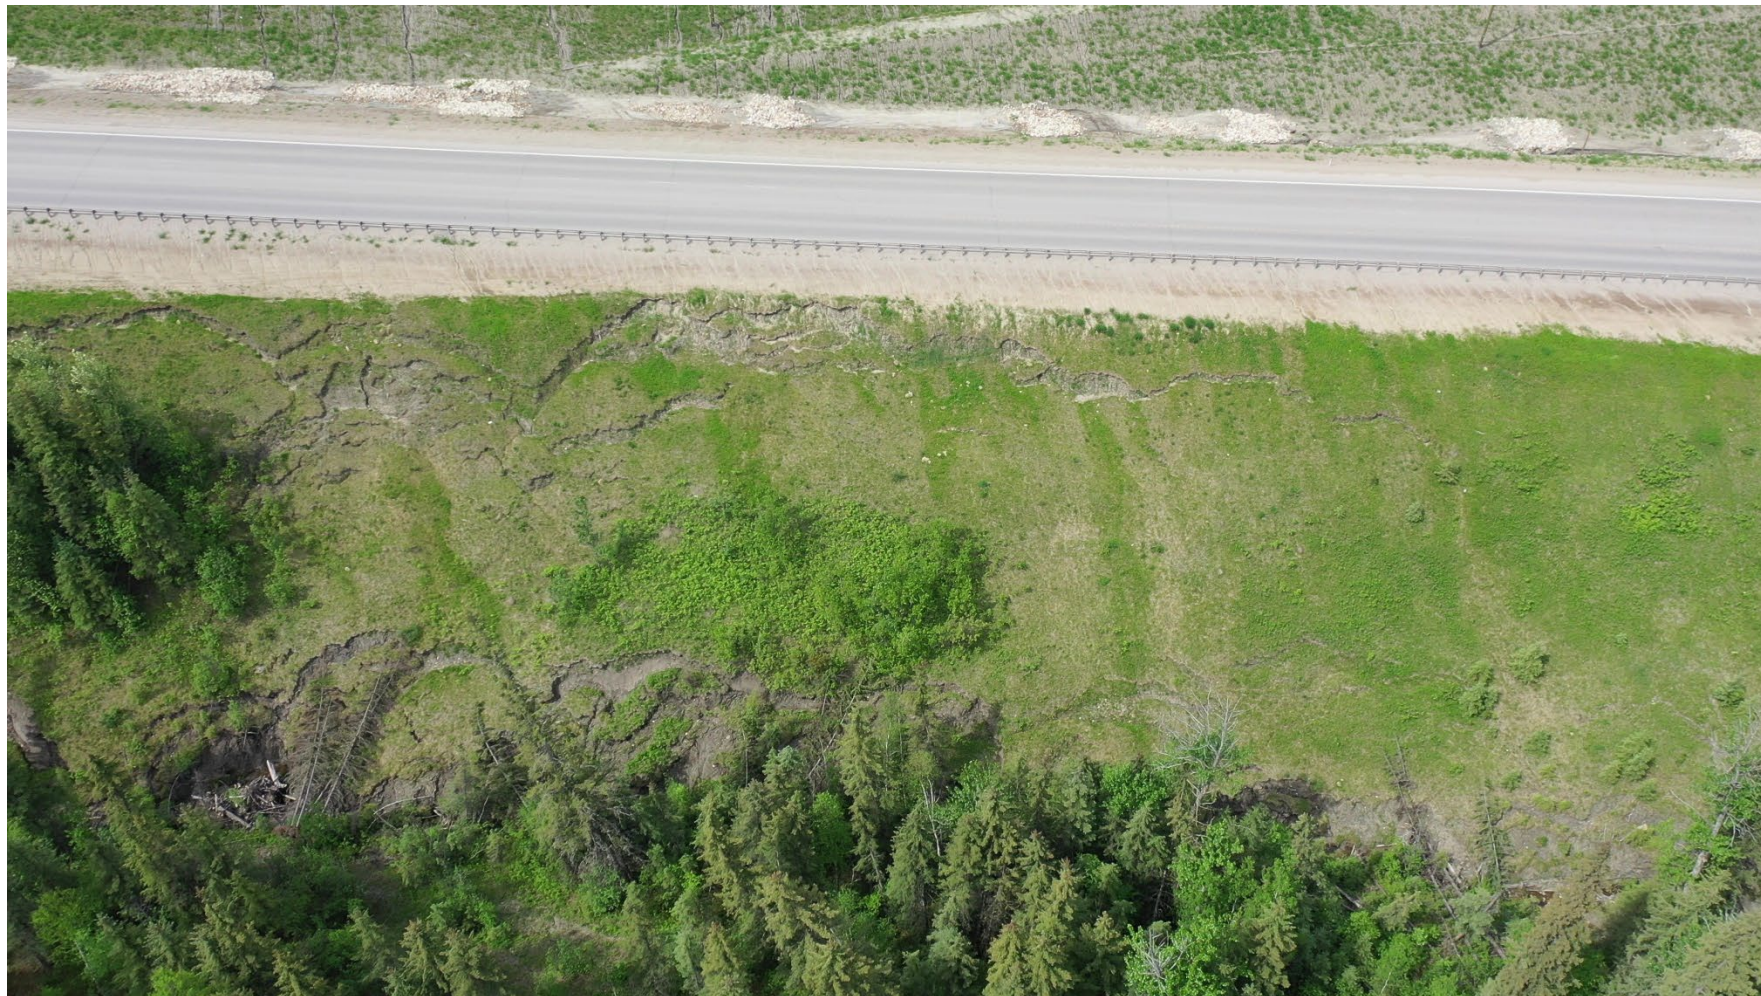
Photo 5 **Series of slides between Hwy 40:38 and Roseham Creek. Photo taken June 15, 2022, with UAV facing west.**

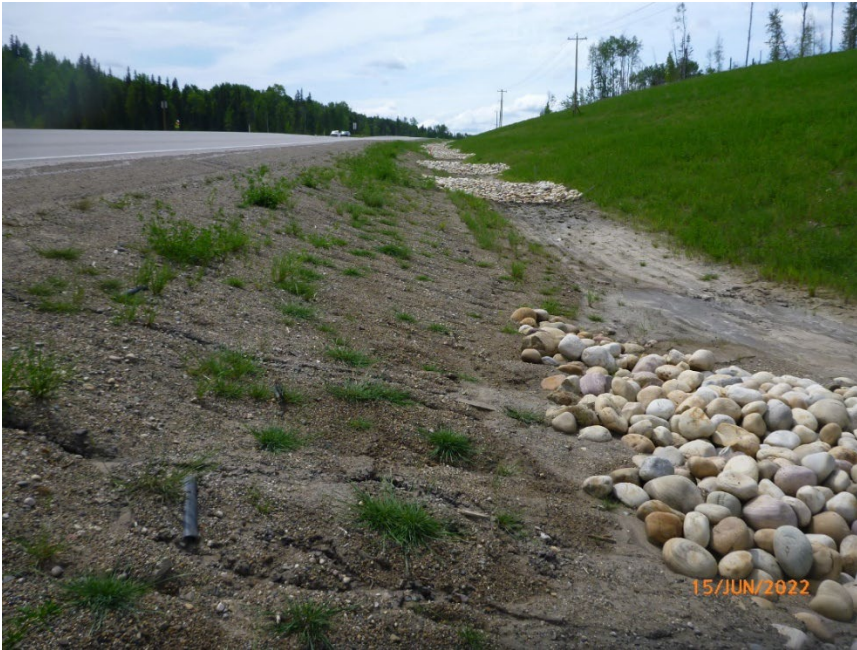
Photo 6 Riprap check dams and rill erosion in/along upslope/west ditch of Hwy 40:38. Photo taken June 15, 2022, facing south.

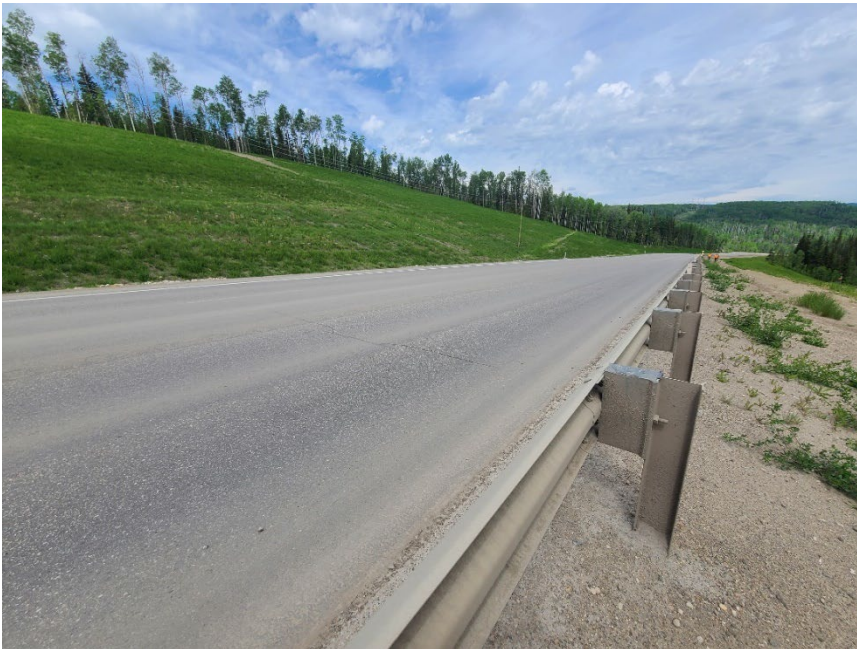
ITEM	CONDITION EXISTS		DESCRIPTION AND LOCATION	NOTICABLE CHANGE FROM LAST INSPECTION	
	YES	NO		YES	NO
Pavement Distress		X	Tension and alligator cracking (due to high groundwater) previously observed by others, but no cracking visible at time of 2022 inspection in recent overlay completed in 2016.		X
Slope Movement	X		Series of slides/slope failures between highway and Roseham Creek that continue to retrogress towards and expand laterally along highway. New slides observed along east creek bank.	X	
Erosion	X		Ongoing erosion and channel degradation along Roseham Creek. Some rill erosion along backslope, upper portion of highway embankment (unvegetated gravelly material), and upslope/west highway ditch.	X

Photo 7 Pavement surface of Hwy 40:38. Photo taken June 15, 2022, facing northwest.

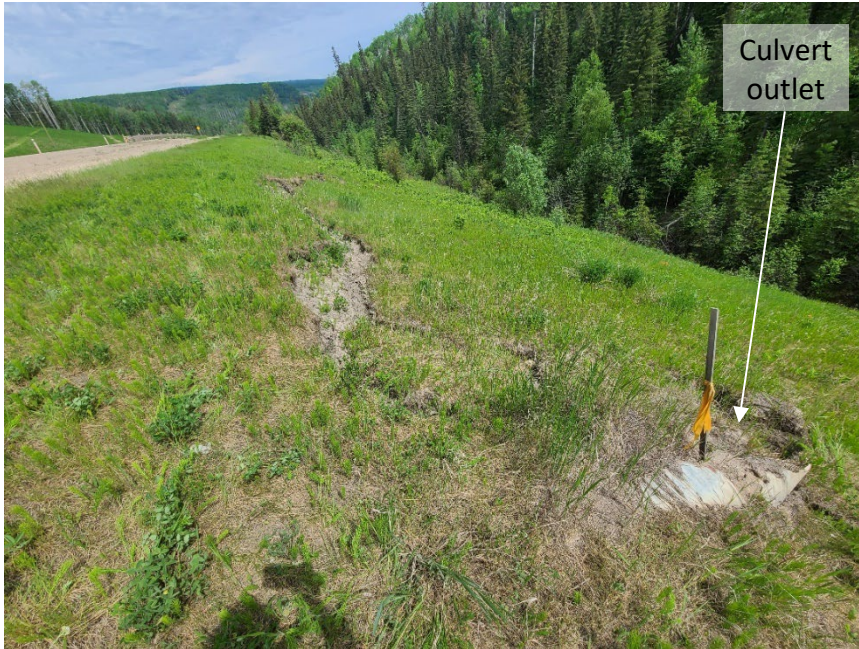
Photo 8 Slides scarps between Hwy 40:38 and Roseham Creek. Culvert outlet on east side of highway at WP218 blocked with soil, inlet not visible in west highway ditch. Photo taken June 15, 2022, facing north.

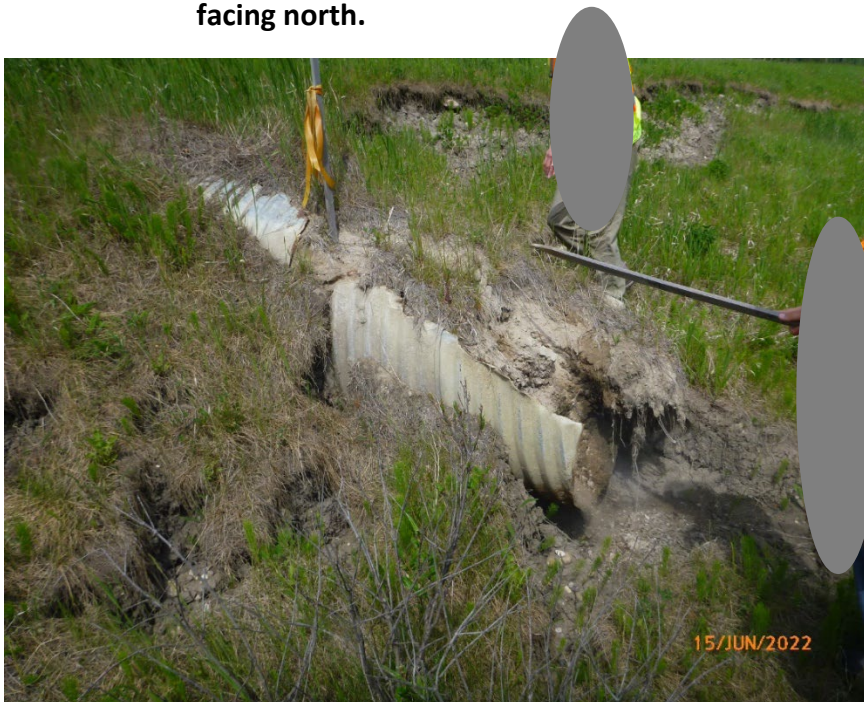
Photo 9 Culvert outlet on east side of Hwy 40:38 at WP218 blocked with soil, inlet not visible in west highway ditch. Some seepage around outlet. Photo taken June 15, 2022, facing north.

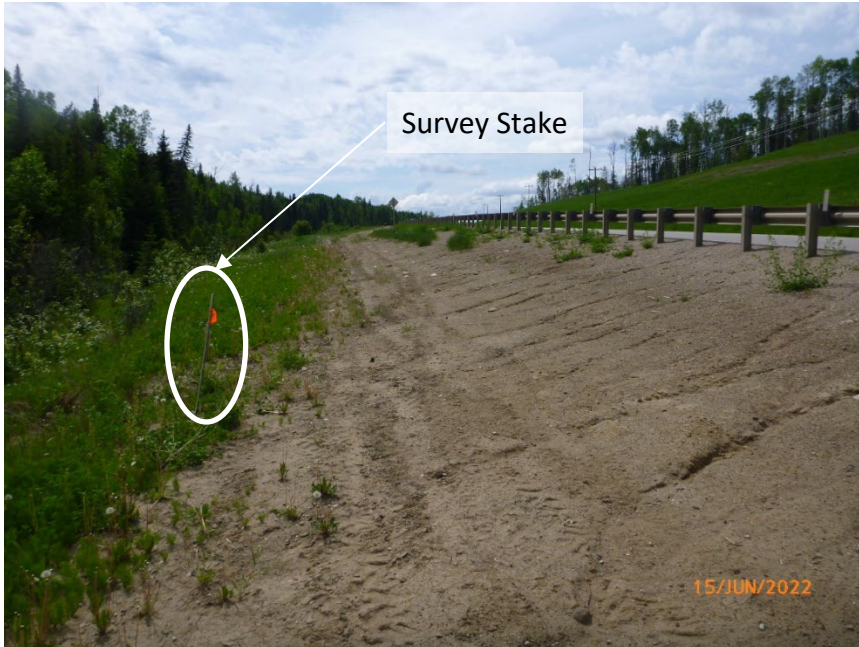
Photo 10 Rill erosion along downslope/east side of Hwy 40:38 embankment. Note reference/survey stake with flagging (circled in white) placed 1.0 m upslope of slide scarp to monitor retrogression at WP221. Photo taken June 15, 2022, facing south.

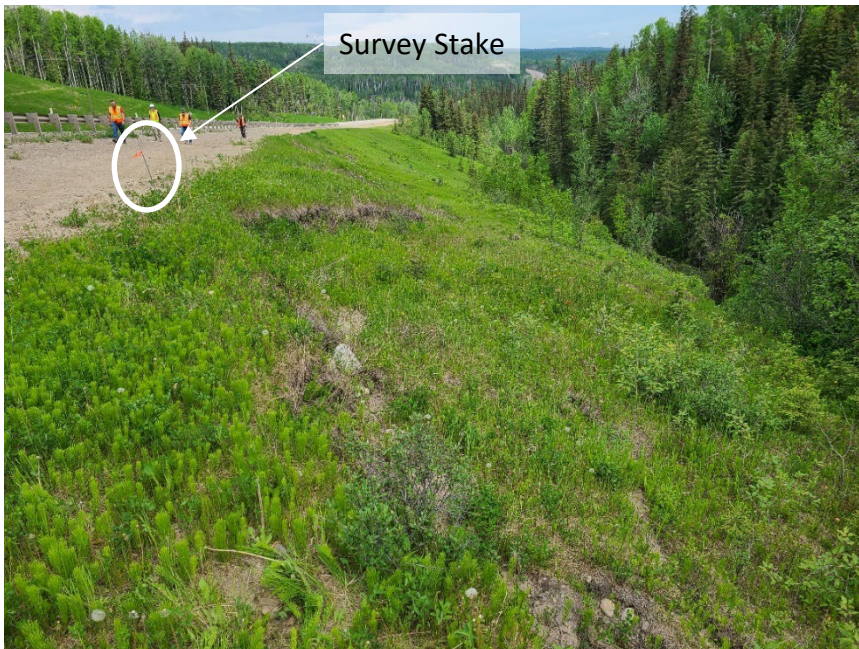
Photo 11 Slides scarps between Hwy 40:38 and Roseham Creek). Note reference/survey stake with flagging (circled in white) placed 1.0 m upslope of slide scarp to monitor retrogression at WP221. Photo taken June 15, 2022, facing north.
