July 15, 2025

CON0022166 Peace Region (Grande Prairie District – South) GRMP Instrumentation Monitoring Site GP003; H40:38, km 52.134 Cutbank River (South) Roseham Creek Section C – 2025 Spring Readings

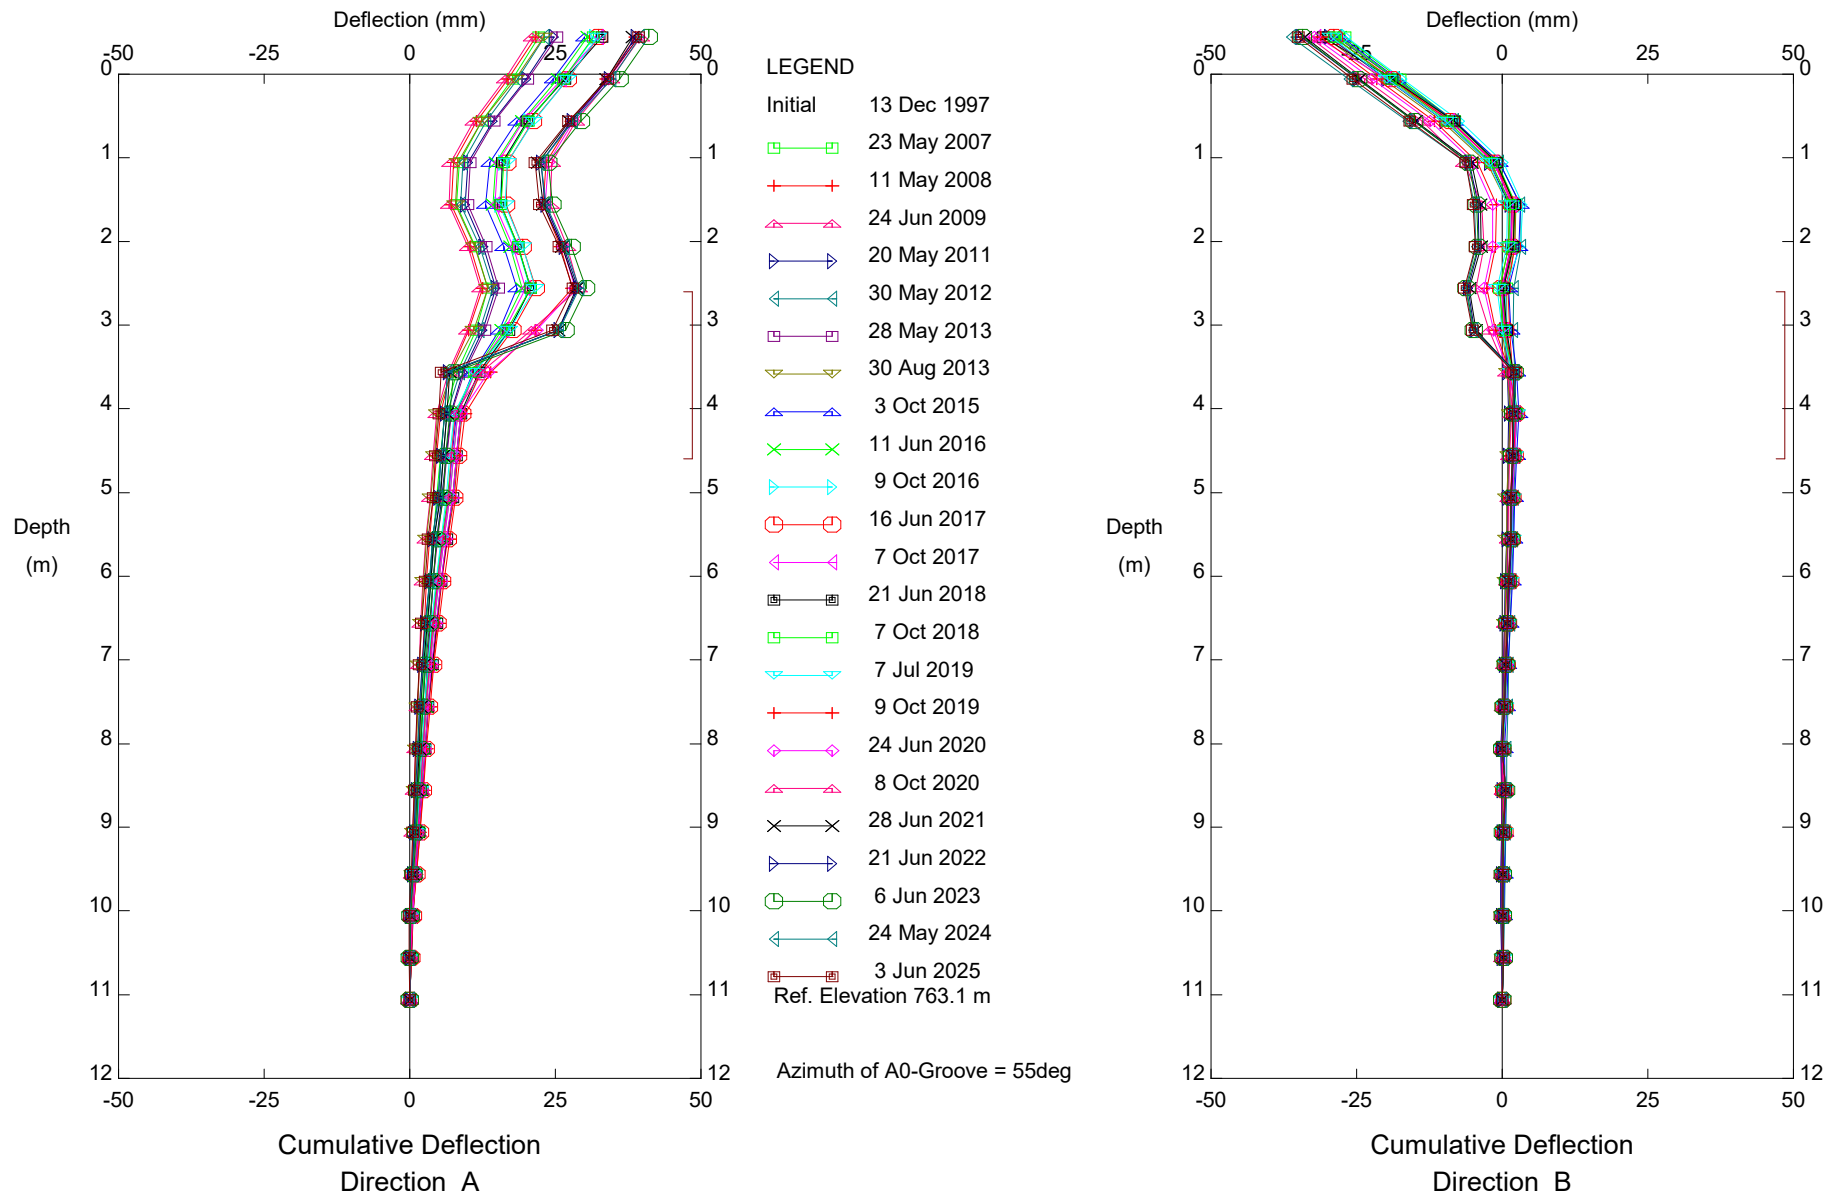
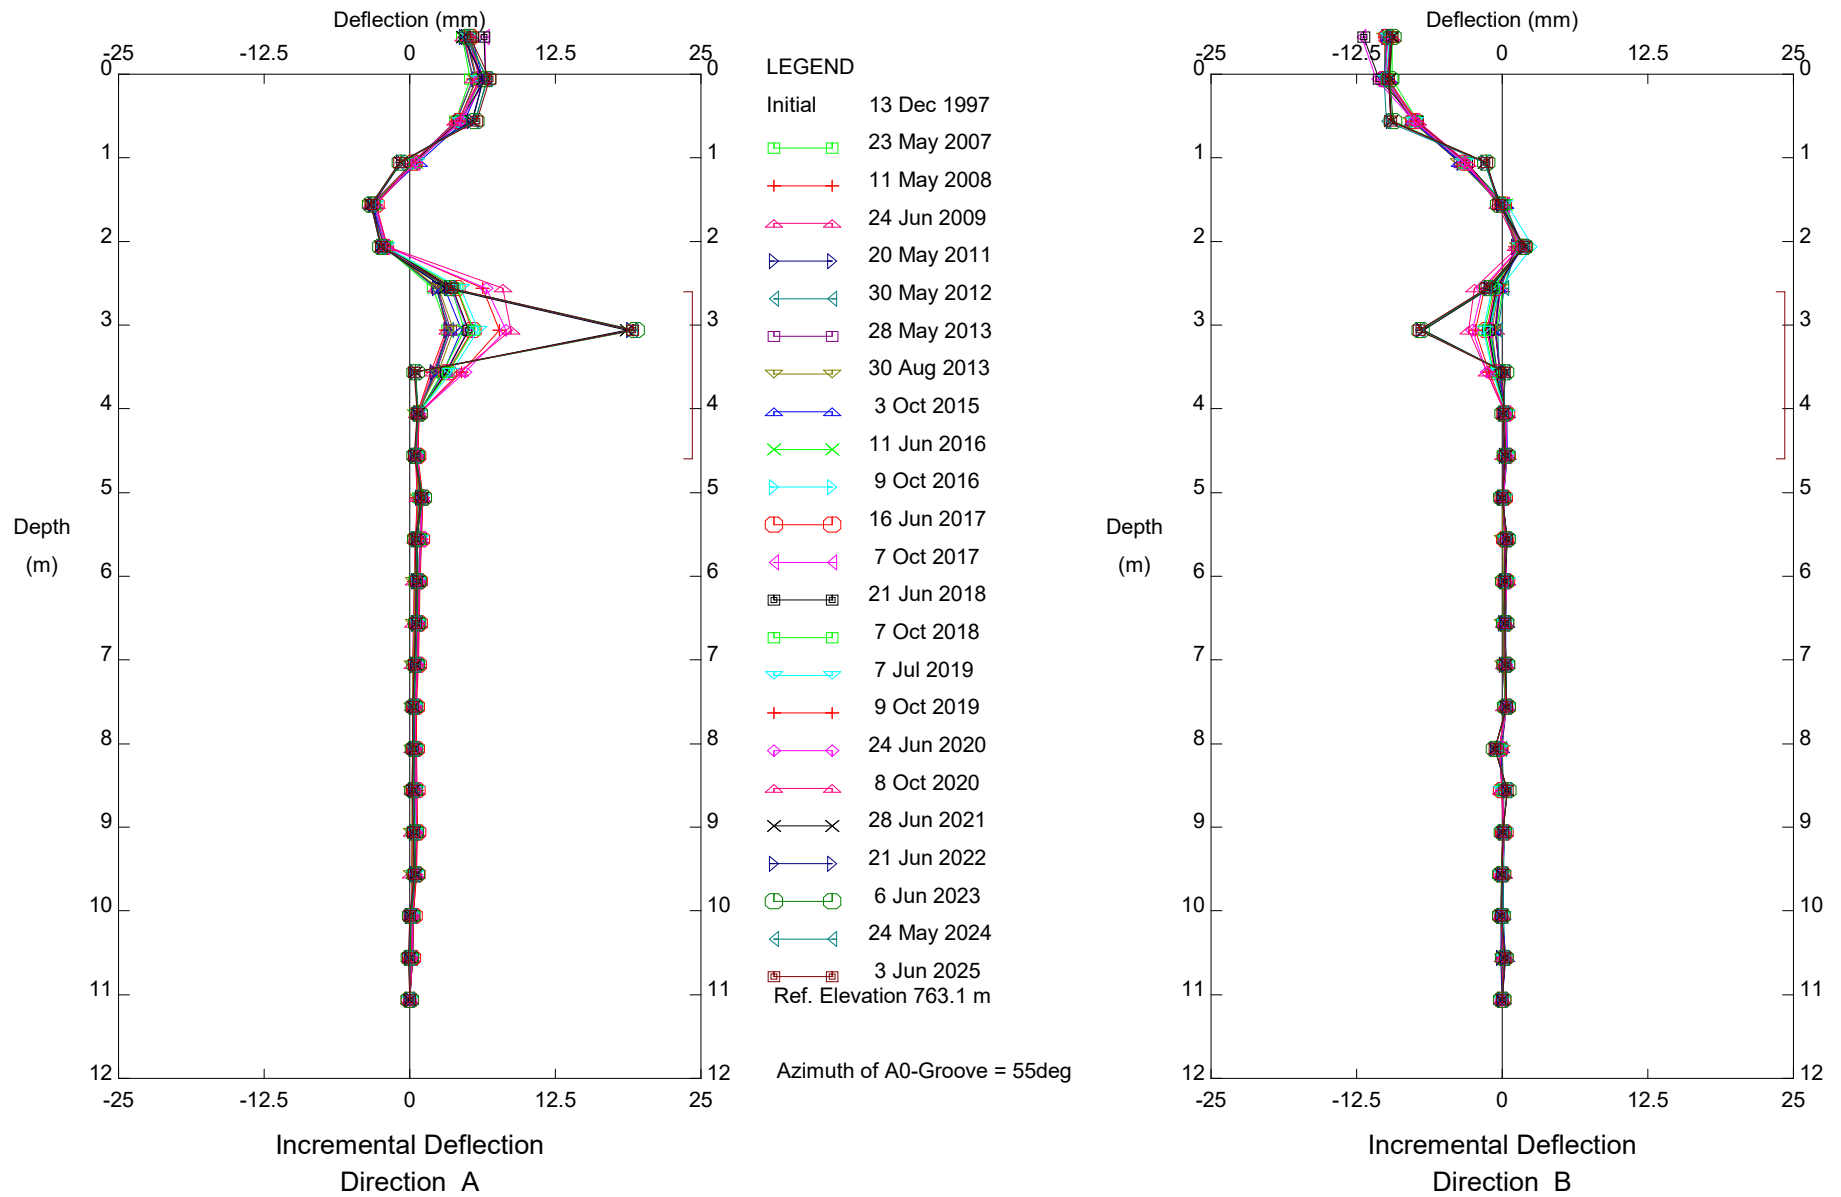
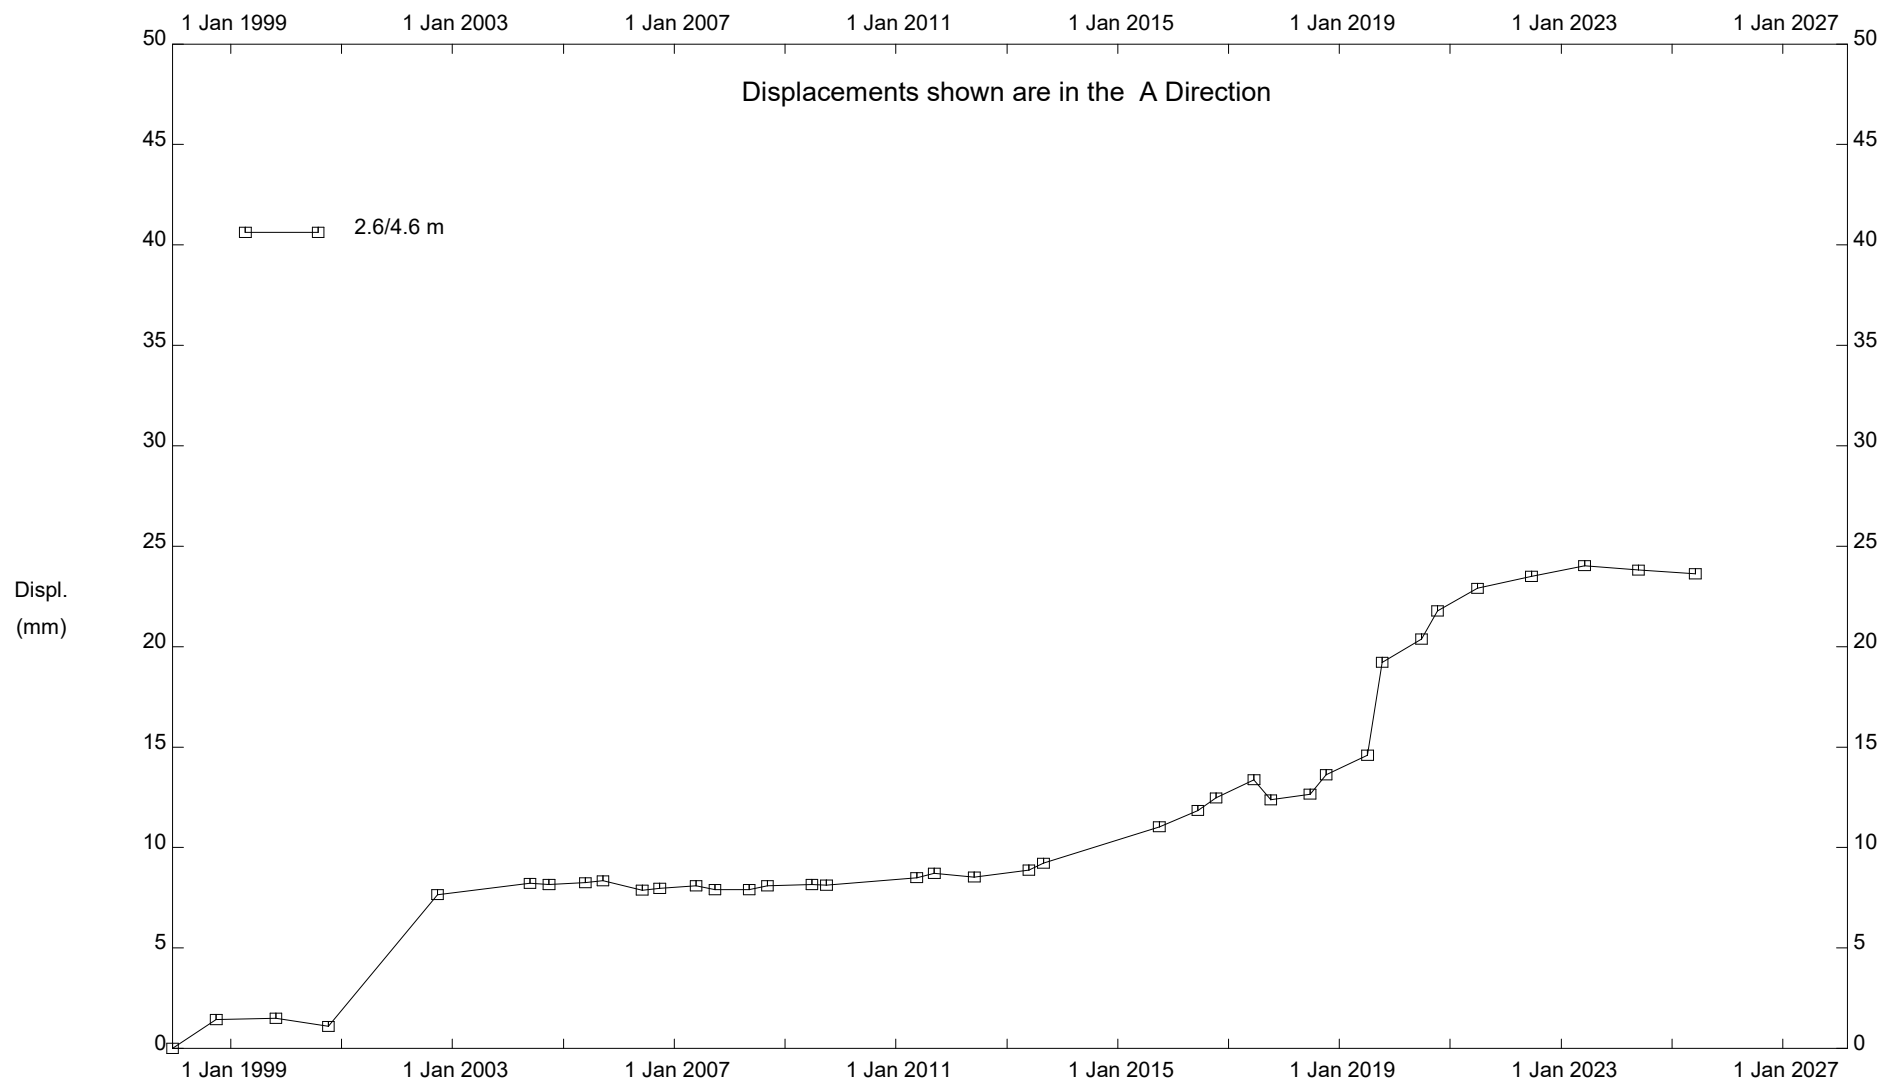
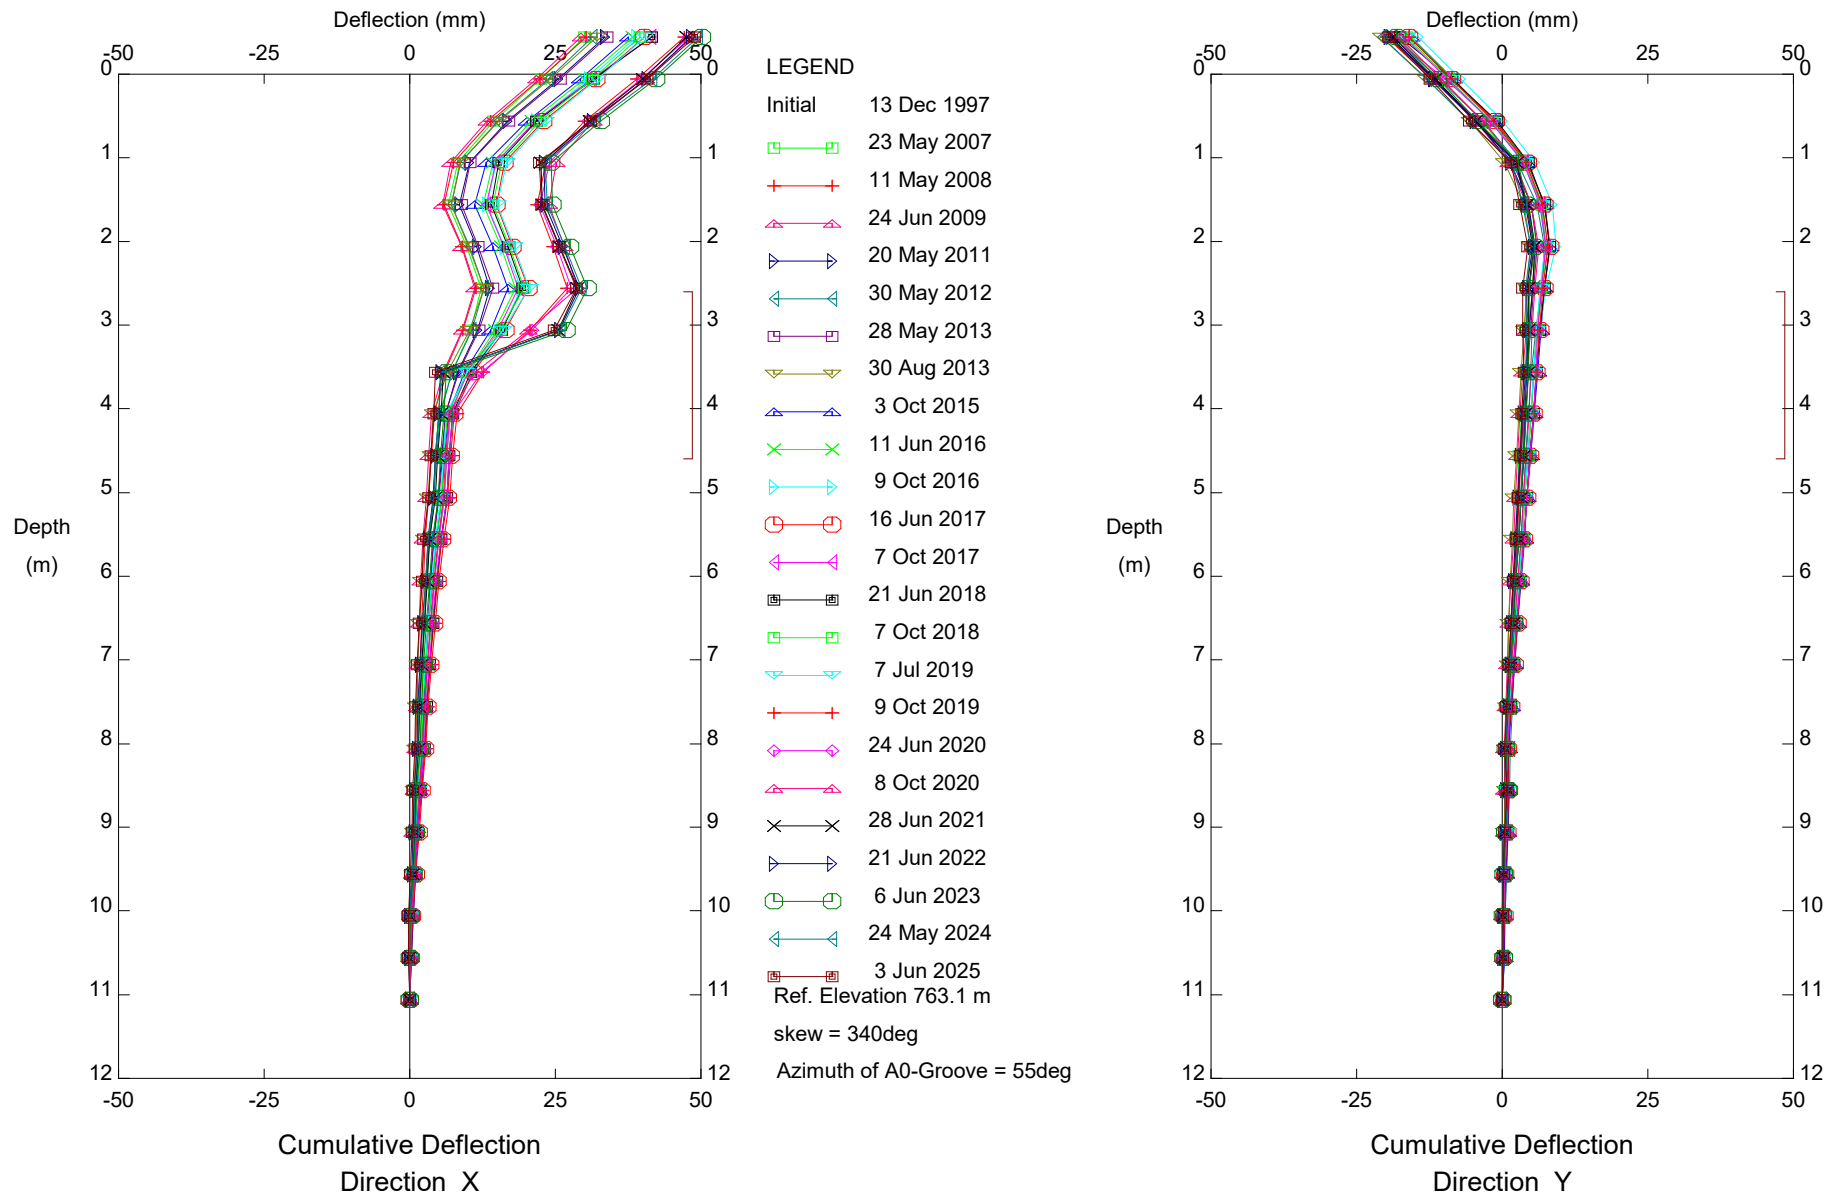
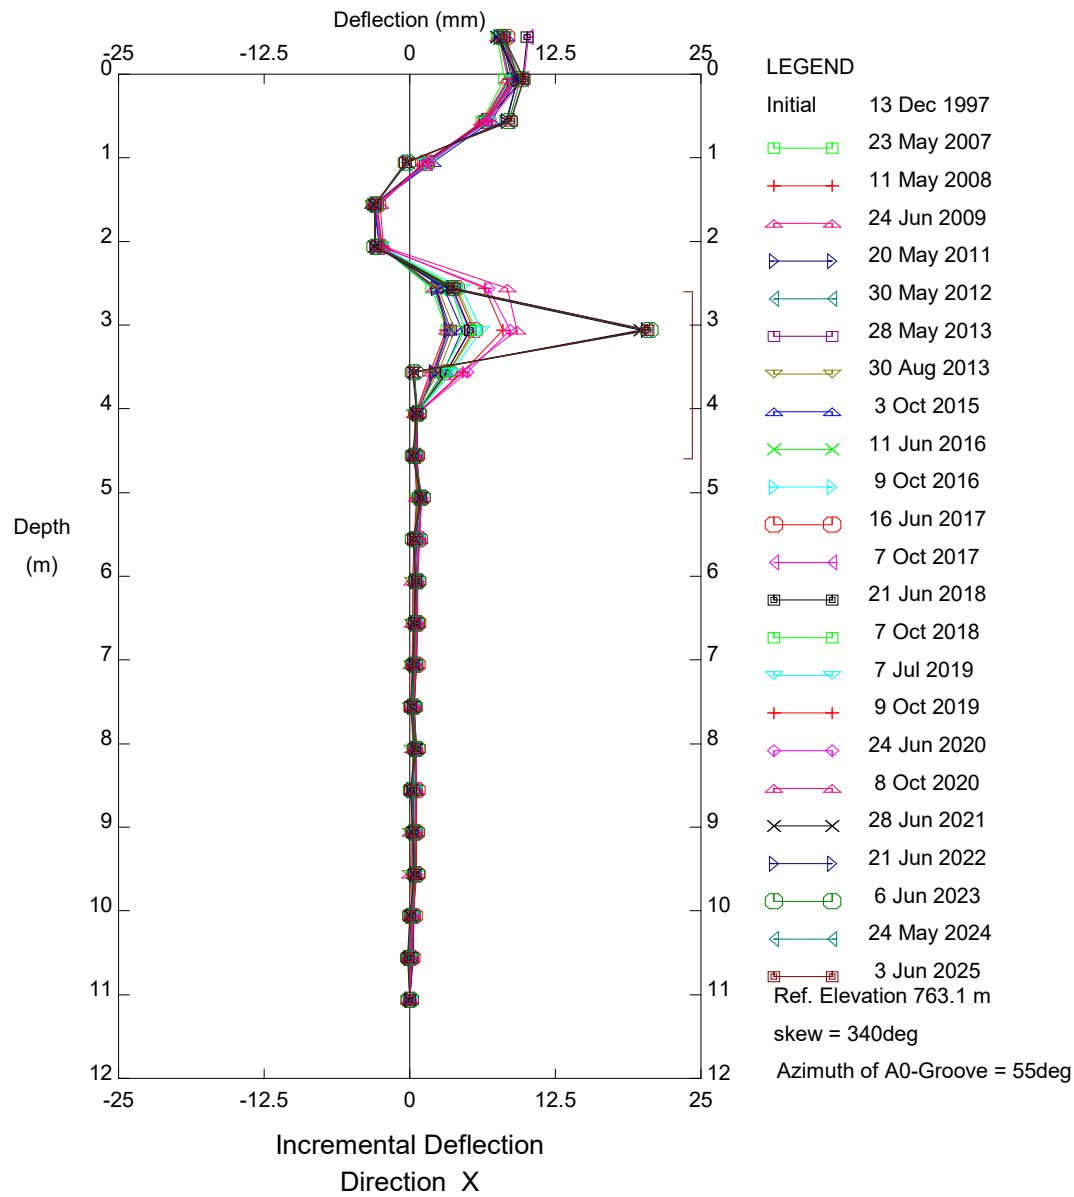
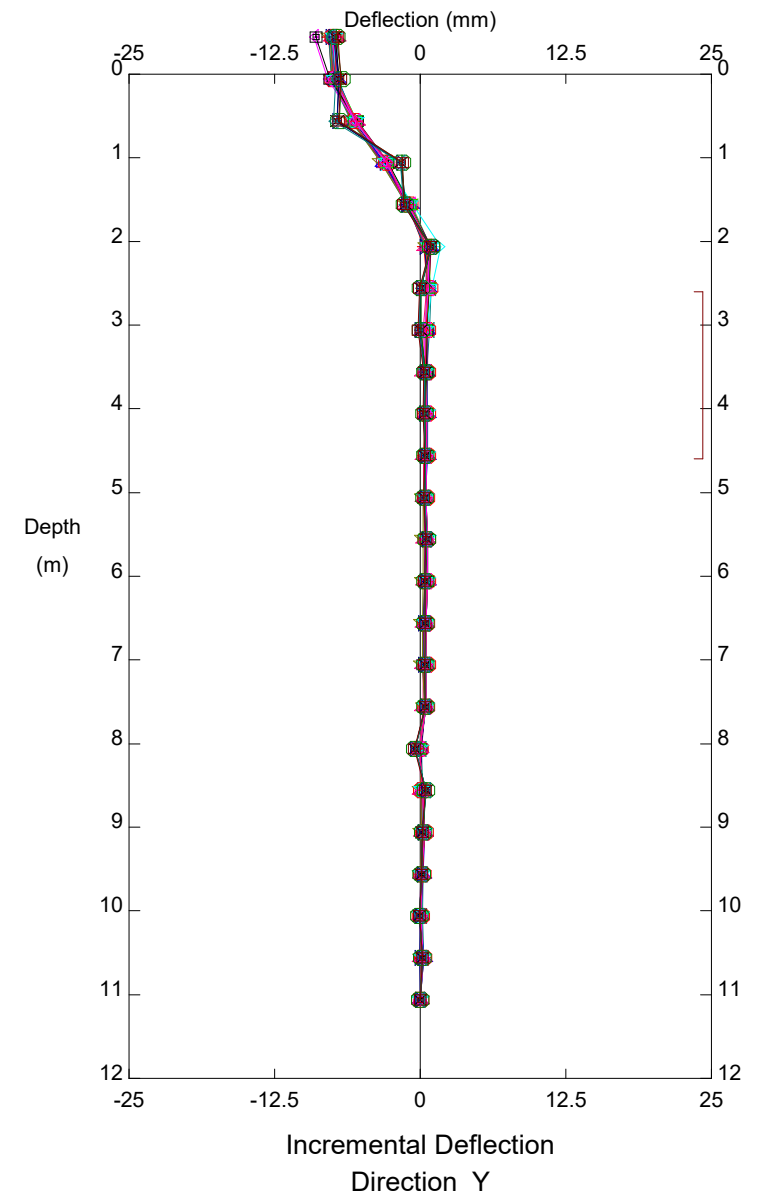
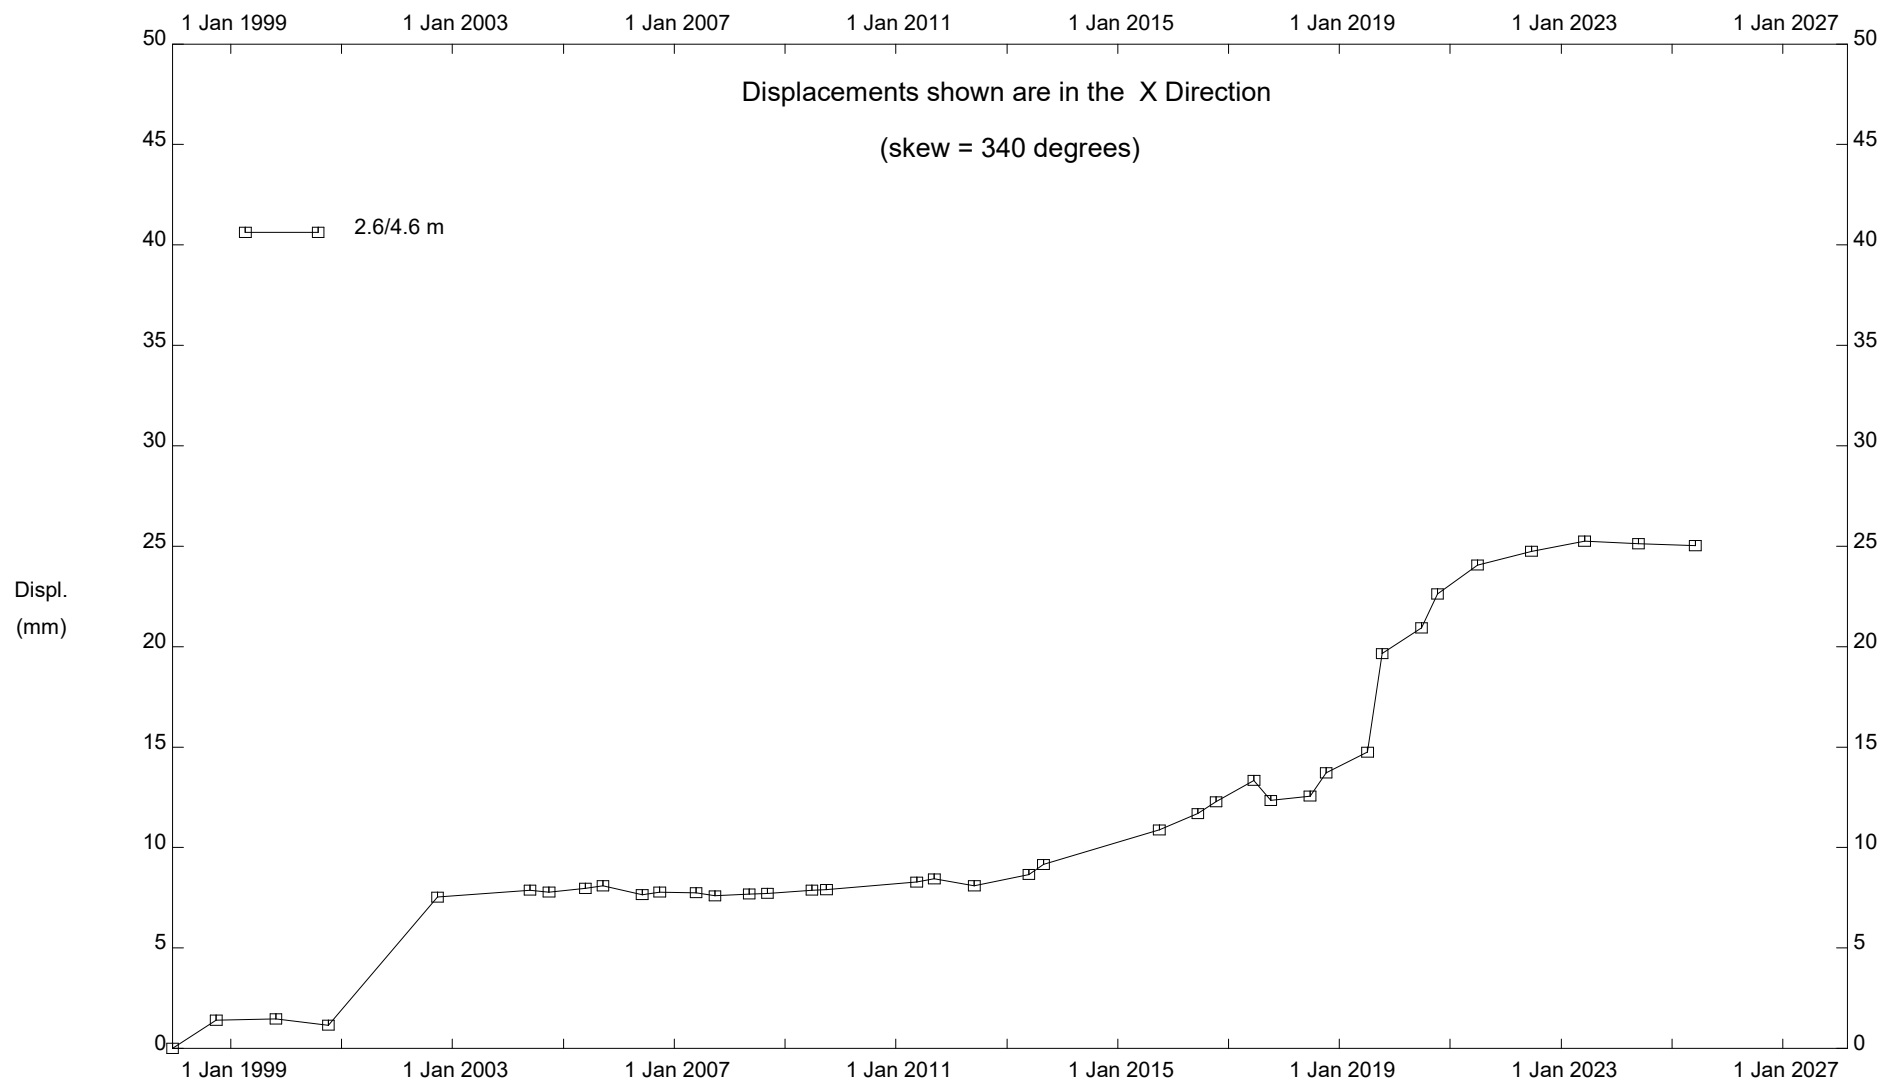
GP003; H40:38, Cutbank River (South), Inclinator SI-02
 Alberta Transportation

Distributed movement is being recorded in SI-2 from ground surface to bottom of casing, with some more defined movement being recorded at an approximate depth of 2.6 m to 3.6 m below ground surface.

SI-2 is located approximately 40 m from the toe of the highway embankment and Roseham Creek. The depth of defined movement recorded in SI-2 is approximately 1.5 m to 2.5 m above Roseham Creek. The rate of movement being recorded in SI-2 was relatively slow (less than 1 mm/year) between 1997 and 2015 before increasing to an approximate rate of 19 mm/year in late 2019. The increased rate of movement was also observed on site when a larger-than-typical asphalt crack was observed during the 2015 Section B inspection. The increased rate of movement may have been caused by creek erosion at the toe of the highway embankment and/or increased water level from an increase in groundwater seeping through the embankment fill. In the mid-2010s, an approximate 0.5 m to 1.0 m increase in porewater pressure was recorded in PN-3 and PN-5, and the rate of movement recorded in SI-2 correspondingly increased from less than 1 mm/year to an approximate rate of 19 mm/year. Since the mid- to late-2010s, an approximate 0.5 to 1.0 m decrease in porewater pressure has been recorded in PN-3 and PN-5. The rate of movement recorded in SI-2 also began to decrease in 2019/2020 and, since June 2022, has been less than 1 mm/year. It is noted that a negative rate of movement has been recorded during the past two readings indicating movement is within the accuracy of the SI reading equipment.

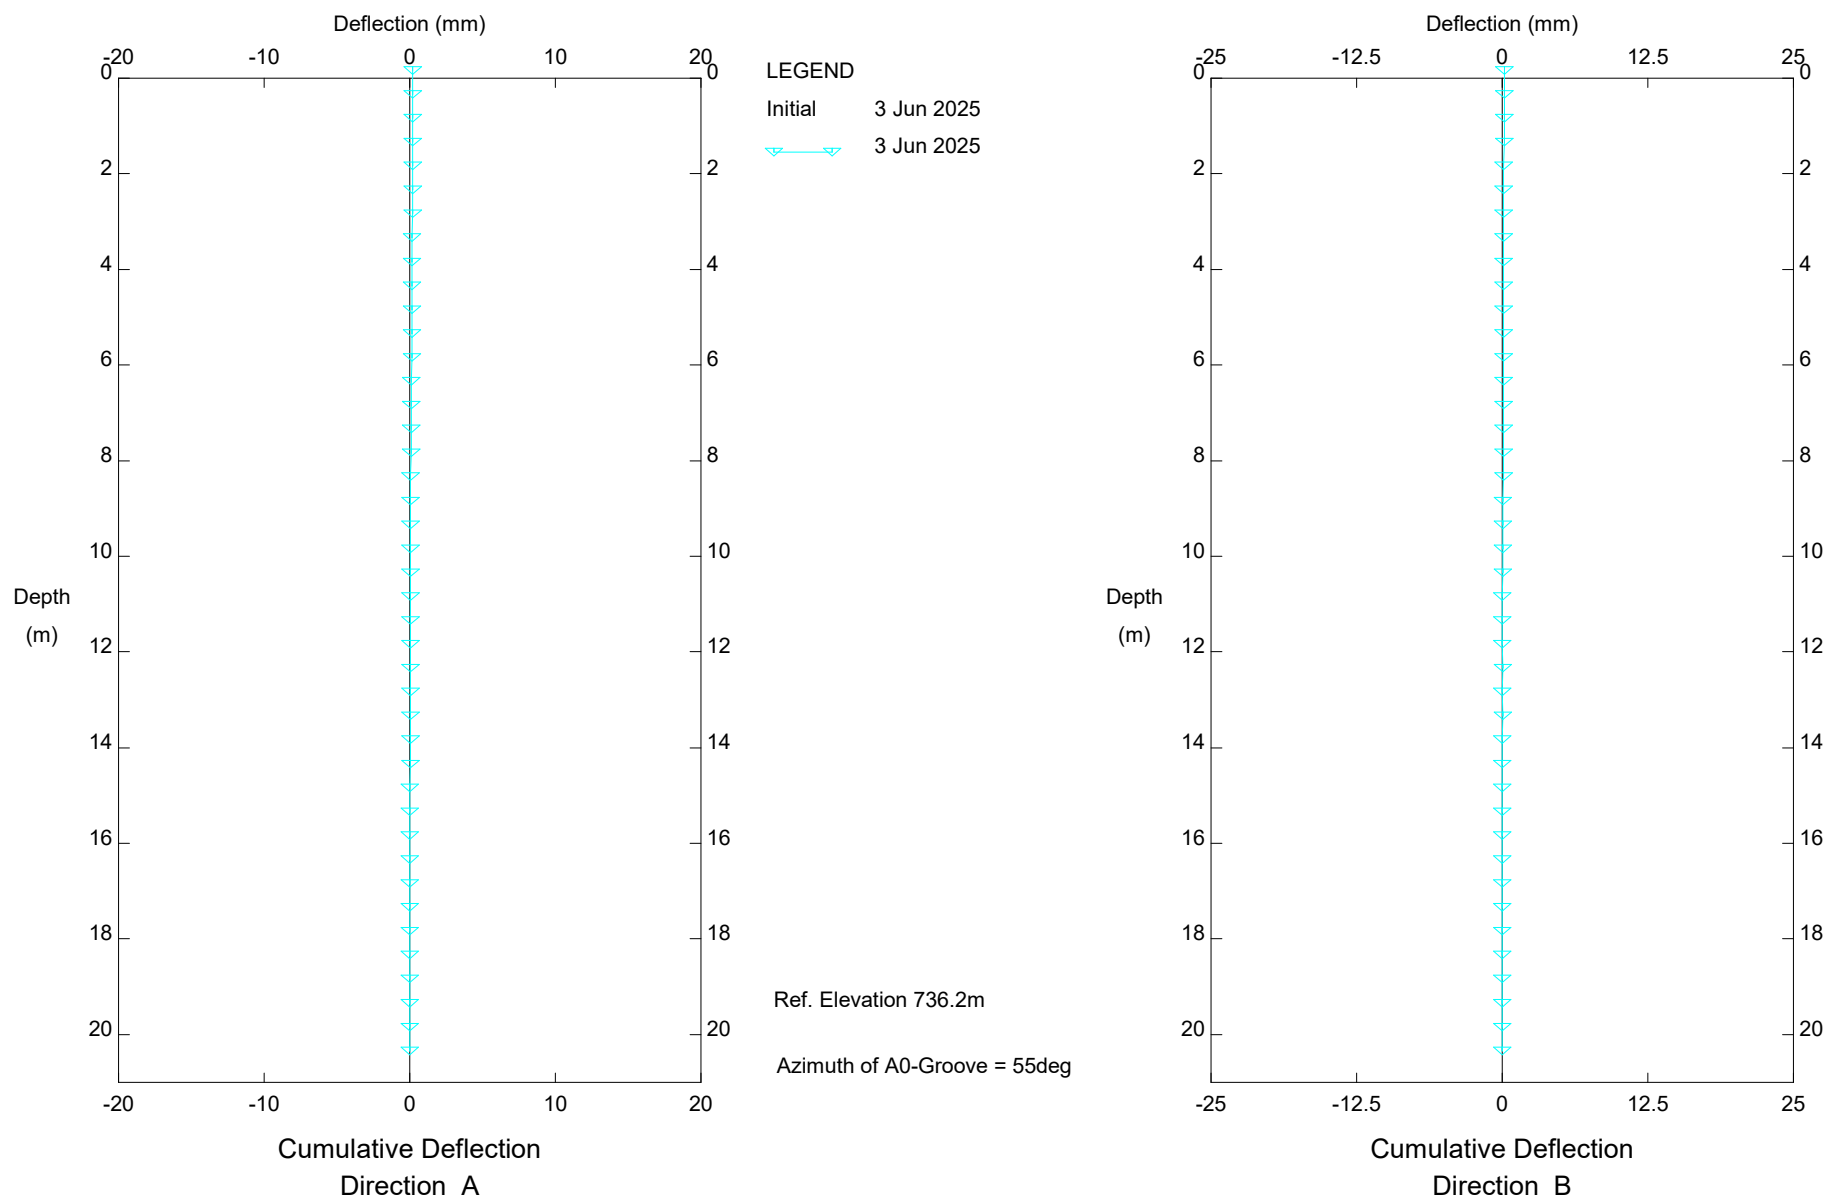
GP003; H40:38, Cutbank River (South), Inclinator SI25-3

SI25-1 through 3 were installed in April 2025 and initialized in June 2025. More data is needed to assess movement trends in these instruments.
