**ALBERTA TRANSPORTATION
GEOHAZARD ASSESSMENT PROGRAM
PEACE REGION – GRANDE PRAIRIE DISTRICT
2018 INSPECTION**

Site Number	Location	Name	Hwy	km
GP34	NW of Grande Cache	2.9 km S of Kakwa River Bridge	40:38	21.0
Legal Description		UTM Co-ordinates (NAD 83)		
NW28-62-4-W6		11U N 6,028,660	E 399,845

Date	PF	CF	Total
Previous Inspection:	May 30, 2017	13	4	52
Current Inspection:	May 23, 2018	13	4	52
Road AADT:	1,160	Year:	2016	
Inspected By:	Don Proudfoot, Nicole Wilder (Thurber) Ed Szmata, Rocky Wang, Dwayne Lowen (AT)			
Report Attachments:	<input checked="" type="checkbox"/> Photographs <input checked="" type="checkbox"/> Plans <input type="checkbox"/> Maintenance Items

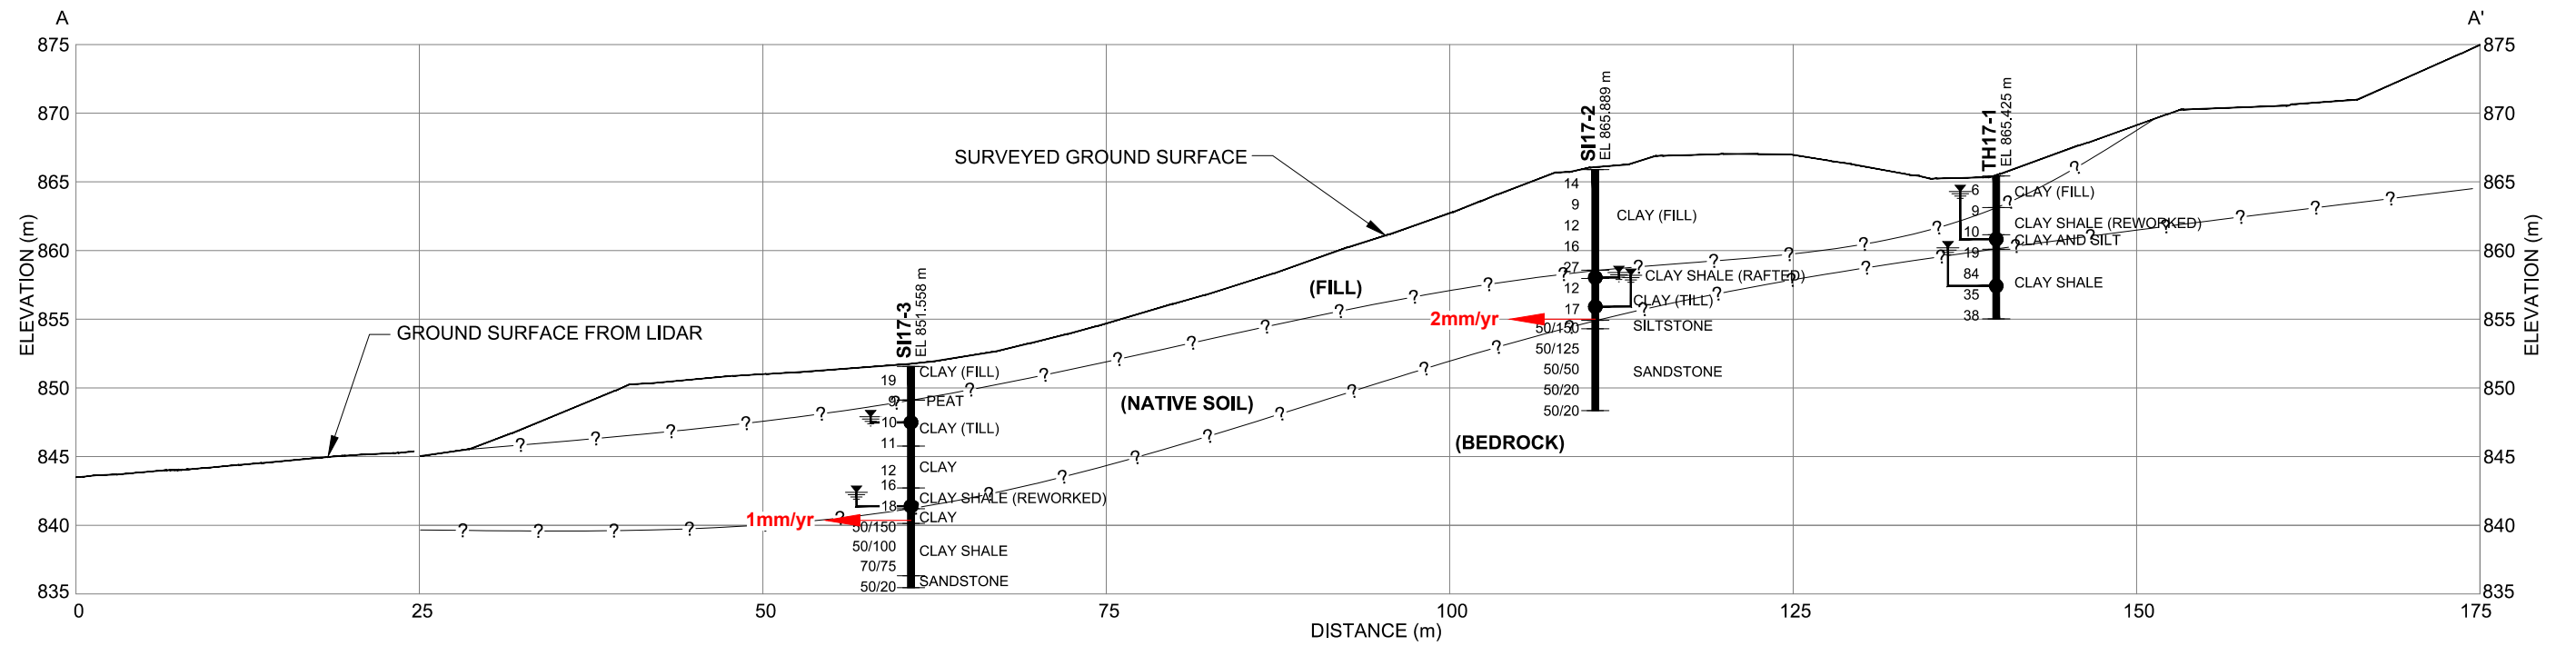
PEACE REGION (GRANDE PRAIRIE)
GP34-1: HWY 40:38, 2.9km SOUTH OF
KAKWA RIVER BRIDGE
CROSS-SECTION A - A'

The last set of inclinometer monitoring (from June 2018) showed that SI 17-5 had sheared off at 7.3 m and SI 17-6 showed movement of 36 mm/yr (showed on attached section B-B'), while much slower rates of 1 to 2 mm/yr were measured in SI's 17-2 and 17-3 (shown on attached section A-A'). These are similar rates indicated for SI17-2/17-3 prior to June 2018. The high rates of movement in SI17-5 and SI17-6 coincide with the large crack observed in the pavement during the 2018 inspection date and indicate movements have re-activated in the former slide area.

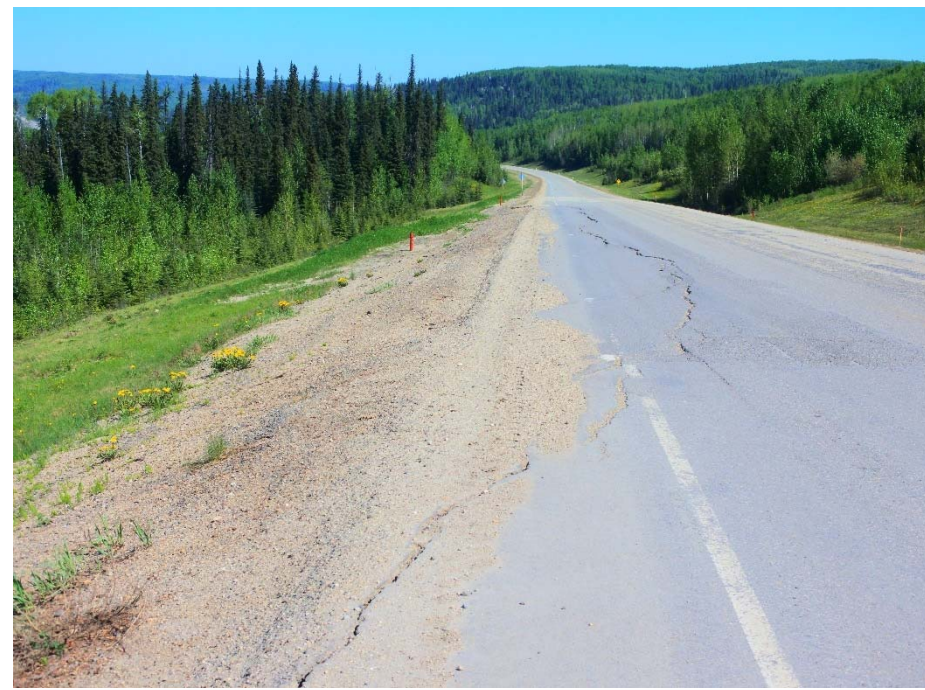
Photo 1.
Looking north at the patched southbound lane and reflective scarp crack from the south end of the patch.

Continue to patch and possibly mill the highway that is affected by the slide scarp area. The dip and crack further north may also require similar maintenance in the future.

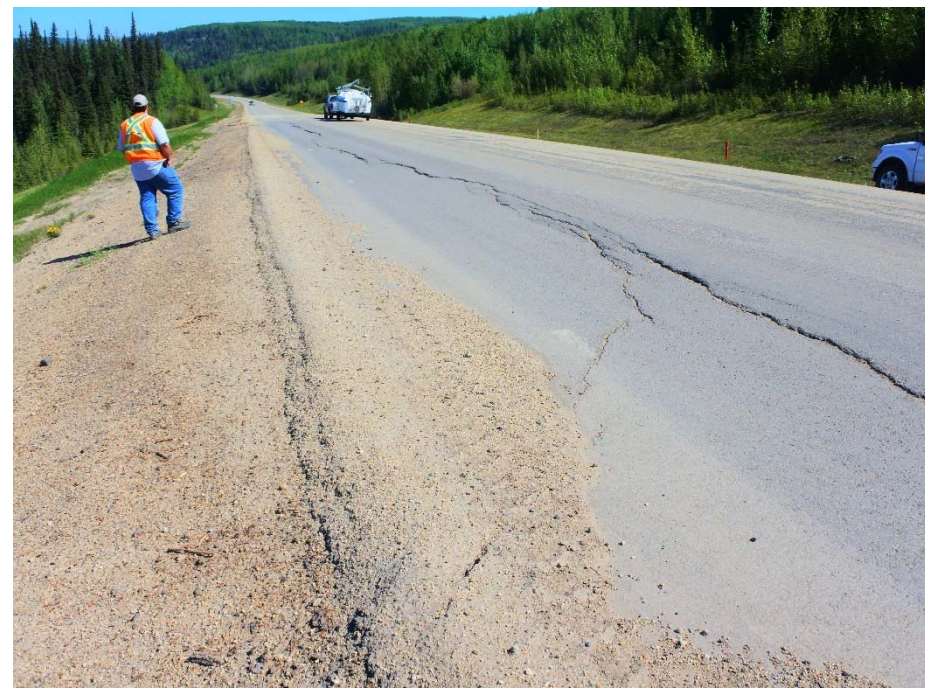
Photo 2.
Looking north at scarp crack from the south end of the patch.

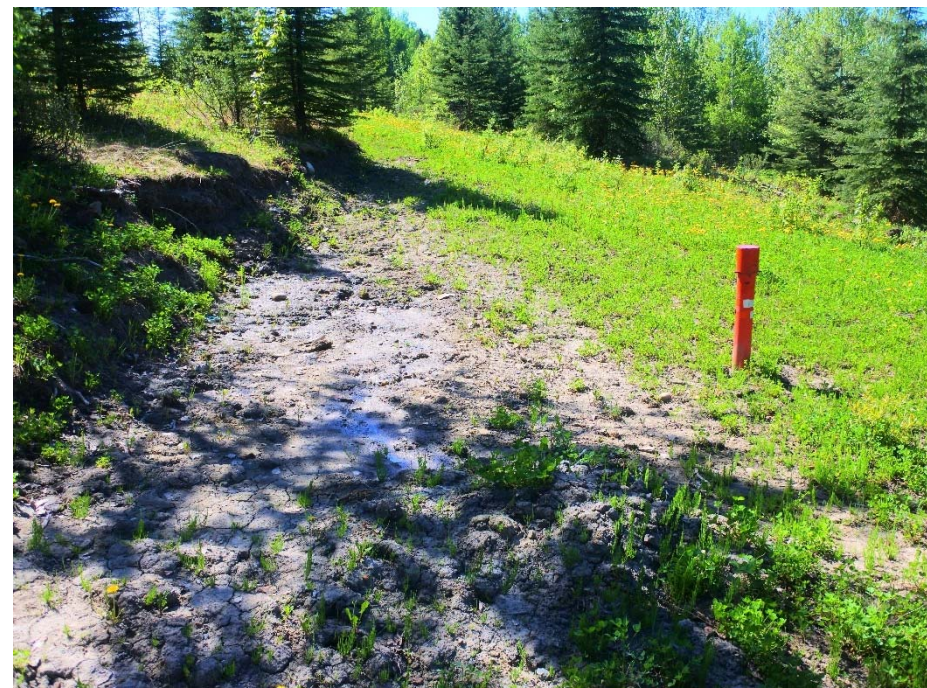
Photo 3.
Looking at SI17-6
at the toe of the
west embankment
where the ground
was wet.

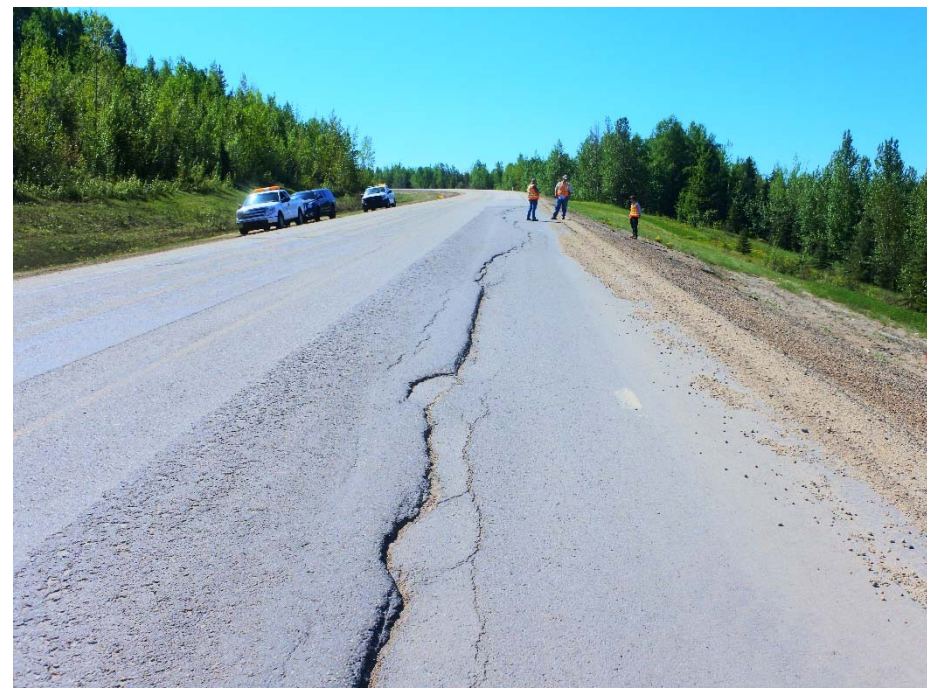
Photo 4.
Looking south at
scarp crack where
the deepest drop
exists.

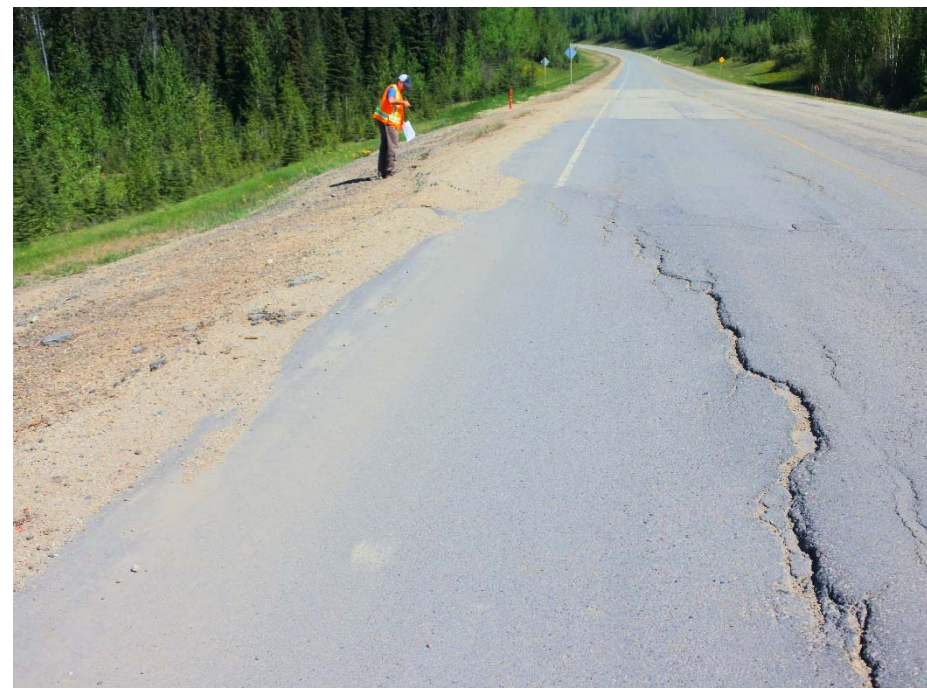
Photo 5.
Looking north at
the north end of the
scarp crack.

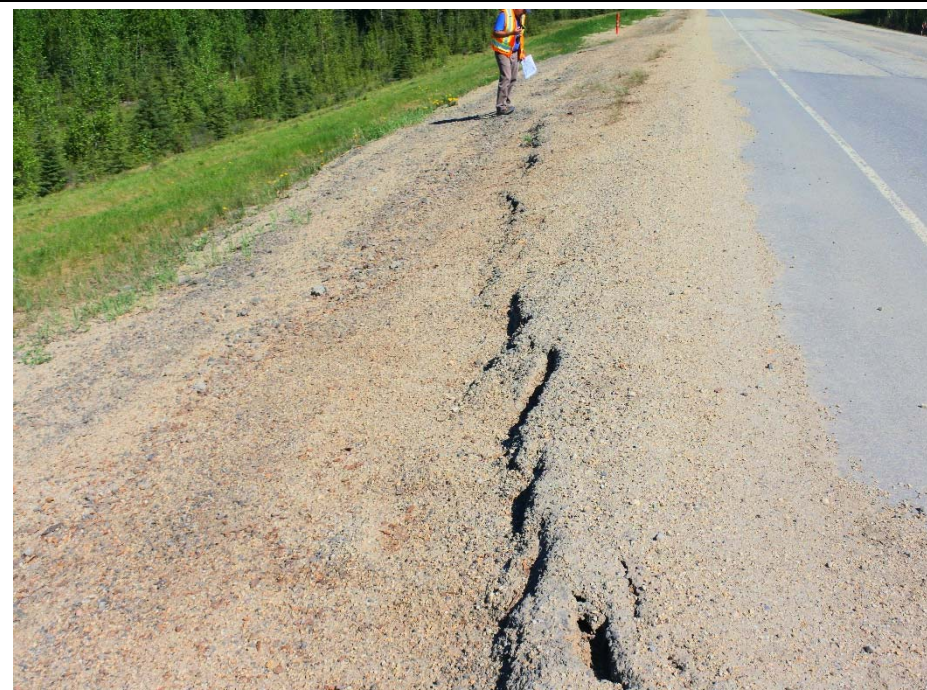
The diagonal crack (see Photo 6), and the movement rates suggest the start of movements further to the north.

Photo 6.
Looking north at
where the scarp
crack extends off of
the shoulder and
into the
embankment.

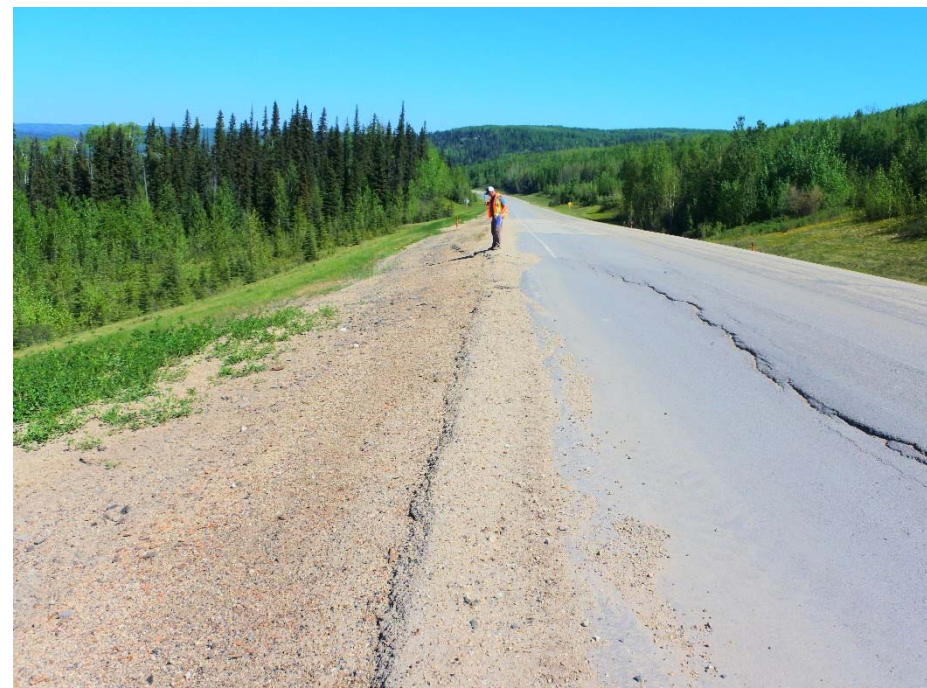
Photo 7.
Looking north towards the north end of the scarp crack and patch, with SI17-2 in the background.

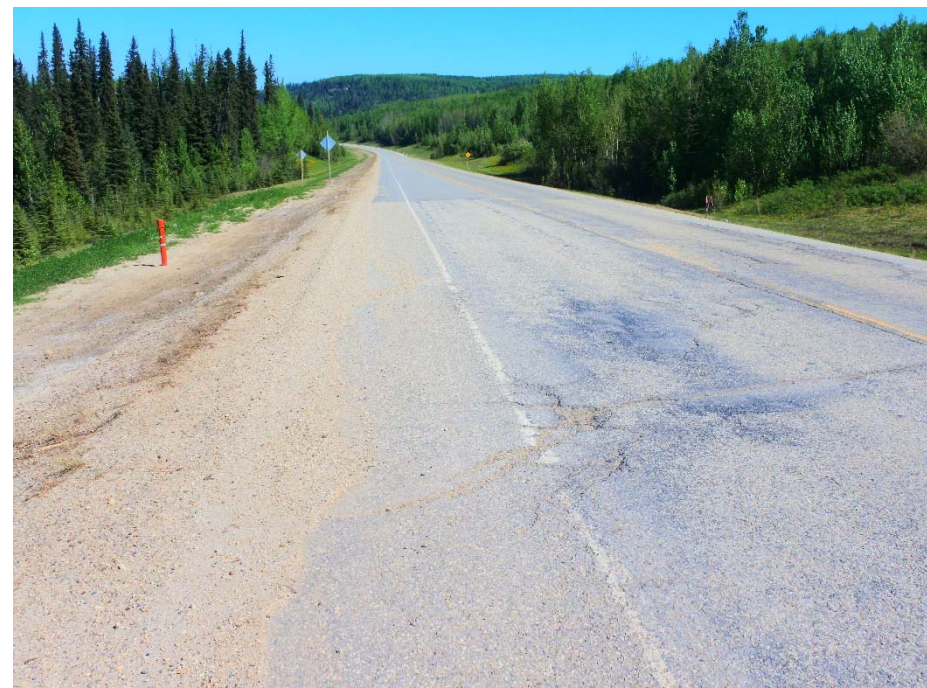
Photo 8.
Looking north at dip in the SBL.
