**ALBERTA TRANSPORTATION  
GEOHAZARD ASSESSMENT PROGRAM  
PEACE REGION – GRANDE PRAIRIE DISTRICT  
2019 INSPECTION**

<b>Site Number</b>	<b>Location</b>	<b>Name</b>	<b>Hwy</b>	<b>km</b>
GP34	NW of Grande Cache	2.9 km S of Kakwa River Bridge	40:38	21.0
<b>Legal Description</b>		<b>UTM Co-ordinates (NAD 83)</b>		
NW28-62-4-W6		11U N 6,028,660	E 399,845

<b>Primary Site Issue:</b>	Landslide in a ~25 m high sidehill highway embankment fill	
<b>Dimensions:</b>	About 100 m long by ~200 m wide	
<b>Date of any remediation:</b>	Within a couple years after construction initiation (early 1980's), dewatering measures consisting of vertical wells (and possibly horizontal drains) were installed, along with a 6 m high toe berm.	
<b>Maintenance:</b>	A full SB lane/shoulder acp patch was placed over the cracked area in June 2015. In summer 2016, 50 mm was milled out of the S.B. lane and was overlaid over the cracked area. An area north of the site was also overlaid over both lanes.	
<b>Observations:</b>	<b>Description</b>	<b>Worse?</b>
<input checked="" type="checkbox"/> Pavement Distress	A headscarp crack is affecting an approximate 80 m length of pavement along the southbound lane/shoulder. The c

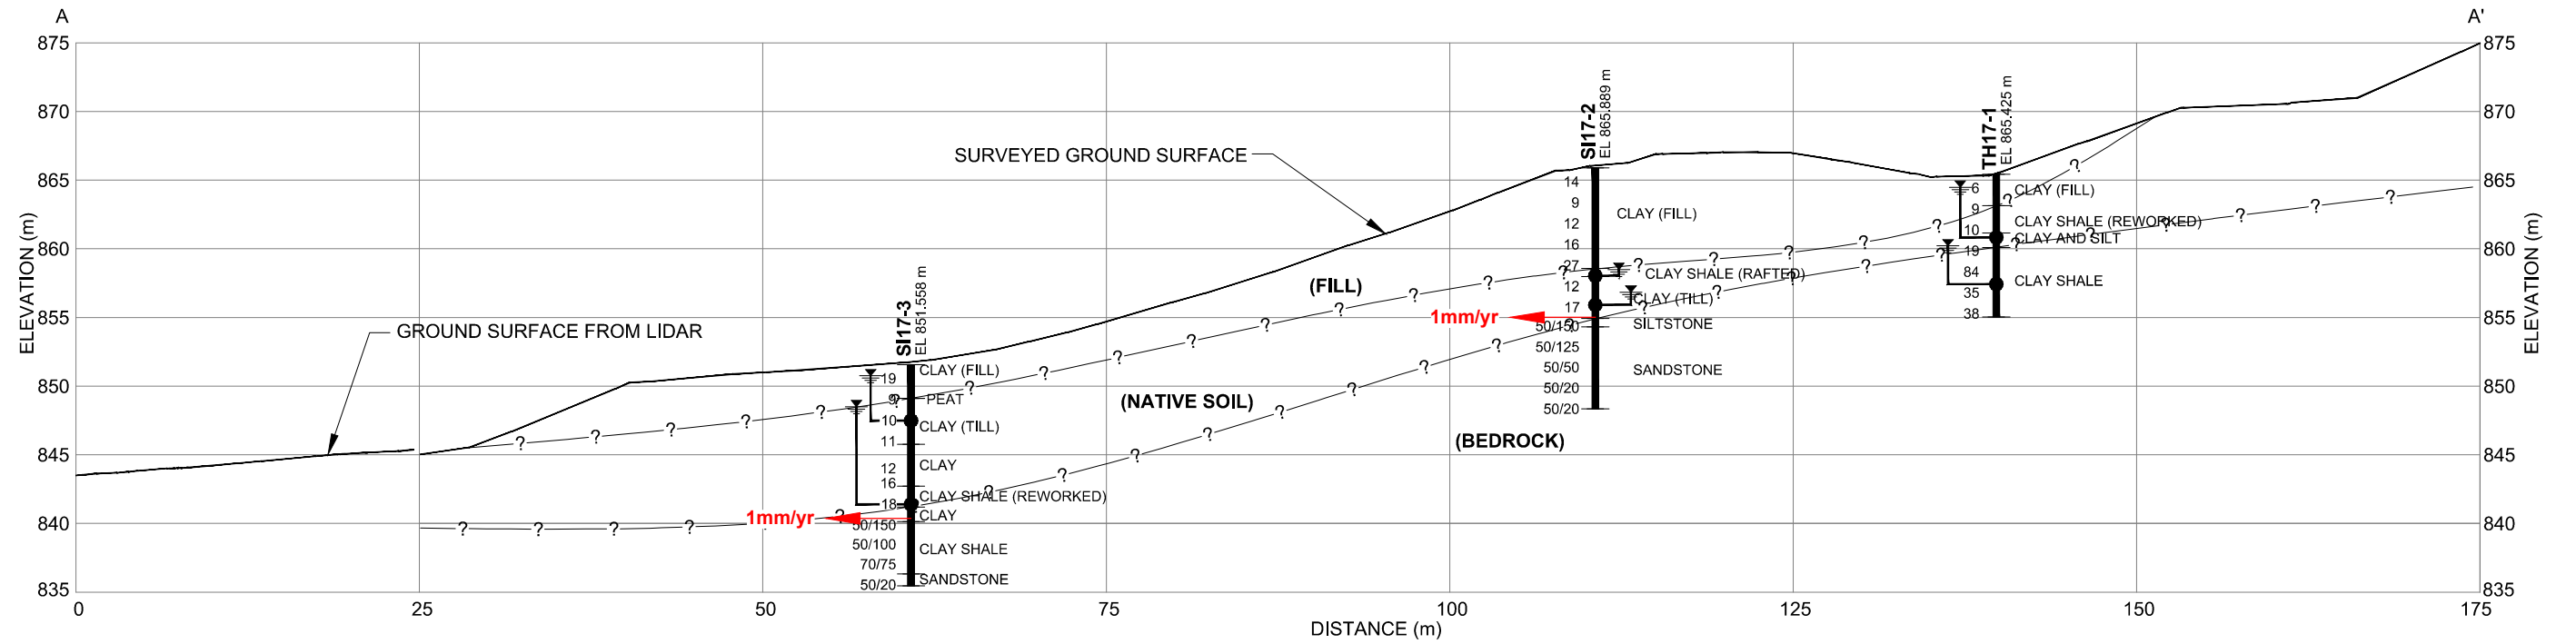
**CROSS-SECTION A - A'**

The last set of inclinometer monitoring (from October 2019) showed that SI 17-5 had sheared off at 7.3 m and SI 17-6 had sheared off at 6.7 m while much slower rates of 1 mm/yr were measured in SI's 17-2 and 17-3 (shown on attached section A-A').

These are similar rates indicated for SI17-2/17-3 prior to October 2019. The high rates of movement in SI17-5 and SI17-6 coincide with the large crack observed in the pavement during the 2018 inspection and subsequent worsening of the cracks in 2019 which have re-activated in the former slide area.

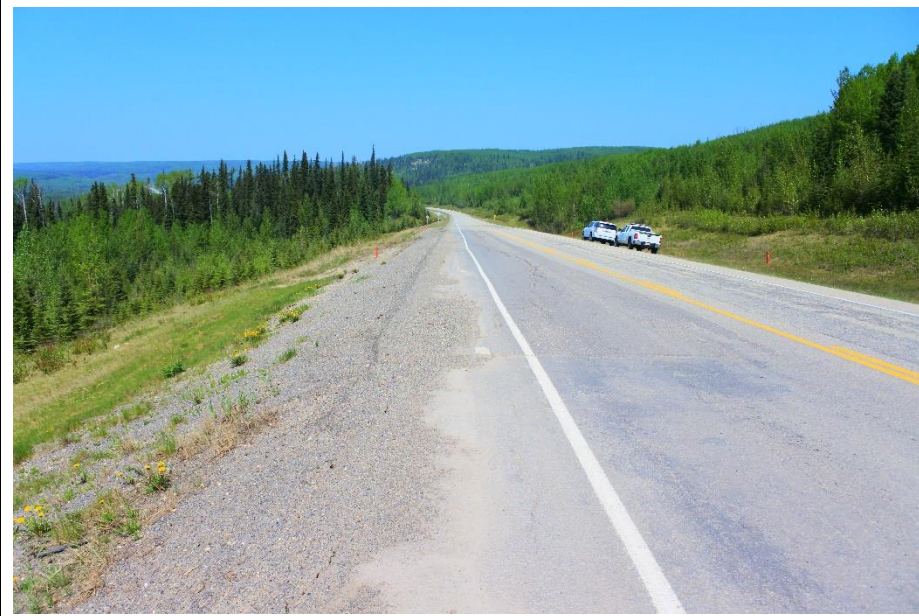
**Photo 1.**  
Looking north at the patched southbound lane and reflective scarp crack from the south end of the patch.

Continue to patch and possibly mill the highway that is affected by the slide scarp area. The dip and crack further north may also require similar maintenance in the future.

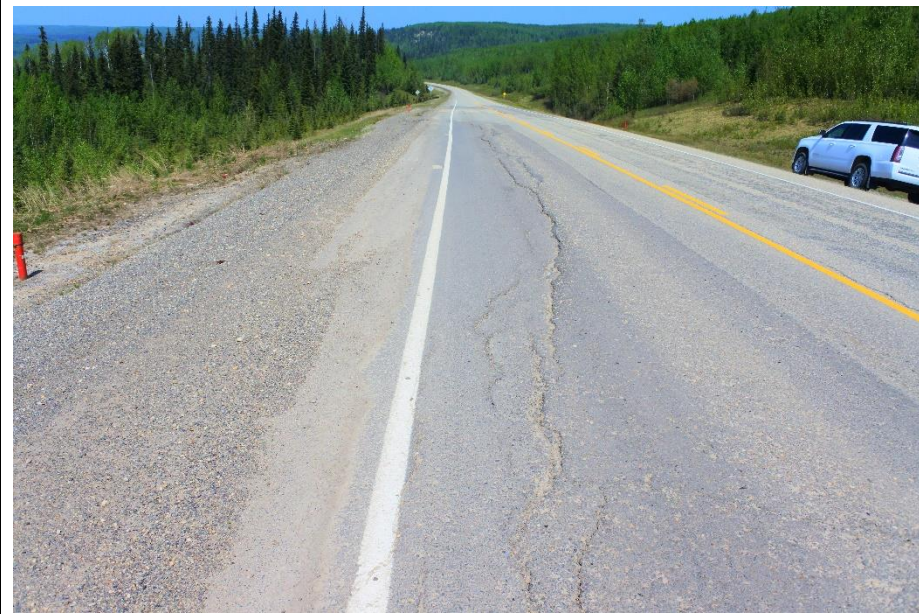
**Photo 2.**  
Looking north at scarp crack from the south end of the patch.

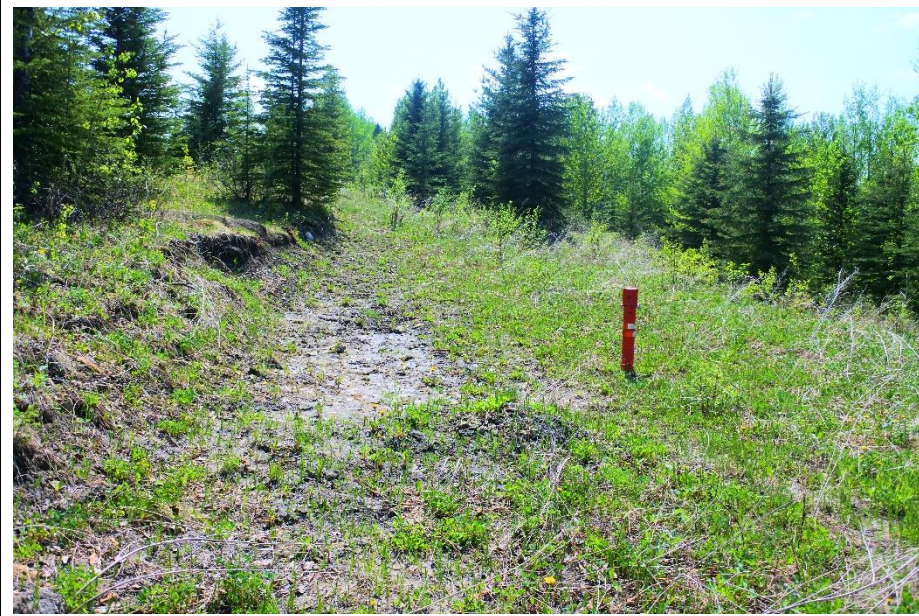
**Photo 3.**  
Looking at SI17-6  
at the toe of the  
west embankment  
where the ground  
was wet.

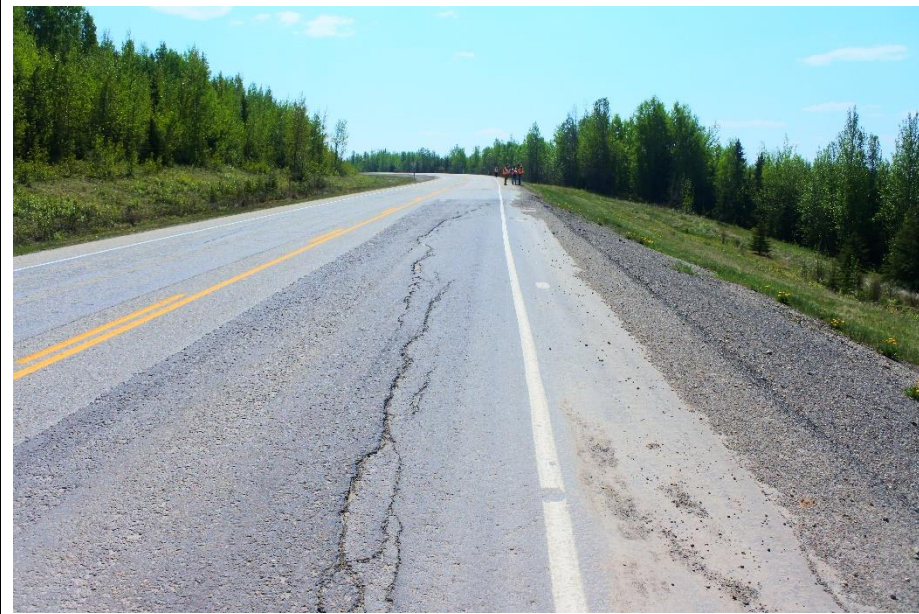
**Photo 4.**  
Looking south at  
scarp crack where  
the deepest drop  
exists.

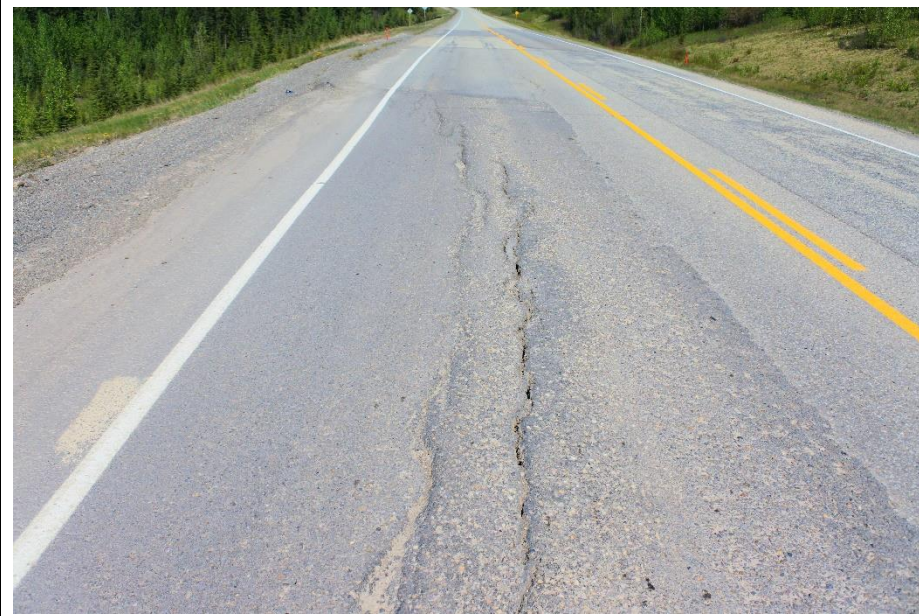
**Photo 5.**  
Looking north at  
the north end of the  
scarp crack.

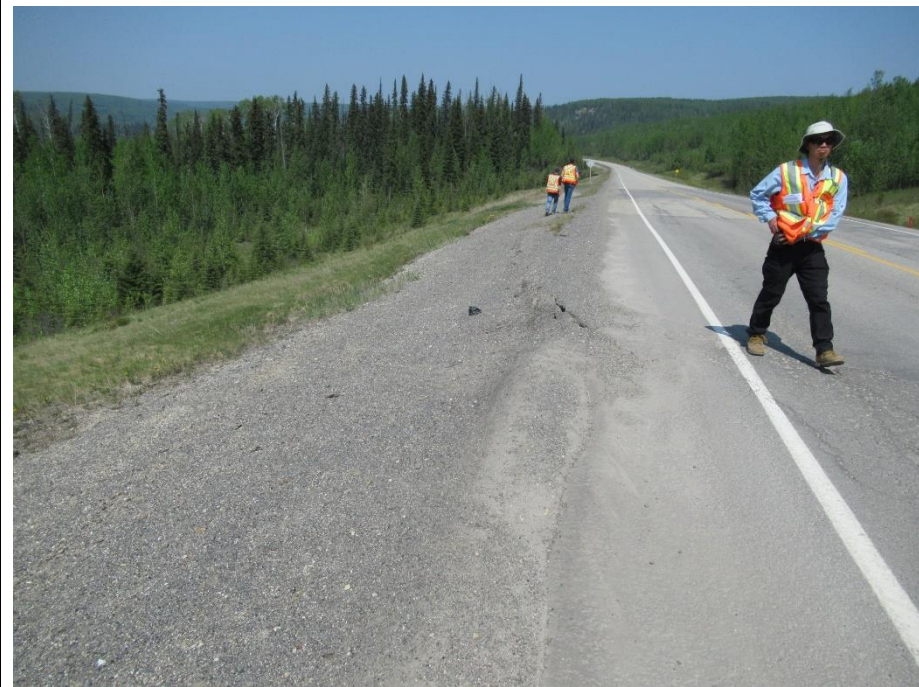
The diagonal crack (see Photo 6), and the movement rates suggest the start of movements further to the north.

**Photo 6.**  
Looking north at  
where the scarp  
crack extends off of  
the shoulder and  
into the  
embankment.

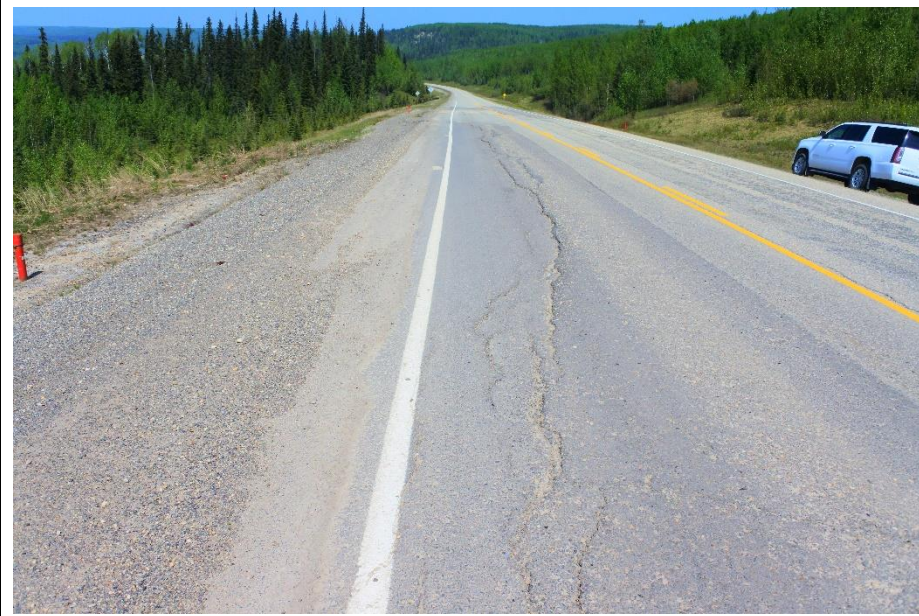
**Photo 7.**  
Looking north  
towards the north  
end of the scarp  
crack and patch,  
with SI17-5 on  
the left

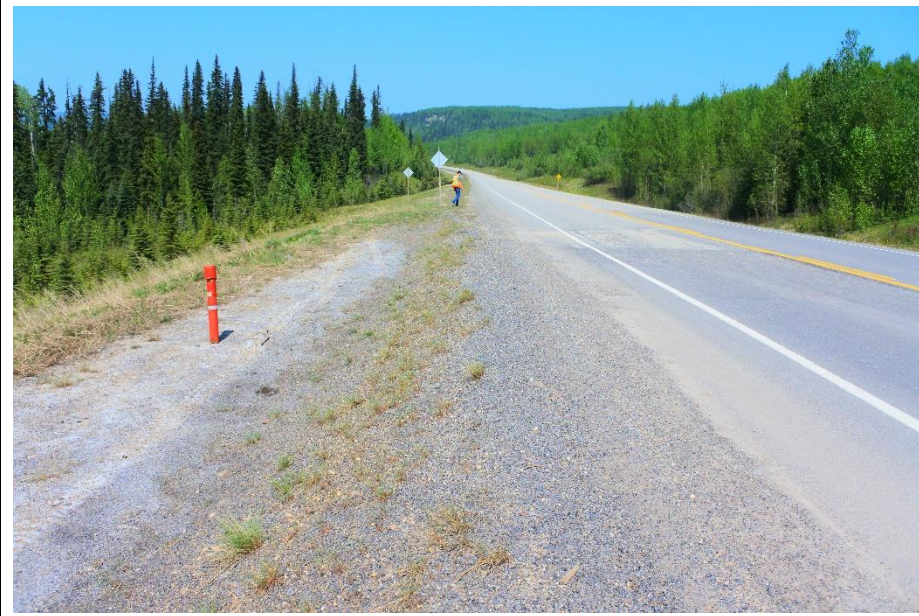
**Photo 8.**  
Looking north at dip  
in the SBL.
