November 30, 2022

**CON0022166 Peace Region (Grande Prairie District – South) GRMP Instrumentation Monitoring Site GP034; H40:38, km 21.016 Slide 2.9 km South of Kakwa River Bridge Section C – 2022 Fall Readings**

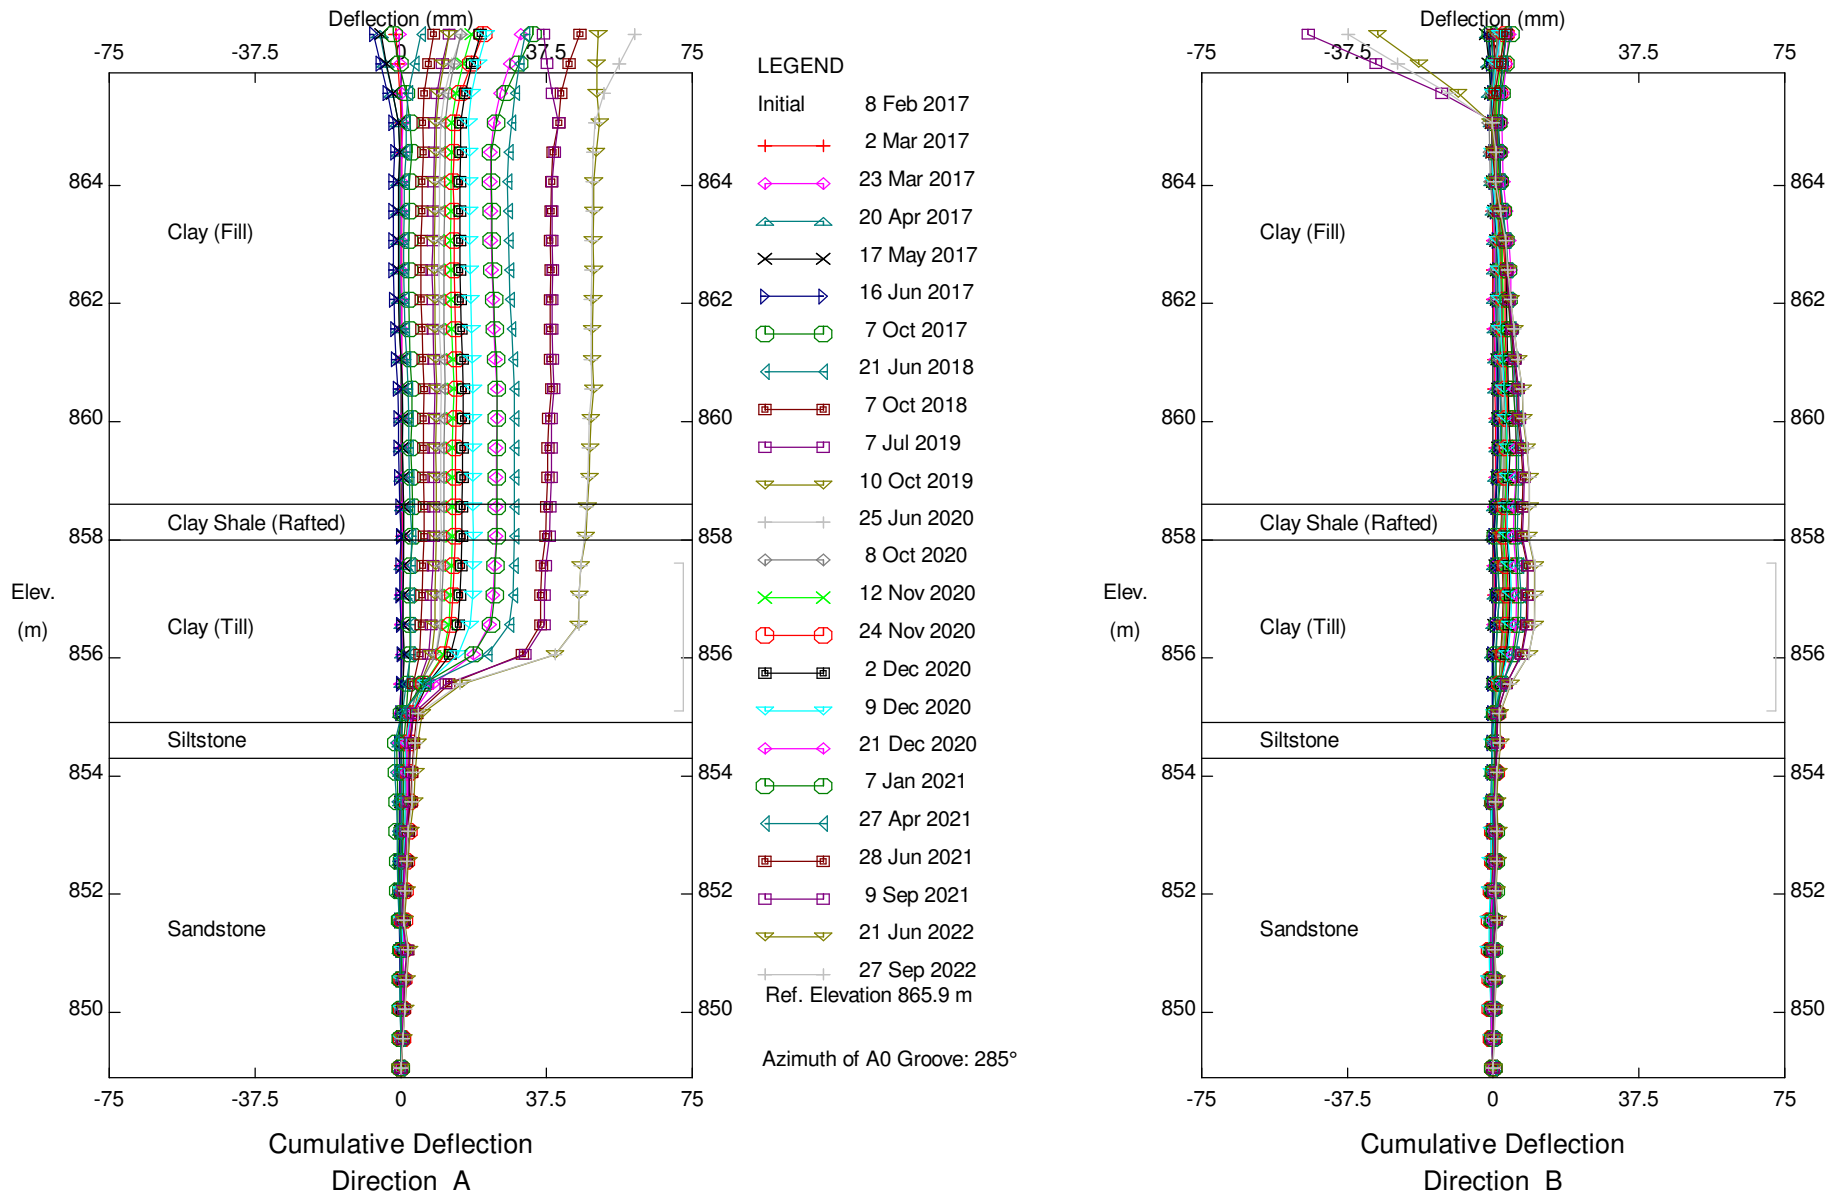
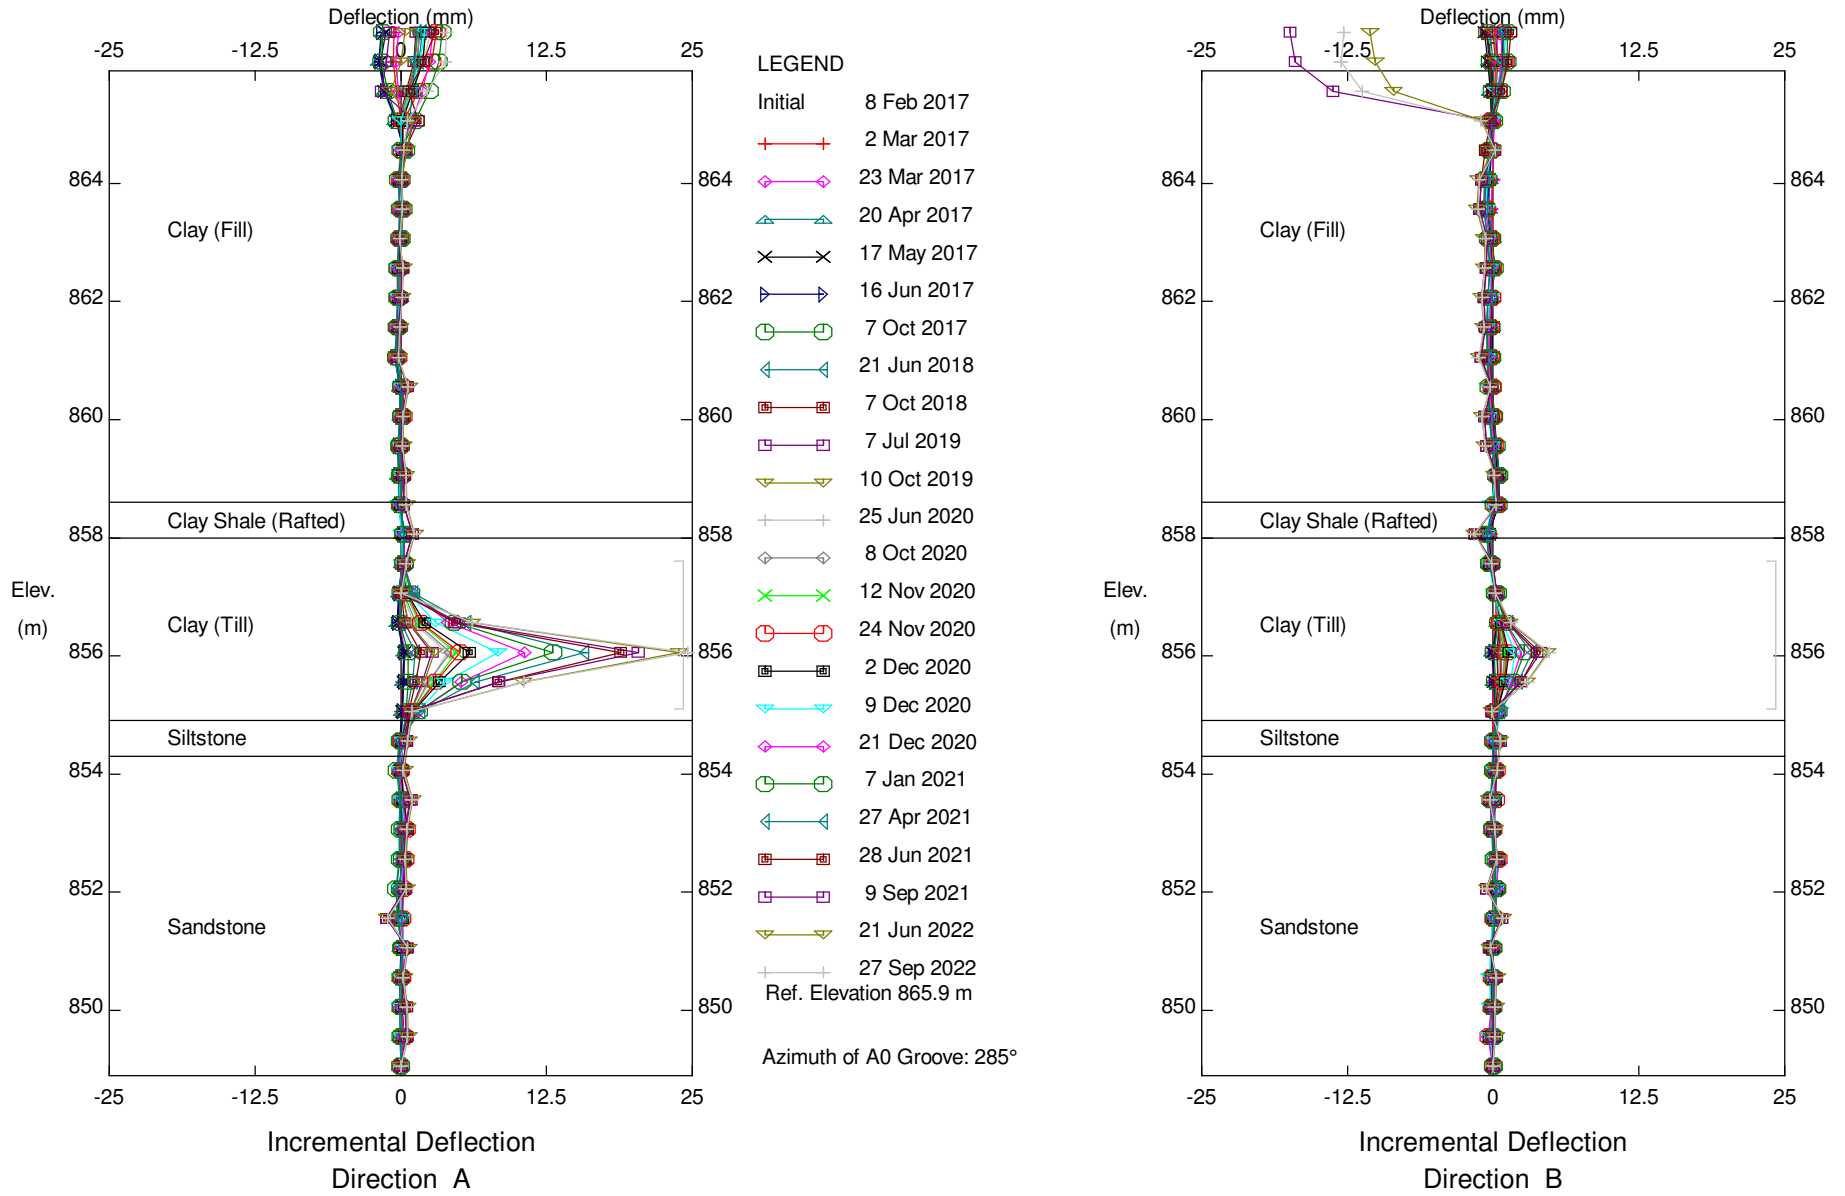
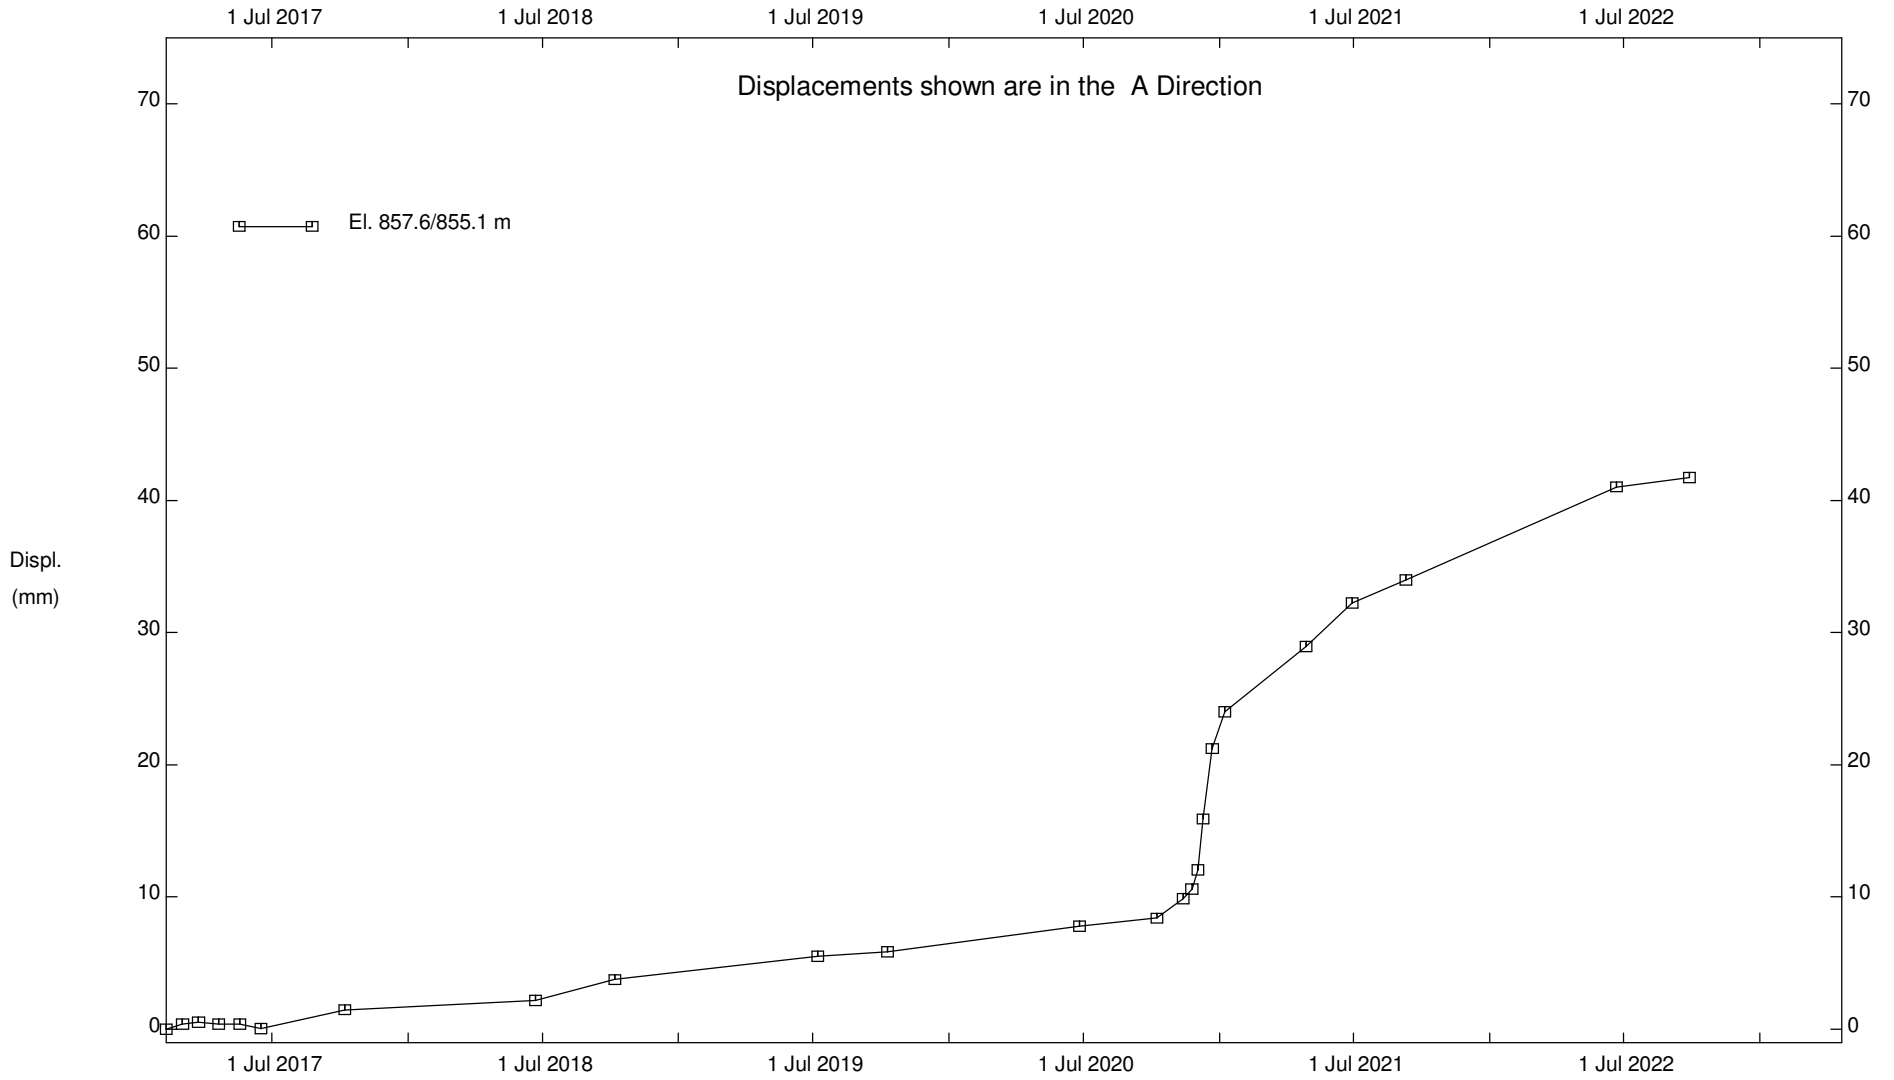
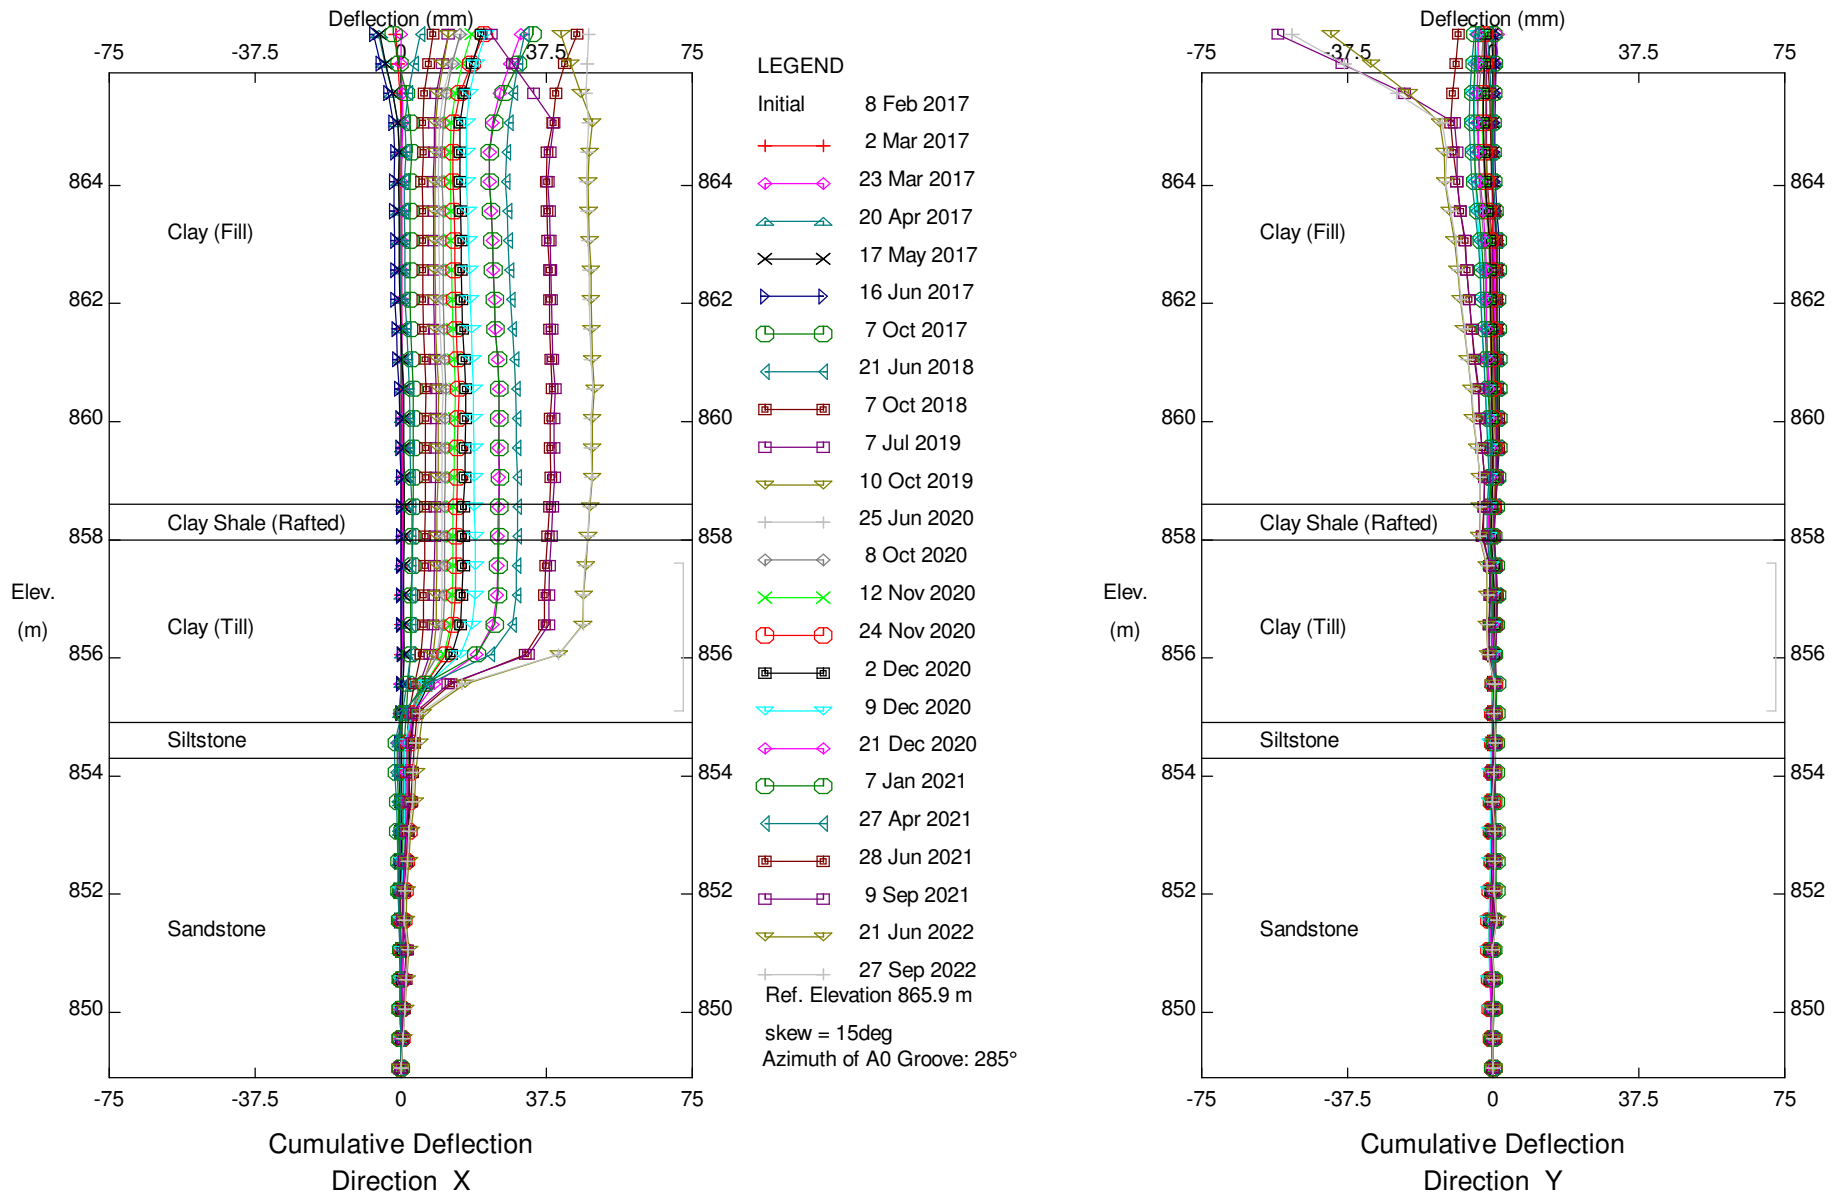
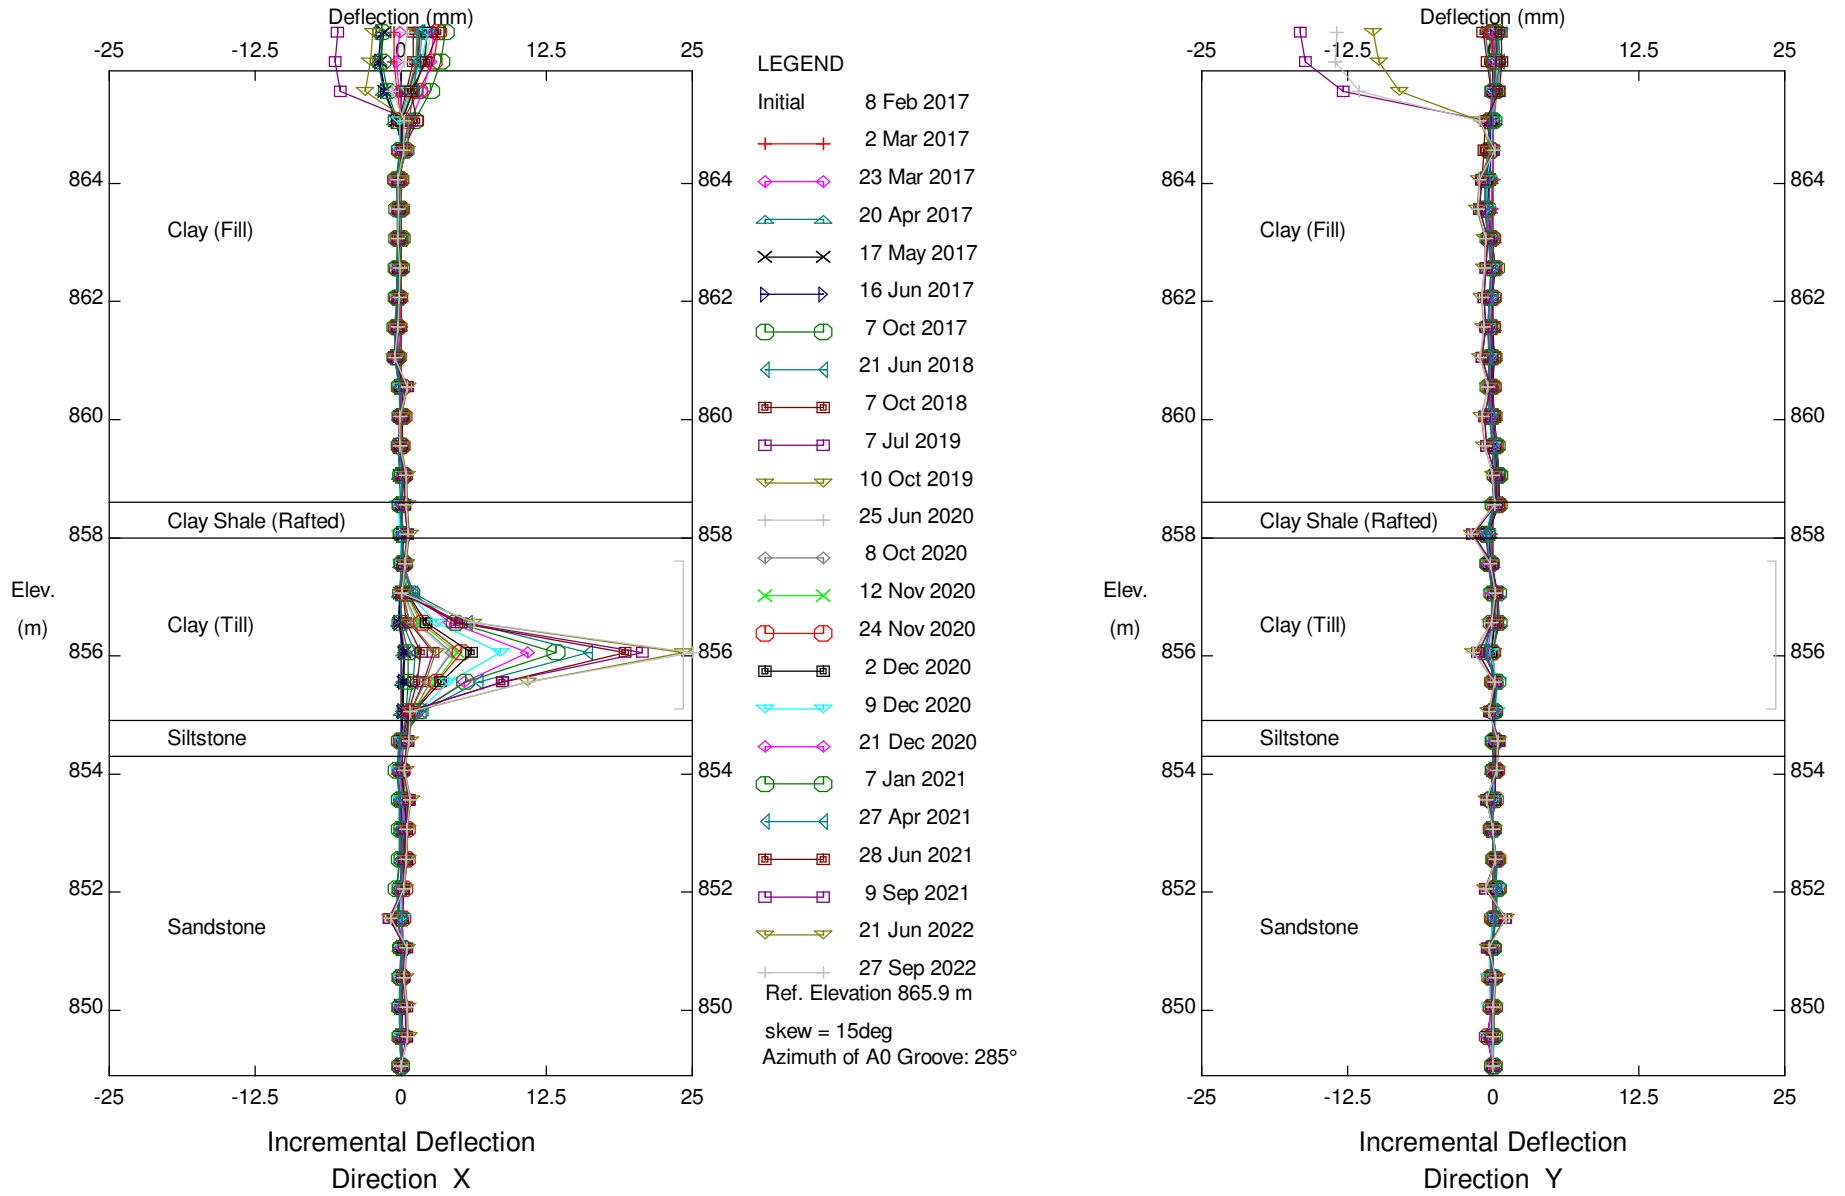
GP034; H40:38, Inclinometer SI17-2

- SI17-2 between an approximate depth of 9.3 m and 10.8 m below ground surface (elevation 856.6 m to 855.1 m) at the bottom of a clay till foundation unit overlying bedrock (siltstone); and
- SI17-3 between an approximate depth of 13.0 m and 14.5 m below ground surface (elevation 841.6 m to 840.1 m) in a clay foundation unit overlying bedrock (clay shale).

The rate of deep foundation movement being recorded in SI17-2 and SI17-3 was relatively slow and steady (less than 5 mm/year) between February 2017 (installation date) and October 2020 but increased up to approximately 212 mm/year and 5519 mm/year, respectively, when construction began in late-2020. Since January 2021, the rate of deep foundation movement recorded in SI17-2 and SI17-3 has decreased significantly and is currently less than 10 mm/year.

The elevated porewater pressures recorded in PN17-5B (did not stabilize in September 2022) and PN17-6B, installed depth near approximate elevations of 855 m and 845 m, respectively, are potentially attributing to the increased rate of movement recorded in SI17-2 at an approximate depth of 10 m below ground surface. The time required for excess porewater pressures to decrease could take several months, with accompanied continued movement in the foundation.
