November 30, 2022

**CON0022166 Peace Region (Grande Prairie District – South) GRMP Instrumentation Monitoring Site GP034; H40:38, km 21.016 Slide 2.9 km South of Kakwa River Bridge Section C – 2022 Fall Readings**

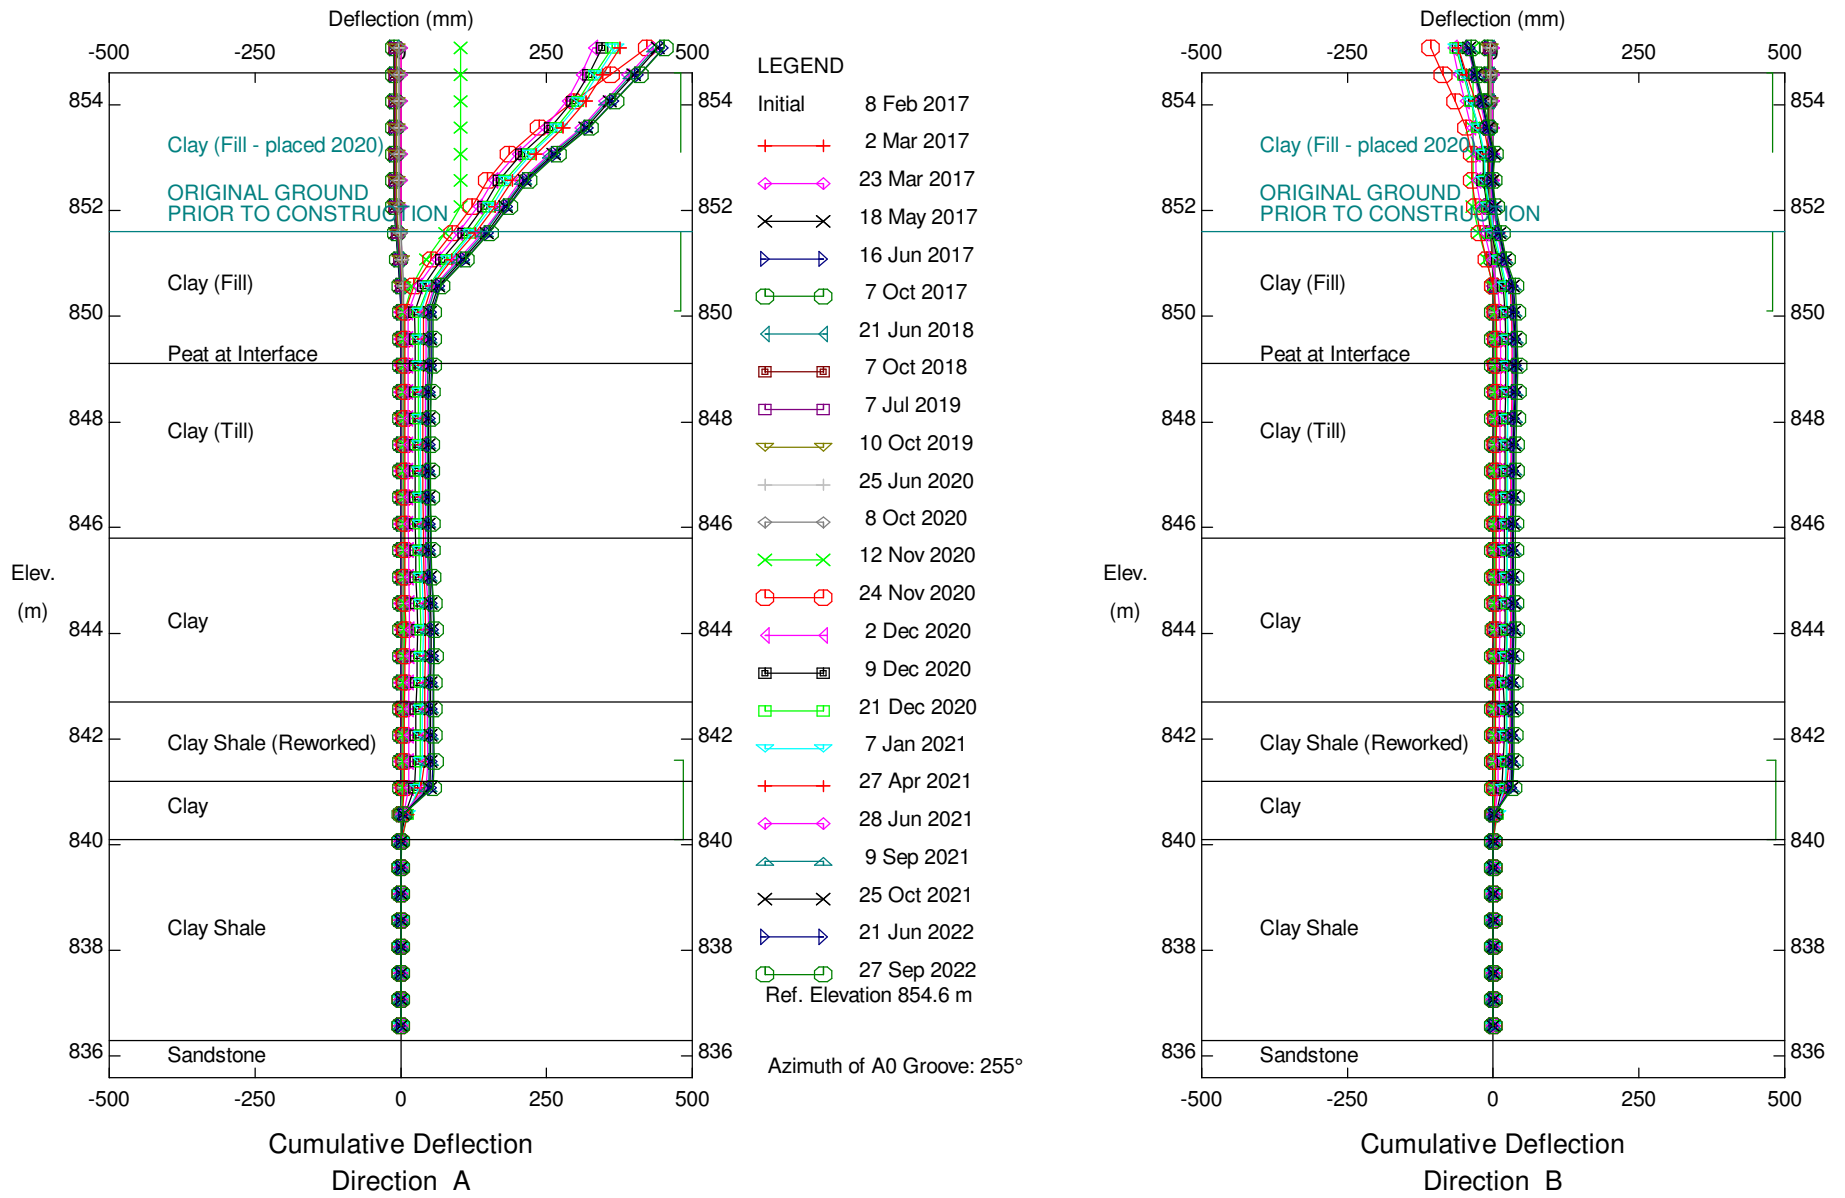
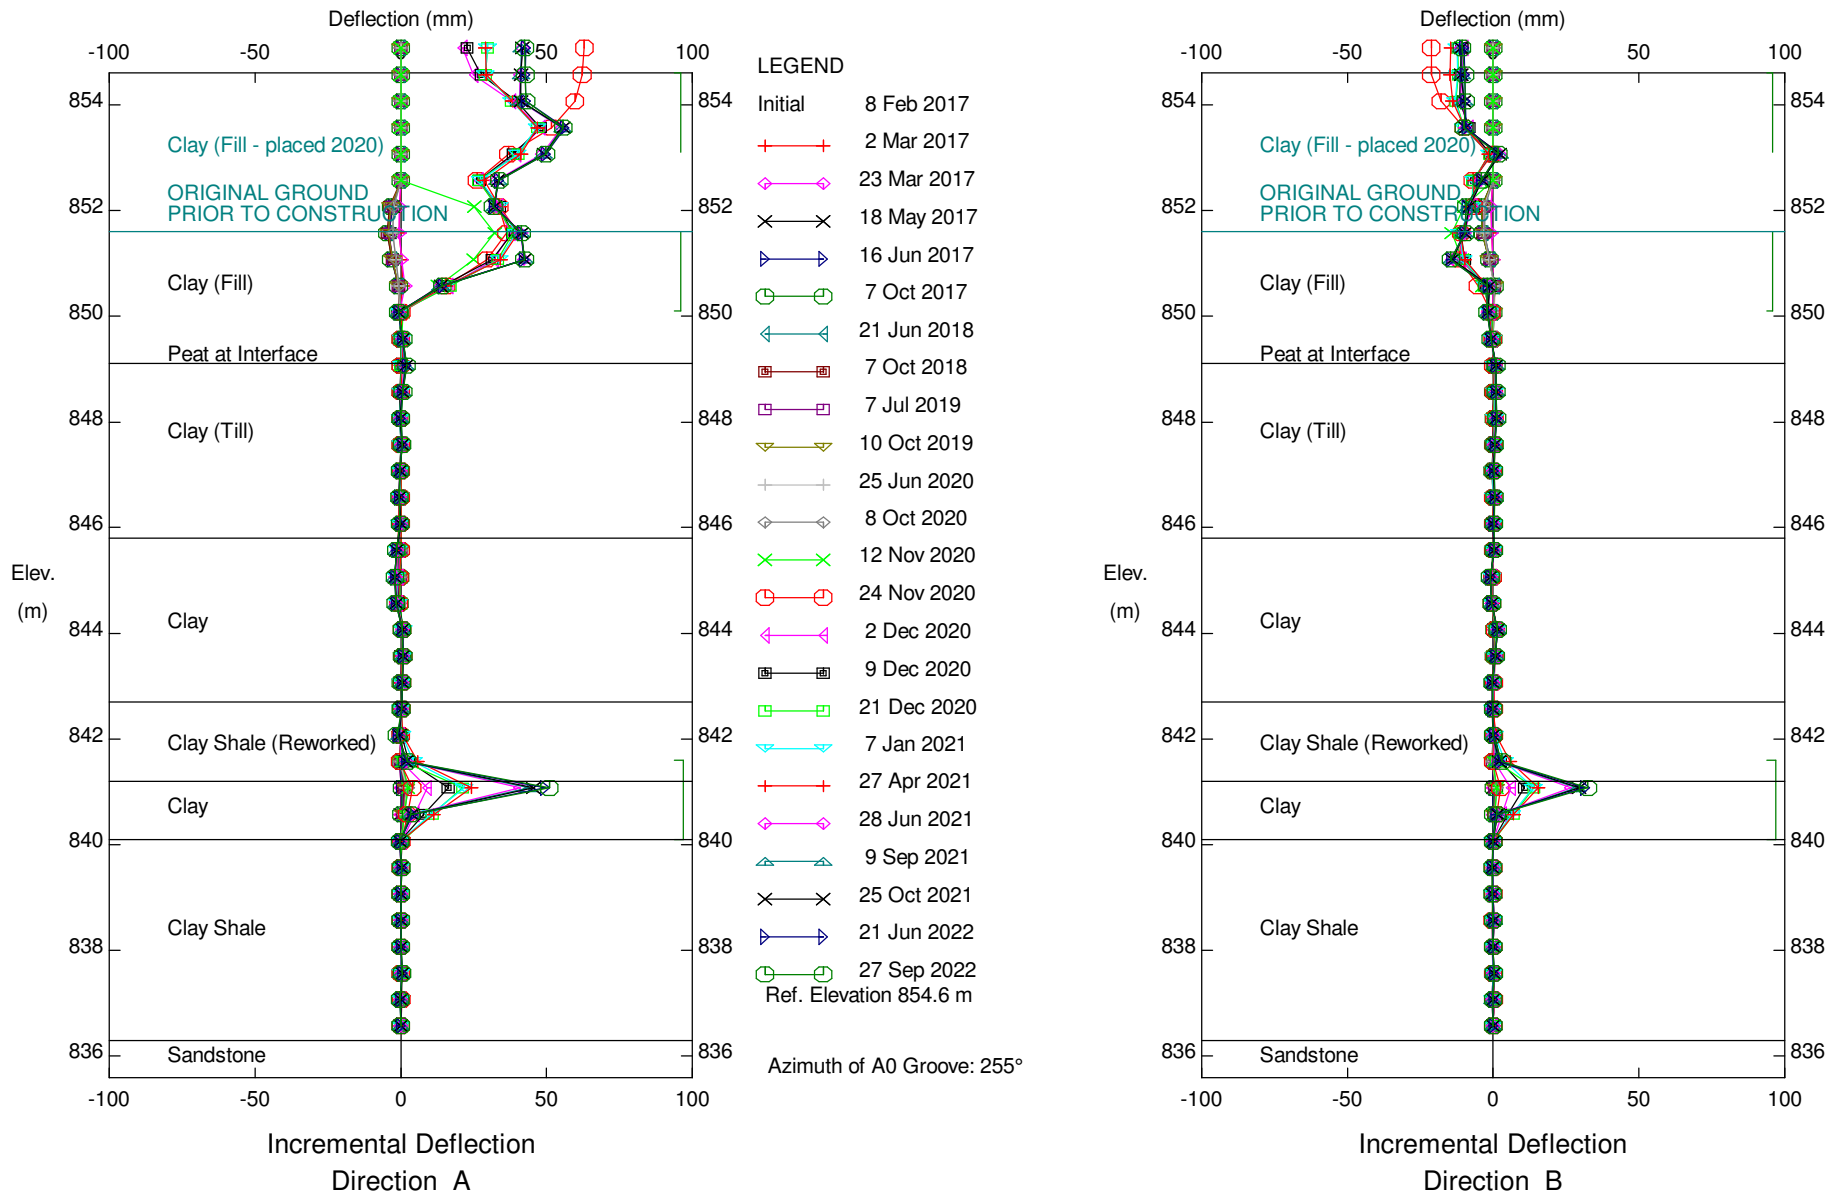
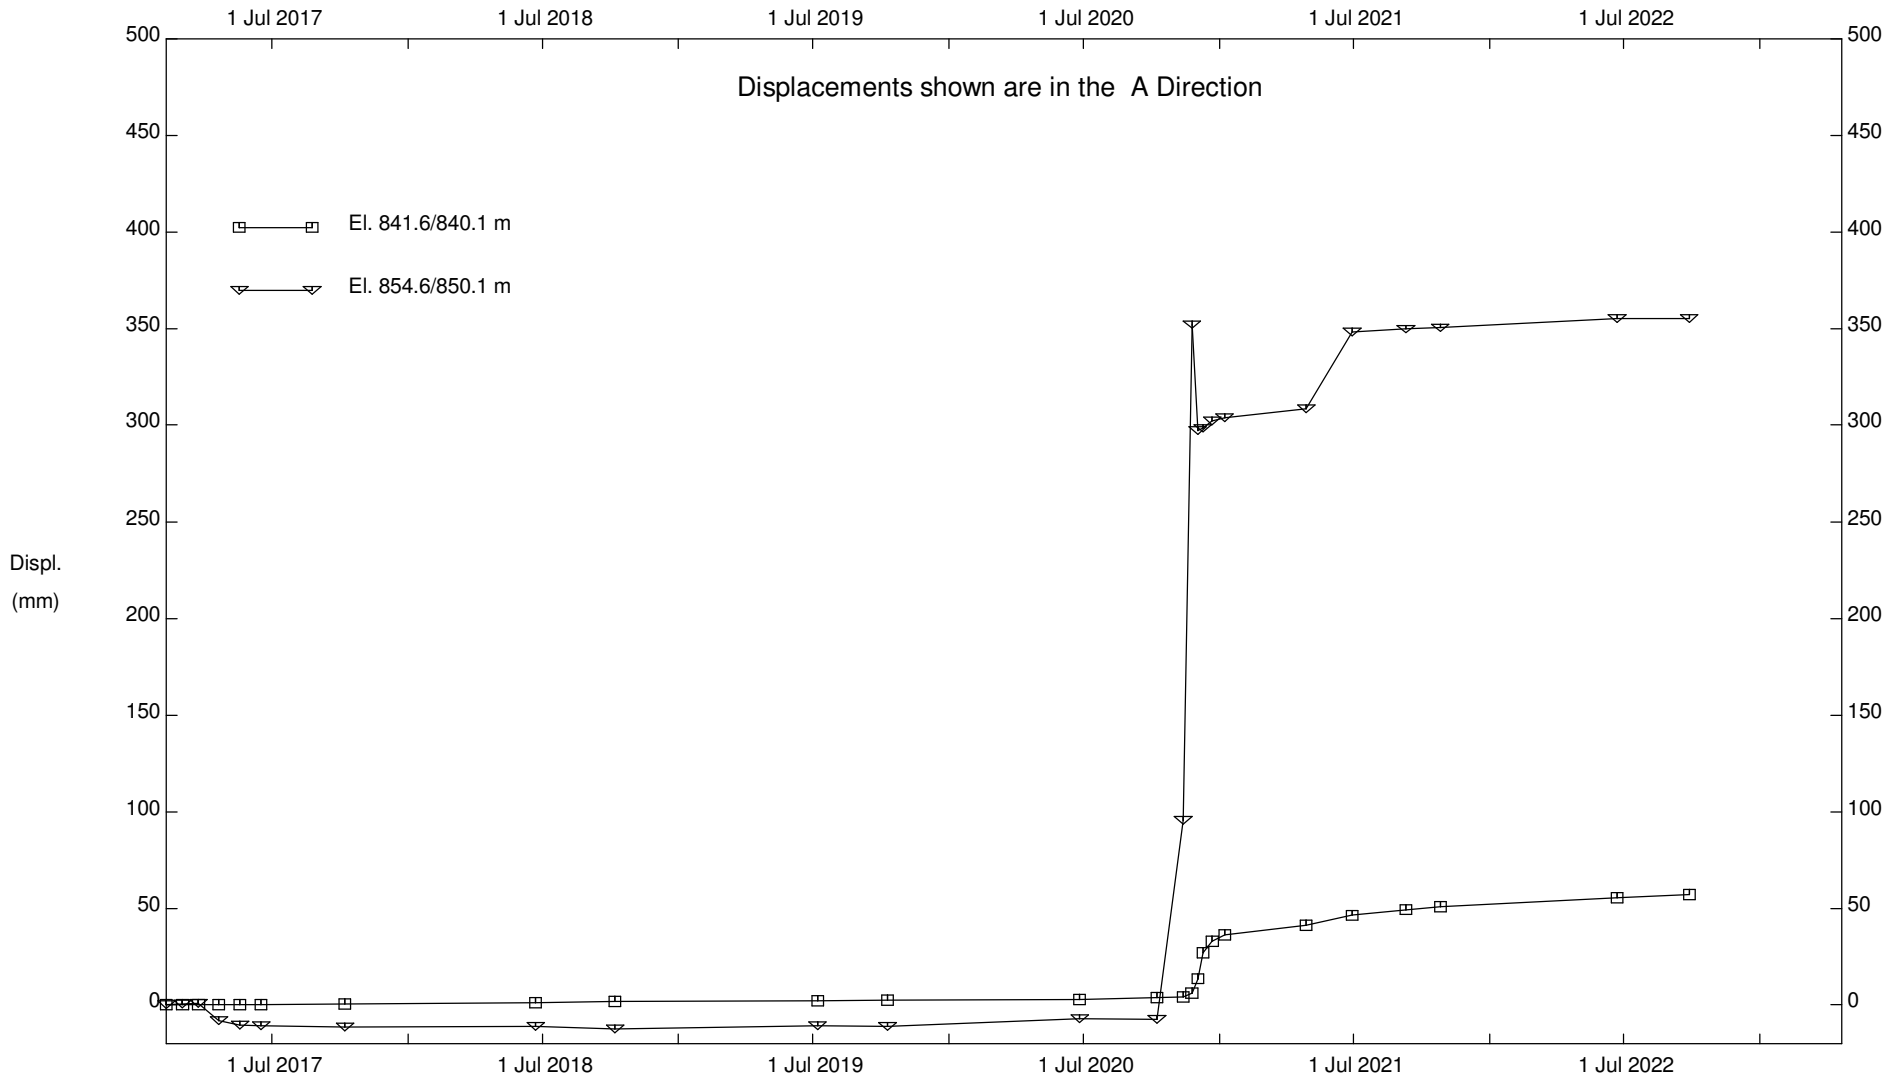
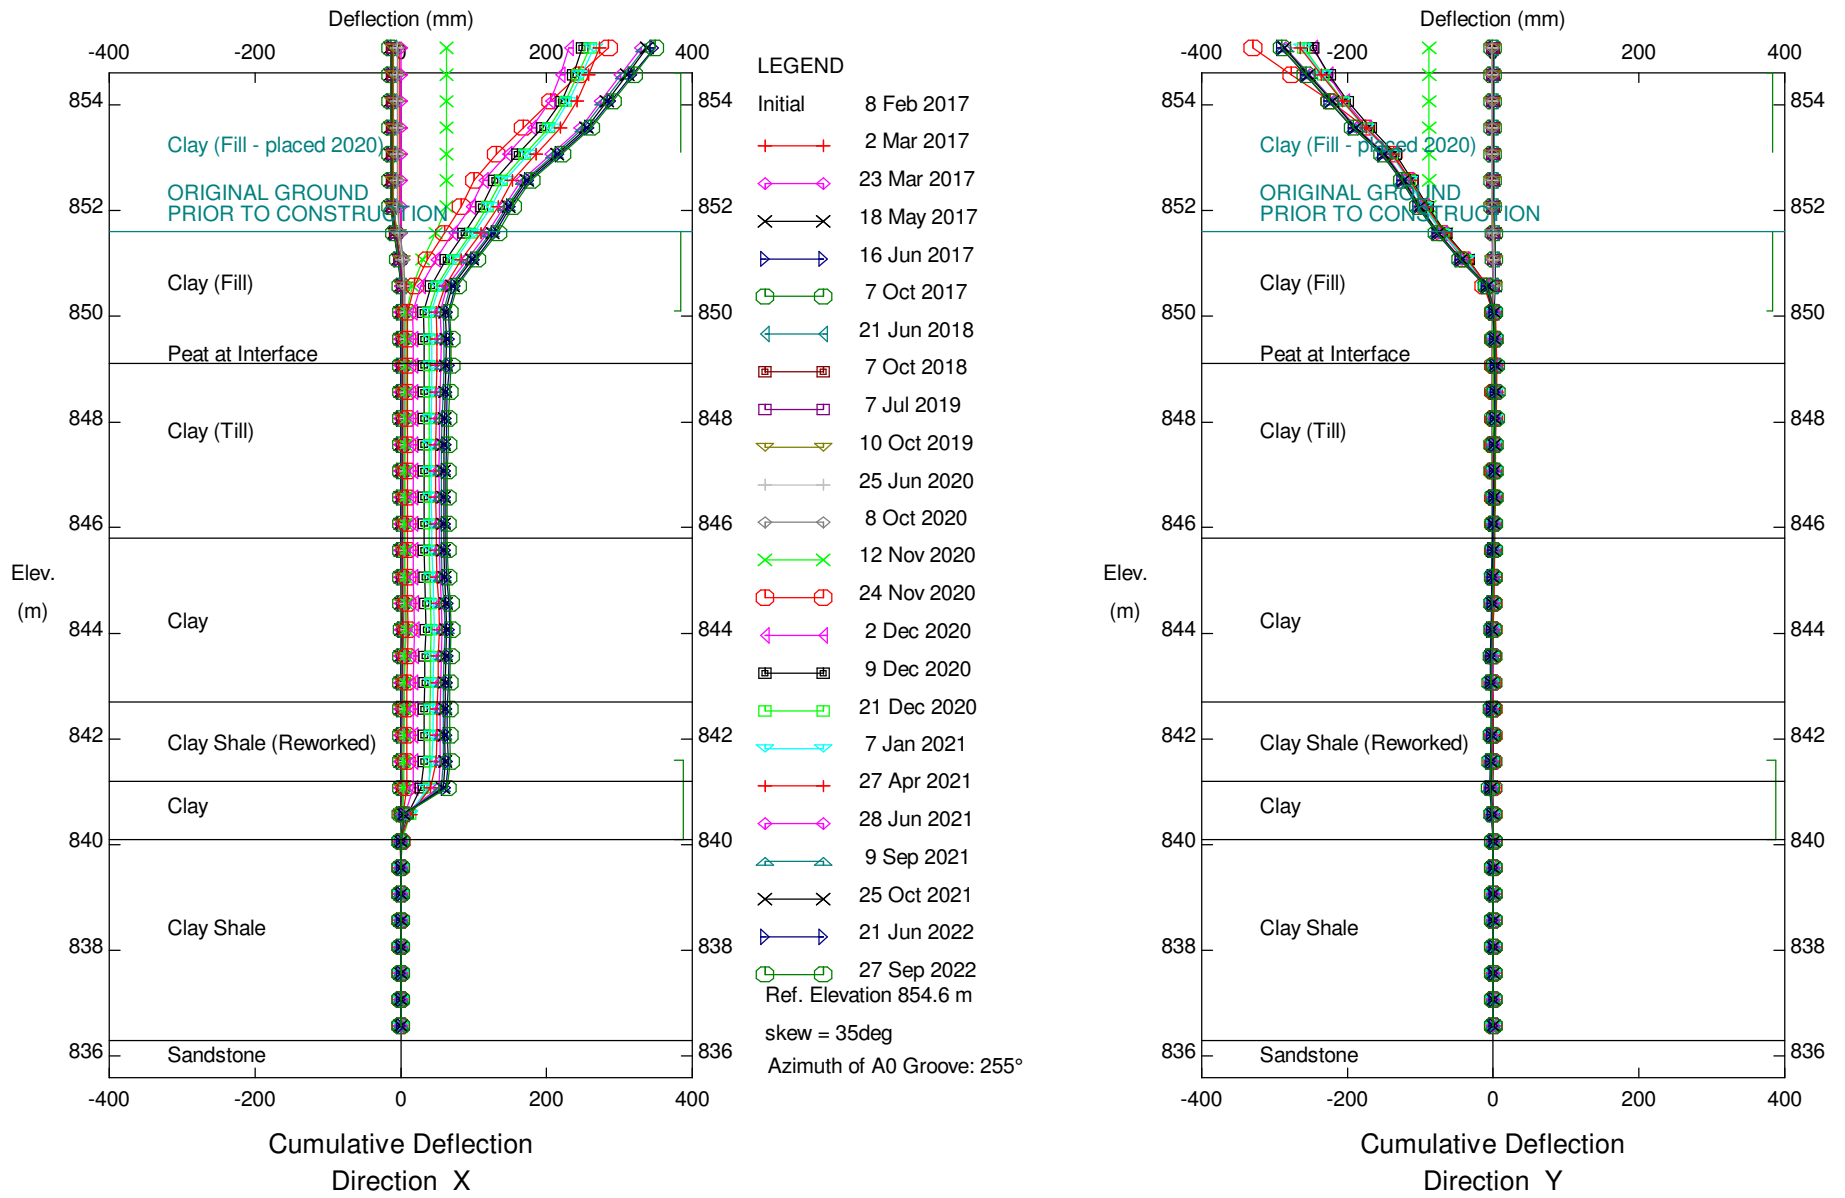
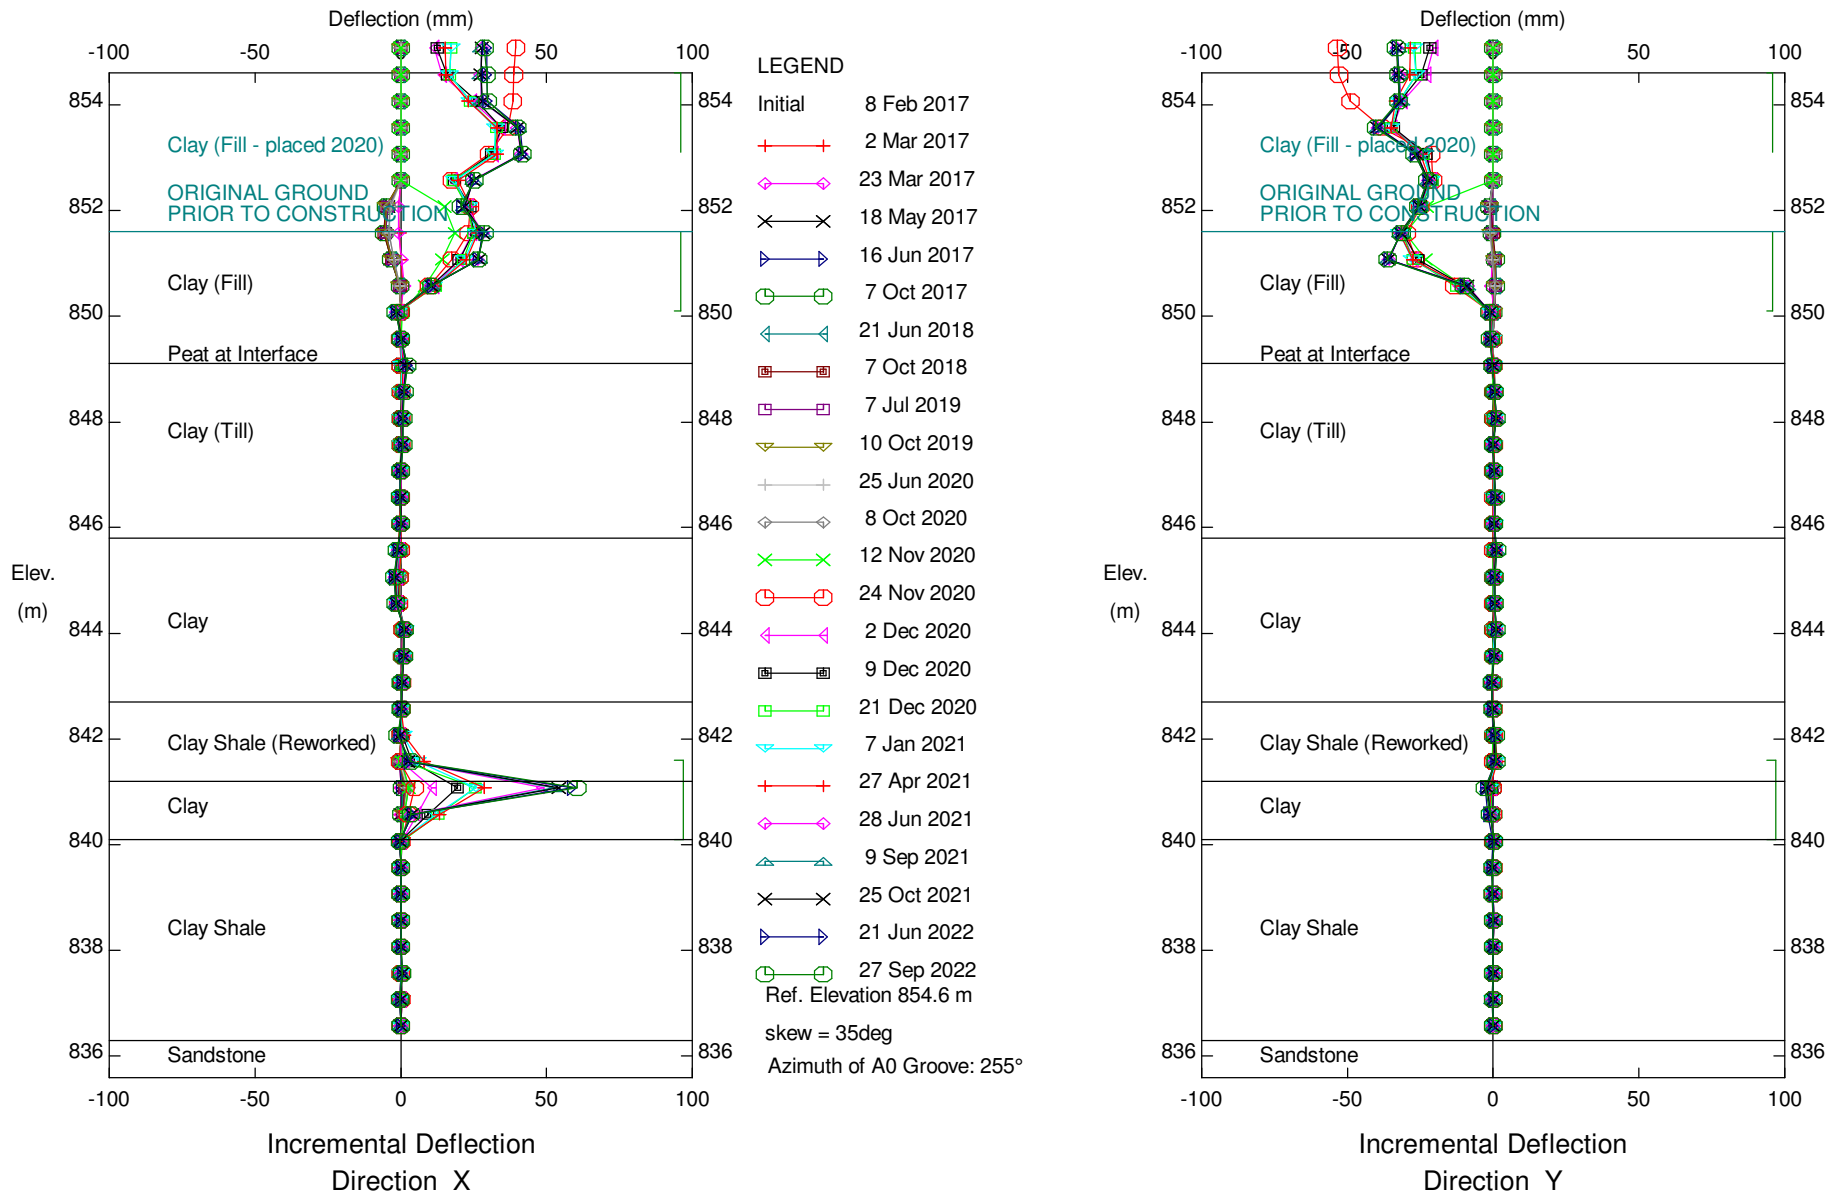
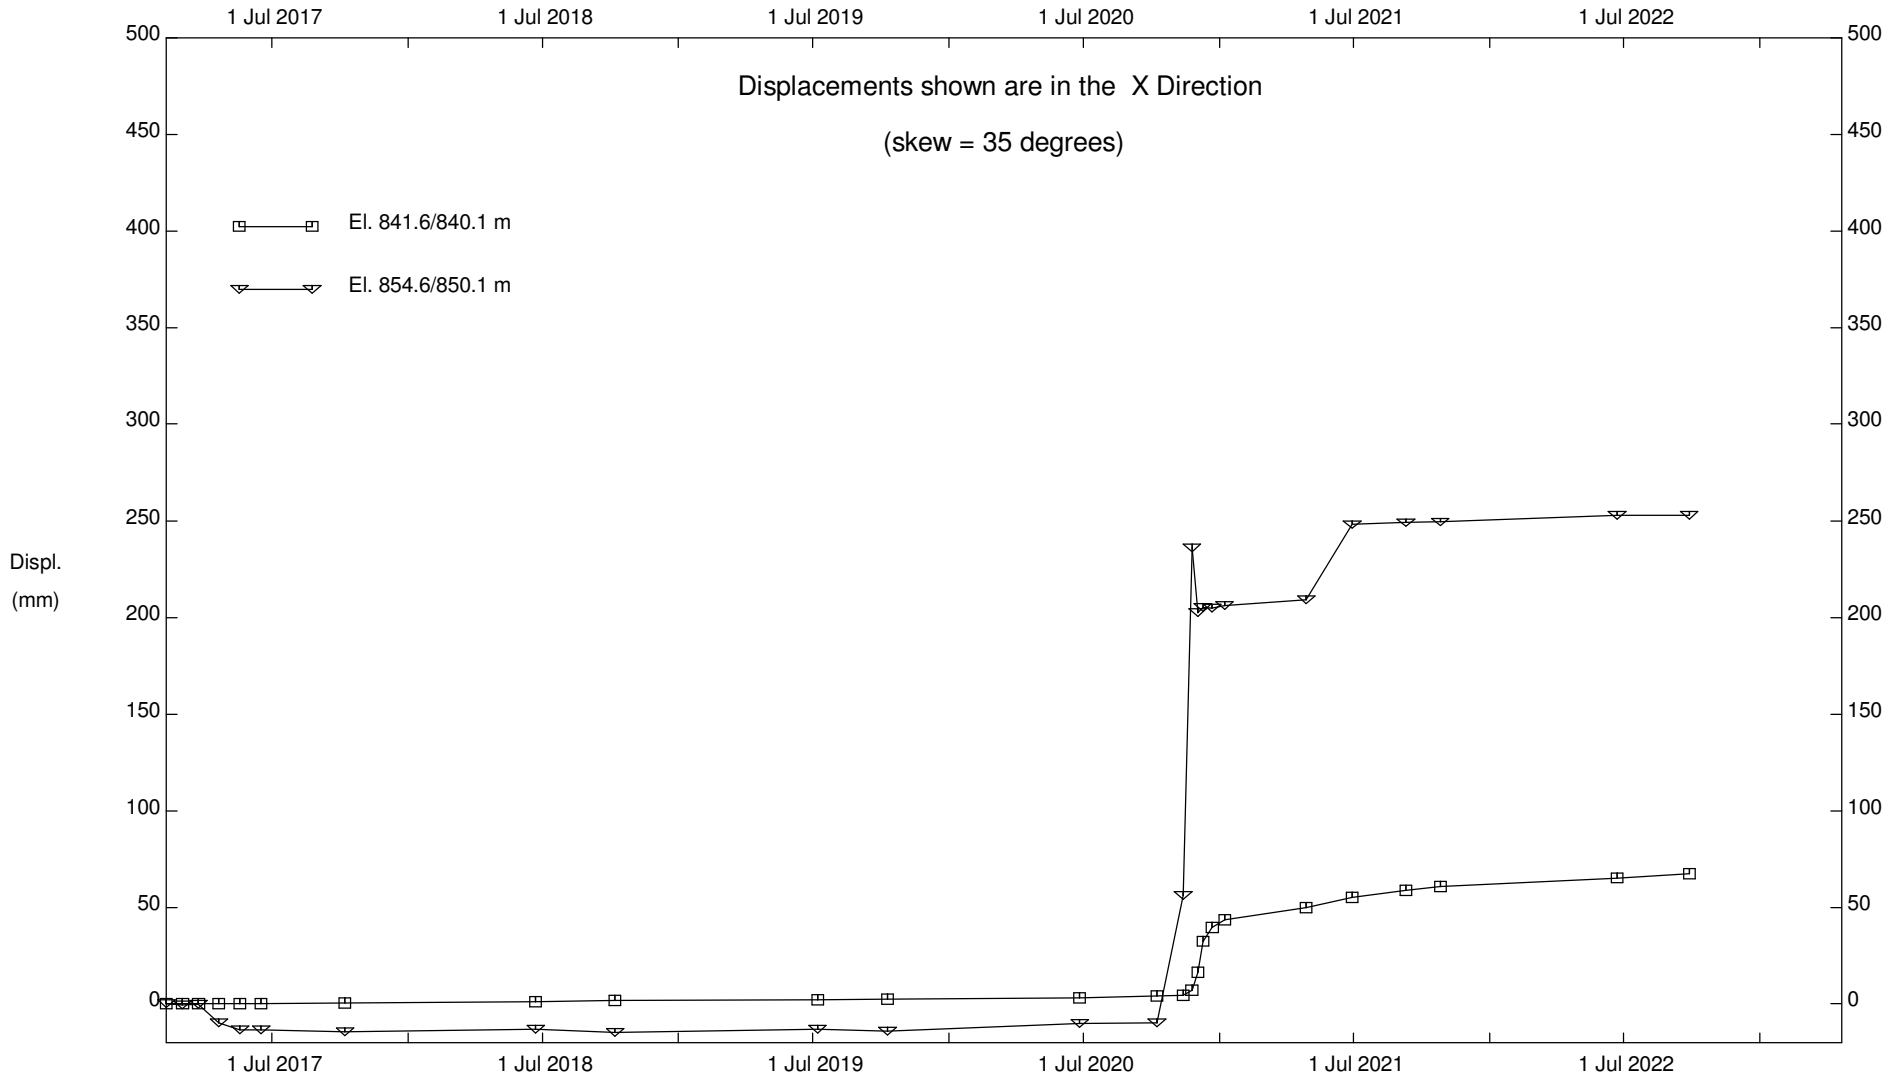
GP034; H40:38, Inclinator SI17-3

- SI17-2 between an approximate depth of 9.3 m and 10.8 m below ground surface (elevation 856.6 m to 855.1 m) at the bottom of a clay till foundation unit overlying bedrock (siltstone); and
- SI17-3 between an approximate depth of 13.0 m and 14.5 m below ground surface (elevation 841.6 m to 840.1 m) in a clay foundation unit overlying bedrock (clay shale).

Distributed movement is also being recorded in SI17-3 from the top of the casing to an approximate depth of 4.5 m below ground surface in the fill placed during late-2020 construction.

The rate of deep foundation movement being recorded in SI17-2 and SI17-3 was relatively slow and steady (less than 5 mm/year) between February 2017 (installation date) and October 2020 but increased up to approximately 212 mm/year and 5519 mm/year, respectively, when construction began in late-2020. Since January 2021, the rate of deep foundation movement recorded in SI17-2 and SI17-3 has decreased significantly and is currently less than 10 mm/year.

Since November 2020, shallow movements have been recorded in the upper 5 m of SI17-3, in the clay fill placed during late-2020 construction. This shallow movement is believed to be causing the pavement cracking observed on site and may be an extension upwards along the backscarp, associated with deeper movement. The rate of shallow movement recorded in SI17-3 in late-2020 is difficult to ascertain due to the SI casing being extended in November 2020. Between December 2020 and April 2021, the rate of movement decreased to approximately 15 mm/year, before increasing to approximately 230 mm/year in June 2021. Since September 2021, the rate of movement recorded is now less than 10 mm/year. Increased movement, which could impact the highway, may occur in response to periods of heavy or prolonged rainfall, resulting in higher groundwater conditions.
