<b>SITE NUMBER AND NAME:</b> <b>GP034 Slide South of Kakwa River</b>	<b>HIGHWAY &amp; KM:</b> 40:38, 21.016	<b>PREVIOUS INSPECTION DATE:</b> June 13, 2023	<b>INSPECTION DATE:</b> <b>June 3, 2025</b>
<b>LEGAL DESCRIPTION:</b> NW 28-62-04-W6M	<b>NAD 83 COORDINATES:</b> UTM    Northing    Easting 11       6028755    399896	<b>RISK ASSESSMENT:</b> PF: 5    CF: 4    TOTAL: 20	
<b>AVERAGE ANNUAL DAILY TRAFFIC (AADT):</b> 1,040 (north) & 900 (south) (Reference No. 70000944, 2024)		<b>CONTRACT MAINTENANCE AREA (CMA):</b> 504

**SITE INSPECTION FORM**

PEACE REGION (GRANDE PRAIRIE DISTRICT-SOUTH)  
GEOHAZARD RISK MANAGEMENT PROGRAM

Site Plan  
GP034 - Slide South of Kakwa River  
Hwy 40:38, km 21.016

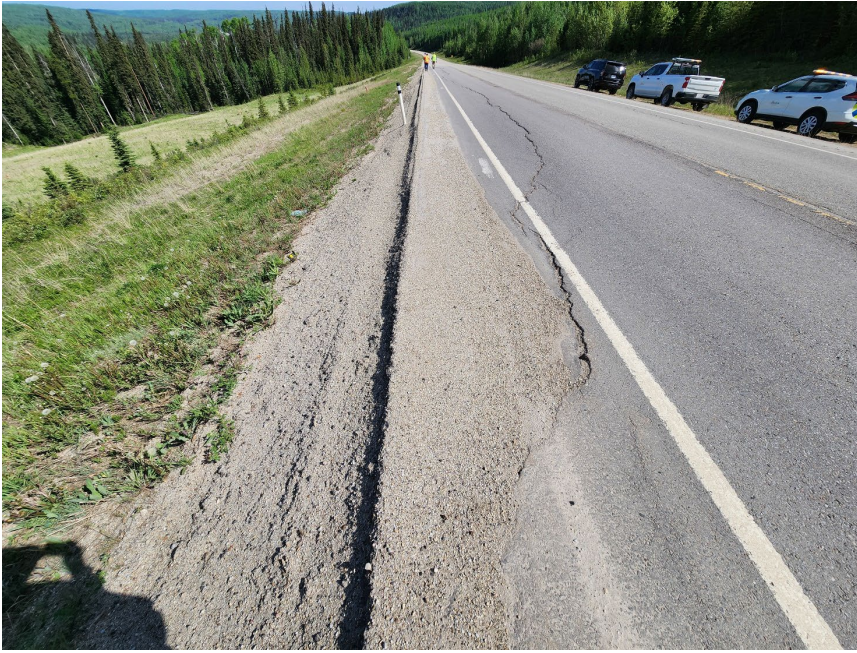
Cracking (up to approximately 10 mm wide and 80 m long) and settlement differential along cracks (differential along cracks up to approximately 15 mm) observed in the southbound lane during the 2025 inspection (Photos 1 through 4) was not visible during the 2023 inspection.

Shallow movement recorded in SI17-3 is believed to be causing the pavement cracking observed on site and may be an extension upwards along a backscarp, associated with deeper movement. Otherwise, deep movements recorded in SI17-2 and SI17-3 have slowed since early 2021. Movements recorded in the SIs did not appear to increase in response to a 5.2 magnitude earthquake that occurred near the site in February 2025.

**Photo 1**      **Cracking through pavement surface of Hwy 40:38. Photo taken June 2, 2025, facing northeast.**

- Continue to patch and pave this section of highway as needed.
- If movements continue and further repair/stabilization work is required, TEC should consider a mitigation method that improves the stability of the highway surface but does not change the state of stress of the slope and trigger more deep-seated movements. Possible repair options could include construction of deep cast-in-place piles through the toe berm and across the failure surface, or construction of a driven-steel wall or a soil nail-reinforced-earth-retaining wall below the edge of pavement to stabilize the small wedge of soil that is moving below the west (southbound) lane of the highway. Estimated cost: approximately \$2,000,000 to \$4,000,000 (deep cast-in-place piles), \$800,000 to \$1,500,000 (100-m-long driven-steel wall), and \$400,000 to \$600,000 (100 soil nails), respectively.

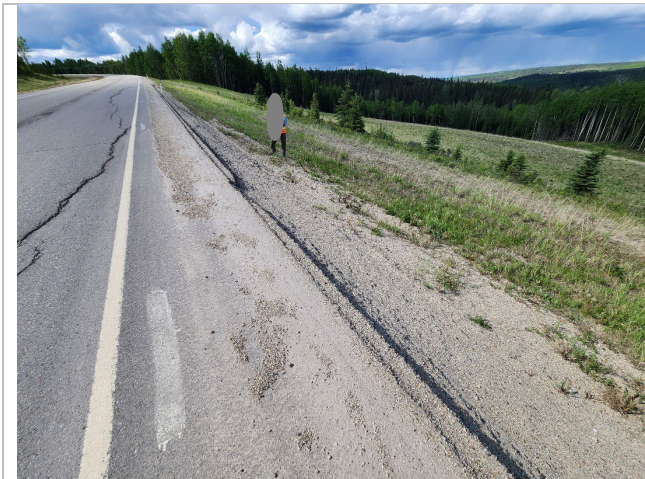
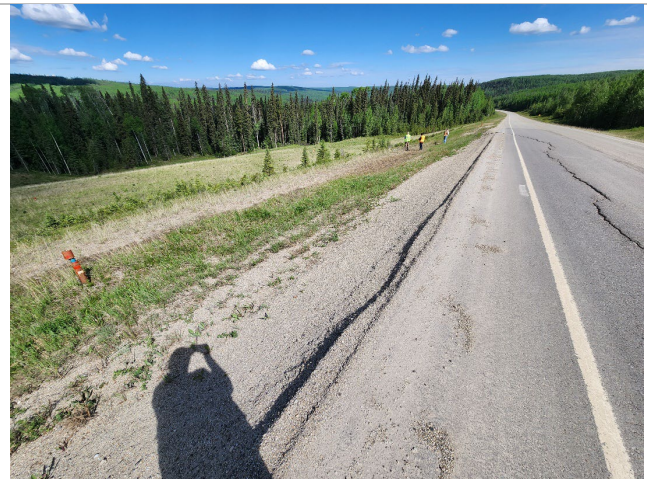
**Photo 2**      **Cracking through pavement surface of Hwy 40:38. Photos taken June 2, 2025, facing southwest and northwest, respectively.**

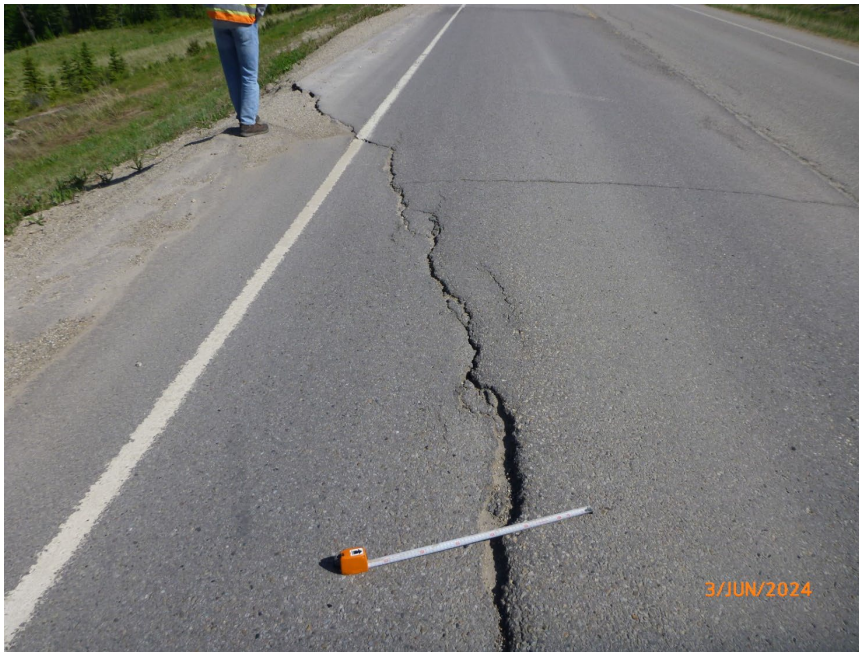
**Photo 3**      **Cracking through pavement surface of Hwy 40:38. Photo taken June 2, 2025, facing north.**

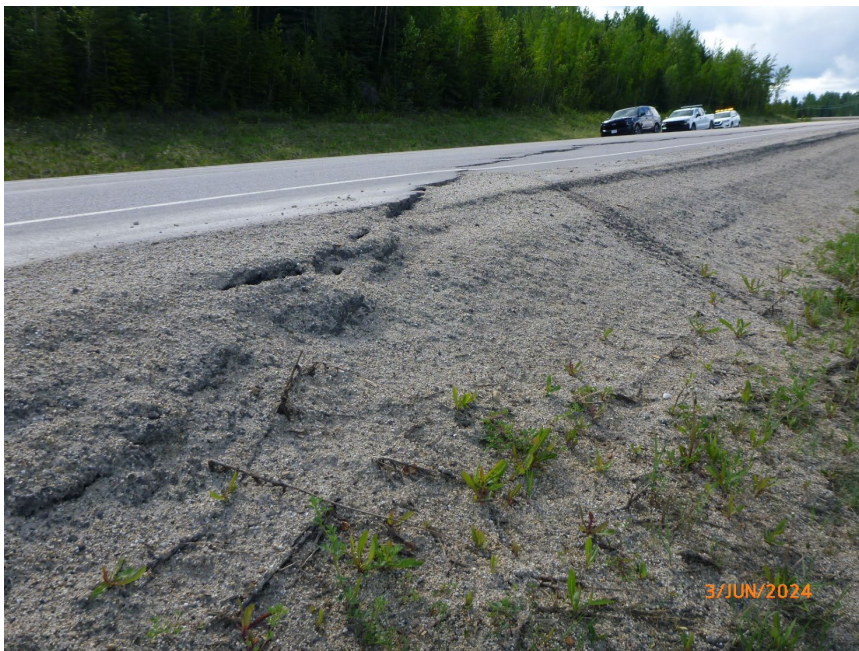
**Photo 4**      **Cracking through pavement surface of Hwy 40:38. Photo taken June 2, 2025, facing southeast.**

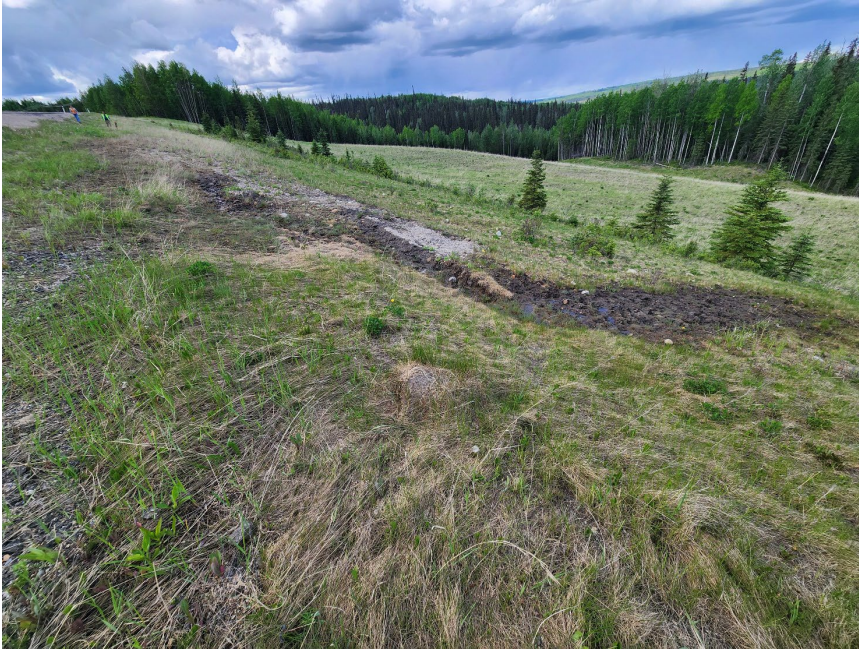
**Photo 5** Wet area on south slope of Hwy 40:38. Photo taken June 2, 2025, facing southwest.

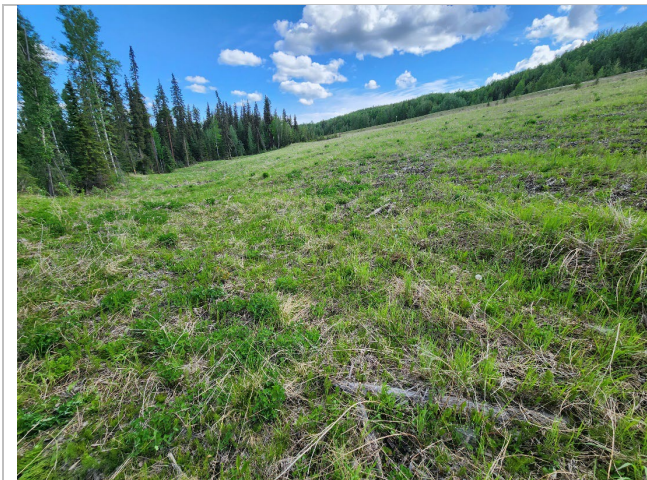
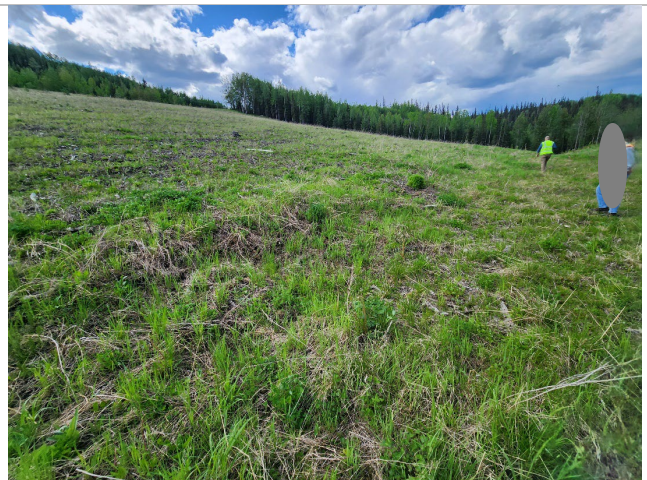
**Photo 6** South slope of Hwy 40:38. Photos taken June 2, 2025, northeast and southeast, respectively.

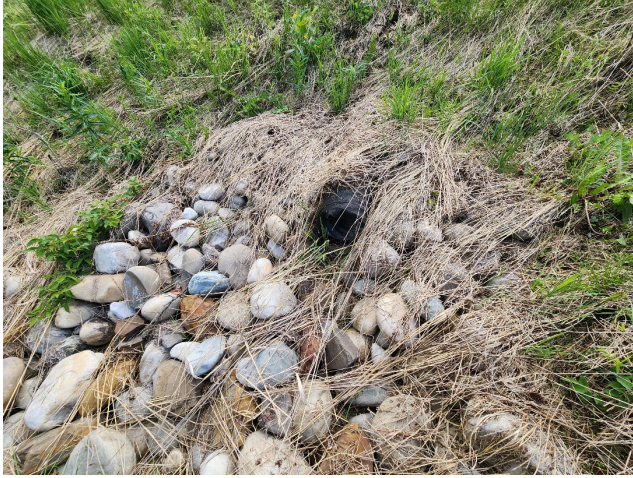
**Photo 7      Drain outlets. Photos taken June 2, 2025.**

West drain at toe of toe berm.

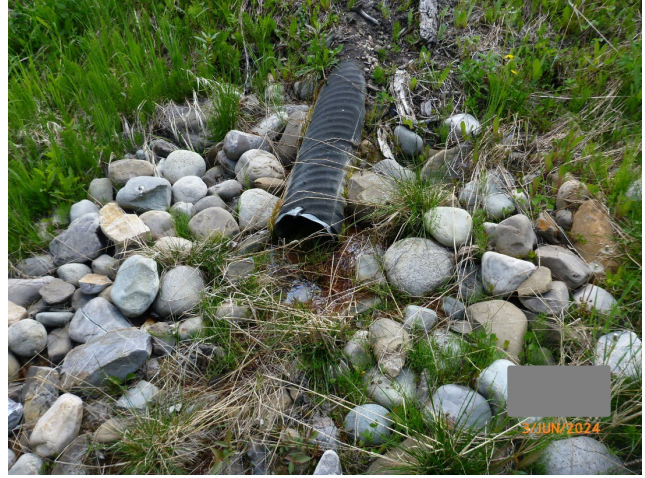
Water was observed flowing from the middle drain at the toe of the toe berm (Photo 8) during the 2023 and 2025 inspections.

Middle drain at toe of toe berm.

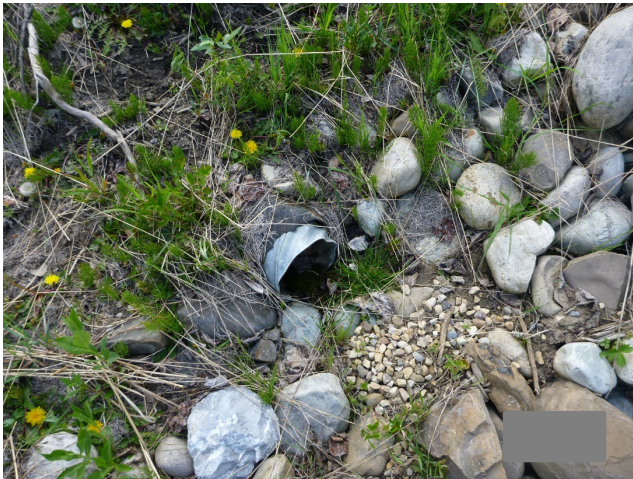
East drain at toe of toe berm.

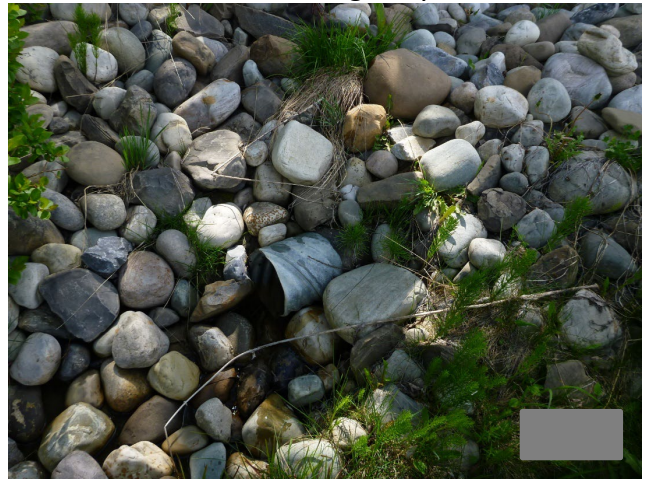
Drain in north highway ditch.

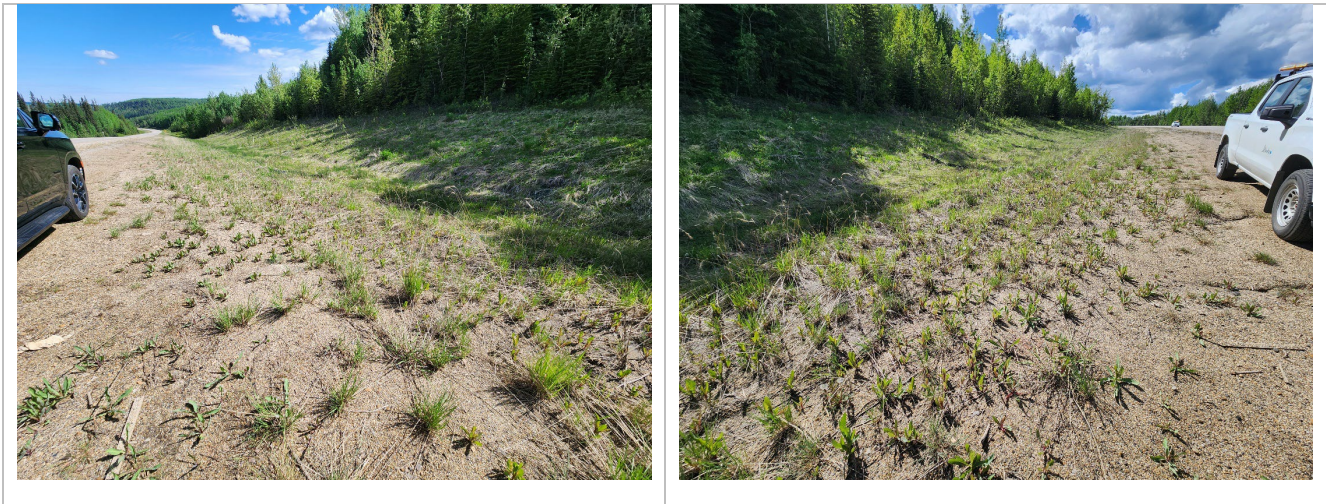
In 2020, a groundwater interception trench consisting of non-woven geotextile surrounding granular filter materials and a perforated collection pipe was installed approximately 4 m below the east highway ditch. At the time of the 2025 inspection, some water was discharging from the collection pipe outlet (Photo 8) and the ditch channel was damp.

**Photo 8** Ditch on east side of Hwy 40:38. Photos taken June 2, 2025, facing northeast and southeast, respectively.

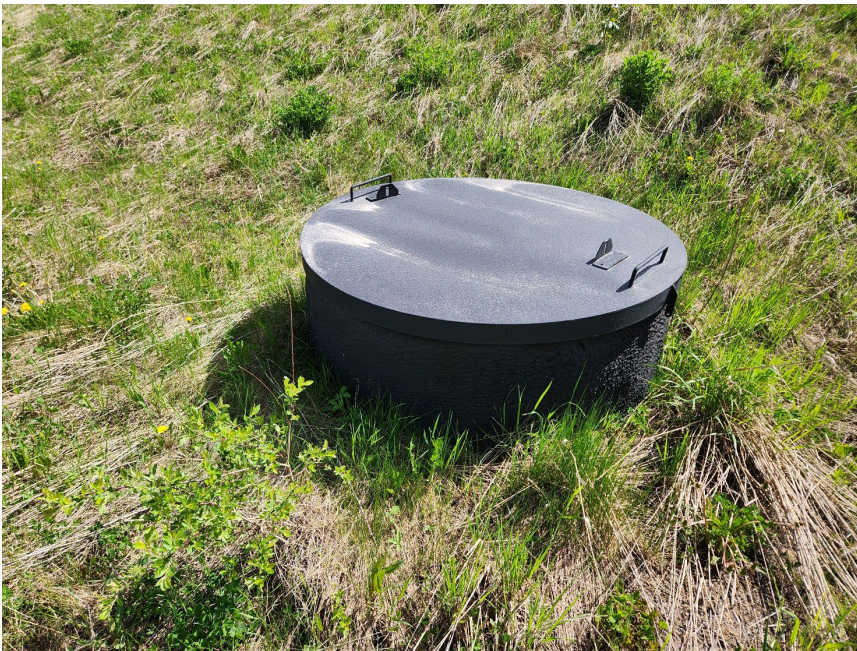
**Photo 9** Inlet of drainage galley in ditch on east side of Hwy 40:38. Photo taken June 2, 2025.
