**CON0022166 Peace Region (Grande Prairie District – South) GRMP Instrumentation Monitoring Site GP034; H40:38, km 21.016 Slide South of Kakwa River  
Section C – 2025 Spring Readings**

TITLE  
Site Plan  
GP034 - Slide South of Kakwa River  
Hwy 40:38, km 21.016

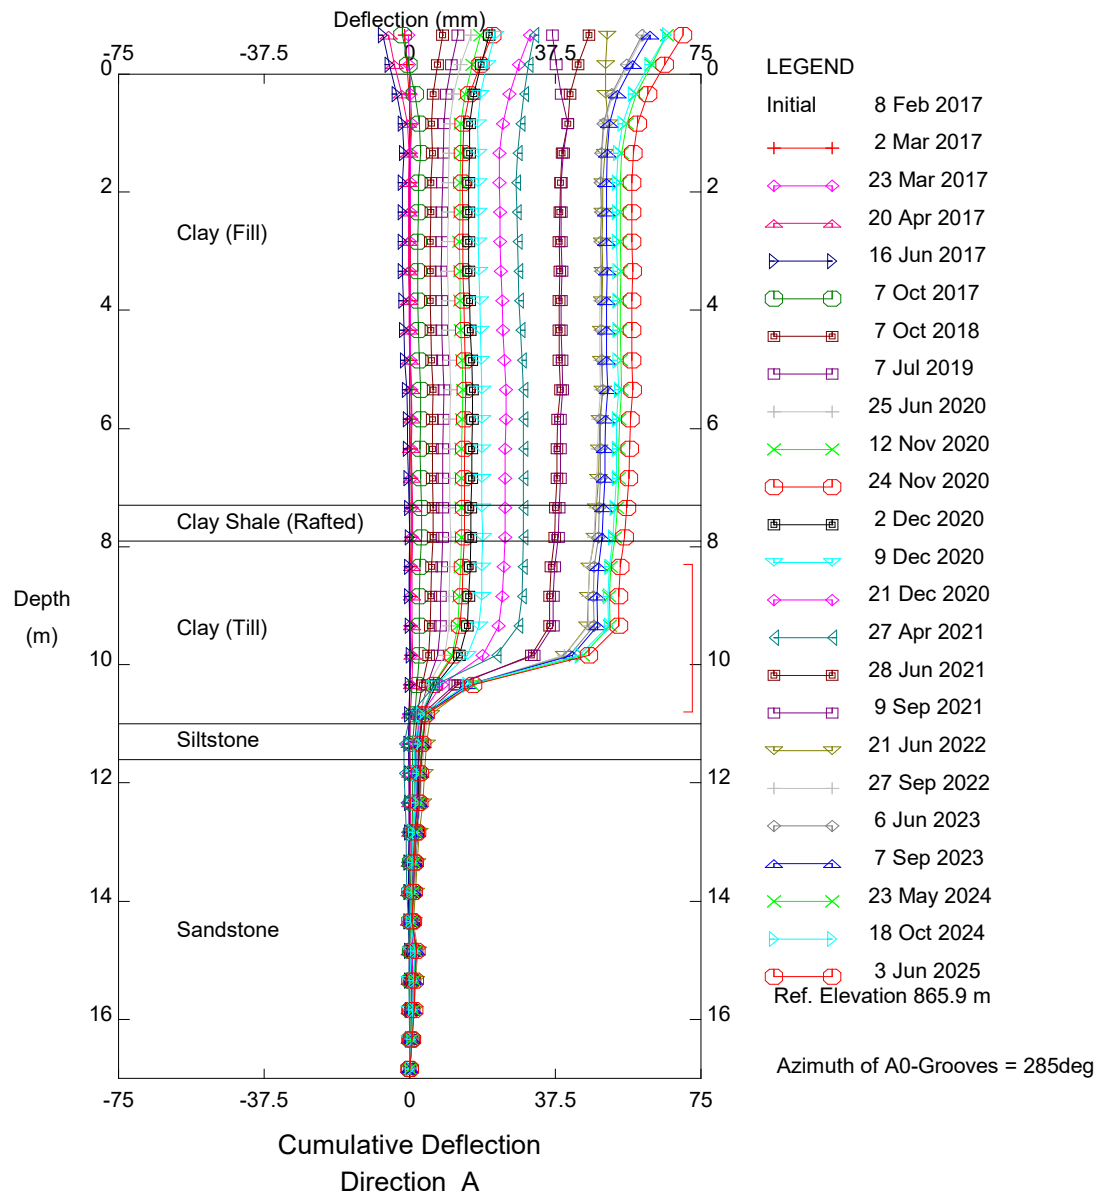
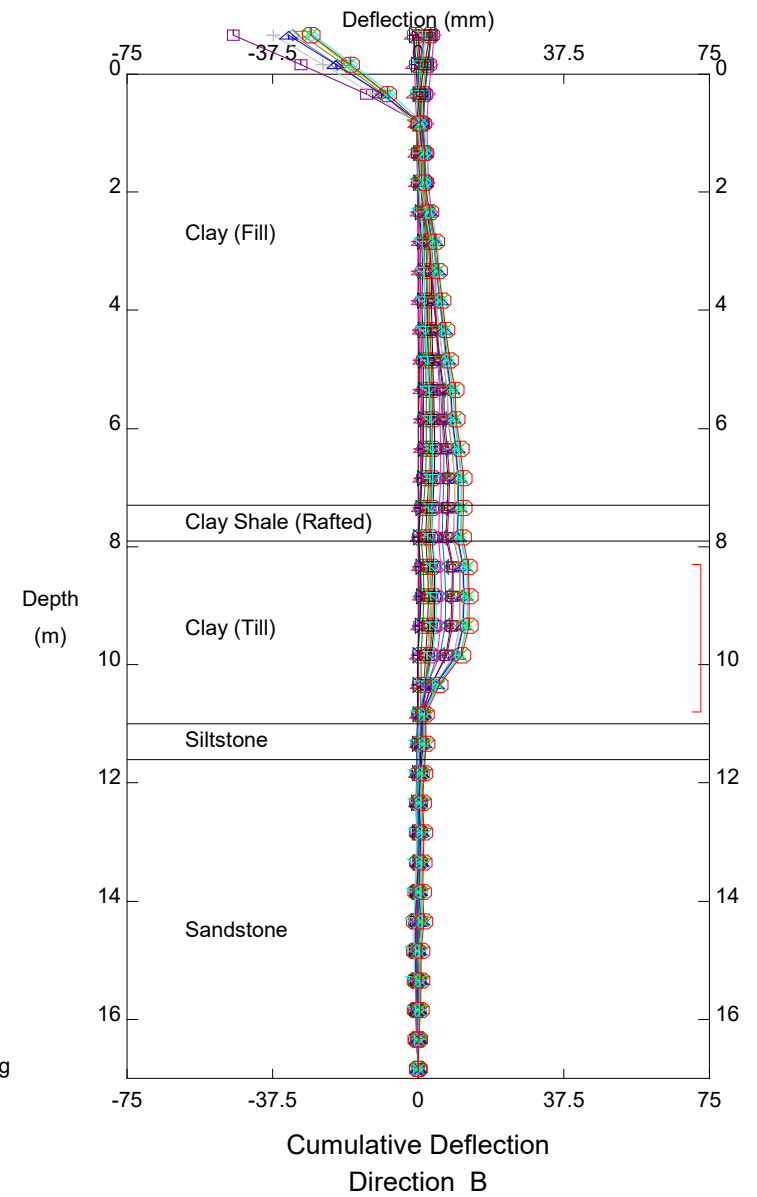
GP034; H40:38, Slide S. of Kakwa River, Inclinometer SI17-2

- SI17-2 between an approximate depth of 9.3 m and 10.8 m below ground surface (approximately elevation 856.6 m to 855.1 m) at the bottom of a clay till foundation unit overlying bedrock (siltstone); and
- SI17-3 between an approximate depth of 13.0 m and 14.5 m below ground surface (approximately elevation 841.6 m to 840.1 m) in a clay foundation unit overlying bedrock (clay shale).

The rate of foundation movement being recorded in SI17-2 and SI17-3 was relatively slow and steady (less than 5 mm/year) between February 2017 (installation/initialization) and October 2020 but increased up to approximately 212 mm/year and 867 mm/year, respectively, when toe berm construction began in late 2020. Since January 2021, the rate of foundation movement recorded in SI17-2 and SI17-3 has been decreasing and is currently less than 3 mm/year. It is noted that the rate of movement recorded in SI17-2 and SI17-3 does not appear to have increased in response to a 5.2 magnitude earthquake that occurred near the site in February 2025.

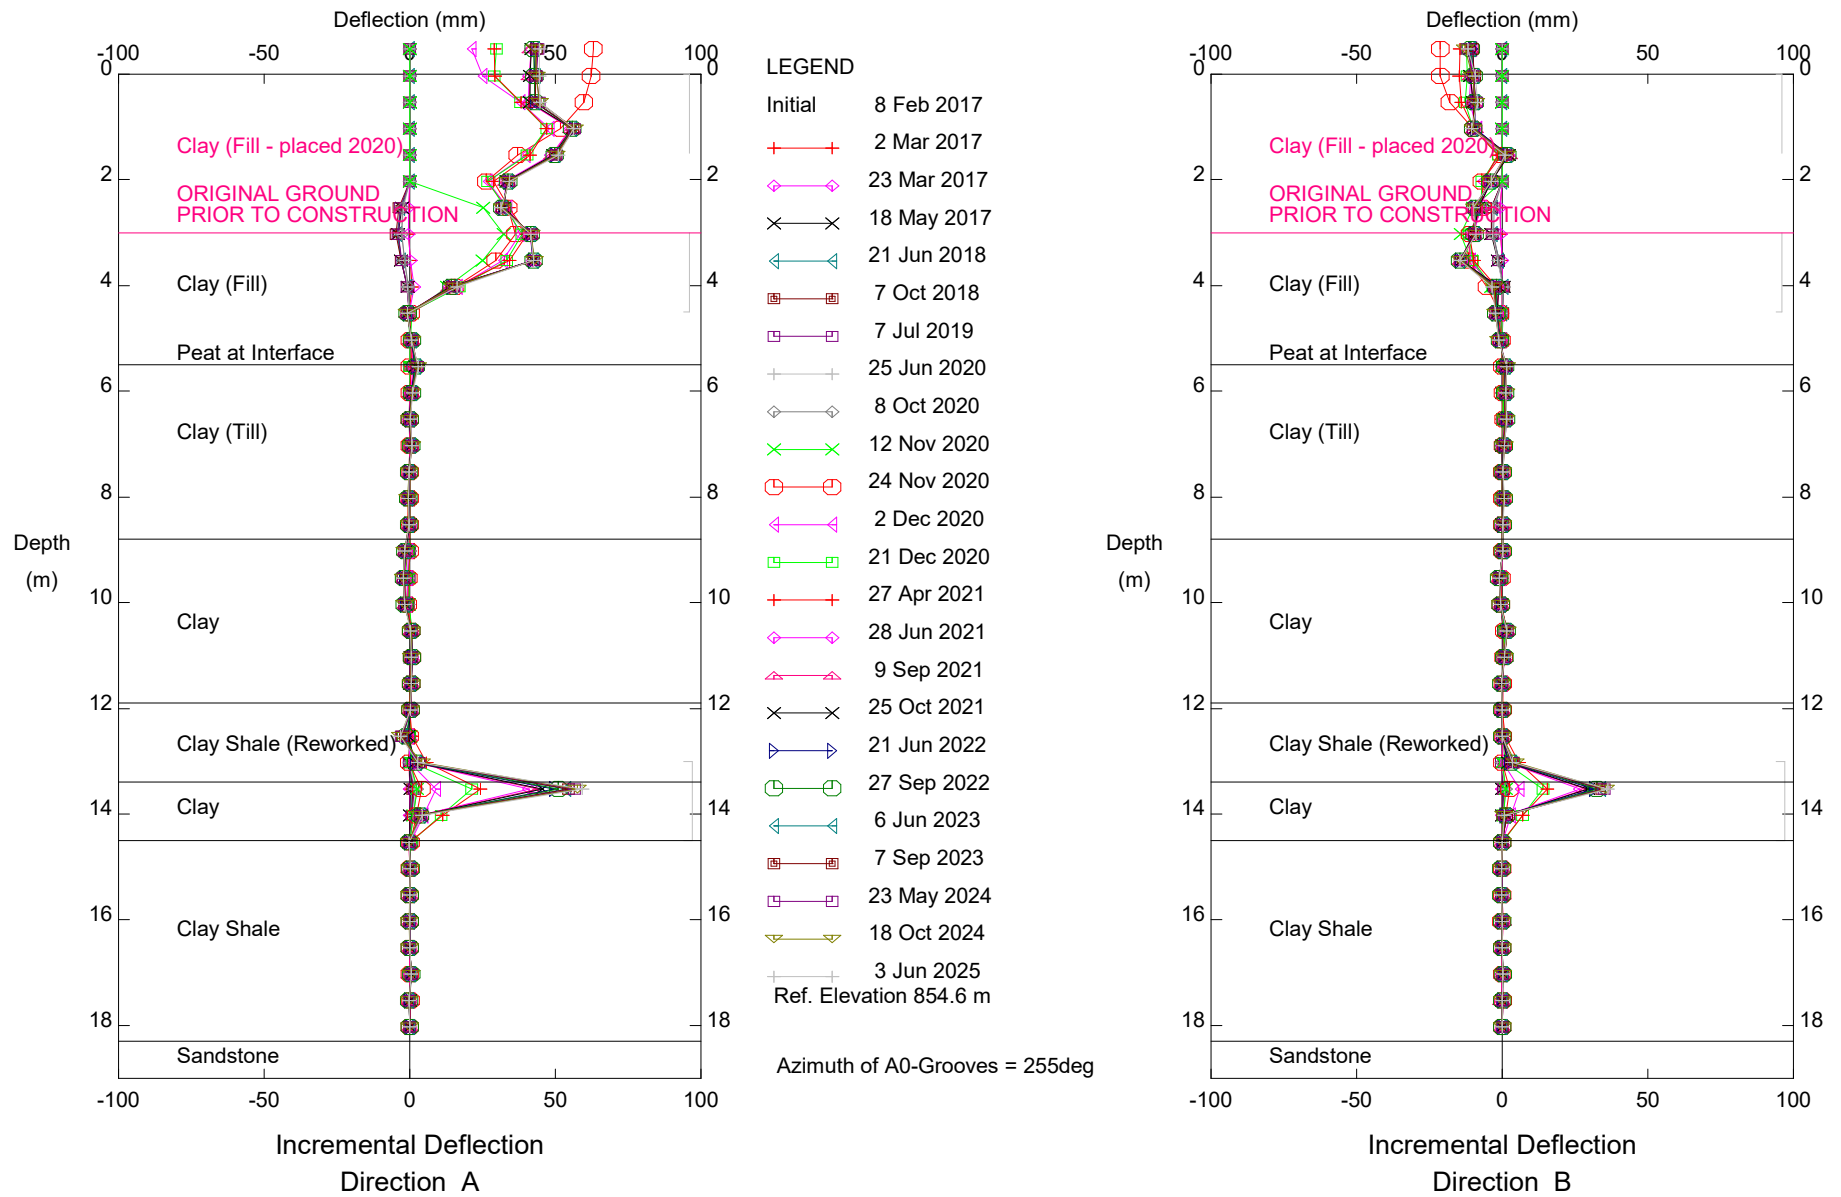
GP034; H40:38, Slide S. of Kakwa River, Inclinator SI17-3

Shallow distributed movement is also being recorded in the upper 4.5 m of SI17-3 in the toe berm fill placed in late 2020.

The shallow fill movement being recorded in SI17-3, since toe berm construction in late 2020, is believed to be causing the cracks observed in the pavement surface and along the highway embankment and may be an extension upwards along the backscarp, associated with deeper movement. The rate of shallow movement recorded between late 2020 and September 2021 is difficult to assess due to the SI casing being extended in November 2020 and the SI reading equipment being changed four times between November 2020 and June 2021. The maximum rate of movement recorded during toe berm construction was approximately 5,519 mm/year. Since September 2021, the rate of shallow fill movement recorded in SI17-3 has been decreasing and is currently less than 3 mm/year.

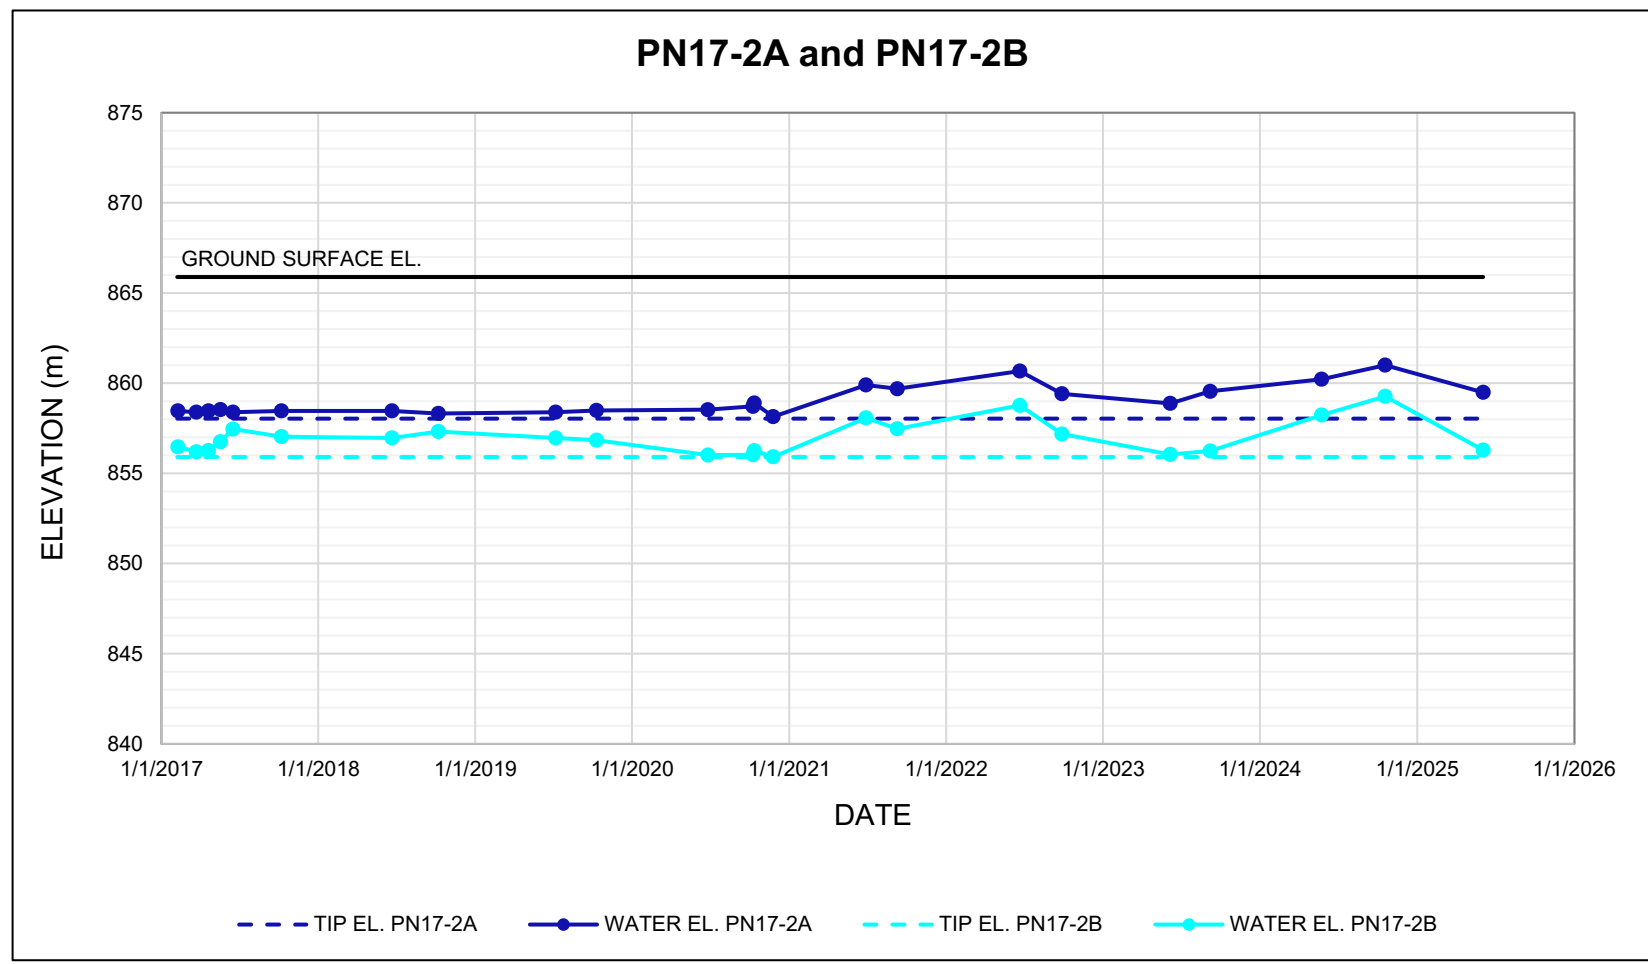
PEACE REGION (GRANDE PRAIRIE DISTRICT - SOUTH) GEOHAZARD RISK MANAGEMENT PROGRAM	
		TITLE PIEZOMETER DATA GP034 - SLIDE S. OF KAKWA RIVER HWY 40:38, KM 21.016	
SCALE	--	PROJECT No.	FIG No.
		A05116A01

Before toe berm construction, relatively steady porewater pressures were recorded in PN17-2A/B (located below highway shoulder, outside toe berm footprint) and PN17-6A/B (located below toe berm crest, downslope of highway). Following toe berm construction in late 2020:

- **PN17-6A:** Porewater pressures recorded in this instrument increased approximately 4.7 m between October 2020 and June 2021 before decreasing approximately 4.0 m between June 2021 and June 2022. This increase and decrease are most likely due to construction-induced porewater pressure response followed by post-construction porewater pressure dissipation, respectively. Since June 2022, porewater pressures recorded in PN17-6A have been fluctuating (approximately 1.3 m to 2.9 m reading to reading, with the fall reading higher than the spring reading and sometimes near ground surface) likely in response to seasonal variations in freshet and precipitation infiltration.

- **PN17-6B:** This instrument did not stabilize between November 2020 and September 2022. Since September 2022, porewater pressures recorded in this instrument have been relatively steady and approximately 1.5 m to 2.5 m higher than readings obtained before toe berm construction in late 2020.

- **PN17-2A/B:** Porewater pressures recorded in these instruments were relatively steady before construction, and have been fluctuating from tip elevation (i.e., dry) to approximately 3.0 m and 3.4 m above tip elevation, respectively, after construction likely due to seasonal variations in precipitation and freshet infiltration. Overall, porewater pressures recorded after construction are approximately 1 m to 2 m higher than those recorded before construction.

Currently, the porewater pressures recorded in PN17-2A/2B/6A/6B are between approximately elevation 849.7 m and 859.5 m, which is just below to above the zone of movement recorded in SI17-3 between approximately elevation 850.1 m and 854.6 m. Increases in groundwater level could trigger increased movement, which could impact the highway.

PN17-1A/B and PN-4A/B were destroyed in 2020 during construction, and PN-3A/B and PN-5A/B have also become inoperable (i.e., readings do not stabilize). Replacement of these instruments or installation of new instruments near the location of observed groundwater discharge should be considered if site conditions deteriorate and/or repair work were to be resumed.
