**ALBERTA TRANSPORTATION
GEOHAZARD ASSESSMENT PROGRAM
PEACE REGION – GRANDE PRAIRIE DISTRICT
2020 INSPECTION**

Site Number	Location	Name	Hwy	km
GP38B	NW of Grande Cache	1.6 km N of Kakwa River Bridge	40:38	25.5
Legal Description		UTM Co-ordinates (NAD 83)		
SE8-63-4-W6		11U N 6,032,885	E 398,710

Date	PF	CF	Total
Previous Inspection:	May 28, 2019	3	2	6
Current Inspection:	May 26, 2020	3	2	6
Road AADT:	1,370		Year:	2019
Inspected By:	Don Proudfoot, Nicole Wilder (Thurber) Ed Szmata, Rishi Adhikari (AT)			
Report Attachments:	<input checked="" type="checkbox"/> Photographs <input checked="" type="checkbox"/> Plans <input type="checkbox"/> Maintenance Items

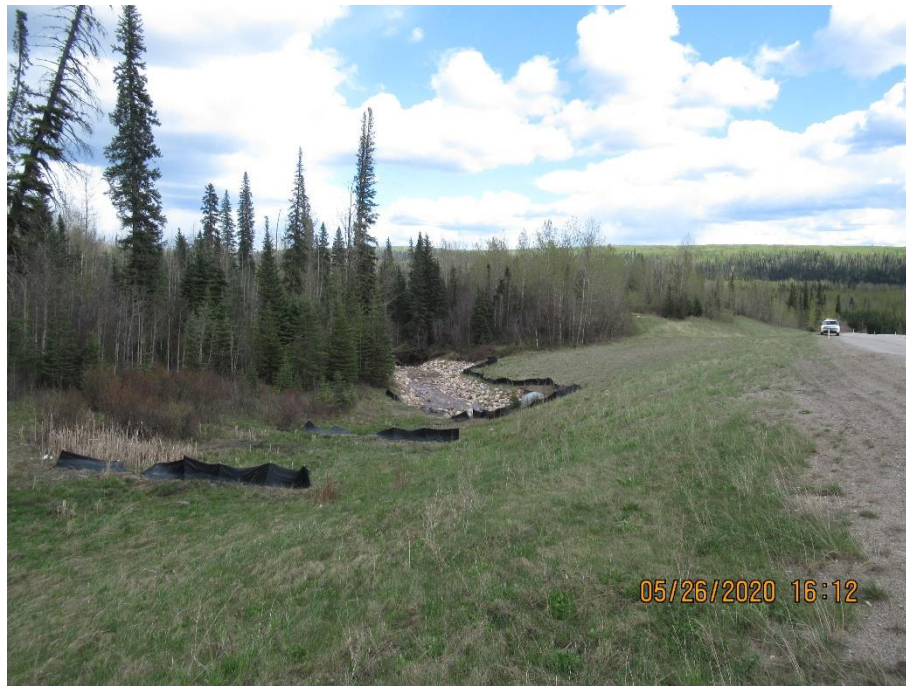
Photo 1.
Looking south at
culvert outlet and
where slide has
been replaced with
fill and new ACP
patch.

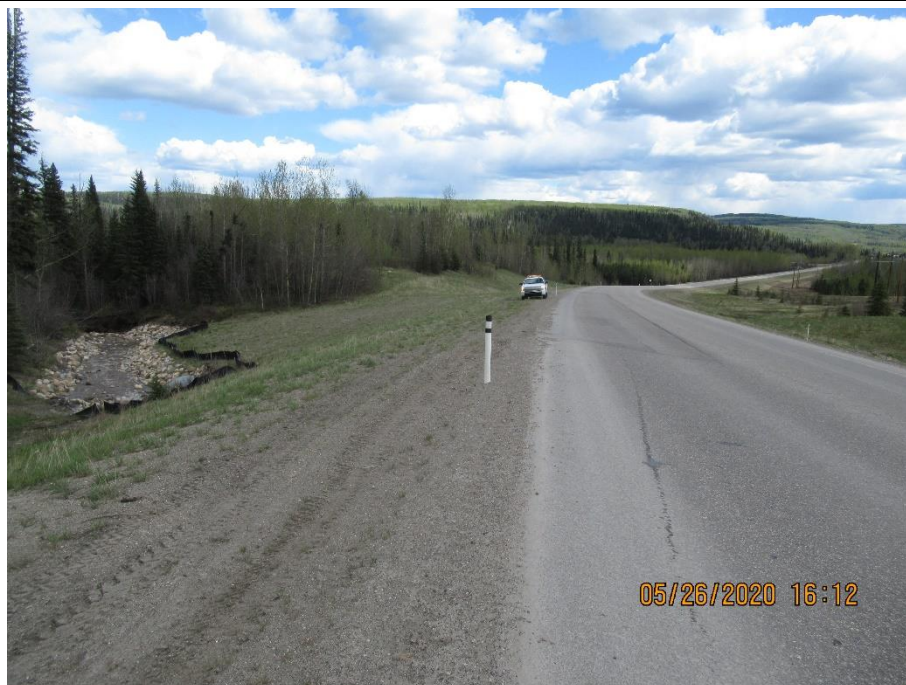
Photo 2.
Looking south
where slide mass
has been replaced.

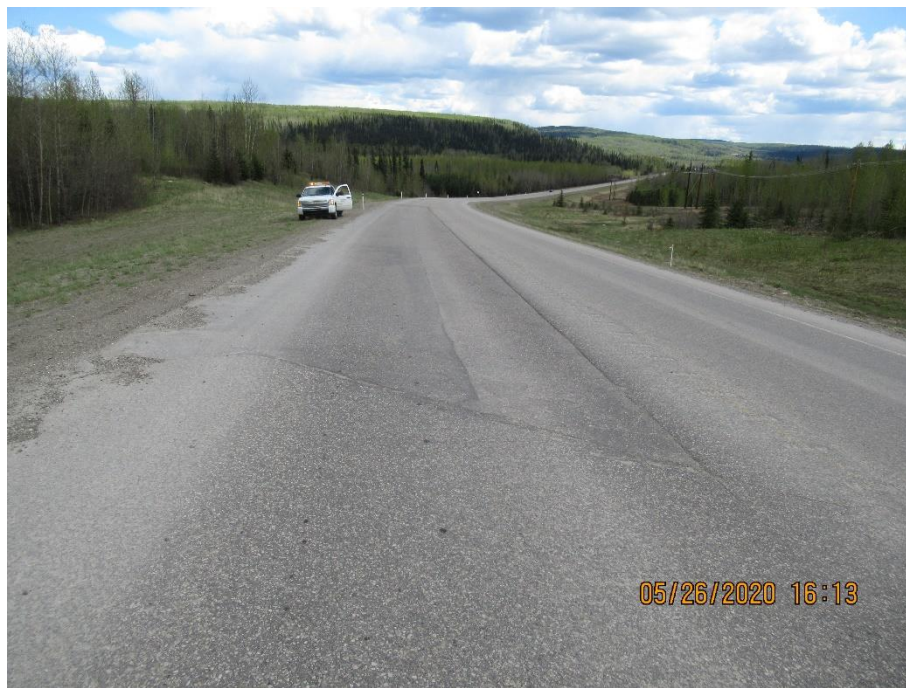
Primary Site Issue:	The original issue was a landslide in an 8 m high sidehill highway embankment fill. There is now a bit of settlement under the asphalt patch and minimal surficial erosion along where the slide was repaired.	
Dimensions:	The original slide was about 20 m long by ~10 m wide	
Date of any remediation:		
Maintenance:	In June 2016, an overlay was placed. The northbound lane was patched after construction of landslide remedial measures in 2018.	
Observations:	Description	Worse?
<input checked="" type="checkbox"/> Pavement Distress	The pavement patch has settled a bit since the end of construction. Appeared to be in similar condition in 2020.	<input type="checkbox"/>
<input type="checkbox"/> Slope Movement		<input type="checkbox"/>
<input checked="" type="checkbox"/> Erosion	Minimal surficial erosion was observed where the slide was repaired from surface flow runoff creating rills. Grass growth in this area is somewhat sparse but is growing.	<input checked="" type="checkbox"/>

Photo 3.
Looking south at
most recent ACP
patch where slide
was repaired.

Further patching may be required if the patch continues to settle. Surficial erosion should be monitored so that it does not become a major issue.

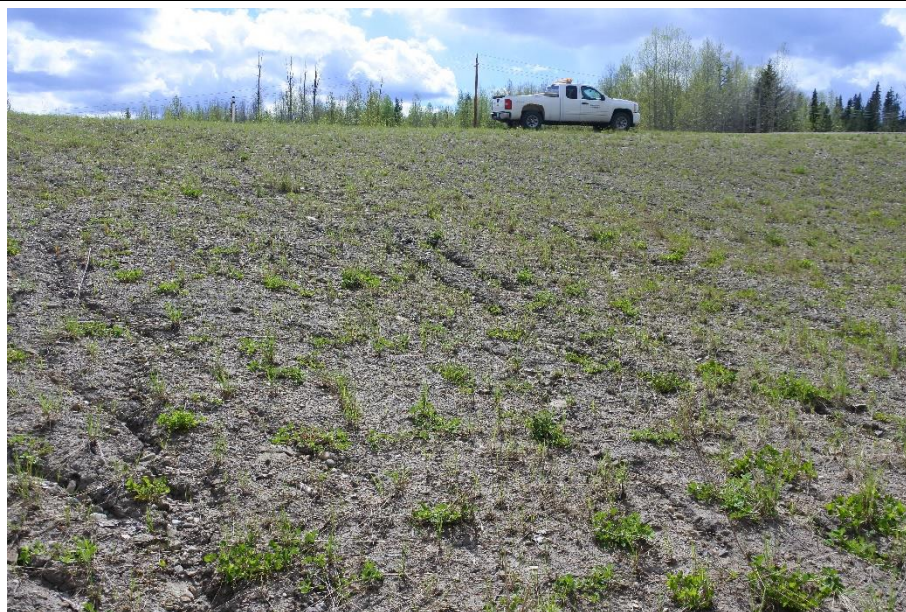
Photo 4.
Looking north at
side slope of slide
repair.

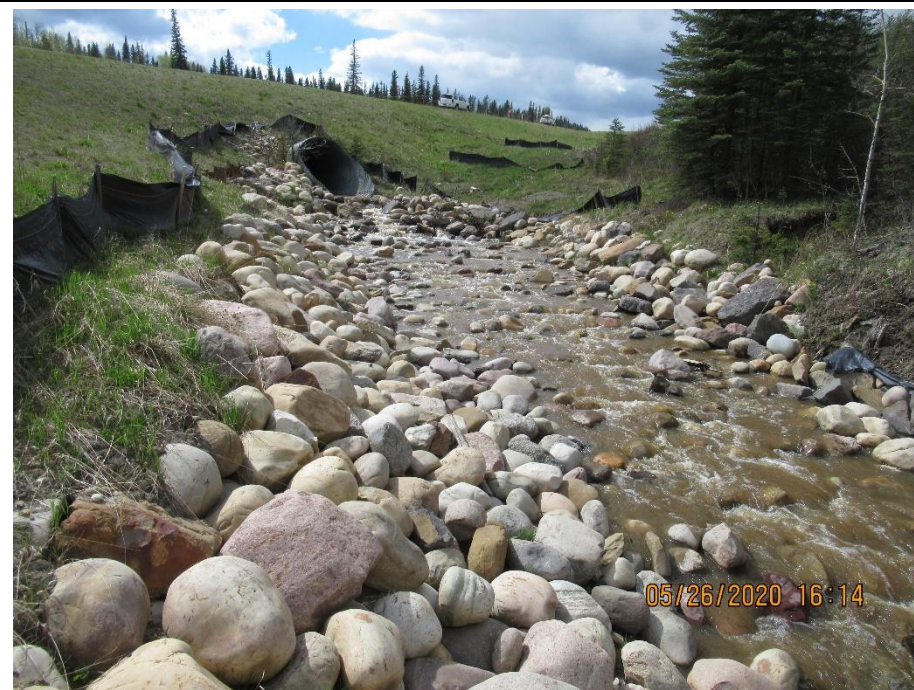
A 3 m diameter SPCSP culvert exists adjacent to the northeast side of where the slide scarp was located. This culvert did not have any identifiable distress; however, a small slump was observed in the south channel bank downstream of the culvert riprap plunge pool.

Photo 5.
Looking west at the
3 m diameter
SPCSP outlet,
plunge pool, and
east highway
embankment.

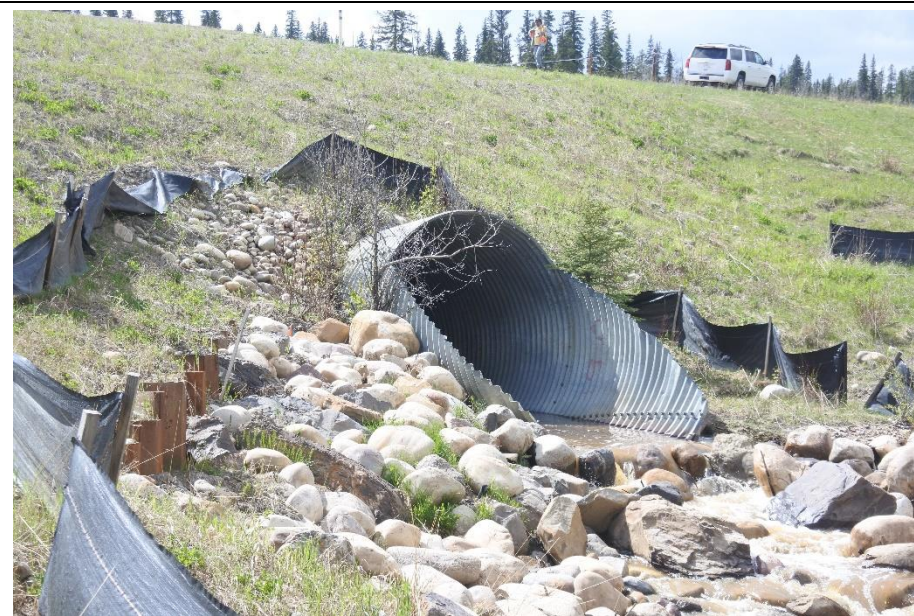
Photo 6.
Looking west at the
3 m diameter
SPCSP outlet,
riprap and top of
sheet pile wall.

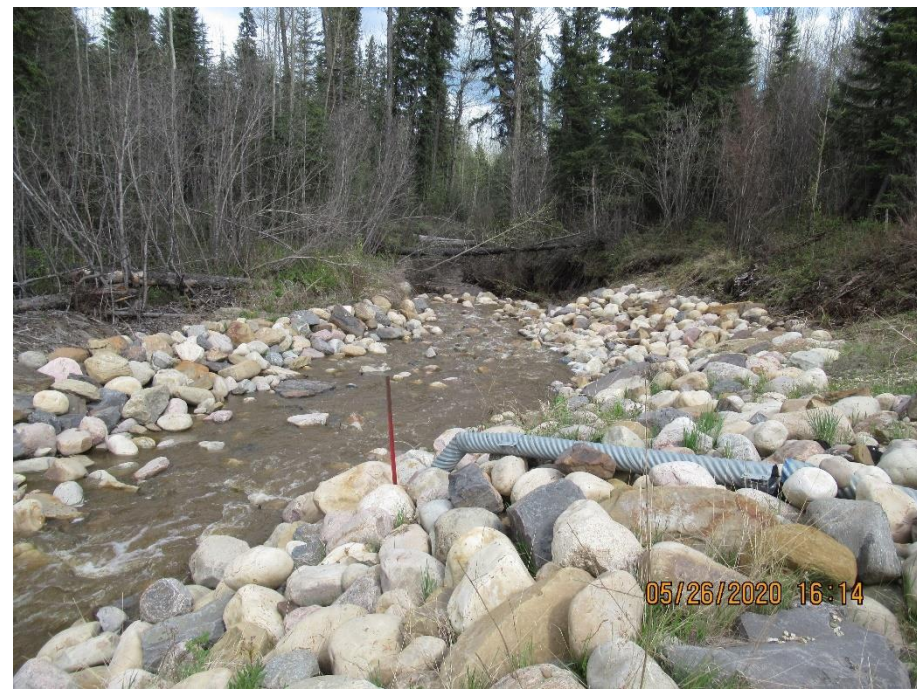
Photo 7.
Looking east at
where the subdrain
pipe has
disconnected.
