SITE INSPECTION FORM

SITE NUMBER AND NAME: GP038-I and -II Slides 1.6 km and 2.0 km North of Kakwa River Bridge (North Little Prairie Creek)		HIGHWAY & KM: 40:38, 25.831 and 25.426	PREVIOUS INSPECTION DATE: May 26, 2020	INSPECTION DATE: June 15, 2022
LEGAL DESCRIPTION: GP038-I SE 08-63-04 W6M GP038-II SE 08-63-04 W6M	NAD 83 COORDINATES: UTM Northing Easting 11 6033163 398377 11 6032912 398677	RISK ASSESSMENT: PF: 4 CF: 2 TOTAL: 8 PF: 2 CF: 4 TOTAL: 8		
AVERAGE ANNUAL DAILY TRAFFIC (AADT): 1000 (north) & 960 (south) (Reference No. 70000851, 2021)		CONTRACT MAINTENANCE AREA (CMA): 504

PEACE REGION
(GRANDE PRAIRIE DISTRICT – SOUTH) GRMP
SITE INSPECTION FORM

PEACE REGION (GRANDE PRAIRIE DISTRICT-SOUTH)
 GEOHAZARD RISK MANAGEMENT PROGRAM

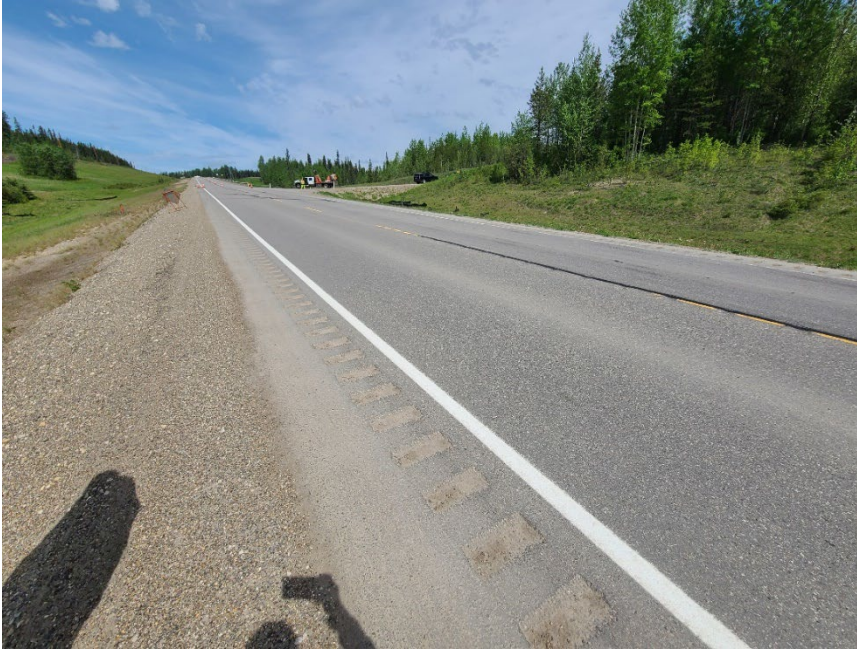
ITEM	CONDITION EXISTS		DESCRIPTION AND LOCATION	NOTICABLE CHANGE FROM LAST INSPECTION	
	YES	NO		YES	NO
Pavement Distress	X		Minor cracking and a small dip at both sites (WP211 at GP038-I site) . As well, as some pavement settlement at GP038-I at WP 213. Prior to repair, alligator cracking previously observed in payment surface at GP038-II site.		X
Slope Movement	X		Movements recorded in SI are slow to indiscernible (less than 10 mm/year).		X
Erosion	X		Some rill erosion along upper portion of highway embankment (unvegetated gravelly material).		X
Seepage	X		At GP038-I site wet area and cattails along north side of toe berm at WP212. At GP038-II wet area to north of culvert outlet.		X
Culvert Distress	X		Outlet drain at GP038-II separated at joint. Culvert outlet and riprap at GP38-II site is a barrier to fish passage.		X

Photo 1 Minor cracking and dip in pavement surface of Hwy 40:38 at GP038-I site at WP211. Photo taken June 15, 2022, facing northwest.

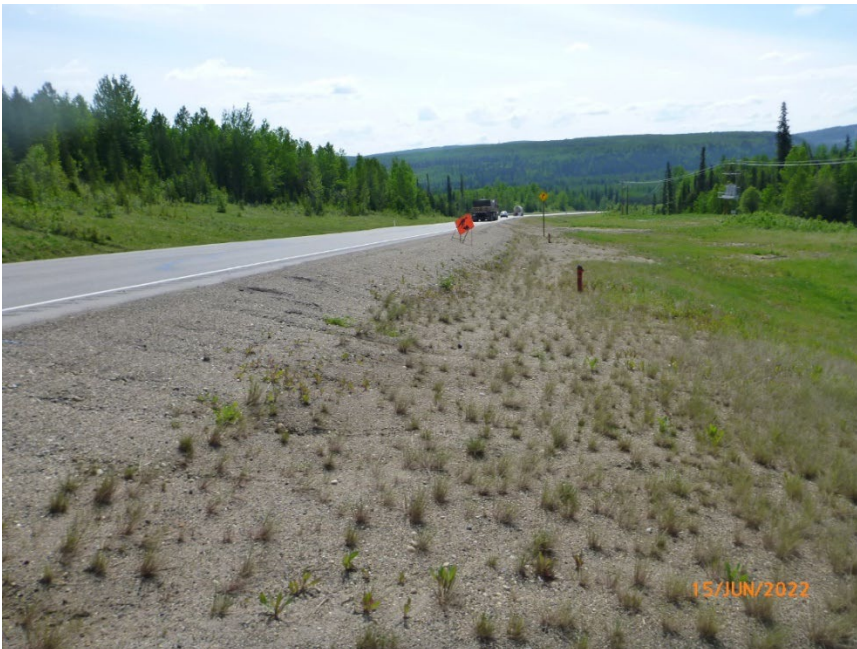
Photo 2 Settlement in pavement surface of Hwy 40:38 at GP038-I site at WP213. As well as rill erosion along south side of highway embankment. Photo taken June 15, 2022, facing southeast.

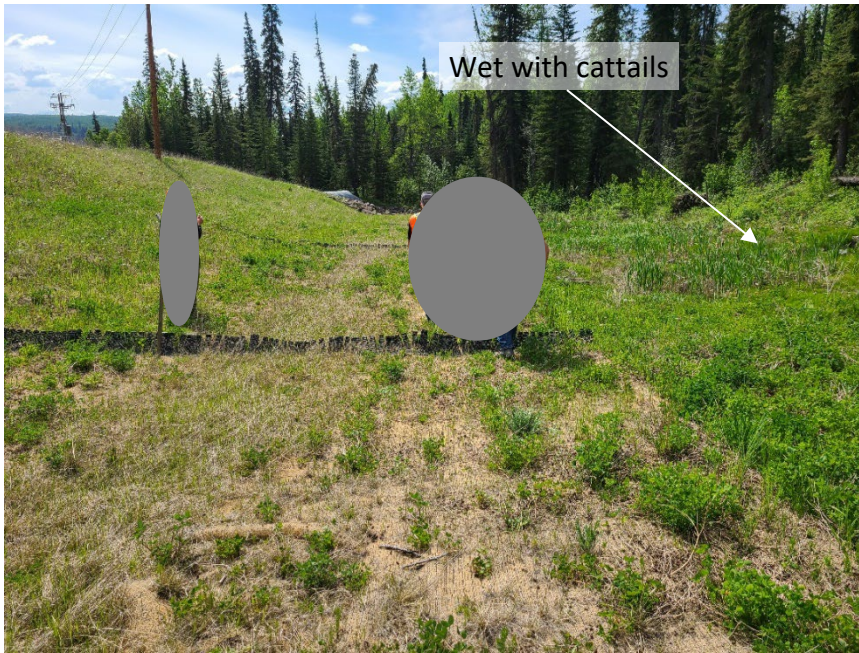
Photo 3 Wet area and cattails at WP212 along north side of toe berm at GP038-I site. Photo taken June 15, 2022, facing southeast.

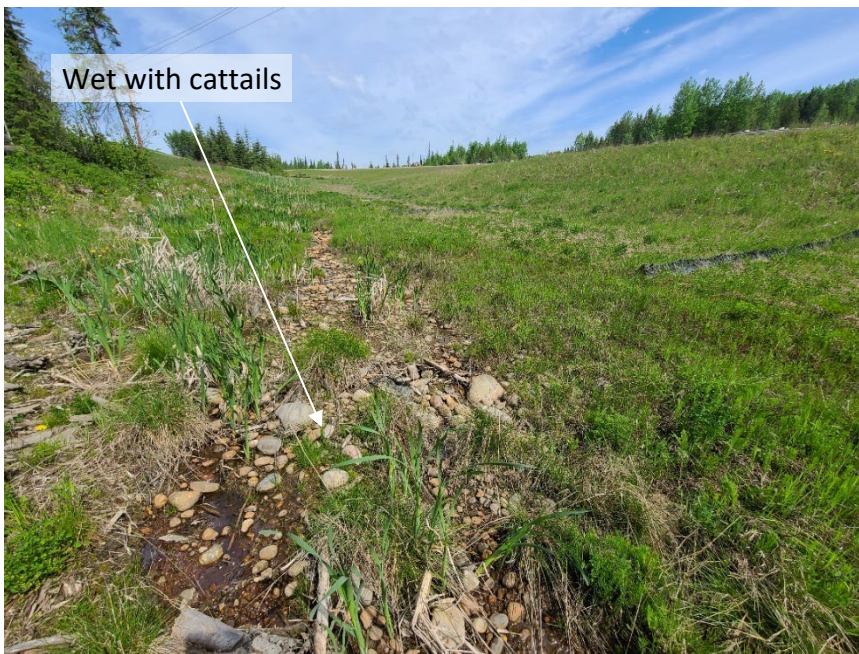
Photo 4 Flowing water and cattails at WP212 along north side of toe berm at GP038-I site. Photo taken June 15, 2022, facing north.

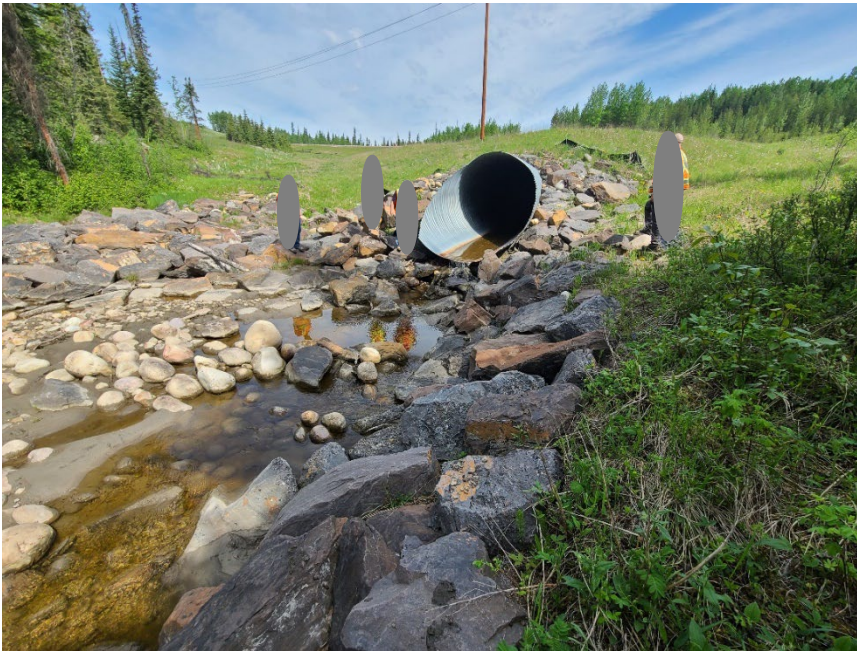
Photo 5 Outlet of culvert at GP038-I site. Photo taken June 15, 2022, facing north.

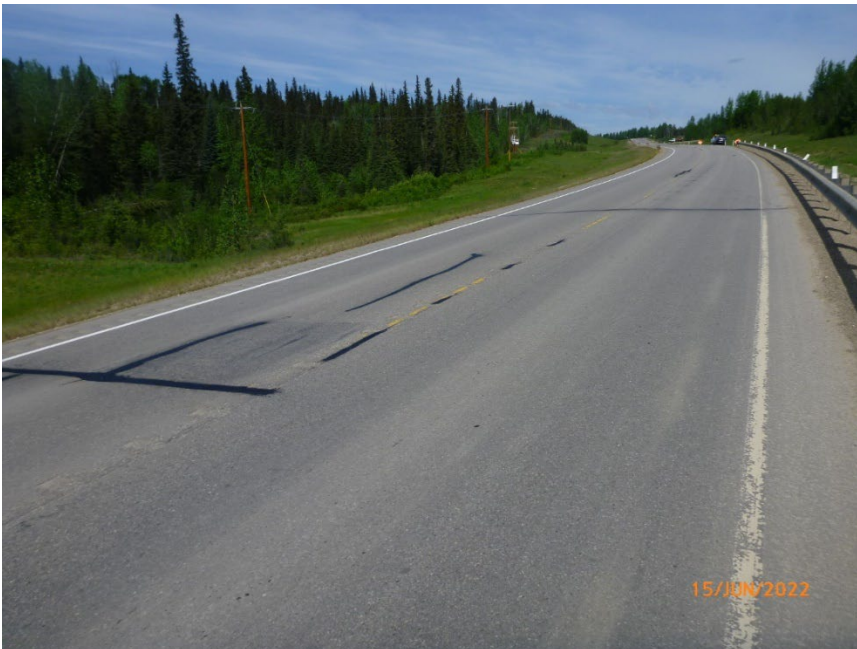
Photo 6 Minor cracking in pavement surface of Hwy 40:38 at GP038-II site. Photo taken June 15, 2022, facing northwest.

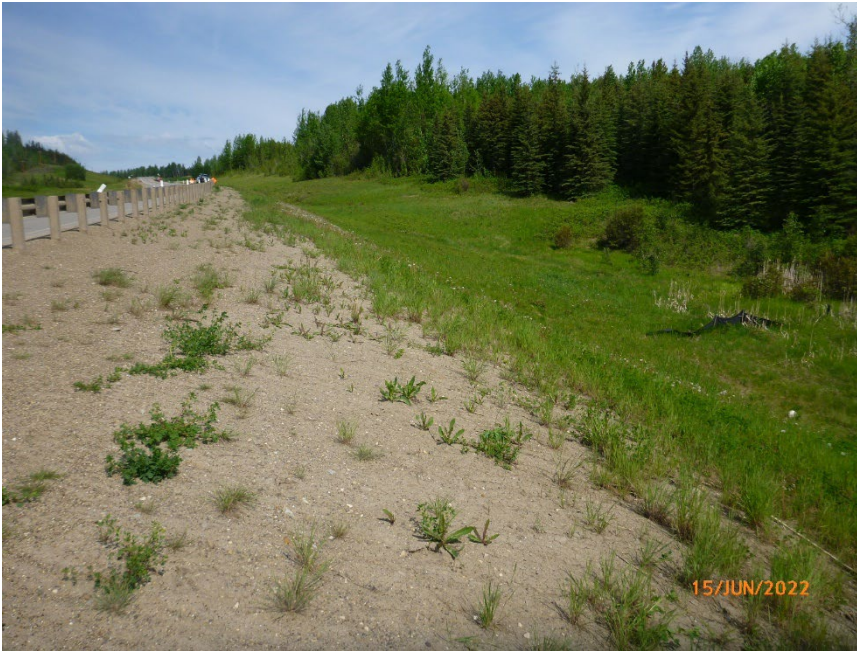
Photo 7 Highway embankment and ditch above and north of GP038-II site. Photo taken June 15, 2022, facing northwest.

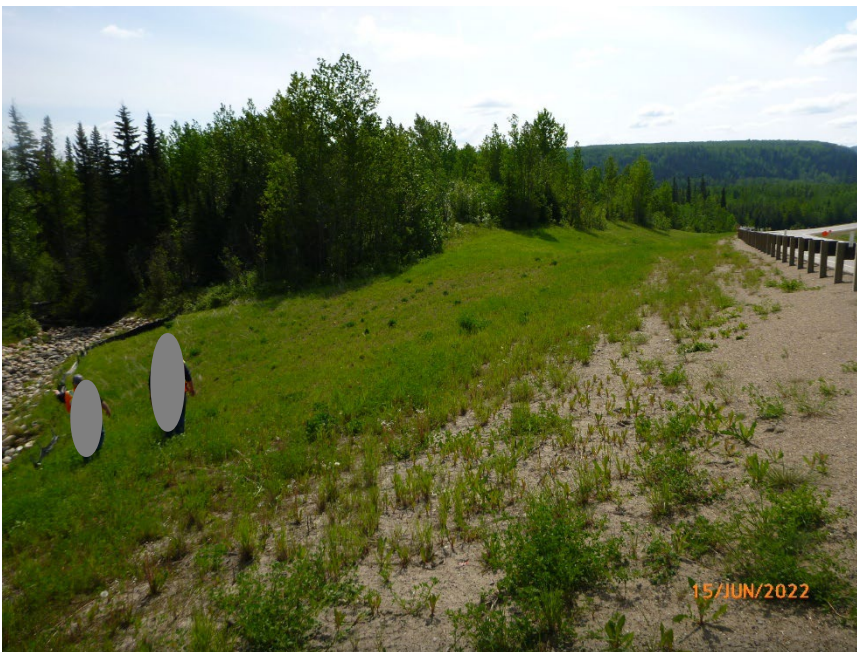
Photo 8 Highway embankment and ditch above and south of GP038-II site. Photo taken June 15, 2022, facing southeast.

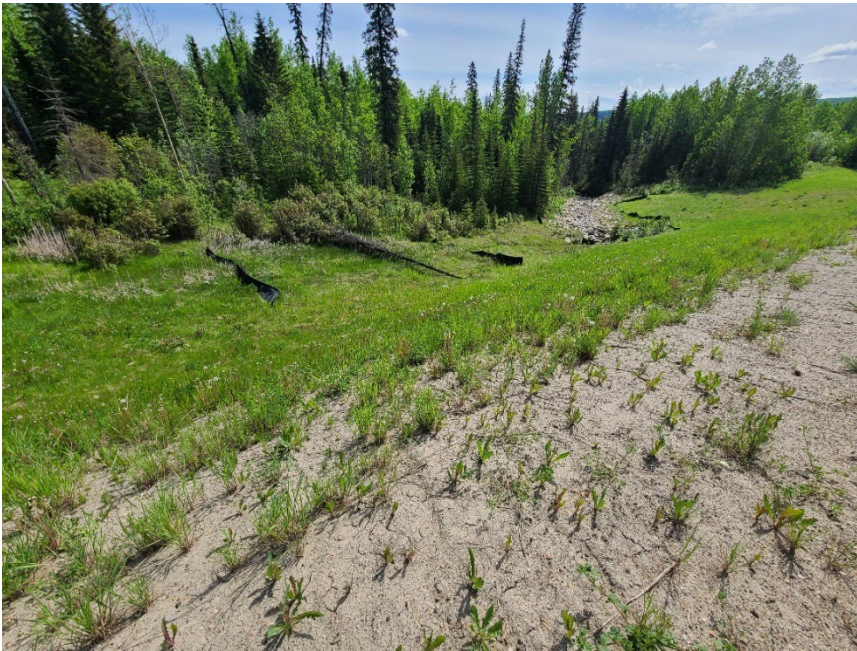
Photo 9 Overview of GP038-II site. Photo taken June 15, 2022, facing southeast.

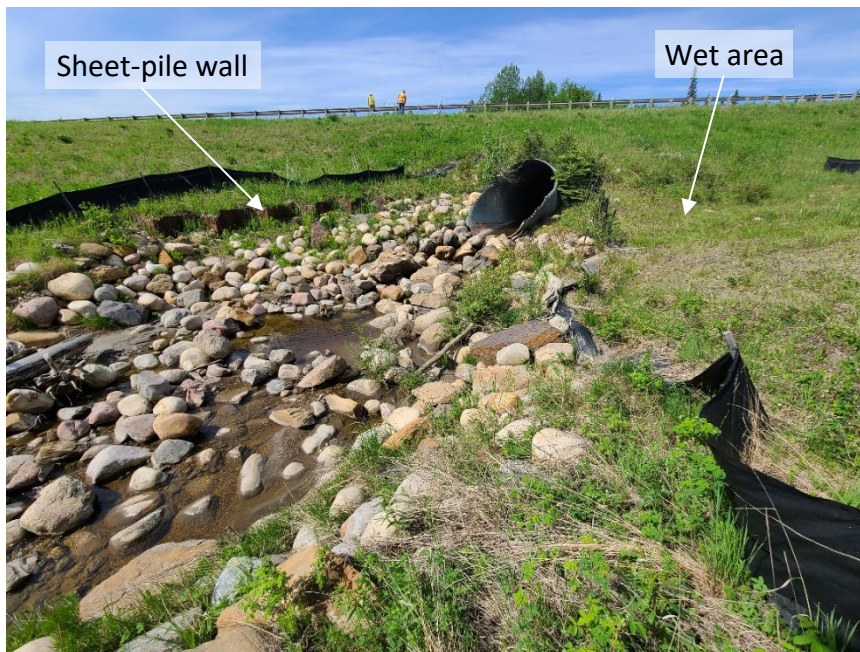
Photo 10 Outlet of culvert at GP038-II site. Note sheet-pile wall along south side and wet area along north side of culvert inlet/creek channel. Photo taken June 15, 2022, facing west.

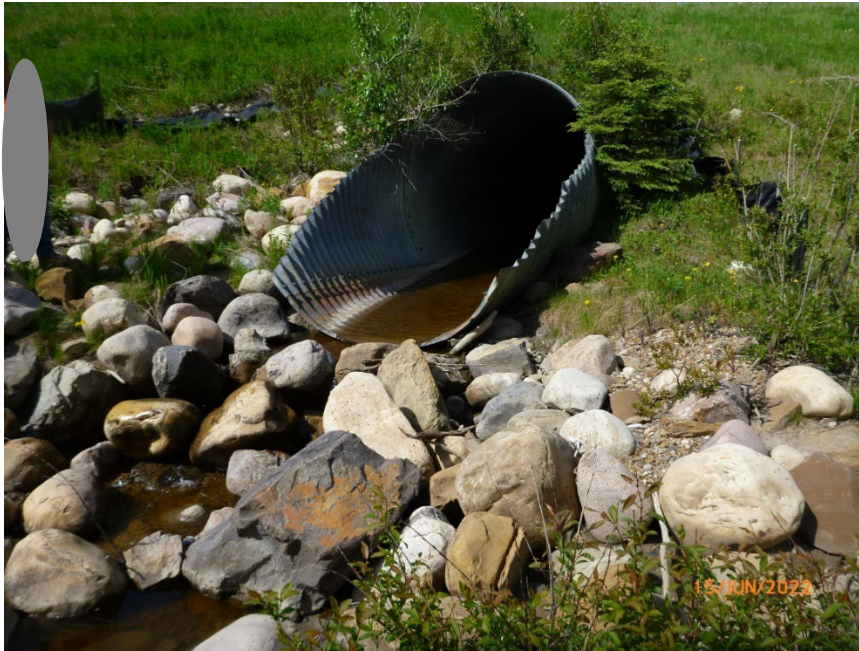
Photo 11 Culvert outlet and riprap at GP38-II site is a barrier to fish passage. Photo taken June 15, 2022, facing southwest.

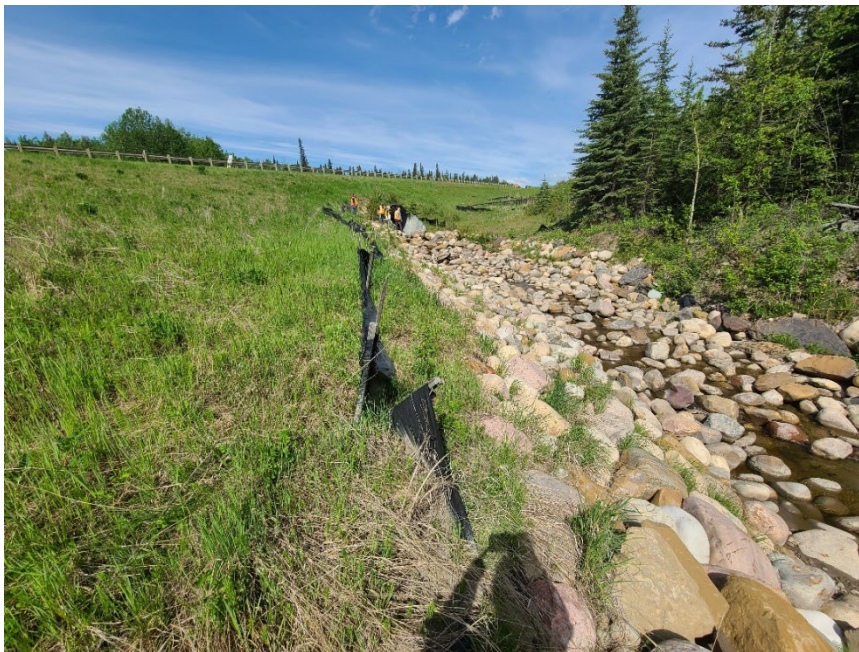
Photo 12 Channel downstream of culvert at GP038-II site. Photo taken June 15, 2022, facing northwest.

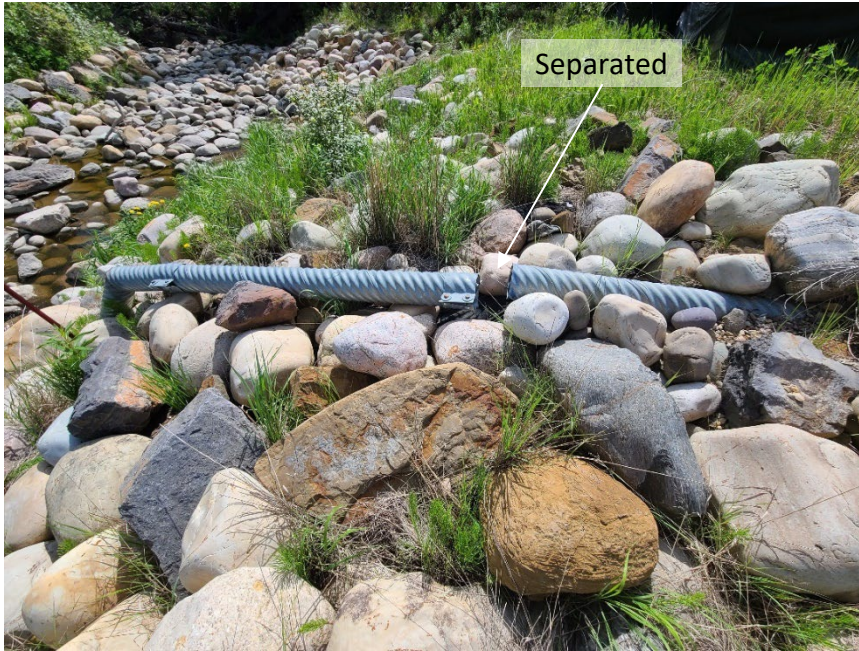
Photo 13 Subdrain outlet at GP038-II separated and not flowing. Photo taken June 15, 2022, facing east.
