July 15, 2025

CON0022166 Peace Region (Grande Prairie District – South) GRMP Instrumentation Monitoring Site GP038-I and -II; H40:38, km 25.831 and km 25.426
Slides 1.6 km and 2.0 km North of Kakwa River Bridge (North Little Prairie Creek Slide)
Section C – 2025 Spring Readings

PROJECT
PEACE REGION (GRANDE PRAIRIE DISTRICT-SOUTH)
GEOHAZARD RISK MANAGEMENT PROGRAM

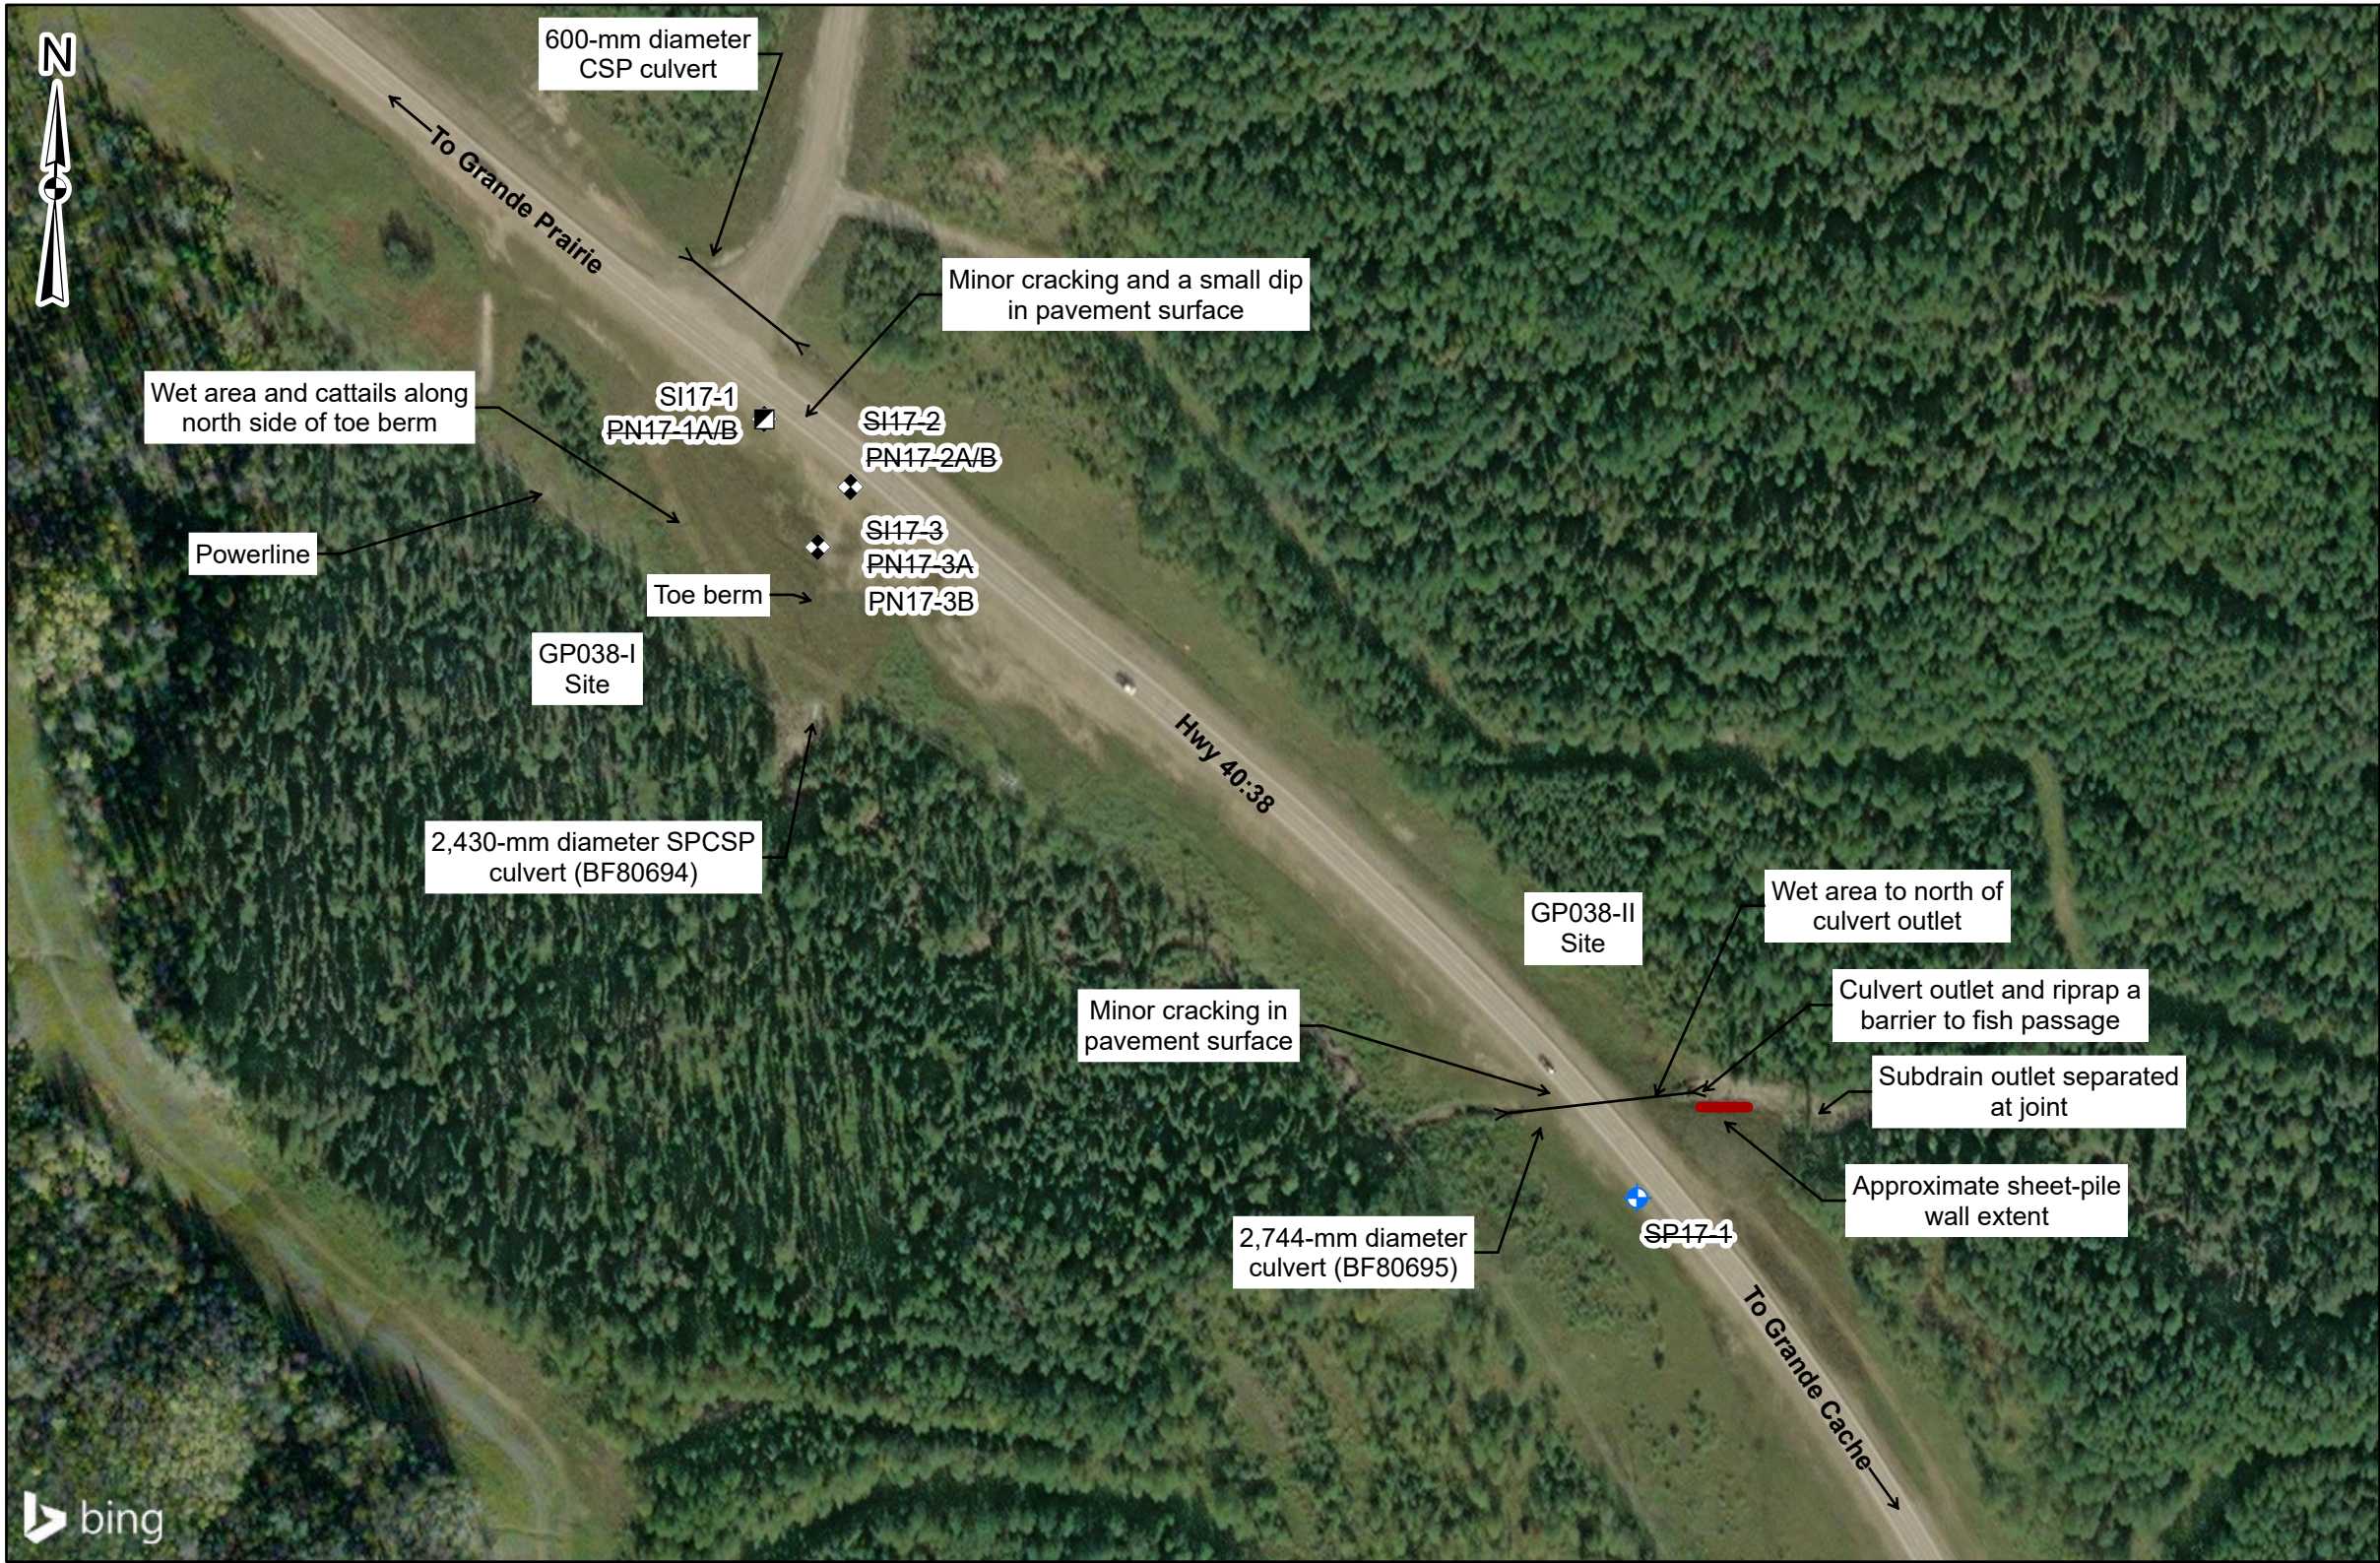
SCALE 1:2,500 PROJECT No. A05116A01 FIG No. 1

KCB has been reading the instruments at this site since the spring of 2021. Instrumentation installation details are tabulated in Table 1.1. Instrument locations are shown on Figure 1. Any instruments not included in Table 1.1 or shown on Figure 1 are assumed to be inoperable and are not presented or discussed herein.

During the spring 2025 readings, PN17-1A and PN17-2A/B were found to be inoperable (appeared to have been chewed off to ground surface) and could not be repaired. The instruments will not be read again. As discussed in Section 3, no replacement instruments are recommended at this time.

Above-ground-steel-casing protectors for some instruments are close to pavement edge. These are potential roadside hazards to motorists who go off the highway. These should be removed if the instrument(s) are inoperable or replaced with flush-mounted casing protectors if instruments are operable.

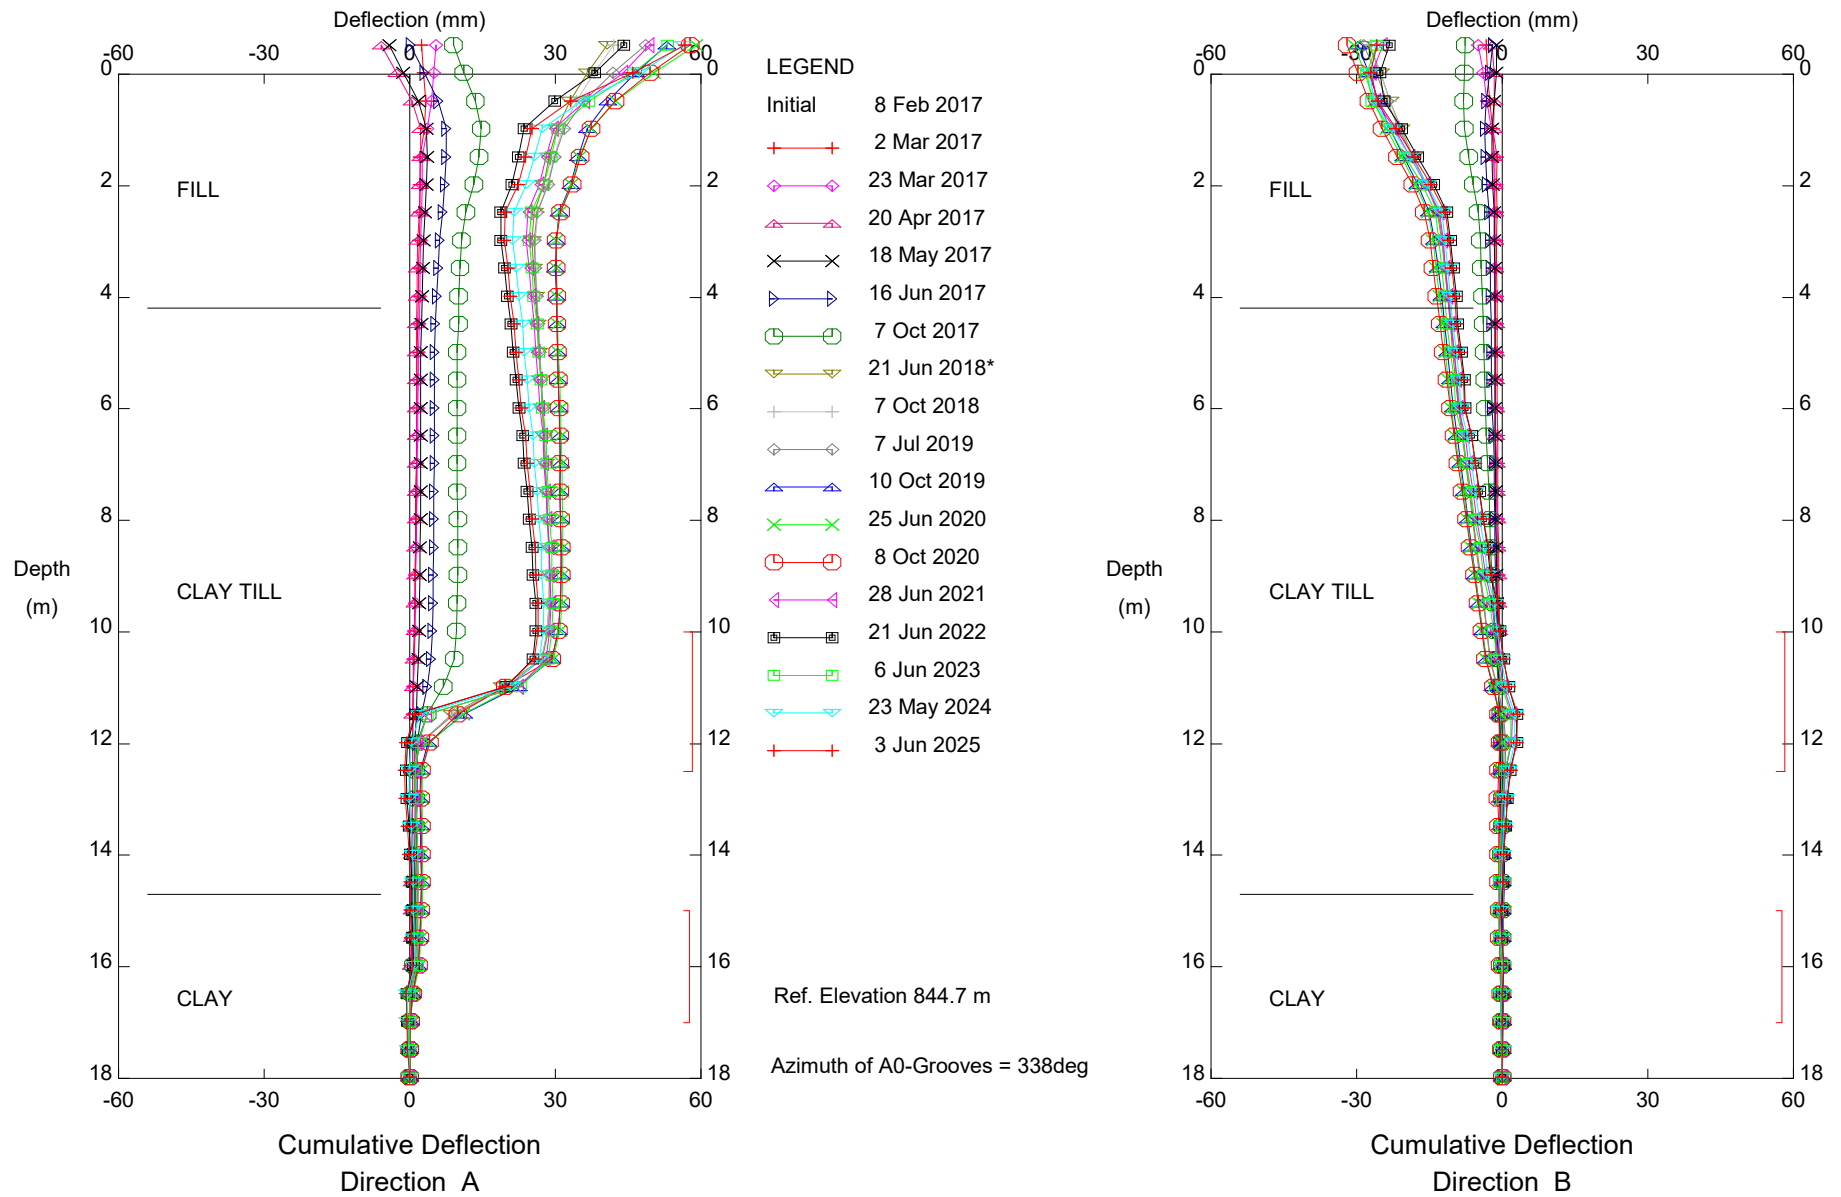
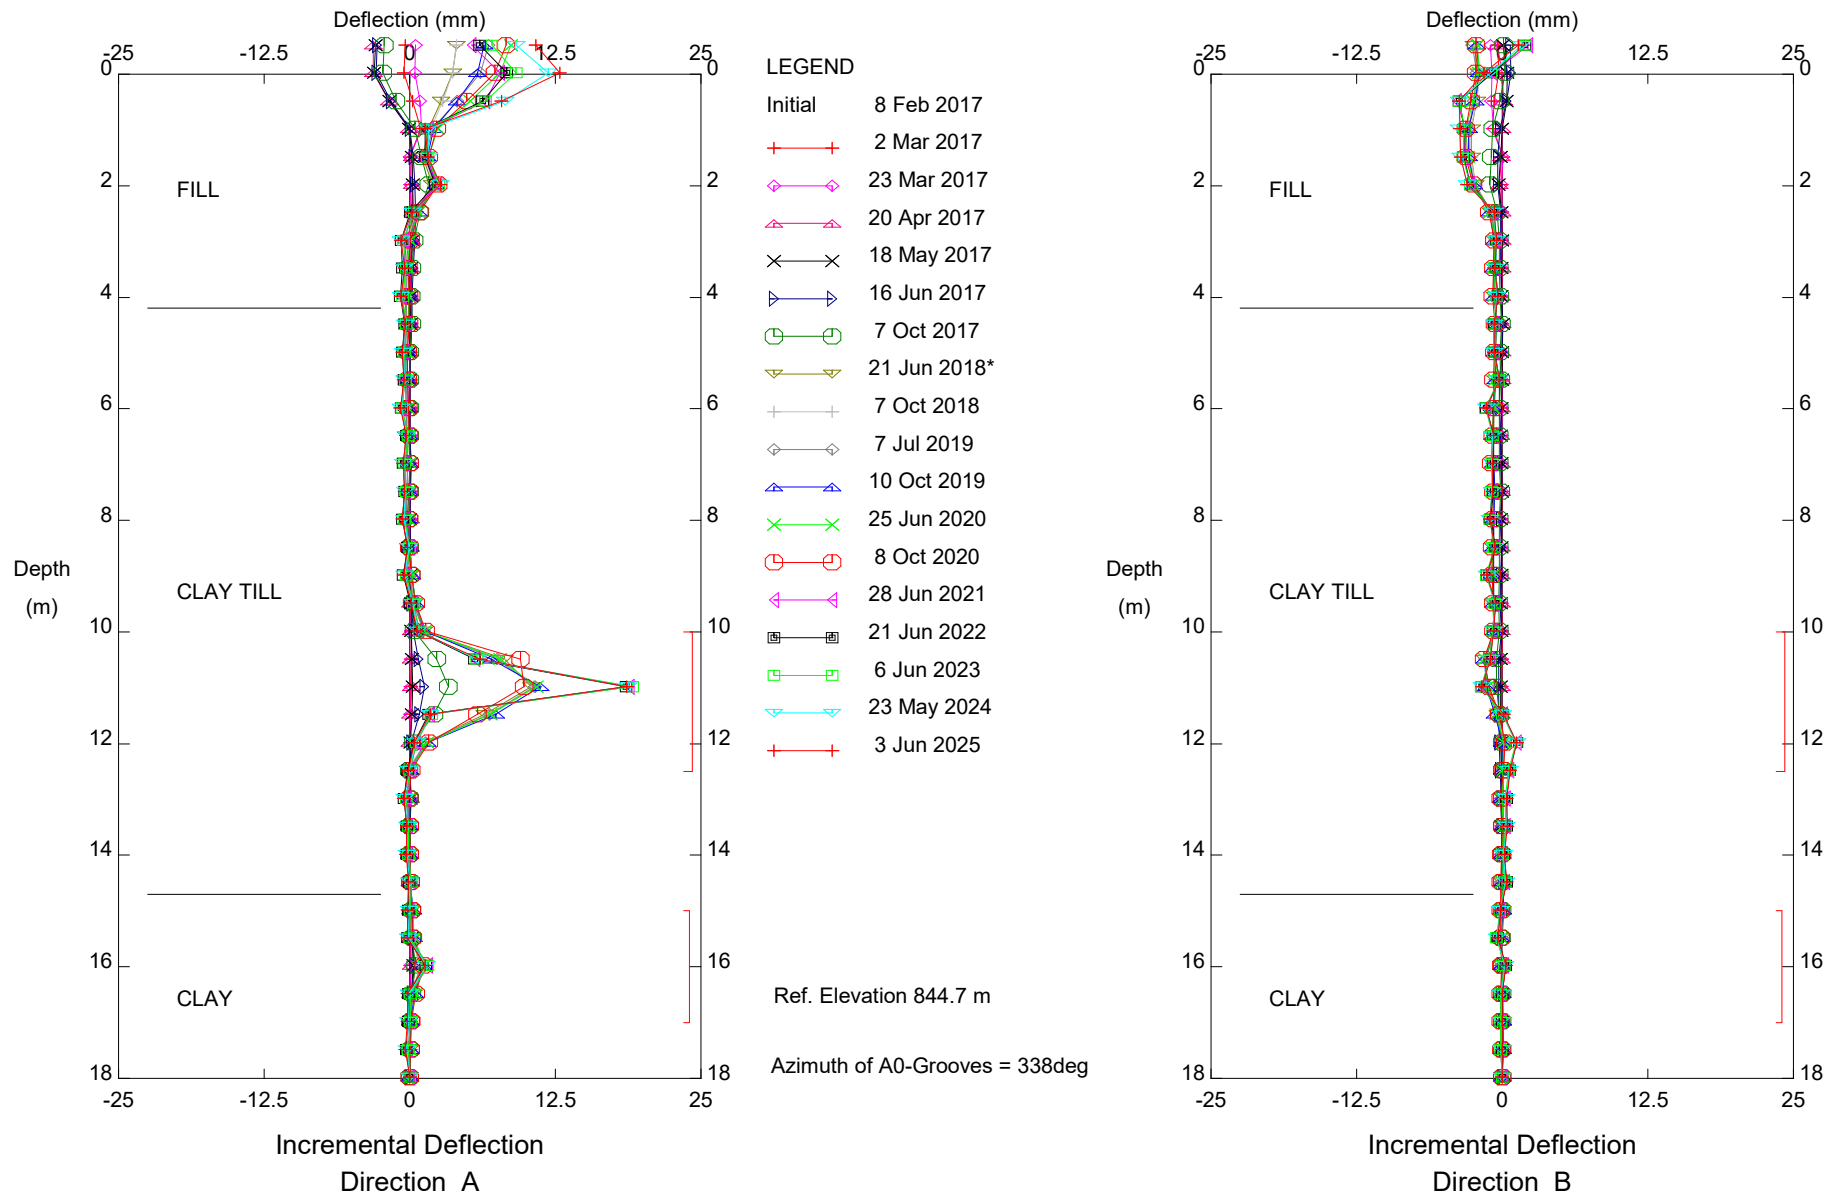
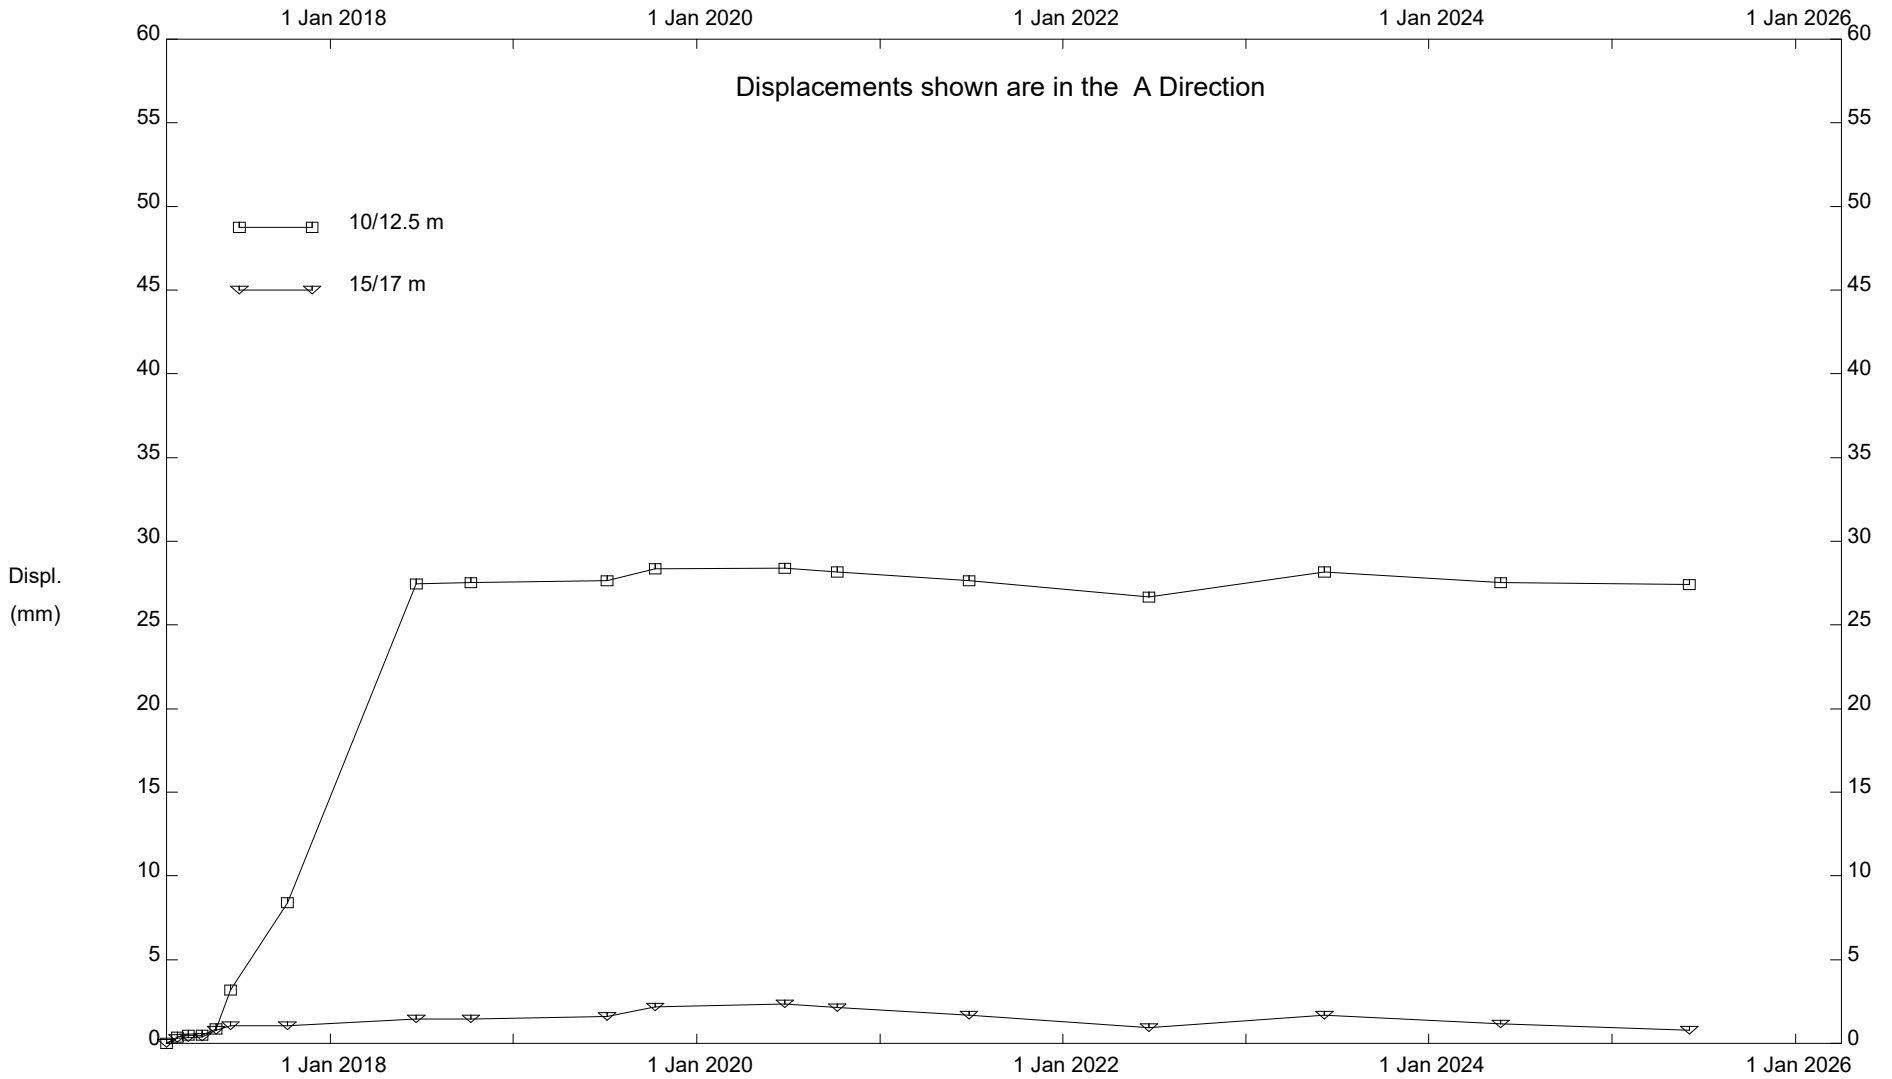
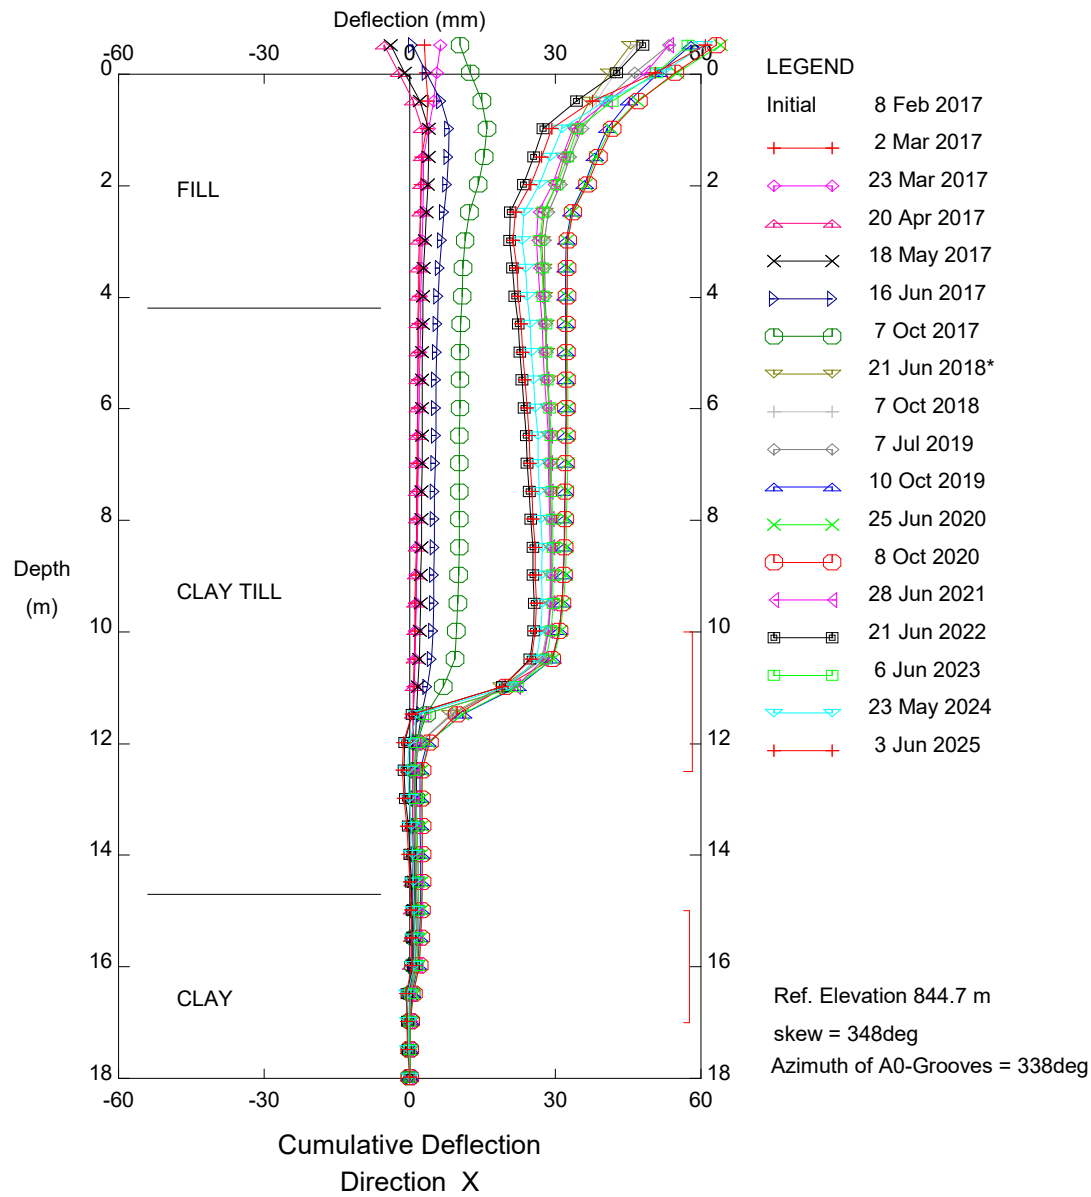
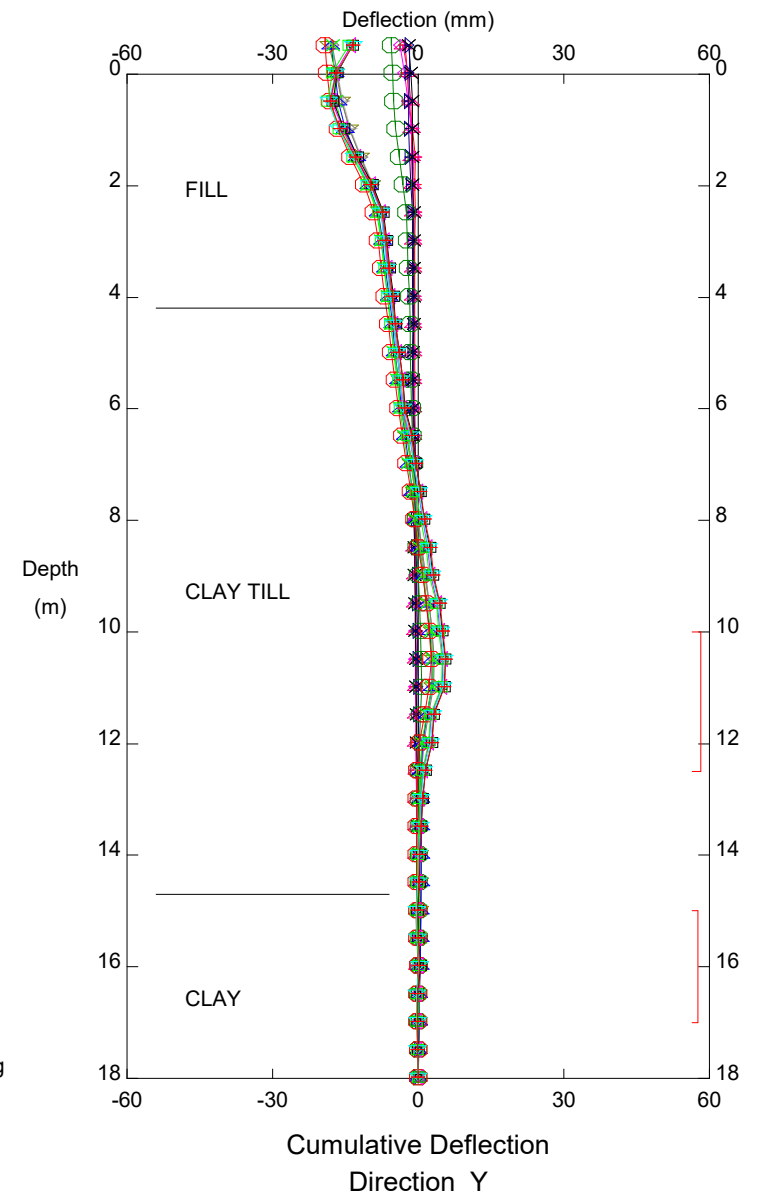
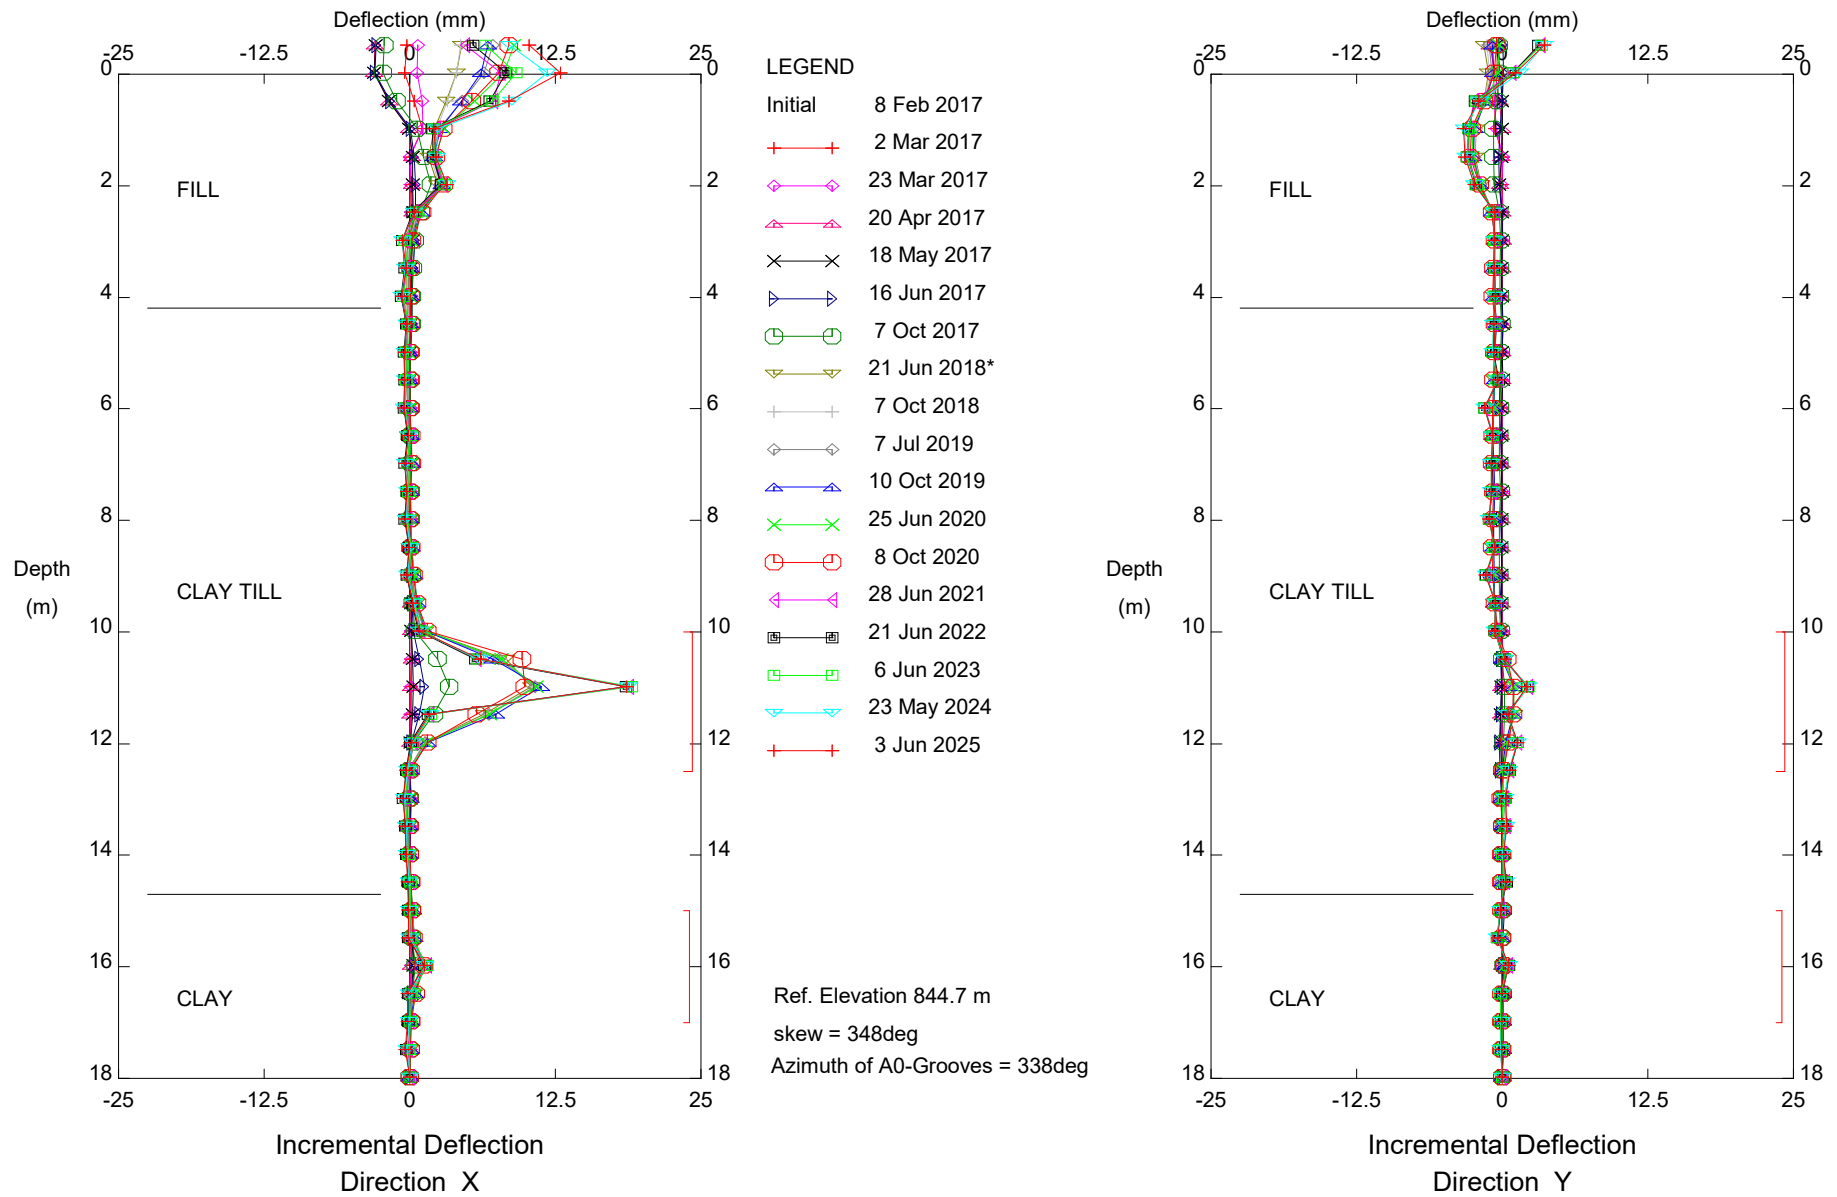
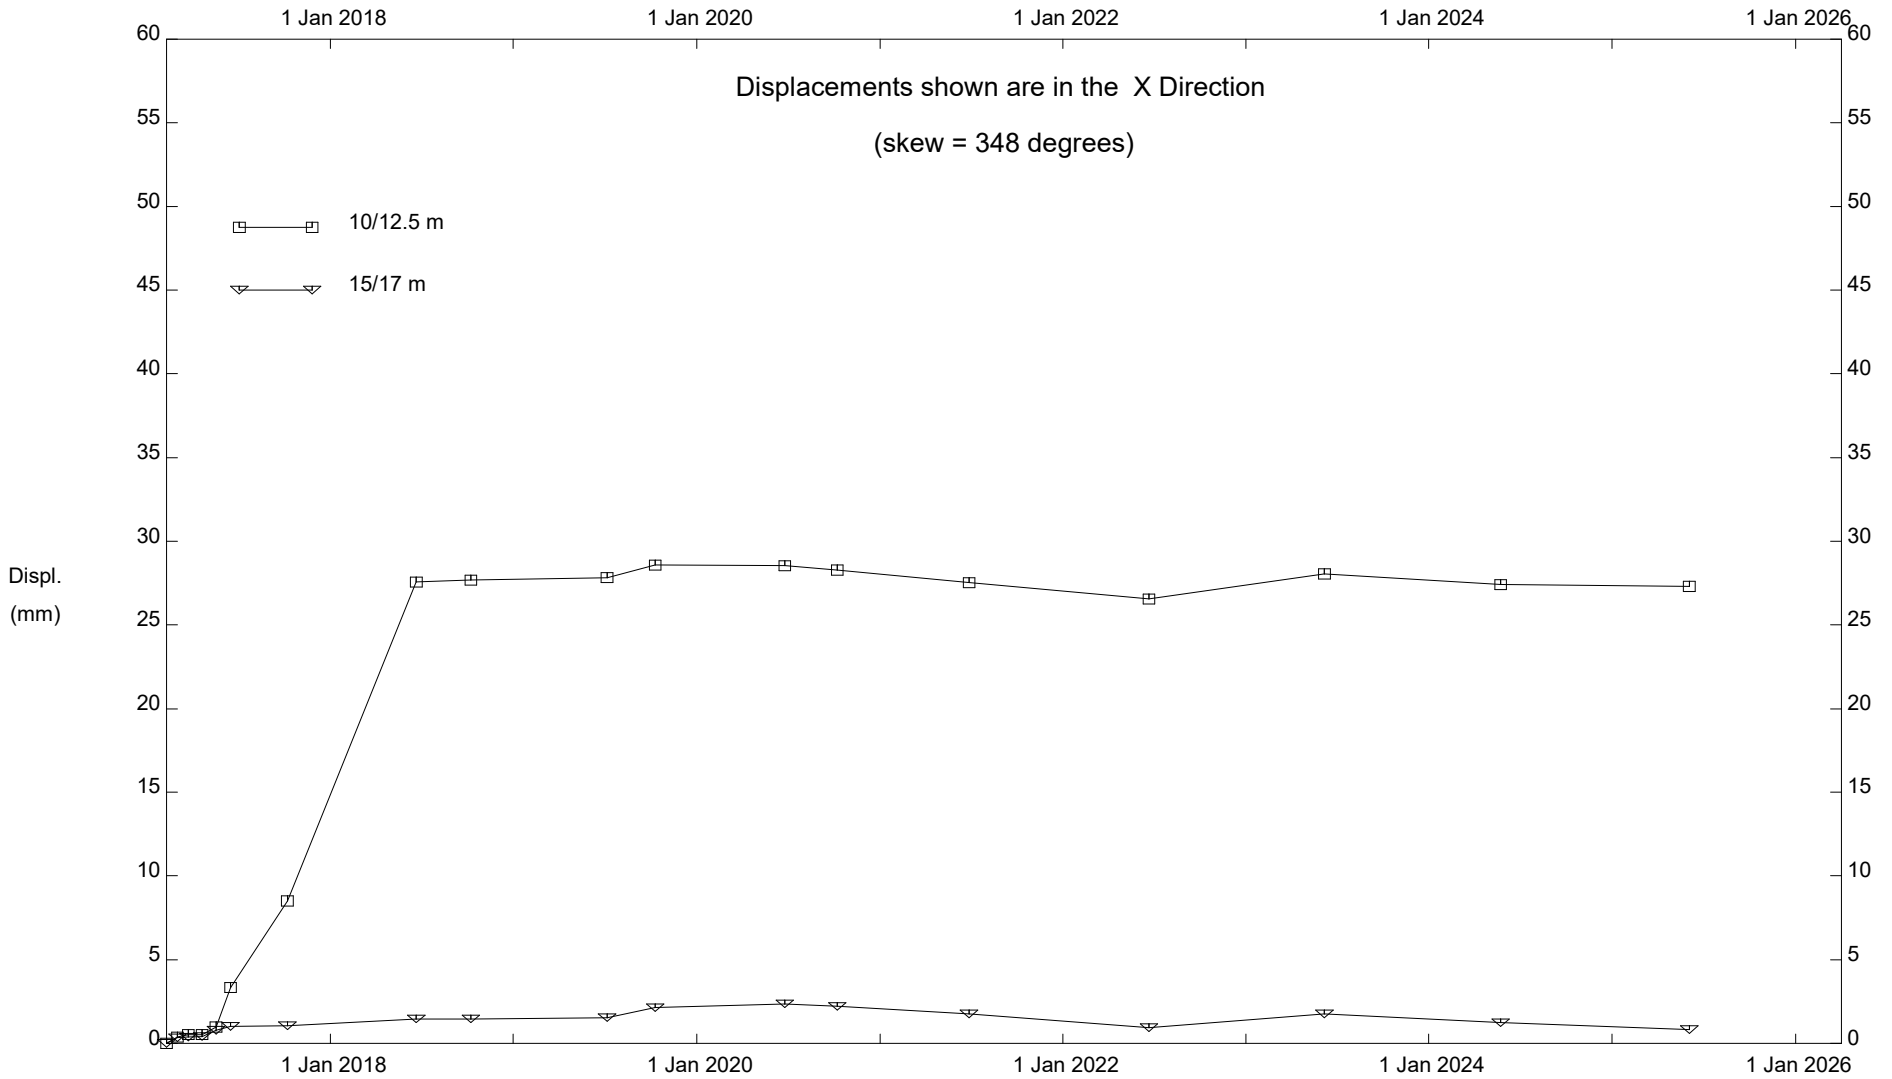
GP038-I; H40:38, Kakwa River Bridge, Inclinometer SI17-1

Discrete movement (i.e., occurring on a defined failure plane) is being recorded in SI17-1 from an approximate depth of 10.0 m to 12.5 m below ground surface (approximately elevation 832.2 m to 834.7 m) and possibly from 15.0 m to 17.0 m (approximately elevation 827.7 m to 829.7 m). The upper and lower zones of movement are occurring in the clay till and the underlying clay foundation units, respectively. Shallow distributed movement is also being recorded in the fill from an approximate depth of 2.5 m below ground surface to ground surface (approximately elevation 842.2 m to 844.7 m).

Between June 2017 and June 2018, an increased rate of movement (approximately 29 mm/year) was recorded in the upper monitoring zone of SI17-1, likely in response to toe berm construction in 2017 and 2018. Since June 2018, the rate of movement has decreased and is currently less than 1 mm/year indicating the toe berm is stabilizing the highway embankment. The rate of movement recorded in the lower monitoring zone of SI17-1 has been slow (less than 1 mm/year) since installation and is within the accuracy of the SI reading equipment.

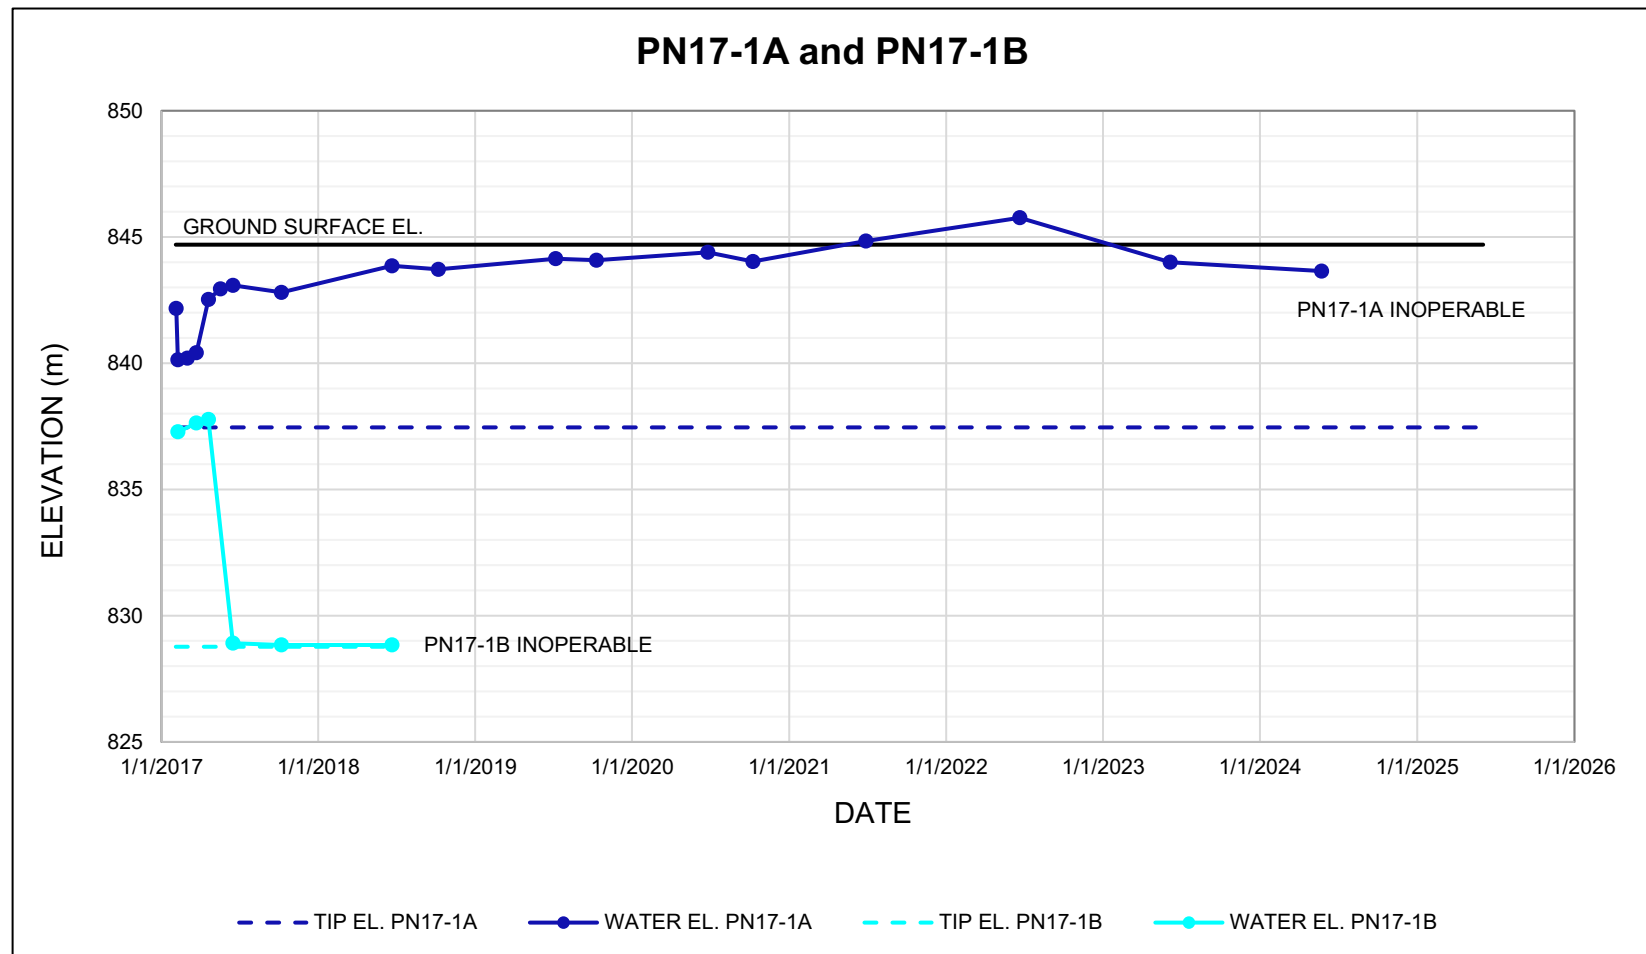
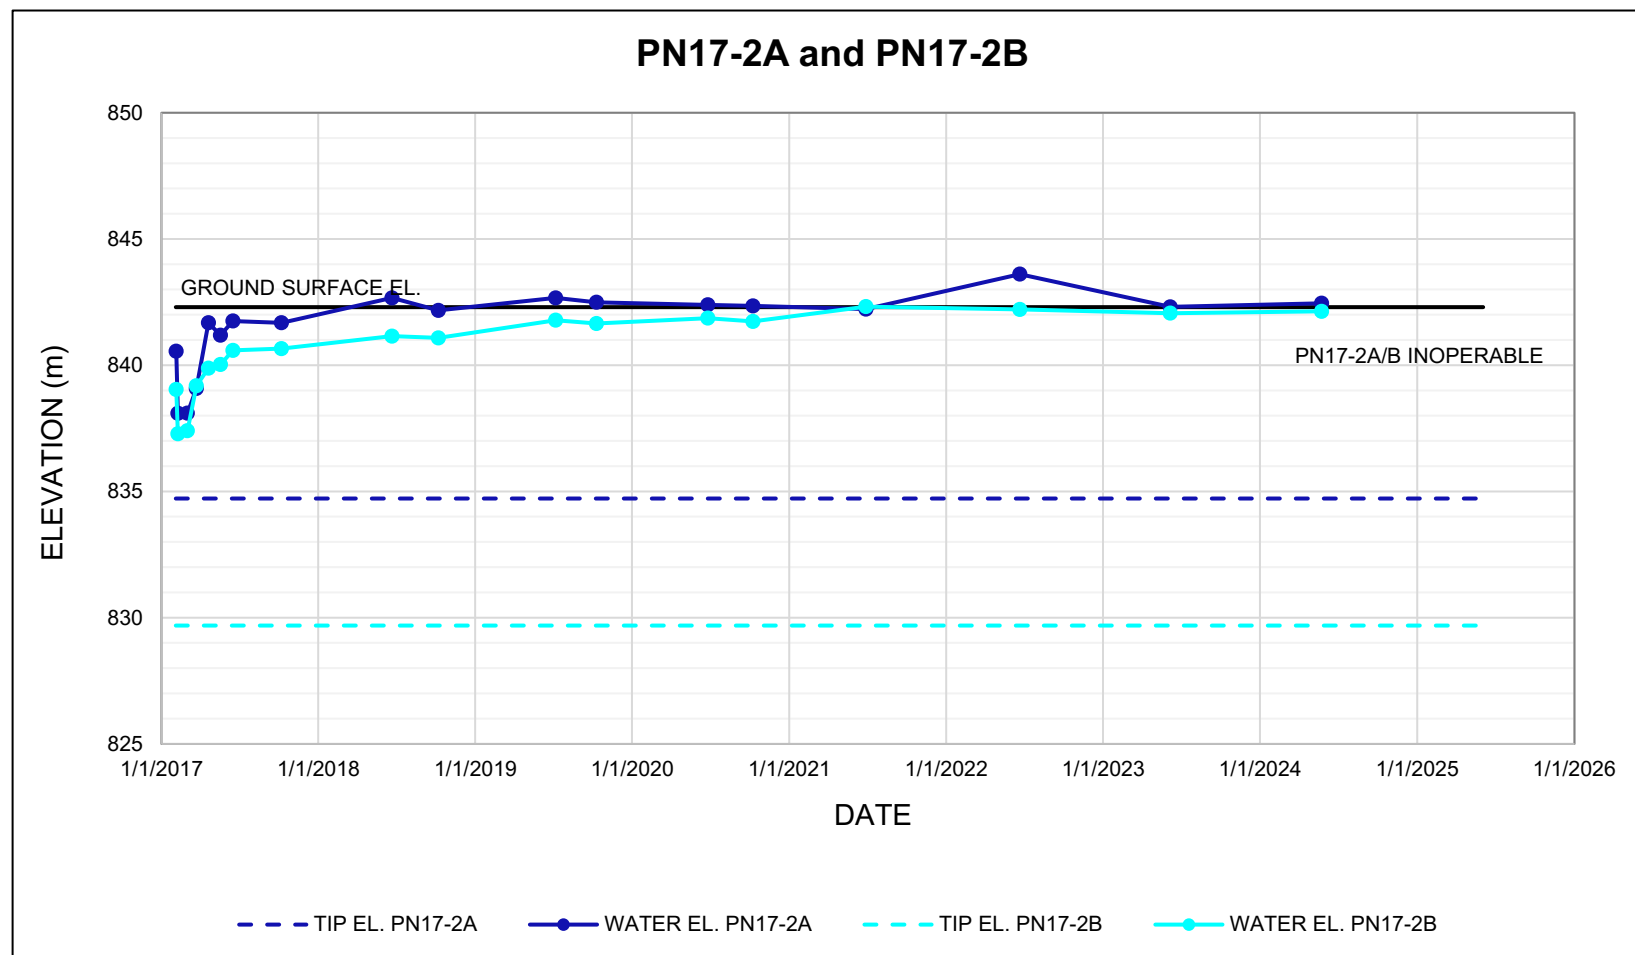
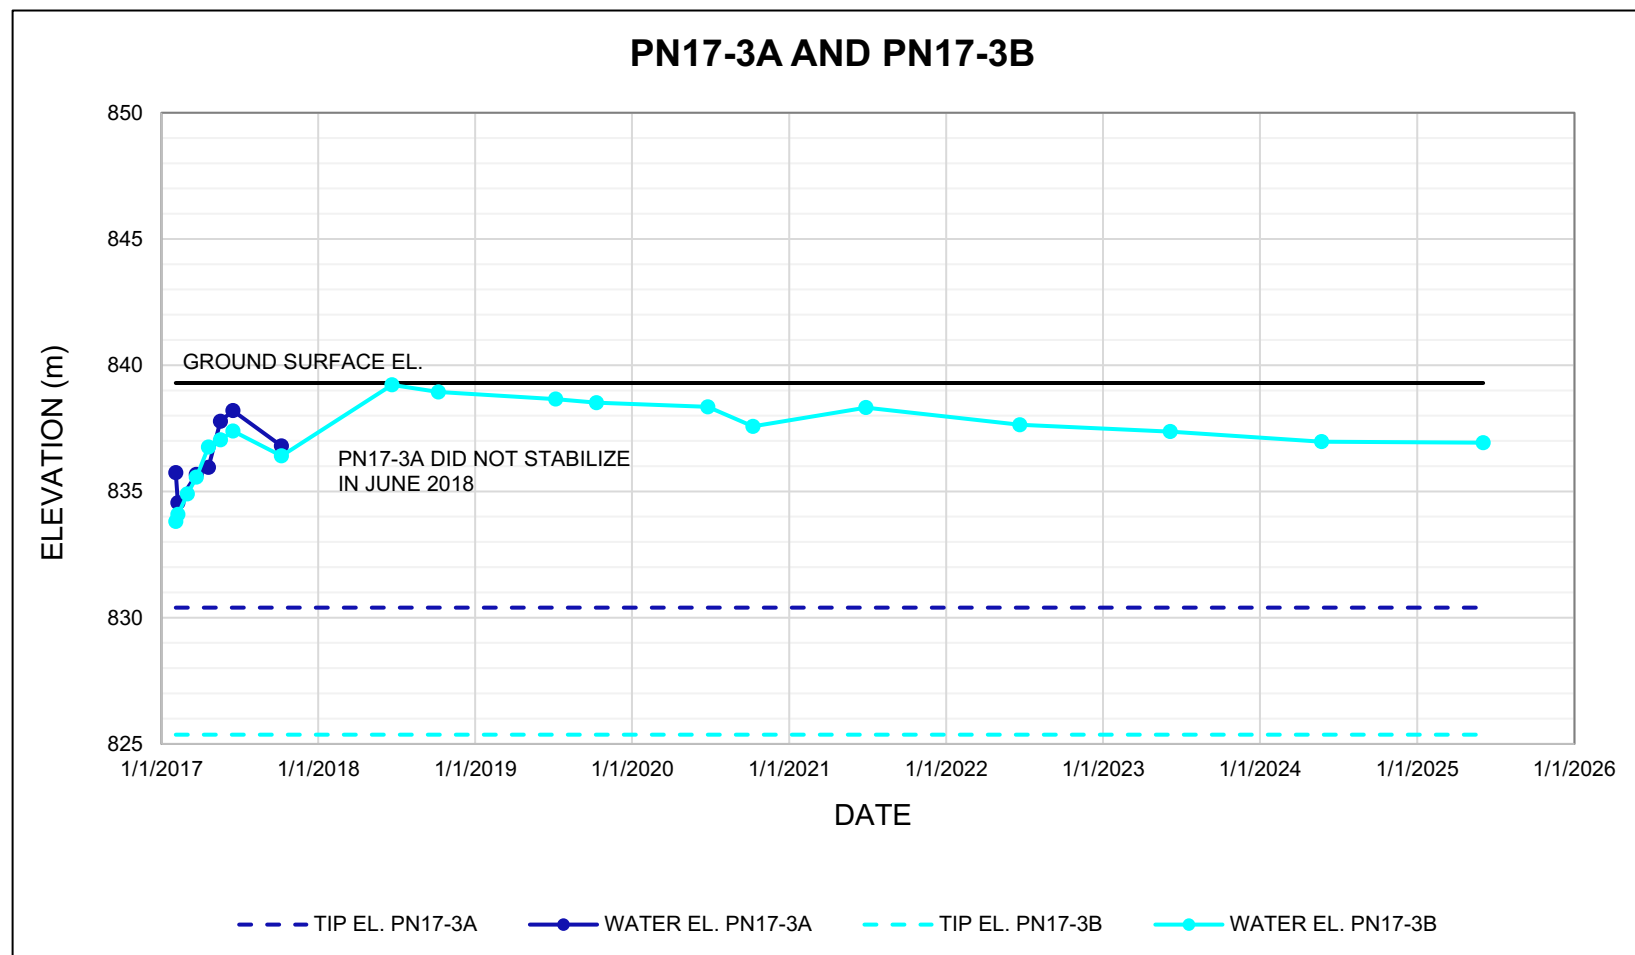
PEACE REGION (GRANDE PRAIRIE DISTRICT - SOUTH) GEOHAZARD RISK MANAGEMENT PROGRAM	
		TITLE PIEZOMETER DATA GP038-I - SLIDE 2.0 KM N. OF KAKWA RIVER BRIDGE HWY 40:38, KM 25.831	
SCALE	--	PROJECT No.	FIG No.
		A05116A01

Before several piezometers (e.g., PN17-1A and PN17-2A/B) became inoperable (last reading spring 2024), the water levels/porewater pressures recorded in the instruments were relatively high and had been near to above ground surface since mid-2017, indicating the presence of a high groundwater table. The relatively high-water level recorded in the piezometers could result in embankment instability and explain the pavement cracking observed at this site. However, the cracking, in combination with the observed pavement dip and settlement, could also be due to settlement of the recently placed fill. Reactivation of the slide could occur due to continued erosion (less likely) or increases in water level. However, the large toe berm should reduce the potential for reactivation of the slide.

Since mid-2018, an approximate 2.3 m decrease has been recorded in PN-3B, which is installed below the toe berm in a clay foundation unit. The recorded decrease is most likely due to porewater pressures dissipating following toe berm construction between 2017/2018.

Since SP17-1 was the last operable piezometer at the GP038-II site and PN17-3B is the last operable piezometer at the GP038-I site, replacement piezometers could be considered. However, since mid-2018, relatively steady water levels had been recorded in the piezometers and instrument replacements are likely not needed unless site conditions visually change from previous observations (e.g., the slide or area of known high groundwater table appears to be expanding and impacting the highway).
