**ALBERTA TRANSPORTATION
GEOHAZARD ASSESSMENT PROGRAM
PEACE REGION – GRANDE PRAIRIE DISTRICT
2018 INSPECTION**

Site Number	Location	Name	Hwy	km
GP44 Call Out	South of Grande Prairie	Cutbank River North	40:40	1
Legal Description		UTM Co-ordinates (NAD 83)		
NE21-65-5-W6		11U N 6,056,500	E 391,430

PEACE REGION (GRANDE PRAIRIE)
GP44: HWY 40:40, km 1.0, CUTBANK RIVER NORTH
NE 21-65-5-W6M

2018 INSPECTION PLAN

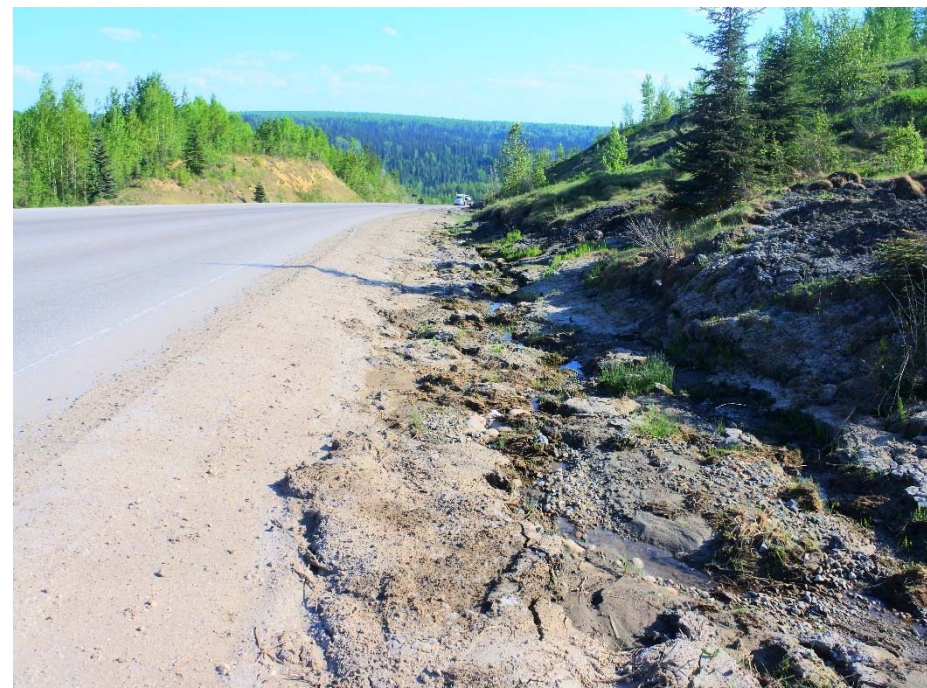
Photo 1.
Looking south
along at seepage
into the west ditch
at the north end of
the site.

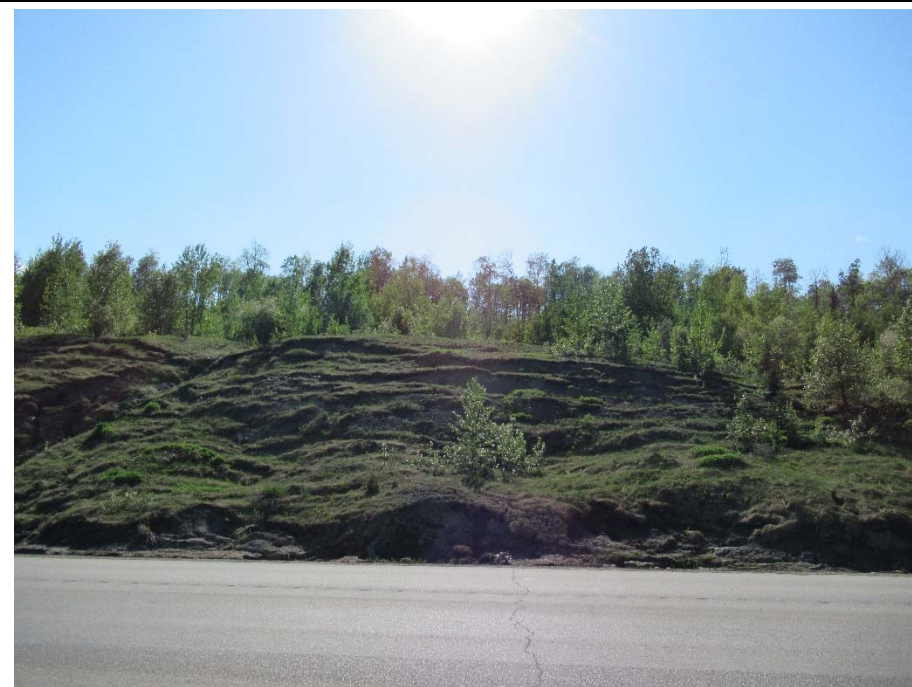
Photo 2.
Looking west at the
northern section of
the slide mass.

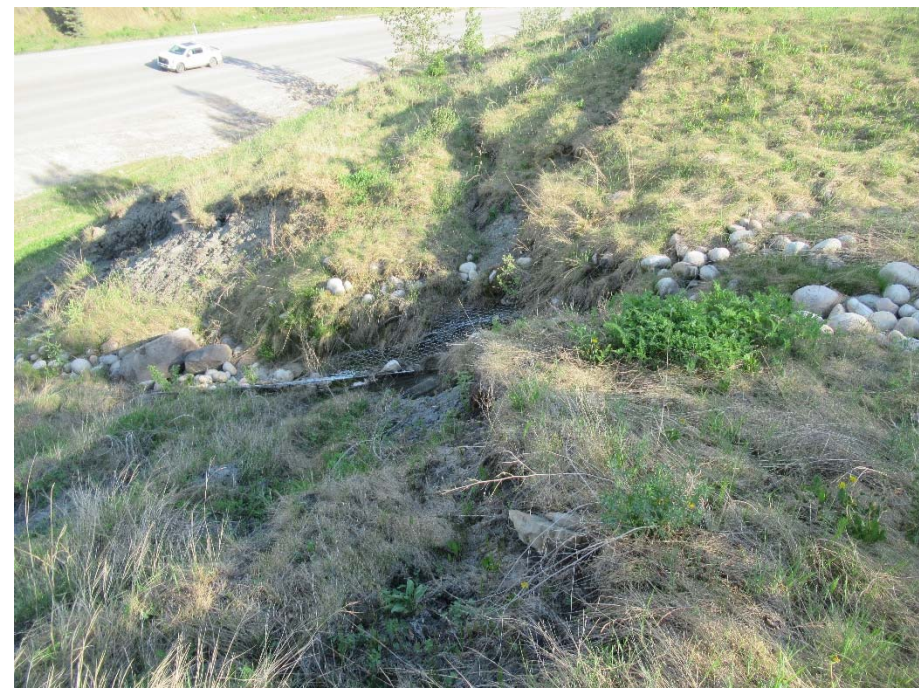
Photo 3.
Looking south at
the deteriorated
gabion armour.

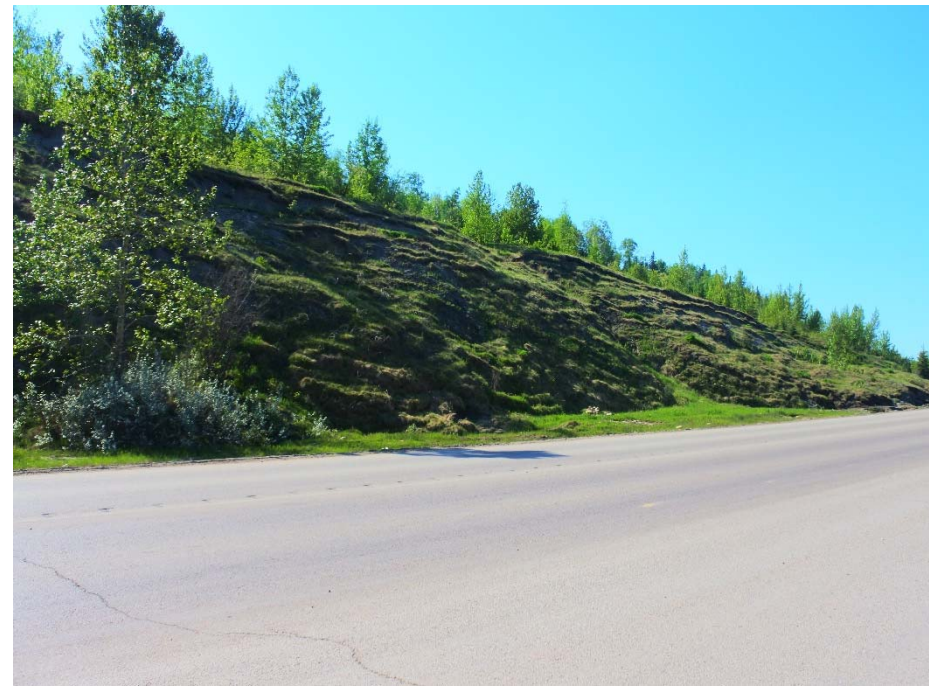
Photo 4.
Looking north at
the toe slumping
into the west ditch.

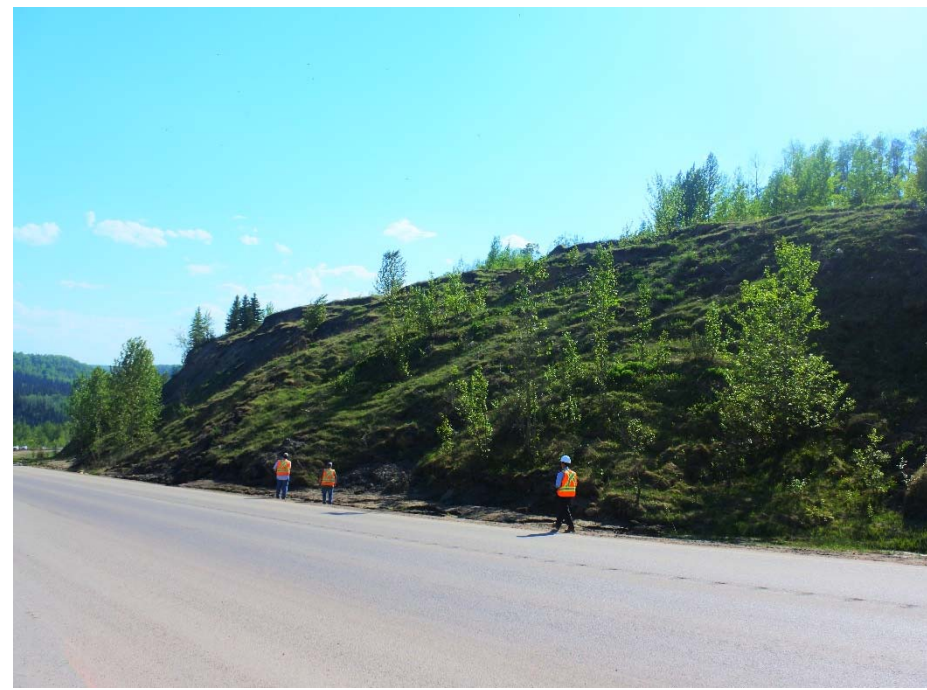
Photo 5.
Looking north at
the north end of the
scarp crack.

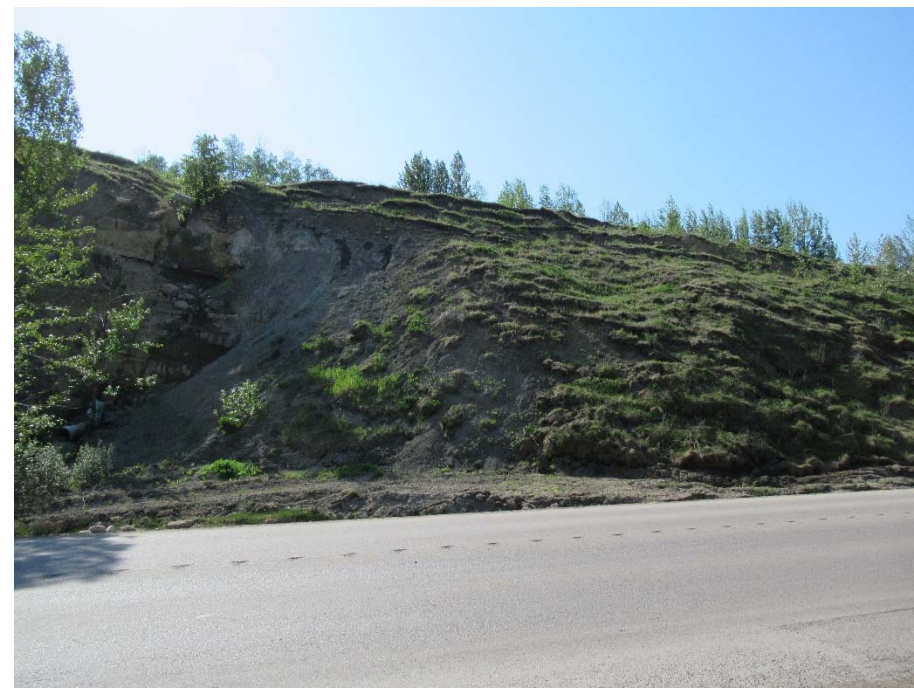
Photo 6.
Looking west at
erosion caused by
a broken 600 mm
CSP exposed in
the slumping
backslope.

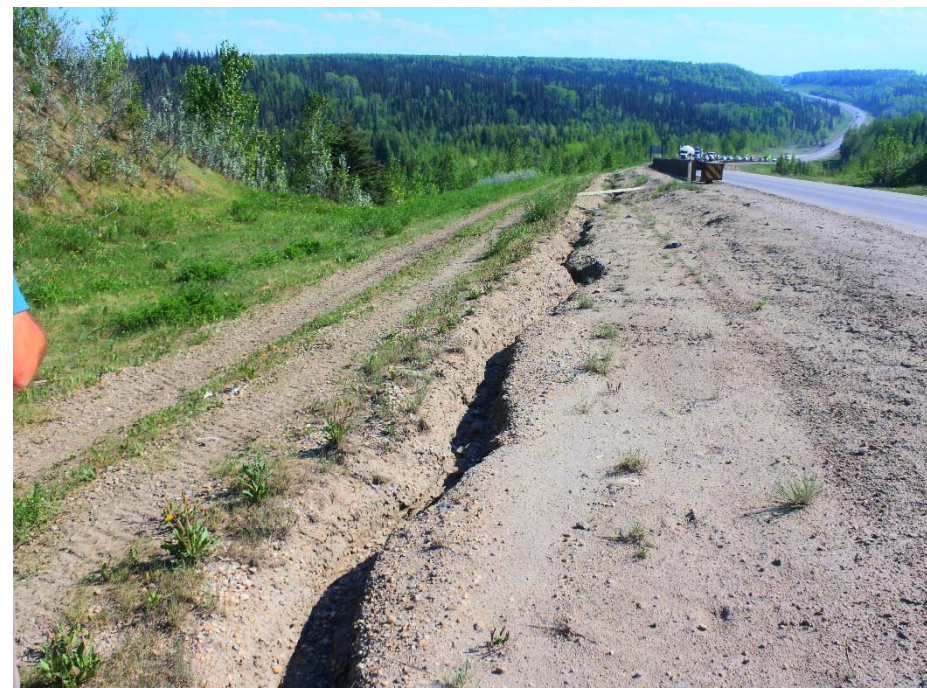
Photo 7.
Looking south at new erosion observed on the east side of the highway.

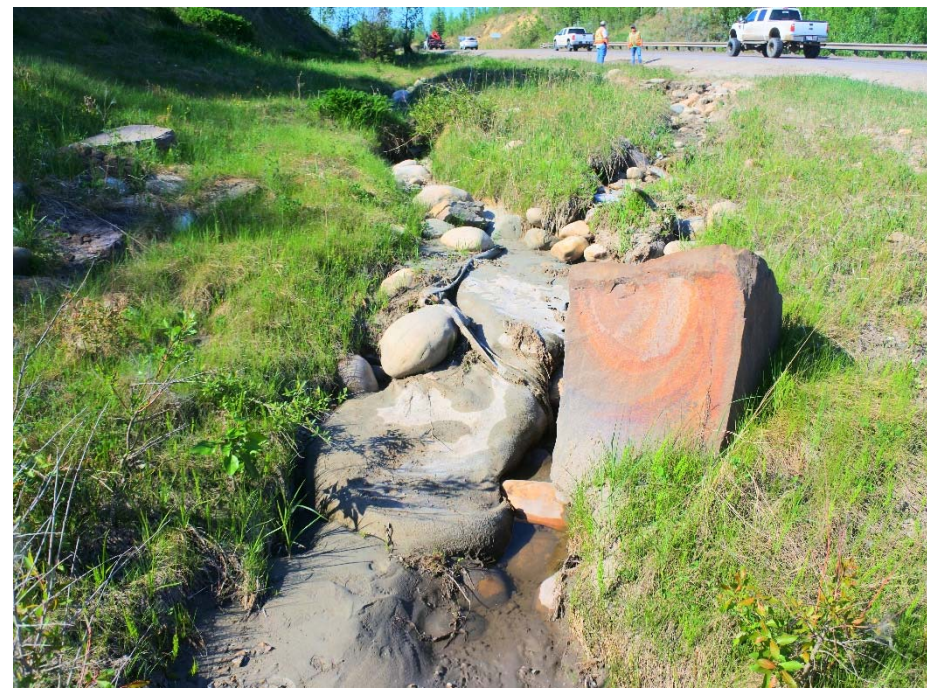
Photo 8.
Looking north at large fallen boulder in erosion gully.

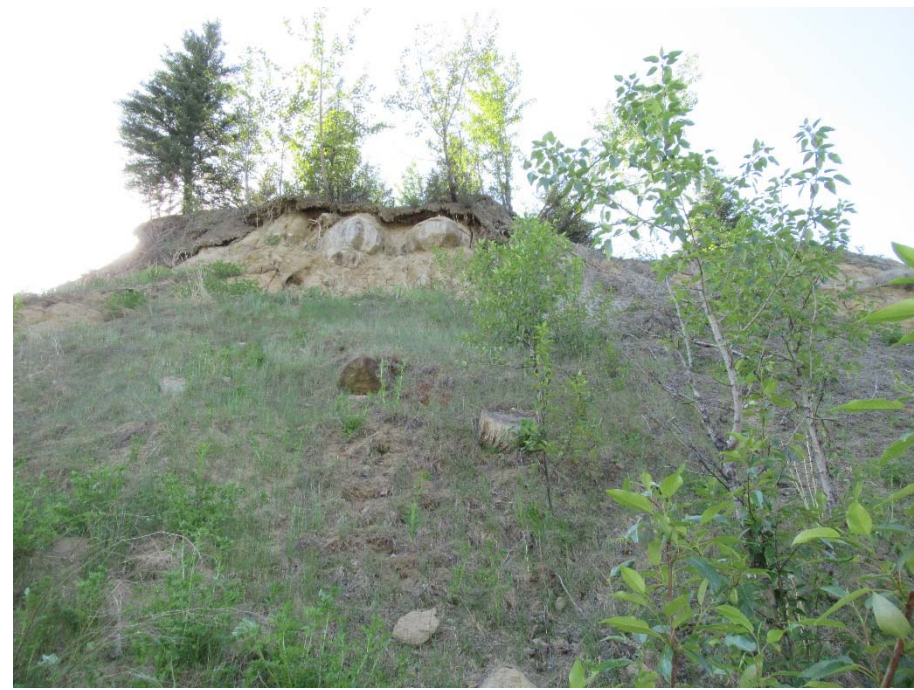
Photo 9.
Looking west up at hanging boulders that will eventually fall into ditch or highway.

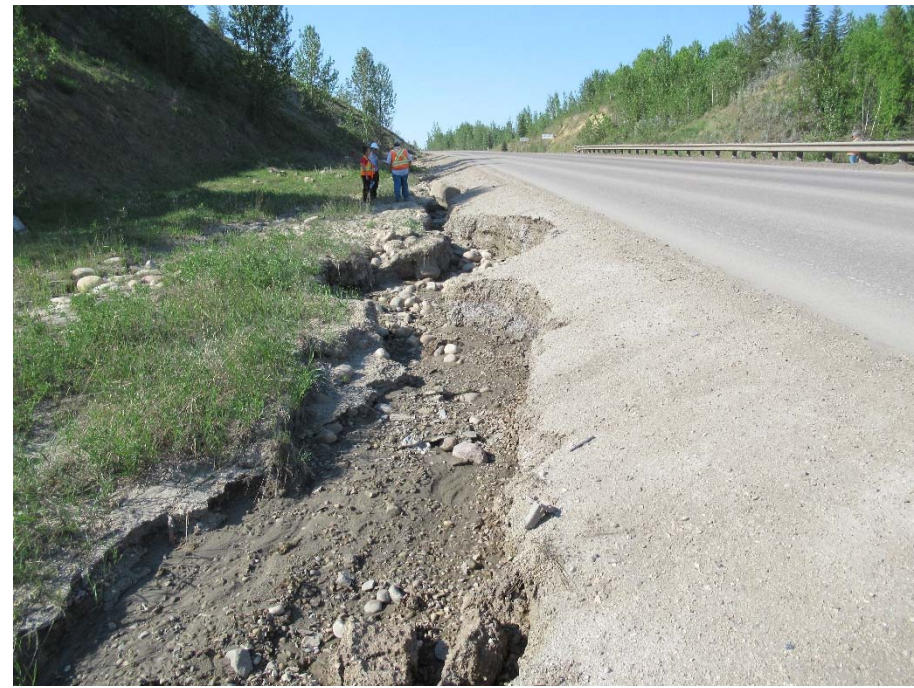
Photo 10.
Looking north at the west ditch erosion gully which has formed around the toe of slide encroaching against the highway embankment near middle of site.

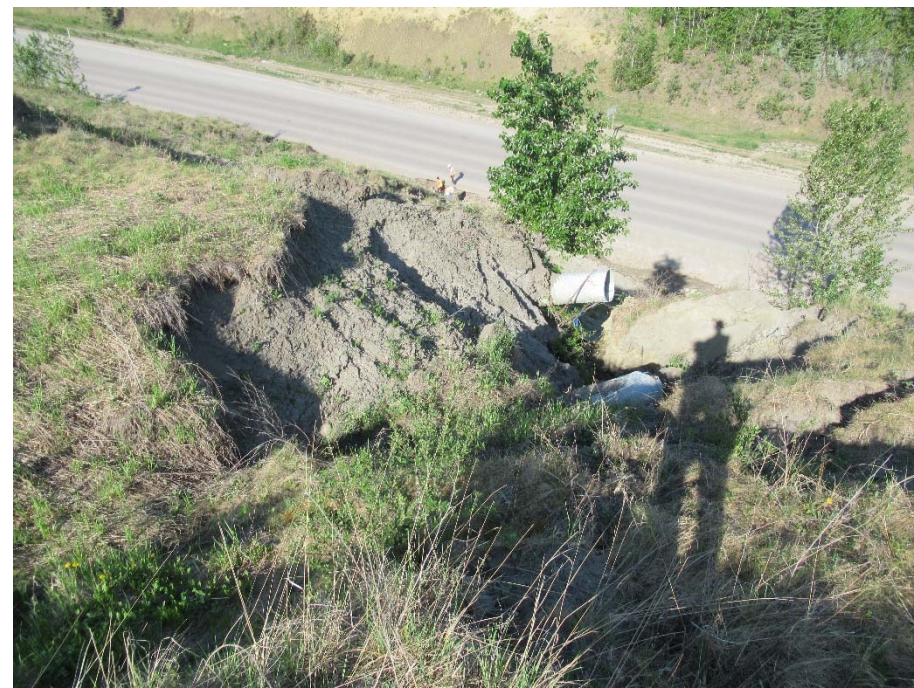
Photo 11.
Looking down towards road from the slope crest at the eroded gully caused by the broken 600 CSP.

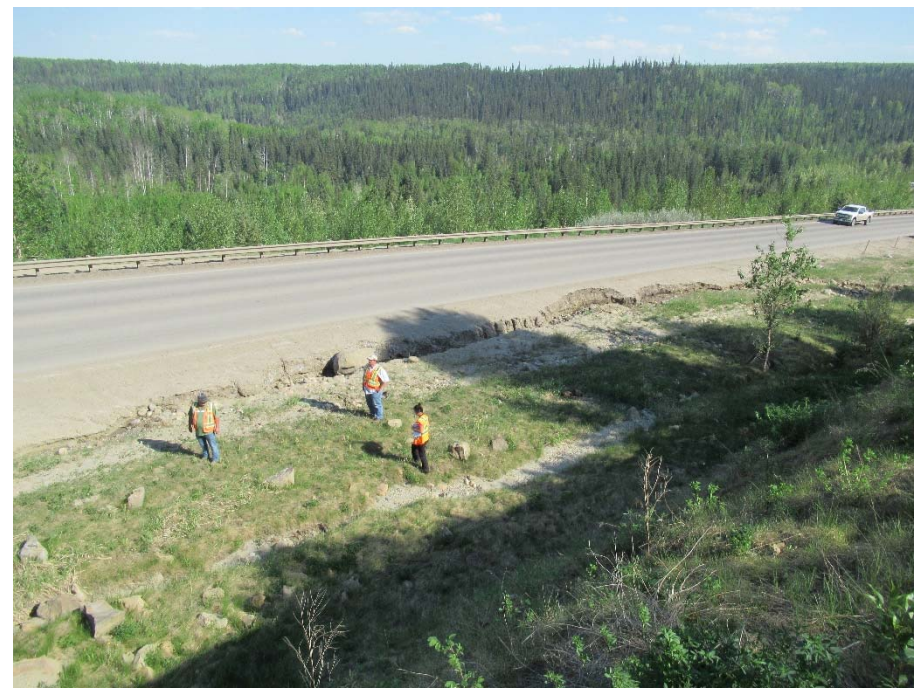
Photo 12.
Looking southeast down at erosion gully that runs along the west ditch/shoulder.

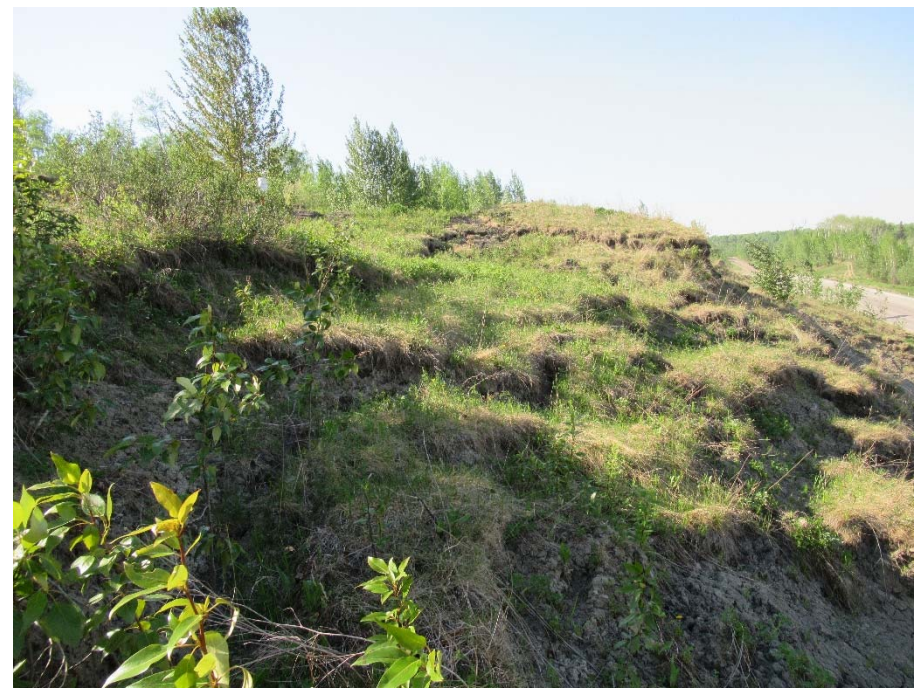
Photo 13.
Looking north at
recent area of
movement

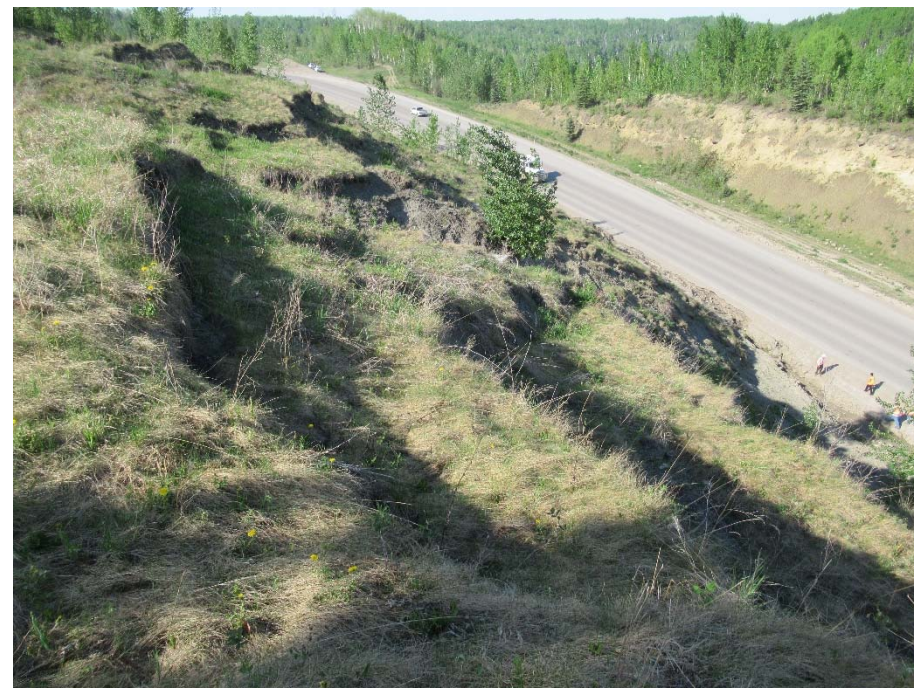
Photo 14.
Looking north at
sloughed material
just north of photo
13.
