SITE INSPECTION FORM

SITE NUMBER AND NAME: GP044 Cutbank River Slide (North)		HIGHWAY & KM: 40:40, 1.002	PREVIOUS INSPECTION DATE: May 23, 2018	INSPECTION DATE: June 15, 2022
LEGAL DESCRIPTION: NE-21-65-05-W6M	NAD 83 COORDINATES: UTM Northing Easting 11 6056410 391477		RISK ASSESSMENT: PF: 9 CF: 2 TOTAL: 18	
AVERAGE ANNUAL DAILY TRAFFIC (AADT): 2290 (north) & 2170 (south) (Reference No. 70000761, 2021)			CONTRACT MAINTENANCE AREA (CMA): 504

PROJECT
 PEACE REGION (GRANDE PRAIRIE DISTRICT-SOUTH)
 GEOHAZARD RISK MANAGEMENT PROGRAM

TITLE
 Site Plan
 GP044 - Cutbank River Slide (North)
 Hwy 40:40, km 1.002

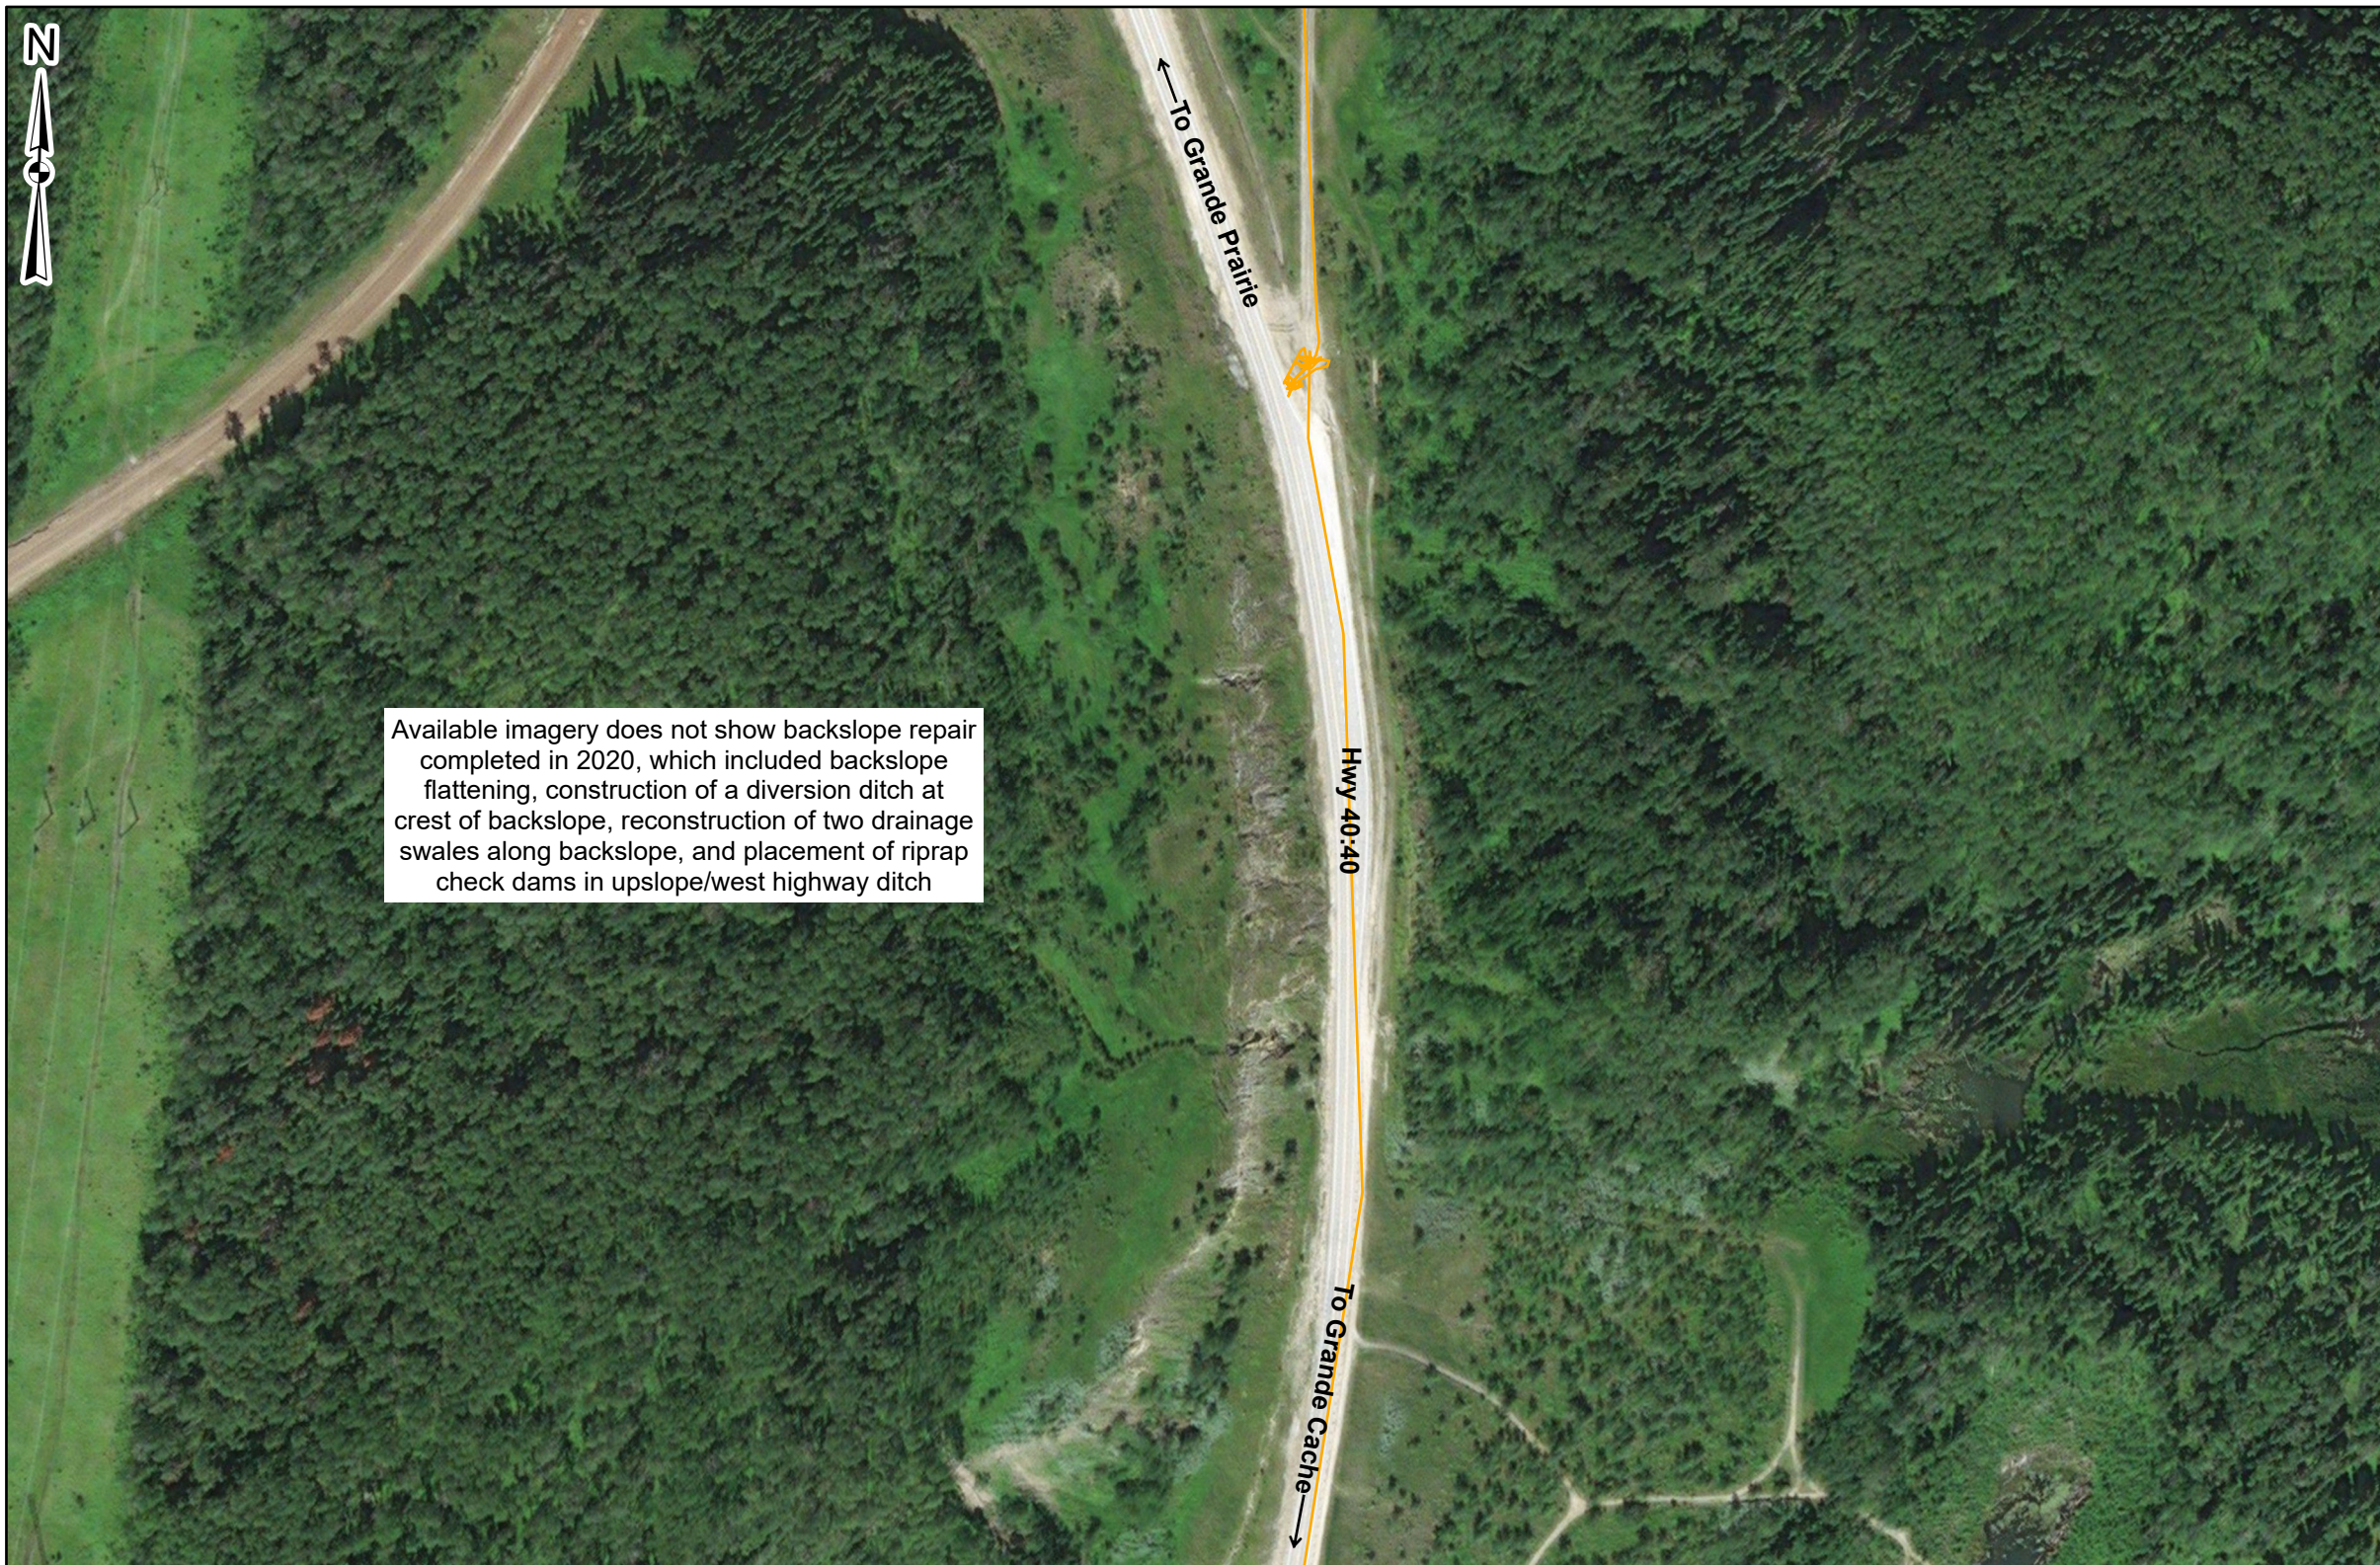
Available imagery does not show backslope repair completed in 2020, which included backslope flattening, construction of a diversion ditch at crest of backslope, reconstruction of two drainage swales along backslope, and placement of riprap check dams in upslope/west highway ditch

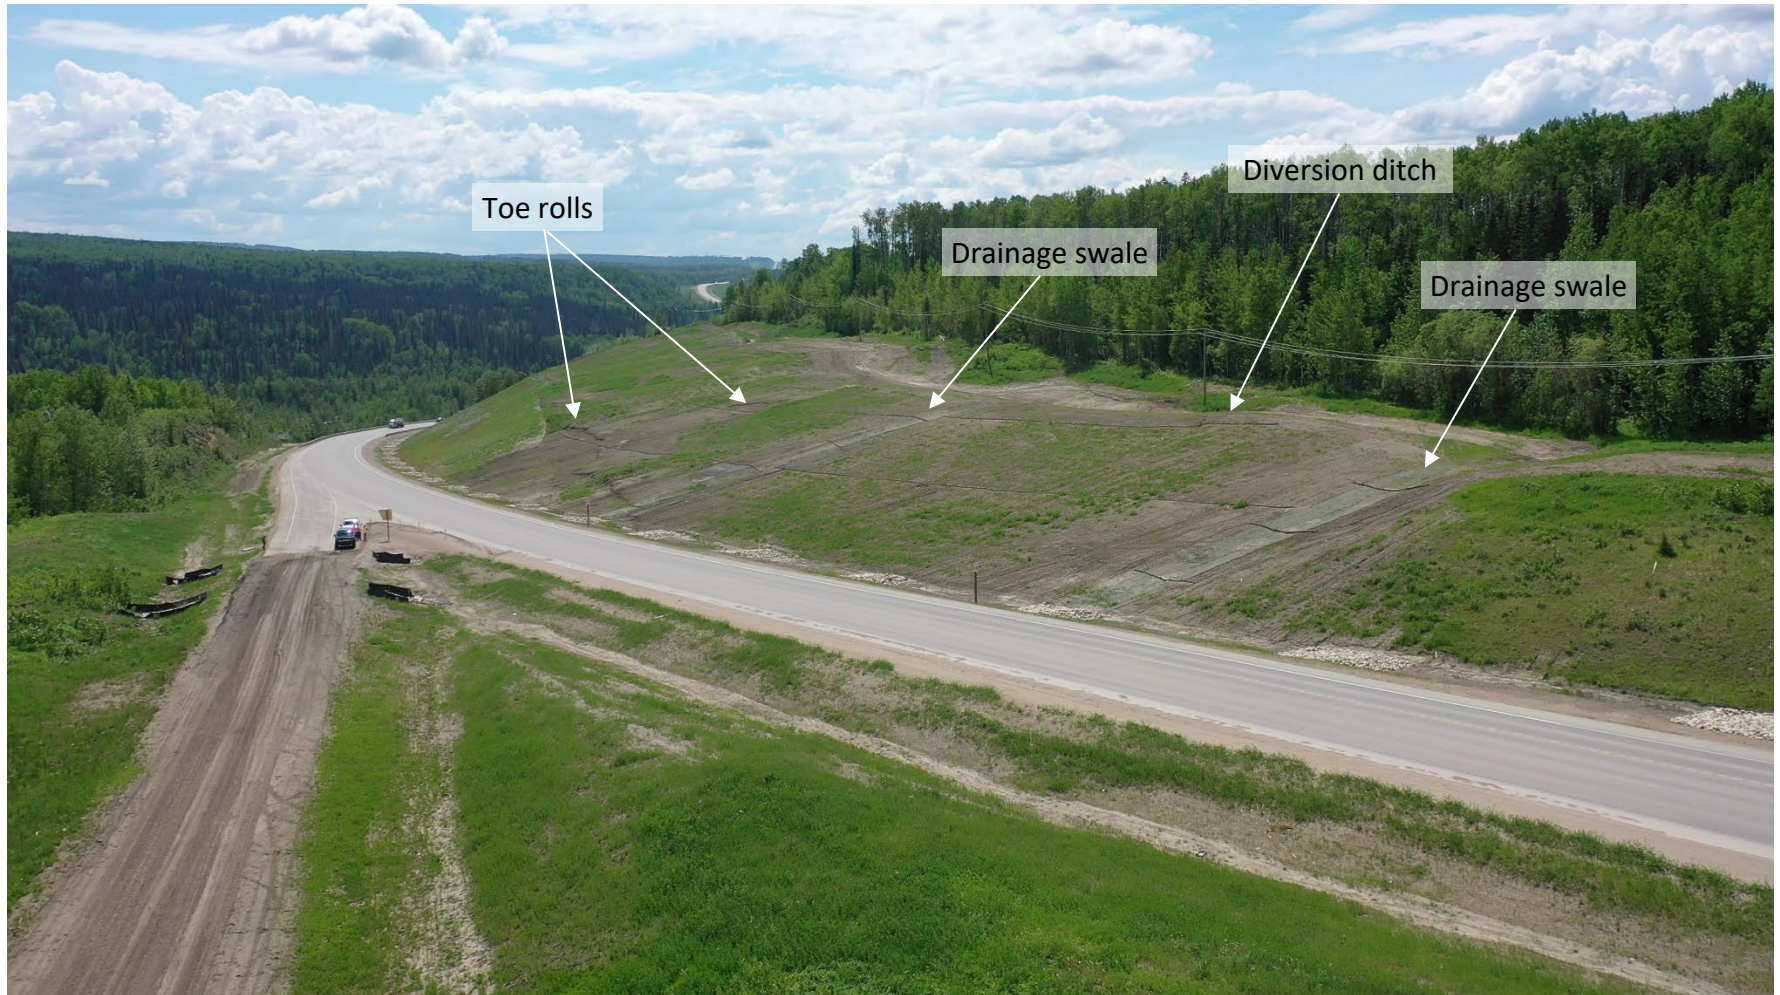
Photo 1 Overview of GP044 site on Hwy 40:40. Photo taken June 15, 2022, facing southwest from northern site limit.

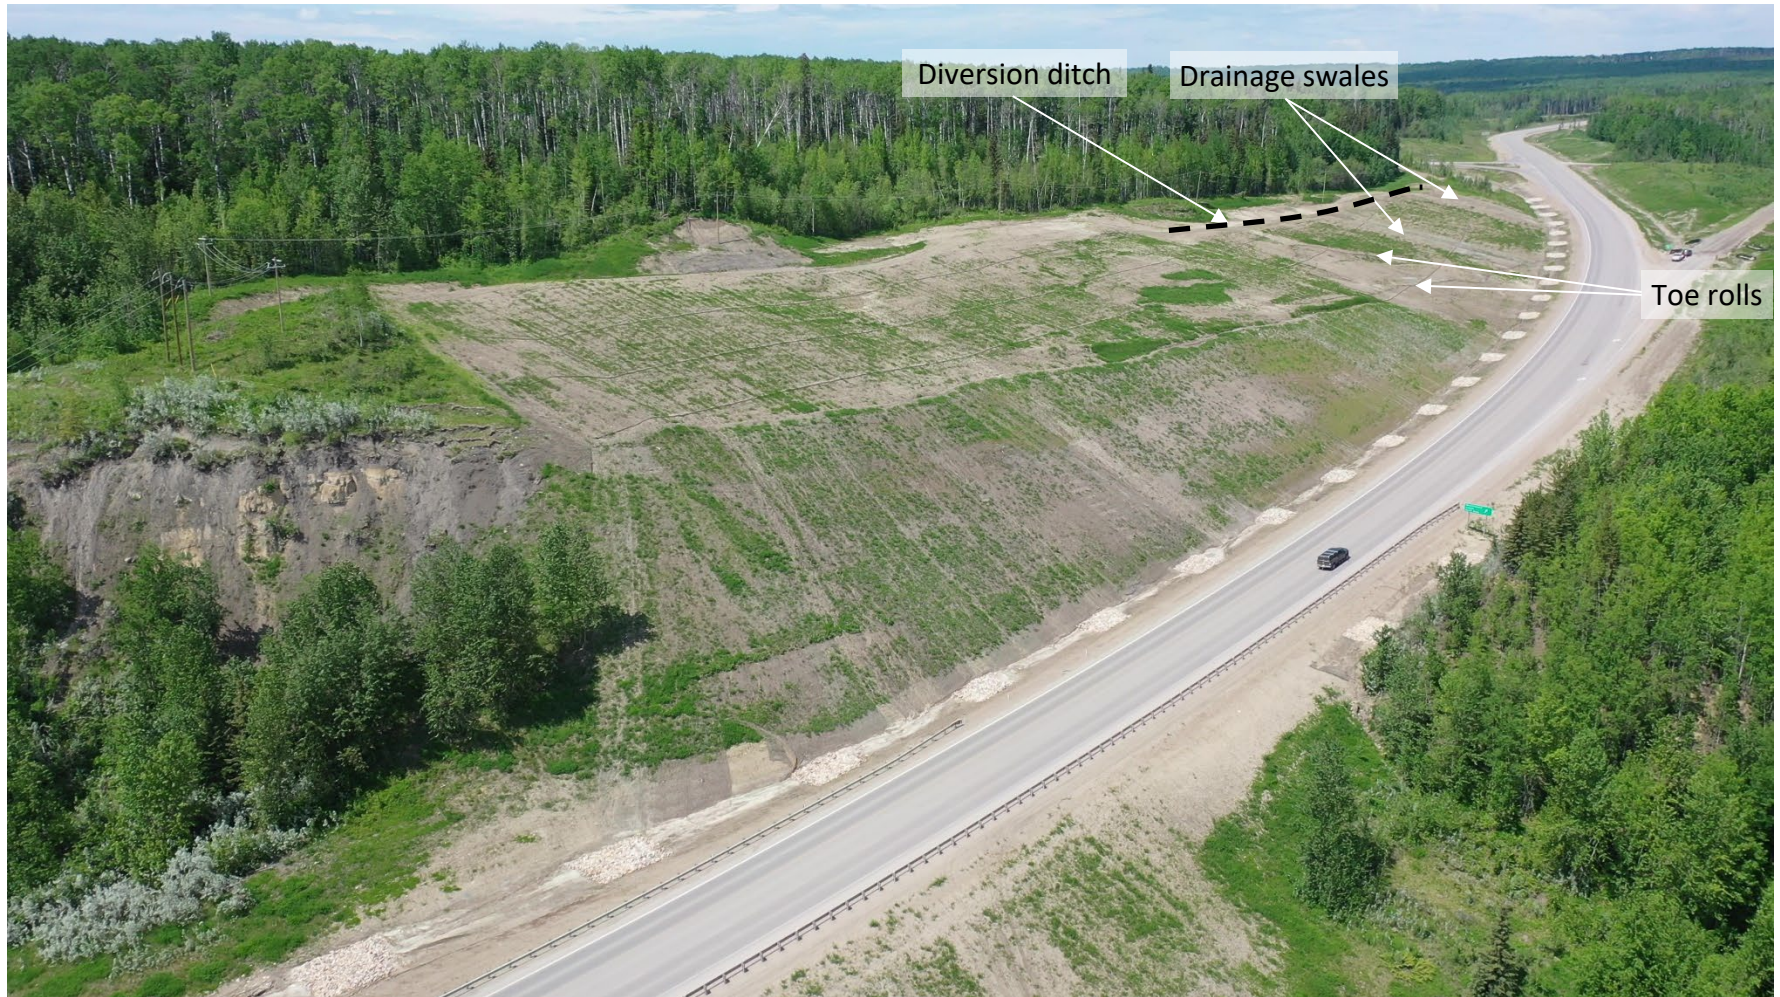
Photo 2 Overview of GP044 site on Hwy 40:40. Photo taken June 15, 2022, facing southwest from southern site limit.

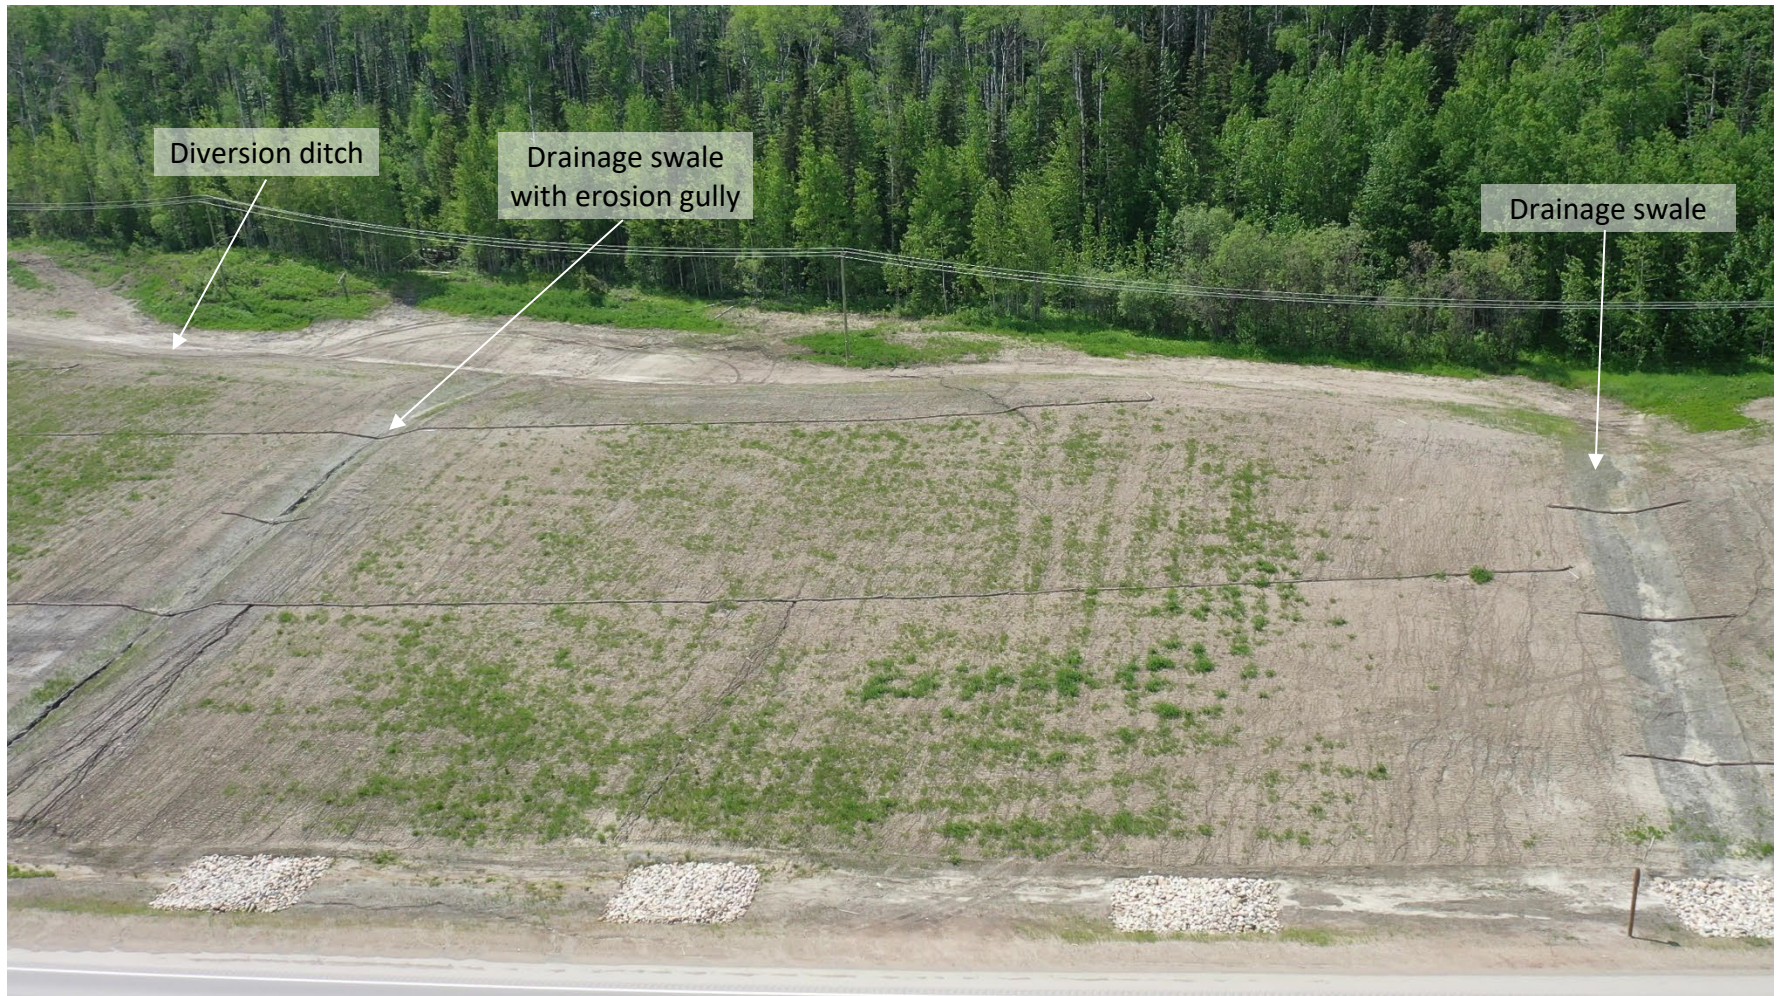
Photo 3 Backslope along west side of Hwy 40:40. Note rill and small gully erosion on backslope, and small gully eroded down south drainage swale. Photo taken June 15, 2022, facing north.

- Monitor recent repair and erosion gully forming in drainage swale. If erosion worsens, drainage swale at gullies at southern site limit may need to be armored with riprap.

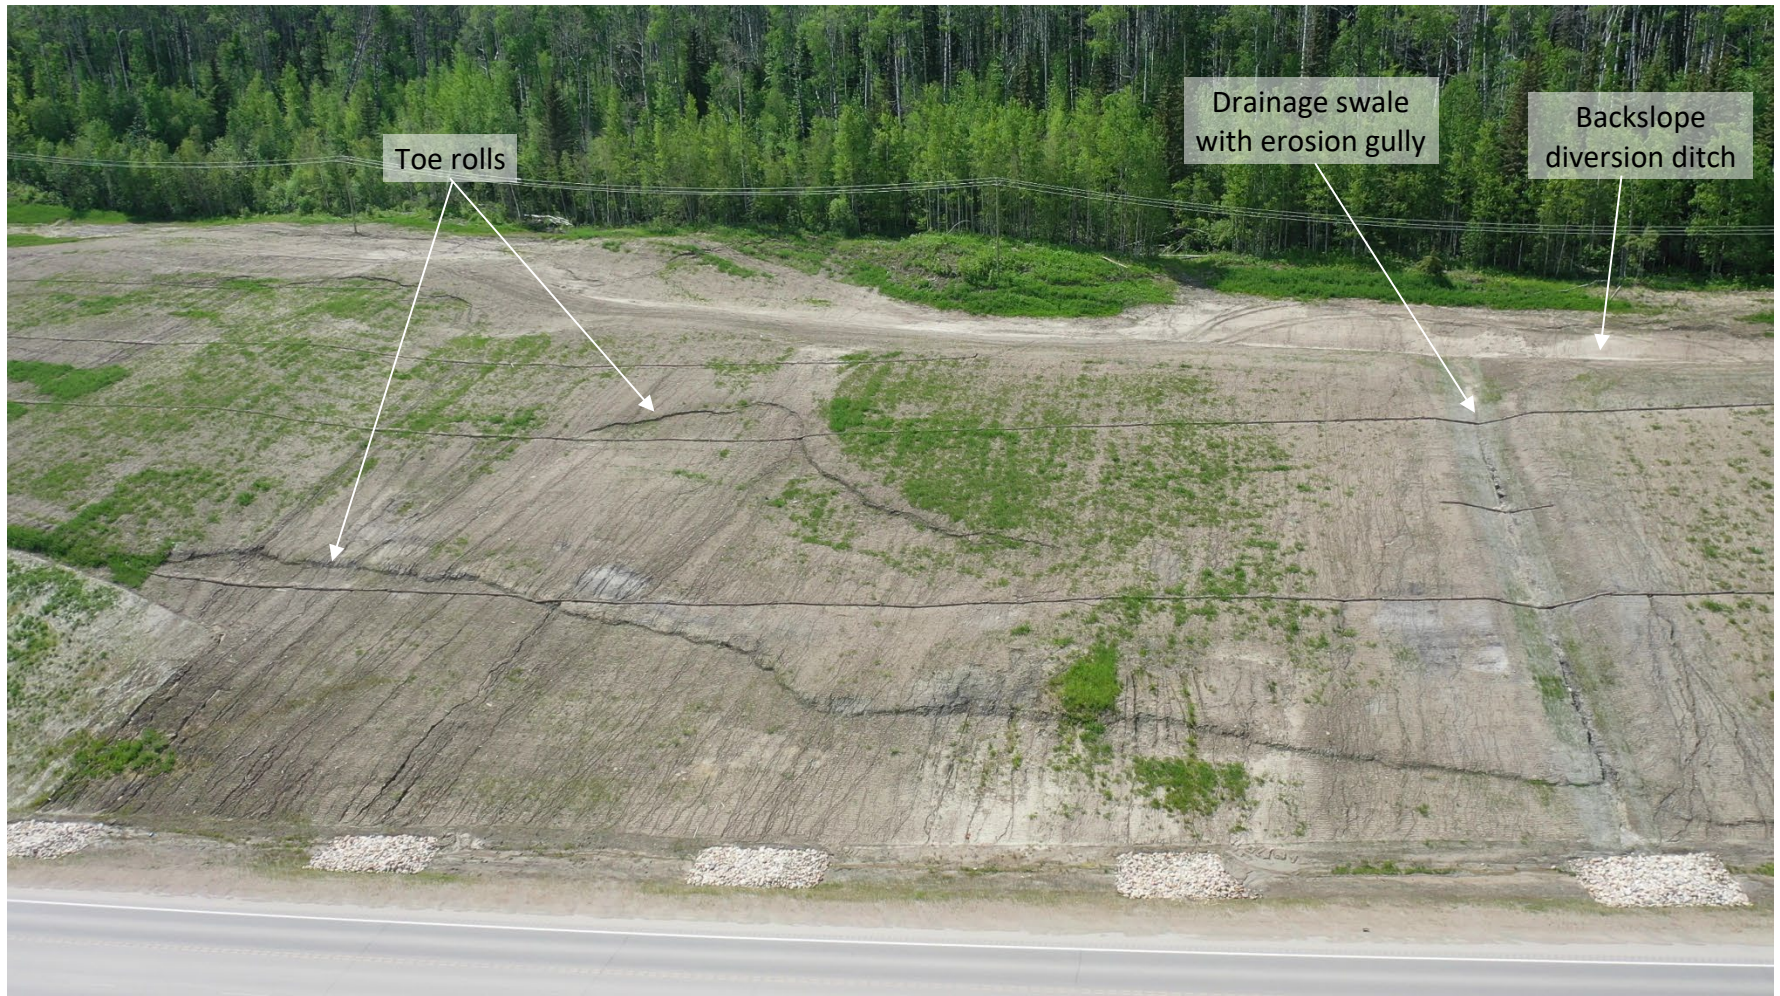
Some thin translational movement observed on backslope with mid-slope toe rolls in areas of sliding.

Photo 4 Backslope along west side of Hwy 40:40. Note rill and small gully erosion, and toe roll on backslope. Also, small gully eroded down center of south drainage swale. Photo taken June 15, 2022, facing north.

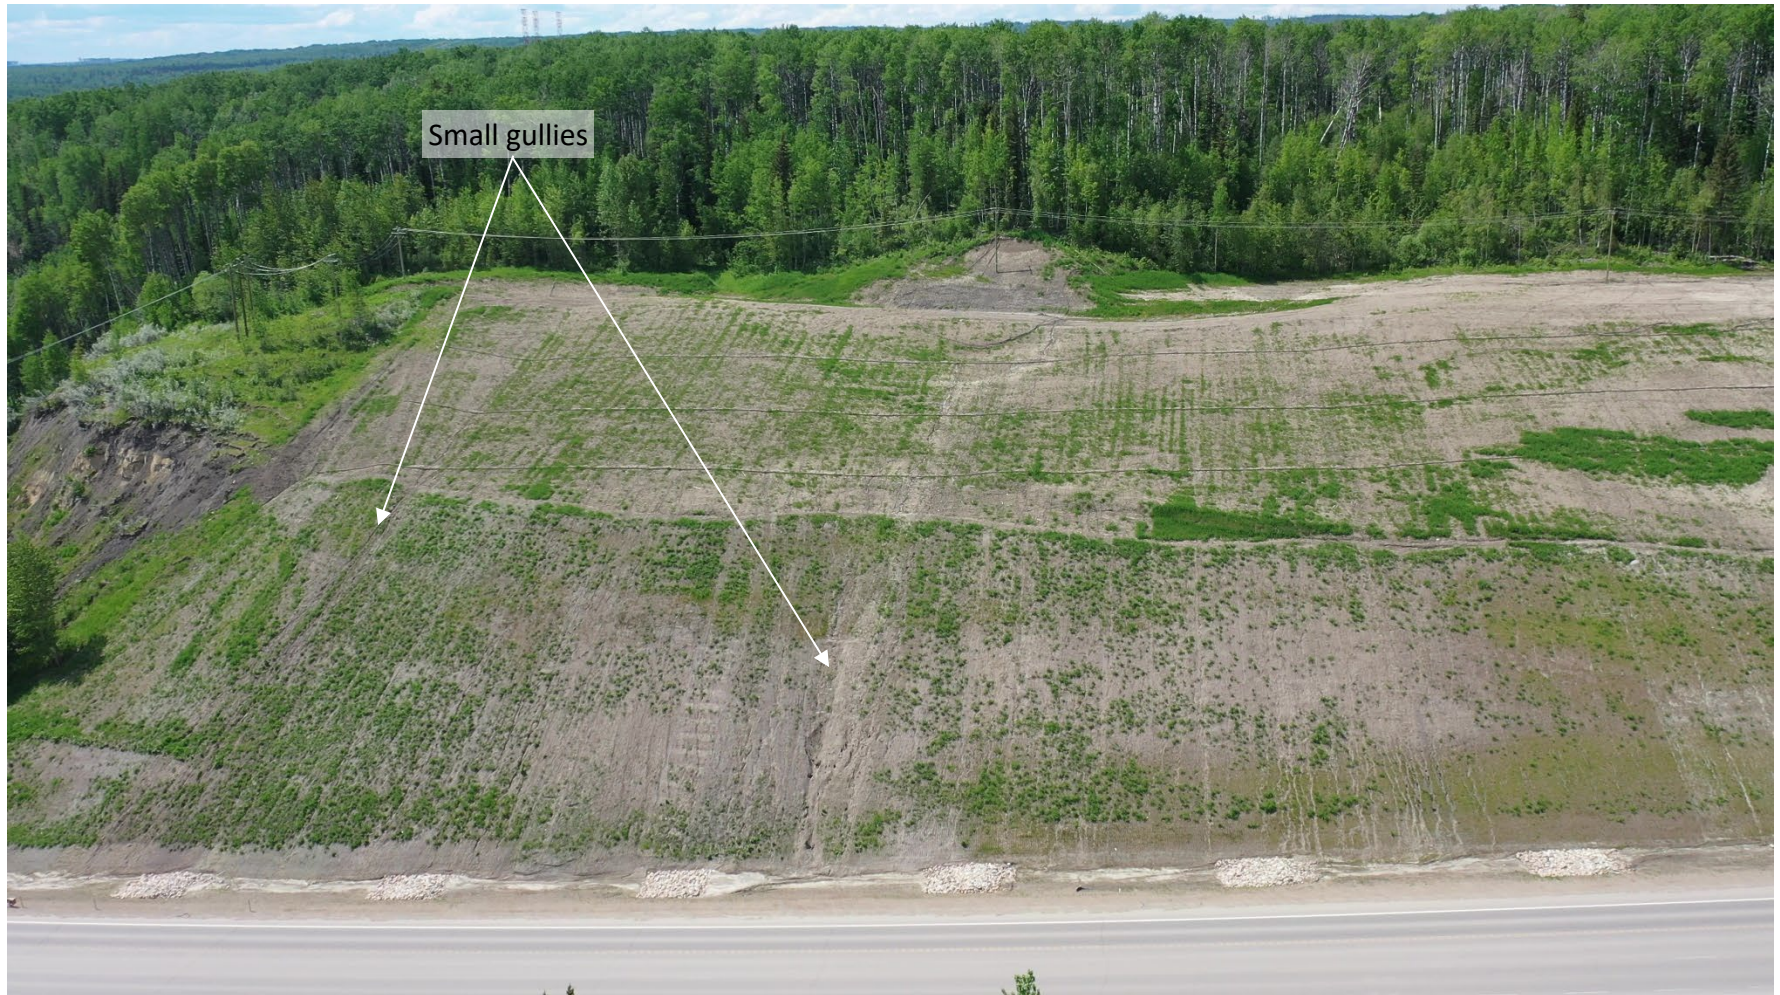
Photo 5 Backslope along west side of Hwy 40:40. Note rill and small gully erosion on backslope. Photo taken June 15, 2022, facing north.
