**BRIEF FILE REVIEW
(LANDSLIDE RISK ASSESSMENT)**

| 1) | Site (GP1) | Hwy 40:42 Wapiti Hill Slide (Wapiti River Valley Slope Slide) |

ANNUAL INSPECTION REPORT

Slide Name: Hwy 40:42 Wapiti River Slide (GP-1)
Location: Hwy 40:42 approximately 5 km south of Wapiti River Bridge
(Jct SH 666)

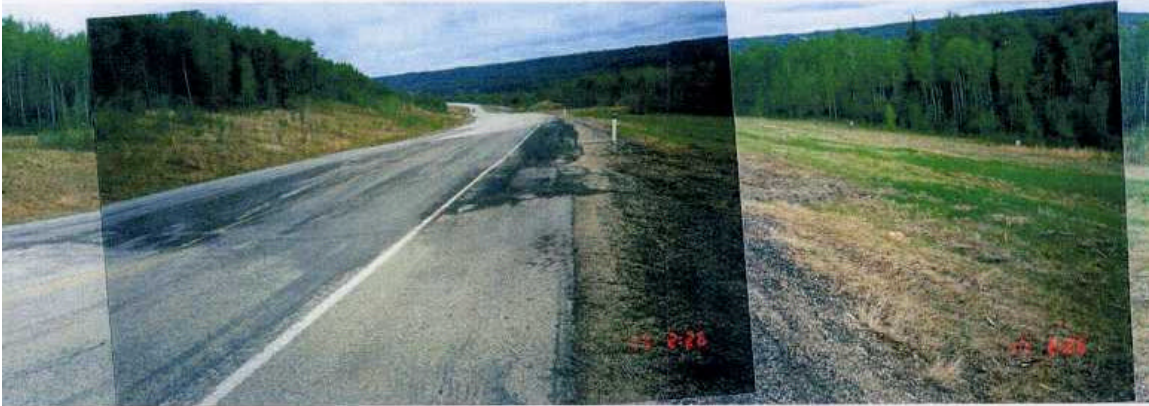
Looking towards Grande Prairie, headscarp crack and settlement transgressed past centreline to backslope ditch.

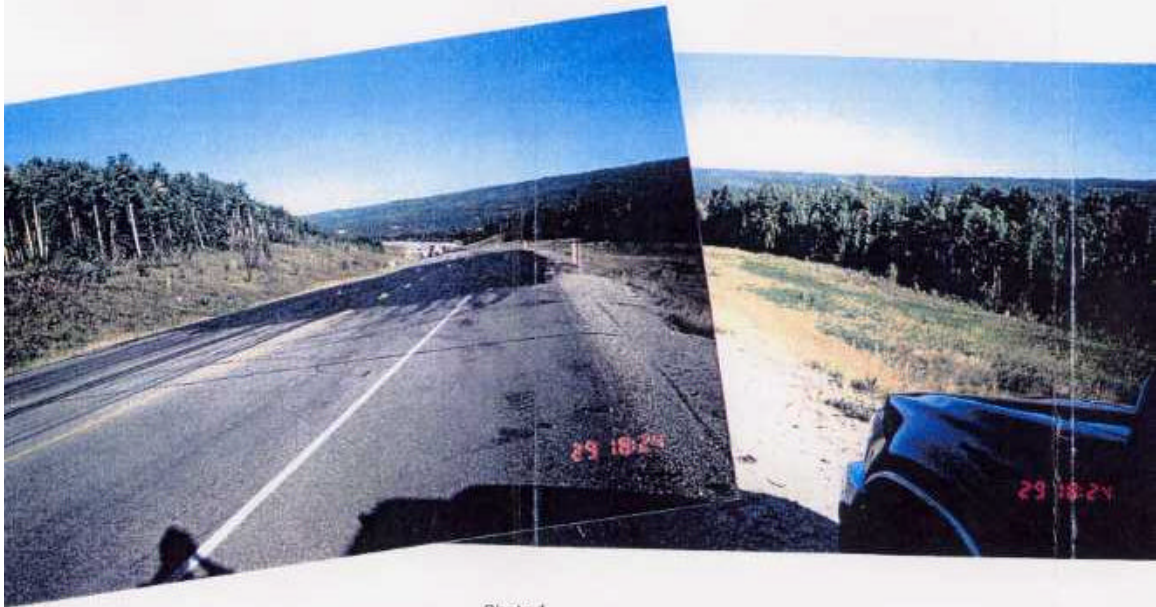
No obvious deterioration of the site was observed in the June 2000 site inspection. Near the area of SI installations, the pavement patching area at the headscarp and roadway settlement area was estimated for approximately 75 m stretch of roadway and extending past centerline. Approximately 75 m north, another settlement stretch (approximately 40 m) was noted.

Photo 1
Slide head scarp (pavement cracking) across centerline (looking north towards Grande Prairie). Photo taken August 30, 1998.

Since the settlement rate is slow (approximately 25 mm per year) and movement is deep (+20 m depth), it is pragmatic to maintain the roadway through continual patching as the present condition of the road surface is acceptable. This site requires a detailed review to provide an economical solution as the affected area can be huge.
