**ALBERTA TRANSPORTATION
GEOHAZARD ASSESSMENT PROGRAM
PEACE REGION–GRANDE PRAIRIE
2017 INSPECTION REPORT**

Site Number	Location	Name	Hwy	km
GP001	Wapiti Hill South of Grande Prairie	Wapiti Hill (5 km's S. of Wapiti R. Bridge)	40:42	25.393
Legal Description		UTM Co-ordinates		
NE¼ 18-070-05 W6M		11U E 388597	N 6103792

**PEACE REGION (GRANDE PRAIRIE) 2017
GP01-1: HWY 40:42 WAPITI HILL
(5km SOUTH OF WAPITI RIVER BRIDGE)**

DWG No. 13353-GP01-1-1

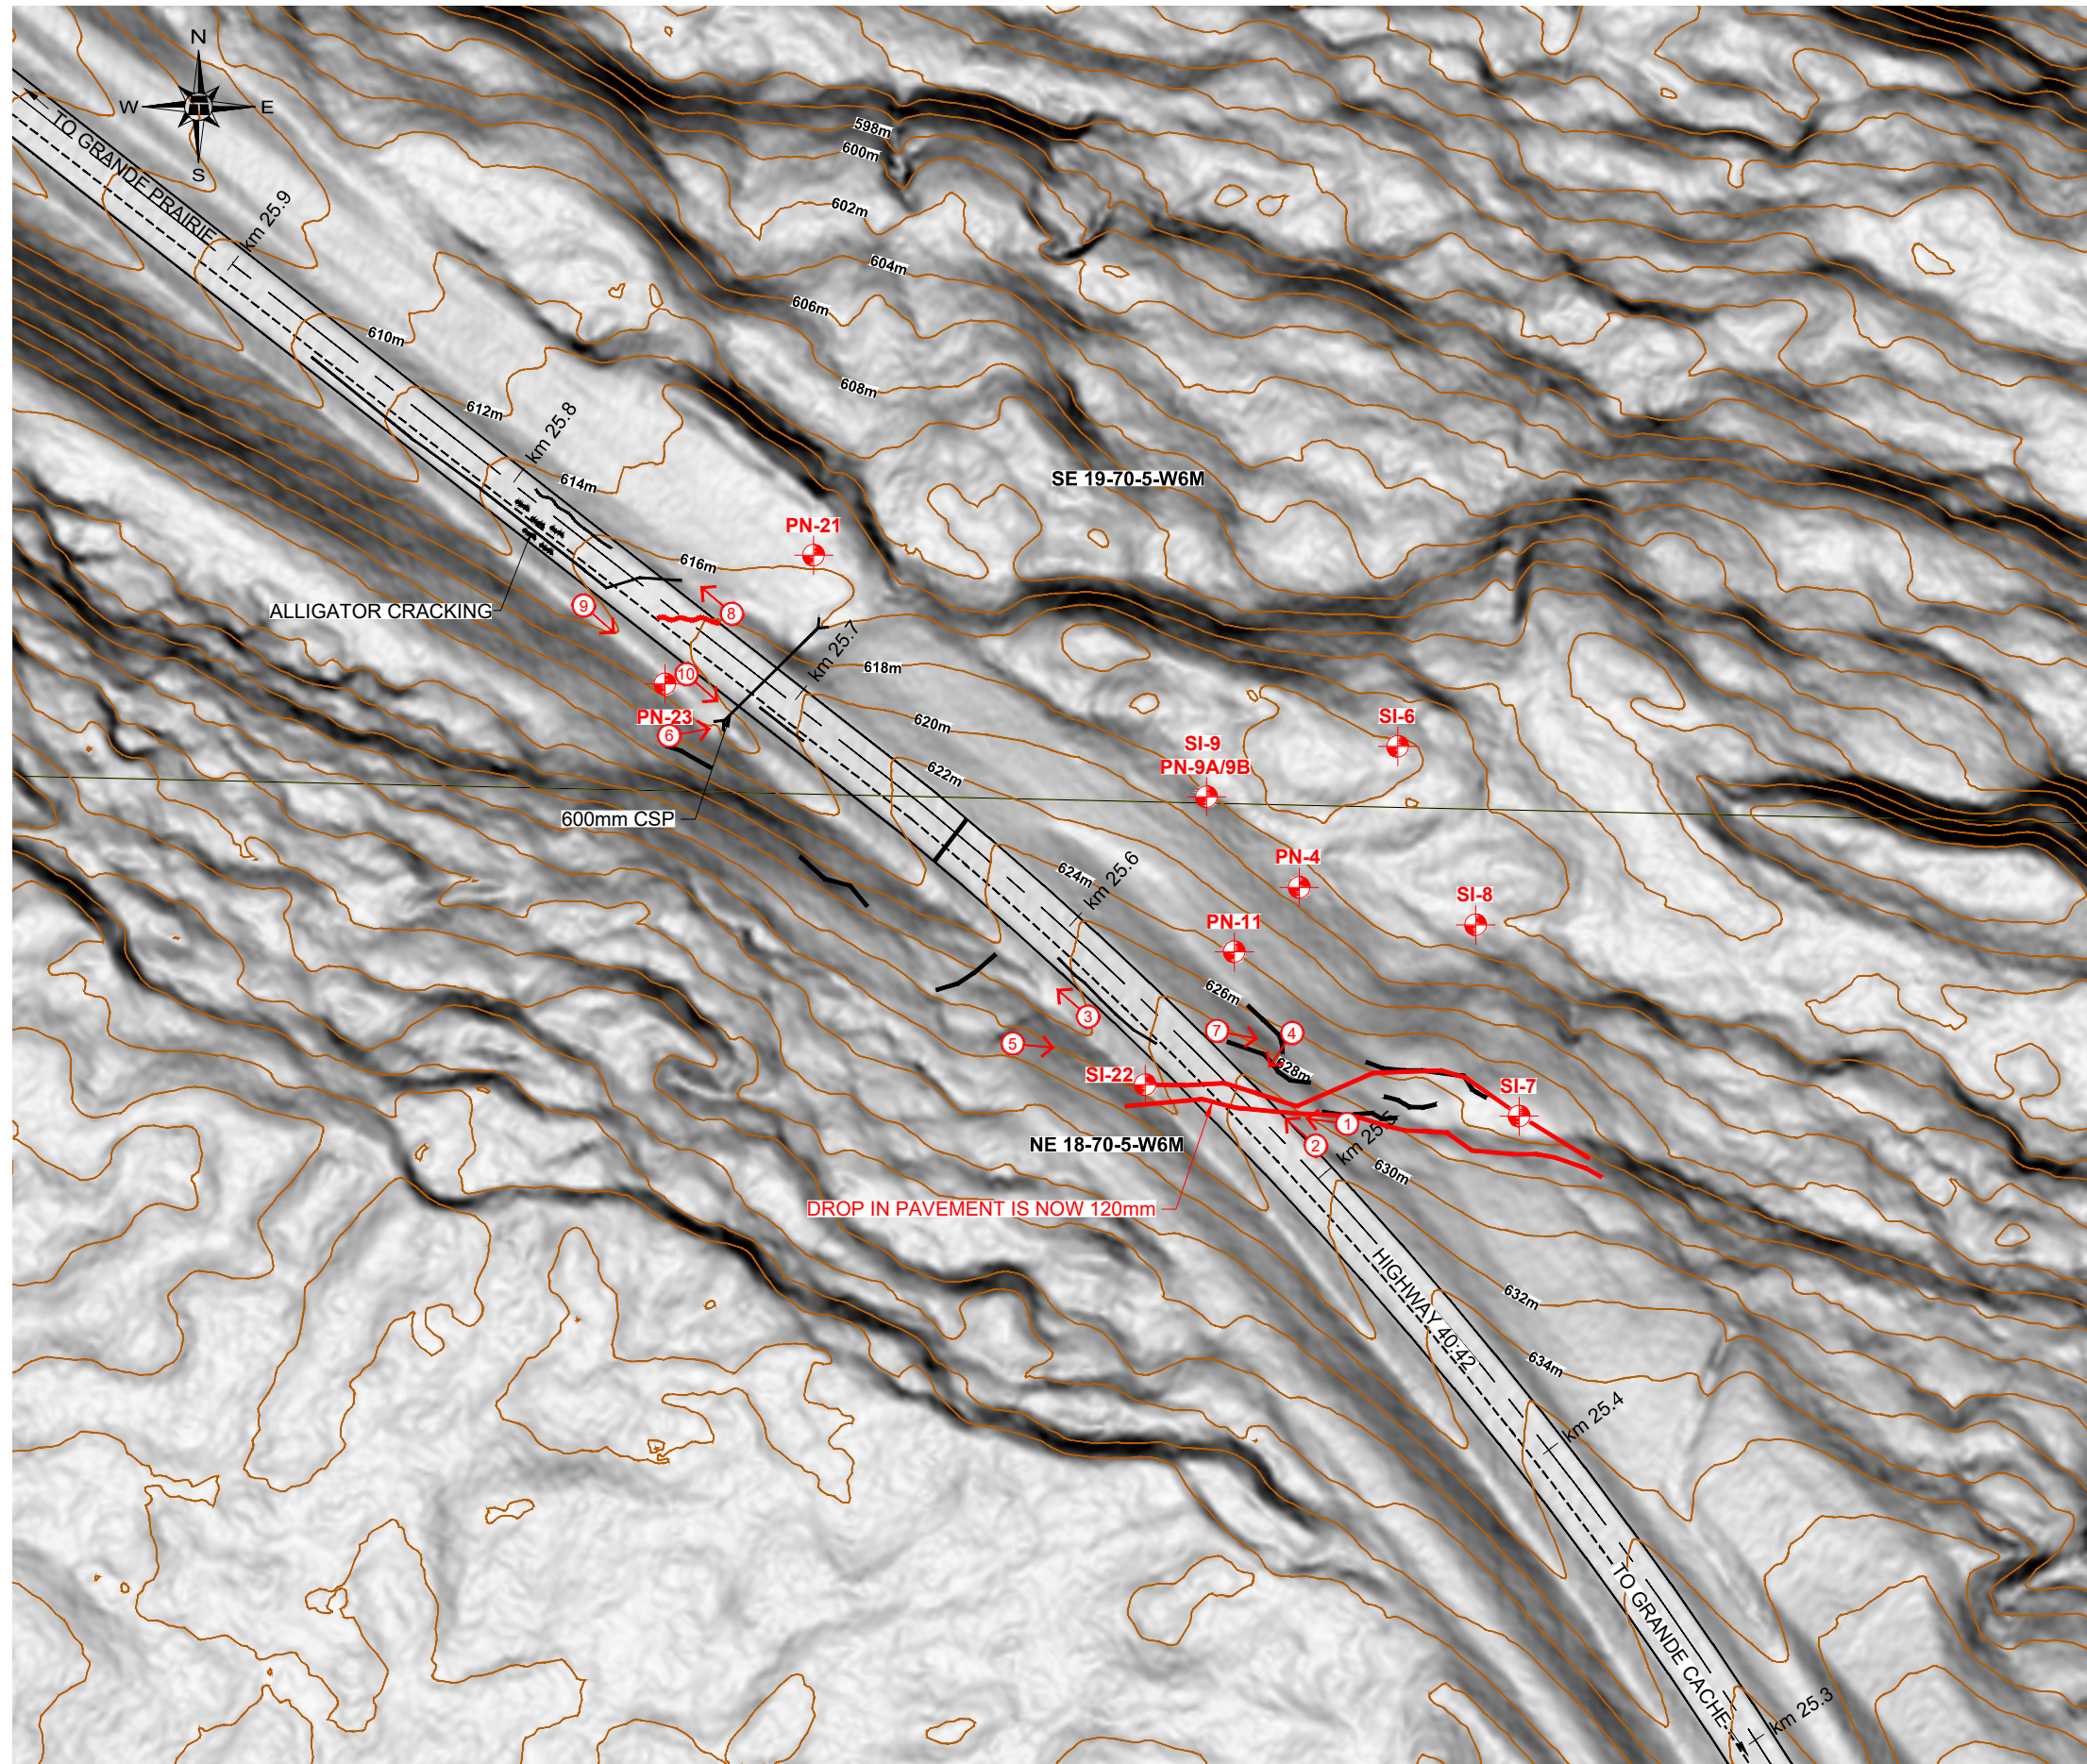
Primary Site Issue:	<p>This section of highway 40:42 was constructed as a side hill embankment fill crossing through the backscarp of a large landslide on the south valley slope of the Wapiti River. About a 300 m long section of the roadway is currently affected by the landslide and cracks on the pavement structure require regular milling and patching in order to maintain the highway.</p> <p>During the initial construction in 1981, soft and wet ground conditions were encountered on the exposed subgrade which required sub-excavation and placement of about 2 m of additional fill. Seepage was observed on the backslope cut above the highway and a lateral subdrain pipe was installed along the ditch at the toe of the backslope.</p> <p>As early as 1985 some settlement on the roadway surface and failures on the backslope were observed.</p> <p>In September of 1990, additional lateral and finger subdrains were installed to collect water seeping from the backslope and a berm was built at the toe of the embankment side slope in an effort to improve stability of the embankment.</p> <p>Several geotechnical investigations were conducted by TRANS from 1990 to 1998. Slope inclinometers and piezometers installed at the site indicated slow creep movement of the valley slope and groundwater levels at about 10 m in depth.</p> <p>A quarry has been operated near the bottom of the valley slope in the lower river terrace immediately below this section of the highway.</p>

Over last several years, this site has been relatively dormant with little signs of active slope movement aside from slow development of the cracks on the roadway pavement surface, which have been regularly addressed by TRANS by milling and patching maintenance efforts. The subdrains installed along the backslope ditch appear to have performed as per the designs intent at this site in improving the stability of the embankment and backslope.

The large landslide in the area appears to govern the global stability of the roadway embankment. Due to the size of the landslide, realigning the highway further into the backslope would be prohibitive and would take several years to implement.

There is a possibility that the currently dormant landslide could be activated from the adjacent quarry operation or the erosion of the Wapiti River at the bottom of the valley slope. The global stability of the valley slope in this area should be monitored periodically.

In the short term, it is recommended that the cracks in the pavement be sealed or overlain with asphalt patches and the drops along the backscarp be milled. The area be closely monitored for early signs of slope movement.

In the long term, the section of the roadway affected by the landslide could be realigned into the backslope, which would require a substantial backslope cut generating a large amount of surplus material for disposal. The estimated length of highway to be realigned would be in the order of about 3 km to 5 km. Alternatively, the backslope cut volumes could be marginally reduced by a combination of partial roadway realignment and construction of tie-back reinforced cast-in-place concrete piles to stabilize the backslope. It should be noted that the latter option only partially solves the landslide issues by diverting roadway alignment away from it. It is possible that the landslide could develop retrogressively and encroach into the realigned highway in the future after the partial realignment.

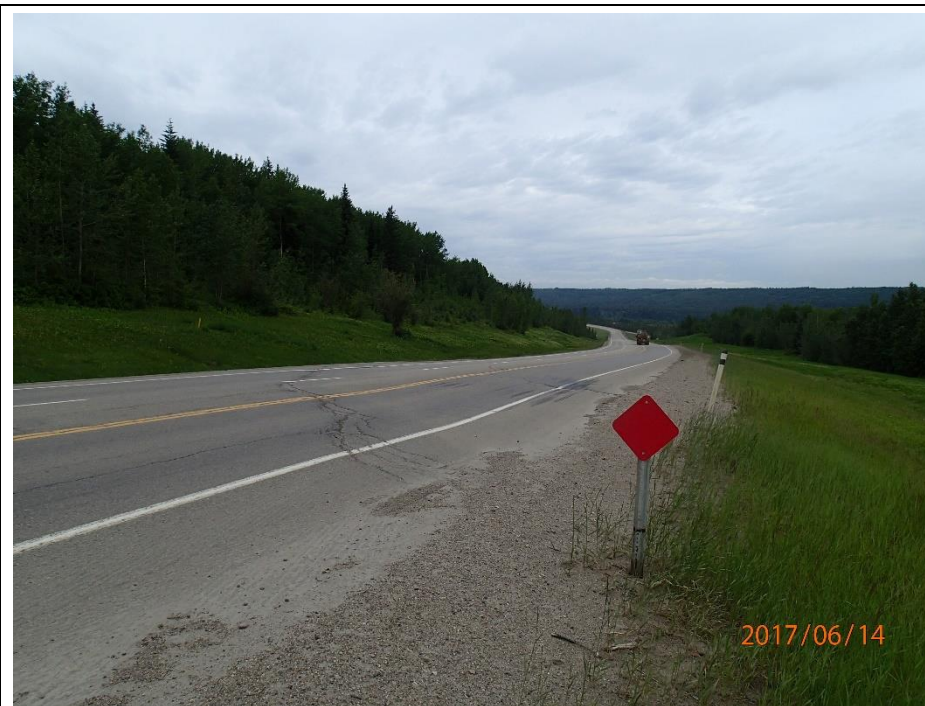
Photo 1.
Looking west from
the NBL shoulder
at km 25.51 across
the dip the
roadway. No
significant change
since 2016.

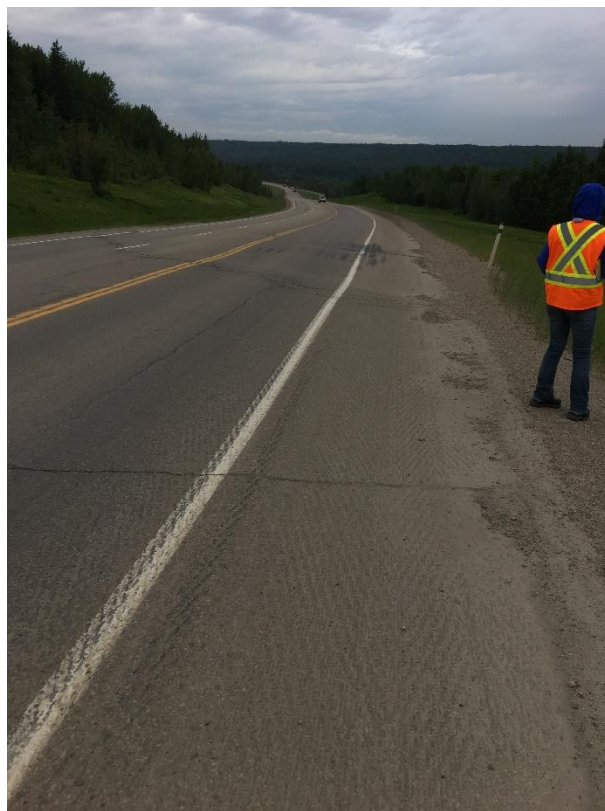
Photo 2.
Looking northwest
across the dip in
the roadway from
the NBL shoulder.

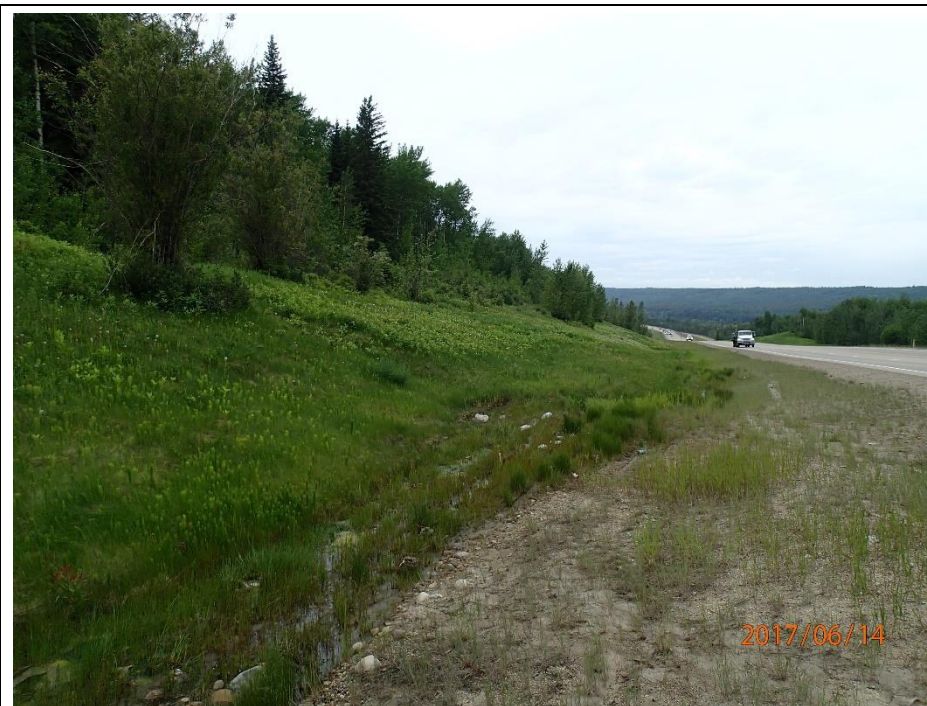
Photo 3.
Looking northwest
along the NBL
ditch.

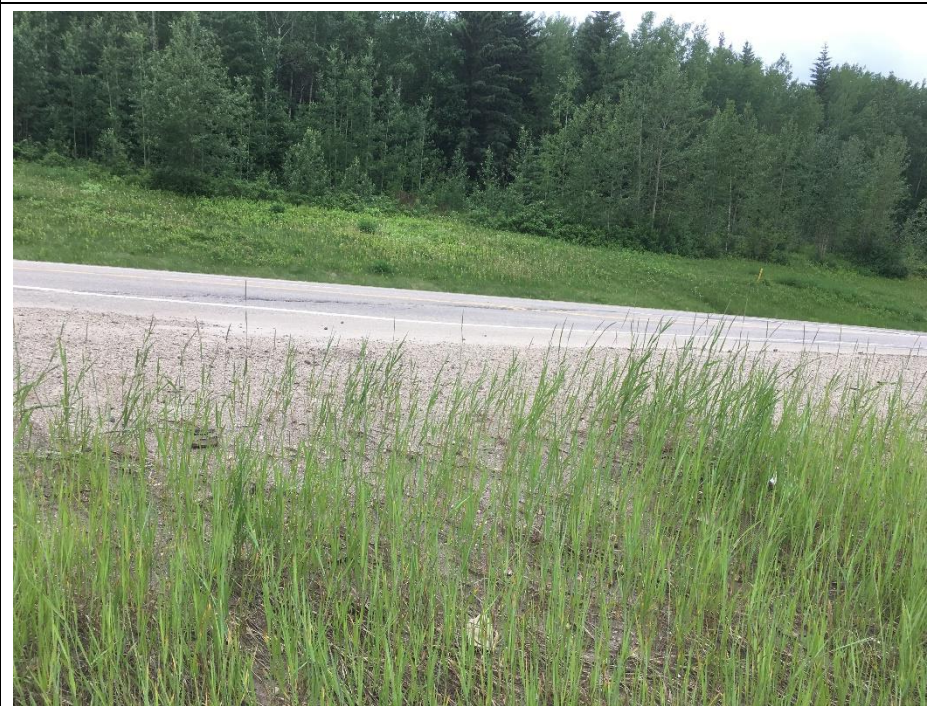
Photo 4.
Looking west
towards dip in the
roadway at km
25.51.

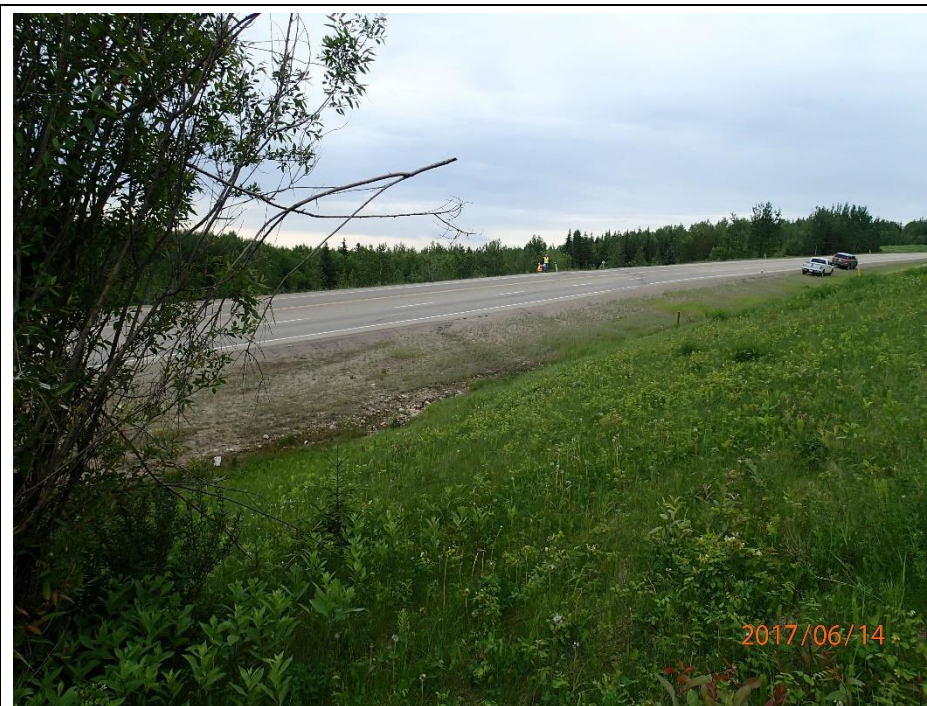
Photo 5.
Looking east from
west cut slope at
where dip crosses
the road.

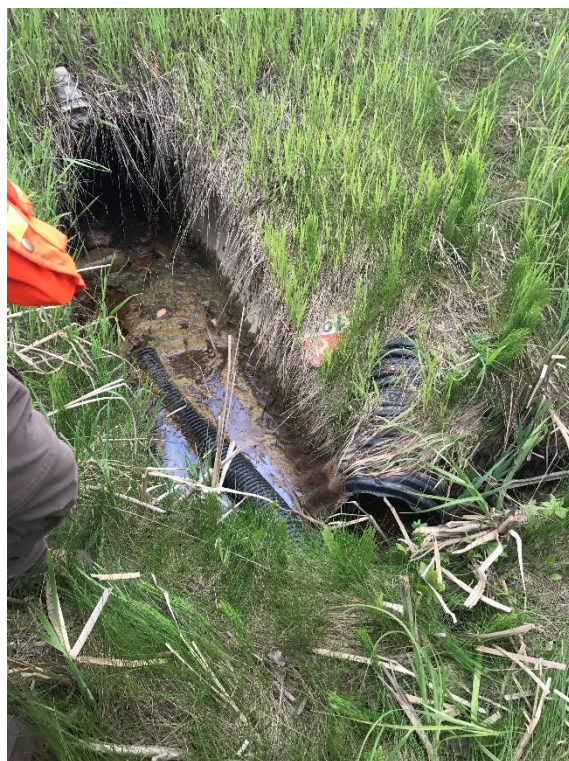
Photo 6.
Looking northeast
in the SBL ditch
towards the inlet of
the centerline
culvert at km 25.71.
A 450 mm subdrain
pipe and a 150 mm
subdrain pipe both
discharge water
into the culvert
inlet.

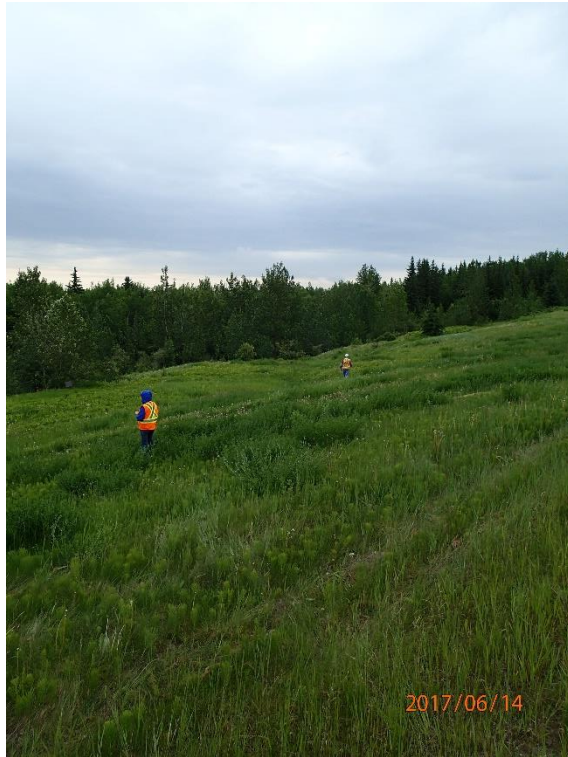
Photo 7.
Looking northeast from the NBL shoulder towards where scarp crack in road extends into the downslope.

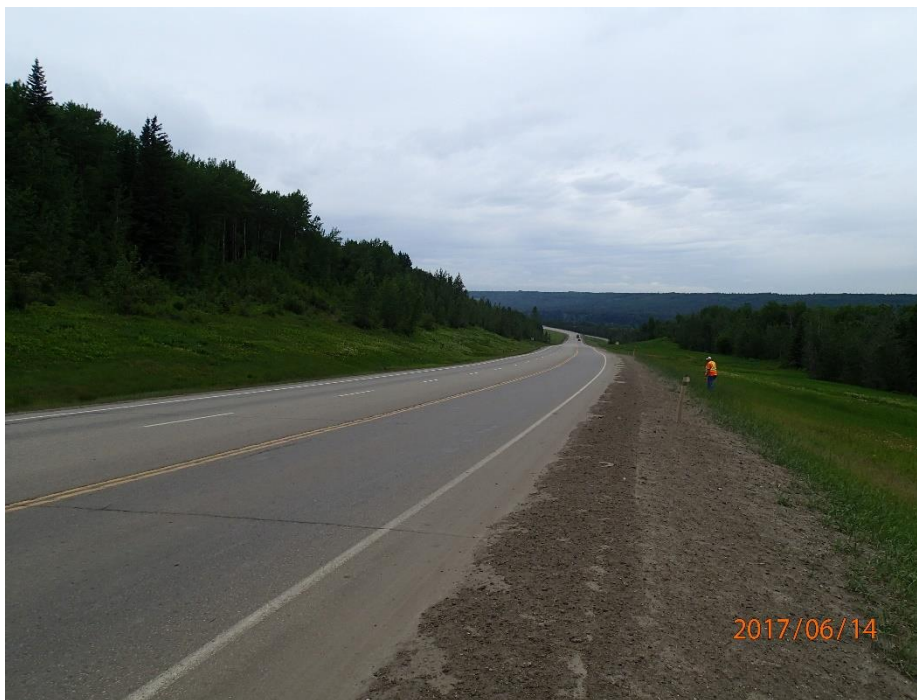
Photo 8.
Looking northwest at km 25.75 along the NBL shoulder at cracks in the roadway shoulder.

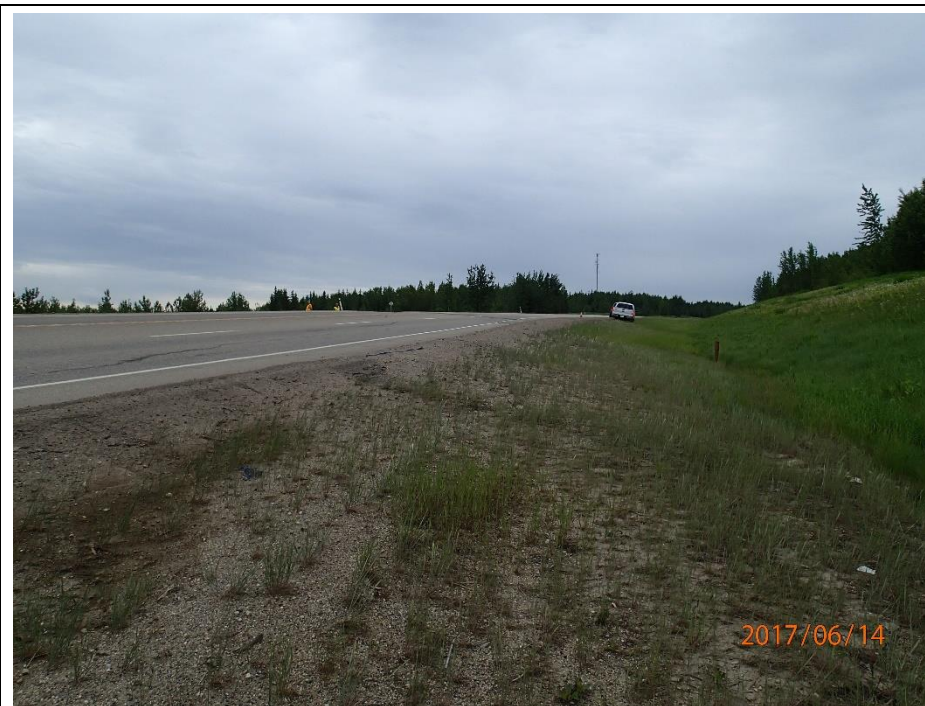
Photo 9.
Looking southeast
at km 25.8 along
the SBL shoulder at
longitudinal cracks
in the SBL ACP.

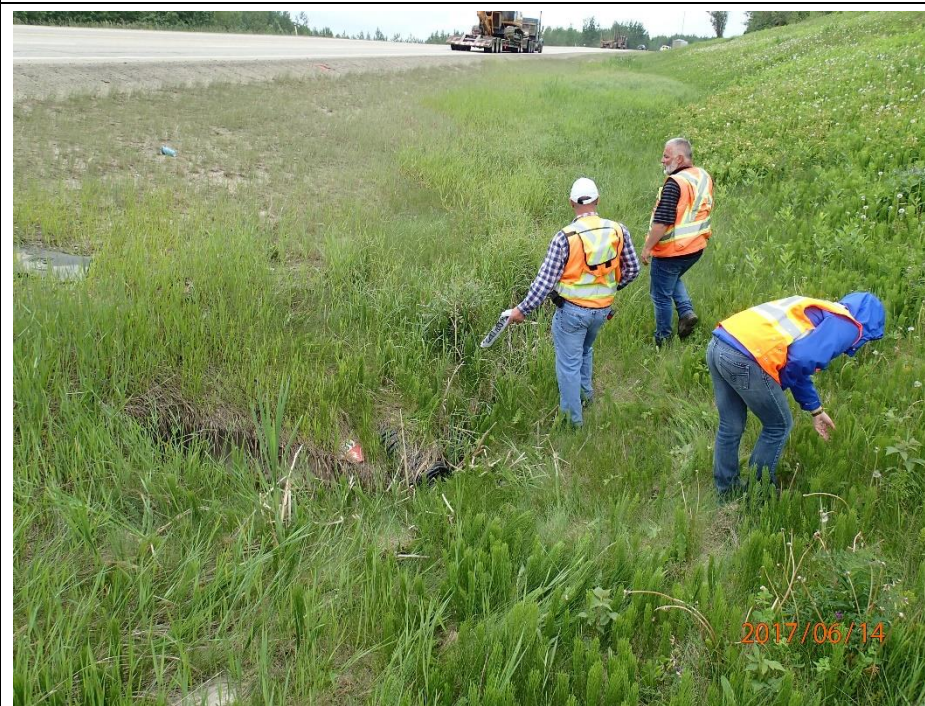
Photo 10.
Looking southeast
at km 25.71 at west
ditch and culvert
inlet.
