<b>SITE NUMBER AND NAME:</b> GP045 Smoky River East Valley Slope Slide and Sinkhole		<b>HIGHWAY &amp; KM:</b> 43:04, 35.005	<b>PREVIOUS INSPECTION DATE:</b> May 30, 2020	<b>INSPECTION DATE:</b> July 19, 2021
<b>LEGAL DESCRIPTION:</b> SW 16-72-02 W6M	<b>NAD 83 COORDINATES:</b> UTM Northing Easting 11 6121684 420116		<b>RISK ASSESSMENT:</b> Slide: PF: 10 CF: 3 TOTAL: 30 Sinkhole: PF: 11 CF: 6 TOTAL: 66	
<b>AVERAGE ANNUAL DAILY TRAFFIC (AADT):</b> 5930 (west) & 6470 (east) (Reference No. 30720 & 70000114)			<b>CONTRACT MAINTENANCE AREA (CMA):</b> 504

PROJECT	GRANDE PRAIRIE SOUTH REGION GEOHAZARD RISK MANAGEMENT PROGRAM	
TITLE	Site Plan GP045 Smoky River East Valley Hwy 43:04, km 35.005	
SCALE	PROJECT No.	FIG No.
1:1,500	A05116A01	1

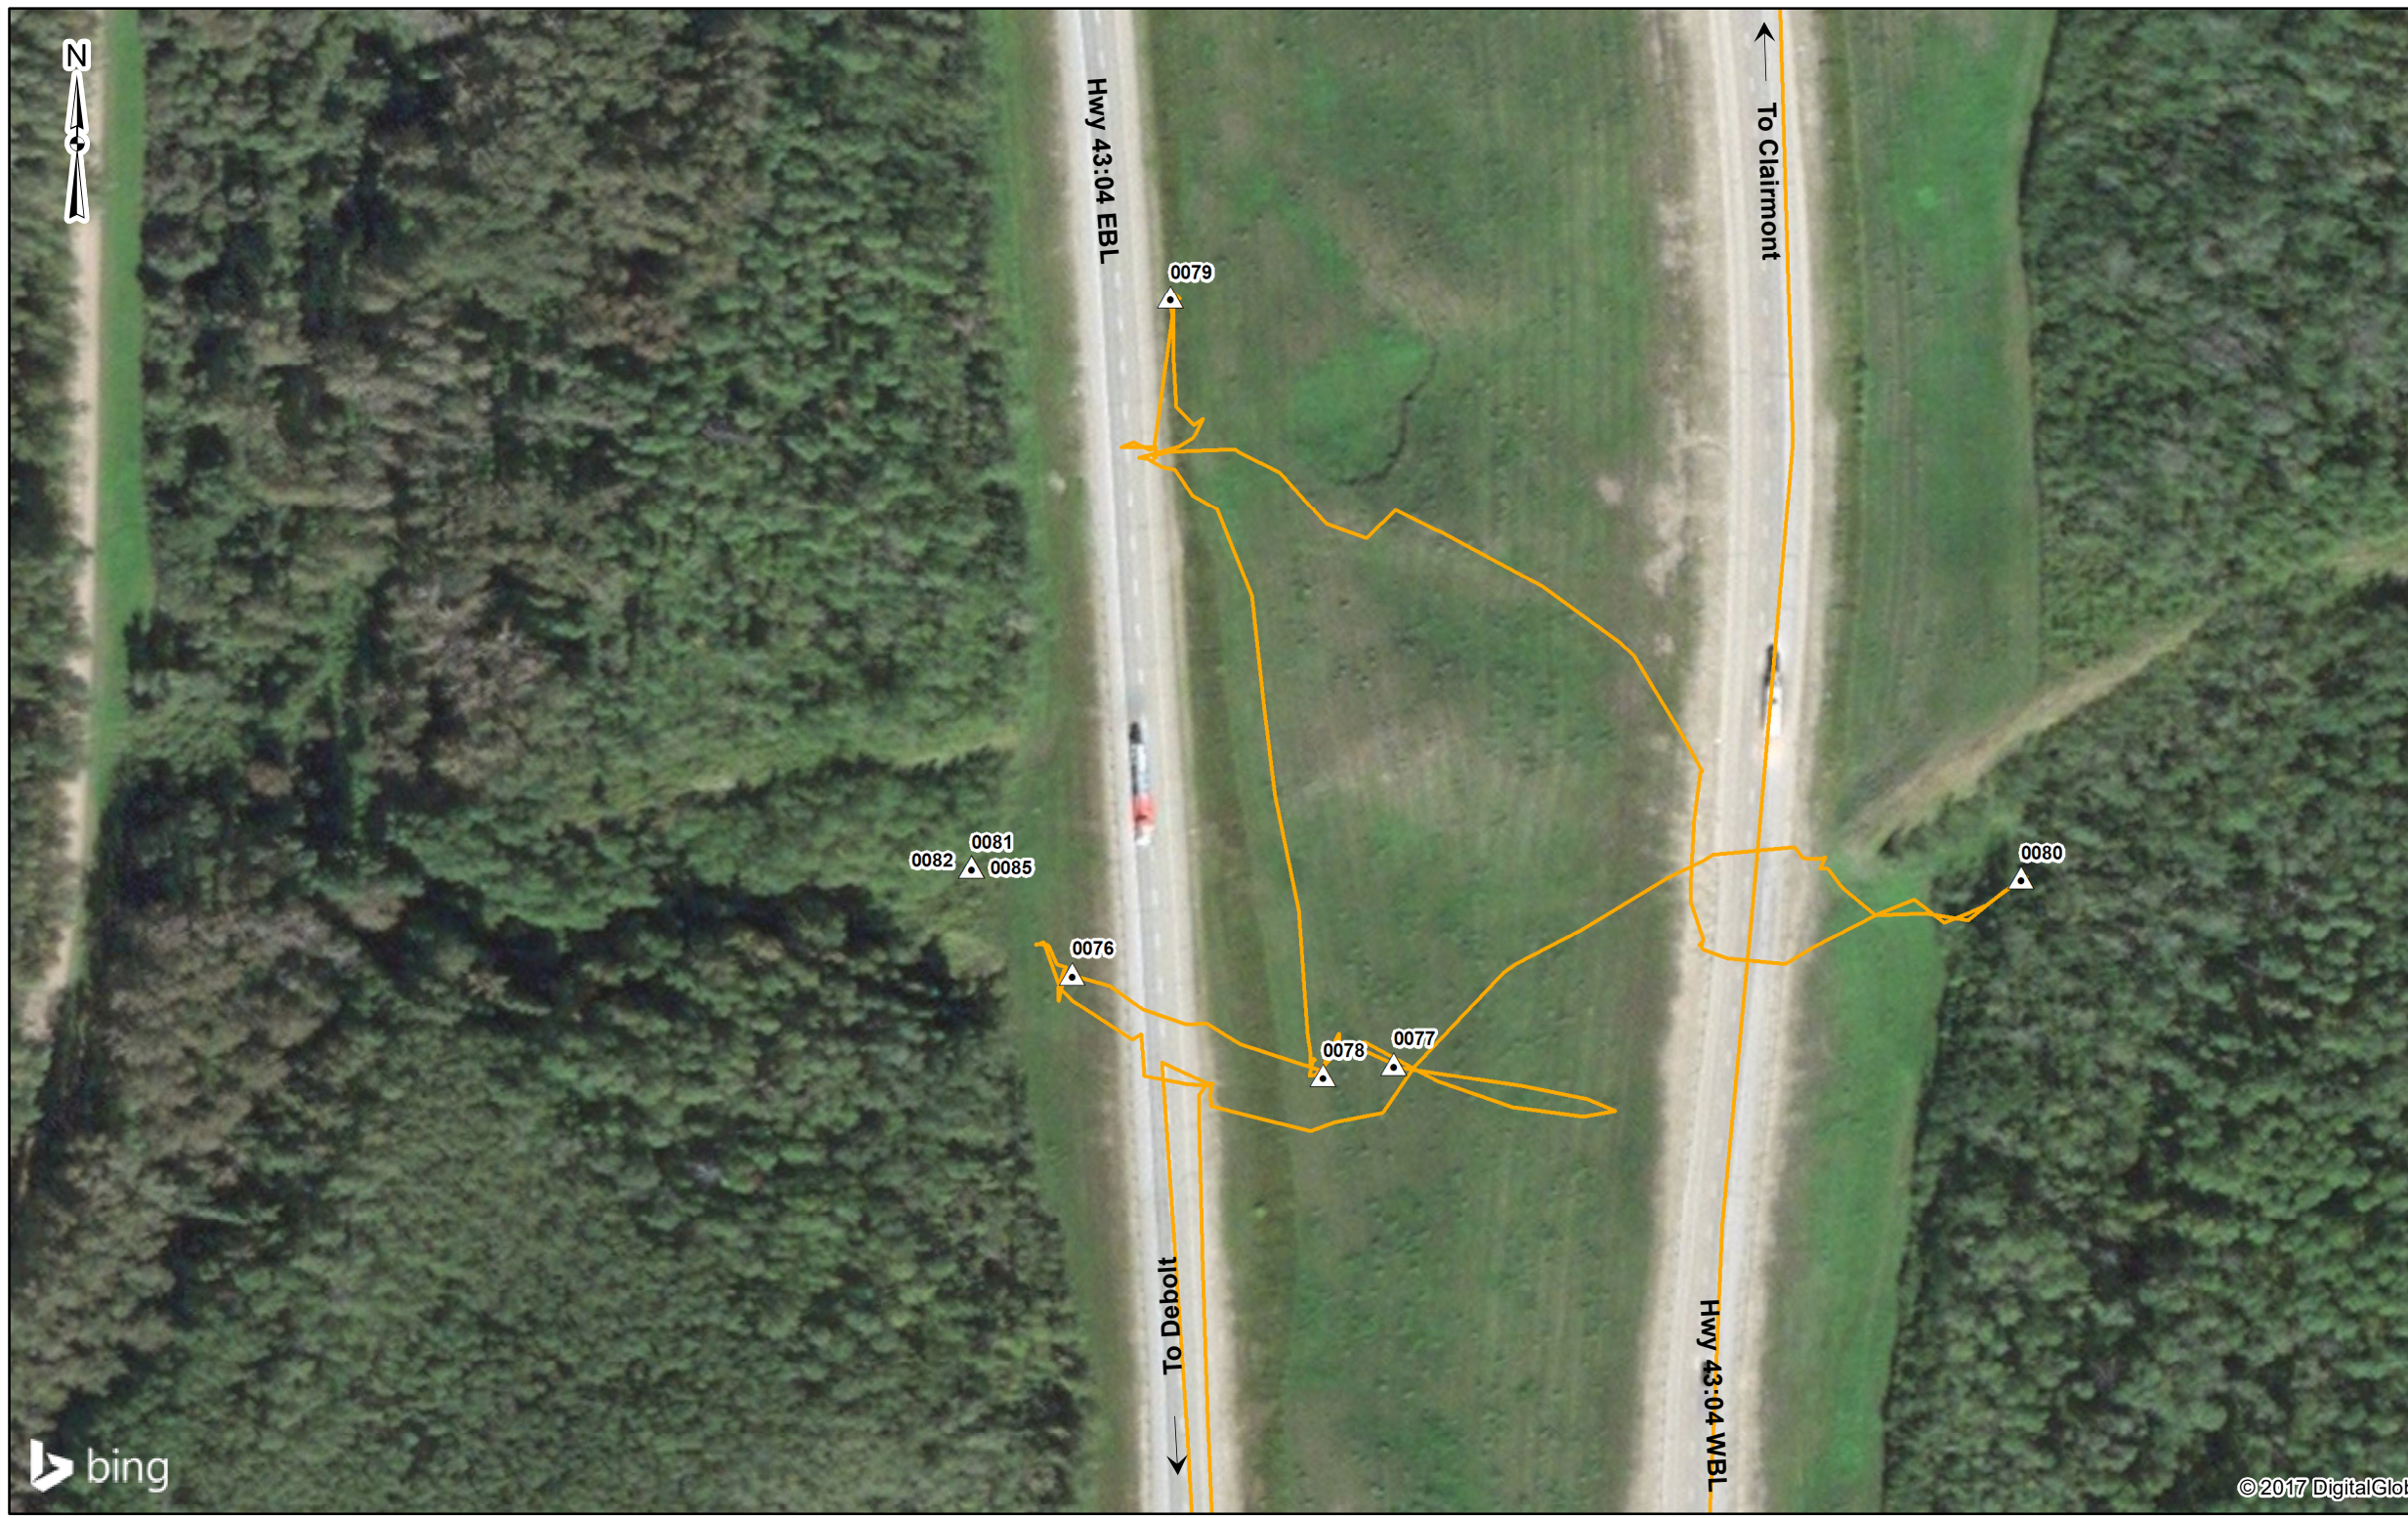
- WP077 and 078 mark the east and west limits of the sinkhole on north side of EBLs
- AT says the sinkhole is bigger now, about twice the size it was a year or two ago

Landslide about 200 m west of sinkhole, WP079

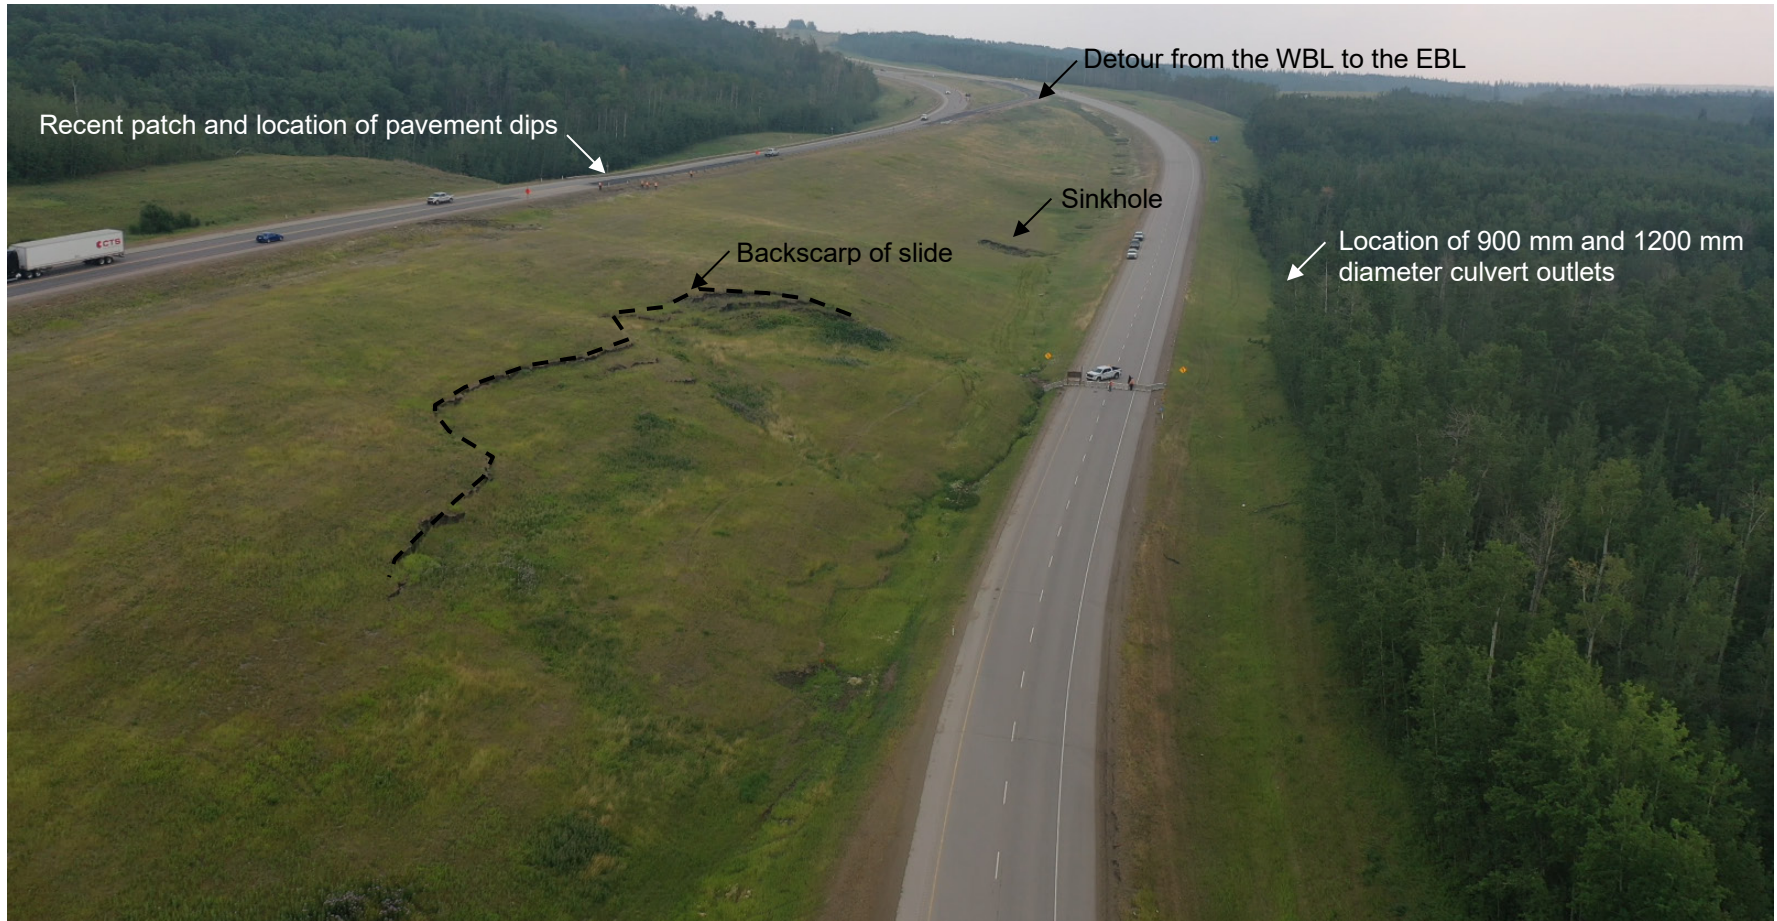
**Photo 1** Overview of the GP045 site, highlighting the slide, sinkhole, culvert outlet location, and recent asphalt patching. Photo taken July 19, 2021 facing east.

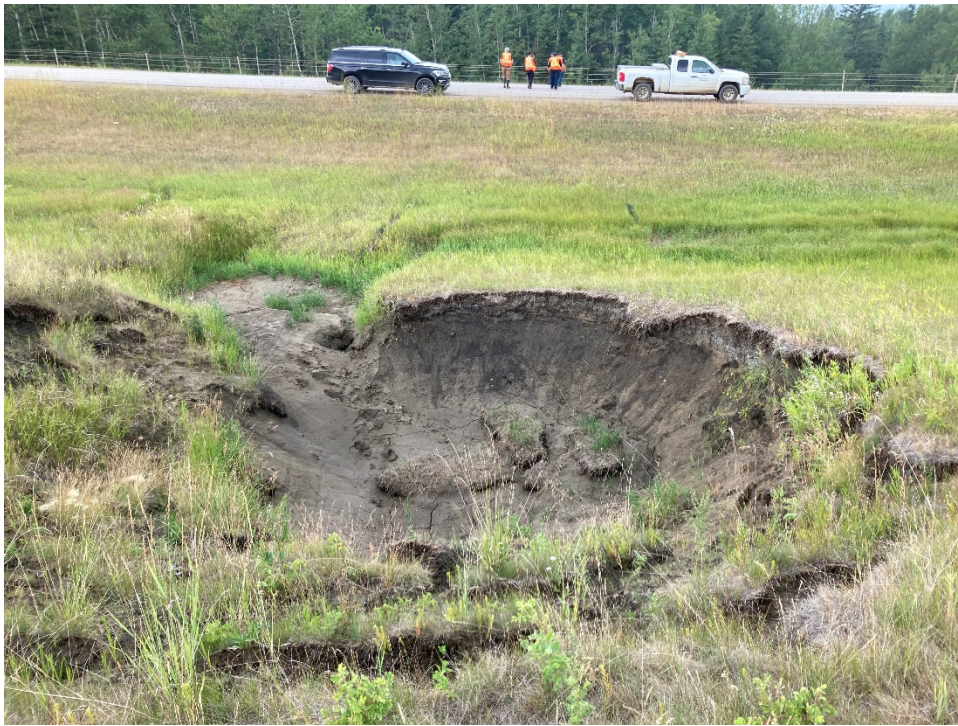
- Location where sinkhole appears to be where the two pipes (original 1.2-m-diameter CSP and 0.9-m-diameter steel pipe culvert) joined, could have been a push pit for the drilled-in-place 900 mm culvert

**Photo 2 Sinkhole located on the north side of the EBL lanes of Hwy 43. Photo taken July 19, 2021 facing south.**

- KCB requested to prepare a proposal for camera survey of the inlet and outlet of the culvert to assess for damage or a bad joint and also to assess for blockage of the culvert. Proposal should include design of culvert repairs at the sinkhole.

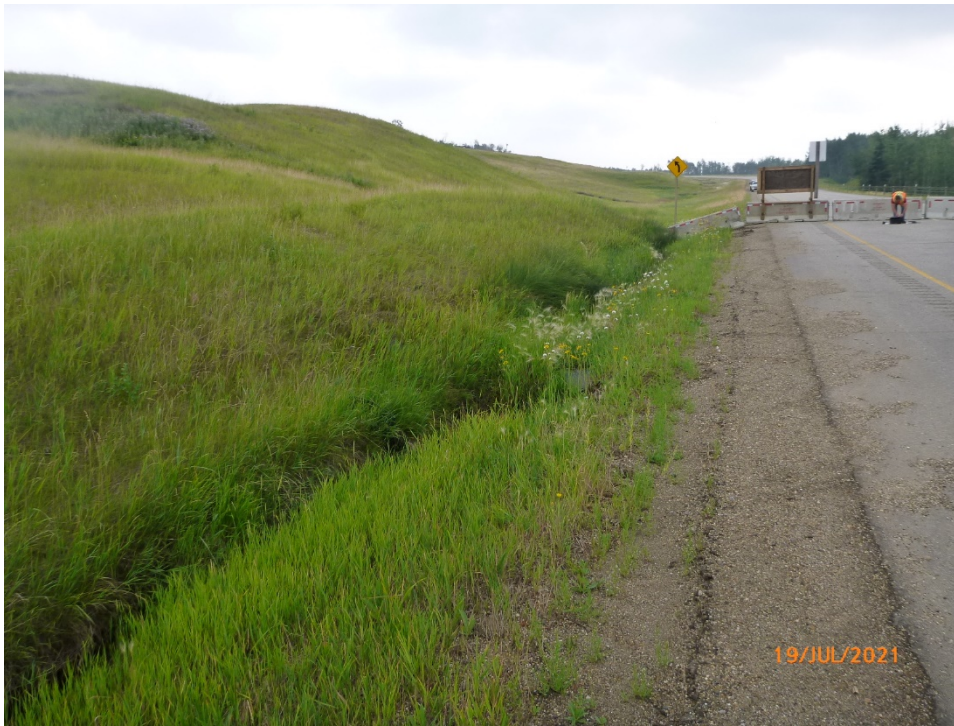
- The slide is in a natural slope between the SBL and the NBL that is approximately 20 m high and slopes at about 5H:1V
- Well-developed toe roll in SBL median ditch.
- AT says that slide has not changed much since last inspection
- Review of drone video and based on the shape of the headscarp indicates that slide appears to have been initiated and then expanded with additional sliding on the flank (the direction of expansion is unknown).

**Photo 4** Toe bulge in the north (eastbound) ditch of Hwy 43. Photo taken July 19, 2021 facing east.

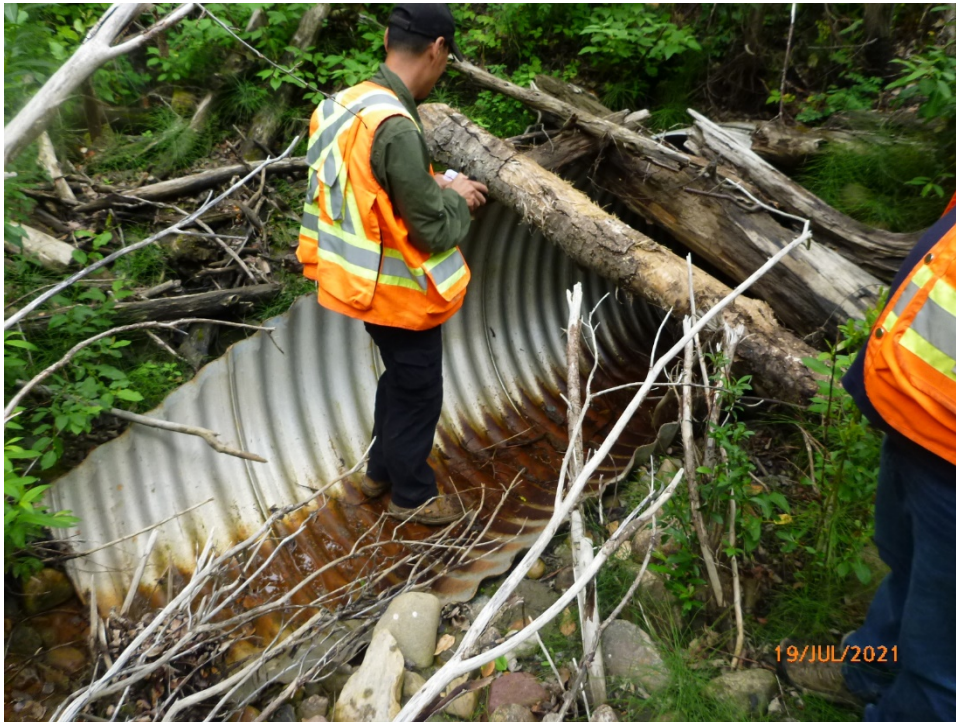
- Went to inlet of 1200 mm CSP culvert (WP080). Inlet has no trash rack and woody debris was found on top of the crown of the culvert. Water flow is rising above the inlet to the culvert and could indicate that the culvert is blocked with woody debris (this could explain the “surging” behaviour observed at the outlet of the 0.9-m-diameter steel pipe culvert)

**Photo 6** Inlet of 1200 mm diameter CSP culvert. Photo taken July 19, 2021 facing southeast.
