SITE INSPECTION FORM

SITE NUMBER AND NAME: GP045 Smoky River East Valley Slope Slide and Sinkhole		HIGHWAY & KM: 43:04, 35.691	PREVIOUS INSPECTION DATE: July 19, 2021	INSPECTION DATE: June 16, 2022
LEGAL DESCRIPTION: SW 16-72-02-W6M NW-09-72-02-W6M	NAD 83 COORDINATES: UTM Northing Easting 11 6121247 420280 11 6121035 420289		RISK ASSESSMENT: Slide PF: 9 CF: 3 TOTAL: 27 Sinkholes & Erosion PF: 9 CF: 4 TOTAL: 36	
AVERAGE ANNUAL DAILY TRAFFIC (AADT): 6230 (west) (Reference No. 30720, 2021) 6790 (east) (Reference No. 7000114, 2021)			CONTRACT MAINTENANCE AREA (CMA): 504

PROJECT	PEACE REGION (GRANDE PRAIRIE DISTRICT-SOUTH) GEOHAZARD RISK MANAGEMENT PROGRAM	
TITLE	Site Plan GP045 - Smoky River East Valley Slope Slide and Sinkhole Hwy 43:04, km 35.691	
SCALE	PROJECT No.	FIG No.
1:2,250	A05116A01	1

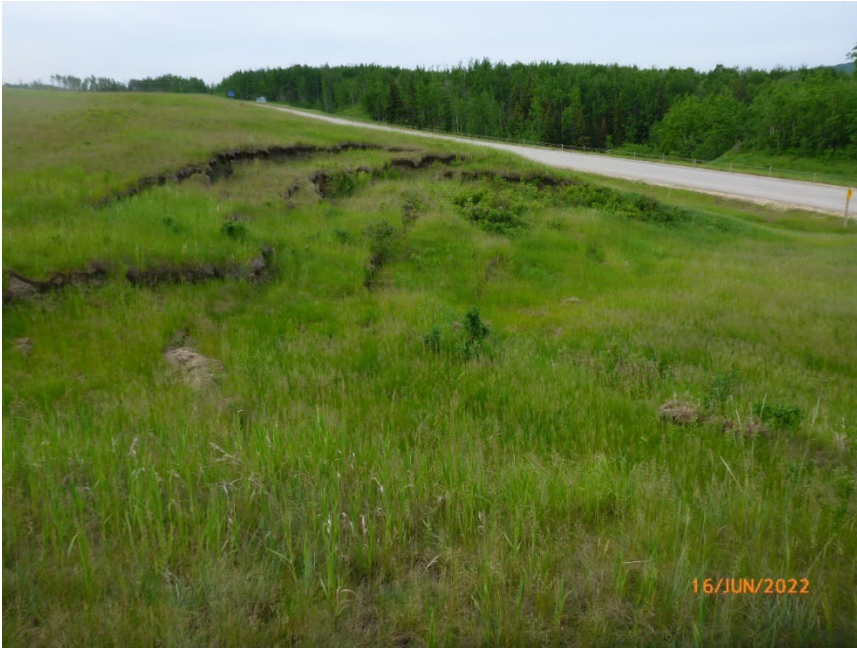
Slope failure at WP079

- Review of unmanned-aerial-vehicle (UAV) flight imagery from 2021 and the shape of the headscarp appears to indicate that the slide has expanded with additional sliding at the flank(s).

Photo 1 Slope failure at WP079 in median backslope above southbound lanes of Hwy 43:04. Photo taken June 16, 2022, facing southwest.

- The repair of the sinkhole and sliding are being conducted under a separate contract.

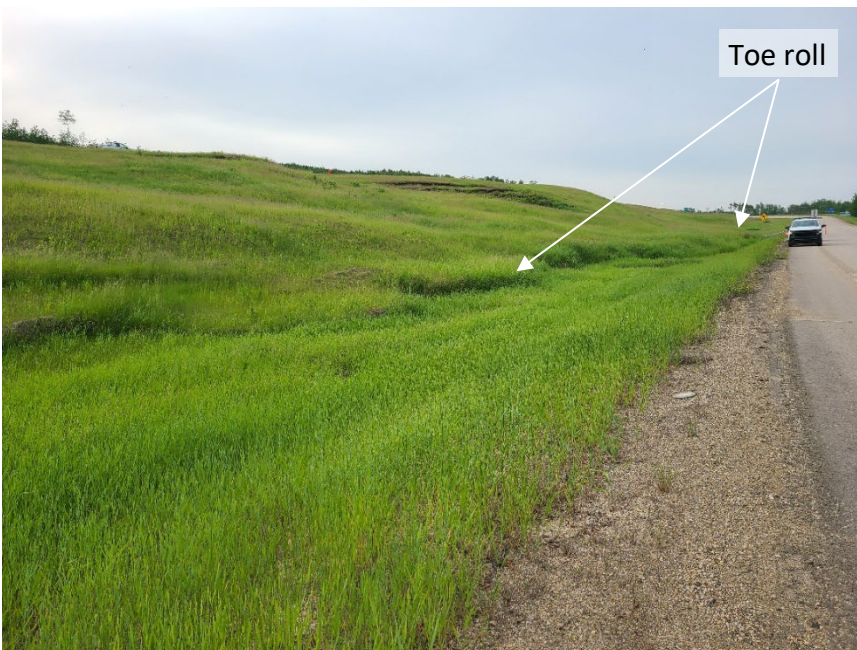
Photo 2 Toe roll at WP079 along/in east ditch of southbound lanes of Hwy 43:04. Photo taken June 16, 2022, facing southeast.

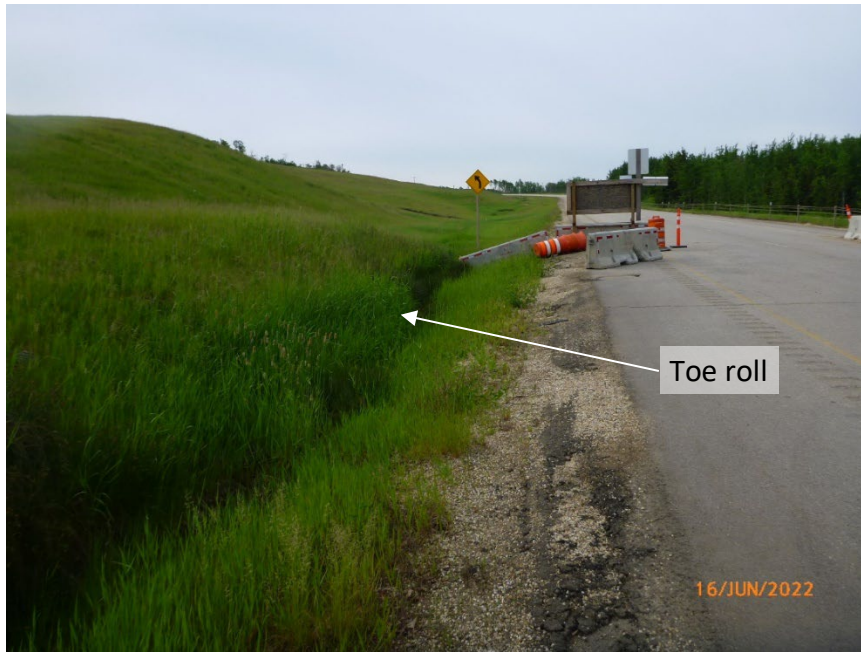
Photo 3 Toe roll in east ditch of southbound lanes of Hwy 43:04. Photo taken June 16, 2022, facing south.

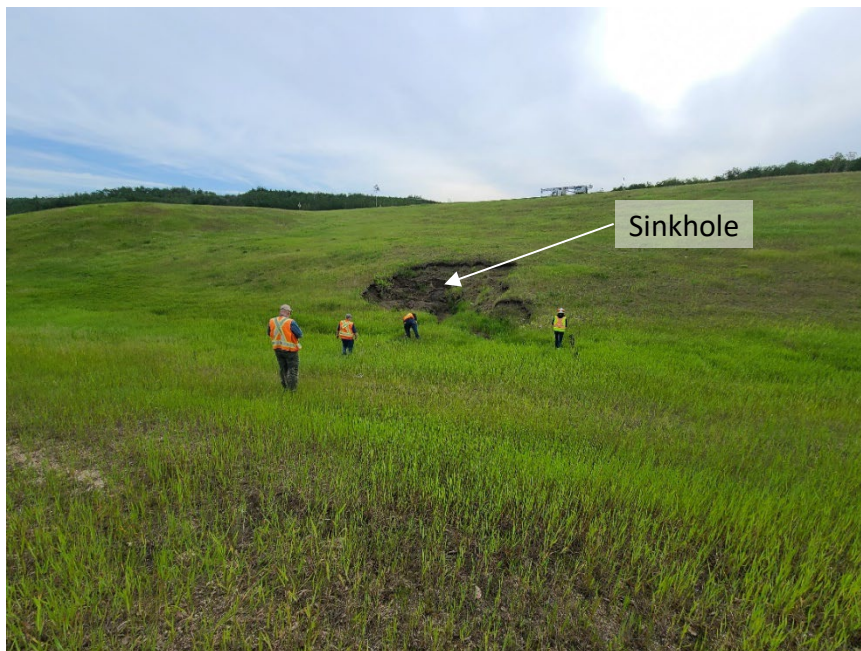
Sinkhole between WP077 and WP078

- The sinkhole in the median appears to be related to the decommissioned CSP culvert, which was replaced with a SWSP culvert.
 - AT reports the SWSP and the original CSP are not properly connected, which could allow material above the connection to enter the culvert and block it. This was confirmed with a camera survey (completed approximately 3 years ago), which showed a “lip” where the CSP and SWSP pipe pieces do not meet. AT has the video footage from the camera survey.

- The method/type of SWSP culvert construction is unknown but appears to have been done with trenchless methods. The sinkhole could also be the location of a push pit if the culvert was drilled in placed.

Photo 4 Sinkhole between WP077 and WP078 in median backslope above of southbound lanes of Hwy 43:04. Photo taken June 16, 2022, facing northwest.

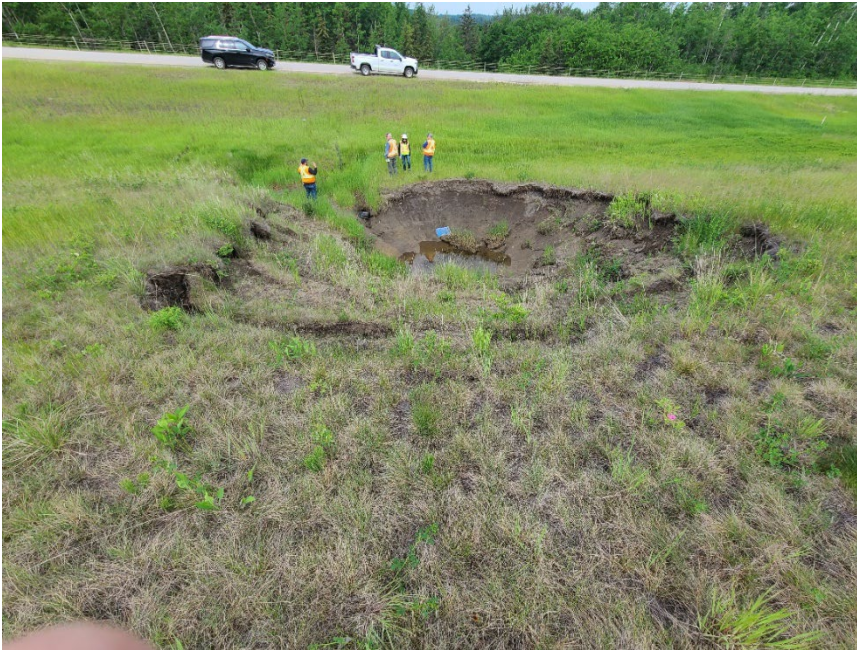
- Ponded water observed in the sinkhole. Since the 0.9-m diameter SWSP culvert outlet downstream is trickling this could indicate either the culvert is full of water and blocked, or the sinkhole is sealed off and can hold water at surface. The alignment of the culvert also includes bends, which could also promote blockage with debris.

Photo 5 Ponded water in sinkhole between WP077 and WP078 in median backslope above of southbound lanes of Hwy 43:04. Photo taken June 16, 2022, facing west.

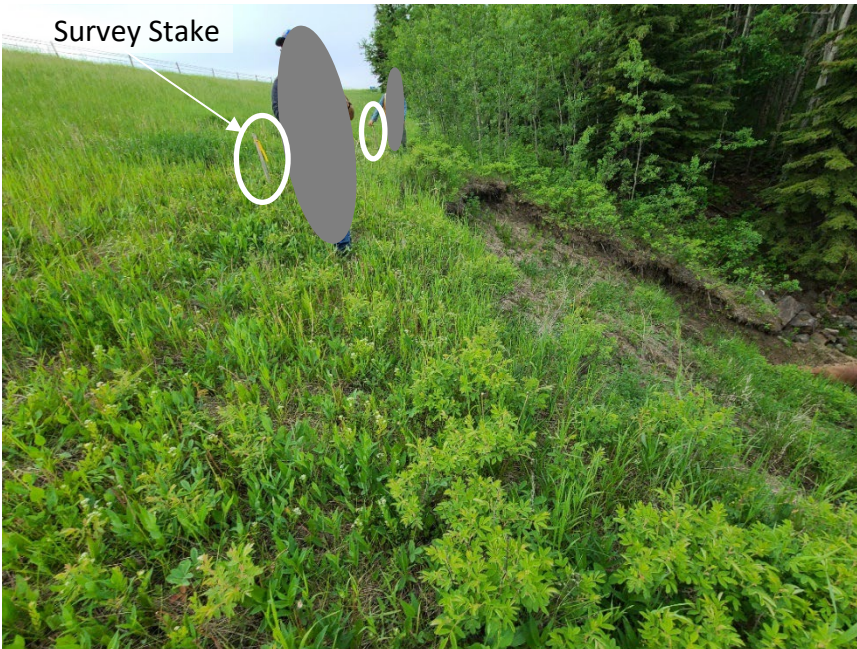
North erosion gully at outlet of 0.9-m diameter smooth-walled-steep-pipe (SWSP) culvert outlet at WP076

- Erosion gully is large, approximately 10 m wide by 15 m long.
- A plunge pool below culvert outlet has exposed natural soil, including gravel, cobbles, and boulders (there is a gravel pit nearby).
- Culvert outlet suspended in air 2 m to 3 m.
- Steady trickle of water from culvert outlet.

Photo 6 Crest of erosion gully at 0.9-m diameter SWSP culvert outlet at WP076. Note reference/survey stakes with flagging (circled in white) placed 2.0 m upslope of erosion gully to monitor retrogression. Photo taken June 16, 2022, facing south.

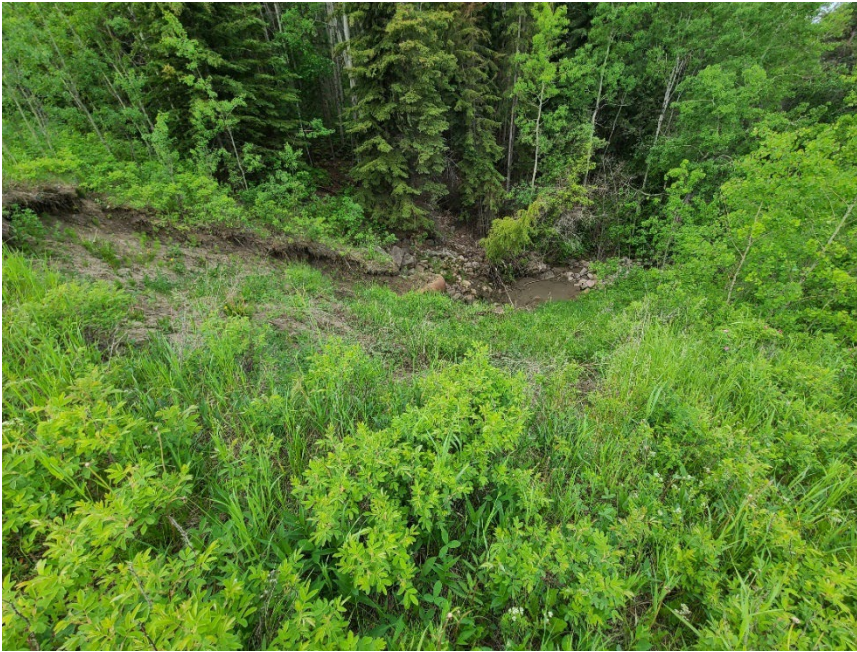
Photo 7 Erosion gully at 0.9-m diameter SWSP culvert outlet at WP076. Photo taken June 16, 2022, facing southwest.

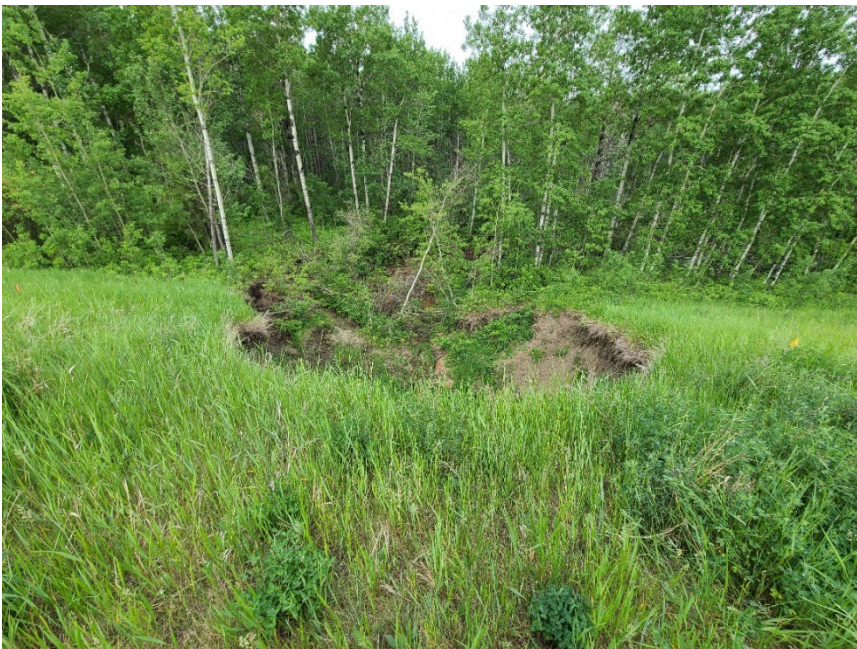
South erosion gully at outlet of 1.2-m diameter corrugated-steel-pipe (CSP) culvert outlet at WP227

- Erosion gully is large, approximately 10 m wide by 20 m long.
- The culvert is partially sleeved with green plastic pipe at the outlet.
- Orange and black utility cables exposed along backslope of gully.

Photo 8 Erosion gully at 1.2-m diameter CSP culvert outlet at WP227. Photo taken June 16, 2022, facing west.

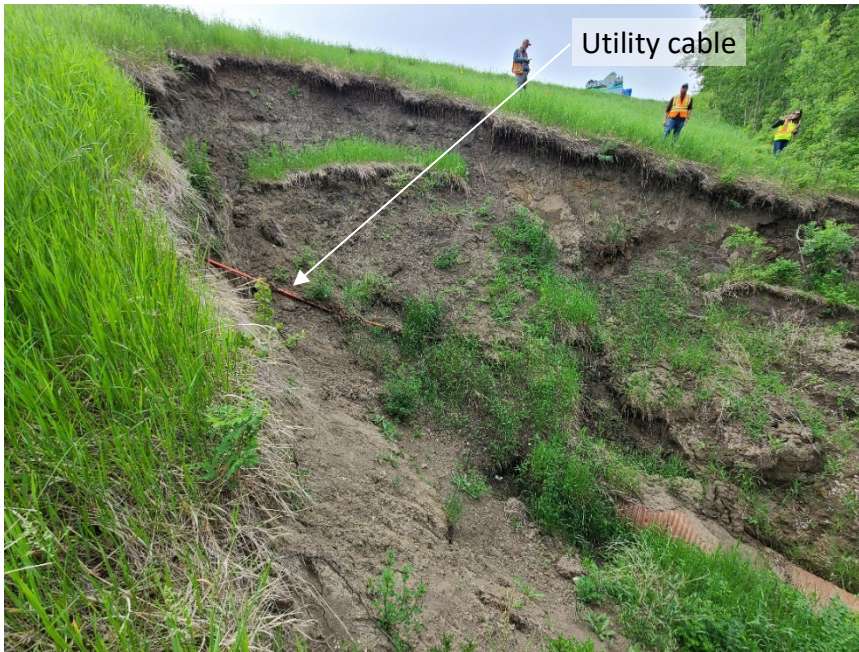
Photo 9 Erosion fully at 1.2-m diameter CSP culvert outlet at WP227. Note red utility cable exposed along gully backslope. Photo taken June 16, 2022, facing southeast.

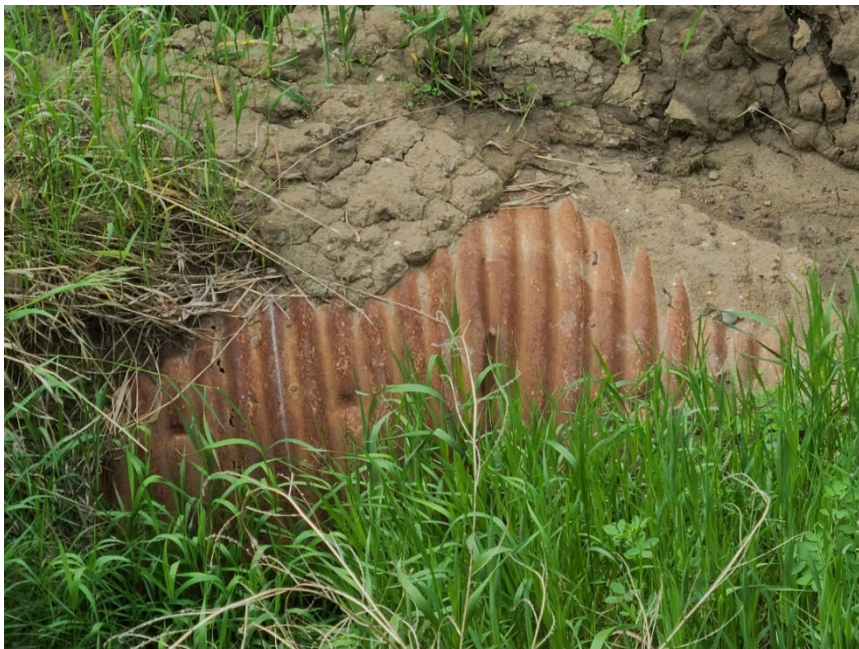
Photo 10 Outlet of 1.2-m diameter culvert corroded with holes at WP227. Photo taken June 16, 2022, facing south.

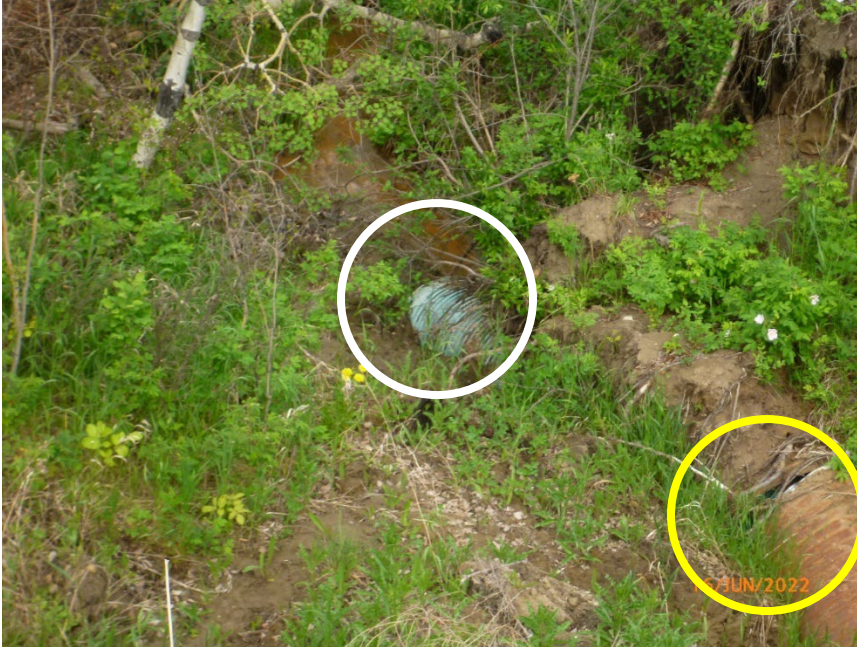
Photo 11 Outlet of 1.2-m diameter culvert partially blocked at WP227. Note green plastic culvert sleeve (circled in white) that was partially inserted into the original CSP culvert (circled in yellow). Photo taken June 16, 2022, facing west.

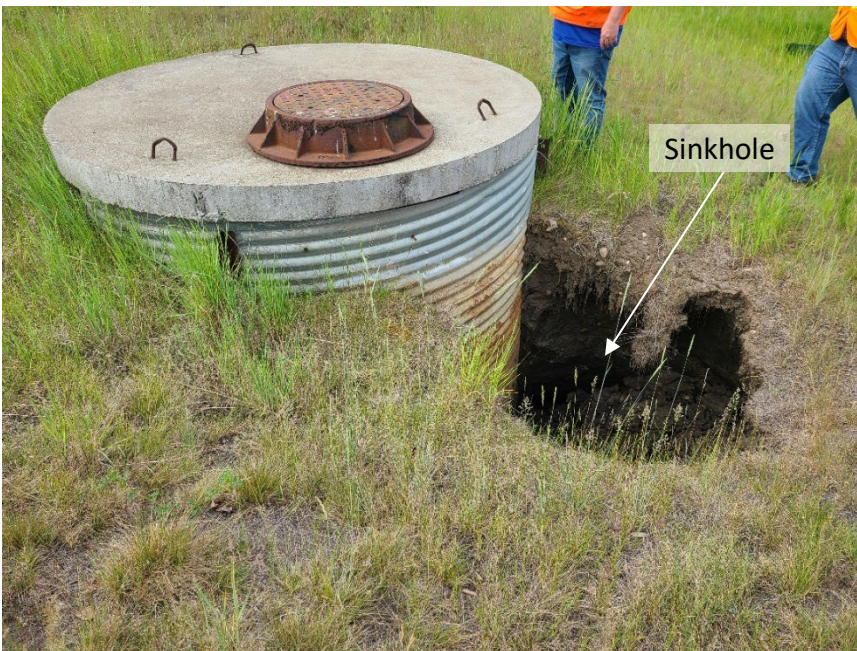
Sinkhole next to inlet of 3.0-m diameter CSP drainage gallery at WP226.

- A sinkhole is approximately 2.0 m wide by 2.5 m deep.
- It is suspected that the connection detail on the south/downstream end is separated, and material is being washed into the pipe resulting in the sinkhole observed at ground surface.

Photo 12 Sinkhole at WP226 next to inlet of CSP drainage gallery in median backslope above of southbound lanes of Hwy 43:04. Photo taken June 16, 2022, facing west.
