SITE INSPECTION FORM

SITE NUMBER AND NAME: GP045 Smoky River East Valley Slope Slide and Sinkhole		HIGHWAY & KM: 43:04, 35.691	PREVIOUS INSPECTION DATE: June 16, 2022	INSPECTION DATE: June 3, 2025
LEGAL DESCRIPTION: SW 16-72-02-W6M NW 09-72-02-W6M	NAD 83 COORDINATES: UTM Northing Easting 11 6121247 420280 11 6121035 420289		RISK ASSESSMENT: Slide PF: 9 CF: 4 TOTAL: 36 Sinkholes & Erosion PF: 10 CF: 3 TOTAL: 30	
AVERAGE ANNUAL DAILY TRAFFIC (AADT): 8,120 (east) & 8,320 (west) (Reference No. 70001011, 2024)			CONTRACT MAINTENANCE AREA (CMA): 504

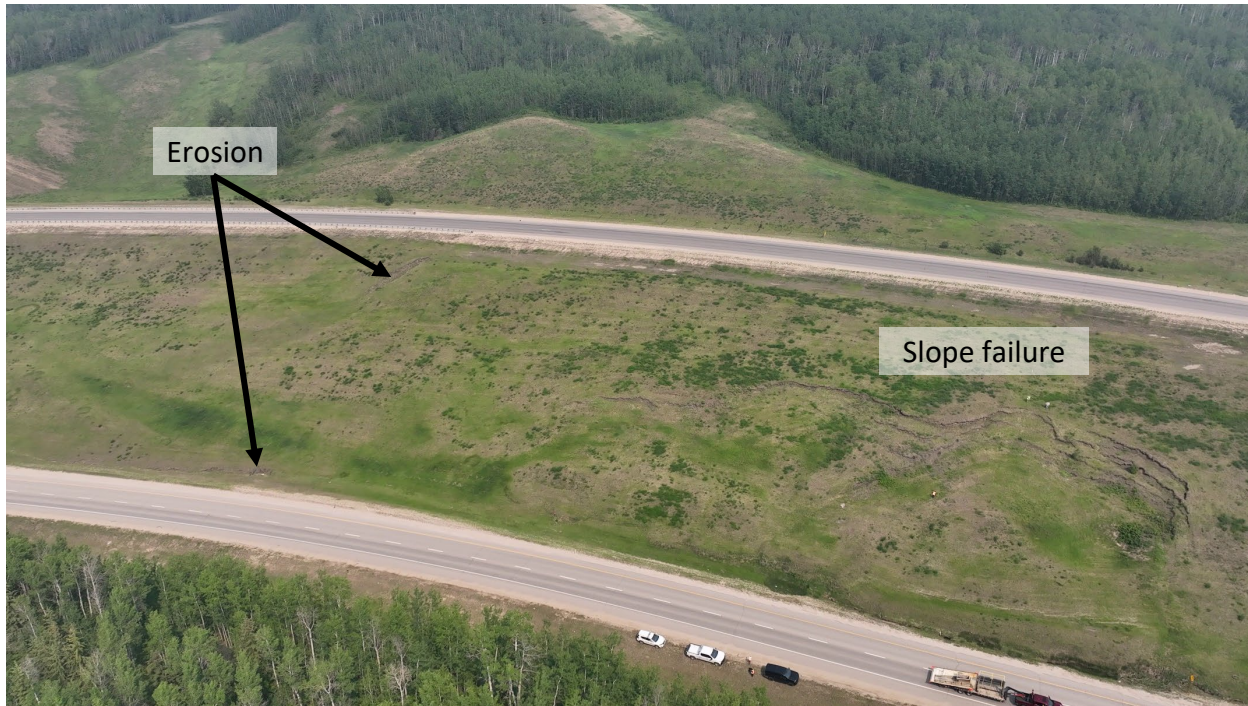
Photo 1 Overview of GP045 site. Photo taken June 3, 2025, facing northeast.

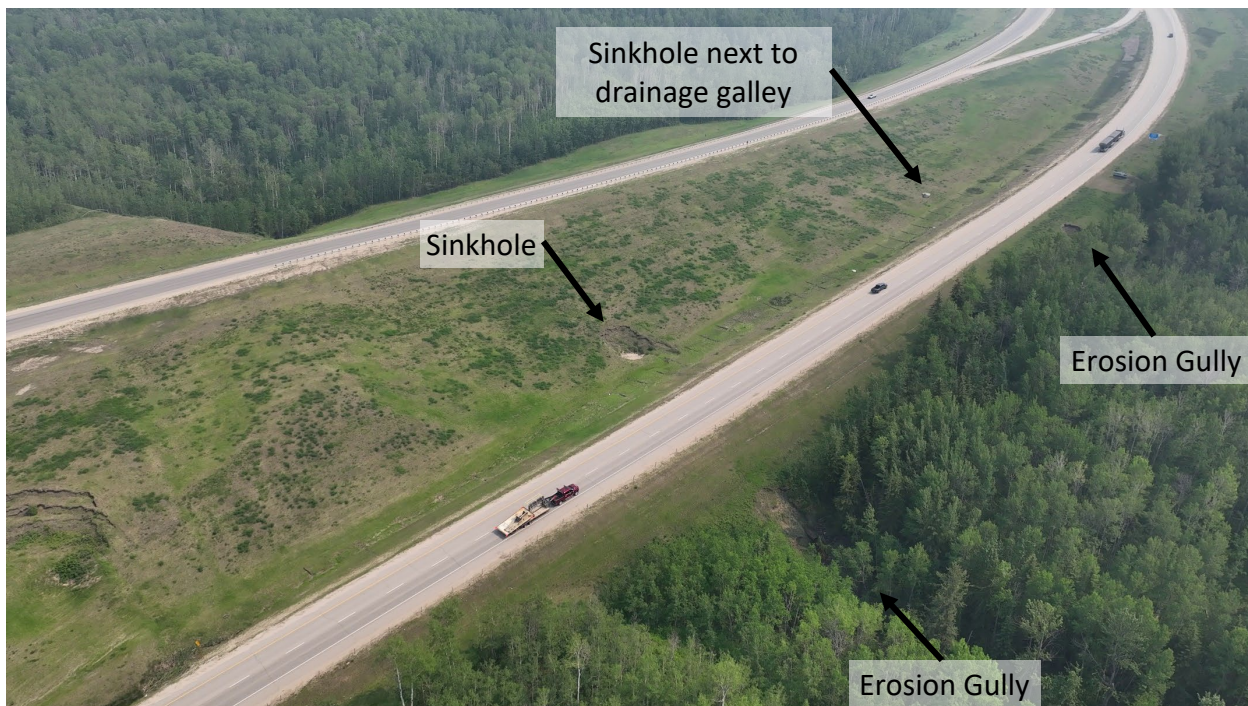
Photo 2 Overview of GP045 site. Photo taken June 3, 2025, facing southeast.

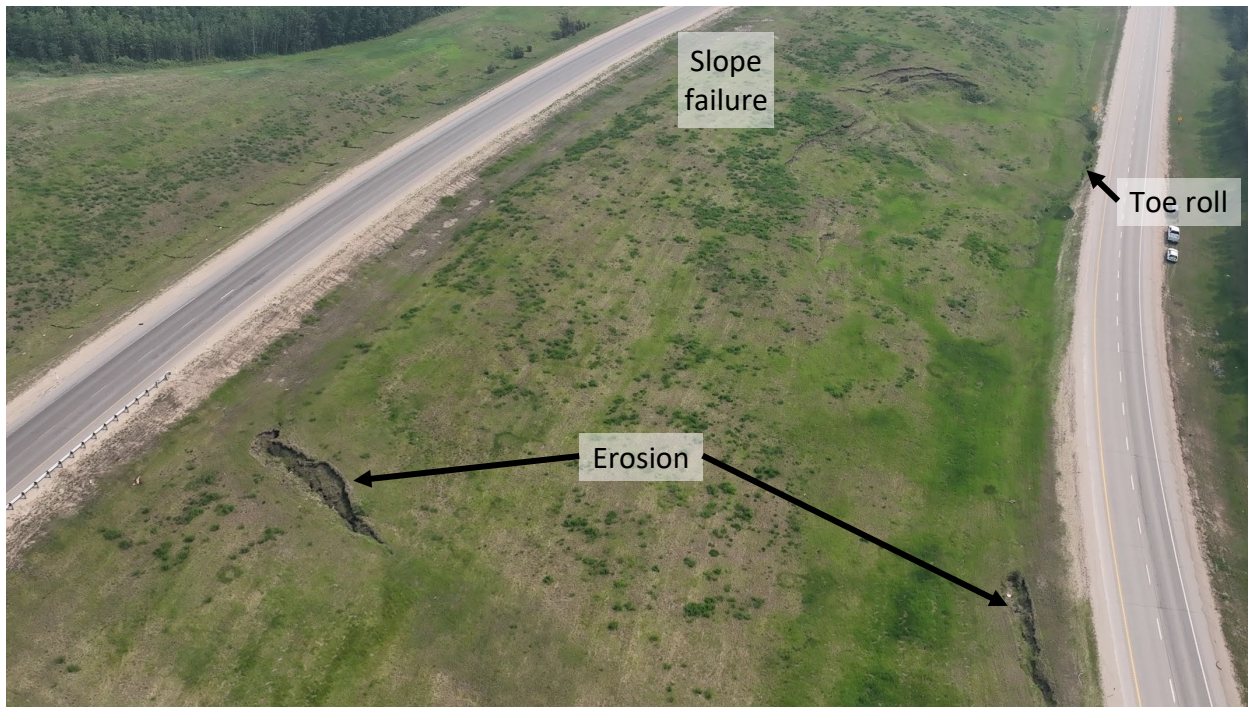
Photo 3 Erosion features and slope failure in median backslope of Hwy 43:04. Note toe roll of slope failure in highway ditch. Photo taken June 3, 2025, facing southeast.

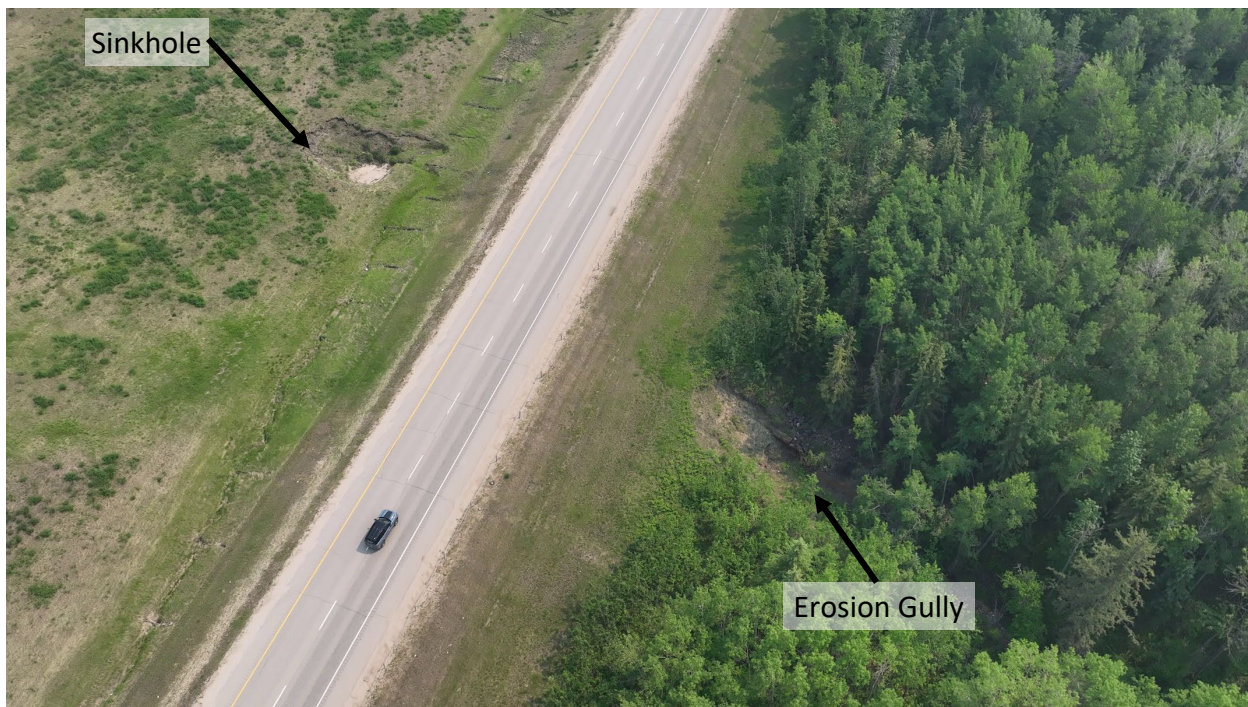
<u>North erosion gully at outlet of 0.9-m diameter smooth-walled-steep-pipe (SWSP) culvert outlet (Photos 4 and 8):</u>			
<ul style="list-style-type: none"> Erosion gully has retrogressed since the 2022 inspection and is large, approximately 10 m wide by 15 m long. A plunge pool below culvert outlet has exposed natural soil, including gravel, cobbles, and boulders (there is a gravel pit nearby). Culvert outlet overhands in air approximately 2 m to 3 m. 			
<u>South erosion gully at outlet of 1.2-m diameter corrugated-steel-pipe (CSP) culvert outlet (Photos 5 and 9):</u>			
<ul style="list-style-type: none"> Erosion gully has retrogressed since the 2022 inspection and is large, approximately 10 m wide by 20 m long. Culvert is partially sleeved with a green plastic pipe at the outlet. Orange and black utility cables exposed along the backslope of the gully. 			
<u>Sinkhole in median backslope next to inlet of 3.0-m diameter CSP drainage gallery (Photos 5 and 10):</u>

Photo 4 Sinkhole in median backslope and erosion gully on west slope of Hwy 43:04. Photo taken June 3, 2025.

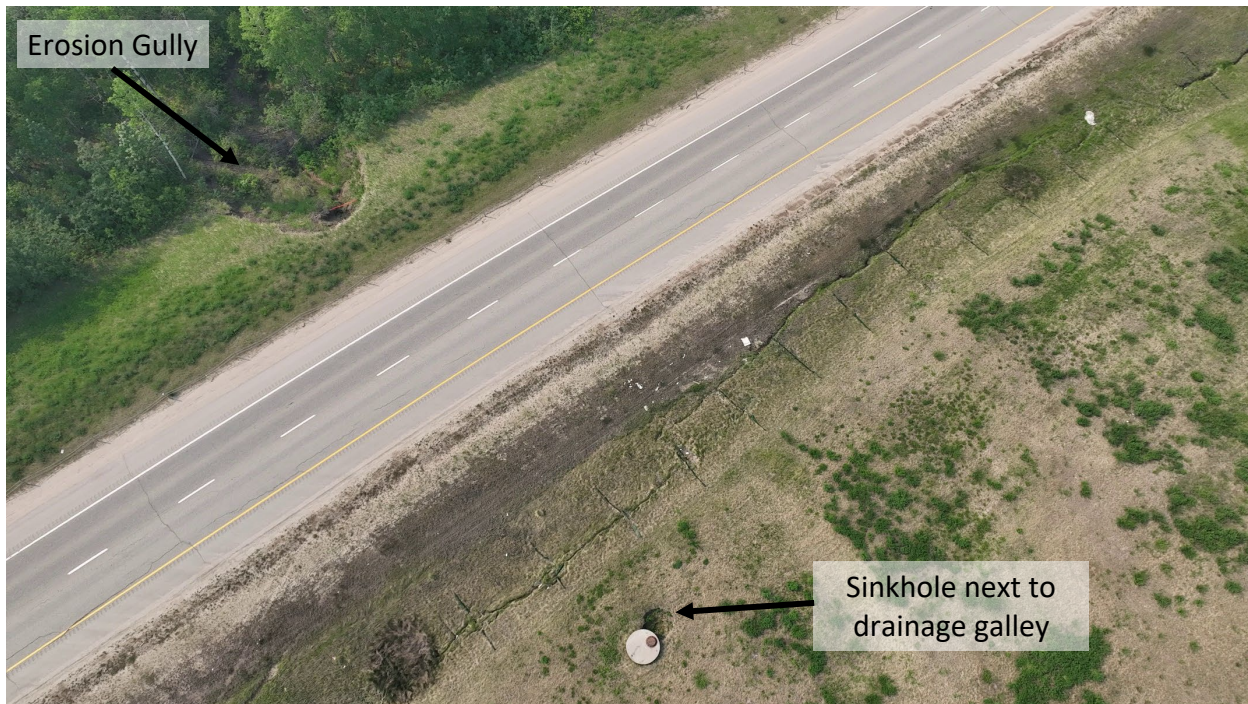
<ul style="list-style-type: none"> Sinkhole is approximately 2.0 m to 3.0 m wide by 2.5 m deep. Sinkhole extents appear to have expanded slightly since the 2022 inspection due to further erosion / collapse, but vegetation has started to grow inside the sinkhole. It is suspected that the connection detail on the south/downstream end is separated, and material is being washed into the pipe resulting in the sinkhole observed at ground surface.

Photo 5 Sinkhole next to inlet of drainage gallery in median backslope and erosion gully on west slope of Hwy 43:04. Photo taken June 3, 2025.

- The repair of the sinkhole and sliding are being conducted under a separate contract.
- End of the high tension cable barrier (HTCB) along the west shoulder of the southbound lanes near the south end of the site is damaged (Photos 11 and 12) and should be repaired.

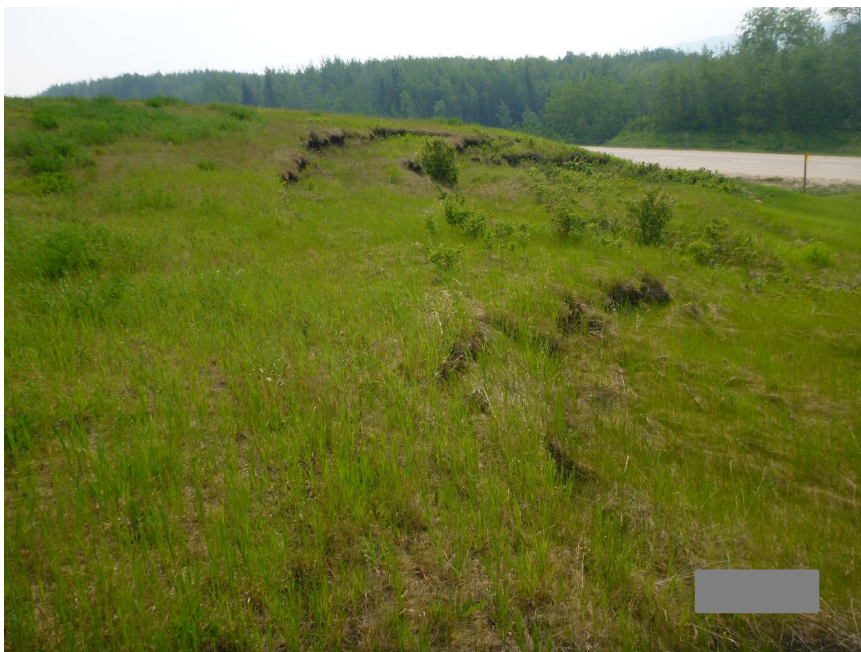
Photo 6 Erosion features in median backslope of Hwy 43:04. Photo taken June 3, 2025, facing southwest.

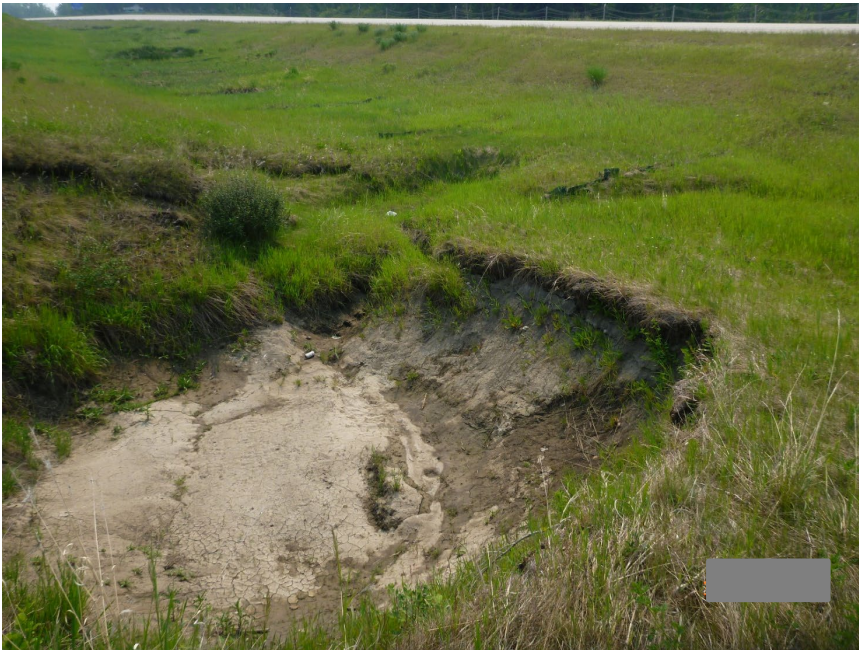
Photo 7 Sinkhole in median backslope of Hwy 43:04. Photo taken June 3, 2025, facing west.

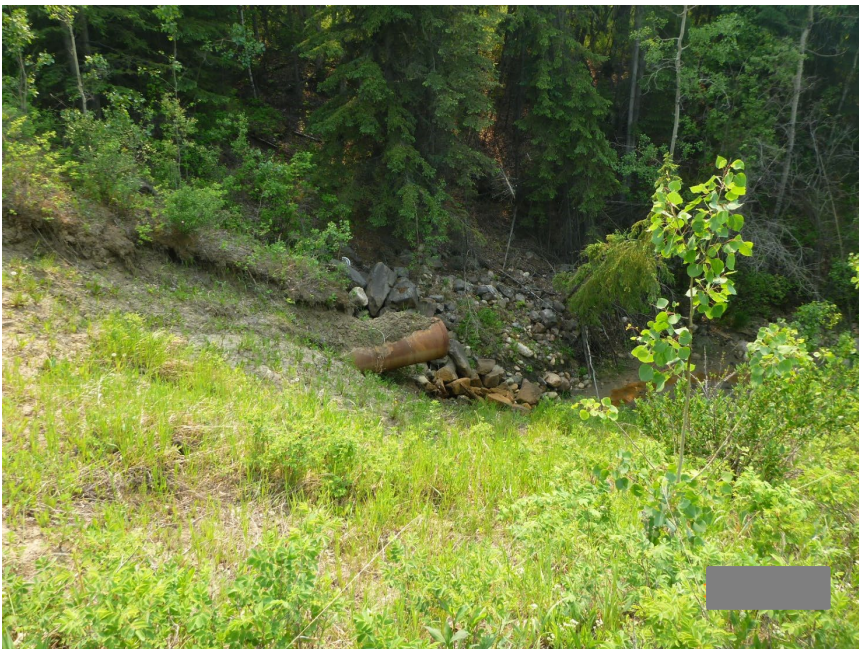
Photo 8 Erosion gully at 0.9-m diameter SWSP culvert outlet on west slope of Hwy 43:04. Note overhang of culvert outlet. Photo taken June 3, 2025, facing southwest.

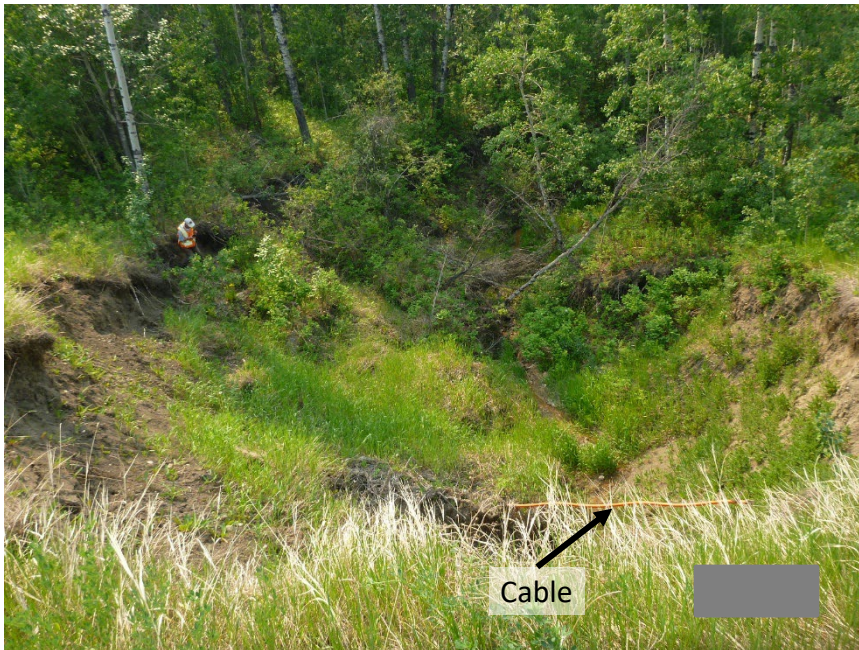
Photo 9 Erosion gully at 1.2-m diameter CSP culvert outlet on west slope of Hwy 43:04. Note red cable exposed along gully backslope. Photo taken June 3, 2025, facing west.

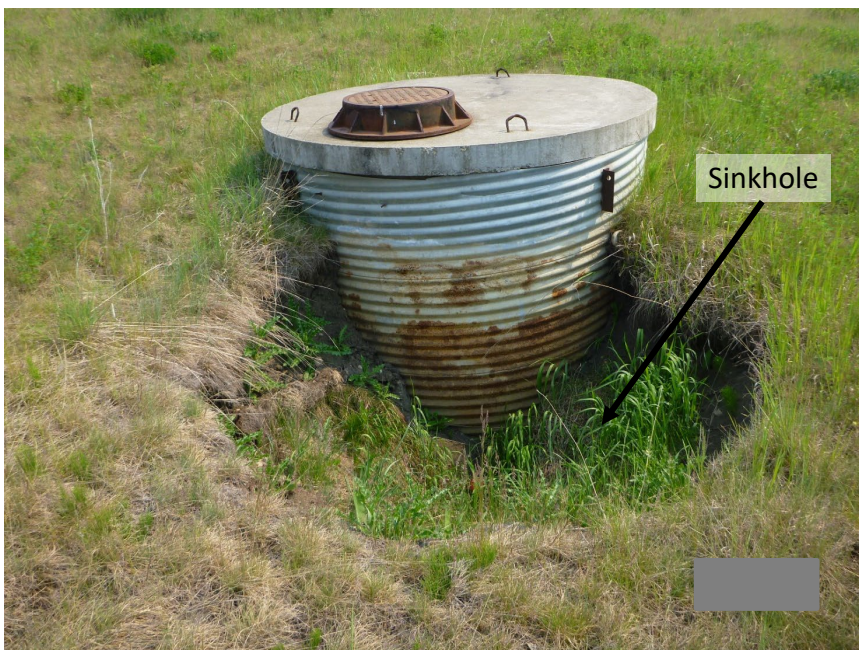
Photo 10 Sinkhole next to inlet of drainage gallery in median backslope of Hwy 43:04. Photo taken June 3, 2025, facing south.

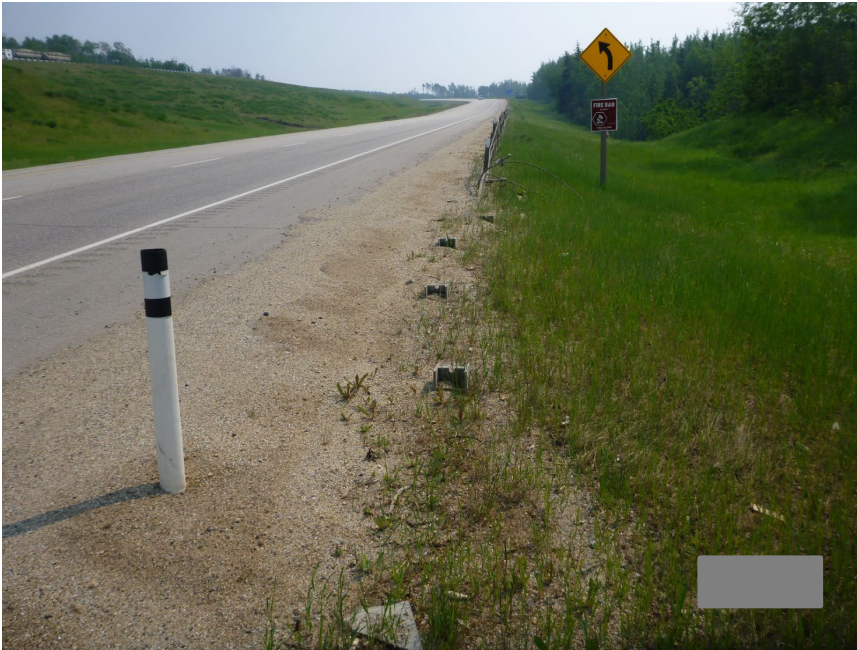
Photo 11 Guardrail damaged along west side of southbound lanes of Hwy 43:04. Photo taken June 3, 2025, facing south.

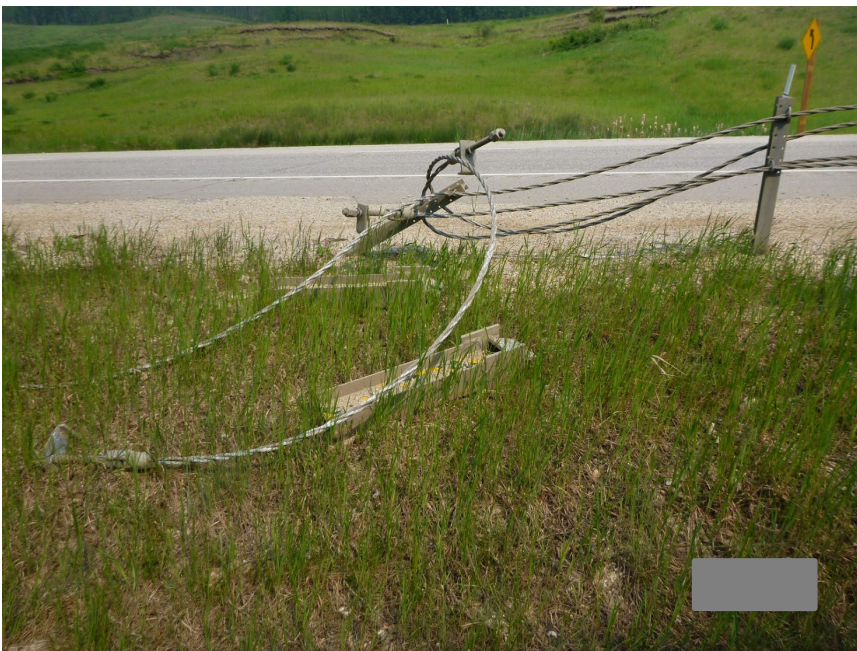
Photo 12 Damaged high-tension cable barrier (HTCB) along west side of southbound lanes of Hwy 43:04. Photo taken June 3, 2025, facing east.
