**ALBERTA TRANSPORTATION  
GEOHAZARD ASSESSMENT PROGRAM  
PEACE REGION – GRANDE PRAIRIE DISTRICT  
2020 INSPECTION REPORT**

Site Number	Location	Name	Hwy	km
GP046	Hwy 43/Smoky River West	Hwy 43/Smoky River West Valley Backslopes	43:04	32
<b>Legal Description</b>		<b>UTM Co-ordinates</b>		
SE¼ 18-072-02 W6M		11U E 417770	N 6121417

Date	PF	CF	Total
<b>Previous Inspection:</b>	30-May-2019	11	4	44
<b>Current Inspection:</b>	27-May-2020	13	4	52
<b>Road AADT:</b>	7650		<b>Year:</b>	2019
<b>Inspected By:</b>	Rishi Adhikari, AT Ed Szmata, AT Dwayne Loewen, AT		Don Proudfoot, Thurber Nicole Wilder, Thurber	
<b>Report Attachments:</b>	<input checked="" type="checkbox"/> Photographs <input checked="" type="checkbox"/> Plans <input checked="" type="checkbox"/> Maintenance Items

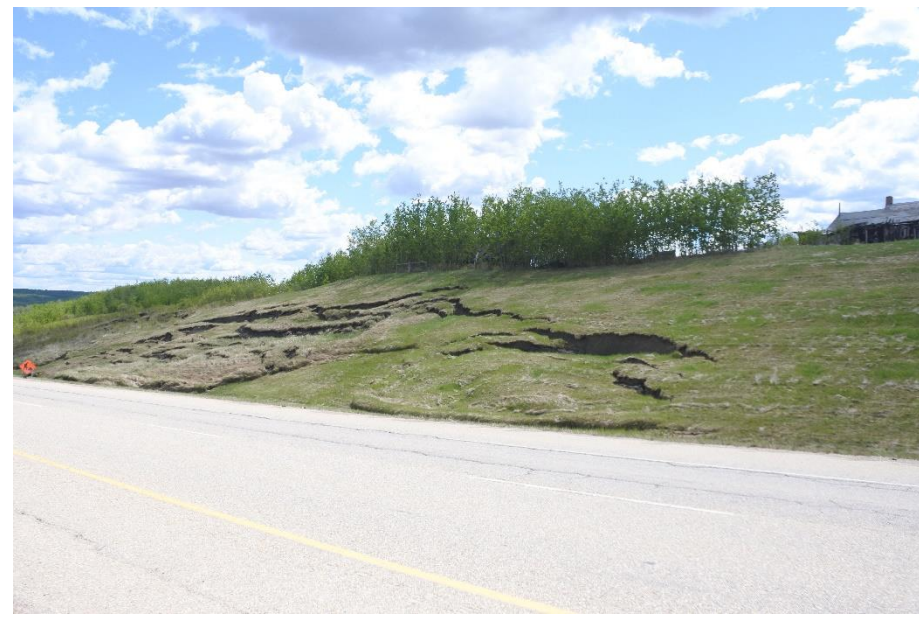
**Photo 1.**  
Looking southeast from the median of Hwy 43:04 towards the slides in the backslope above the EBL. The slides are identified from right to left as Slides 1 to 2 which have now become one slide.

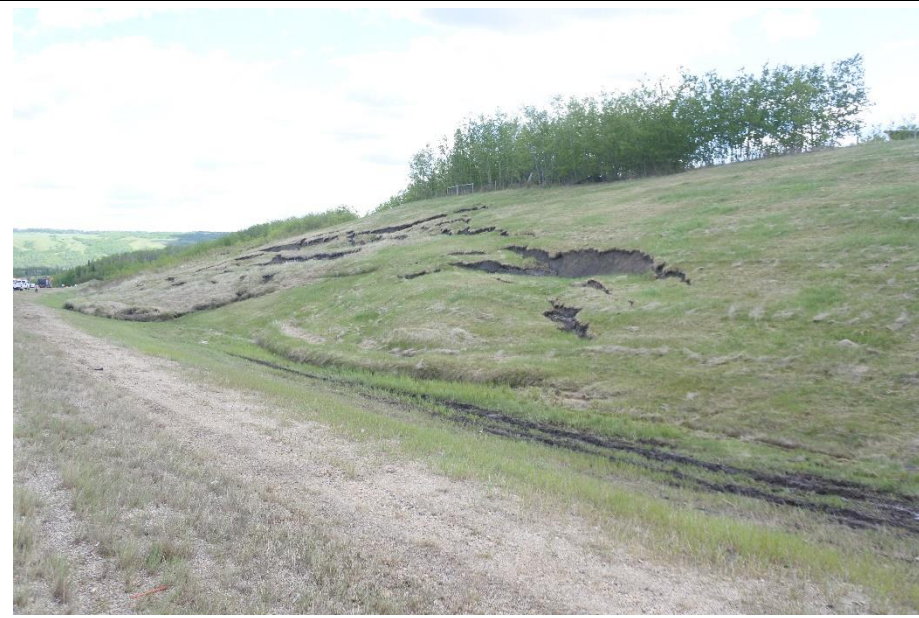
**Photo 2.**  
Looking southeast from the edge of the EBL shoulder towards Slide 1 and 2 which are now one slide. The backscarp has a 2.1 m drop, is about 125 m in width and extends about 32 m down the slope.

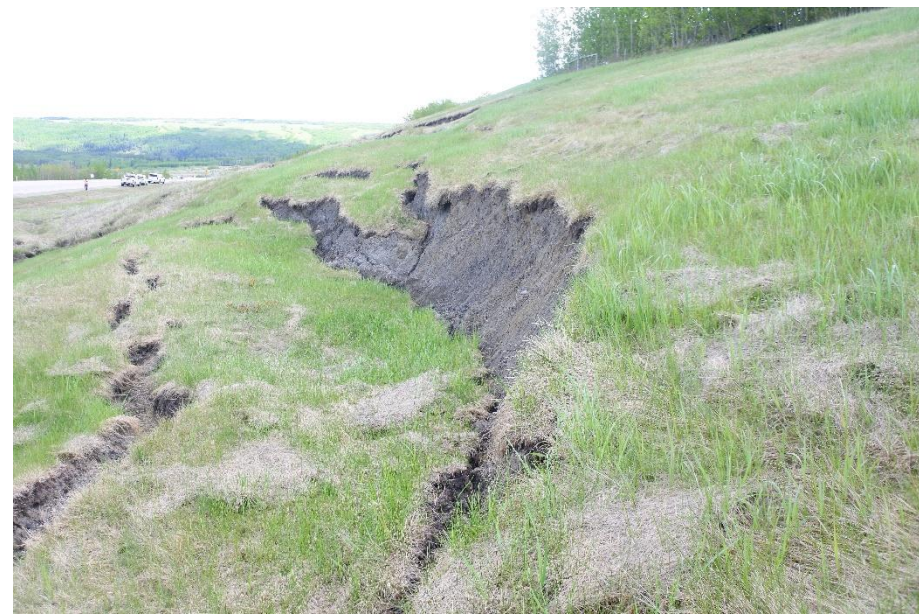
**Photo 3.**  
Looking southeast along the backscarp of Slide 1. The average drop along the backscarp in the western half of the slide is about 2.1 m in height.

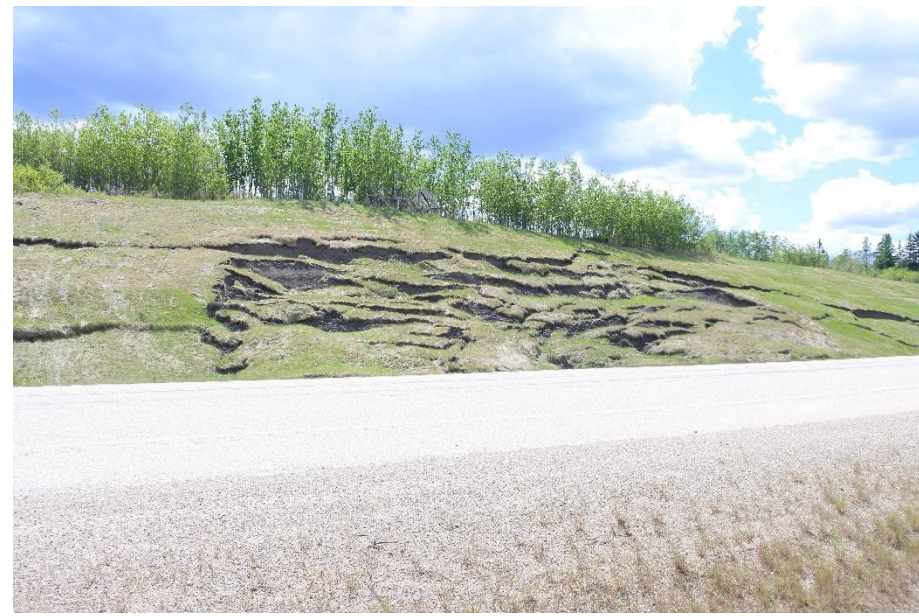
**Photo 4.**  
Looking south from the middle of Slide 1 & 2 at the scarp cracks. The ditch flow of the EBL is impeded by the accumulation of slide debris at the toe.

<b>Maintenance:</b>	No maintenance has been performed recently at the site. To maintain ditch flow, slumped material that accumulates at the toe of the slides and overflows into the EBL south ditch will need to be periodically removed.

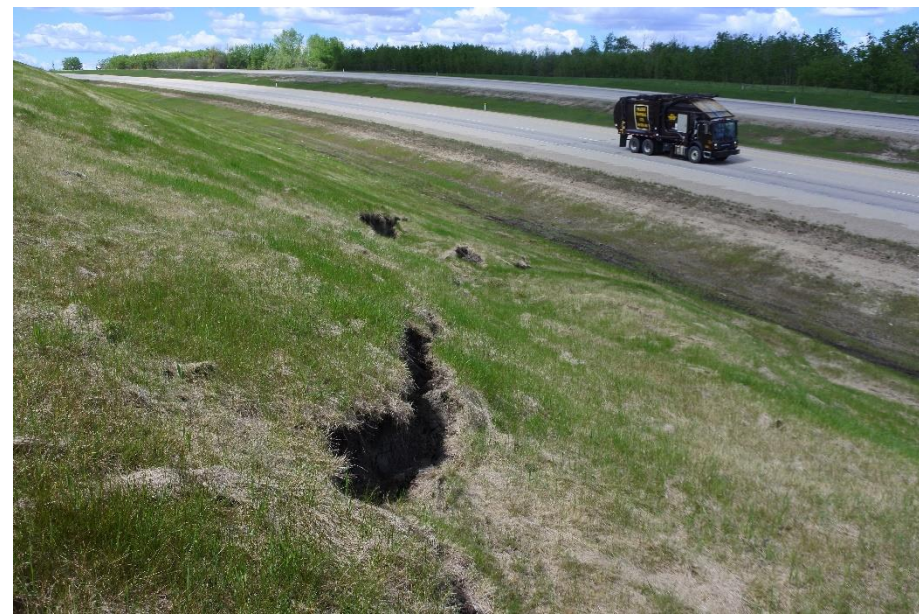
**Photo 5.**  
Looking north at  
small erosion gully  
that is forming from  
surface flow above  
Slide 1.

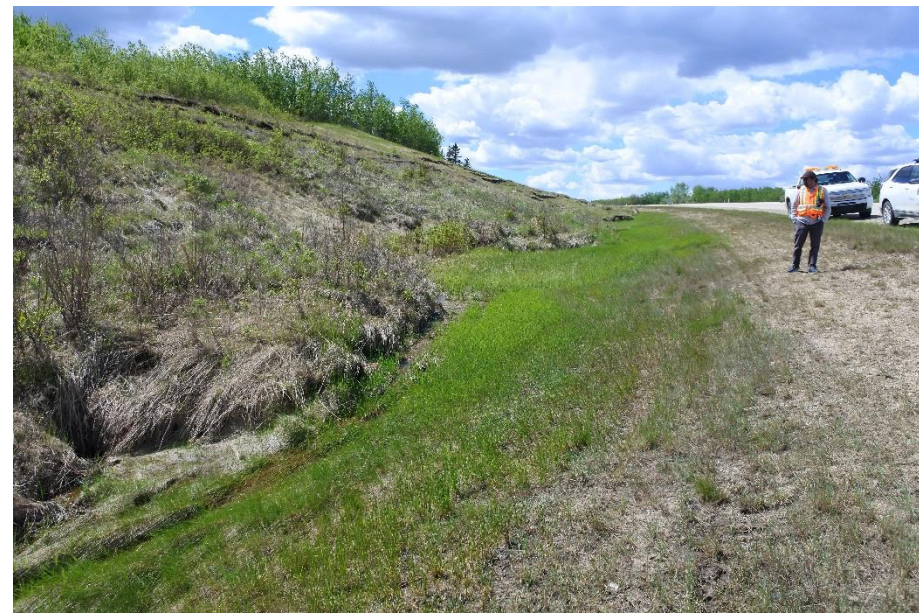
**Photo 6.**  
Looking southwest  
from the EBL of  
Hwy north shoulder  
43:04 at Slide 2.

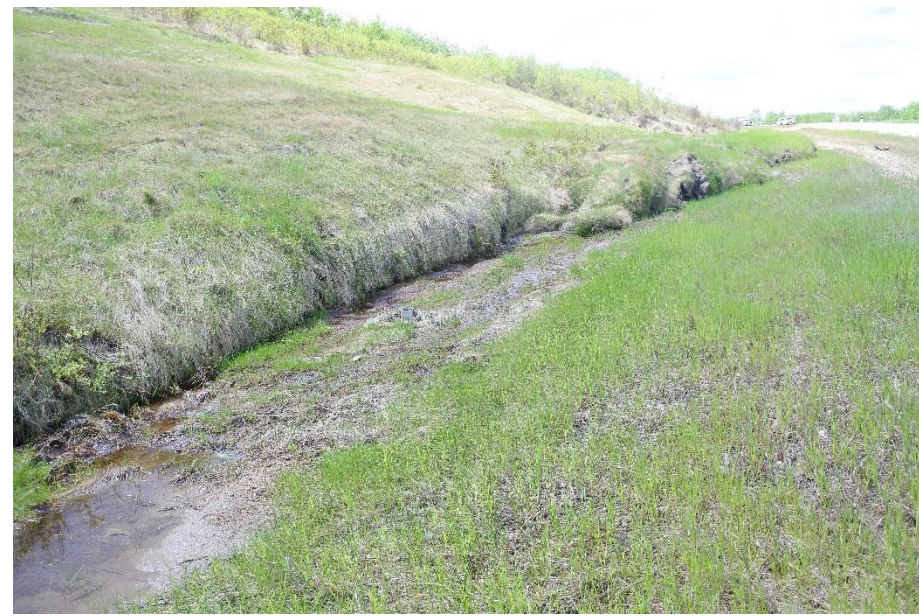
**Photo 7.**  
Looking west  
from EBL ditch at  
Slide 3 Toe Roll.

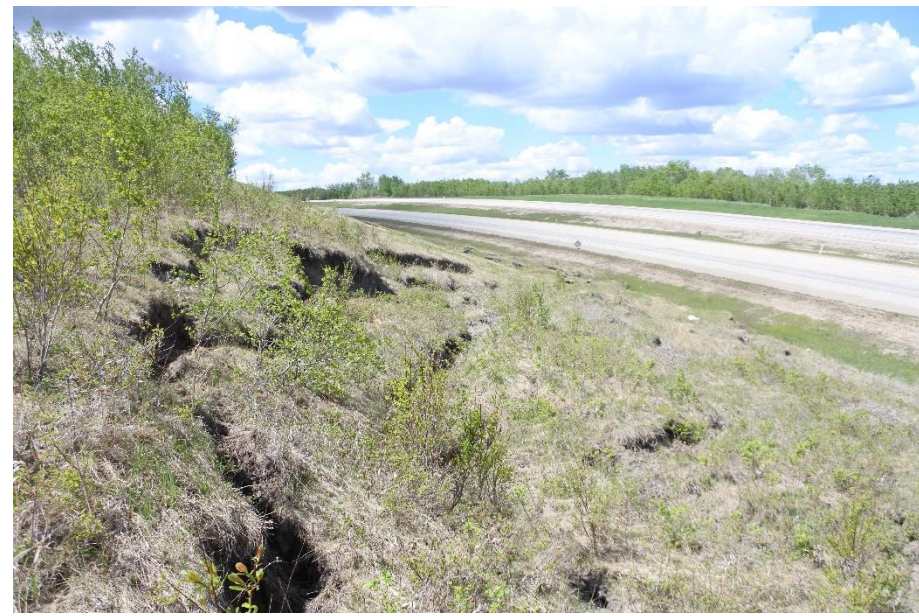
**Photo 8.**  
Looking west from  
the west side of Slide  
3. The height of the  
drop along the  
backscarp varies  
from 1 m to 2 m in  
the western half of  
Slide 3.

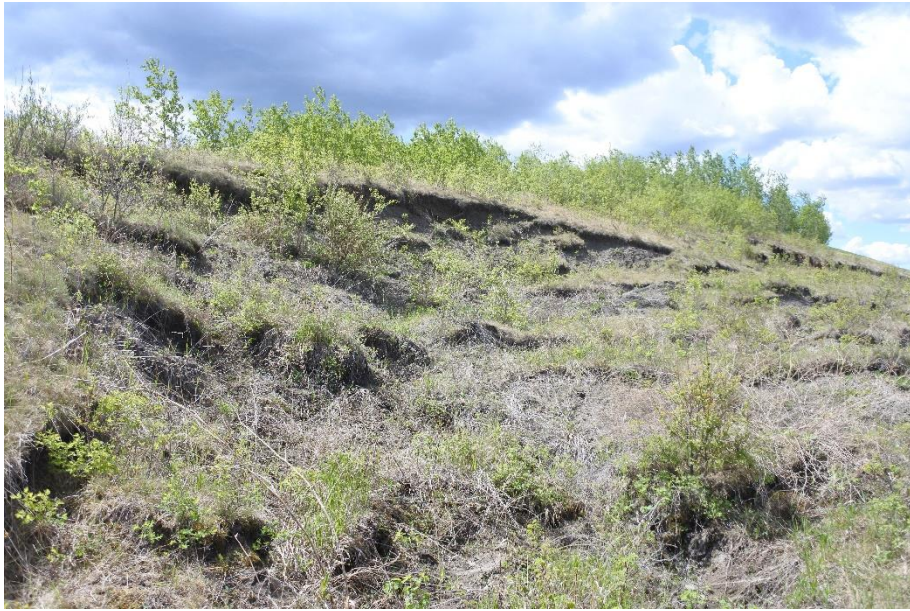
**Photo 9.**  
Looking south at the backscarp of Slide 3 from near the middle of the slide. Slide 3 is about 100 m in width and extends about 35 m down the slope. The height of the drop along the backscarp is of about 1.5 m here.

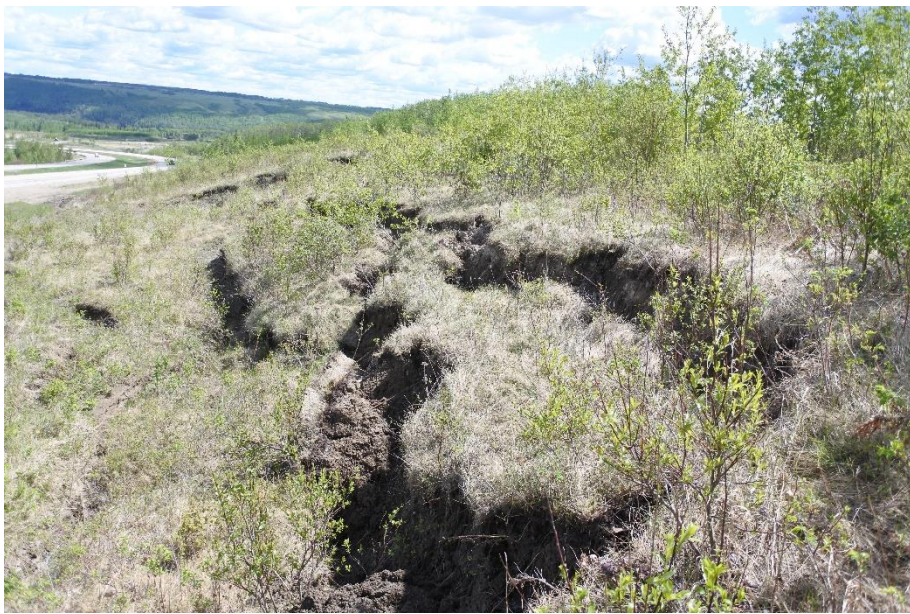
**Photo 10.**  
Looking east along the backscarp of Slide 3 from near the center of the slide. The height of the drop along the backscarp varies from 1.5 m to 3.0 m in the eastern half of the slide.

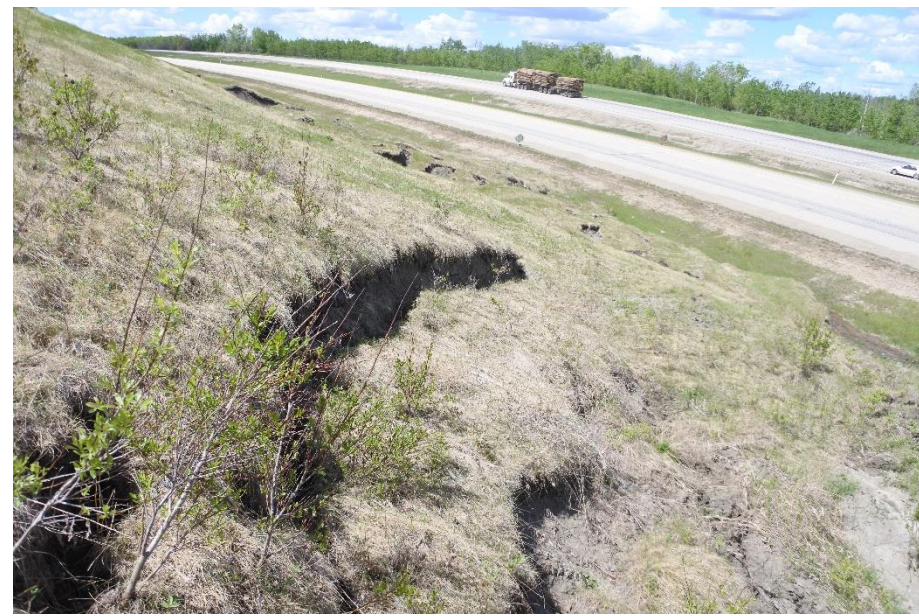
**Photo 11.**  
Looking west across the backscarp from the east side of Slide 3. The drop at the backscarp about 2 m in the east half of the slide.

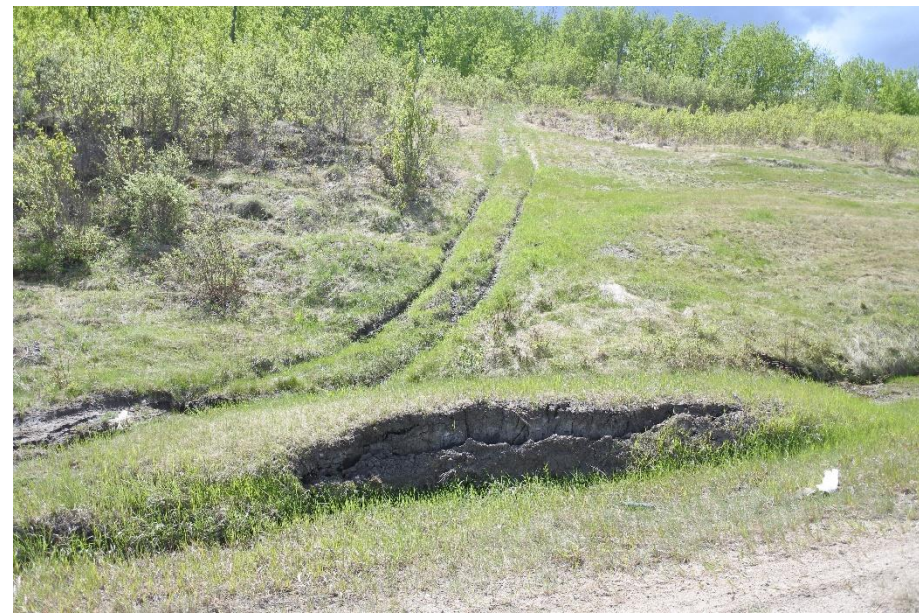
**Photo 12.**  
Looking south from the EBL ditch of Hwy 43:04 at Slide 4. Slide 4 is now about 115 m in width and extends 32 m from the crest of the slope to the level of the ditch south side bottom of the EBL. Slide 4 is now more active than the other 3 slides with a bulge and erosion at the toe.

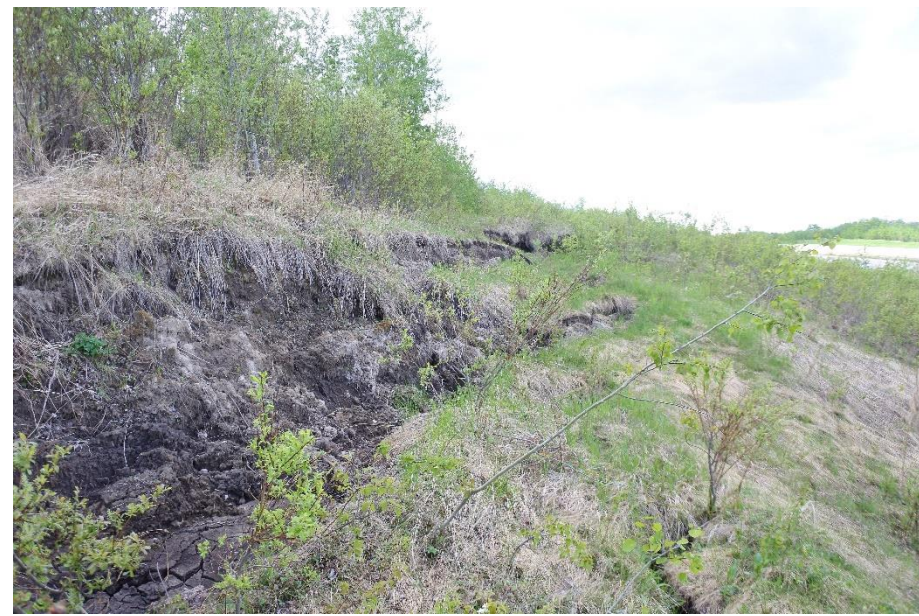
**Photo 13.**  
Looking west across the backscarp from the west side of Slide 4. The drop at the backscarp about 1 to 1.5 m in the west half of the slide.

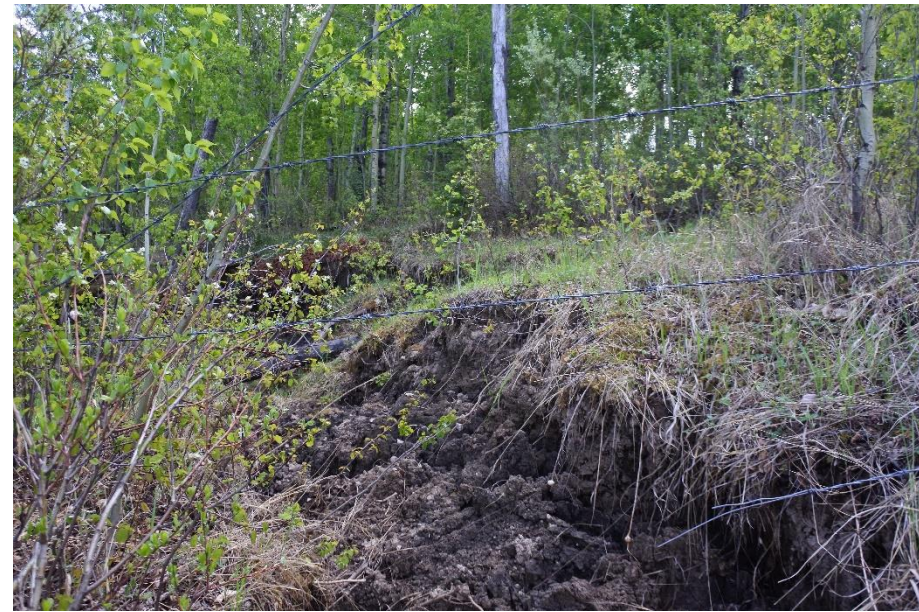
The slides are also progressing upslope and now are encroaching into privately owned land at the crest of the valley slope above the highway.

**Photo 14.**  
Looking southeast at Slide 4 backscarp extending beyond the fence 6-7 m.

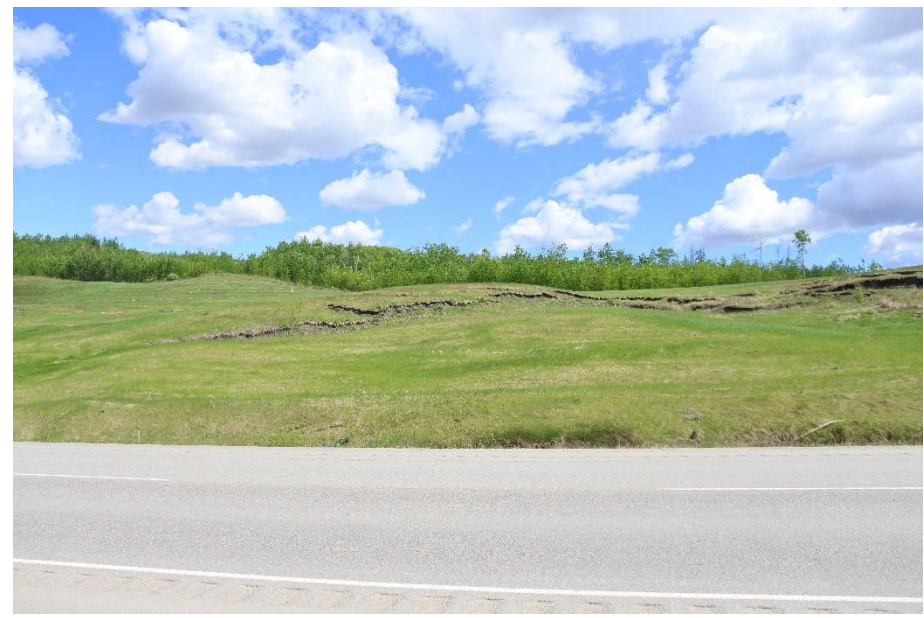
**Photo 15.**  
Looking south at east end of Slide 3 which was the least active in 2020.

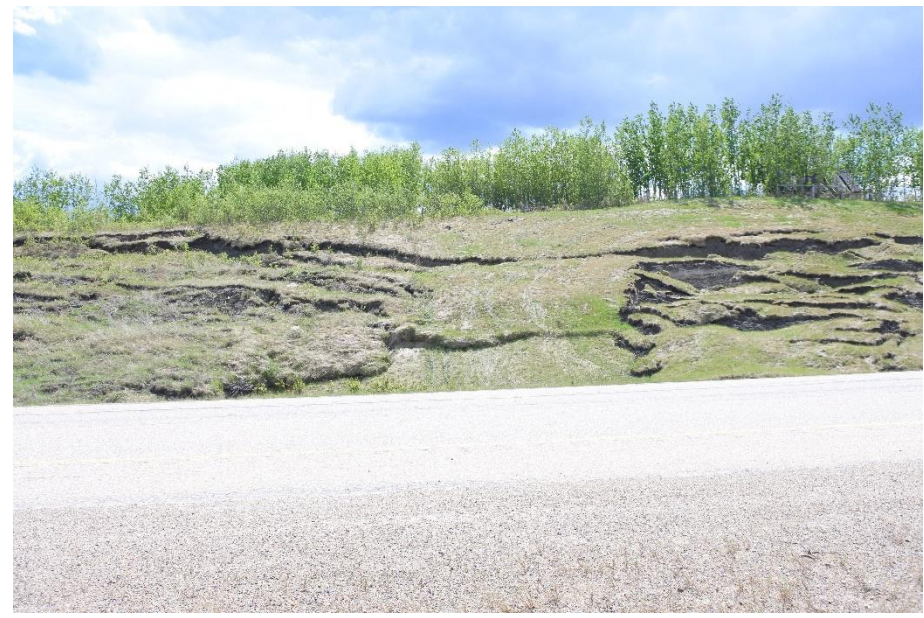
**Photo 16.**  
Looking south where Slide 2 now connects to Slide 3.
