PEACE REGION GRANDE PRAIRIE SOUTH GRMP SITE INSPECTION FORM

SITE NUMBER AND NAME:		HIGHWAY & KM:		PREVIOUS			INSPECTION DATE:	
GP046 Smoky River West Valley		43:04, 32.004		INSPECTION DATE:		≣:	July 19, 2021	
EBL Backslope Slumps		!		May 27, 2020			-	
LEGAL DESCRIPTION:	NAD 83 COORDINATES:			RISK ASSESSMENT:				
	UTM	Northing	Easting					
SW 16-72-02 W6M	11	6121397	417585	PF: 12	CF: 4	TC	OTAL: 48	
AVERAGE ANNUAL DAILY TRAFFIC (AADT):				CONTRACT MAINTENANCE AREA (CMA):				
5930 (west) & 6470 (east) (Reference No. 30720 & 70000114)				504

PRIMARY SITE ISSUE: Four shallow slump failures have appeared in the backslope cut above the EBL of Hwy 43:04 along the midpoint of the descent along the west valley slope of the Smoky River valley about 4.5 kilometers east of Bezanson, Alberta. Three of the slides are now connected (Slide 1 to 3).

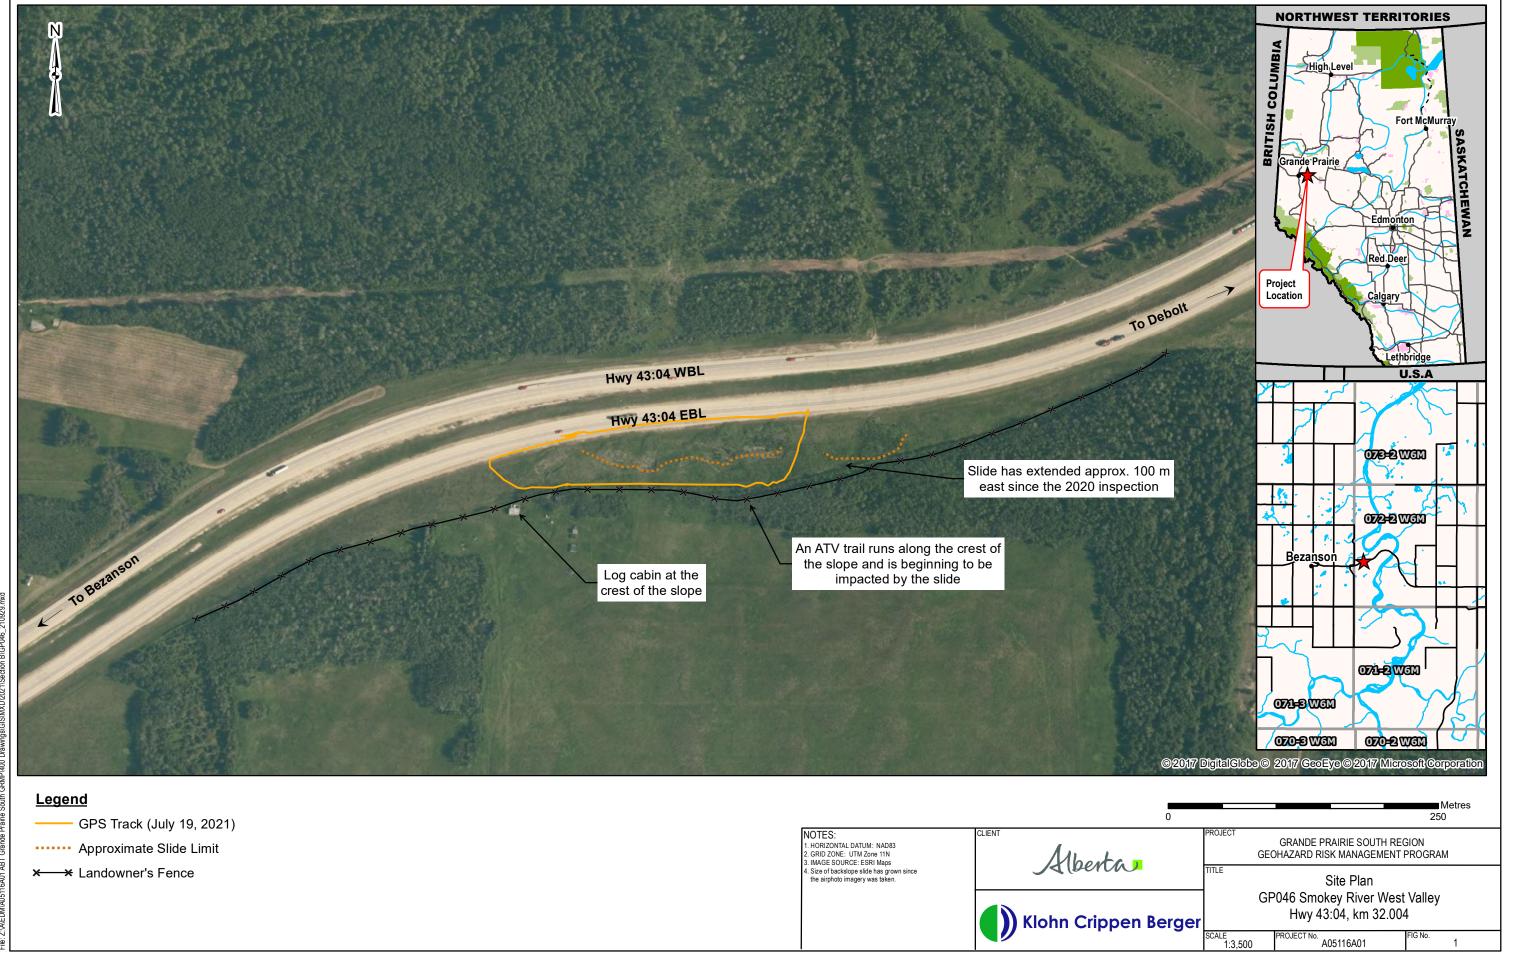
slides 1, 2, and 3 that have coalesced and enlarged. A quad trail is located to the east of the old zone of instability. The GPS track shown in Figure 1 shows the extent of Slides 1 to 3.

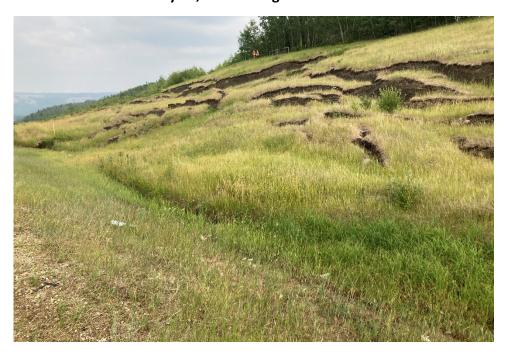
Photo 1 The slides on the south (eastbound) side of Hwy 43 have worsened since the 2020 inspection and have combined into one slide approximately 300 m in length. Photo taken July 19, 2021 facing southeast.

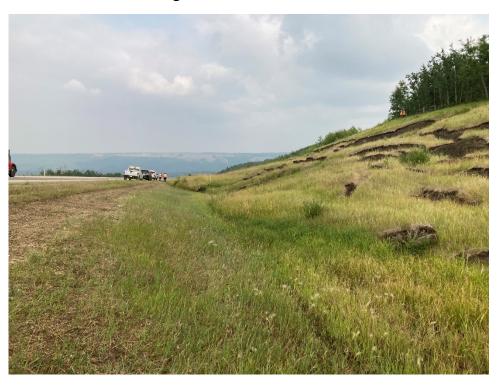
- Area of backslope instability has expended about 100 m to the east. Toe roll of slide is partially blocking
 ditch near west/north extent of the site. Approximately 1.2 m of freeboard between edge of pavement and
 top of toe roll. Toe roll will not result in surface water runoff flowing onto the highway, but continued
 movement will result in a blocked ditch.
- AT says that the site used to be four separate areas of instability that now have coalesced and enlarged.
 The GPS track shown on the accompanying figure was created by walking around the extents of original

Photo 2 The toe of the slide is blocking the south (eastbound) ditch. Photo taken July 19, 2021 facing east.

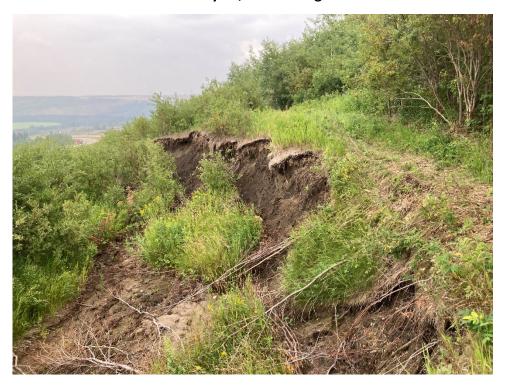
Photo 3 Backscarp of the original slide is impacting an ATV trail at the crest of the slope. Photo taken July 19, 2021 facing east.

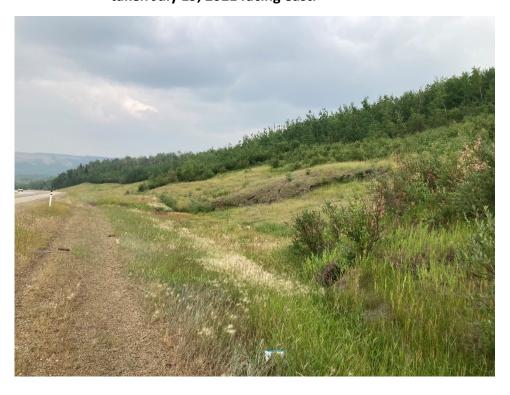
Slide 4 (approximately 20 m further to the east) has increased in size and is about 115 m wide, extends 40 m up the backslope with a distinct toe roll in the ditch. The backscarp varies from 1.0 m to 2.0 m high

Photo 4 A new slide approximately 100 m long, on the east side of the original slides. Photo taken July 19, 2021 facing east.
