**SITE INSPECTION FORM**

<b>SITE NUMBER AND NAME:</b> GP046 Smoky River West Valley EBL Backslope Slumps		<b>HIGHWAY &amp; KM:</b> 43:04, 32.004	<b>PREVIOUS INSPECTION DATE:</b> June 13, 2023	<b>INSPECTION DATE:</b> <b>June 3, 2025</b>
<b>LEGAL DESCRIPTION:</b> SE 18-72-02 W6M	<b>NAD 83 COORDINATES:</b> UTM Northing Easting 11 6121397 417585		<b>RISK ASSESSMENT:</b> PF: 12 CF: 4 TOTAL: 48	
<b>AVERAGE ANNUAL DAILY TRAFFIC (AADT):</b> 8,120 (east) & 8,320 (west) (Reference No. 70001011, 2024)			<b>CONTRACT MAINTENANCE AREA (CMA):</b> 504

PEACE REGION (GRANDE PRAIRIE DISTRICT-SOUTH)  
GEOHAZARD RISK MANAGEMENT PROGRAM

Site Plan  
GP046 - Smoky River W. Valley EBL Backslope Slumps  
Hwy 43:04, km 32.004

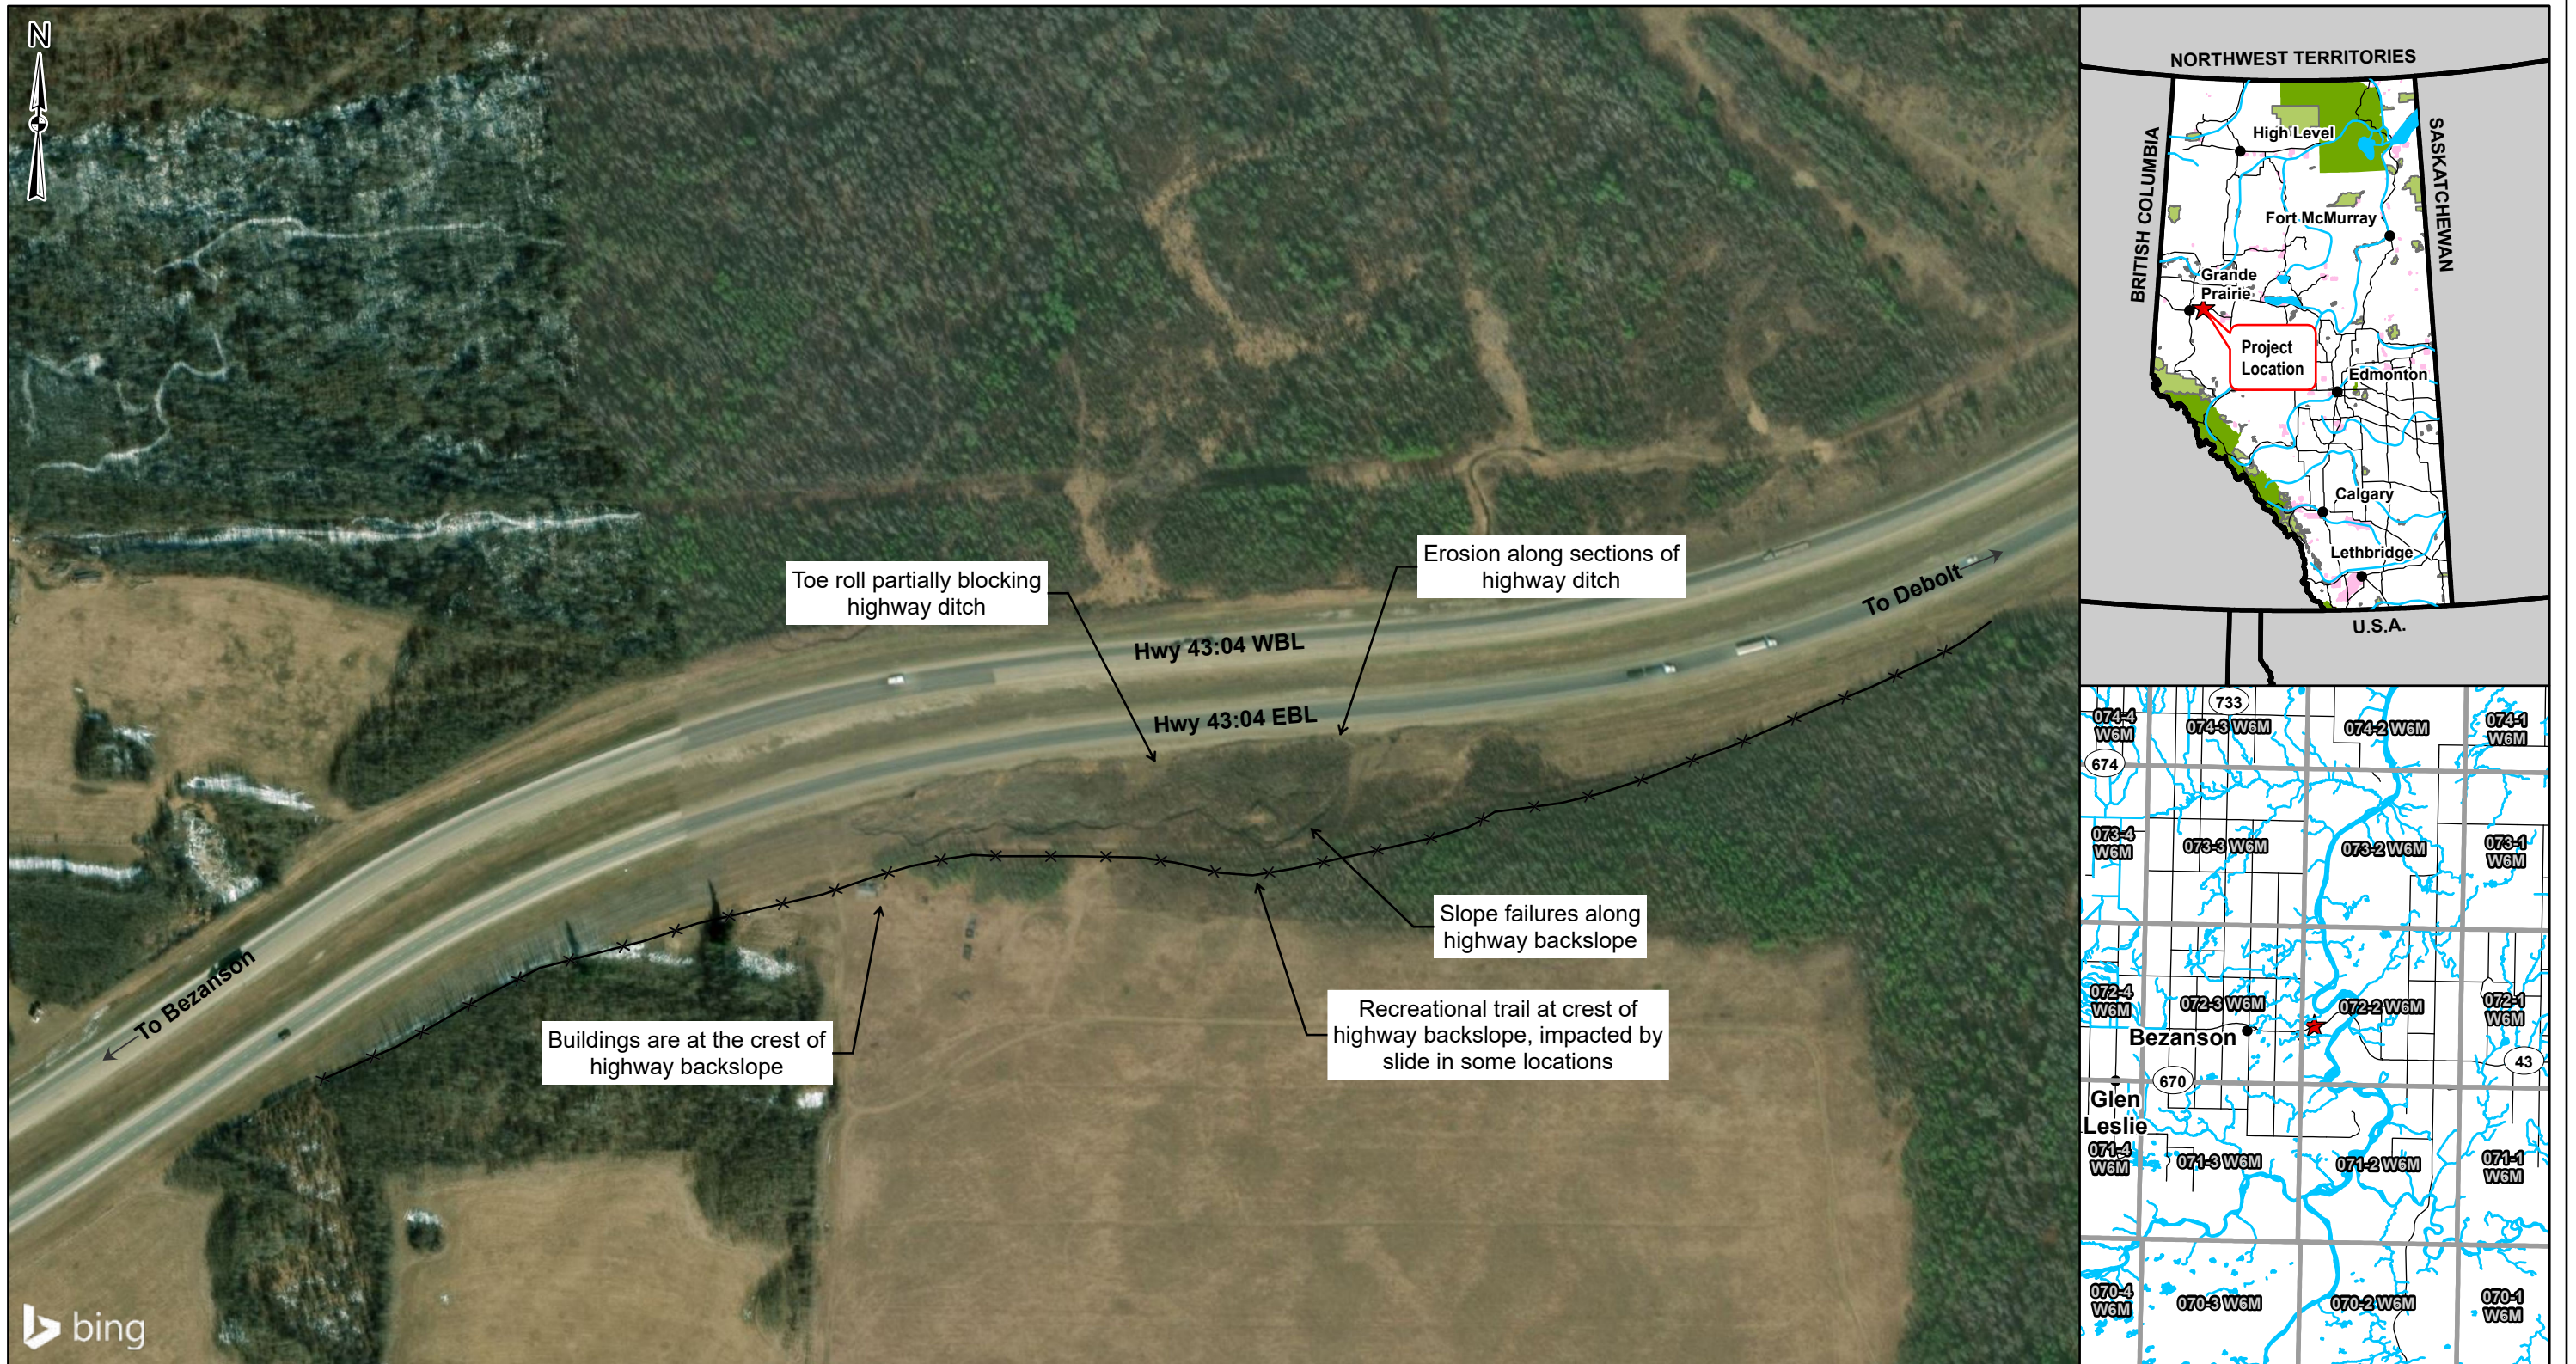
FIG No.  
1

NOTES:  
1. HORIZONTAL DATUM: NAD83  
2. GRID ZONE: UTM ZONE 11N  
3. IMAGE SOURCE: MICROSOFT CORPORATION  
2025 MAXAR CNES, DISTRIBUTION AIRBUS DS  
4. SIZE OF BACKSLOPE SLIDE HAS GROWN SINCE  
AIRPHOTO IMAGERY WAS TAKEN.

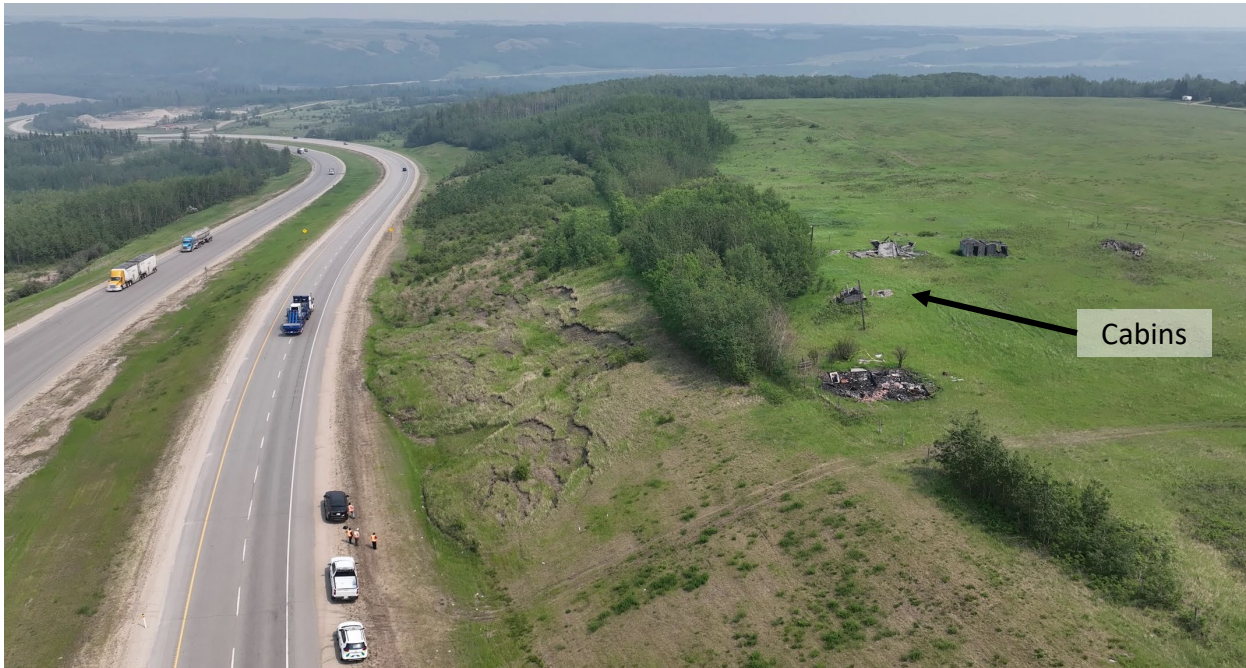
<b>COMMENTS</b>
TEC previously mentioned that it was four of five separate slope instabilities initially, which have expanded and coalesced over the years.
Several well-defined scarps are visible on the backslope from the midpoint to the western site limit indicating the western portion (Photo 1) of the slope instability is more active than the eastern portion (Photo 2) where the ground is more rounded and gentler. At the western site limit where slope instability appears most active, the backscarp appears to be up to approximately 2.5 m high and near vertical.
Backscarp generally within highway right-of-way (ROW) but will eventually encroach onto public property if the slope instability continues to retrogress further upslope. At the crest of the backslope there is: <ul style="list-style-type: none"> <li>some old log cabins which are not currently being impacted by the slope instability but the cabins appear to have historical value (Photos 1 and 9); and</li> <li>a recreational trail which is beginning to be impacted by the slope instability (Photo 10).</li> </ul>

Backslope well vegetated with dense grass and small shrubs, particularly from the midpoint to the eastern site limit (Photos 1 and 2).

**Photo 1** Overview of GP046 site on Hwy 43:04. Note cabins at crest of slope. UAV photo taken June 3, 2025, facing east.

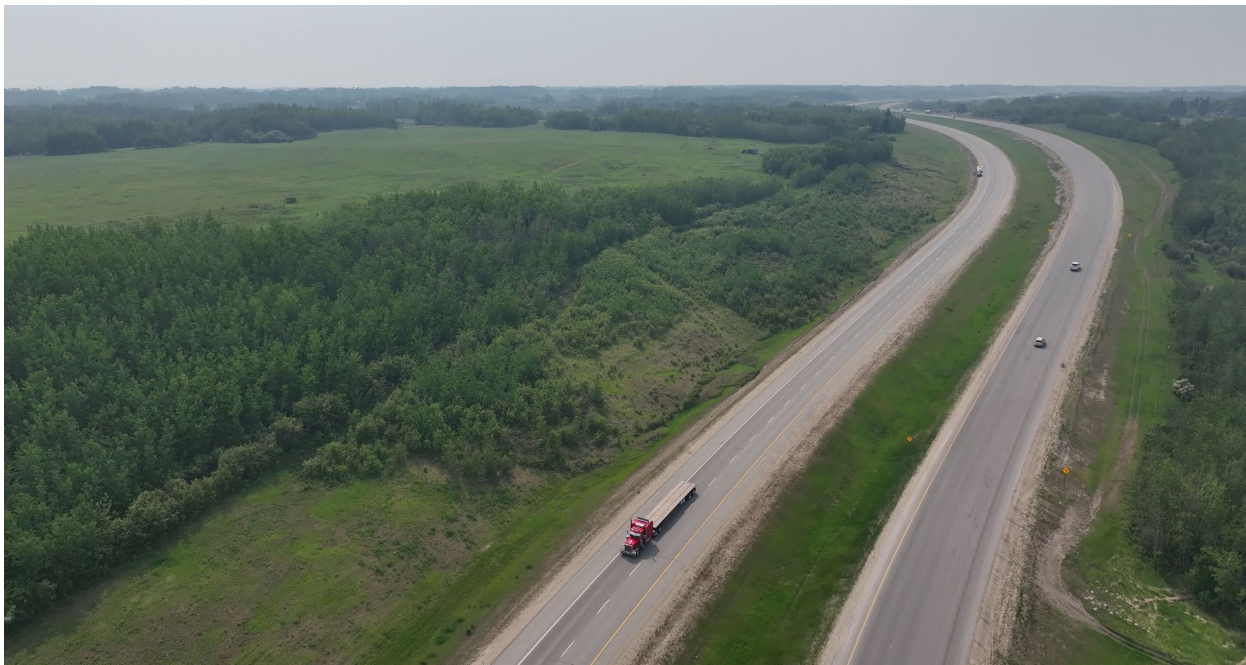
the highway embankment (up to approximately 10 mm to 15 mm deep), particularly near the middle of the site (Photos 2, 5, and 8). Ponded water is also being trapped behind some of the toe rolls (Photo 7) The erosion has worsened since the 2023 inspection.

**Photo 2** Overview of GP046 site on Hwy 43:04. UAV photo taken June 3, 2025, facing west.

- Short-term: Clean out south highway ditch with as little failure material being removed as possible to re-establish ditch flow capacity. If too much material is removed it could exacerbate slope movements. Ditch will likely fill in again and will need ongoing maintenance to maintain ditch flow capacity.
- Long-term: Repair design prepared and tender partially prepared by previous consultant for flattening the backslope to an approximate slope angle of 5H:1V. TEC working to procure land. Work may be included as part of an upcoming overlay project pending land acquisition.

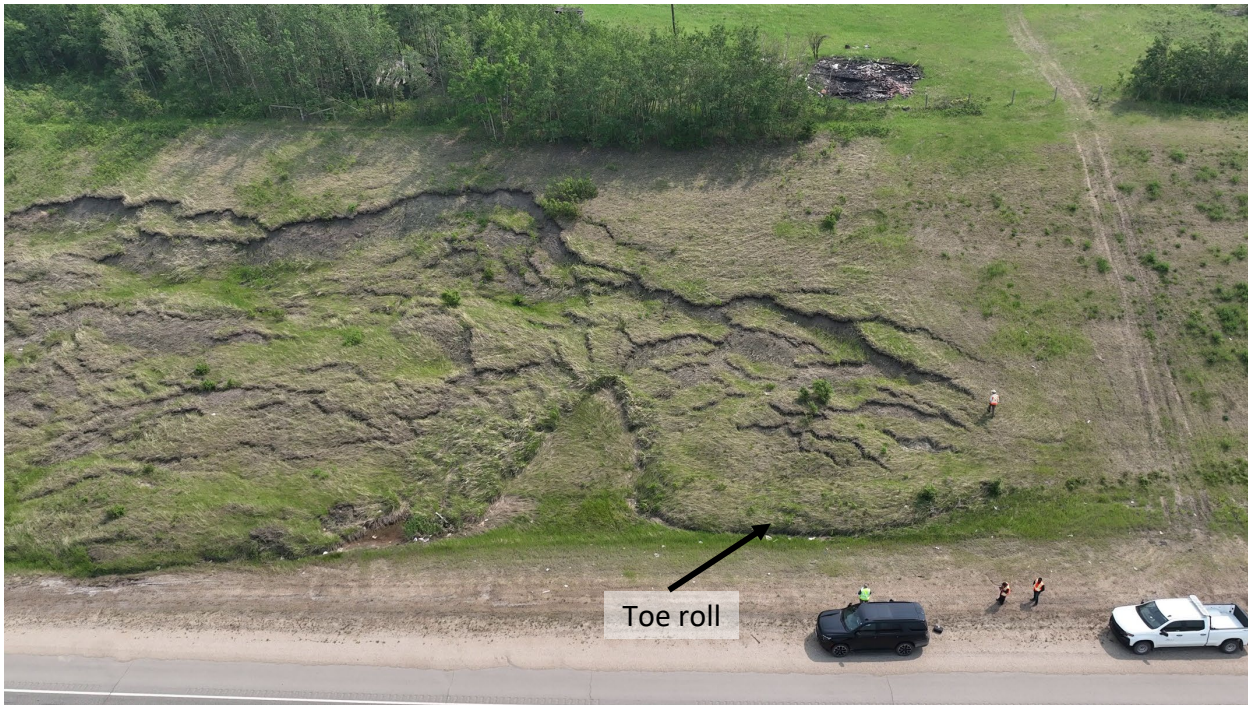
Backslope slope failures are not currently affecting the pavement surface of the highway, but the toe rolls are progressing towards edge of pavement and are partially blocking the south highway ditch (Photos 3 through 7). Some toe rolls are within 2 m to 3 m from edge of pavement. Water flowing around the toe rolls have eroded into

**Photo 3** Slope failures along backslope on south side of Hwy 43:04. Note toe rolls in highway ditch. UAV photo taken June 3, 2025, facing south.

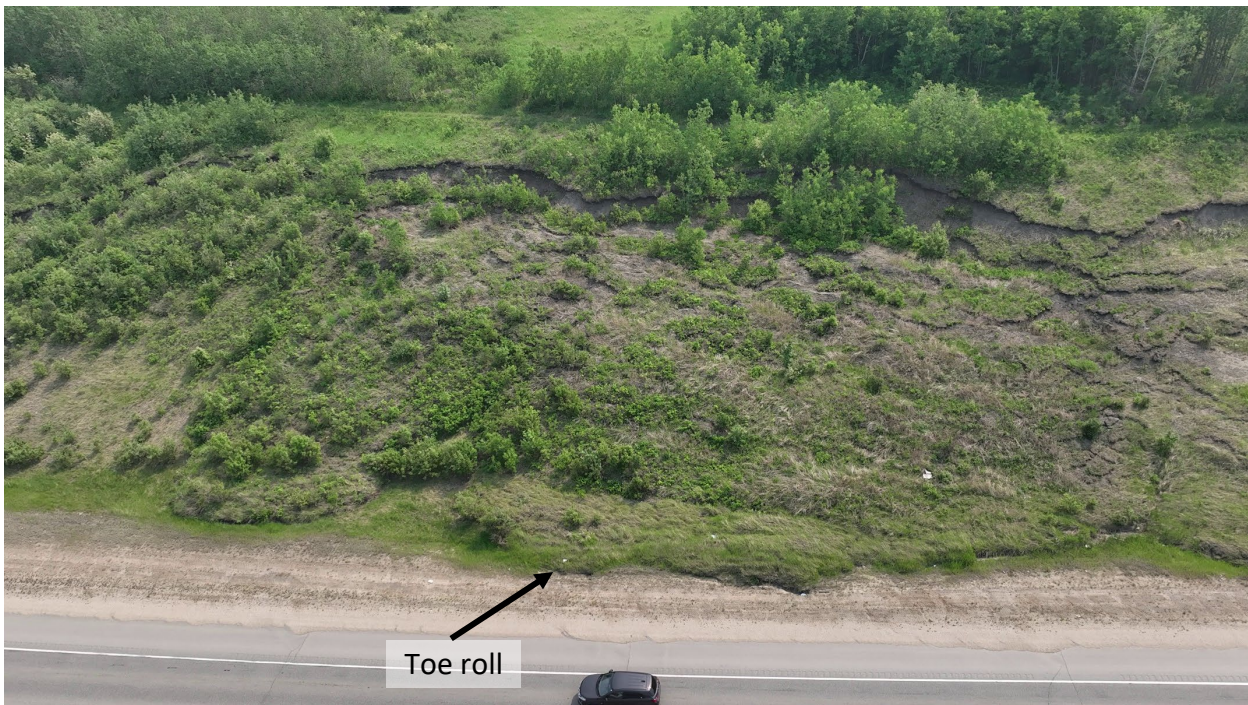
**Photo 4** Slope failures along backslope on south side of Hwy 43:04. Note toe rolls in highway ditch. UAV photo taken June 3, 2025, facing south.

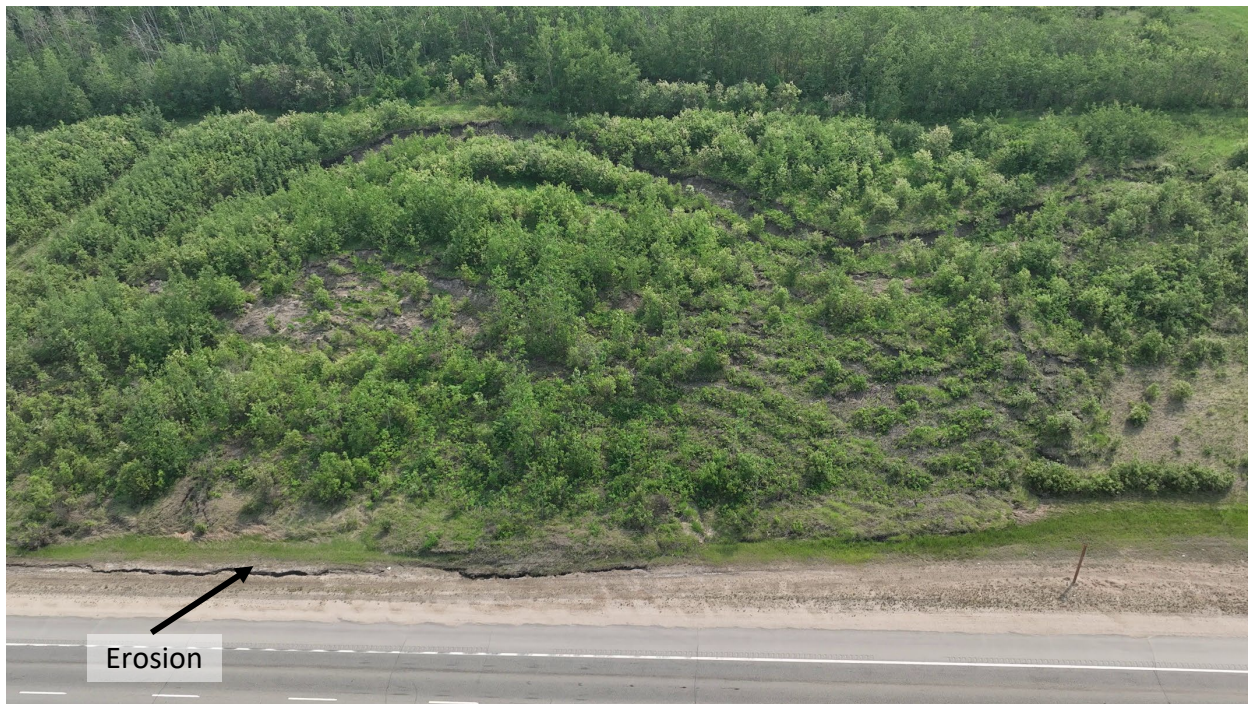
**Photo 5** Slope failures along backslope on south side of Hwy 43:04. Note toe rolls and erosion in highway ditch. UAV photo taken June 3, 2025, facing south.

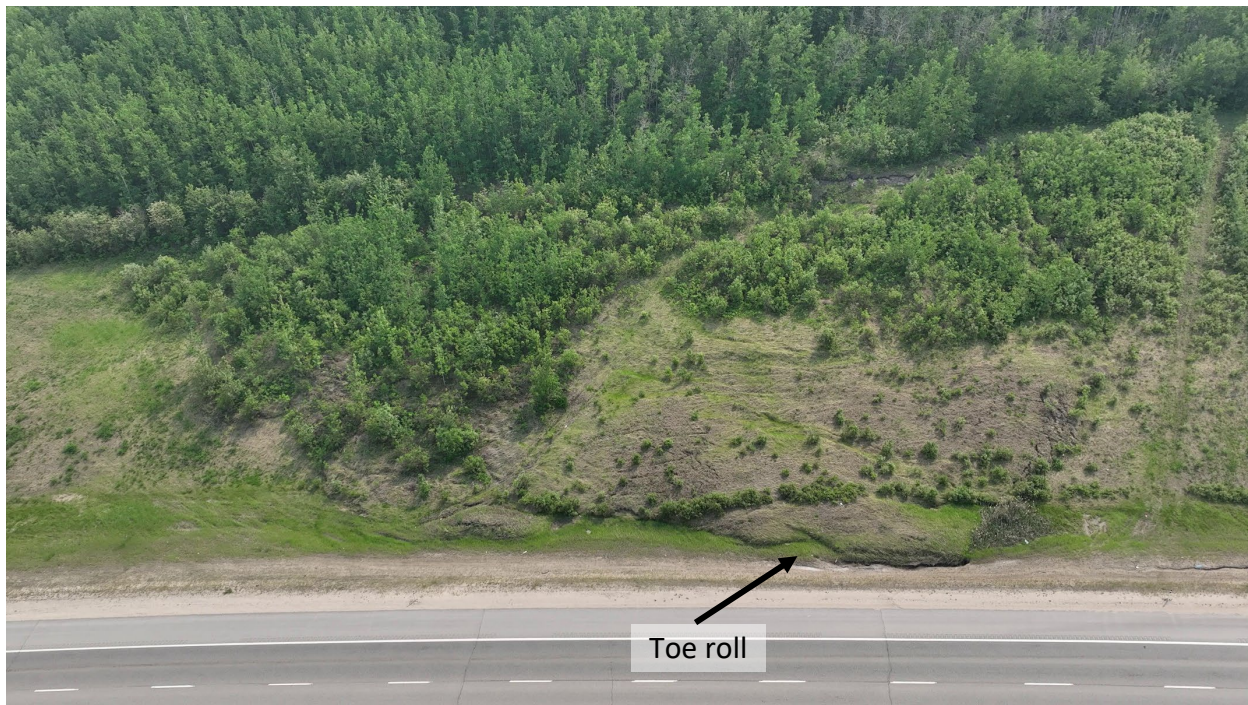
**Photo 6** Slope failures along backslope on south side of Hwy 43:04. Note toe rolls in highway ditch. UAV photo taken June 3, 2025, facing south.

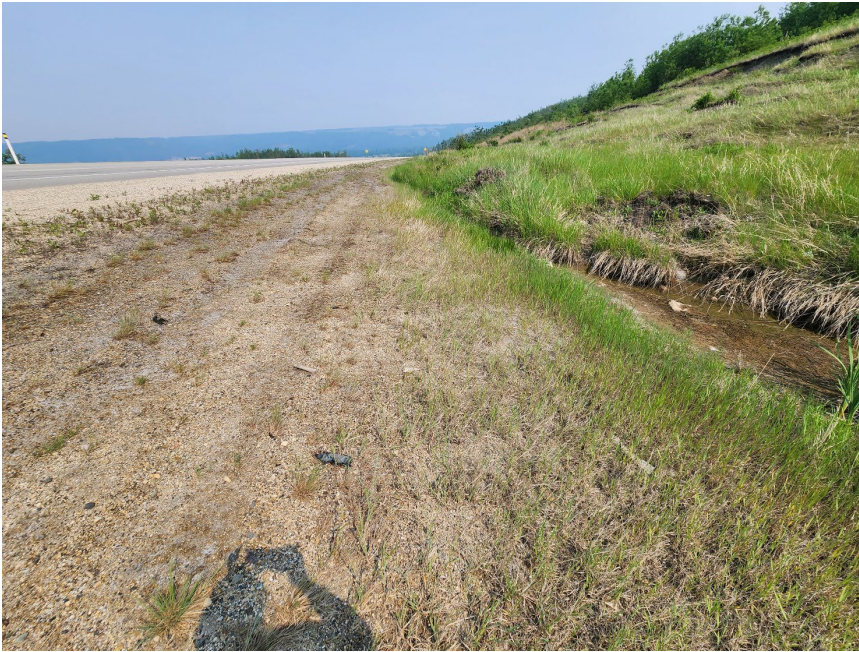
**Photo 7** Toe roll in ditch at toe of backslope on south side of Hwy 43:04. Note ponded water trapped in highway ditch by toe roll. Photo taken June 3, 2025, facing east.

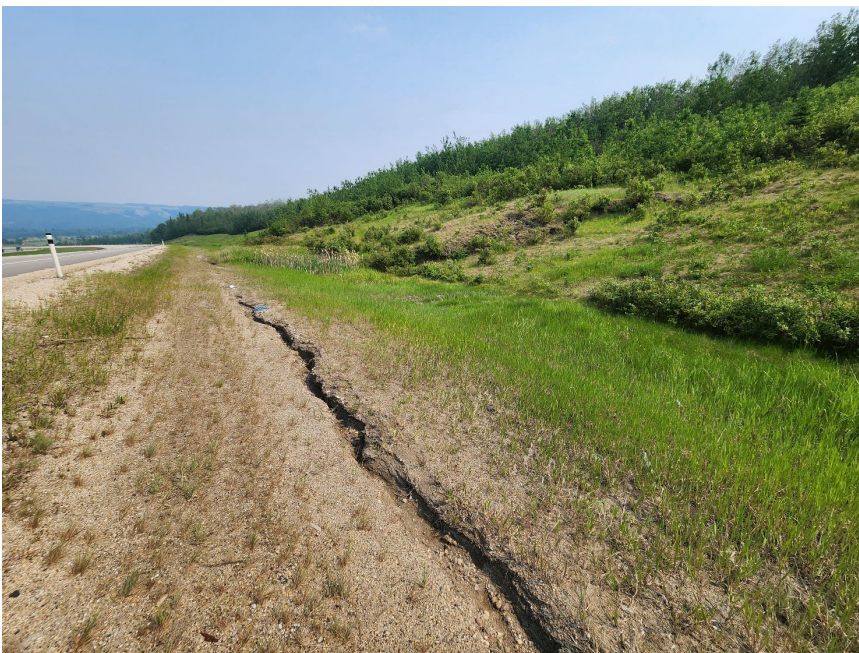
**Photo 8** Erosion in ditch at toe of backslope on south side of Hwy 43:04. Photo taken June 3, 2025, facing east.

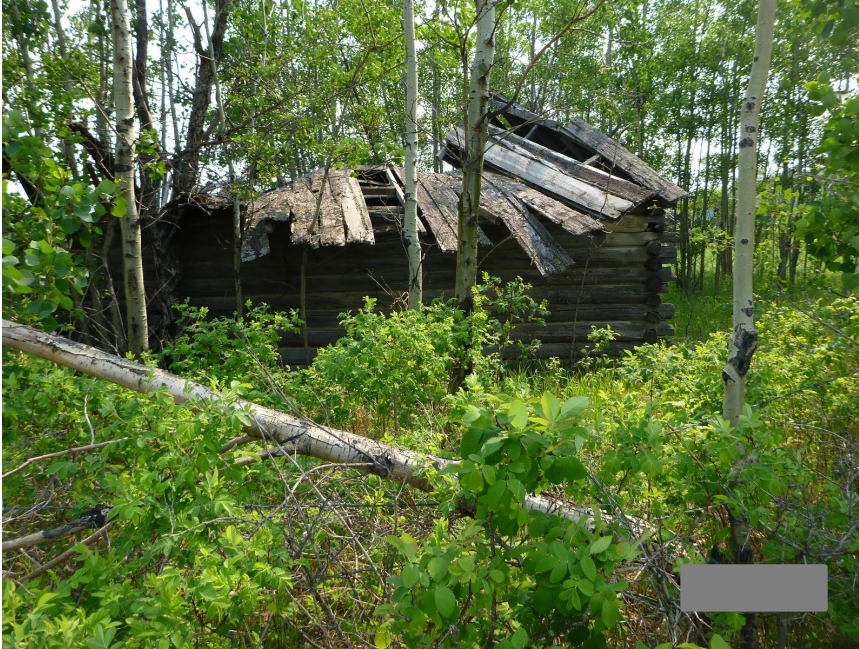
**Photo 9** Cabin at crest Hwy 43:04 backslope. Photo taken June 3, 2025, facing south.

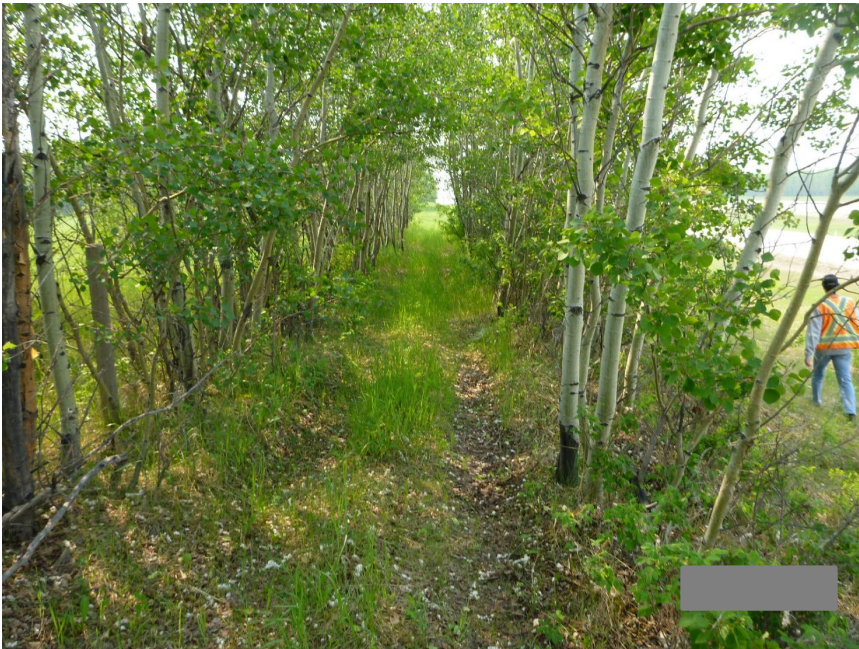
**Photo 10** Recreational trail at crest Hwy 43:04 backslope. Photo taken June 3, 2025, facing south.
