January 17, 2006

EBA File No. 7100131.034

Subject **Hwy 43:06/08 Junction SH 736 at Debolt
Erosion Distress along Headslope Ditches
At Bridge Culvert (BF 74554) Inlet - Call-out Inspection**

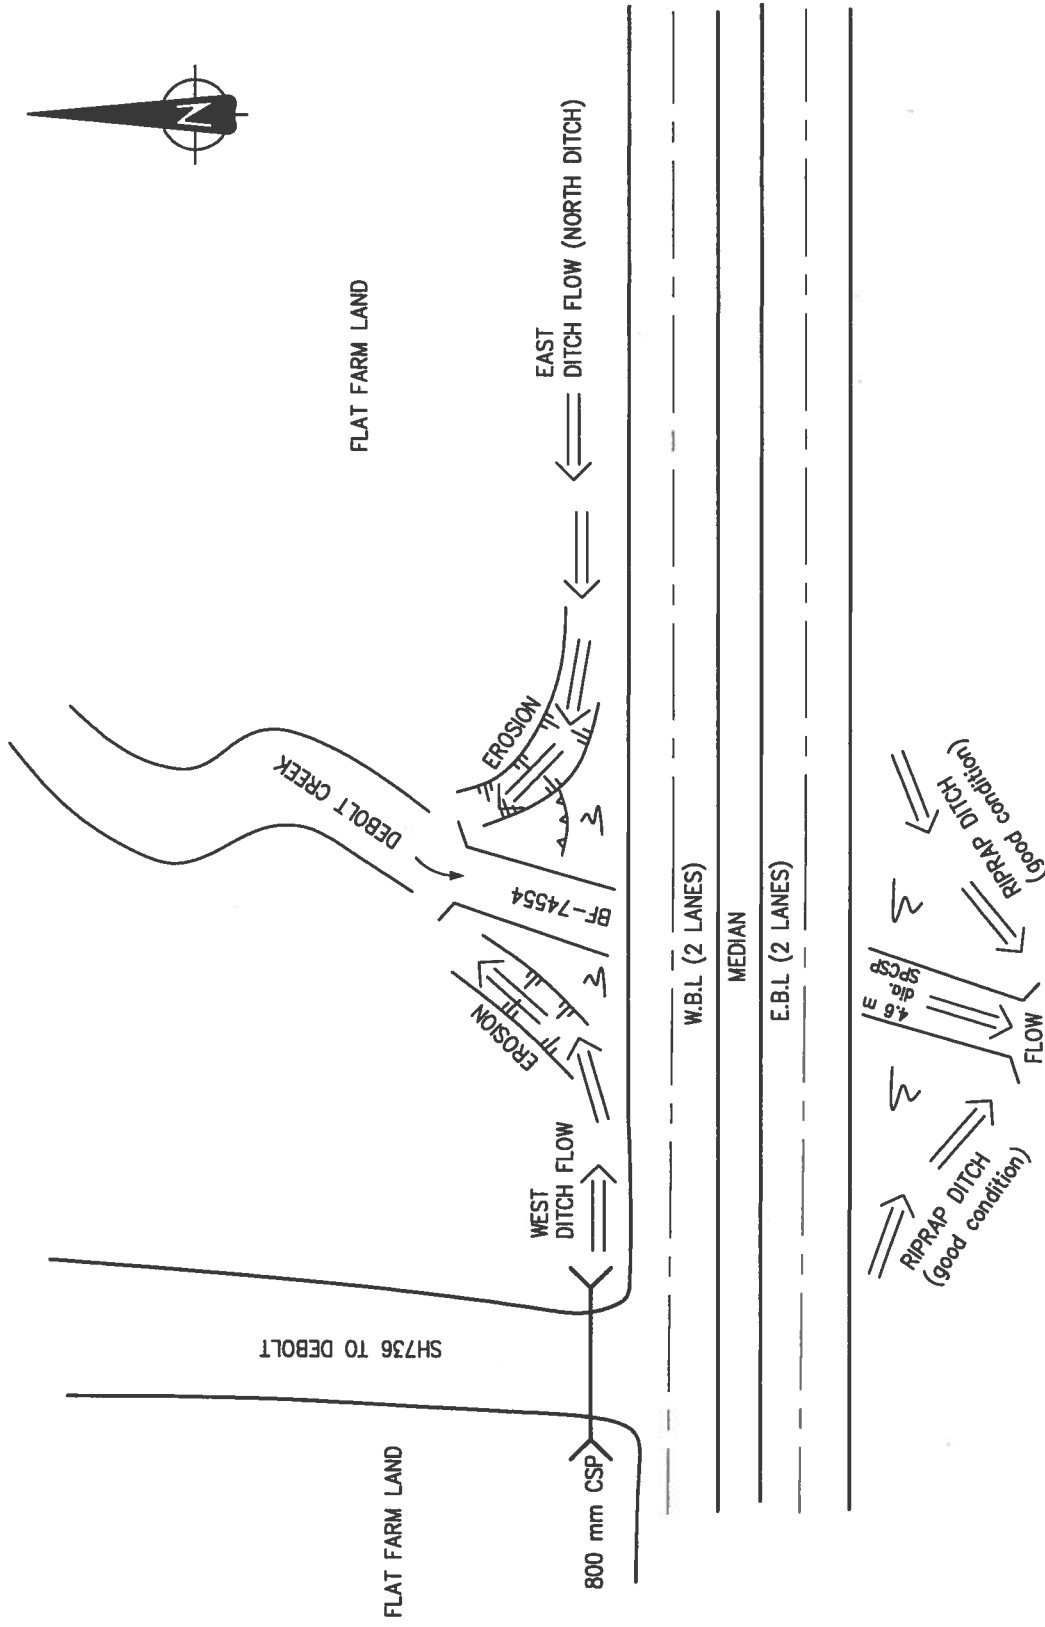
Figure 1
Site Plan

As shown in Figure 1 and the attached photos, the ditch erosion occurred along the highway ditches flowing down the upstream sideslope (north side) at the bridge culvert inlet. The ditch flows are from both the east and west directions along the north ditch of the westbound lanes of this twinned highway.

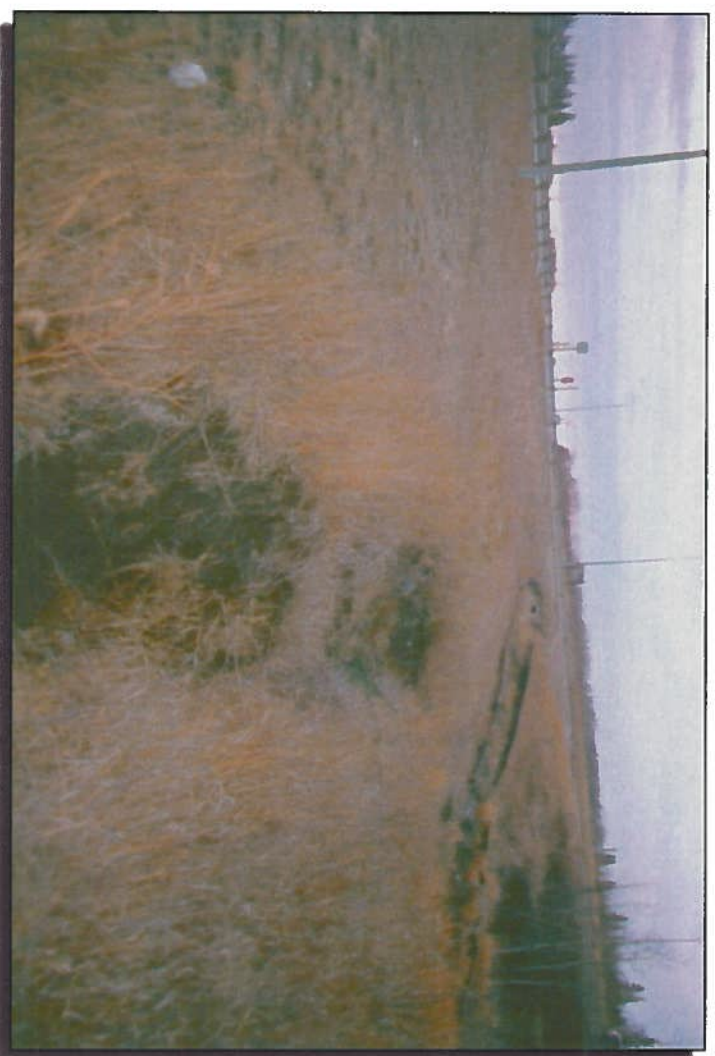
Photo 1

- Looking west at junction SH 736
- Bridge culvert (BF 74554) inlet and Debolt Creek coulee (top right of photo).
- Erosion of highway ditch retrogressed from culvert headslope (u/s) ditch outfall to flat highway ditch at top and east of bridge culvert (centre bottom of photo).
- West side of bridge culvert, west ditch collects from centreline culvert below SH 736 (top centre of photo).

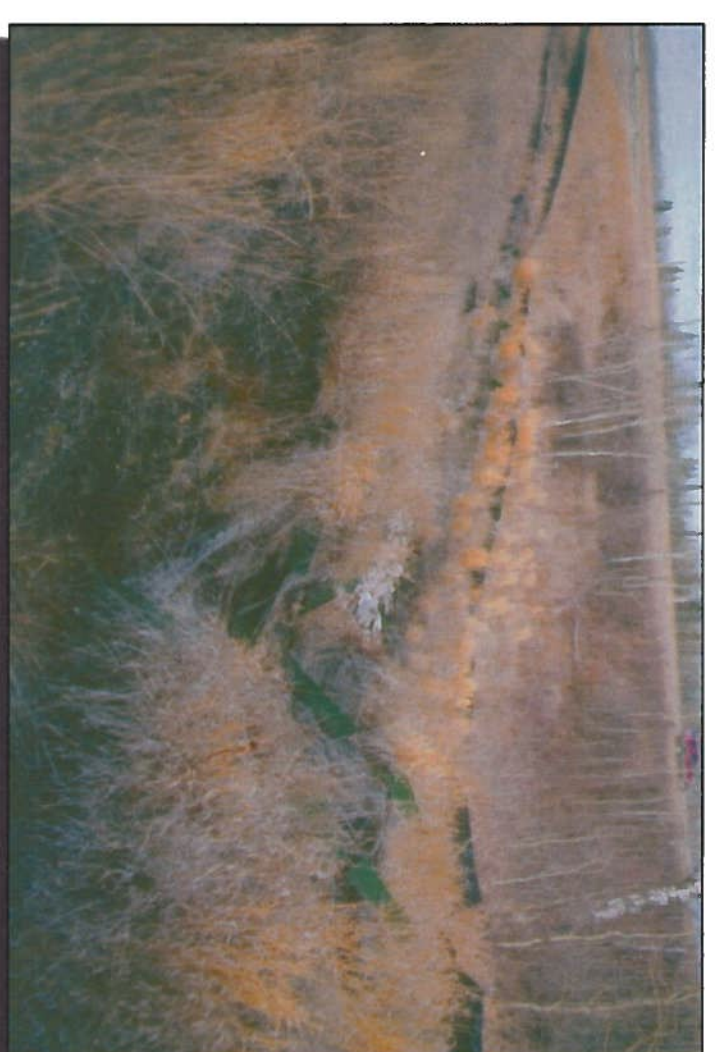
Photo 2

- Looking west at u/s inlet of bridge culvert and Debolt Creek coulee.
- Erosion of headslope ditch (close up).

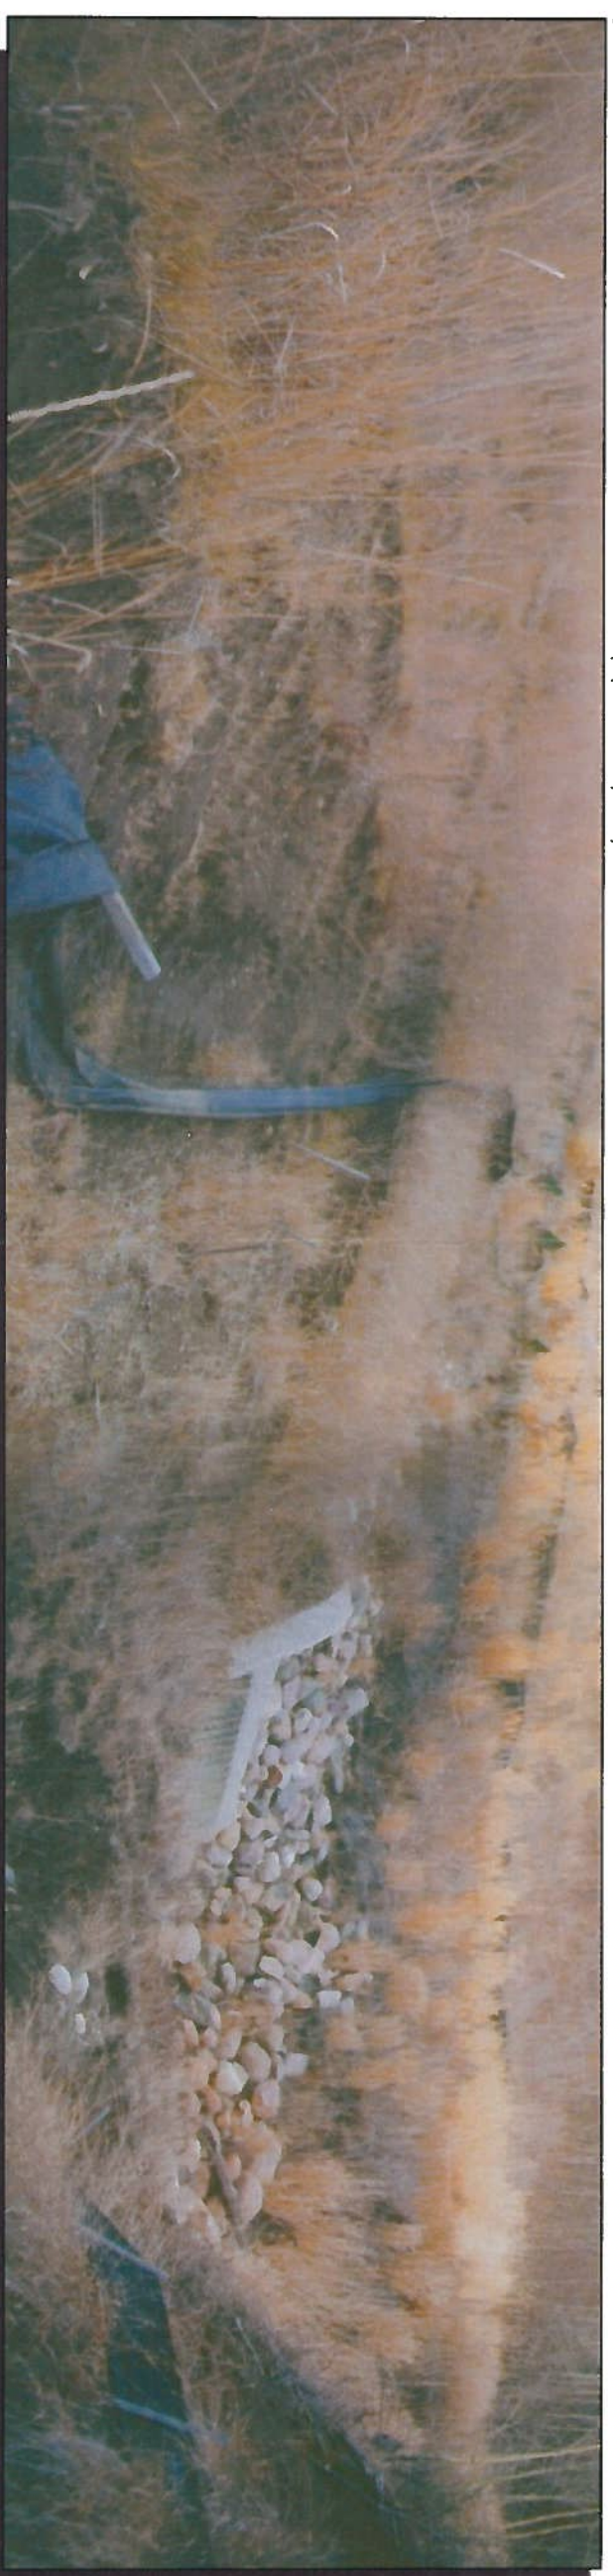
Photo 3

- Looking west at culvert inlet and headslope.
- Close up of erosion and shallow sloughing of headslope.
- East ditch down headslope (bottom of photo).
- West ditch down headslope (top of photo along siltation fences).

- The shallow sloughing of the embankment sideslope can be repaired with regrading, topsoiling, reseeding and installation of erosion protection matting after implementation of either of above options.
- The portion of ditch on the flatter grade should be regraded, topsoiled, seeded, covered with erosion blankets and the permeable ditch barriers reinstalled.

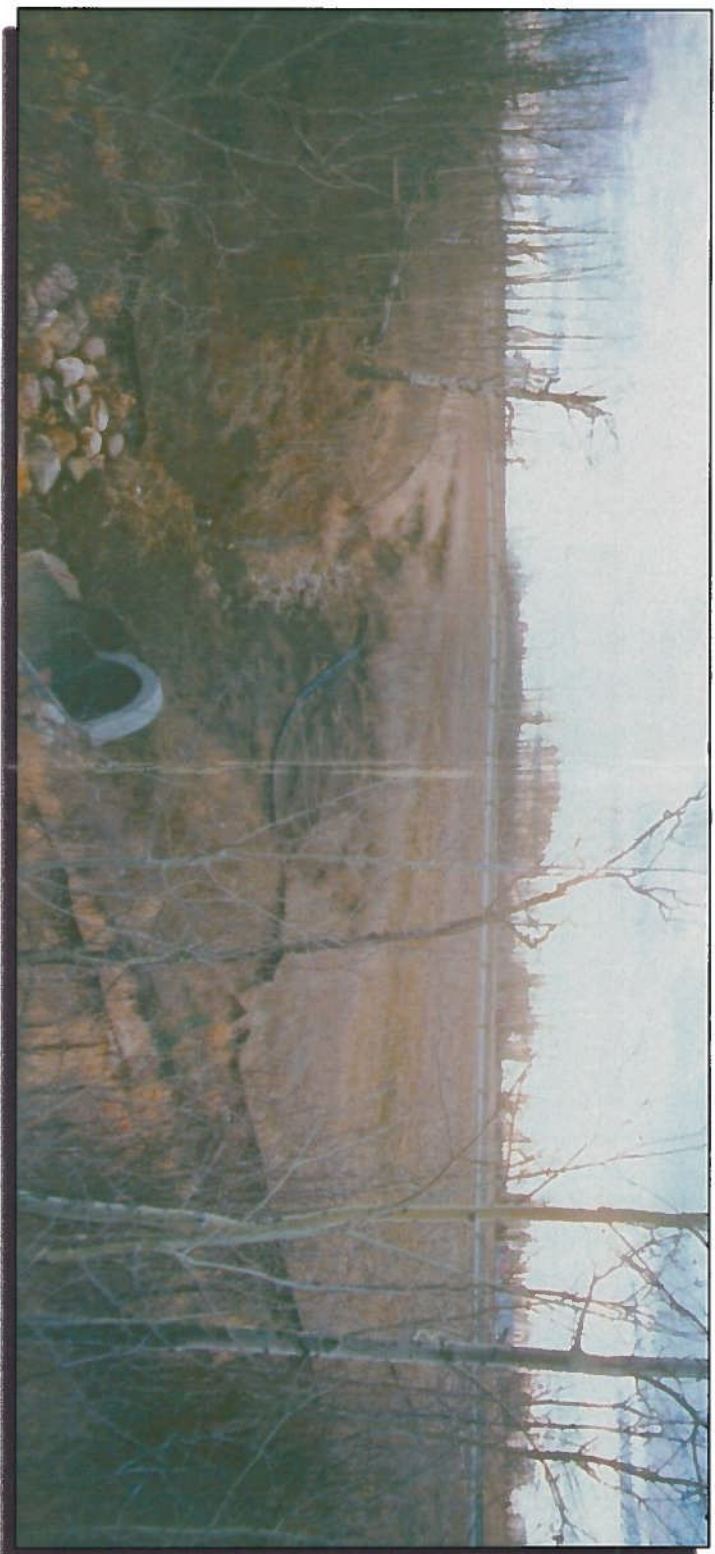
- The erosion originated from a steep ditch section (about 40 to 50 m length) where the ditch discharges into the creek. The erosion scour has retrogressed upslope resulting in erosion along a ditch section (about 50 m length) along the flat grade portion of the highway.
- A steep erosion scarp of about 0.5 to 1 m high is evident along the affected area.
- Previous ditch protection included random riprap lining along the steep section and permeable weave ditch barriers along flat portion of the ditch. The previous erosion protection measures have failed.
- The ditch erosion along the steep section has caused some shallow sloughing of the embankment sideslope east of the culvert.
- Erosion along this east ditch is more severe than the west ditch as noted in Section 2.1.2 below.

Substantial ditch flow is likely generated from a large catchment area causing the current erosion distress of the east ditch at the outflow zone towards the creek. In addition, the records indicate that previous erosion distress prior to the 2001 twinning was noted in the bridge construction records.

From site observation, the undermining of previous riprap ditch lining indicates substantial flow down this ditch.

Photo 4
Looking east at east ditch down u/s headslope.
-Erosion of outfall ditch.

- Downdrain culvert to pipe the ditch flow into Debolt Creek. The size of the culvert should be compatible to ditch flow based on a hydrotechnical assessment.
- Drop structures and hard armour lining to channel the surface flow down the coulee and headslope. This option will require “quality” regrading and reconstruction of the eroded channel to provide a trapezoidal or box channel section. Gabion lining and drop structure may be preferable construction.

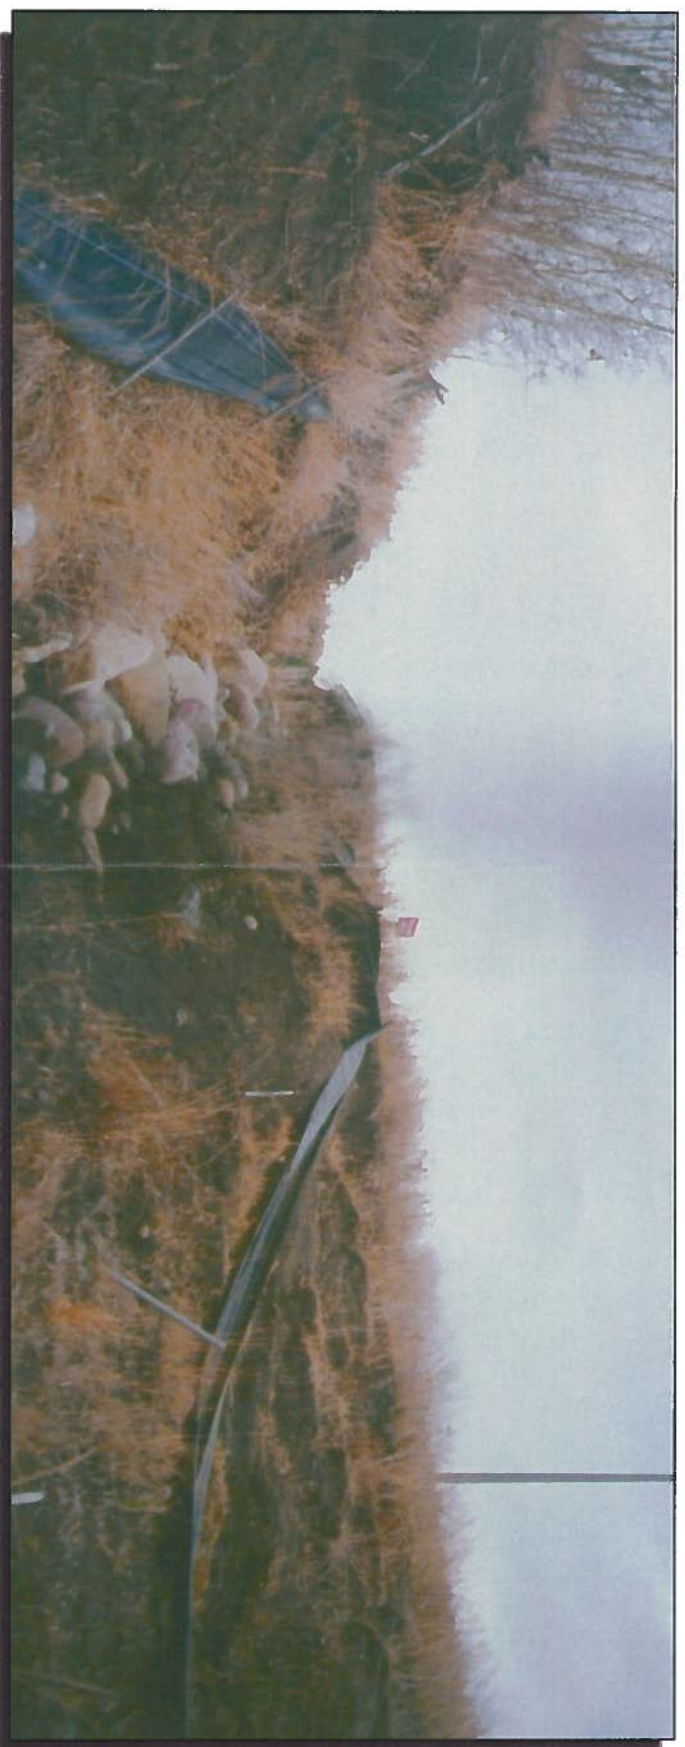
Photo 5
Looking east at east ditch outfall.
-Top portion of outfall ditch (closeup).

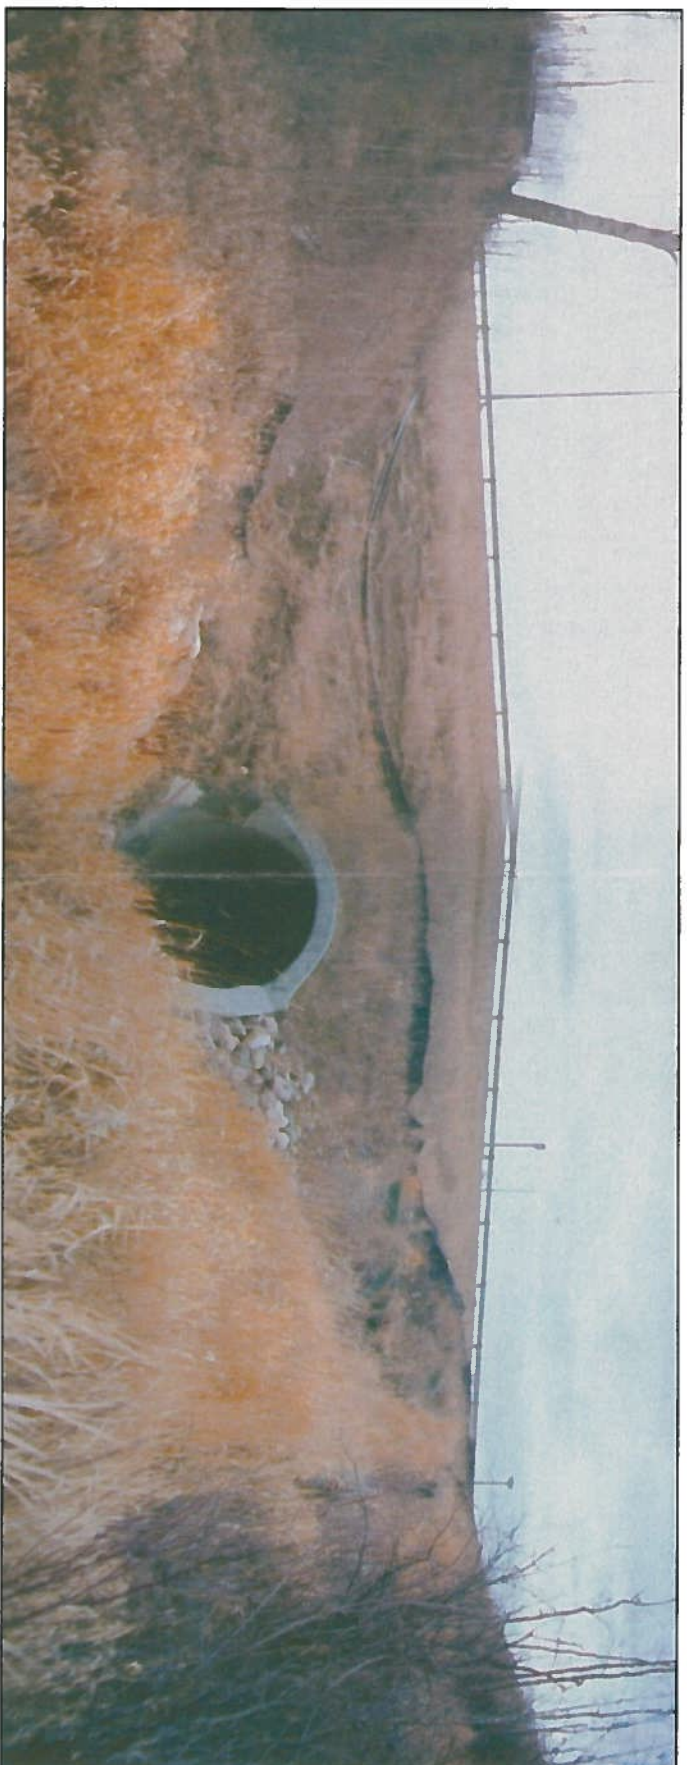
Photo 6
Looking south at inlet and headslope.
-East ditch outfall (on left) with headslope sloughing.
-West ditch outfall (on right).

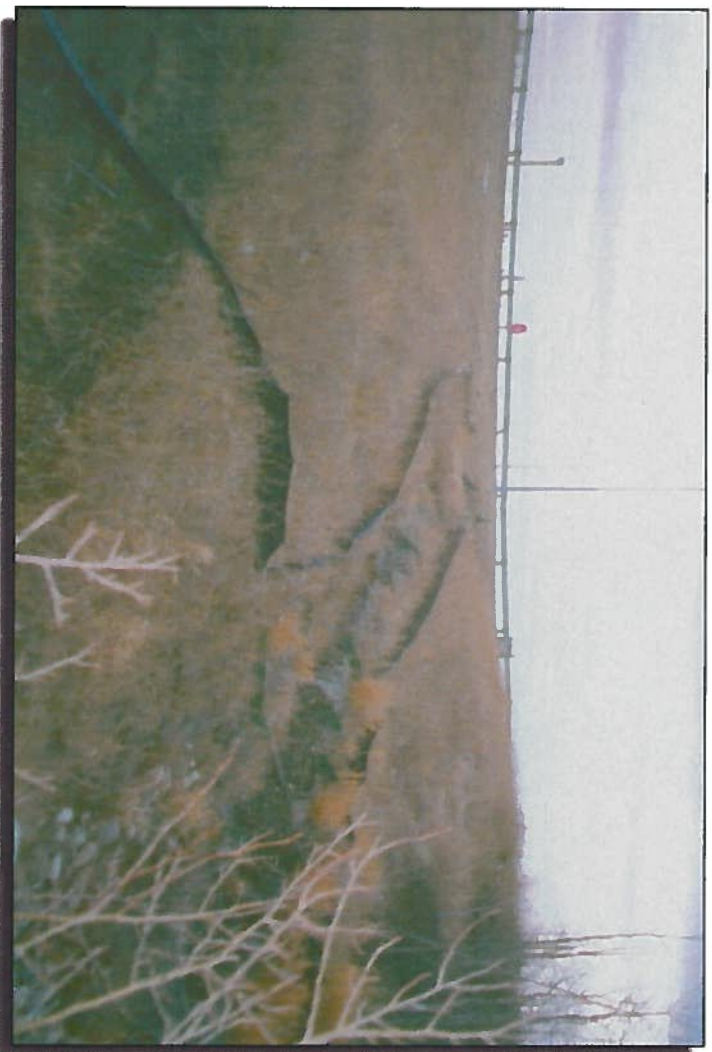
- the erosion is located along a steep ditch section (about 40 to 50 m length) at the discharge to the creek.
- the ditch flow is mainly contributed from outflow from the surface runoff drainage collected from a 0.5 km section of ditch to the west.
- a steep erosion scarp about 0.5 to 1 m high is visible along the affected ditch area.
- previous ditch protection included a combination of random riprap lining and permeable weave ditch barrier. The previous protection installations failed.
- the erosion noted on the west ditch is less than the erosion observed in the east ditch discussed above.

Photo 7
Looking south up headslope at west ditch.
-Outfall and erosion of ditch down headslope.

Possible remediation design options are the same as discussed for the east ditch. The drop structure and hard armour lining option will require “quality” regrading construction of the eroded channel subgrade to a trapezoidal or box channel section. Gabion lining, combined with a drop structure are the preferred design.

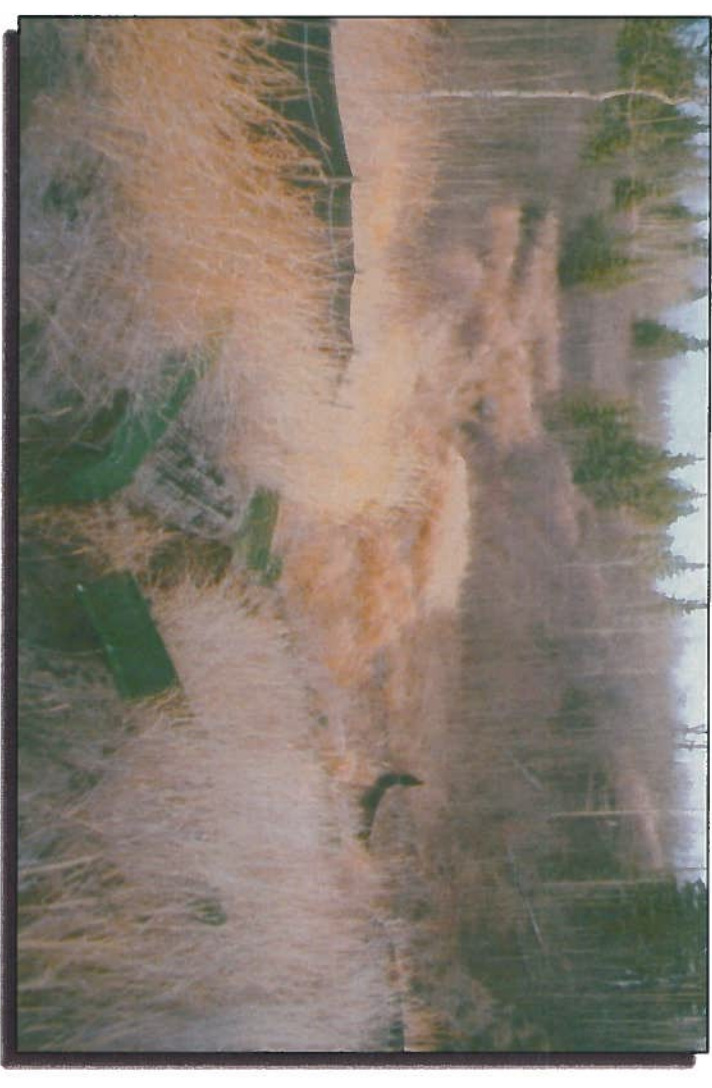
Photo 8
Looking north at Debolt Creek coulee.
-Close up of erosion of west ditch down headslope.
-Creek flow from north to south (towards photo).

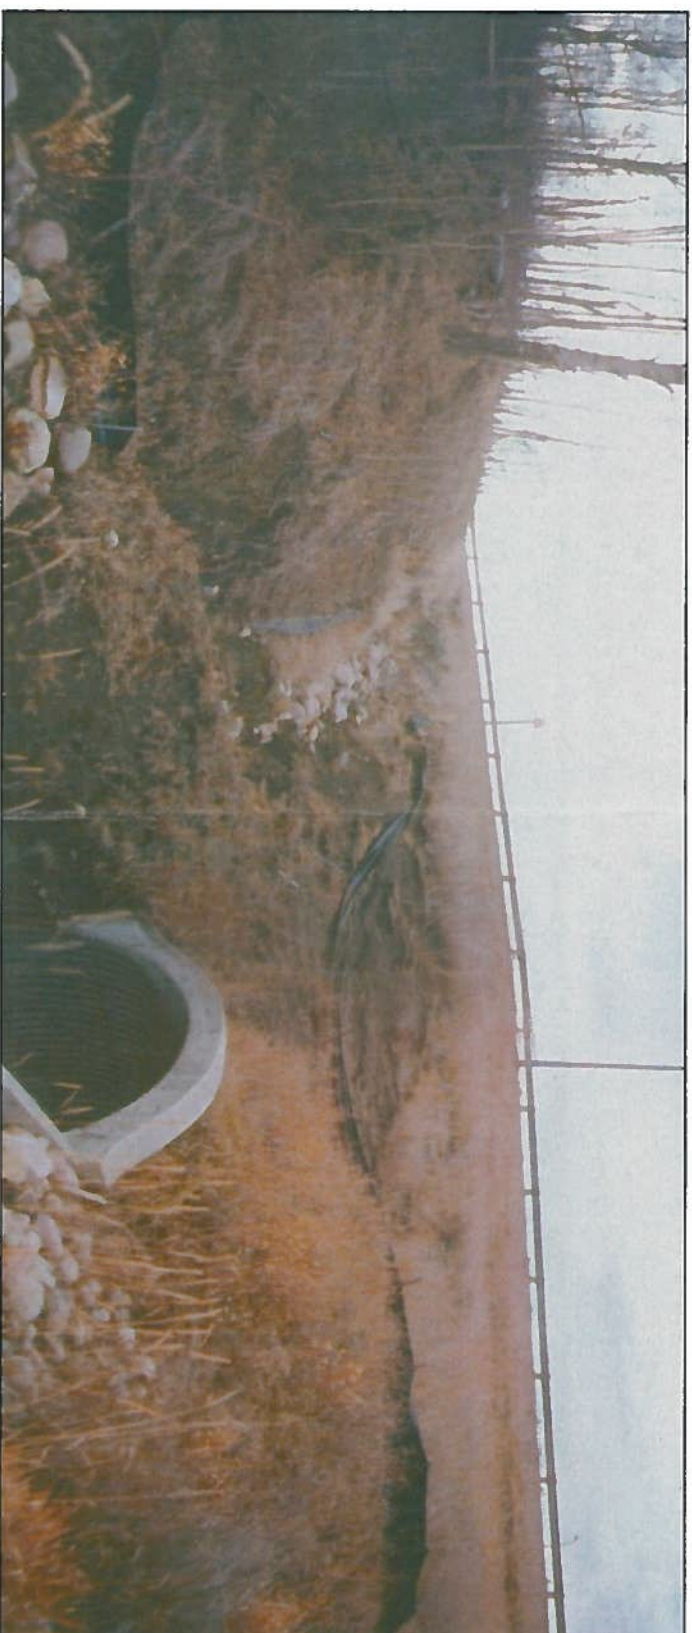
Photo 9
Another looking at east ditch down headslope.

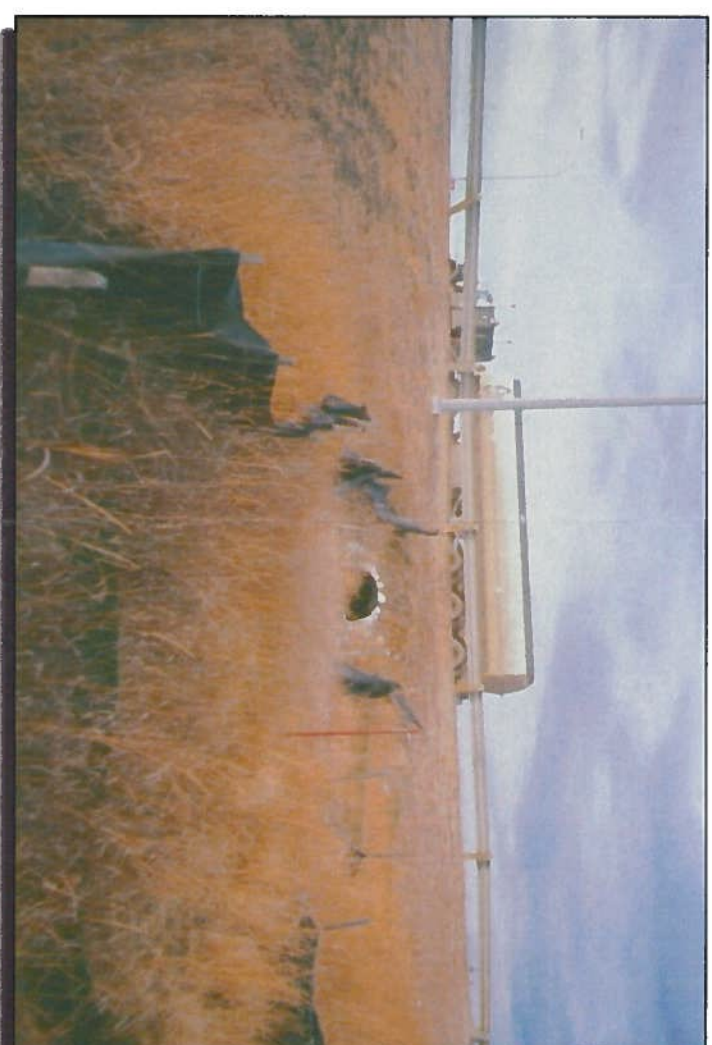
Photo 10
Another look at centreline culvert at SH 736 just west of bridge culvert headslope.
