**ALBERTA TRANSPORTATION
GEOHAZARD ASSESSMENT PROGRAM
PEACE REGION – GRANDE PRAIRIE DISTRICT
2019 INSPECTION**

Site Number	Location	Name	Hwy	km
Call Out	South of Debolt	Debolt Creek Slide	43:04	51.2
Legal Description		UTM Co-ordinates (NAD 83)		
SE11-72-1-W6		11U N 6,119,131	E 434,643

**2019 CALLOUT HWY 43:04 km 51.2
SOUTH OF DEBOLT, AB**

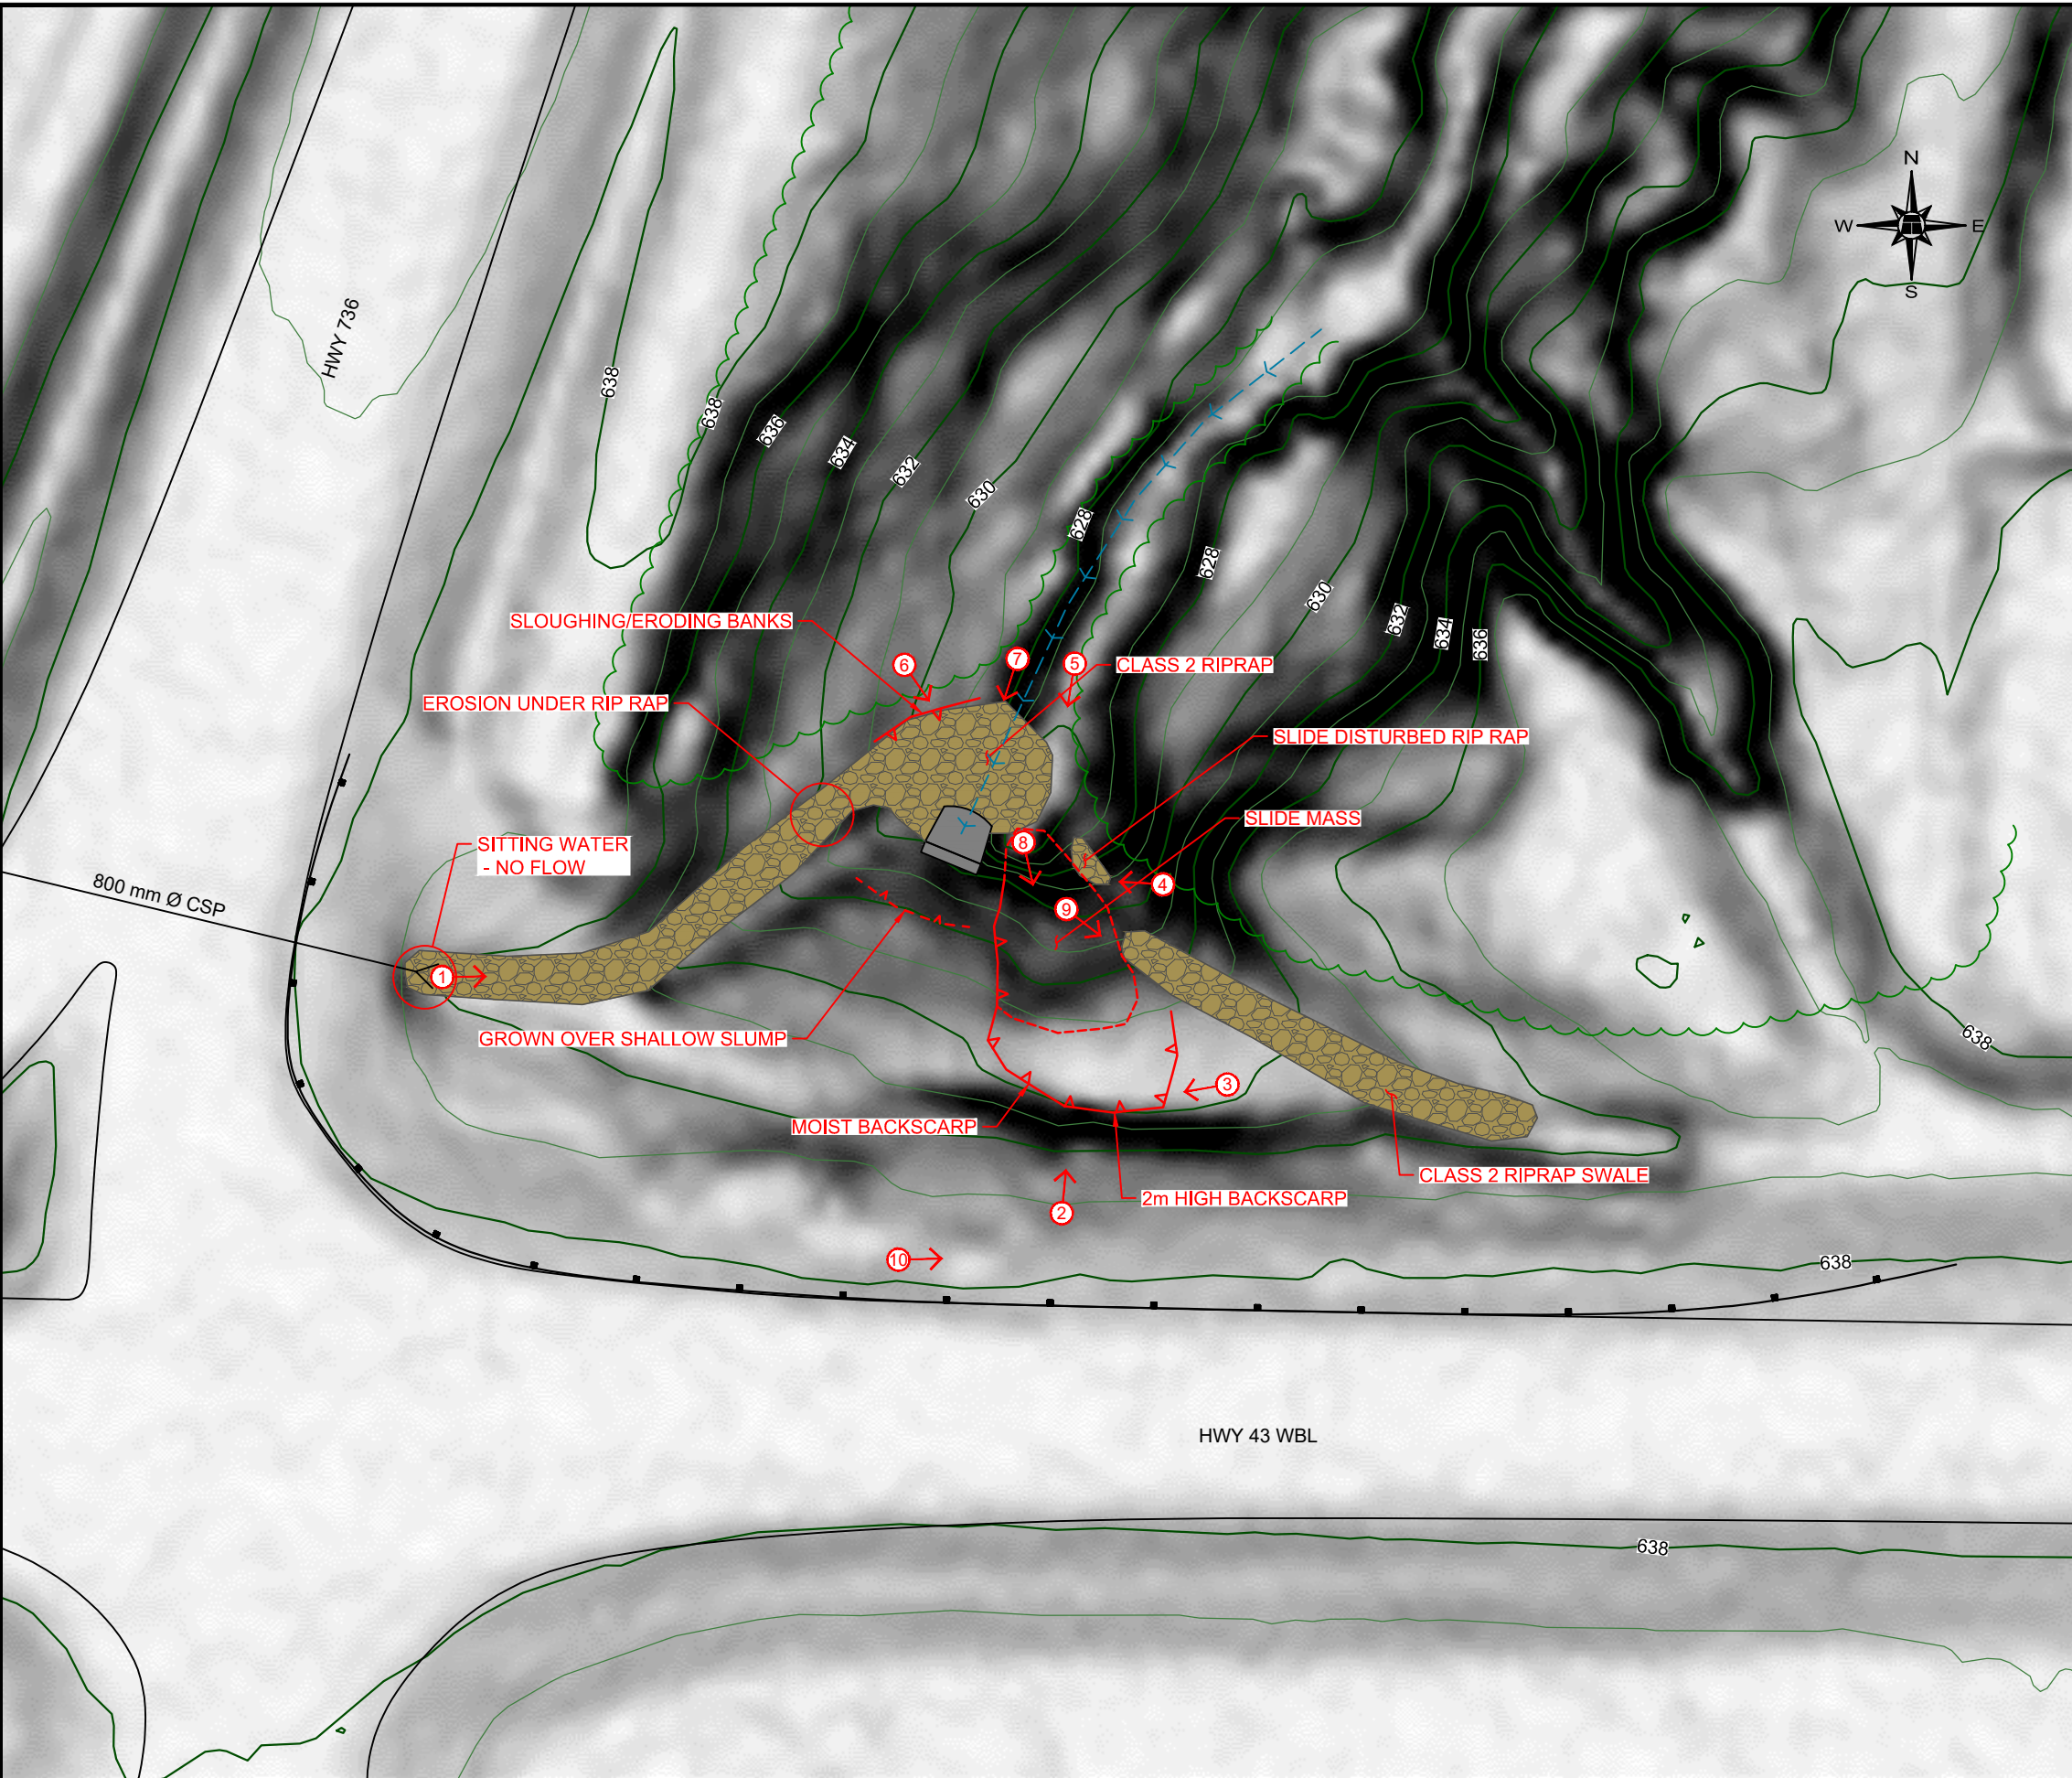
DWG No. 13353-CALLOUT

SITE PLAN

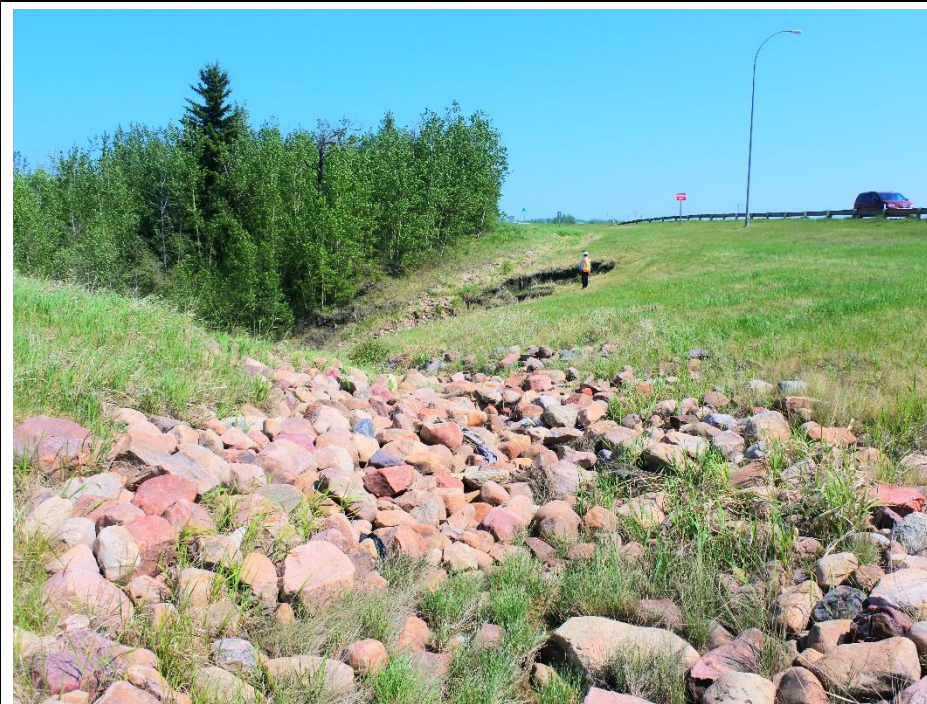
Photo 1.
Looking east from
800 mm CSP
culvert towards
slide.

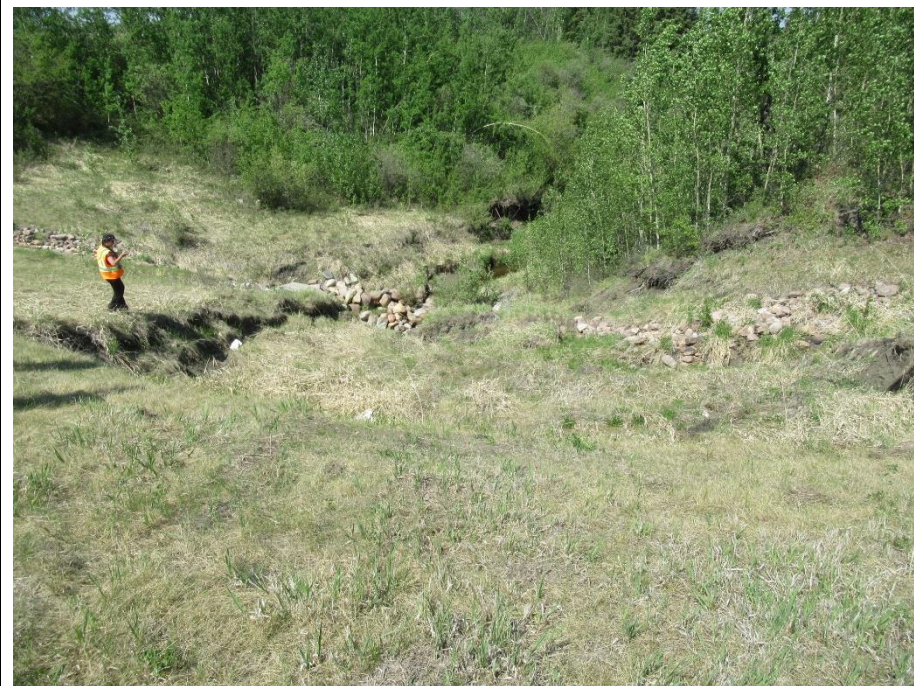
Photo 2.
Looking north at
slide standing
above the
backscarp.

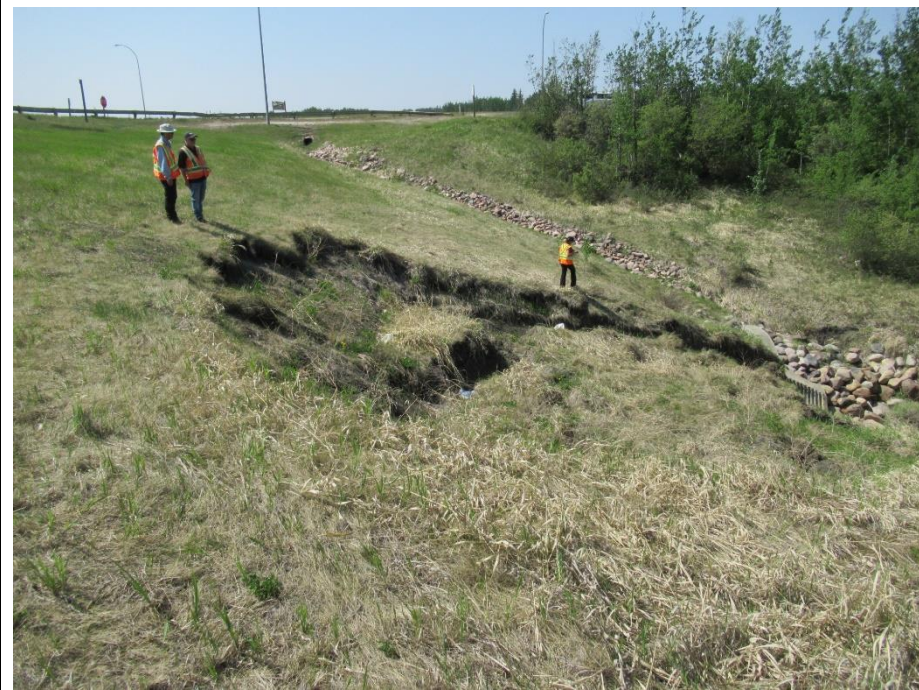
Photo 3.
Looking west at
slide backscarp.

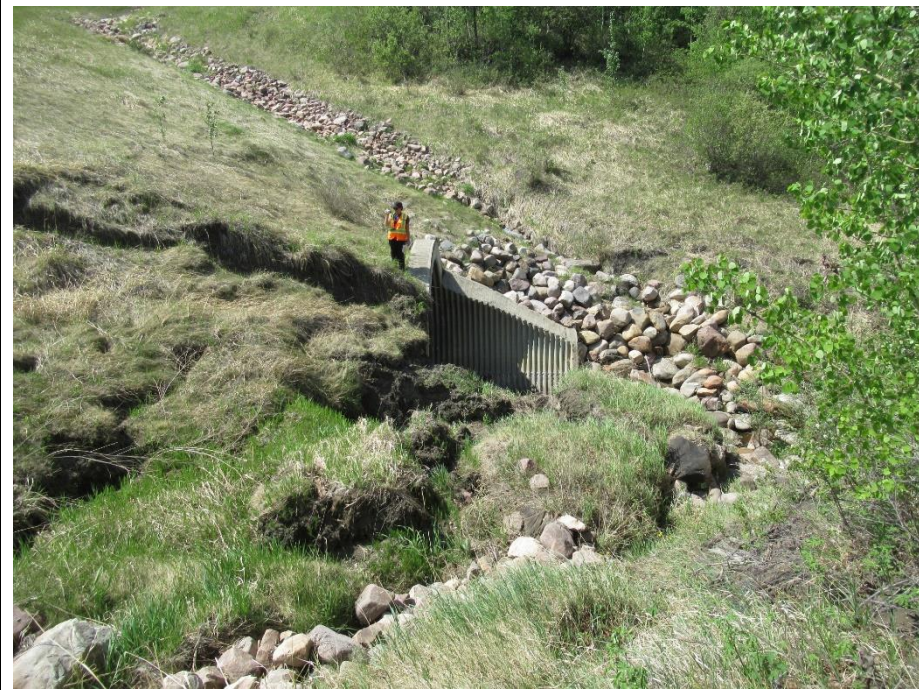
Photo 4.
Looking west
towards culvert
inlet and slide
mass.

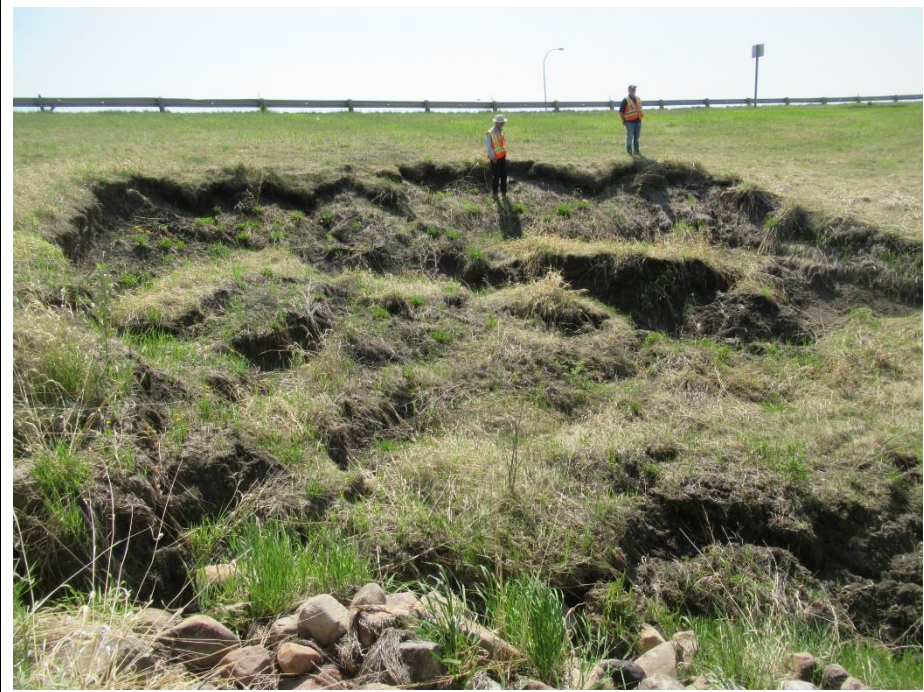
Photo 5.
Looking south
towards slide and
Highway 43.

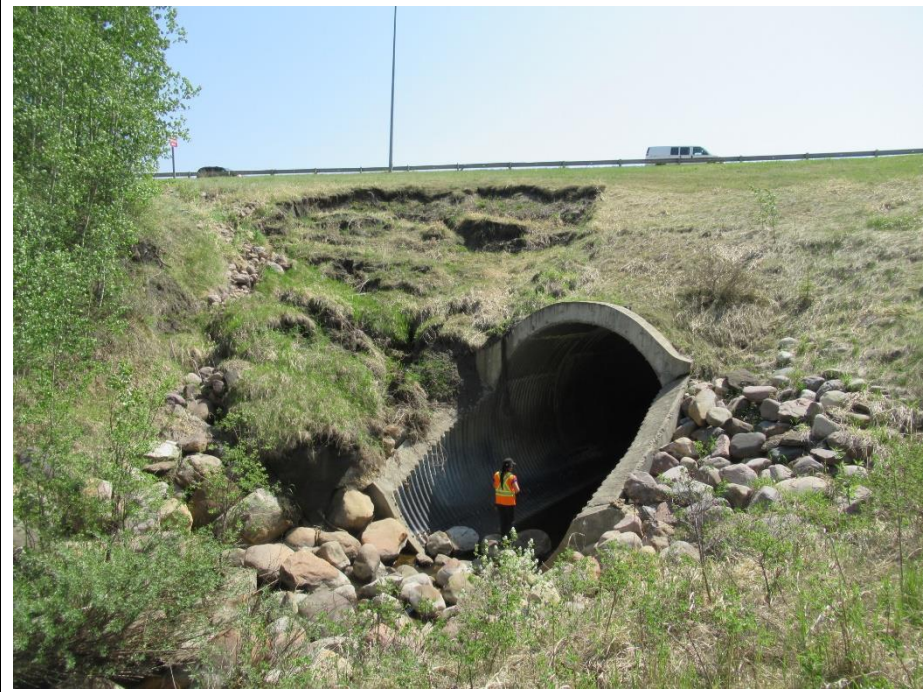
Photo 6.
Looking south
towards culvert
inlet and slide on
the left side of it.

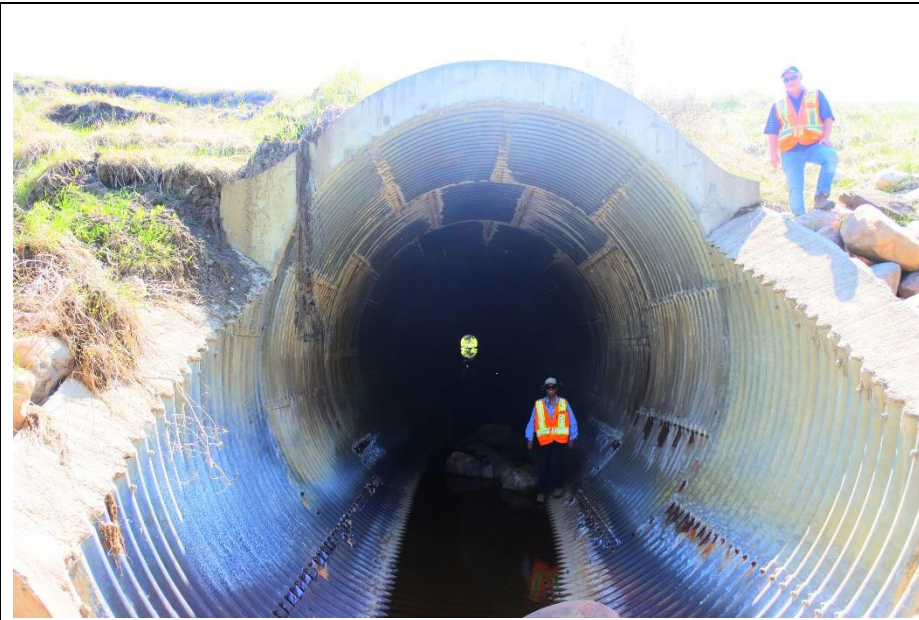
Photo 7.
Looking south at
culvert inlet.

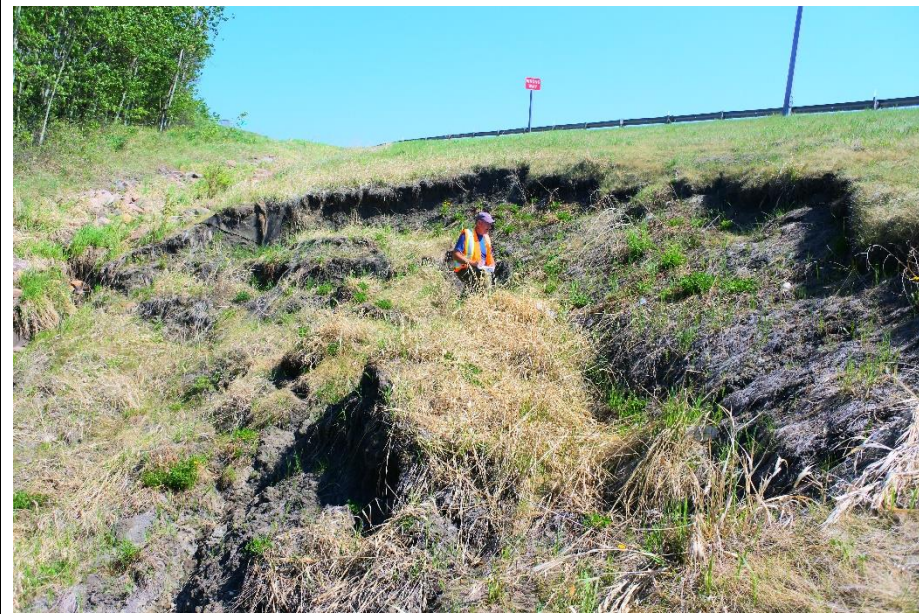
Photo 8.
Looking southeast
at slide scarp.

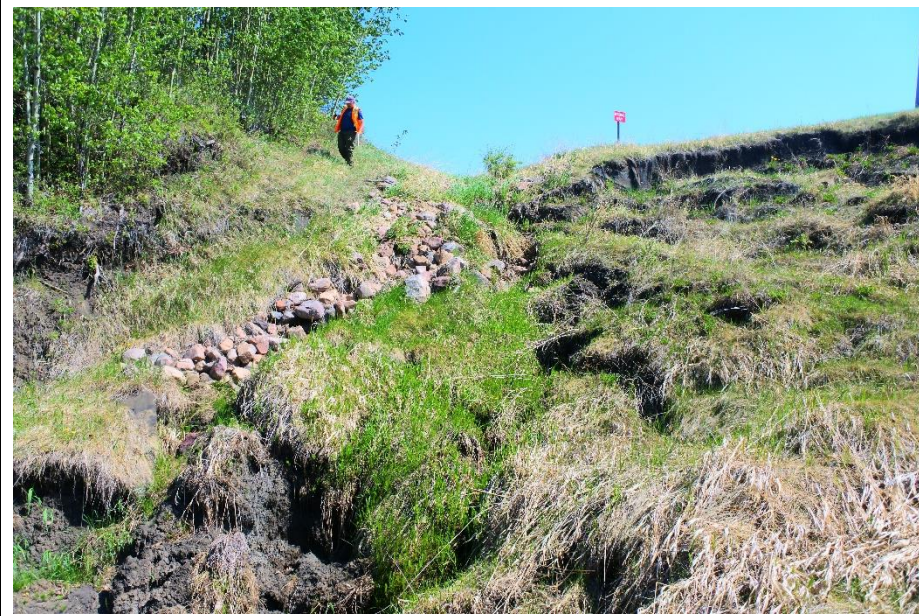
Photo 9.
Looking east at
slide scarp and at
disturbed swale
and riprap.

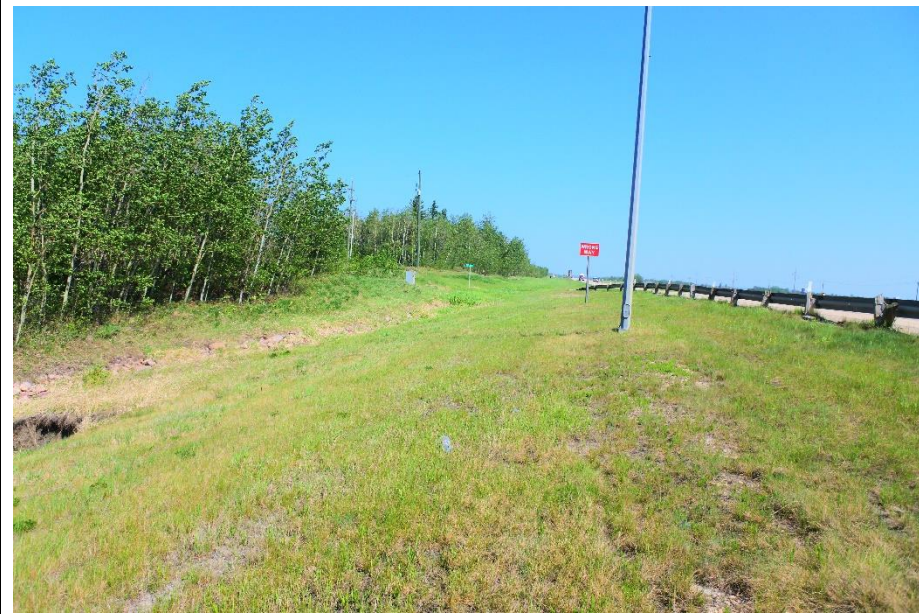
Photo 10.
Looking east
standing south of
the slide scarp.
