**ALBERTA TRANSPORTATION
GEOHAZARD ASSESSMENT PROGRAM
PEACE REGION – GRANDE PRAIRIE DISTRICT
2020 INSPECTION**

Site Number	Location	Name	Hwy	km
GP28	West of Whitecourt	2 Creeks - 0.4 km east of Bridge	43:12	34.5
Legal Description		UTM Co-ordinates (NAD 83)		
SW27-61-16-W5		11U N 6,017,300	E 543,965

**PEACE REGION (GRANDE PRAIRIE)
GP28-1: HWY 43:12 km 34.3 TO 35.0 TWO CREEKS**

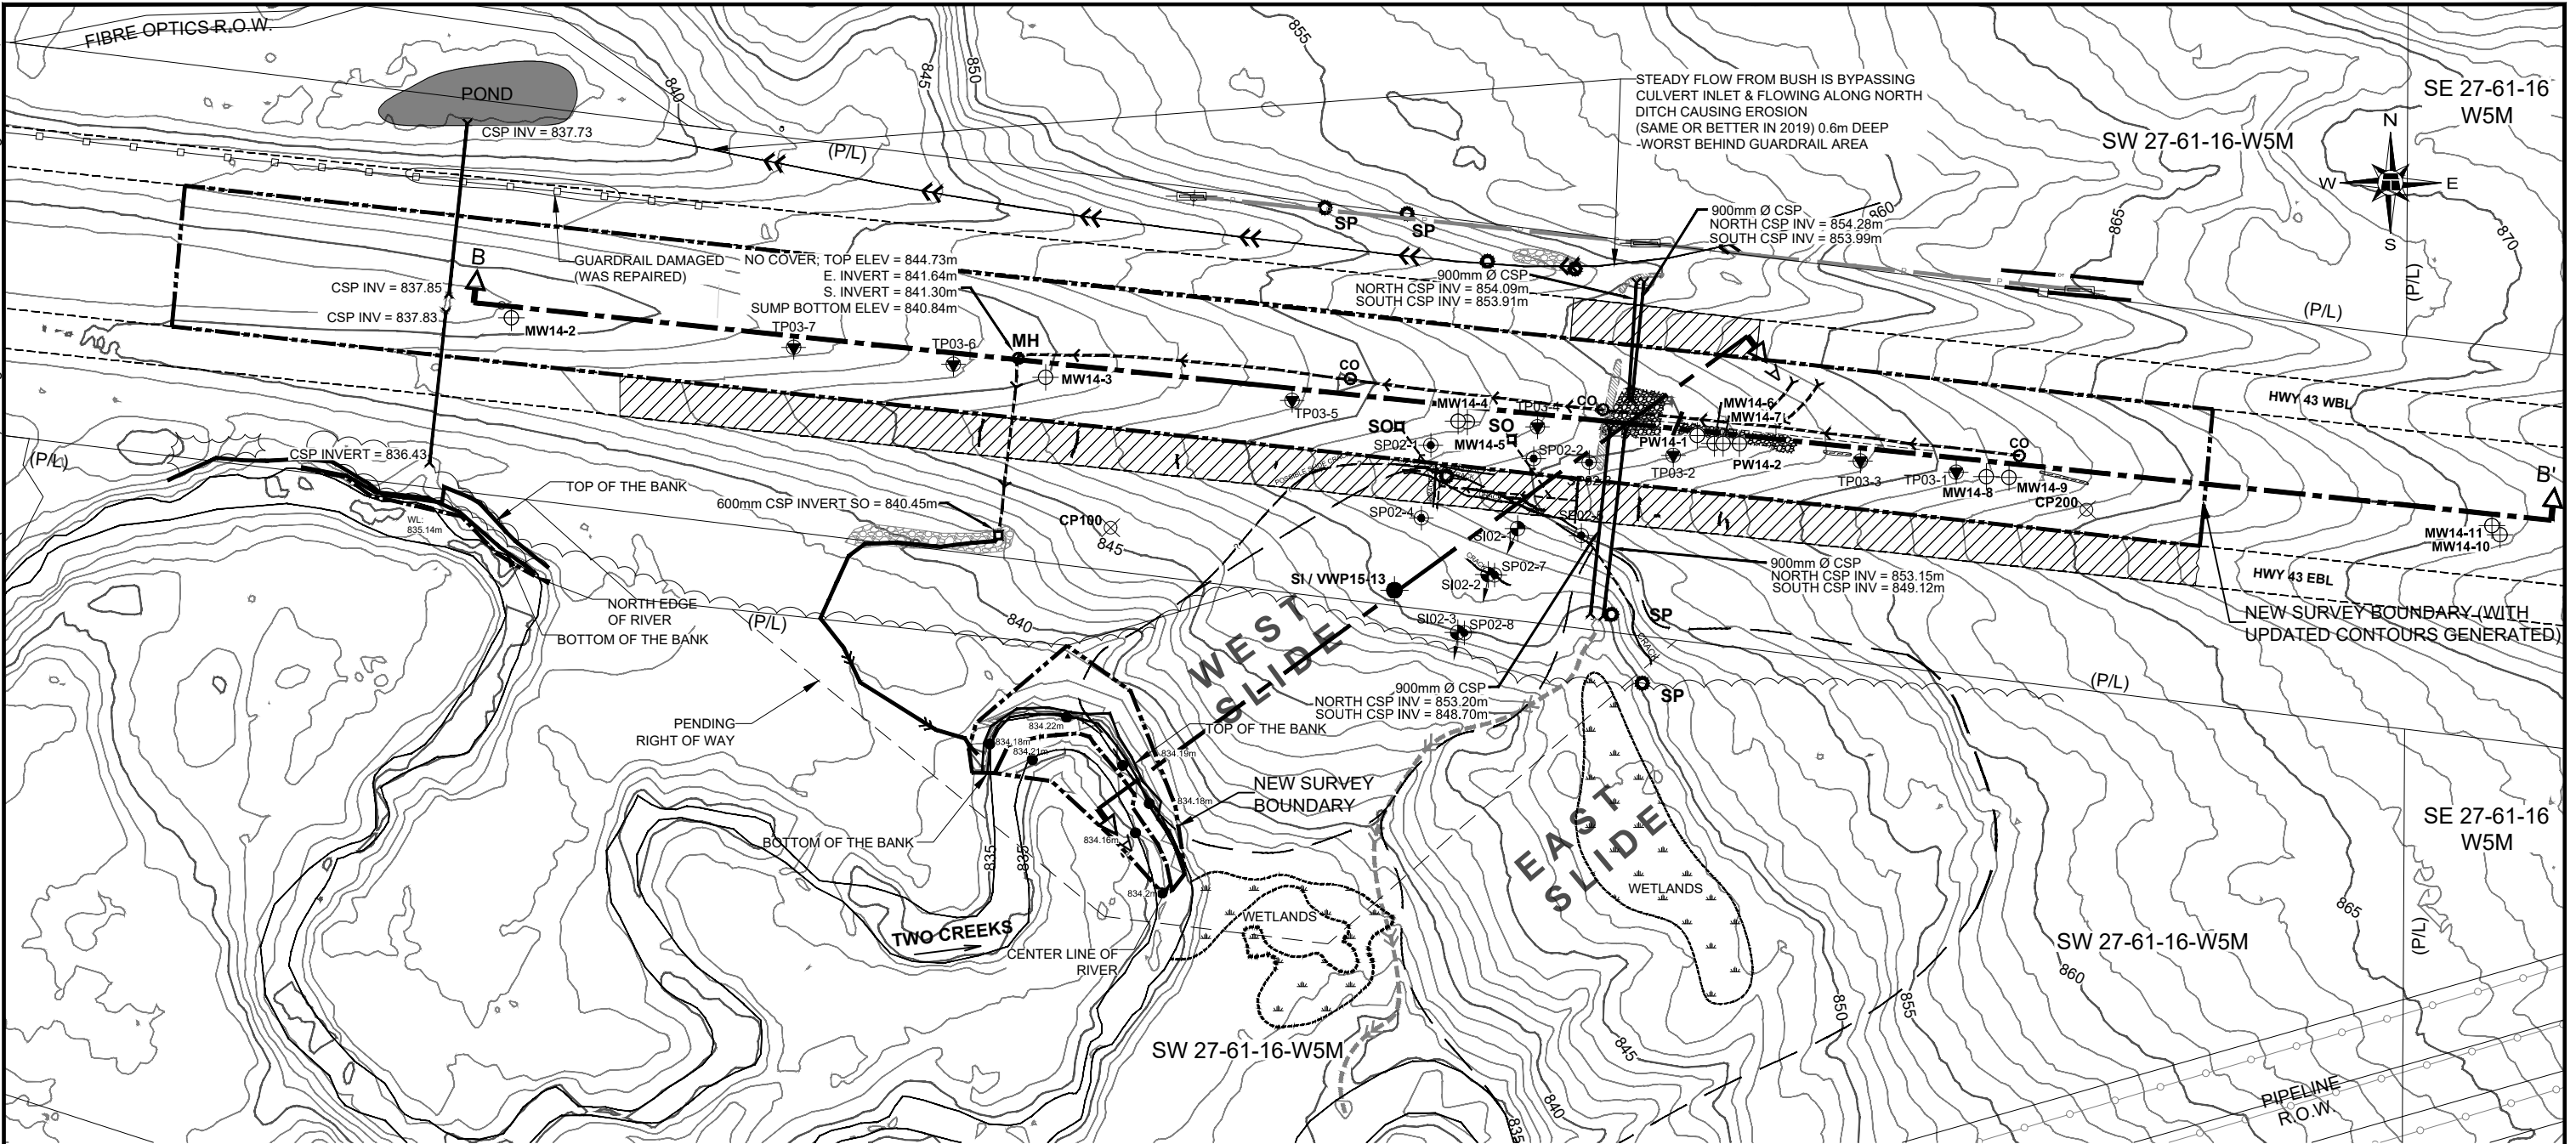
DWG No. 13353-GP28-1-1

2020 INSPECTION PLAN

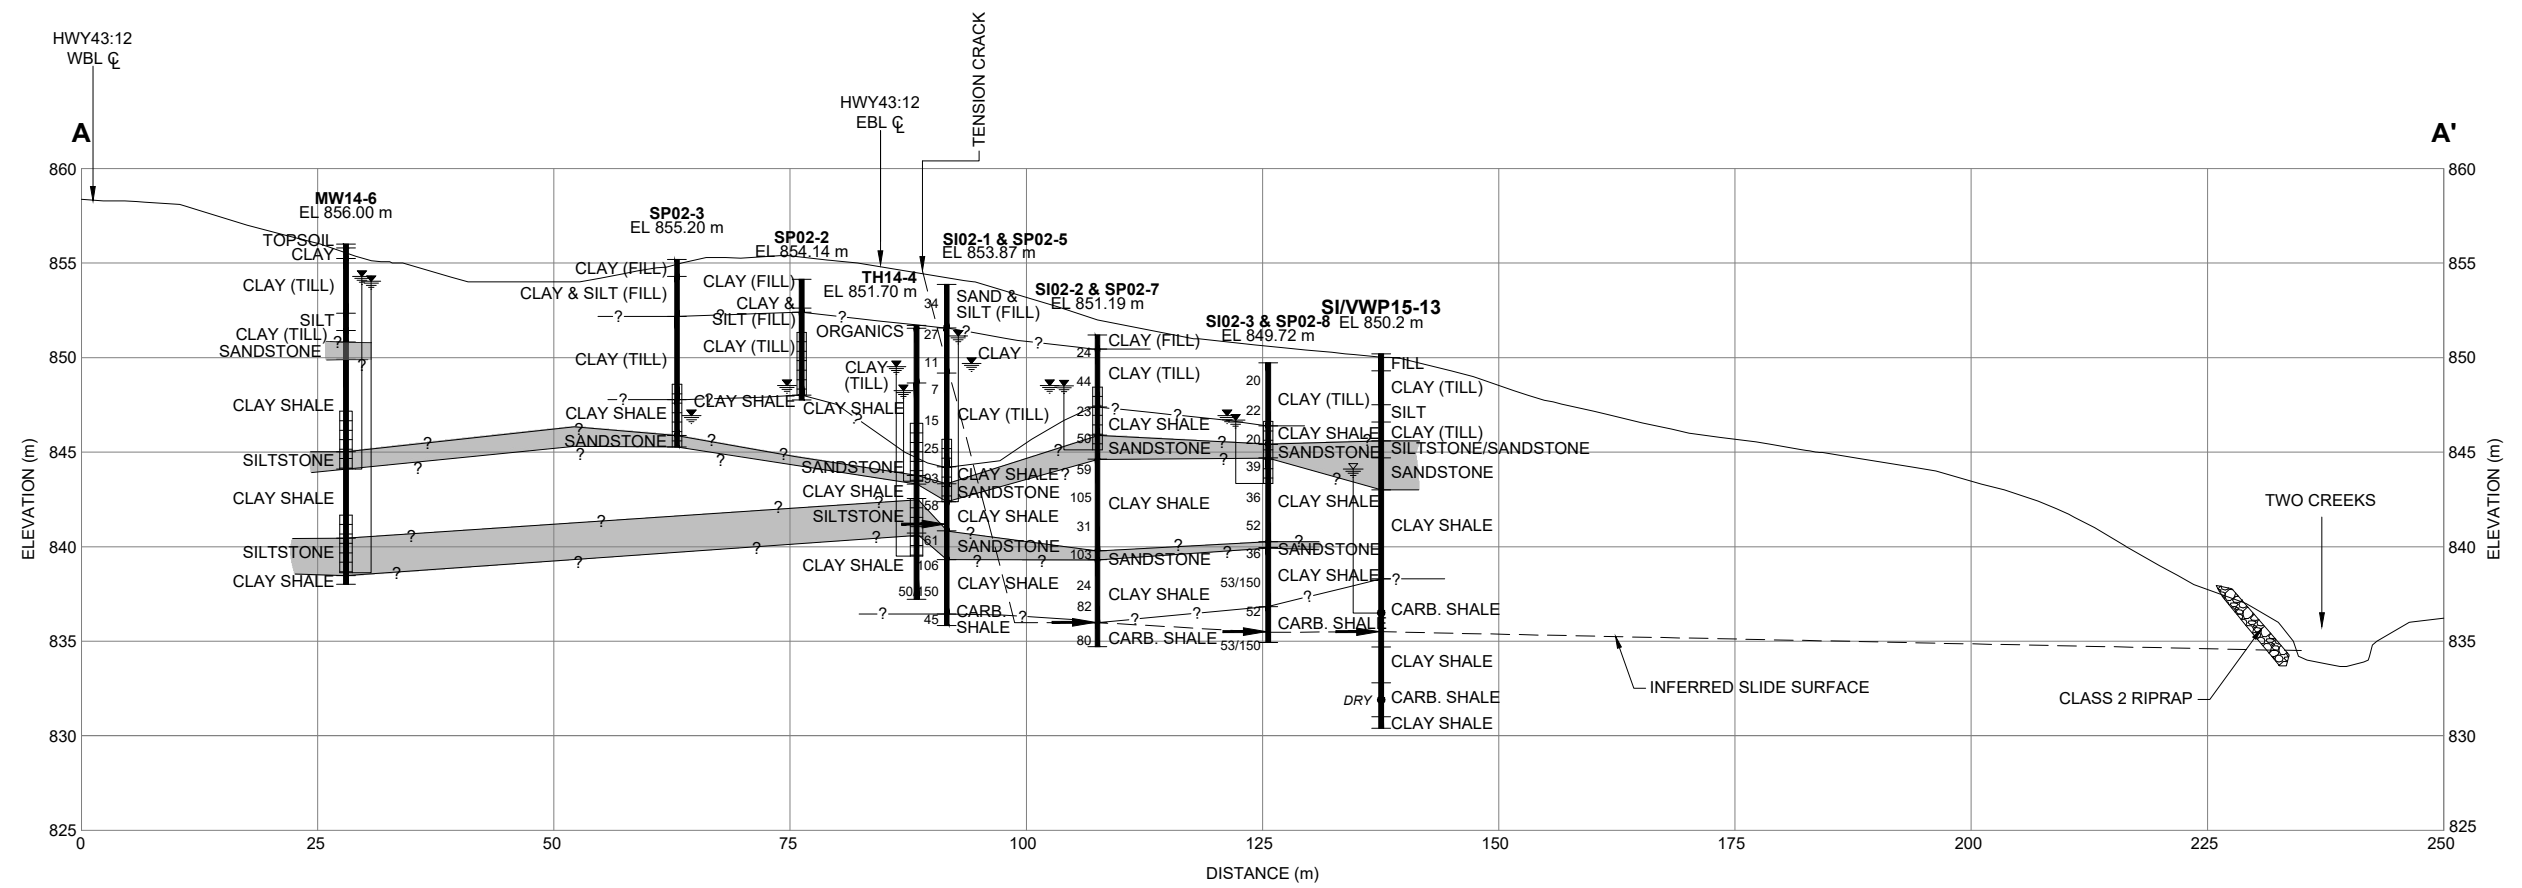
DWG No. 13353-GP28-1-2

CROSS-SECTION A-A'

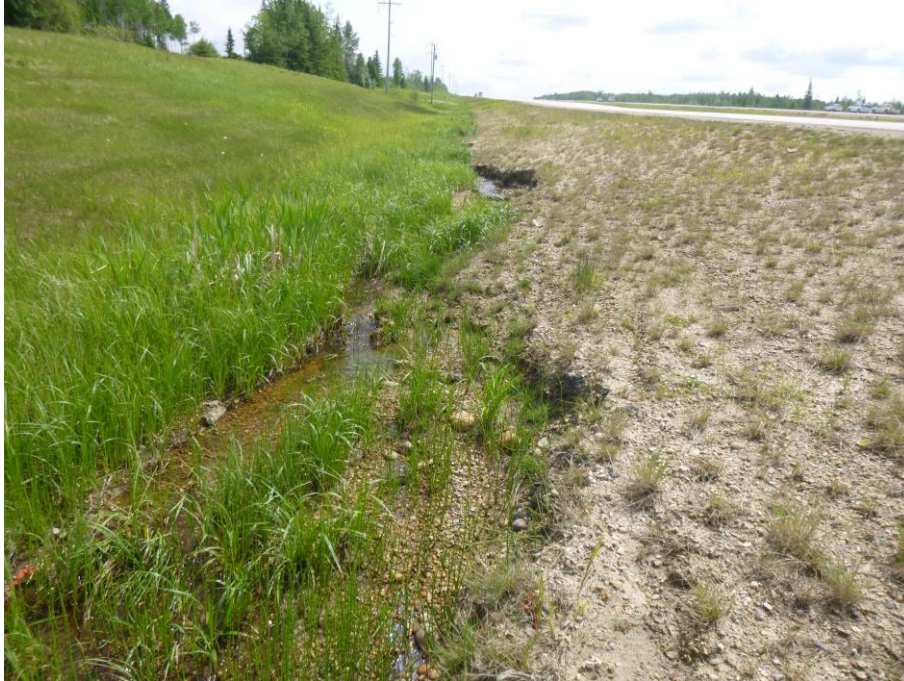
<input checked="" type="checkbox"/> Erosion	Some along the north ditch west of the culvert inlets.	<input checked="" type="checkbox"/>
<input checked="" type="checkbox"/> Seepage	Seepage zones exist in the site area at random locations along the valley slope.	<input type="checkbox"/>

Photo 1 – Looking east at some fresher erosion, caused by flow coming from the bush and bypassing the culvert inlets, and flowing westwards along the south highway ditch.

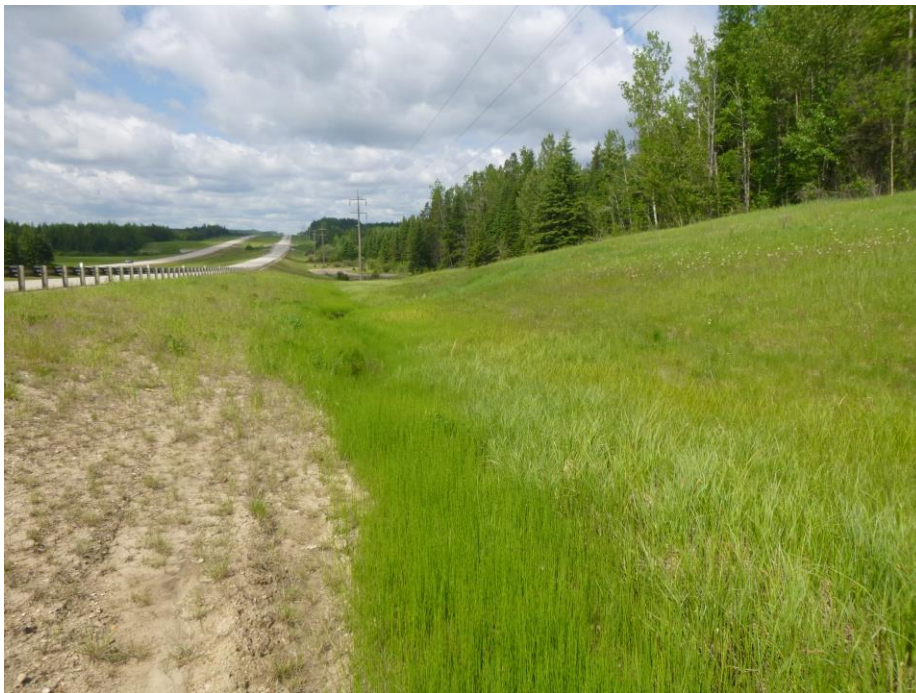
Photo 2 – Looking west along the north ditch at former erosion from flow further east that has grassed in.

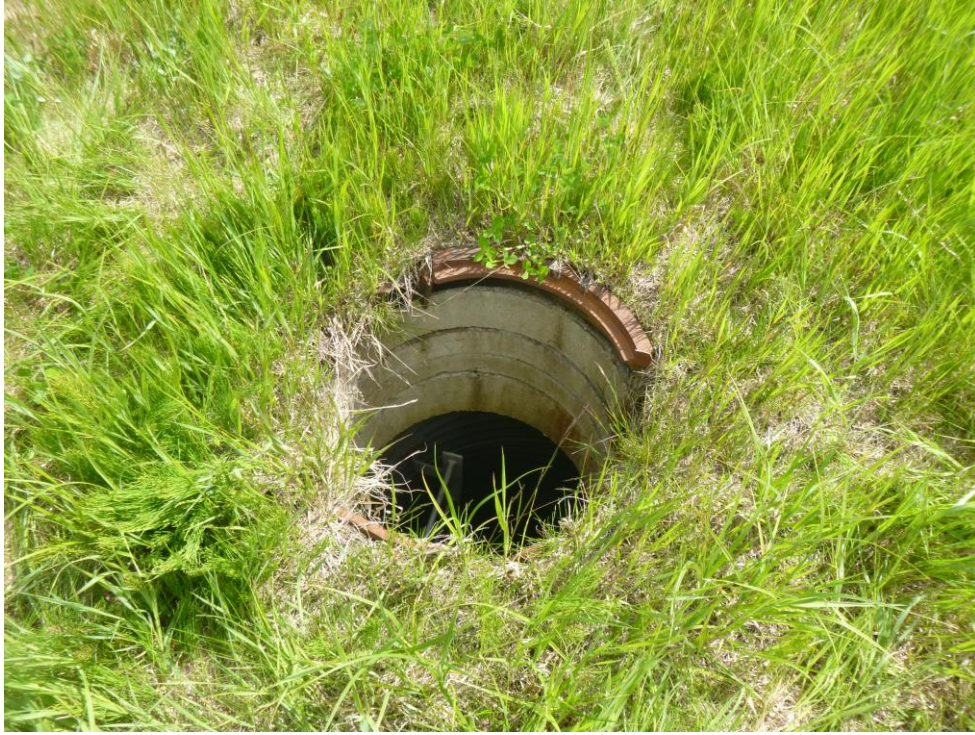
Photo 3 – Looking at a missing lid overtop of the manhole west of the instrumentation that directs water southwards beneath the hwy.

- Crack filling, milling, patching, and/or overlays should be performed on the affected hwy on an as-required basis.
- Remove all of the silt fence from this site that was placed during construction.
- Replace the missing cover from the Manhole covering the subdrain that diverts water southwards beneath the eastbound hwy lanes, and install warning marker posts to avoid somebody falling in and mowers damaging it in the future.

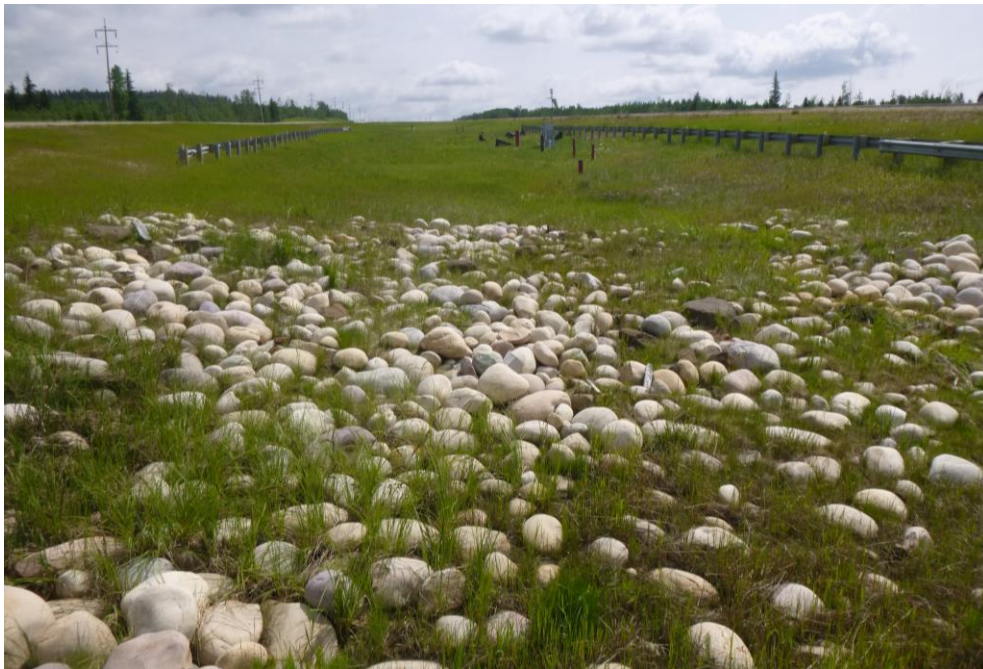
Photo 4 – Looking east along the median at the instrumentation and guardrails from the highway cross culverts.

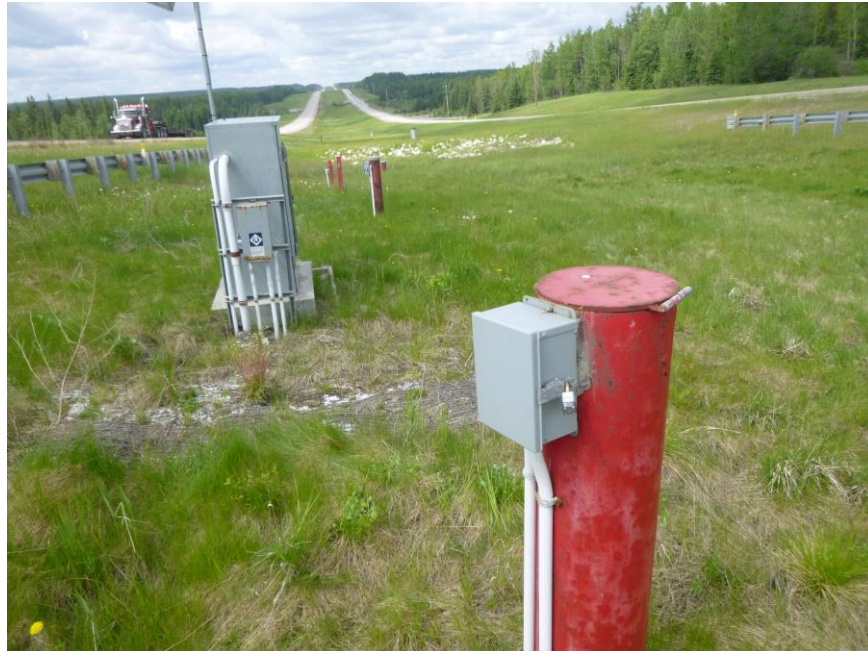
Photo 5 – Looking west along the median at the two pump wells and the Central Monitoring Station (CMS). There are still a couple of small sparsely grassed areas beside the CMS.

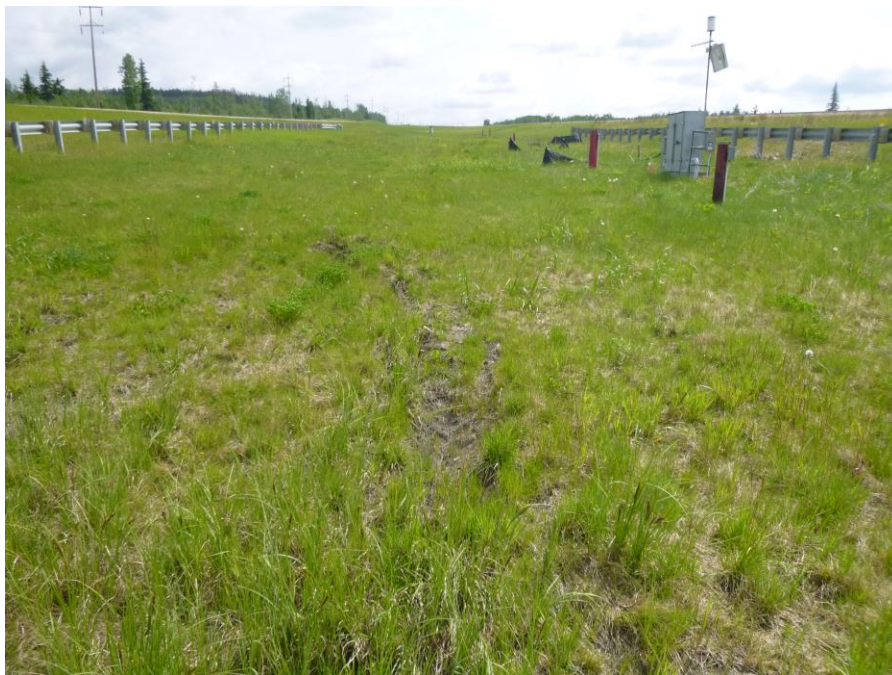
Photo 6 – Looking east along the median at a minor erosion gully. Note the silt fence still remaining east of the central monitoring station.

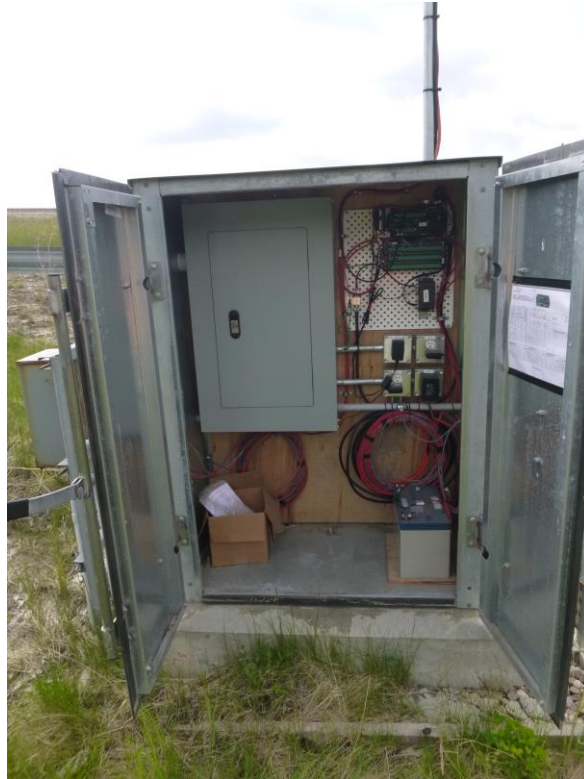
Photo 7 – Looking south at the inside of the CMS (control panel door closed).

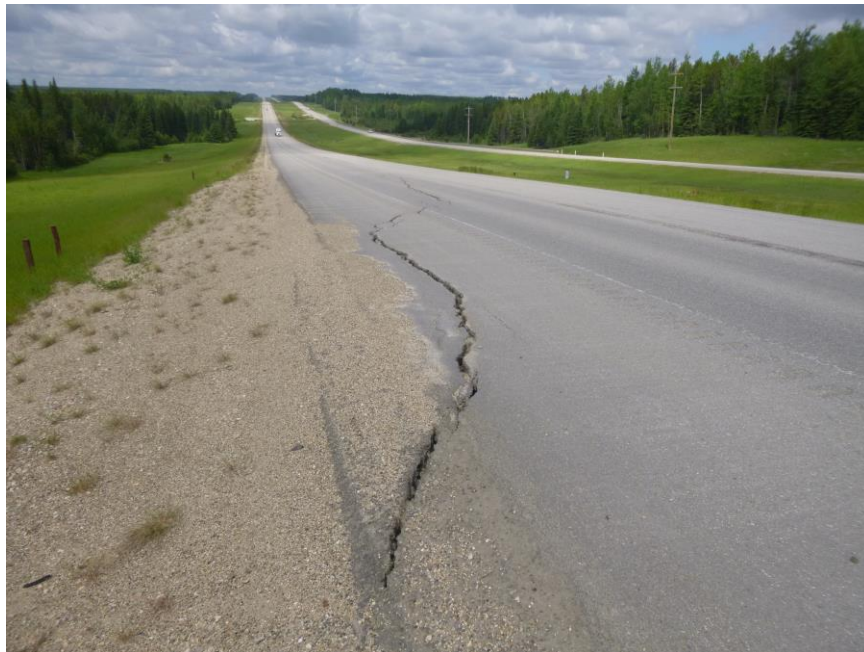
Photo 8 - Looking west along the open slide crack in the highway eastbound lanes. Note the slight dip in the highway south of this crack.

The slide should be regularly monitored for progression of slide movements, especially during spring thaw and periods of high precipitation. If significant movements in the road occur during an event, the eastbound lanes may have to be temporarily shut down and traffic re-routed to the westbound lanes, while repairs are implemented.

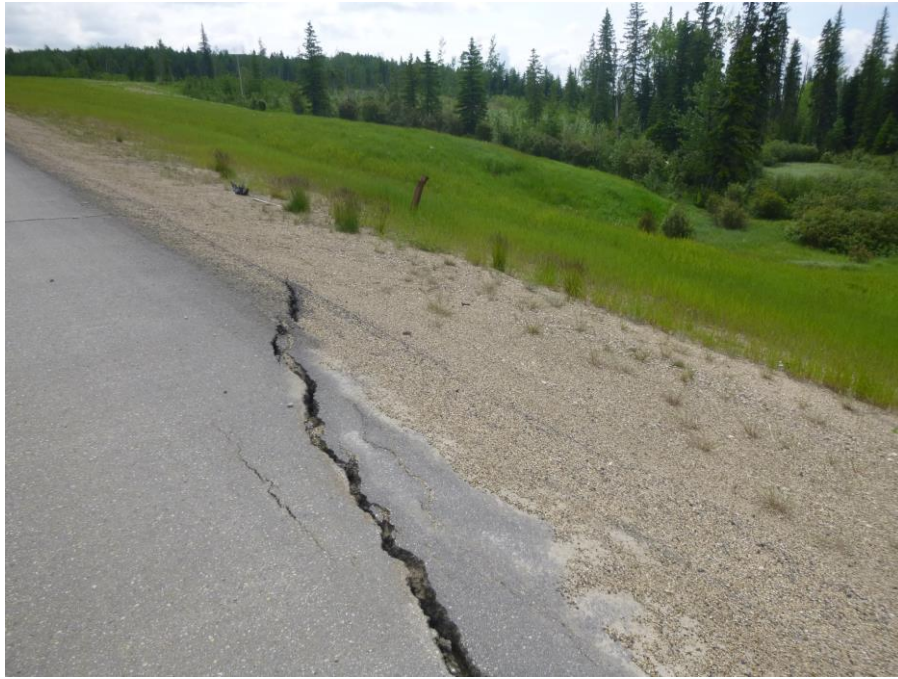
Photo 9 - Looking southeast at the main scarp crack along the south edge of the pavement. Note the subtle scarp extending southeast of the hwy along the top edge of the knob.

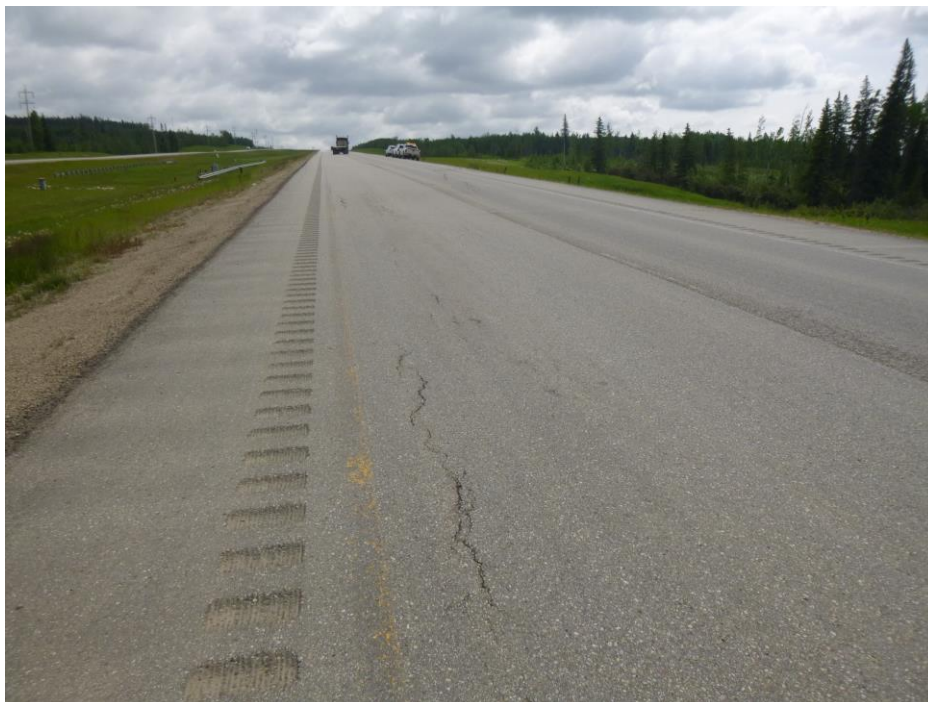
Photo 10 – Looking east at the crack along the outside edge of the EB driving lane.

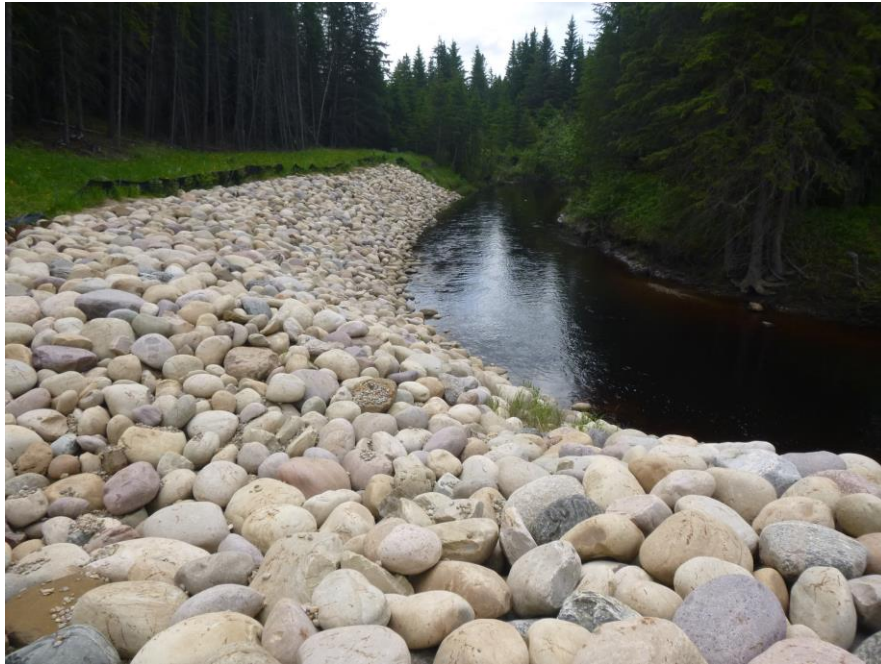
Photo 11 - Looking southeast across the riprap armoured the creek.

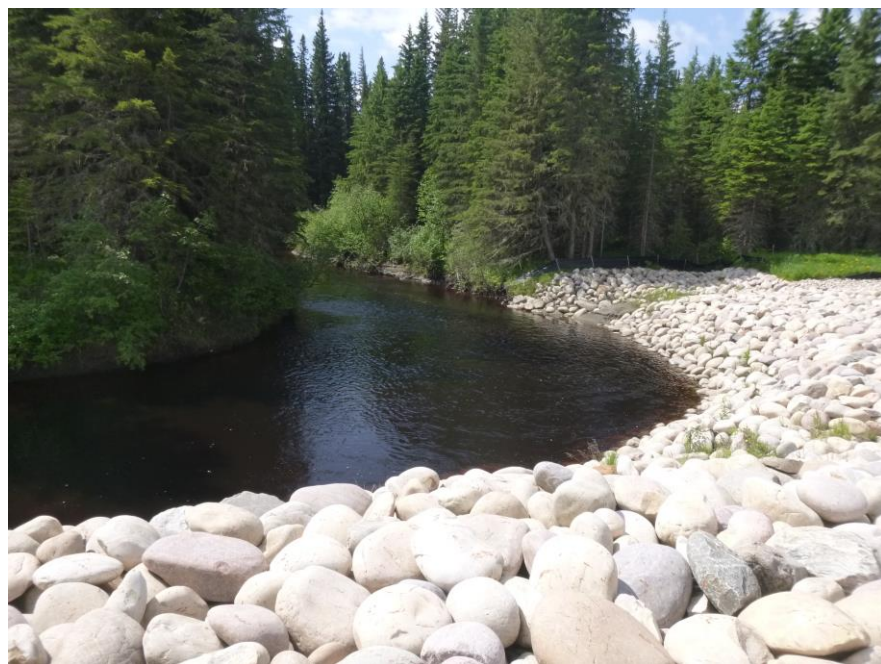
Photo 12 – Looking southwest at the riprap armour. The creek flows adjacent to the front face of the riprap, however no erosion has taken place on the unprotected bank.

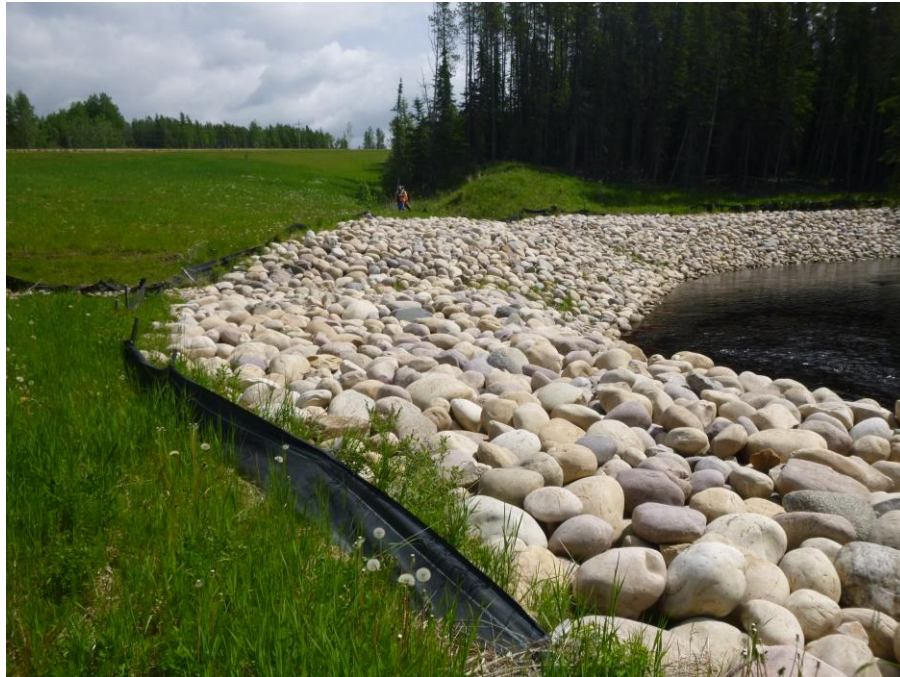
Photo 13 – Looking east across the riprap armour.

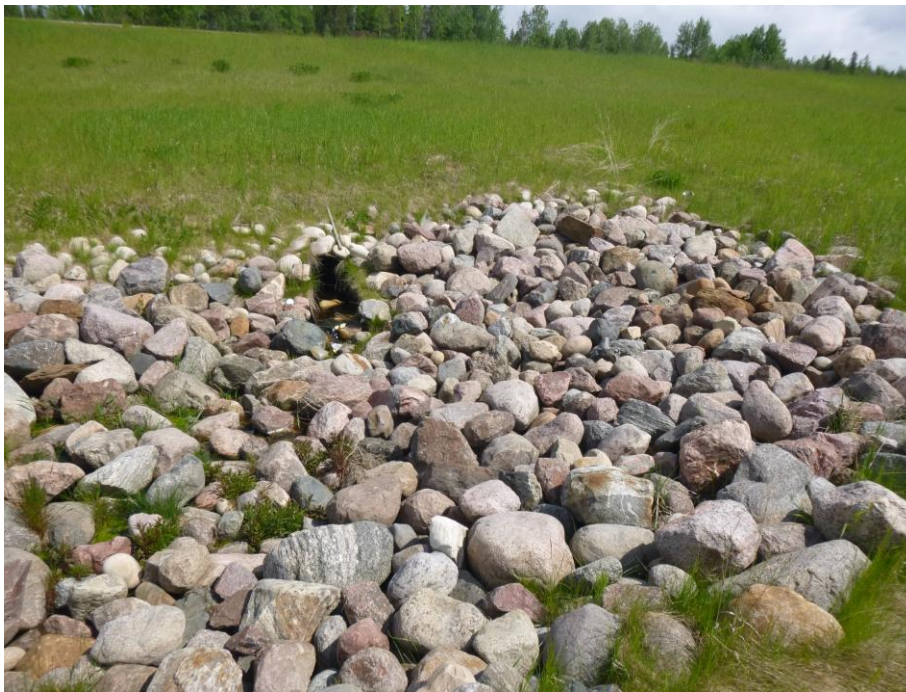
Photo 14 - Looking north at the subdrain outlet and riprapped drainage channel south of the highway.
