SITE NUMBER AND NAME: GP028 Two Creeks		HIGHWAY & KM: 43:12, 34.473	PREVIOUS INSPECTION DATE: June 18, 2020	INSPECTION DATE: July 19, 2021
LEGAL DESCRIPTION: SW 27-61-16-W5M	NAD 83 COORDINATES: UTM Northing Easting 11 6017213 544193		RISK ASSESSMENT: PF: 11 CF: 5 TOTAL: 55	
AVERAGE ANNUAL DAILY TRAFFIC (AADT): 2900 (west) & 2873 (east) (Reference No. 50431250)			CONTRACT MAINTENANCE AREA (CMA): 508

PROJECT	GRANDE PRAIRIE SOUTH REGION GEOHAZARD RISK MANAGEMENT PROGRAM	
TITLE	Site Plan GP028 Two Creek Hwy 43:12, km 34.473	
SCALE	PROJECT No.	FIG No.
1:2,000	A05116A01	1

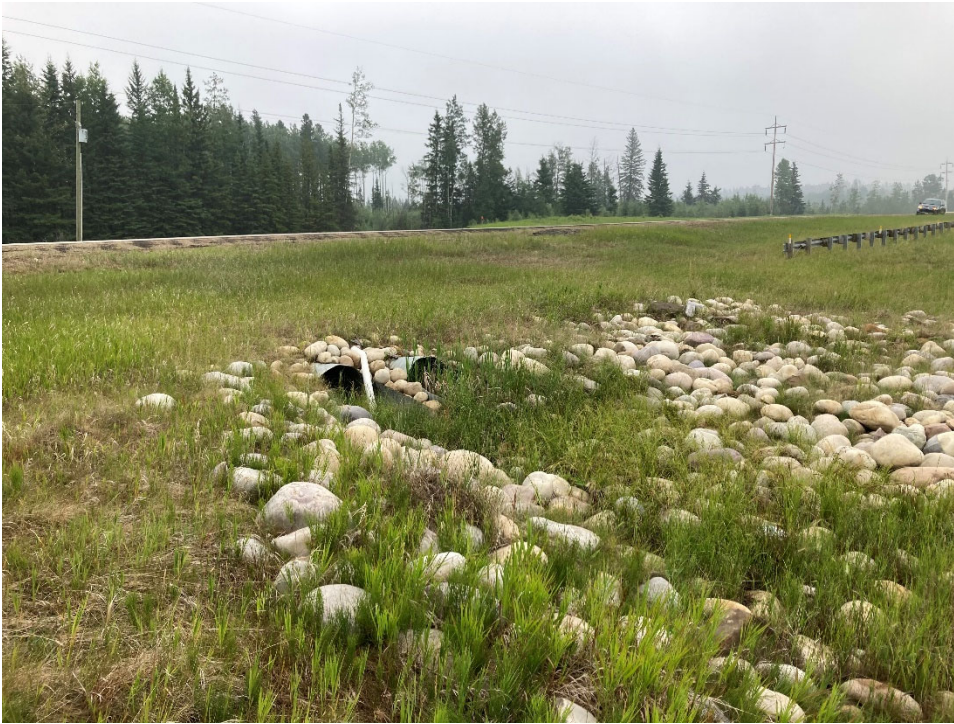
Photo 1 The outlets of the twin CSP culverts underlying the westbound lanes of Hwy 43. Photo taken July 19, 2021, facing northeast.

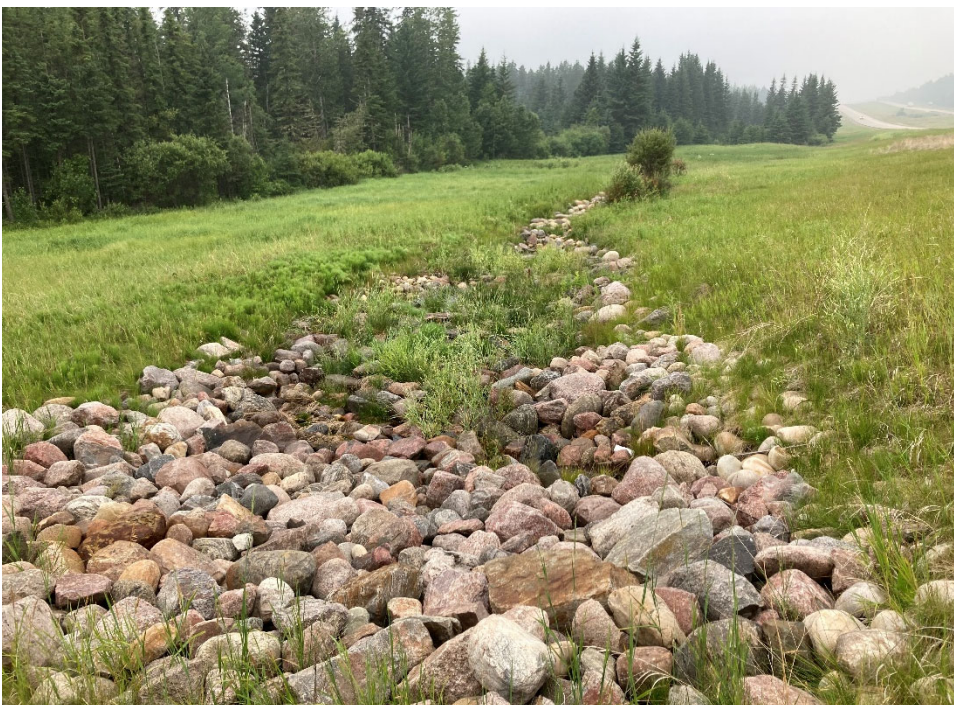
Photo 2 The riprap lined channel at the outlet of the drain pipe underlying the eastbound lanes of Hwy 43. Photo taken July 19, 2021, facing west.

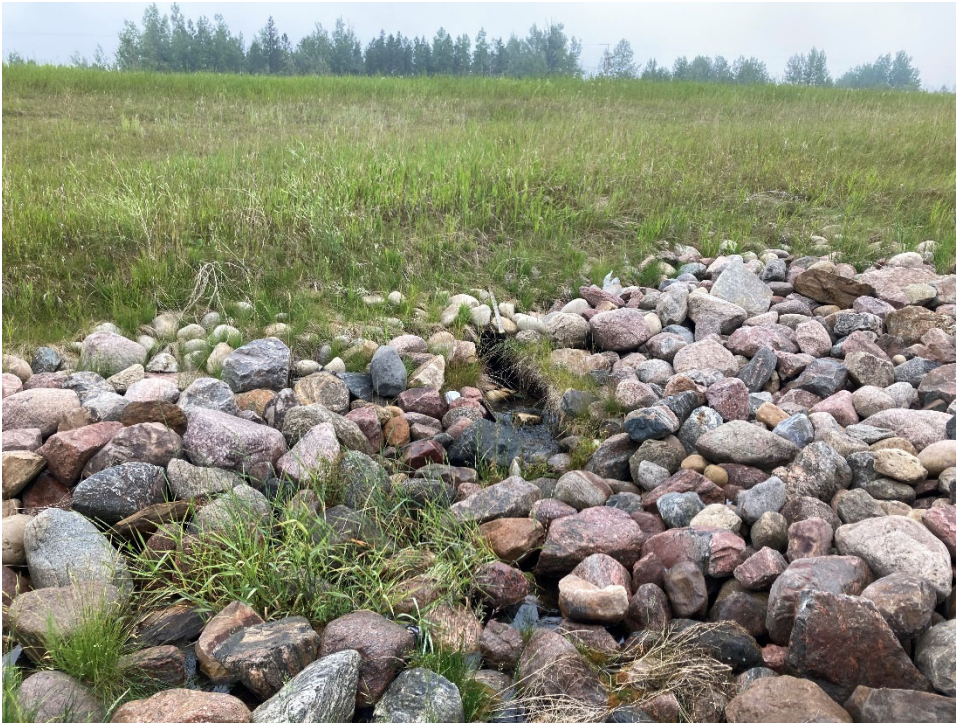
<ul style="list-style-type: none"> - WP074, outlet of median drain system on south toe of EBL embankment, flowing approximately quarter full, but cobbles in the outlet are impeding flow. 	
<ul style="list-style-type: none"> - Riprap armouring on creek bank in good condition. 	
<p>This report is an instrument of service of Klohn Crippen Berger (KCB). The report has been prepared for the exclusive use of Alberta Transportation (Client) for the specific application to the Central Region Geohazard Risk Management Program (Contract No. CON0022166) and it may not be relied upon by any other party without KCB's written consent.</p> <p>KCB has prepared this report in a manner consistent with the level of care, skill and diligence ordinarily provided by members of the same profession for projects of a similar nature at the time and place the services were rendered. KCB makes no warranty, express or implied.</p> <p>Use of or reliance upon this instrument of service by the Client is subject to the following conditions:</p> <ul style="list-style-type: none"> (i) The report is to be read in full, with sections or parts of the report relied upon in the context of the whole report. (ii) The observations, findings and conclusions in this report are based on observed factual data and conditions that existed at the time of the work and should not be relied upon to precisely represent conditions at any other time. (iii) KCB should be consulted regarding the interpretation or application of the findings and recommendations in the report.

Photo 3 The outlet of the drain pipe underlying the eastbound lanes of Hwy 43 was flowing during the site inspection (WP0074). Photo taken July 19, 2021, facing north.

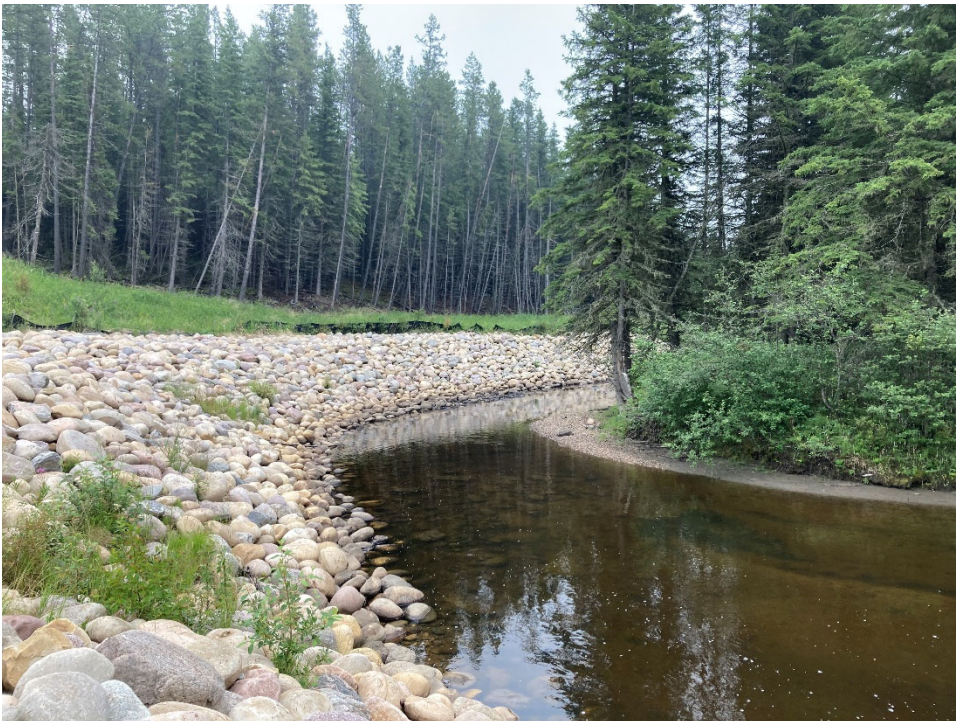
Photo 4 The riprap at the toe of the highway embankment and outside bend of the creek is in good condition. Photo taken July 19, 2021, facing southeast.

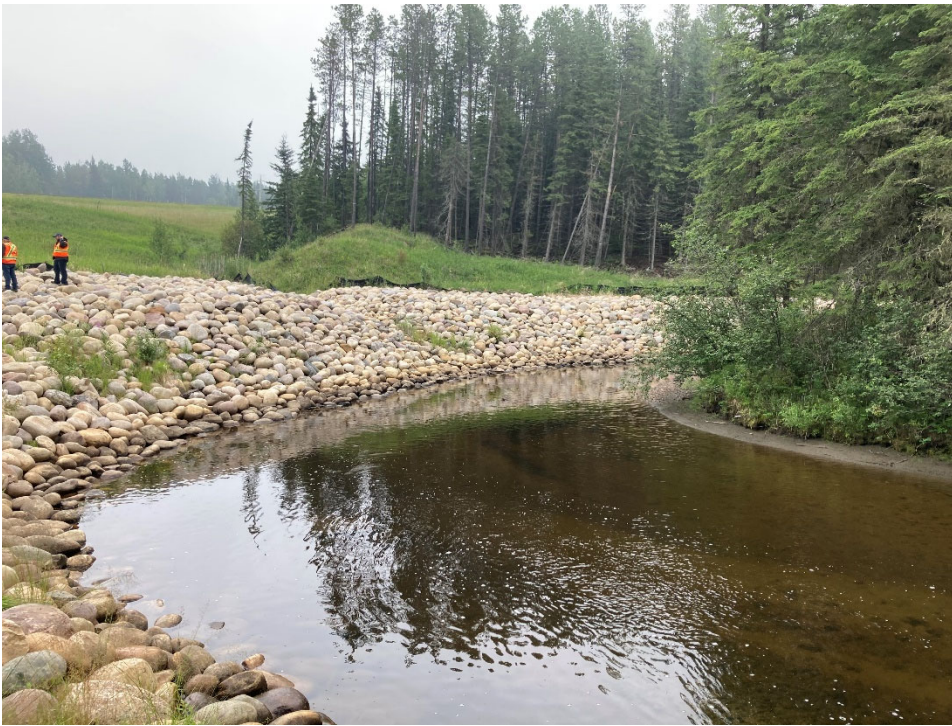
Photo 5 The riprap at the toe of the highway embankment and outside bend of the creek is in good condition. Photo taken July 19, 2021, facing east.

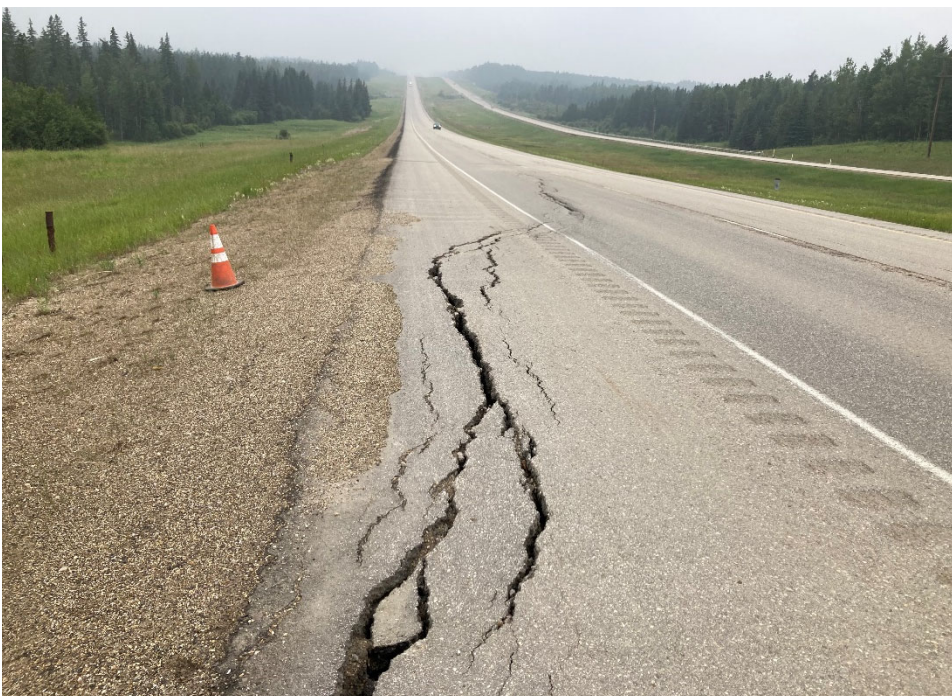
ITEM	CONDITION EXISTS		DESCRIPTION AND LOCATION	NOTICABLE CHANGE FROM LAST INSPECTION	
	YES	NO		YES	NO
Pavement Distress	X		Pavement cracking approx. 0.15 m wide and 0.43 m deep. Approx. 50 mm of pavement settlement in driving lane. Crack starts in shoulder and progresses towards middle of pavement (centreline). Traffic typically changes lanes into passing lane to avoid bump created by settlement.	X	
Slope Movement	X		Pavement settlement (50 mm) and slow movements are being recorded by the one active SI (south of highway)	X	
Erosion	X		Some minor ditch erosion.		X
Seepage		X			X
Culvert Distress	X		Corroding (pavement drain outlet, 3 mbgs) and culvert outlets near instruments are partially blocked with vegetation.		X

Photo 6 Asphalt cracking in the eastbound travel lane extends from the edge of the asphalt to the centreline. The cracking has worsened since the 2020 inspection. Photo taken July 19, 2021, facing west.

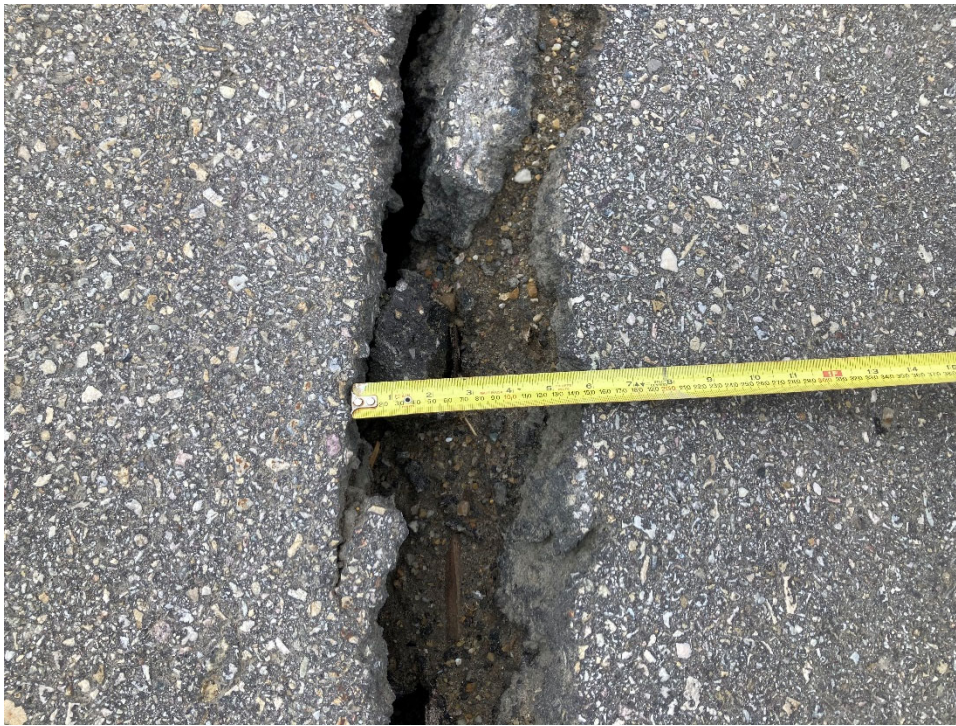
Photo 7 The width of the asphalt cracking in the eastbound travel line is up to 150 mm wide.
Photo taken July 19, 2021.

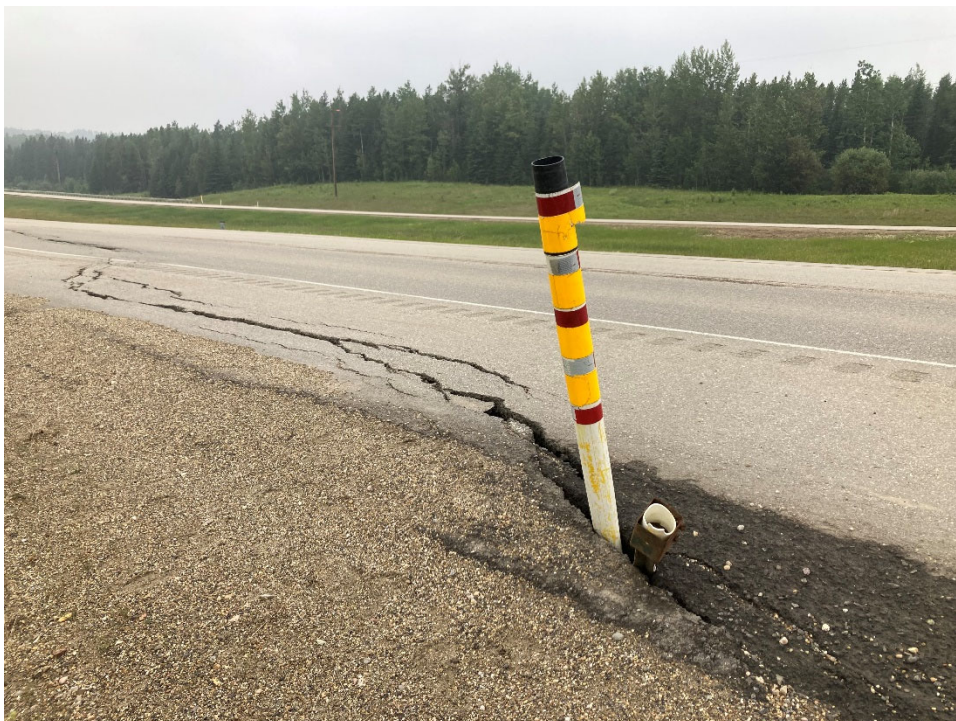
Photo 8 A delineator post was inserted into the asphalt crack at the edge of the highway before the 2021 inspection. Photo taken July 19, 2021, facing north.
