November 28, 2025

**CON0022166 Peace Region (Grande Prairie District – South) GRMP Instrumentation Monitoring
Site GP028; H43:12, km 34.473 Two Creeks
Section C – 2025 Fall Readings**

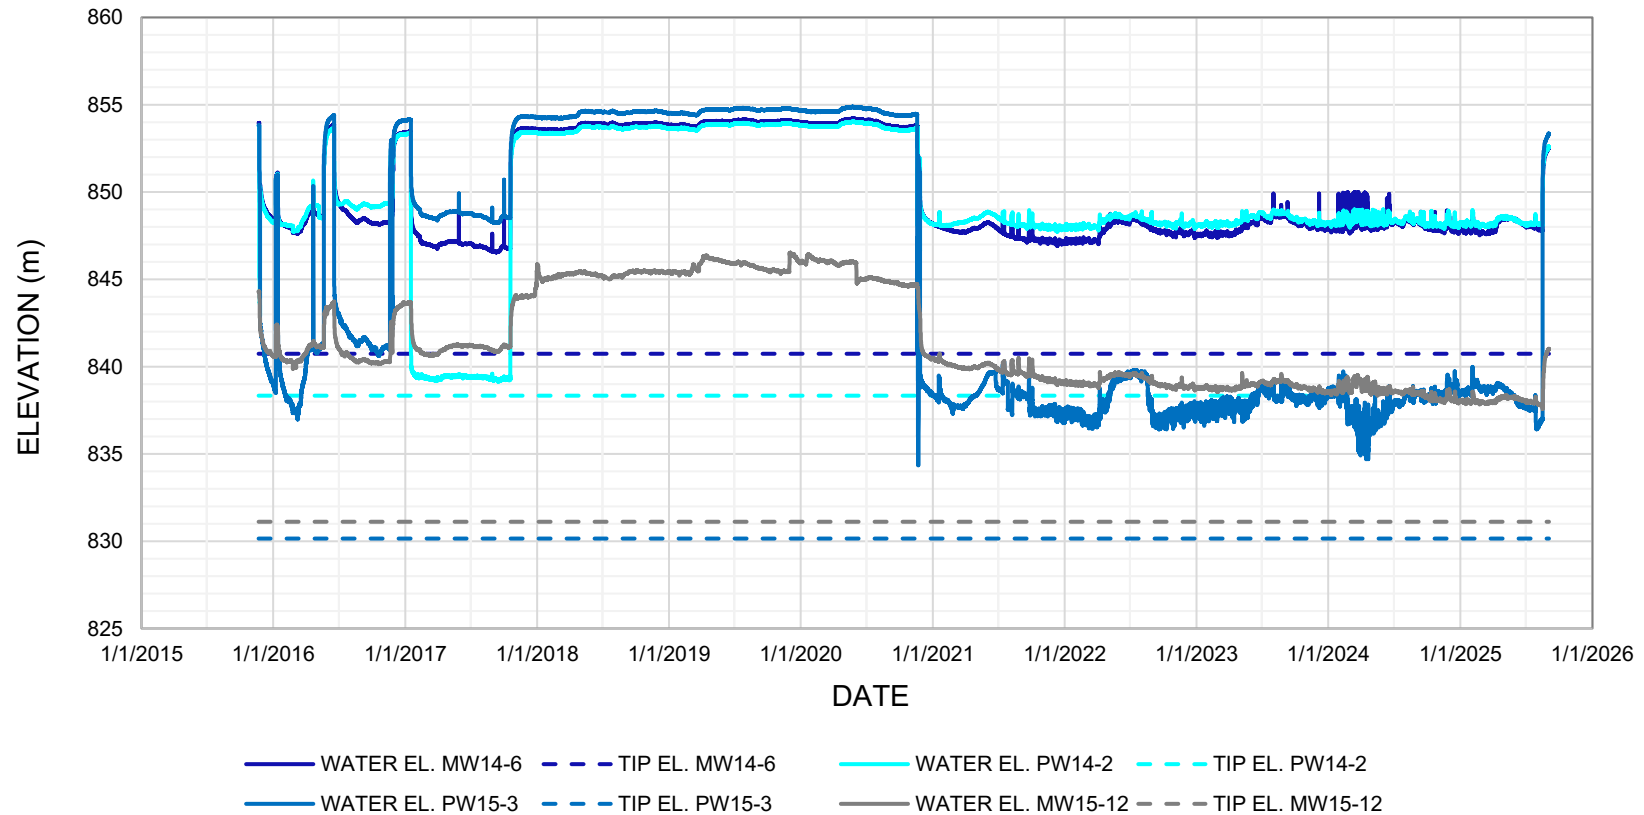
VWP Data from Central Monitoring Station

Since mid-August 2025, an increase in porewater pressure/water level (up to approximately 15 m) was recorded in the VWPs connected to the central monitoring station (PW14-2, MW14-6, PW15-3, and MW15-12). This increase, similar to the increase recorded between fall 2017 and fall 2020, is believed to be caused by the pumping wells not being operational. The pumping wells should be inspected and repaired before the onset of winter, so water levels can decrease before the ground freezes. It is noted that last time high water levels were recorded in these instruments, an increase in water level was also recorded in MW14-7 (monitoring well) and PW14-1 (pumping well), but an increase has yet to be recorded in these instruments at this time.

As discussed in Section 2.3, the pumping wells should be inspected and repaired before the onset of winter, so water levels can decrease before the ground freezes. A plan for routine inspections and maintenance of the pumps should be developed.

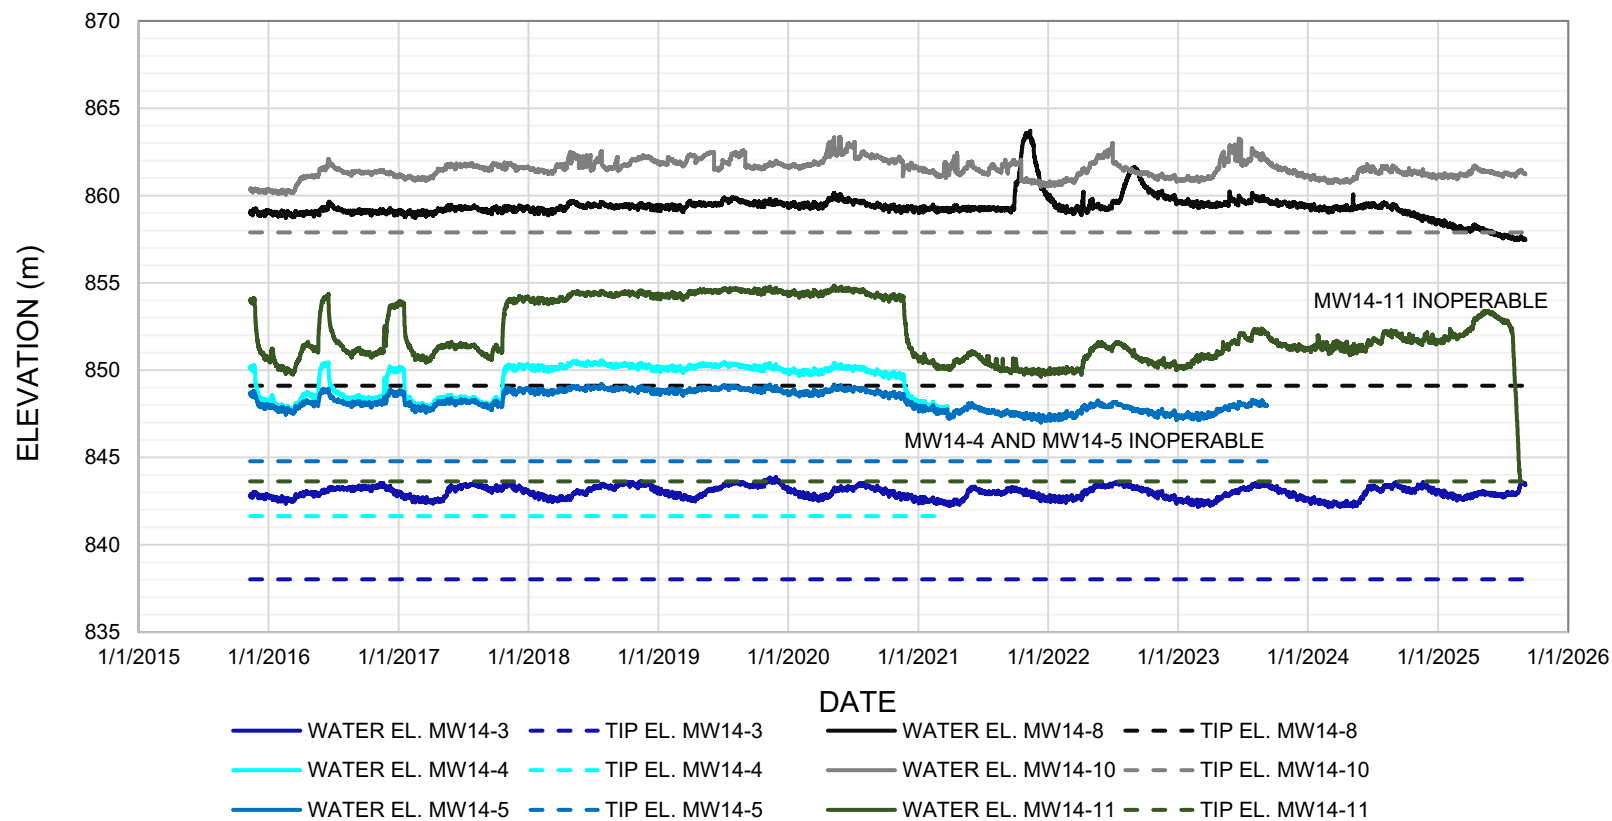
Levellogger Data

⁸ On March 24, 2021, the protective head boxes for MW14-4 and MW14-5 were struck by a vehicle, leaving MW14-4 inoperable. MW14-5 was inoperable during the spring 2024 readings.

The water level recorded in MW14-8 has been decreasing since the spring 2024 readings, which is inconsistent with water levels recorded in the other nearby instruments and could be an indication this instrument is failing. This instrument should continue to be monitored.

MW14-5, which was previously struck by a vehicle in March 2021, could potentially be repaired by removing the headbox, cutting back the casing, installing a new Solinst Levellogger or removing and repairing the existing Solinst Levellogger, which is currently not working and stuck in the casing below where it is bent.
