**PEACE REGION – GRANDE PRAIRIE
GEOHAZARD RISK ASSESSMENT
SITE INSPECTION FORM**

SITE NUMBER GP-30-a	SITE NAME Iosegun River valley crossing West backslope- Catchwater ditch slide	HIGHWAY & KM Hwy 43:12	PREVIOUS INSPECTION DATE May 21, 2013	INSPECTION DATE May 27, 2014
LEGAL DESCRIPTION LSD 2-35-61-18-W5M	NAD 83 COORDINATES N 6,018,494 E 526,876	PREVIOUS RISK ASSESSMENT PF: 10 CF: 3 TOTAL: 30 (downdrain failure)		
		CURRENT 2012 RISK ASSESSMENT PF: 10 CF: 3 TOTAL: 30 (downdrain failure)

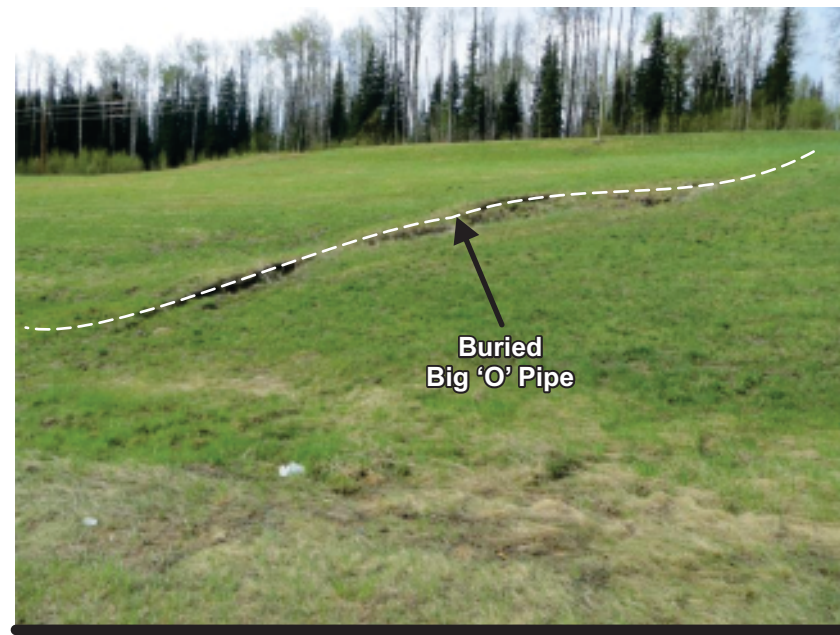
Photo 1

Looking west upgrade at backslope along eastbound lane

- Location of buried buried Big “O” (Elephant Trunk) pipe
- Which has suffered separation at joints and swashing at some sections

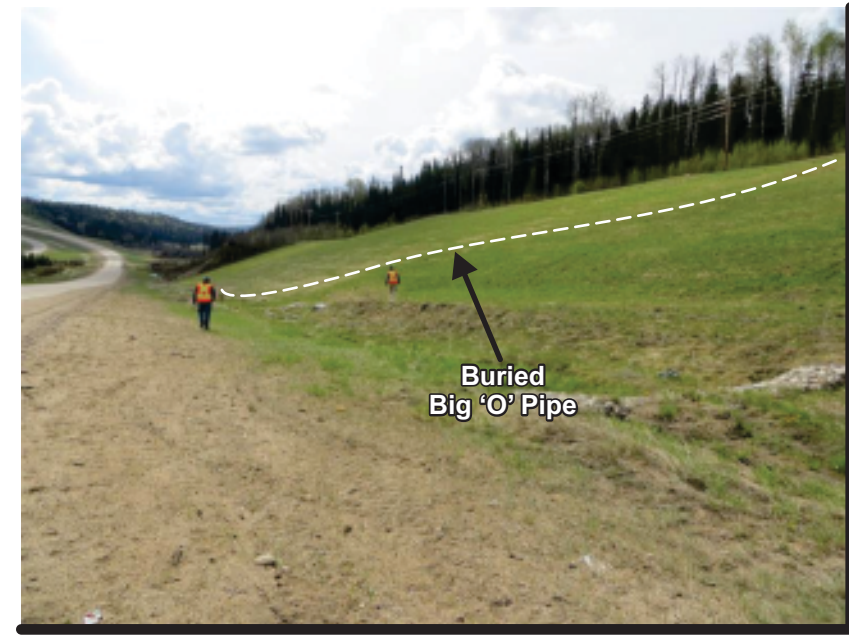
Photo 1a

Another view

- Looking south (towards WhiteCourt)

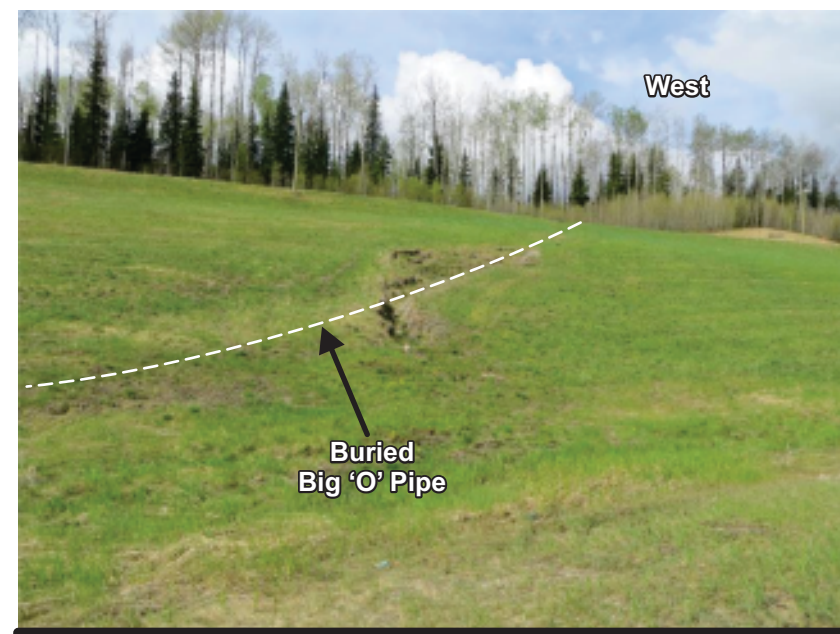
Photo 1b

Another View

- Subsidence of ground along buried pipe alignment have stabilized and not deteriorating

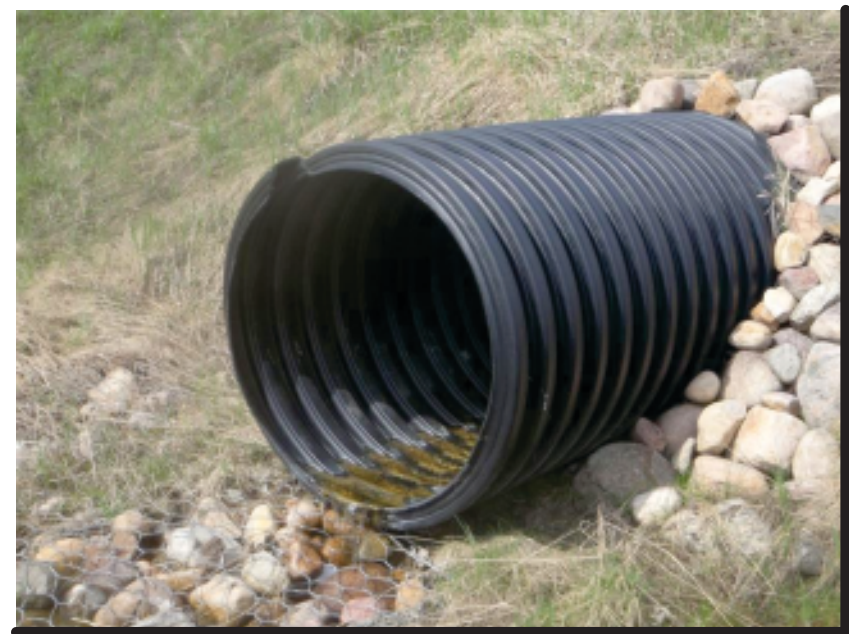
Photo 1c

Outlet of buried Big “O” pipe

- Water outflow onto ditch
- Water passage is functioning despite pipe damages

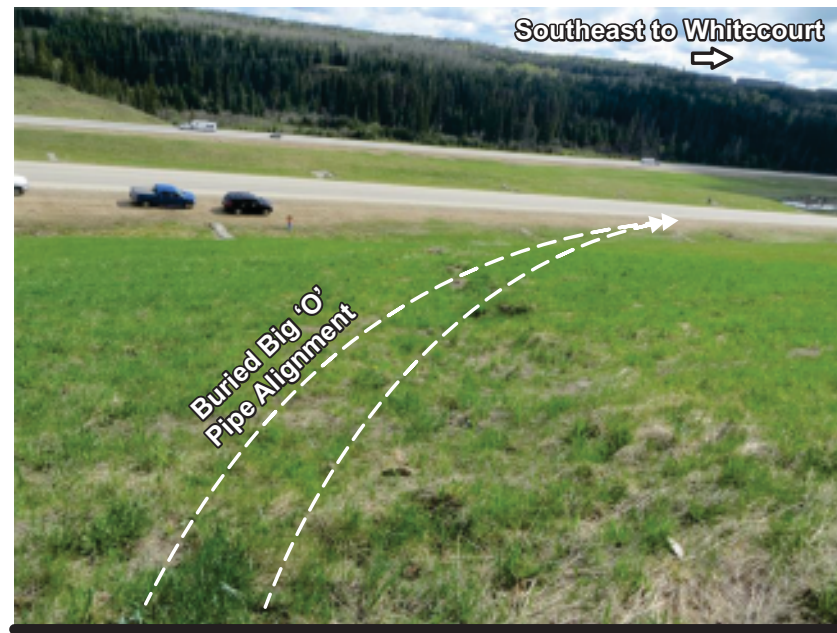
Photo 2

Looking from catchwater ditch from top of backslope

- Backslope not too affected by minor subsidence of soil due to erosion washout from separation of pipe sections
- Backslope in survivable acceptable conditions

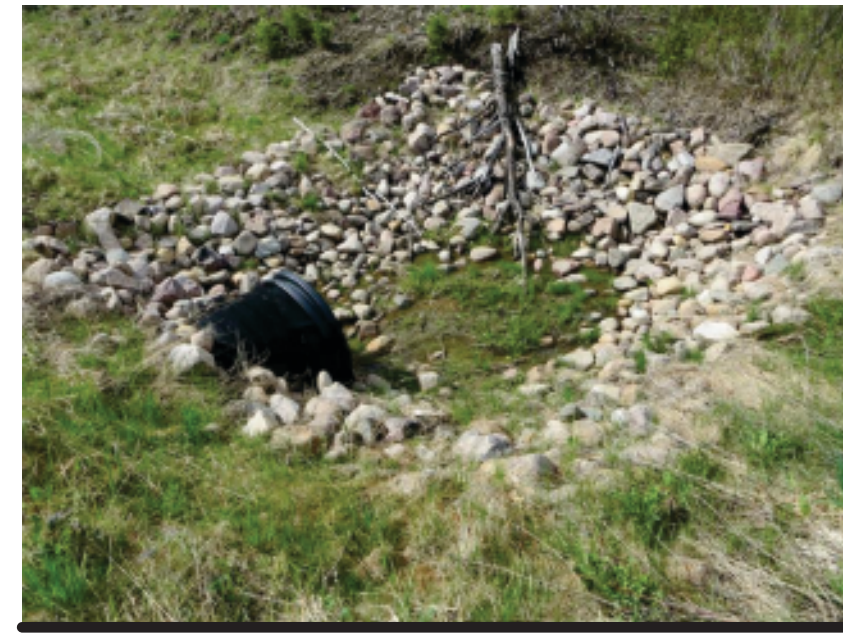
Photo 2a

Catchwater Ditch and pipe inlet conditions

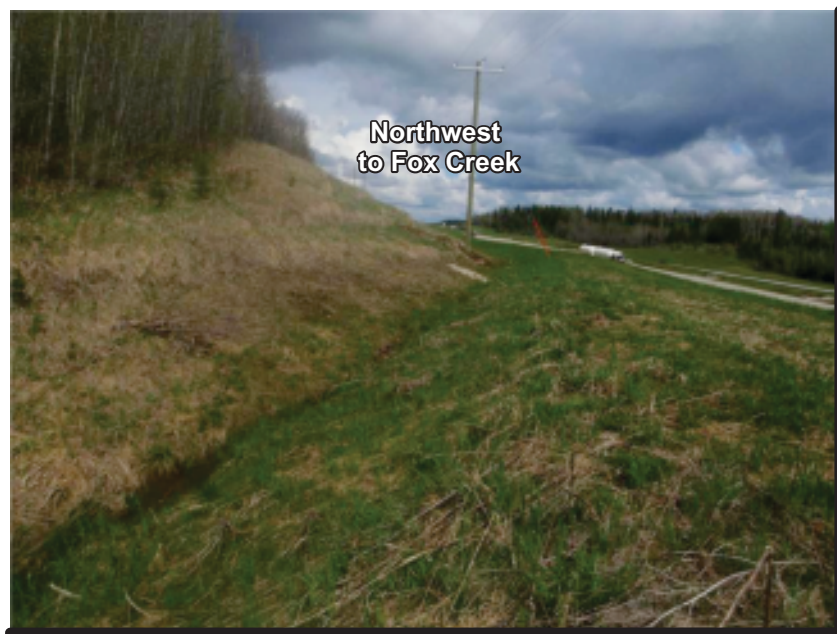
Photo 2b

Catchwater ditch section (top of backslope) at its westerly section prior to flow entry into pipe

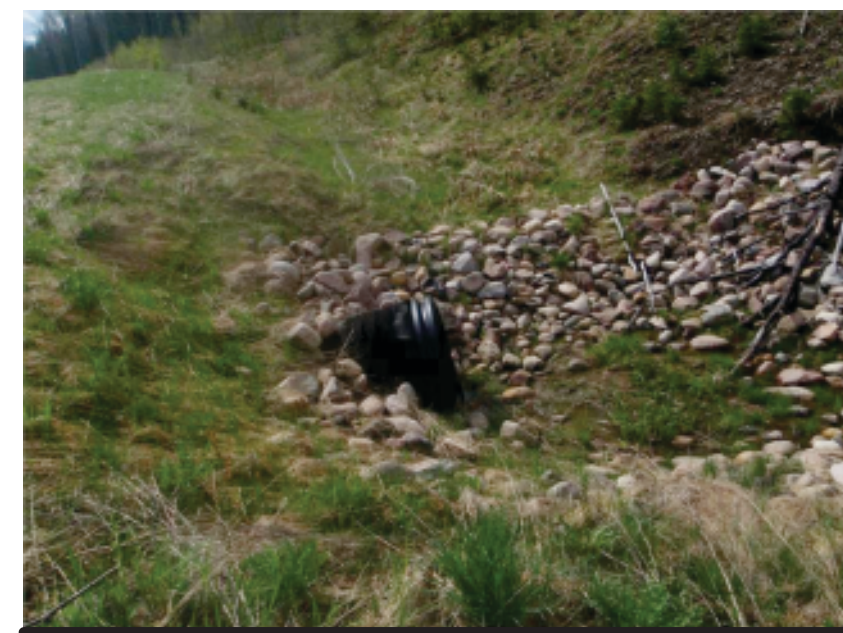
Photo 2c

Catchwater Ditch and pipe inlet conditions
