**PEACE REGION – GRANDE PRAIRIE
GEOHAZARD RISK ASSESSMENT
SITE INSPECTION FORM**

SITE NUMBER GP-30-a	SITE NAME Iosegun River valley crossing West backslope- Catchwater ditch slide	HIGHWAY & KM Hwy 43:12	PREVIOUS INSPECTION DATE May 27, 2014	INSPECTION DATE May 26, 2015
LEGAL DESCRIPTION LSD 2-35-61-18-W5M	NAD 83 COORDINATES N 6,018,494 E 526,876	PREVIOUS RISK ASSESSMENT PF: 10 CF: 3 TOTAL: 30 (downdrain failure)		
		CURRENT 2012 RISK ASSESSMENT PF: 10 CF: 3 TOTAL: 30 (downdrain failure)

**GP-30a, Hwy. 43:12
Iosegun River
West Backslope (Catchwater Ditch) Slide
Page 1 of 2**

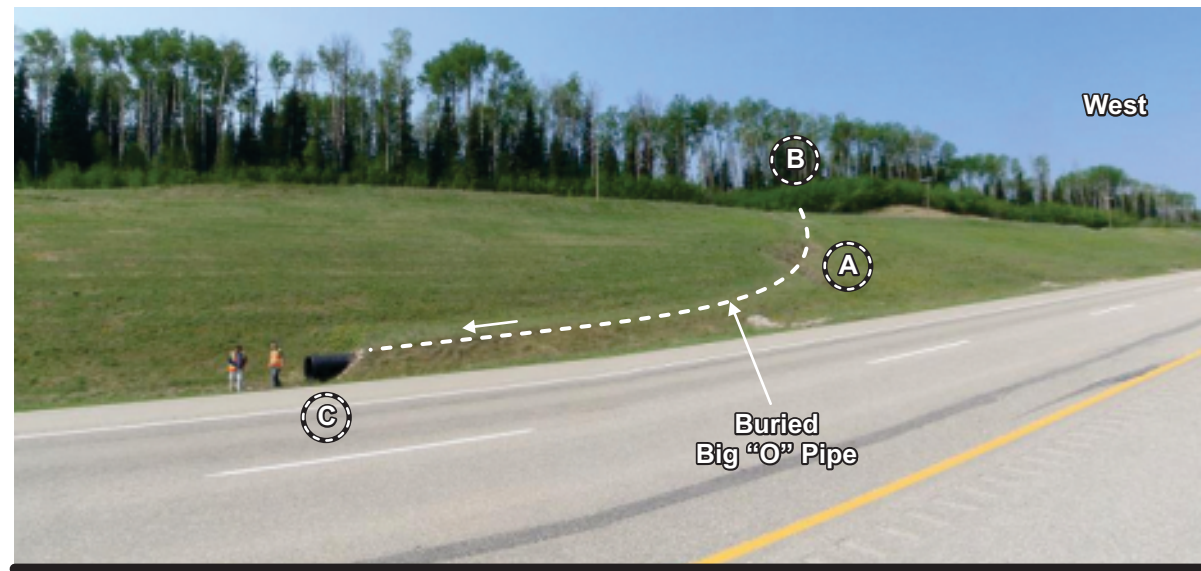
Photo 1

Looking west upgrade at backslope along eastbound lane

- Location of buried Big “O” (Elephant Trunk) pipe B-A-C
- Which has suffered separation at joints and swashing at some sections to result leakage
- Subsidence of ground along buried pipe alignment to have stabilized and not deteriorating
- Backslope in survivable acceptable conditions

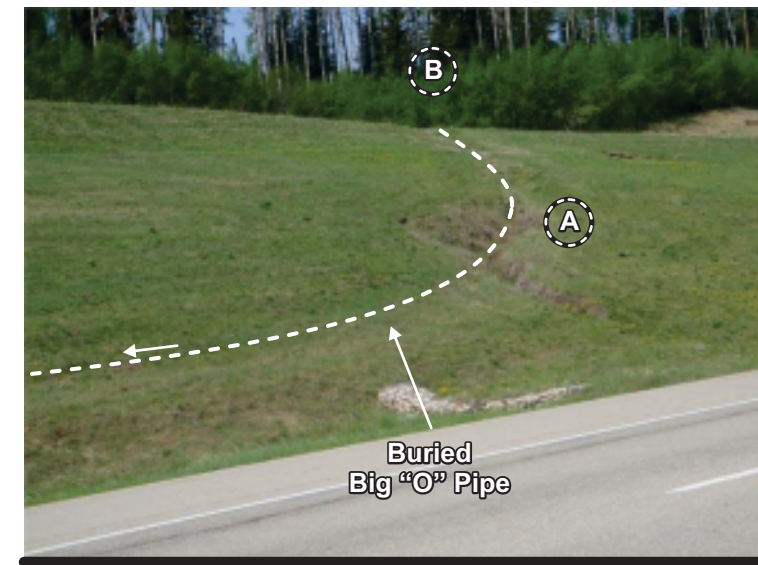
Photo 1a

Looking west upgrade at backslope along eastbound lane

- Location of buried Big “O” (Elephant Trunk) pipe B-A-C
- Which has suffered separation at joints and swashing at some sections to result leakage
- Subsidence of ground along buried pipe alignment to have stabilized and not deteriorating
- Backslope in survivable acceptable conditions

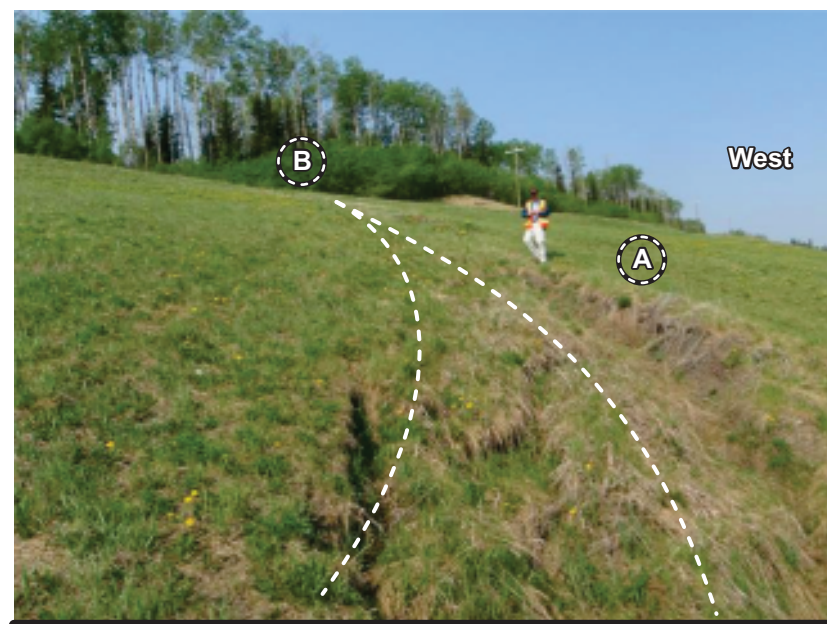
Photo 1b

Slumping and erosion location along buried pipe due to leakage

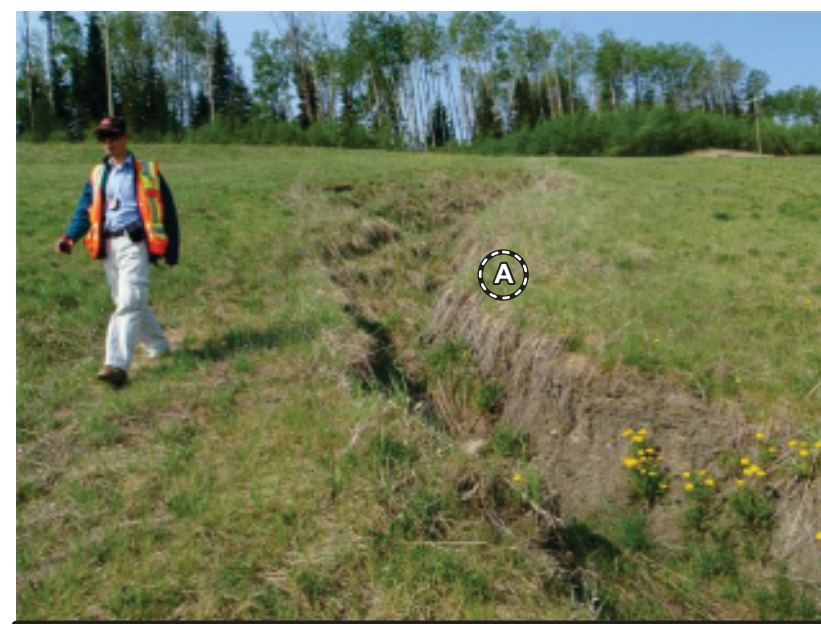
Photo 1c

Slumping and erosion location along buried pipe due to leakage

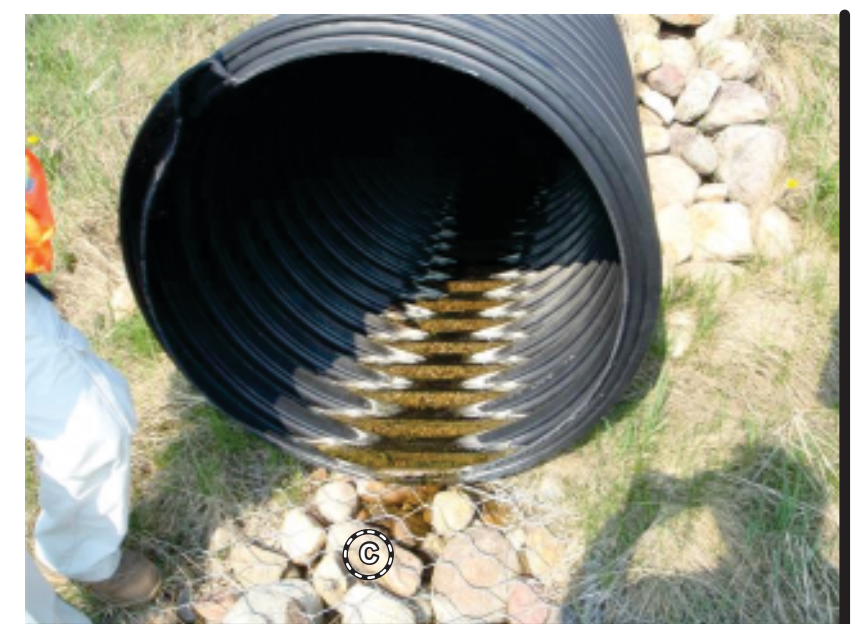
Photo 1d

Outlet of Big “O” pipe

- Water outflow functioning despite pipe leakages

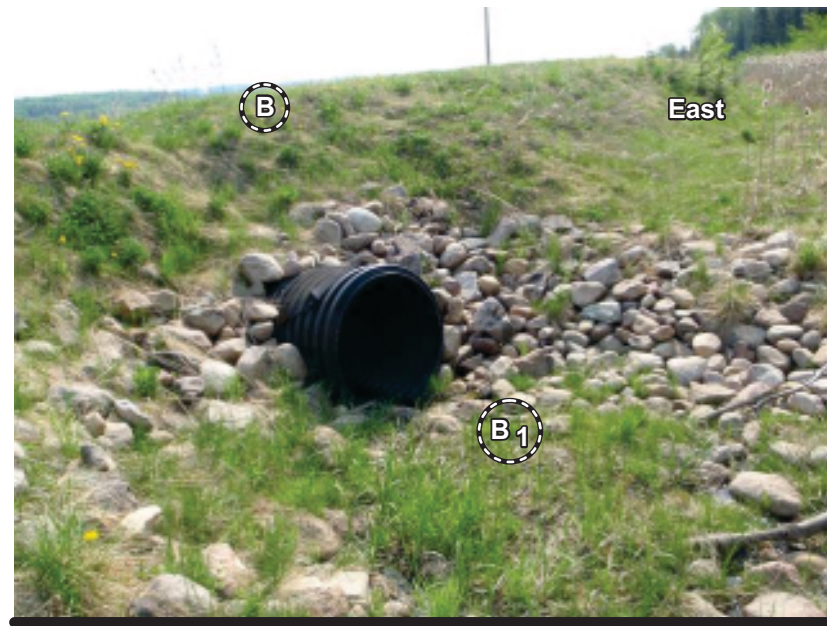
Photo 2
Top of backslope and catchwater ditch
 • Inlet of buried big “O” for inflow from catchwater ditch

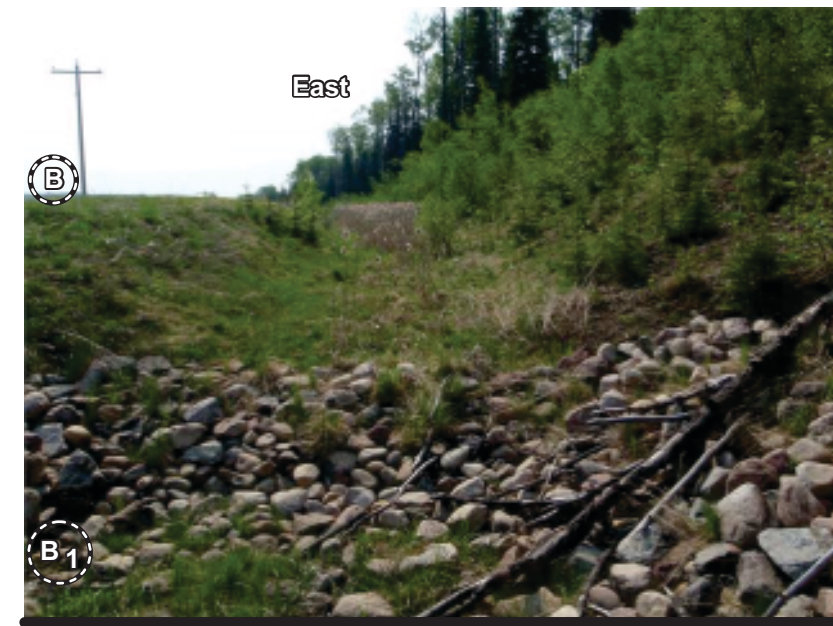
Photo 2a
Catchwater Ditch inflow sections (east end and west end)

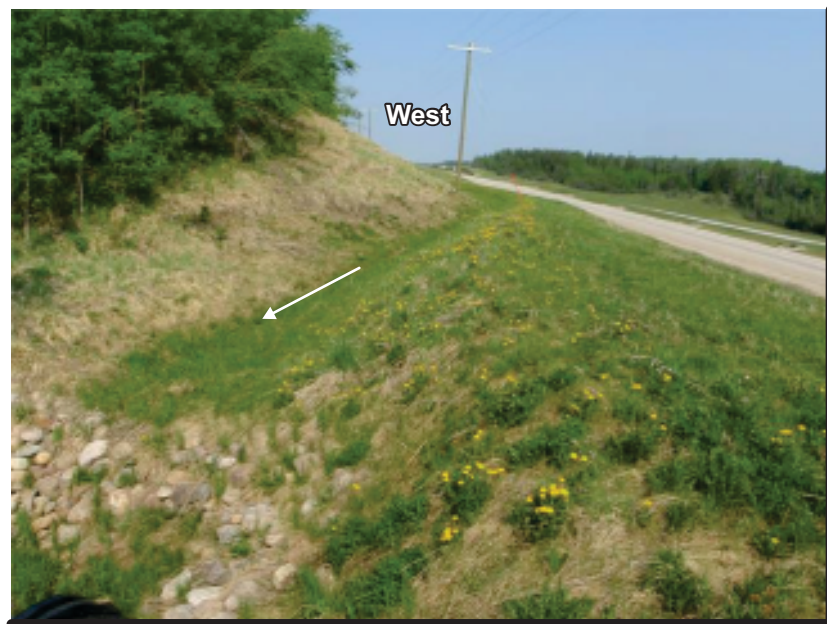
Photo 2b
Catchwater Ditch inflow sections (east end and west end)

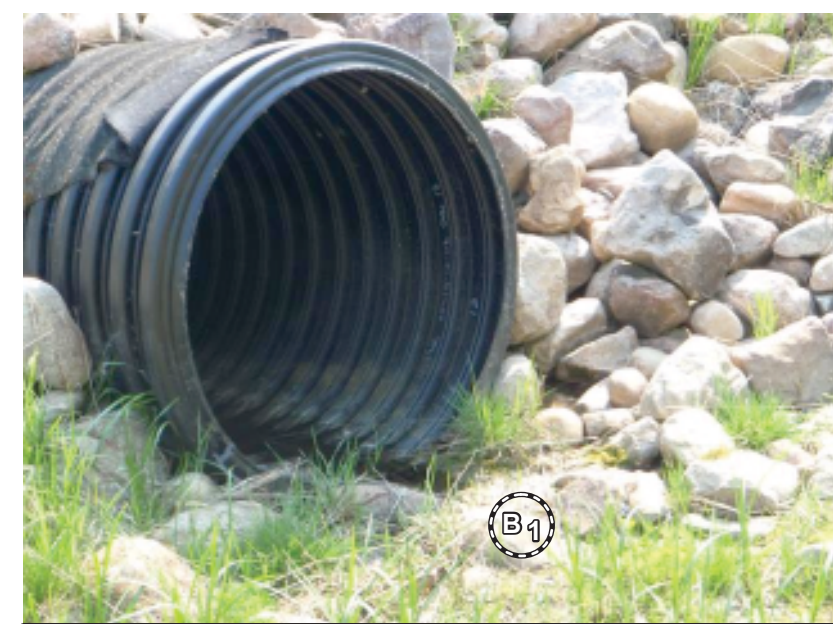
Photo 2c
Top of backslope and catchwater ditch
 • Inlet of buried big “O” for inflow from catchwater ditch
