**ALBERTA TRANSPORTATION
GEOHAZARD ASSESSMENT PROGRAM
PEACE REGION – GRANDE PRAIRIE DISTRICT
2020 INSPECTION**

Site Number	Location	Name	Hwy	km
GP30	East of Fox Creek	Iosegun River (0.5 km W Bridge)	43:12	16.5
Legal Description		UTM Co-ordinates (NAD 83)		
SW35-61-18-W5		11U N 6,018,815	E 526,395

Date	PF	CF	Total
Previous Inspection:	May 13, 2019	11	2	22
Current Inspection:	June 18, 2020	12	2	24
Road AADT:	7,560	Year:	2019	
Inspected By:	Barry Meays (Thurber) Roger Skirrow, Ed Szmata (AT)			
Report Attachments:	<input checked="" type="checkbox"/> Photographs <input checked="" type="checkbox"/> Plans <input checked="" type="checkbox"/> Maintenance Items

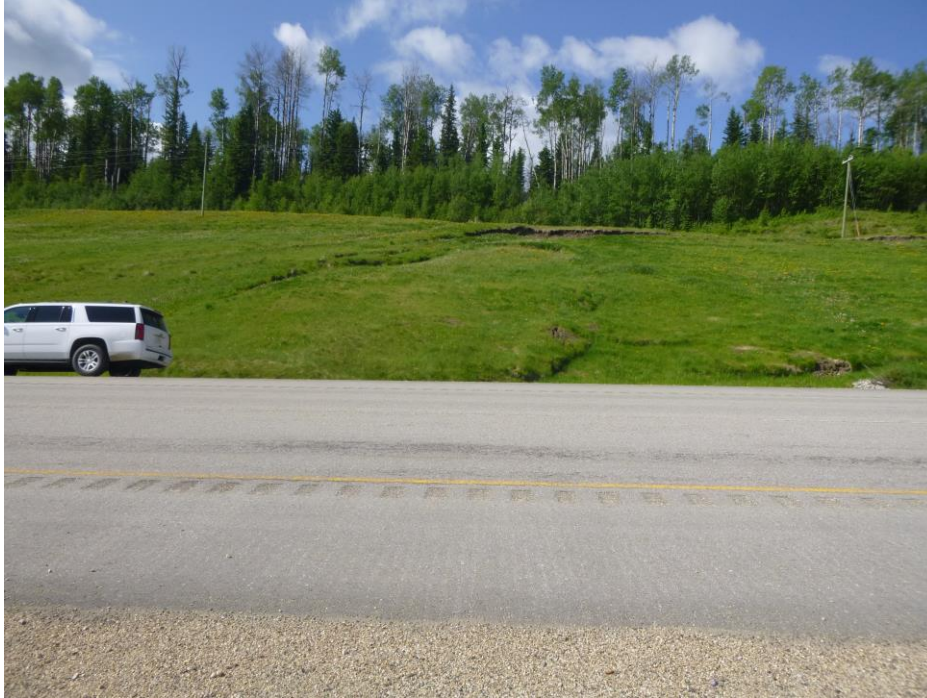
Photo 1 – Looking south (upslope) at the east side of the embankment slide that has fresh movement adjacent to the buried 960 mm diameter “Big O” pipe alignment just east of the slide.

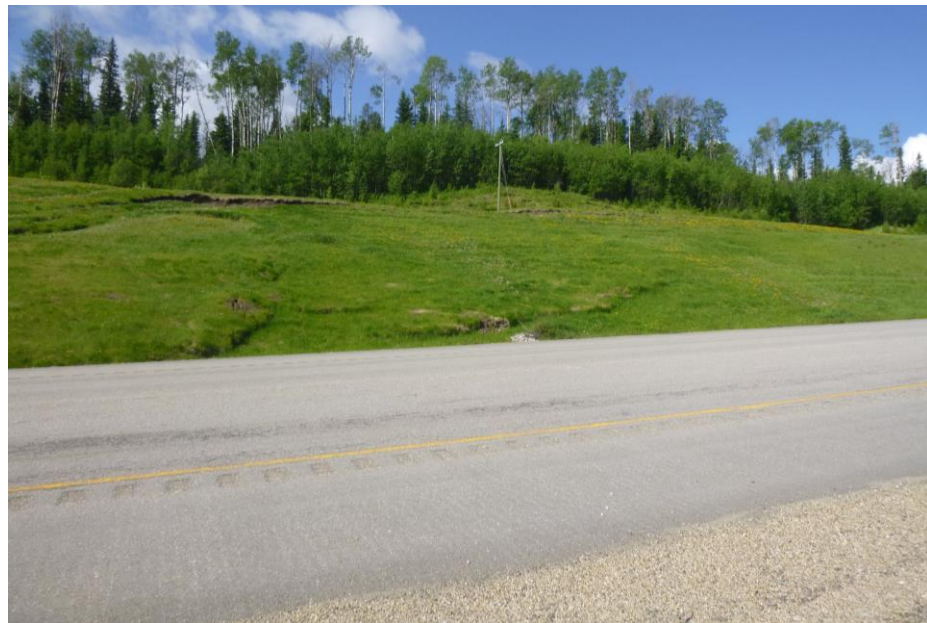
Photo 2 – Looking southeast (upslope) from the highway at the enlarged west side of the embankment slide.

AND 2) The west slump will need to be repaired for either option above, by excavating out the material to below the slide plane, installing a subdrain(s) along the base that outlets into the ditch, and re-compacting the salvaged clay material in place (assume 3m deep average).

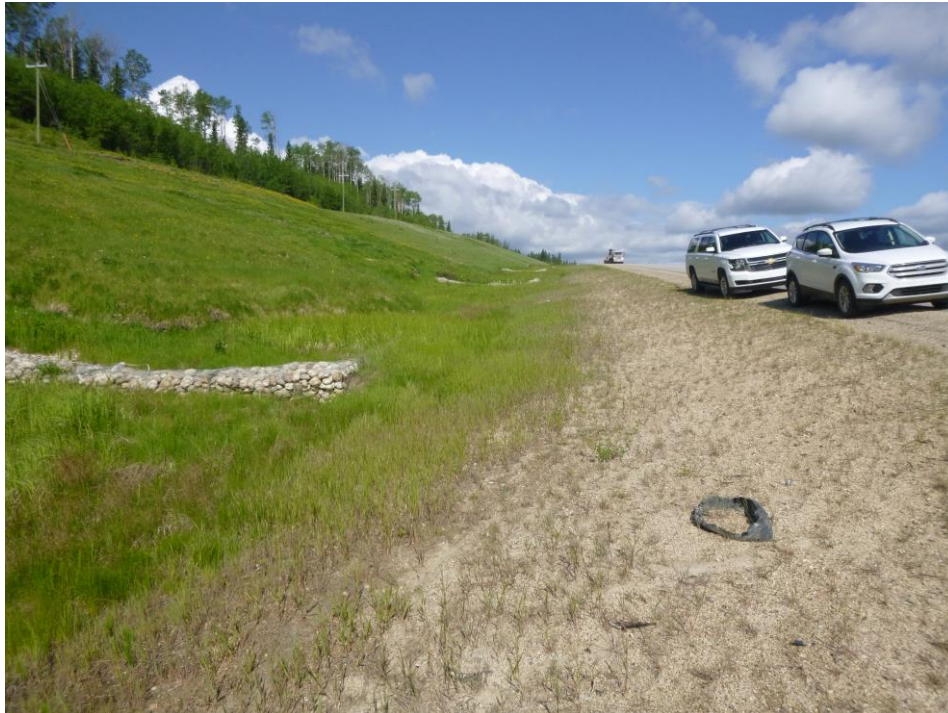
Photo 3 – Looking west at the fresh slide toe encroaching into the south hwy ditch.

Although OK now, the east bound (south) highway ditch at either slide location may need periodic cleaning of toe debris that accumulates if the slide(s) continue to move.

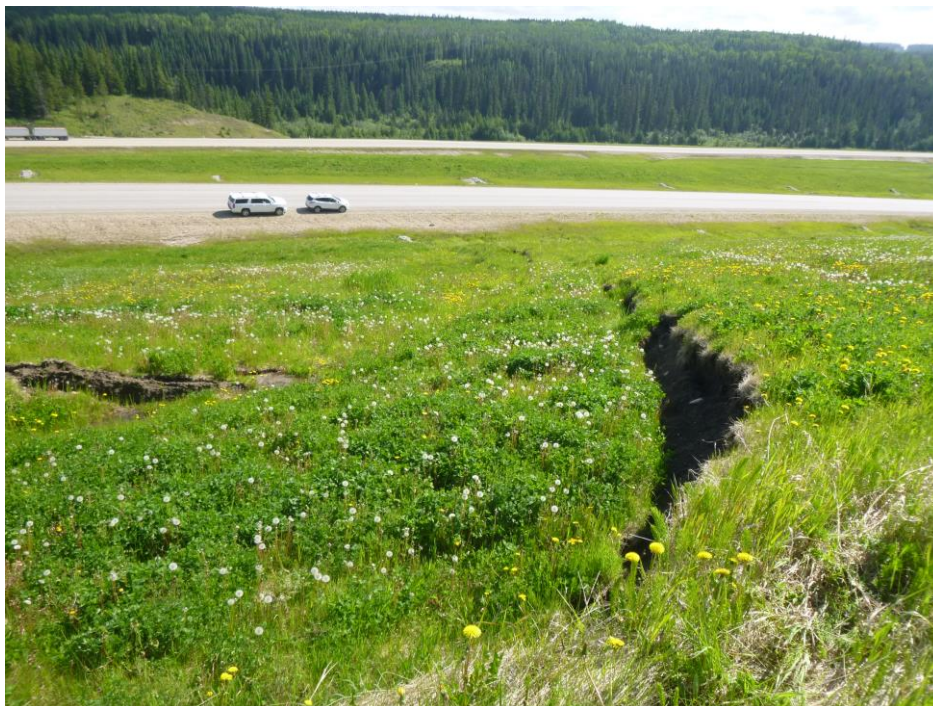
Photo 4 – Looking north downslope along the east edge of the fresh slide.

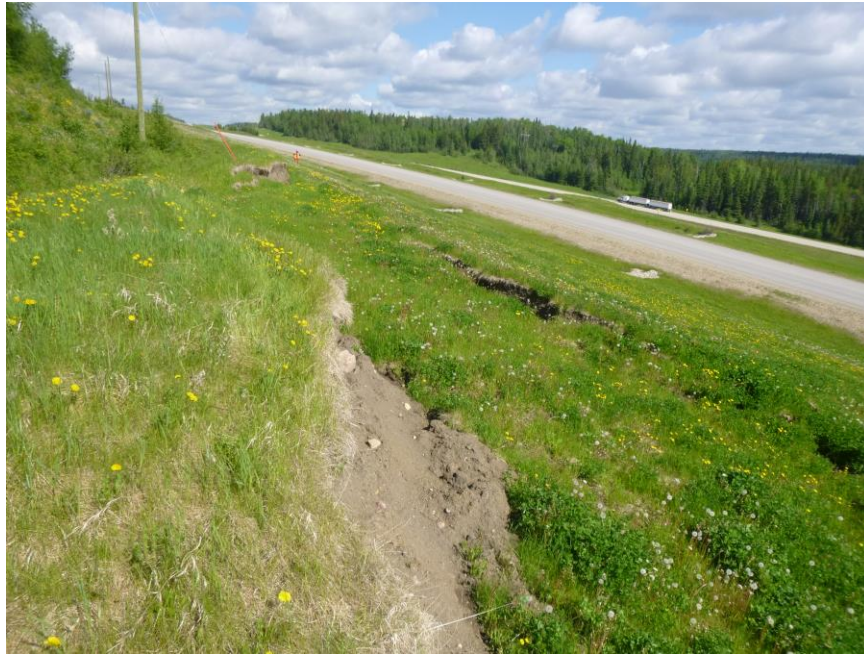
Photo 5 – Looking west along the top of the fresh slide scarp just below the catch water ditch. Note the power pole anchor in the background still intact in a mound of soil but which could soon lose support.

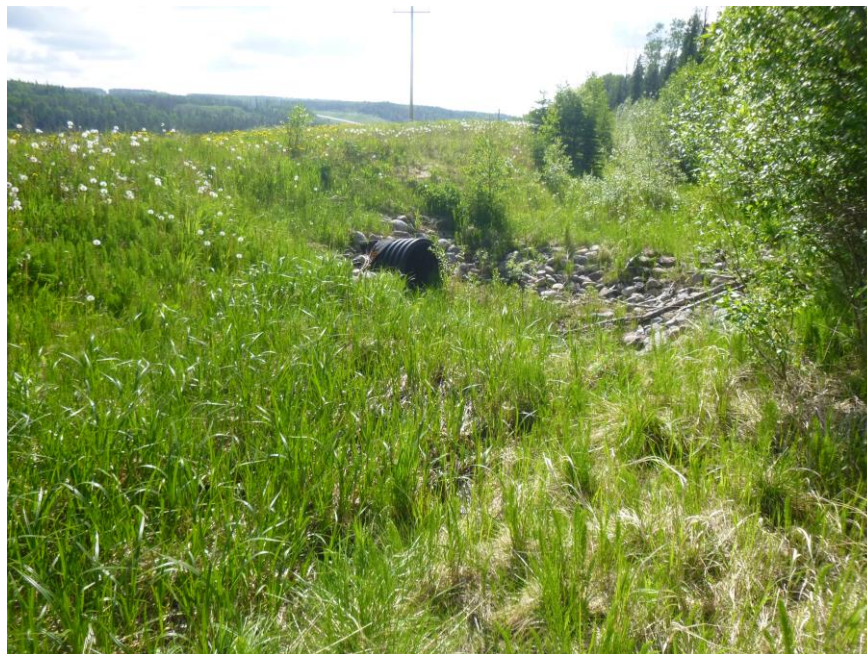
Photo 6 – Looking east along the catch water ditch towards the inlet of the Big O pipe (the inside is squashed on top).

Excavate out, remove and dispose of the existing 960 mm Big O pipe west of the river. Then reconstruct the eroded/settled slope area by either:

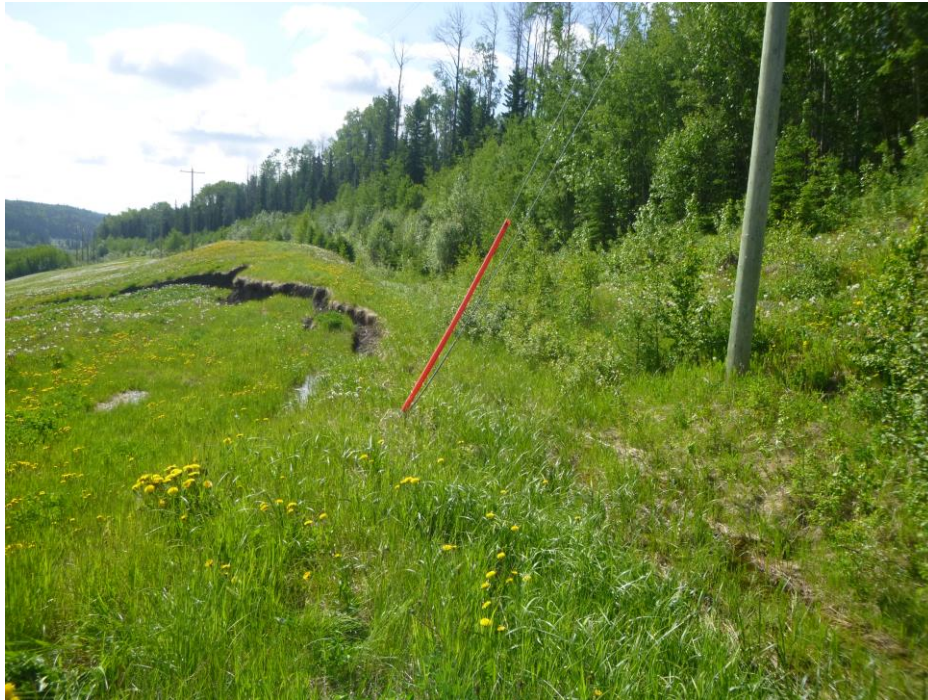
Photo 7 – Looking east along the new slide scarp at the power pole, anchor, and the point where the catchwater ditch breached a short distance east of the power pole anchor.

The erosion and slumps should be regularly monitored for deterioration and enlargement. Install subdrains to control the intermittent seepage that is occurring adjacent to the pavement westbound lanes. Repair the breached catchwater ditch berm by constructing an ~10m long x 2 m high berm in place to redirect catchwater ditch drainage into the Big O pipe inlet further downslope (east).

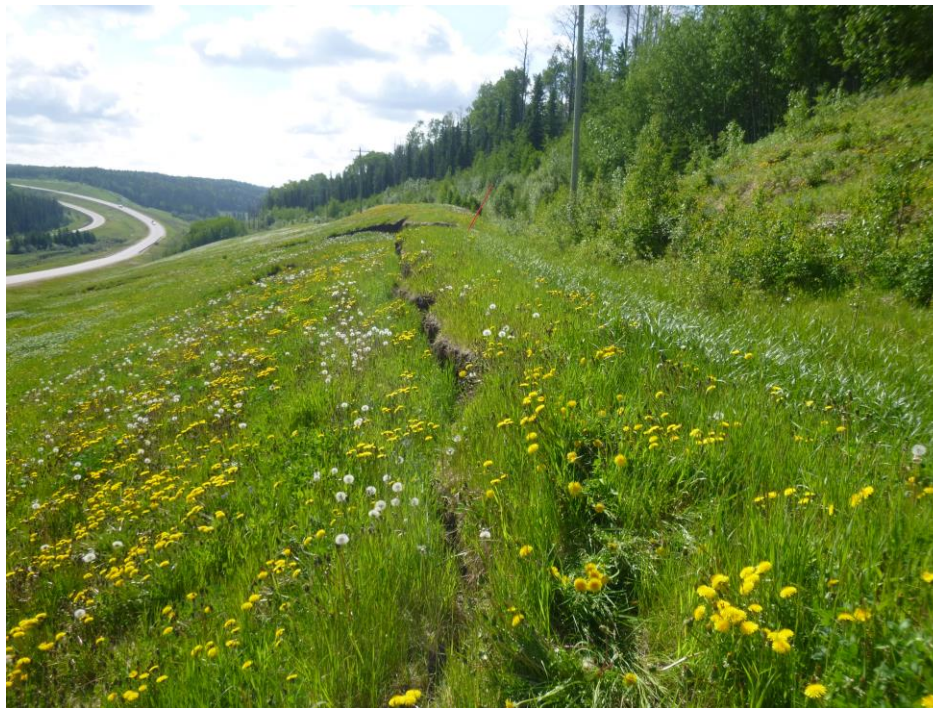
Photo 8 – Looking east along the catchwater ditch and the top of the new slide scarp from the west end.

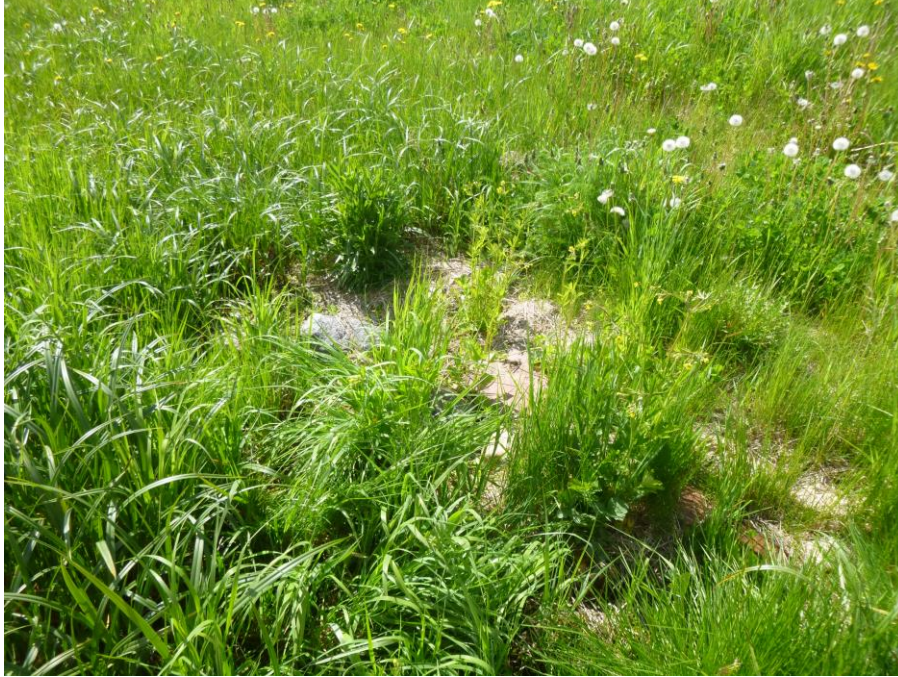
Photo 9 – Looking at a puddle of water on some riprap west of the new slide toe. This may be a possible subdrain outlet.

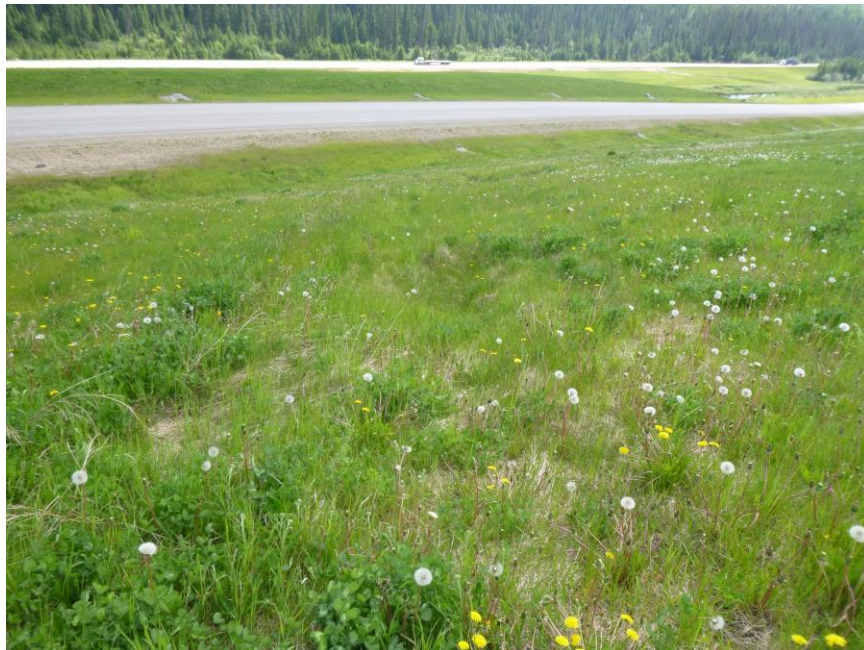
Photo 10 – Looking northeast downslope from ~mid-slope along the settled area and erosion overtop the culvert alignment. Note the settling ponds in the median in the photo background.

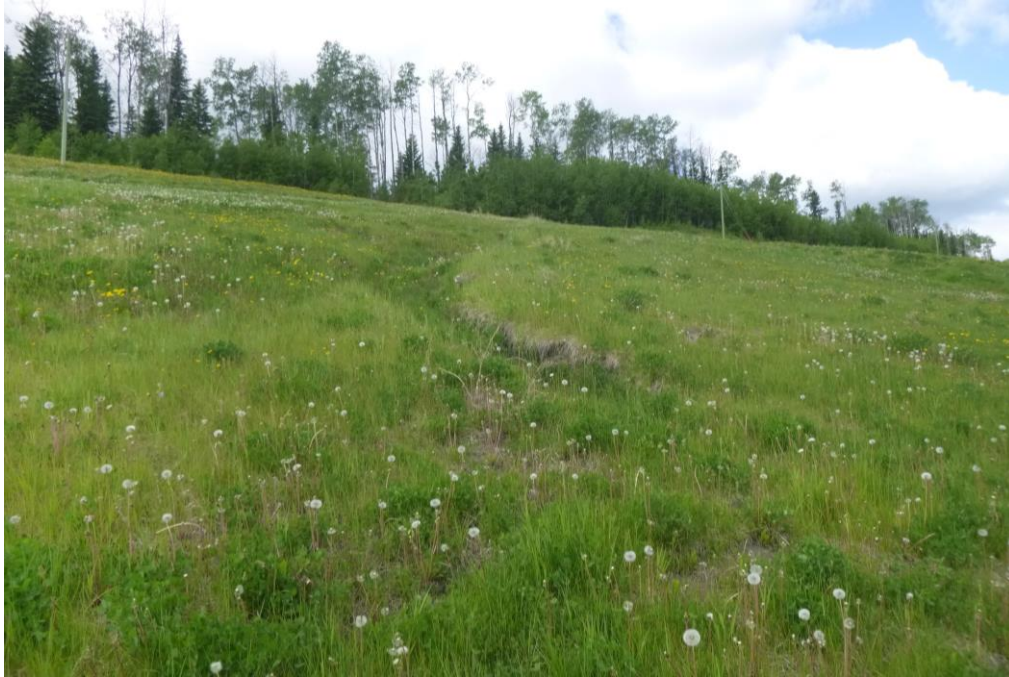
Photo 11 – Looking southwest (upslope) at the sunken depression and erosion overtop the culvert alignment.

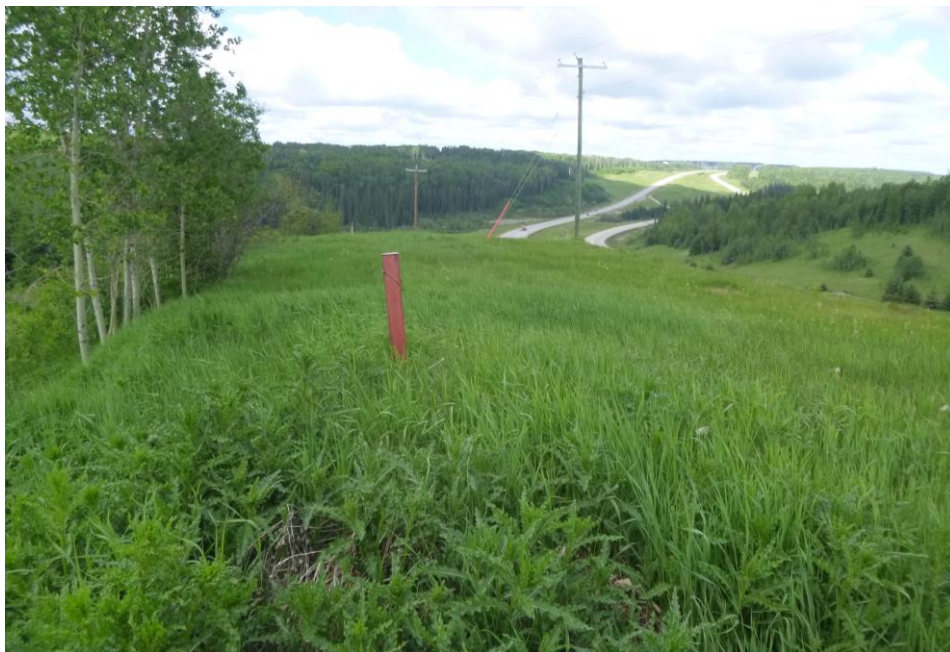
Also as part of the hwy EB lane twinning in ~2002, a vertical inclinometer was installed between the top of the south cut backslope and a pipeline running east-west, for early warning of potential movements in the event the slump on the lower third of the south backslope enlarges which could endanger the pipeline.

Photo 12 – Looking west along the top of the south cut backslope east of the river. Note the inclinometer casing, which was put in as an early warning indicator of potential movement adjacent to a pipeline if the slump below enlarges.

The inclinometer between the backslope slump and the pipeline east of the river should be added into the biannual instrumentation monitoring program to warn of any potential retrogressive movements related to the backslope slump.

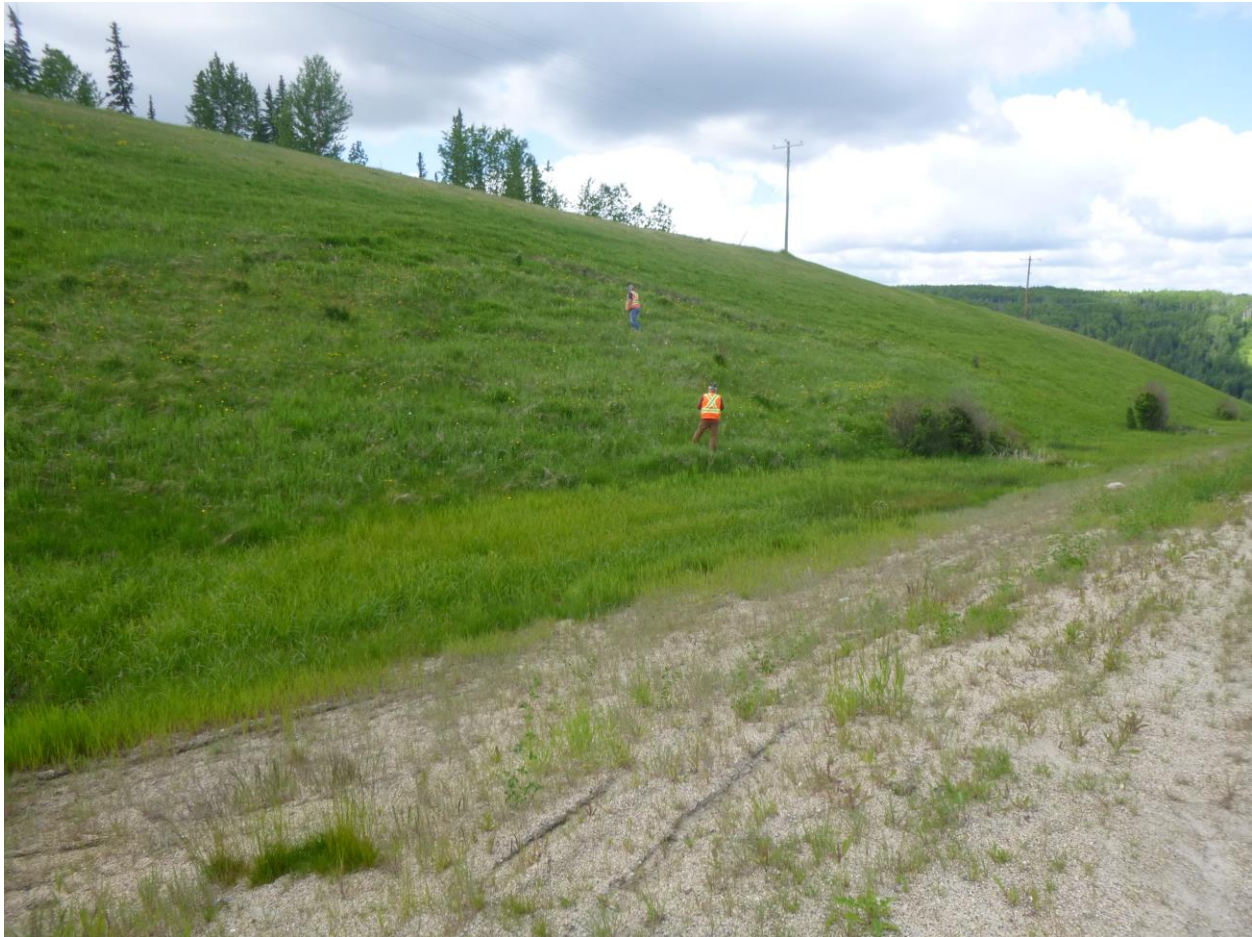
Photo 13 – Looking southwest towards the south cut backslope slide east of the river from the eastbound lanes.

The backslope slump east of the river will also need to be repaired. Due to the higher consequence of failure resulting from a pipeline behind the backslope, it is recommended that the slide be excavated and backfilled in stages with granular fill, topped with topsoil, soil covering and seed. The SI should be read to guide construction and ensure that excessive ground movements are not occurring near the pipeline.
