SITE INSPECTION FORM

SITE NUMBER AND NAME: GP030 Iosegun River Valley Crossing		HIGHWAY & KM: 43:12, 16.726	PREVIOUS INSPECTION DATE: June 18, 2020	INSPECTION DATE: June 16, 2022
LEGAL DESCRIPTION: SW 35-61-18-W5M	NAD 83 COORDINATES: UTM Northing Easting 11 6018758 526645		RISK ASSESSMENT: PF: 8 CF: 2 TOTAL: 16	
AVERAGE ANNUAL DAILY TRAFFIC (AADT): 6290 (west) & 6020 (east) (Reference No. 37630, 2021)			CONTRACT MAINTENANCE AREA (CMA): 504

PEACE REGION
(GRANDE PRAIRIE DISTRICT – SOUTH) GRMP
SITE INSPECTION FORM

PROJECT
 PEACE REGION (GRANDE PRAIRIE DISTRICT-SOUTH)
 GEOHAZARD RISK MANAGEMENT PROGRAM

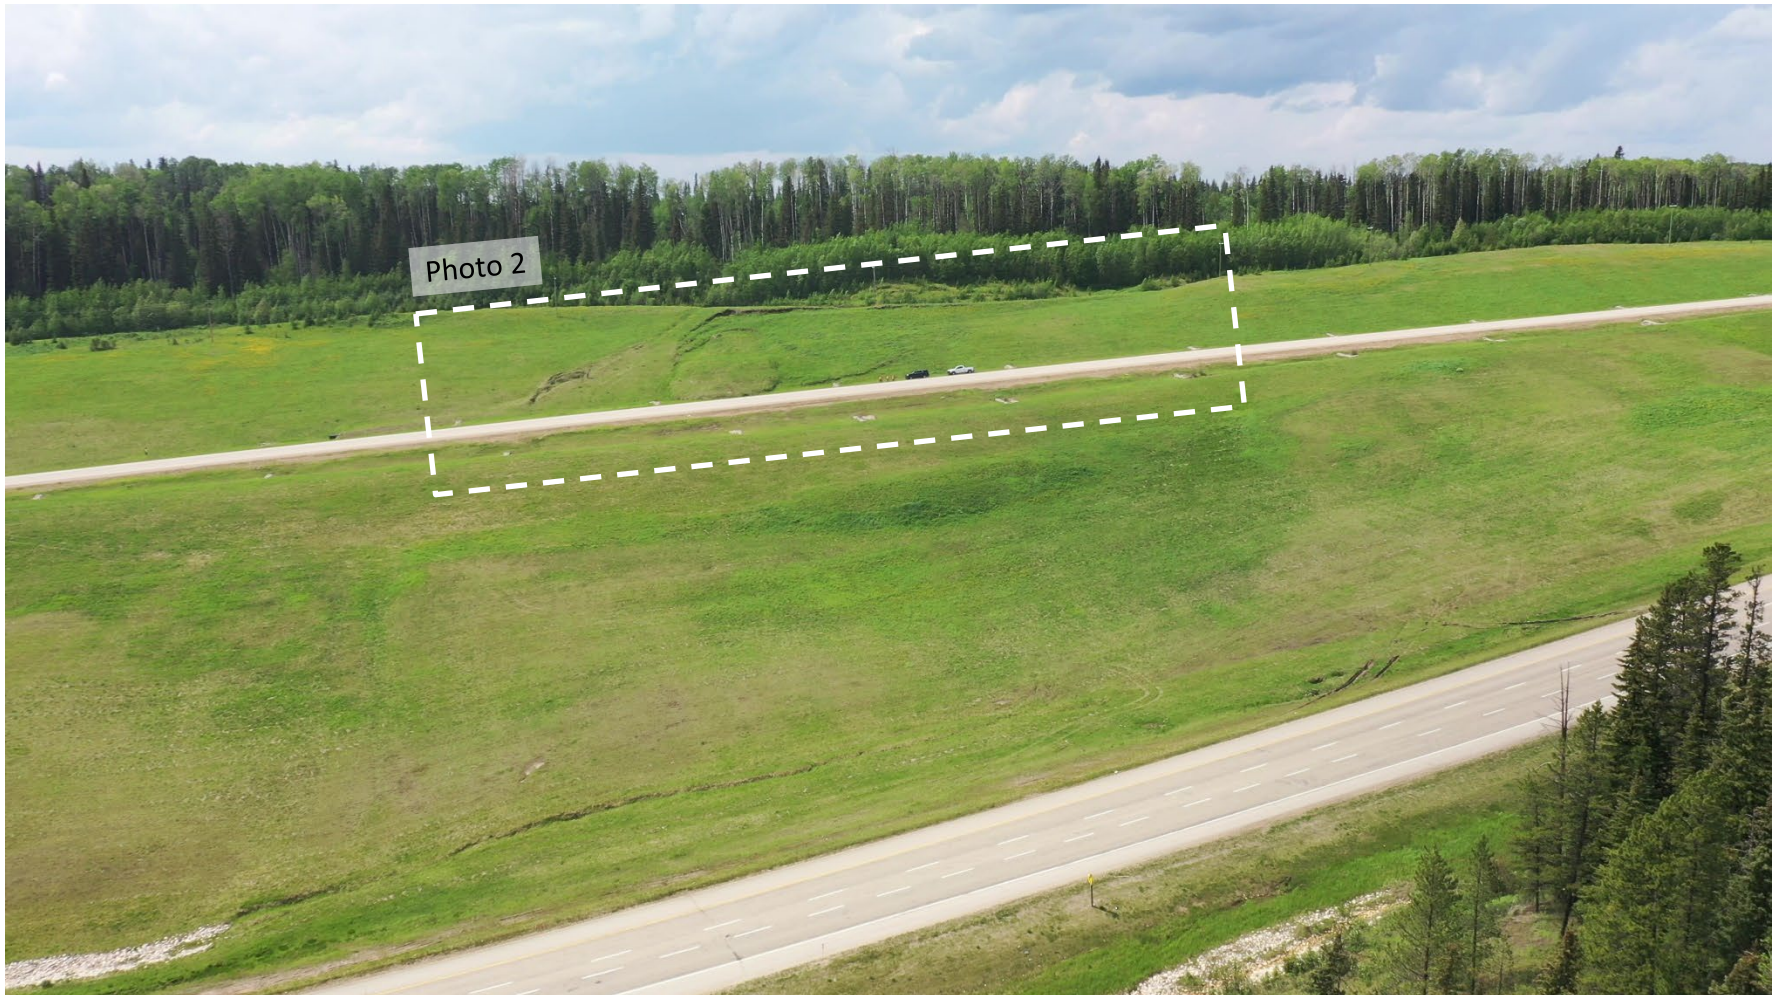
Photo 1 Overview of GP030 site along Hwy 43:12. Photo taken June 16, 2022, with unmanned aerial vehicle (UAV) facing northwest.

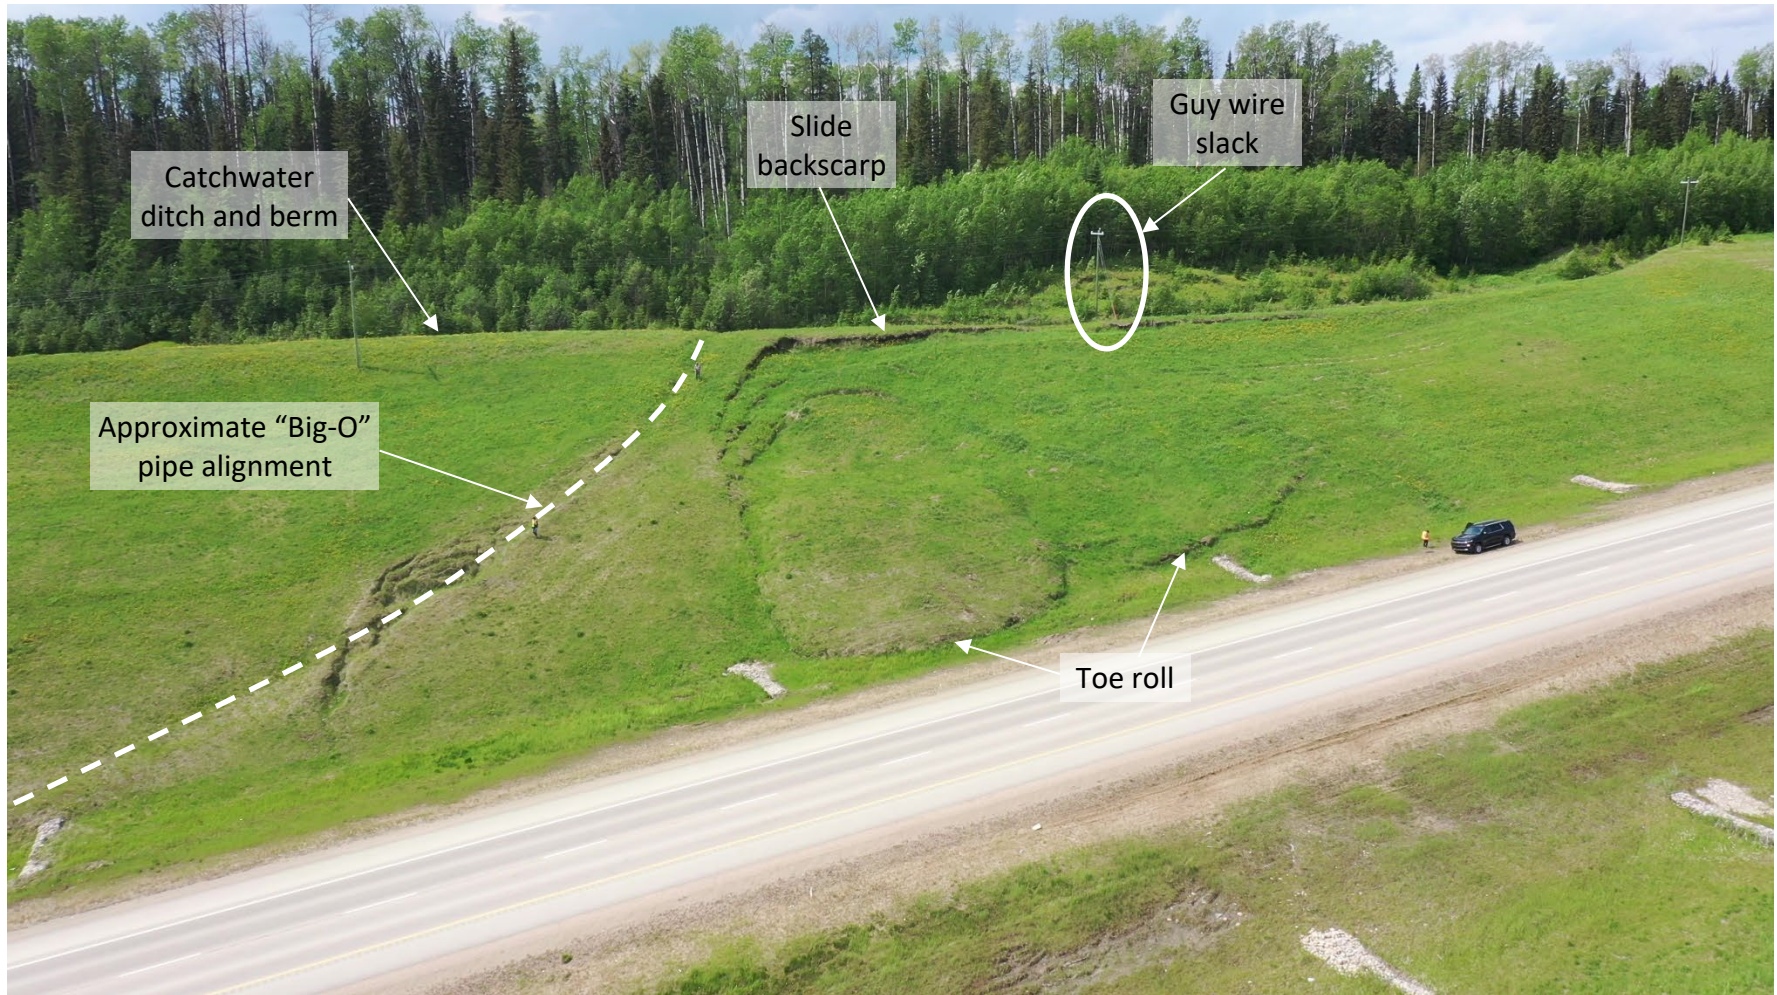
ITEM	CONDITION EXISTS		DESCRIPTION AND LOCATION	NOTICABLE CHANGE FROM LAST INSPECTION	
	YES	NO		YES	NO
Pavement Distress		X	None observed at time of 2022 inspection.		X
Slope Movement	X		Slope failure on west side of buried “Big O” pipe. Extends from backslope crest to west highway ditch. Portion of backscarp along diversion ditch at crest of backslope. Portion of toe roll in west highway ditch, but not currently impeding flow or impacting check dams.	X	
Erosion	X		Sinkholes at WP231 and WP233 above “Big O” pipe on backslope indicating possible piping erosion. Rill and gully erosion above “Big-O” pipe on backslope (at widest/deepest approximately 3.0 m wide by 1.5 m deep).	X	
Seepage	X		Seepage into/out of “Big-O” pipe on slope.		X
Culvert Distress	X		“Big-O” pipe separated confirmed via video in 2011.		X

Photo 2 Slope failure in backslope along west side of Hwy 43:12. Note toe roll in west highway ditch, and slide backscarp and slack power-pole guy wire (circled in white) at WP229 along backslope crest. As well as material slumping, settling, and eroding above “Big-O” pipe (alignment indicated with dotted white line, inlet at WP230 and outlet at WP234). Photo taken June 16, 2022, facing with UAV facing west.

<p><u>Maintenance/Repair/Monitoring Recommendations:</u></p> <ul style="list-style-type: none"> • A series of finger drains (approximately 4 m deep and spaced approximately 10 m apart) backfilled with gravel could be constructed into the backslope to intercept groundwater. Estimated cost: \$50,000 to \$100,000. • Another “Big-O” pipe or slope drain could be constructed to convey water from the diversion ditch to the west highway ditch. Estimated cost: \$50,000 to \$75,000. • Slack power-pole guy wire at crest of backslope at WP229. Anchored adjacent to slide backscarp. Relocated power pole.
<p>This report is an instrument of service of Klohn Crippen Berger (KCB). The report has been prepared for the exclusive use of Alberta Transportation (Client) for the specific application to the Peace Region (Grande Prairie District – South) Geohazard Risk Management Program (Contract No. CON0022166) and it may not be relied upon by any other party without KCB's written consent.</p> <p>KCB has prepared this report in a manner consistent with the level of care, skill and diligence ordinarily provided by members of the same profession for projects of a similar nature at the time and place the services were rendered. KCB makes no warranty, express or implied.</p> <p>Use of or reliance upon this instrument of service by the Client is subject to the following conditions:</p> <ol style="list-style-type: none"> (i) The report is to be read in full, with sections or parts of the report relied upon in the context of the whole report. (ii) The observations, findings and conclusions in this report are based on observed factual data and conditions that existed at the time of the work and should not be relied upon to precisely represent conditions at any other time. (iii) The report is based on information provided to KCB by the Client or by other parties on behalf of the client (Client-supplied information). KCB has not verified the correctness or accuracy of such information and makes no representations regarding its correctness or accuracy. KCB shall not be responsible to the Client for the consequences of any error or omission contained in Client-supplied information. (iv) KCB should be consulted regarding the interpretation or application of the findings and recommendations in the report. (v) This report is electronically signed and sealed and its electronic form is considered the original. A printed version of the original can be relied upon as a true copy when supplied by the author or when printed from its original electronic file.

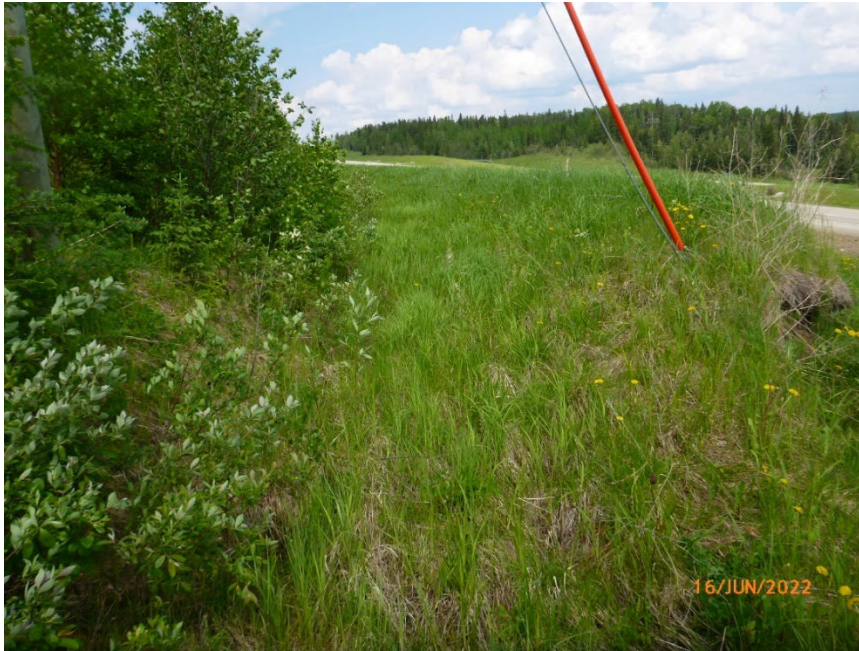
Photo 3 Slack power-pole guy wire at crest of backslope at WP229. Guy wire anchored adjacent to slide backscarp. Photo taken June 16, 2022, facing northwest.

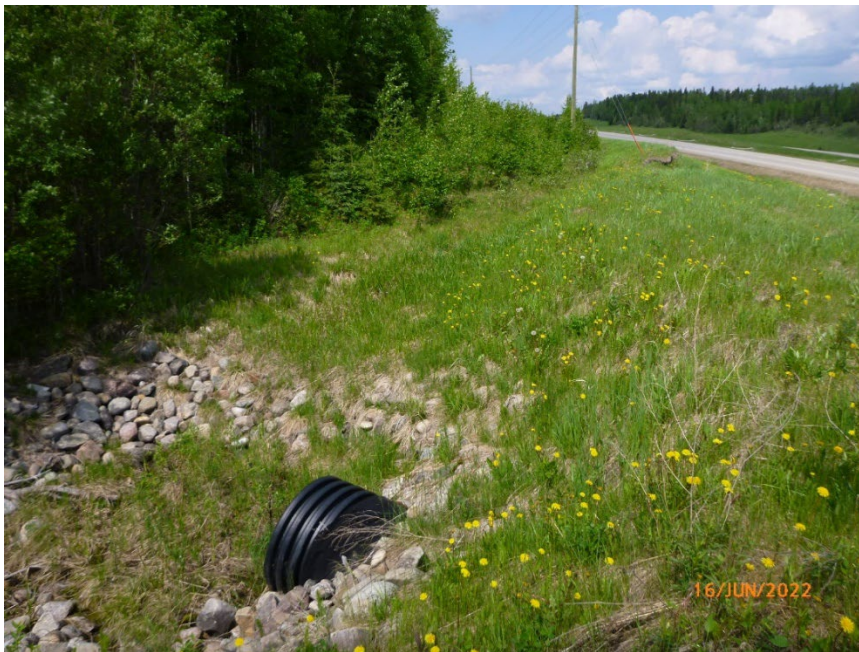
Photo 4 Inlet of “Big-O” pipe at crest of backslope at WP230. Photo taken June 16, 2022, facing northwest.

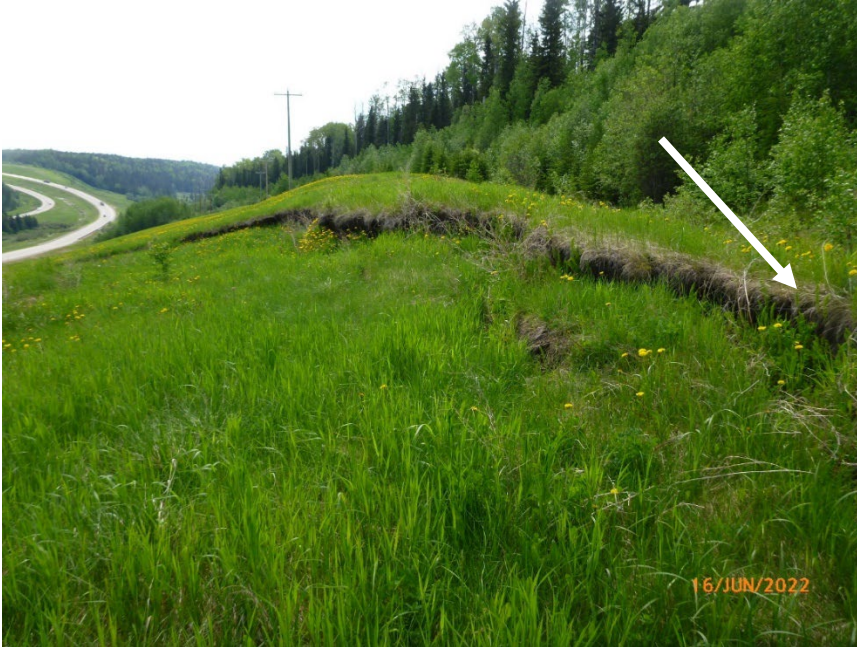
COMMENTS
Slope well vegetated.
Slope failure has intercepted the diversion ditch at the crest of the backslope resulting in intercepted surface water flow from the west of the “Big-O” pipe inlet being discharged onto the slope.
Cracking from slope movement to the west of the “Big-O” pipe has caused movement across the diversion ditch at the crest of the backslope. Diversion water is likely infiltrating into the slope via cracks in the base of the diversion ditch.
The smaller backslope failure along and below the “Big-O” pipe alignment may have been triggered by leakage from the “Big-O” pipe. Water appears to be discharging from the separated joints to ground surface where it flows along the pipe trench, causing erosion. AT recalls that when the pipe separated soon after construction, the joint had separated by approximately 0.5 m.
Seepage observed below outlet of “Big-O” pipe (approximately 0.5 L/minute) could indicate that the trench installed over the slope might be intercepting groundwater. The inlet of the “Big-O” pipe was observed to be dry.

Photo 5 Slide backscarp at crest of backslope. White arrow indicates where diversion ditch intercepted by backslope slide near “Big-O” pipe inlet. Photo taken June 16, 2022, facing southeast.

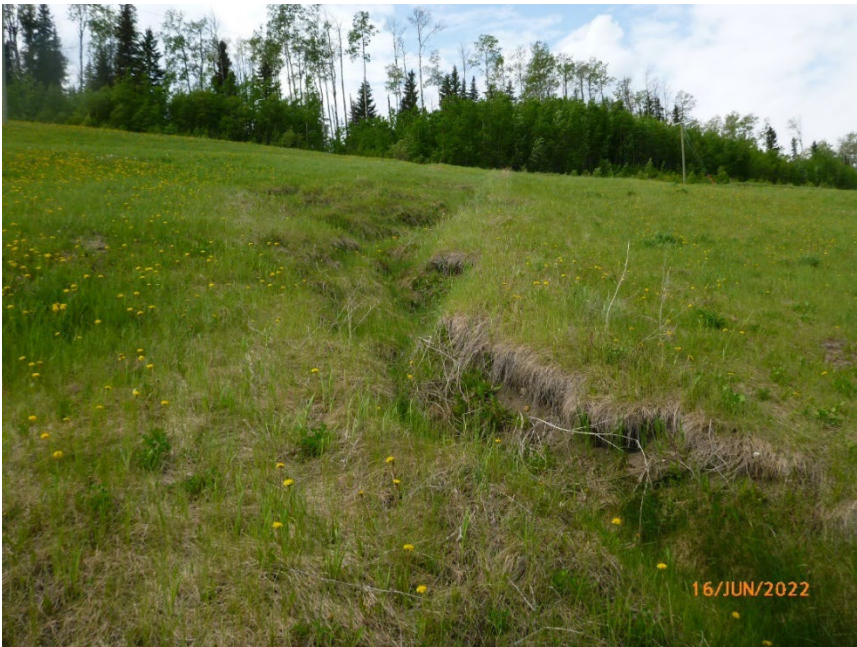
Photo 6 Material slumping, settling, and eroding above “Big-O” pipe on backslope along west side of Hwy 43:12. Photo taken June 16, 2022, facing west.

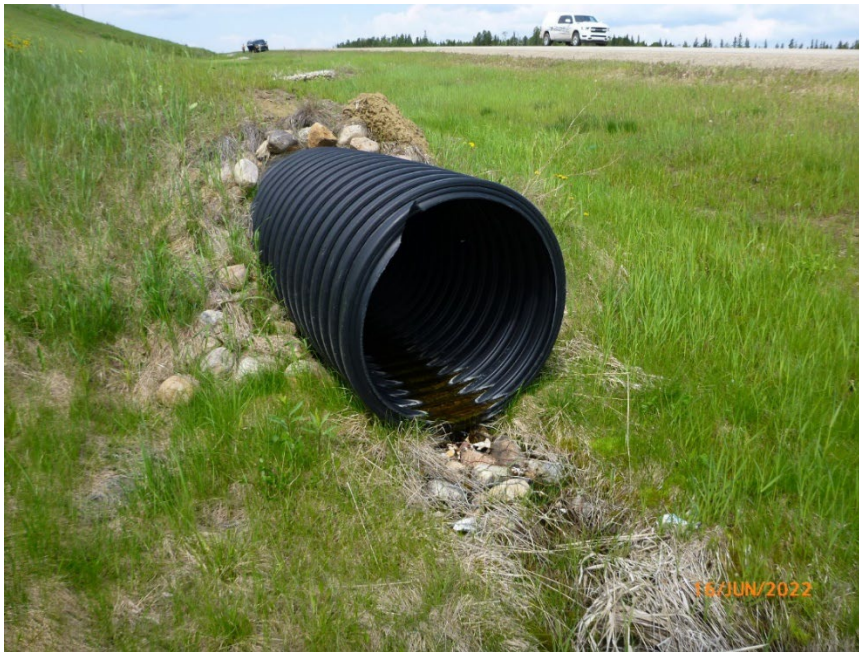
Photo 7 Outlet of “Big-O” pipe in west ditch of Hwy 43:12 at WP234. Photo taken June 16, 2022, facing northwest.

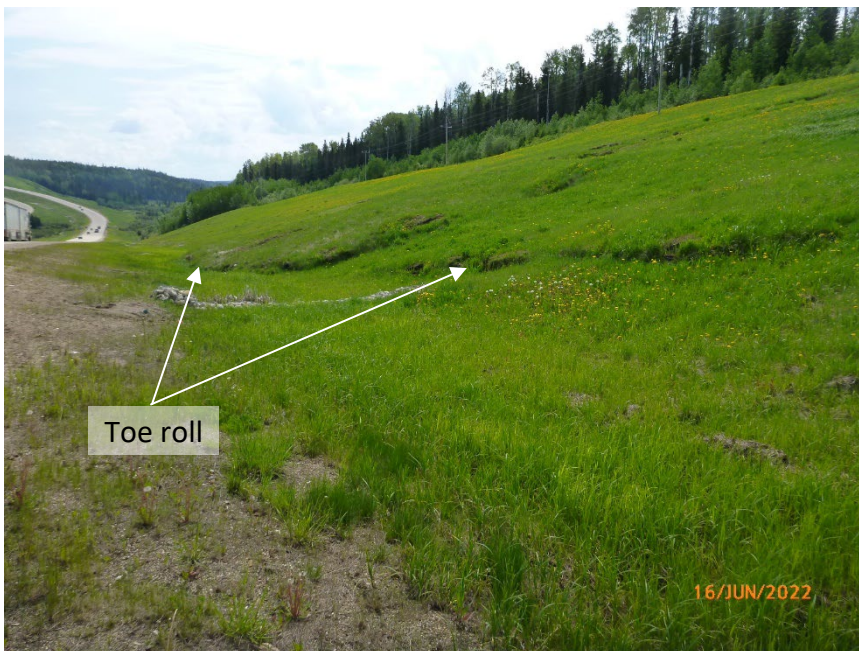
Photo 8 Toe roll in west ditch of Hwy 43:12. Photo taken June 16, 2022, facing southeast.
