**ALBERTA TRANSPORTATION
GEOHAZARD ASSESSMENT PROGRAM
PEACE REGION–GRANDE PRAIRIE
2020 INSPECTION**

Site Number	Location	Name	Hwy	km
GP16	Hwy 666:02 S. of Grande Prairie (Wapiti River Valley Slides)	Mid-Valley/Old Major (Site 1)	666:02	34+773
		Lower Valley (Site 2)		34+837
		Valley Top (Site 3)		34+250
Legal Description (Site 1)		UTM Co-ordinates (Site 1)		
NE¼ 15-070-06 W6M		11U E 383370		N 6103058

Date	PF	CF	Total
Previous Inspection:	30-Aug-2019	13	6	78 (Site 1)
		14	6	84 (Site 2)
		14	5	70 (Site 3)
Current Inspection:	27-May-2020	14	6	84 (Site 1)
		15	7	105 (Site 2)
		14	5	70 (Site 3)
Road AADT:	2680	Year:	2019	
Inspected by:	Ed Szmata, TRANS Dwayne Loewen, TRANS Rishi Adhikari, TRANS		Nicole Wilder, Thurber Don Proudfoot, Thurber	
Report Attachments:	<input checked="" type="checkbox"/> Photographs <input checked="" type="checkbox"/> Plans <input checked="" type="checkbox"/> Maintenance Items

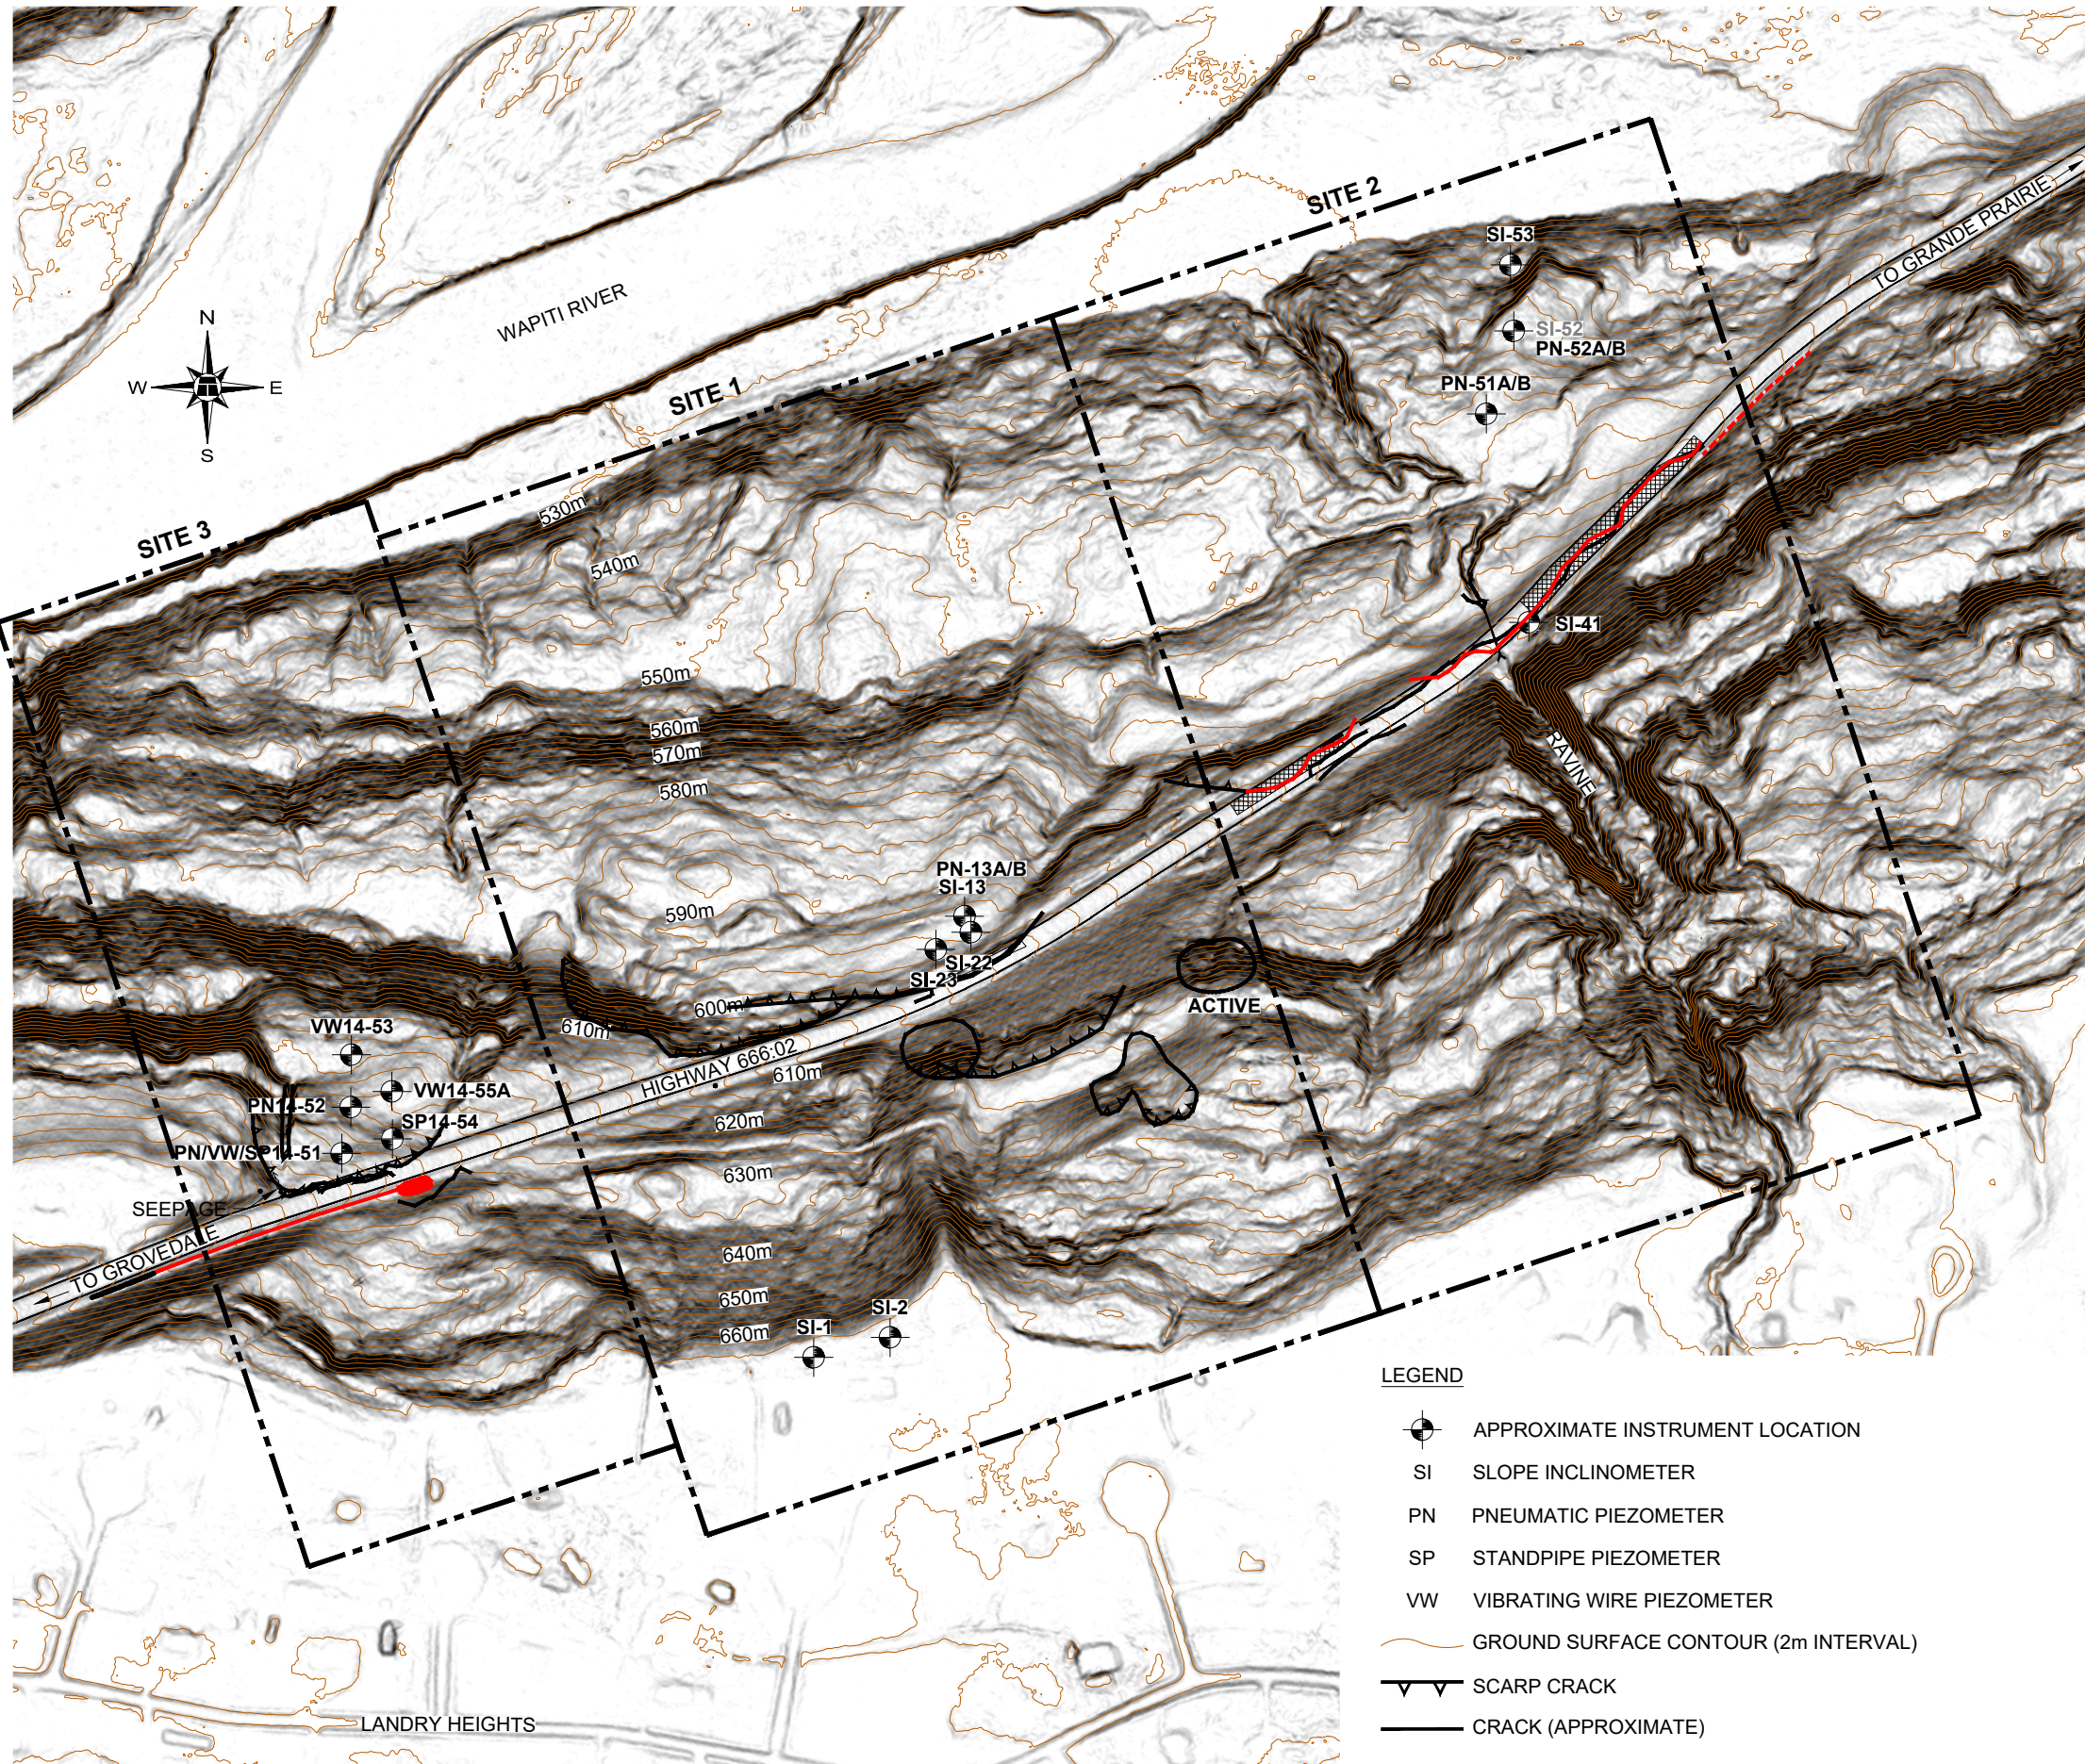
FIGURE 1

**GP016: HWY 666:02, KM 34 SOUTH OF GRANDE PRAIRIE
2020 INSPECTION PLAN**

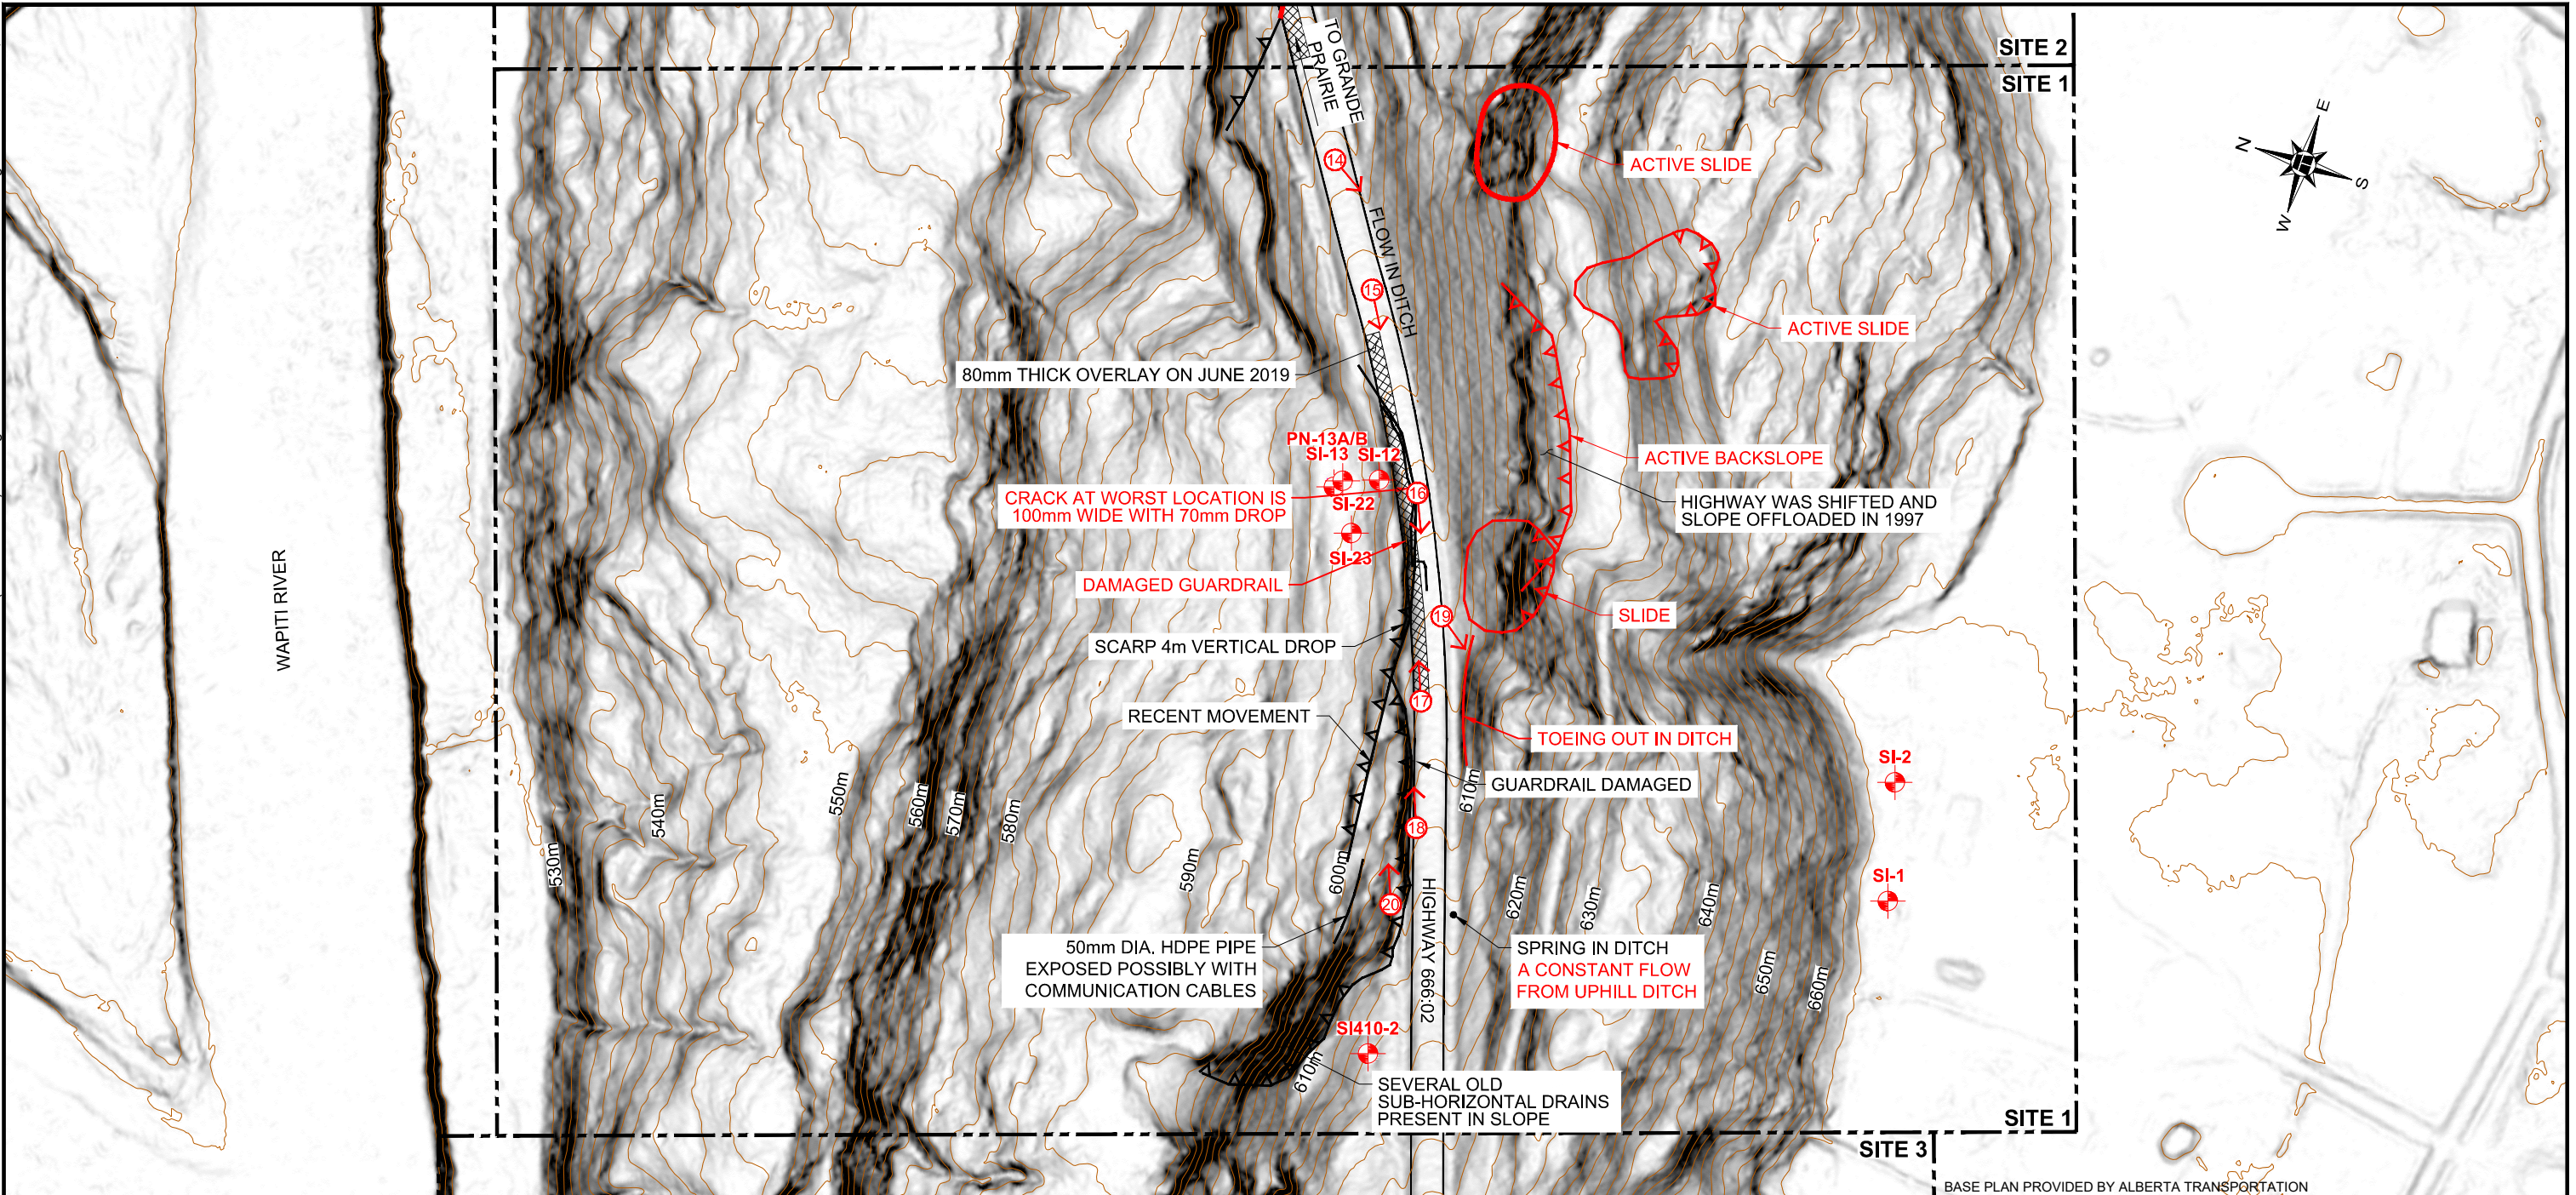
FIGURE 2

Mid-Valley/"Old Major" Landslide (Site 1):

Deep seated landslide, believed to be rotational in nature at a depth of about 20 m to 25 m along the embankment sideslope, which corresponds to the top of the underlying bedrock and is affecting about 300 m of roadway. The toe of the landslide is believed to be at the bottom of the valley possibly within the limits of the Wapiti River bank itself. In addition, the backslope above the highway, which was offloaded and regraded in 1997-1998, has surficial slumps features above and below the intermediate level bench, which periodically cause slide debris to accumulate at the EBL ditch thus blocking the surface water flow.

**GP016: HWY 666:02, KM 34 SOUTH OF GRANDE PRAIRIE
2020 INSPECTION PLAN
SITE 1: MID VALLEY**

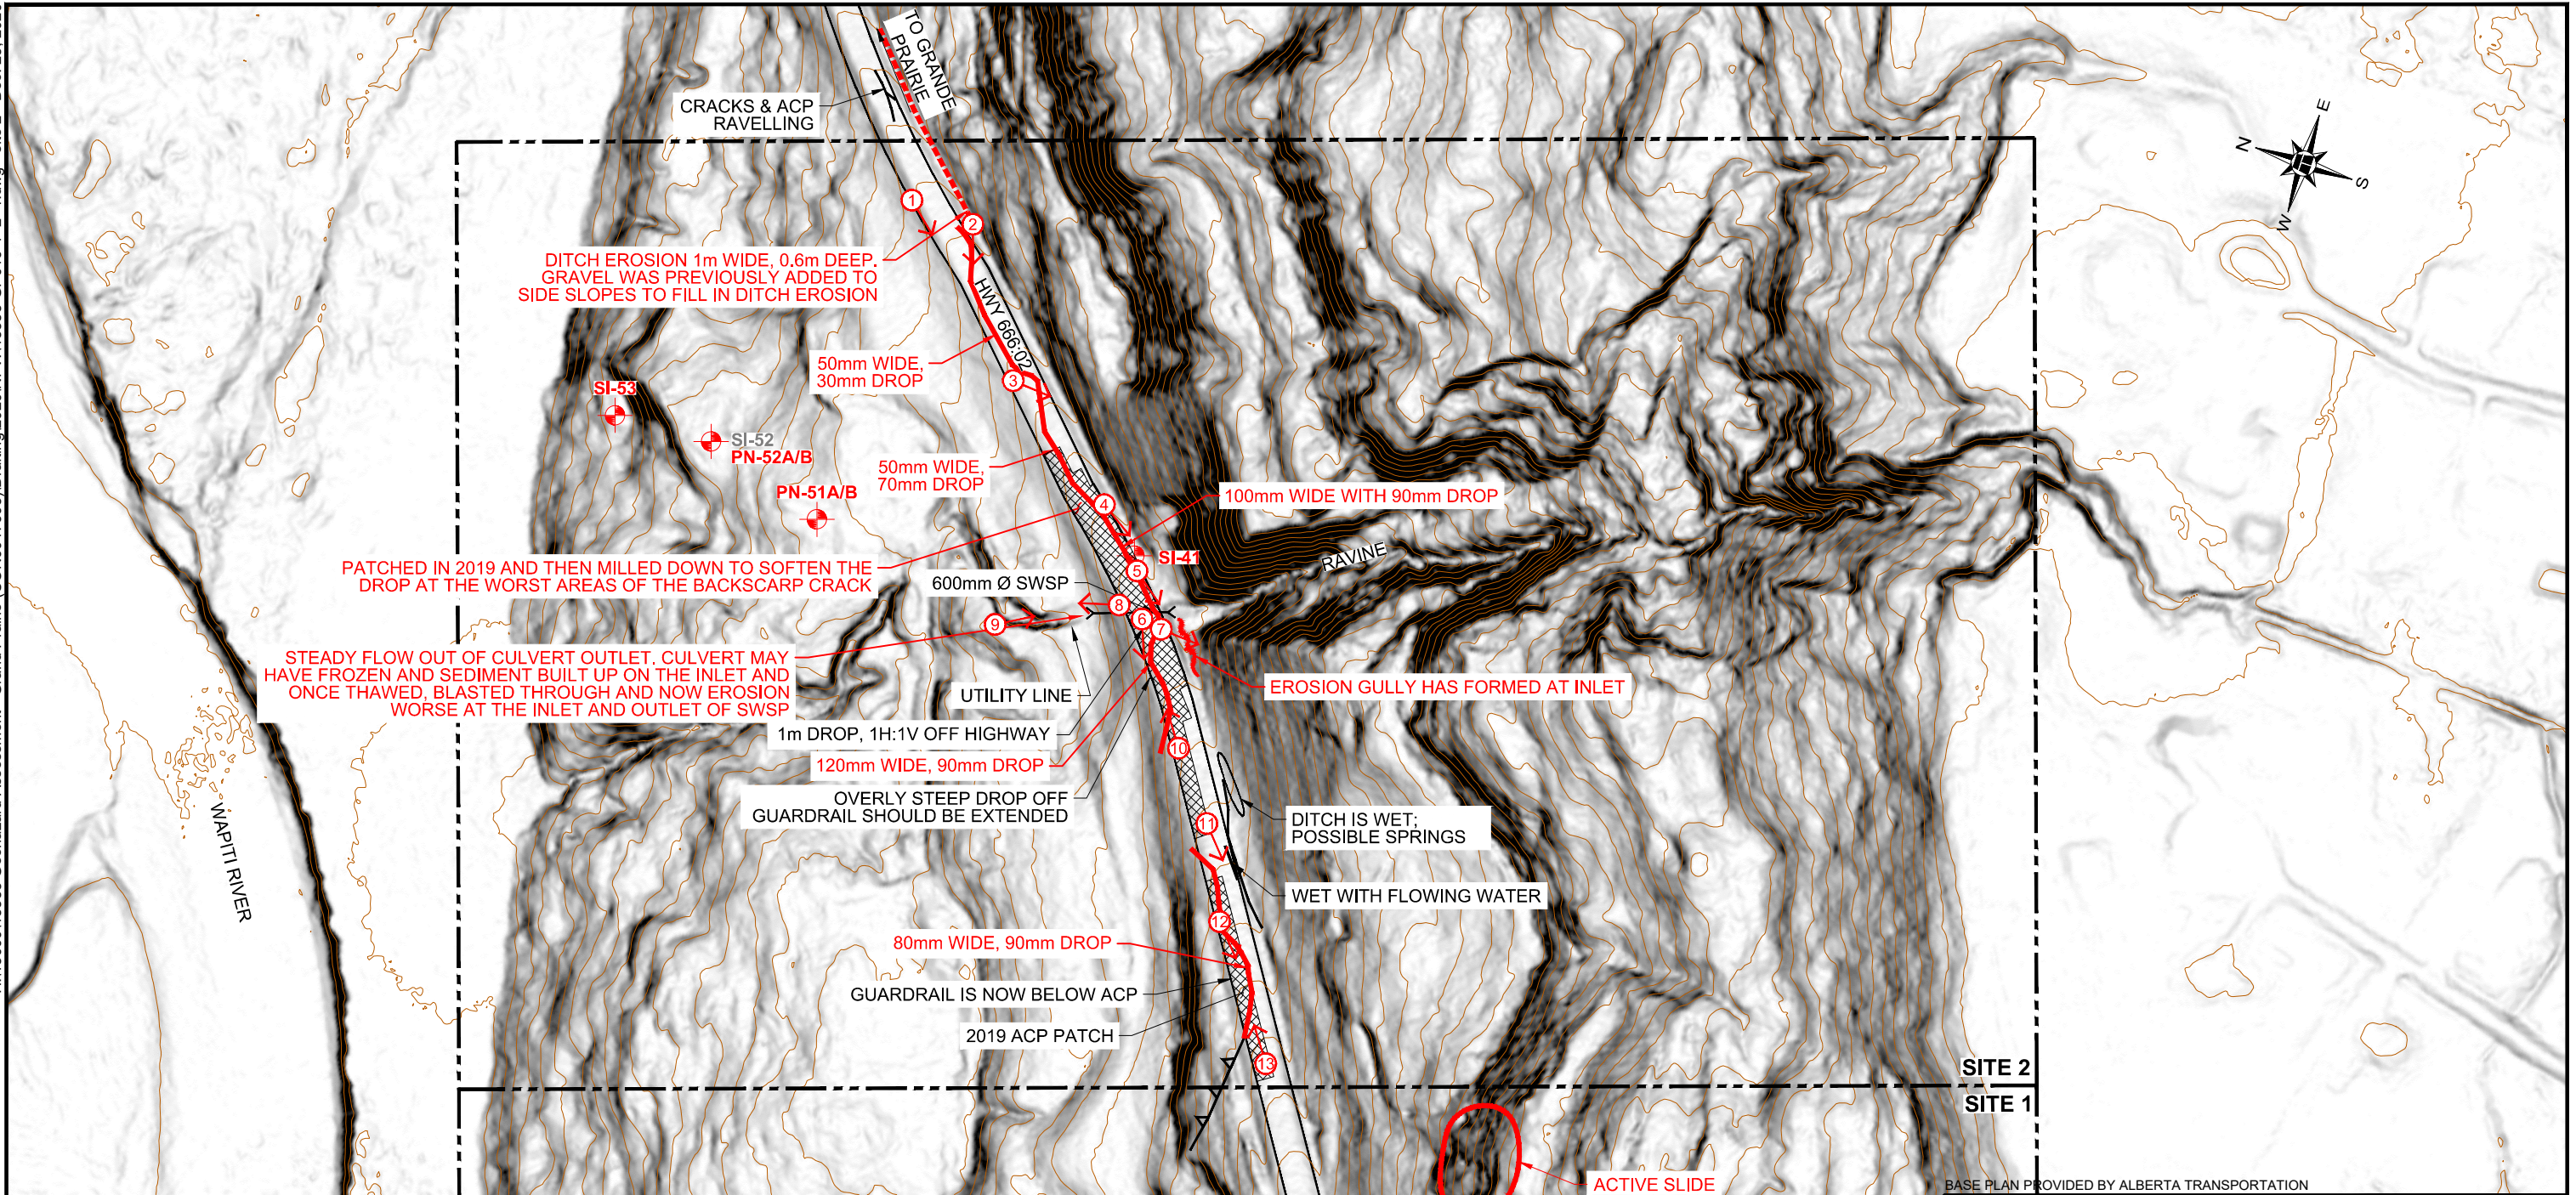
FIGURE 3

Lower Valley Landslide (Site 2):

Deep seated rotational landslide assessed to be at 12m in depth along the embankment sideslope and 18 m in depth at mid slope and at 6 m in depth at the toe which is believed to be about 300 m downslope of the highway embankment, resulting in about 300 m of affected roadway.

GP016: HWY 666:02, KM 34 SOUTH OF GRANDE PRAIRIE
2020 INSPECTION PLAN
SITE 2: LOWER VALLEY

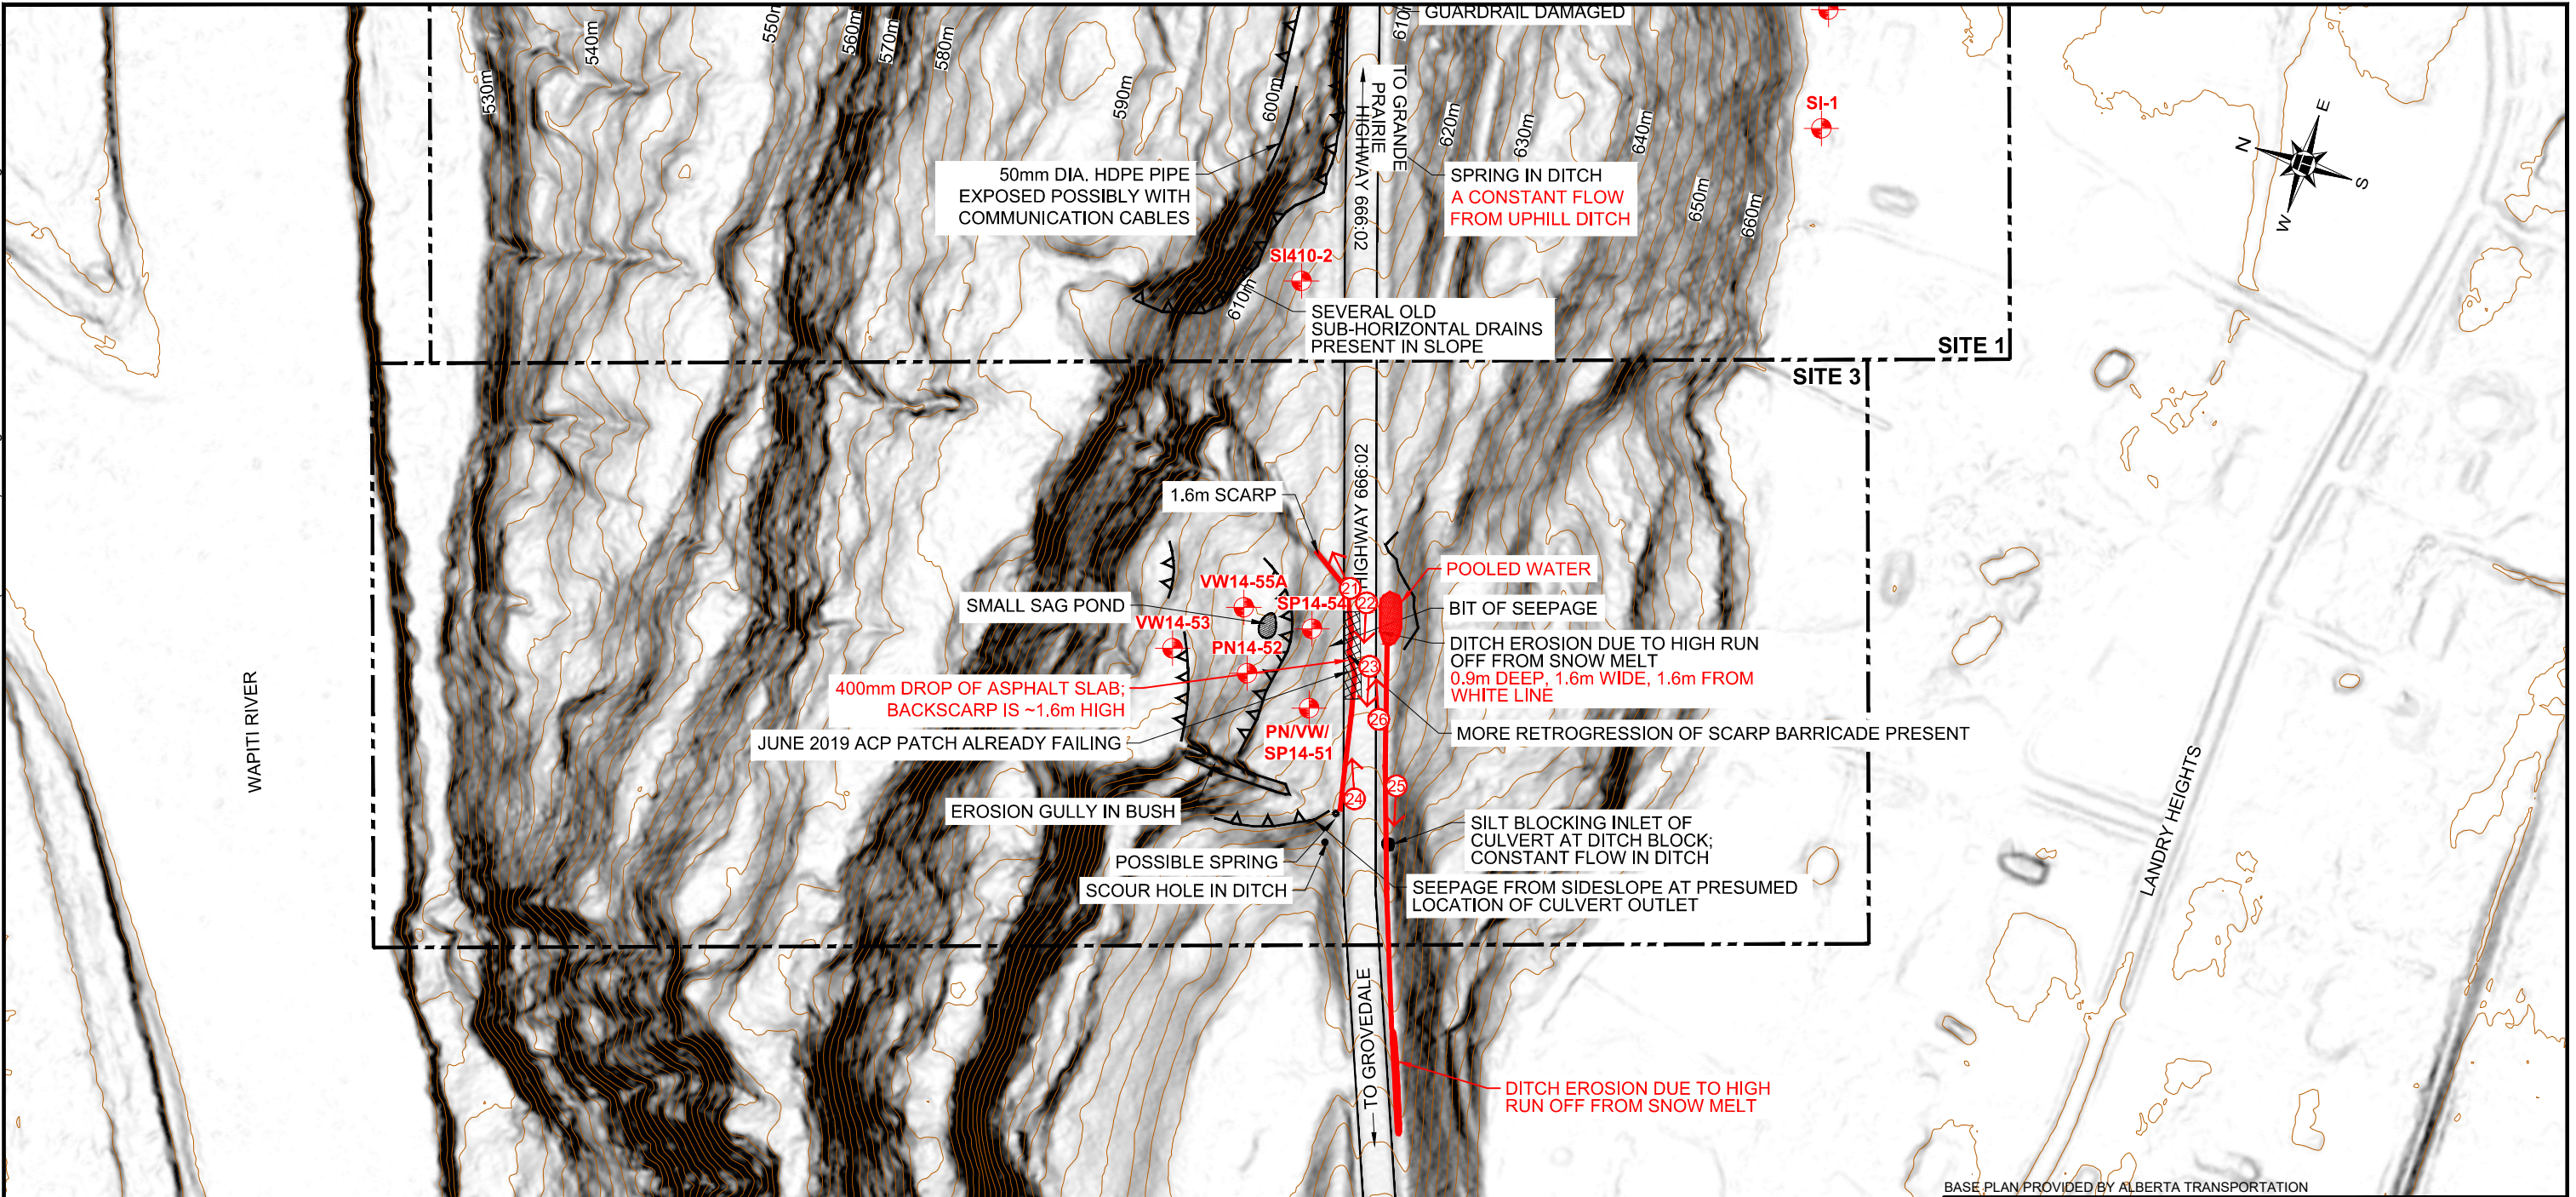
FIGURE 4

Valley Top Landslide (Site 3):

Located near the top of the valley slope, assessed to be at about 7 m to 11 m depth along the highway embankment sideslope and is affecting about 250 m of roadway along the WBL shoulder.

GP016: HWY 666:02, KM 34 SOUTH OF GRANDE PRAIRIE
2020 INSPECTION PLAN
SITE 3: VALLEY TOP

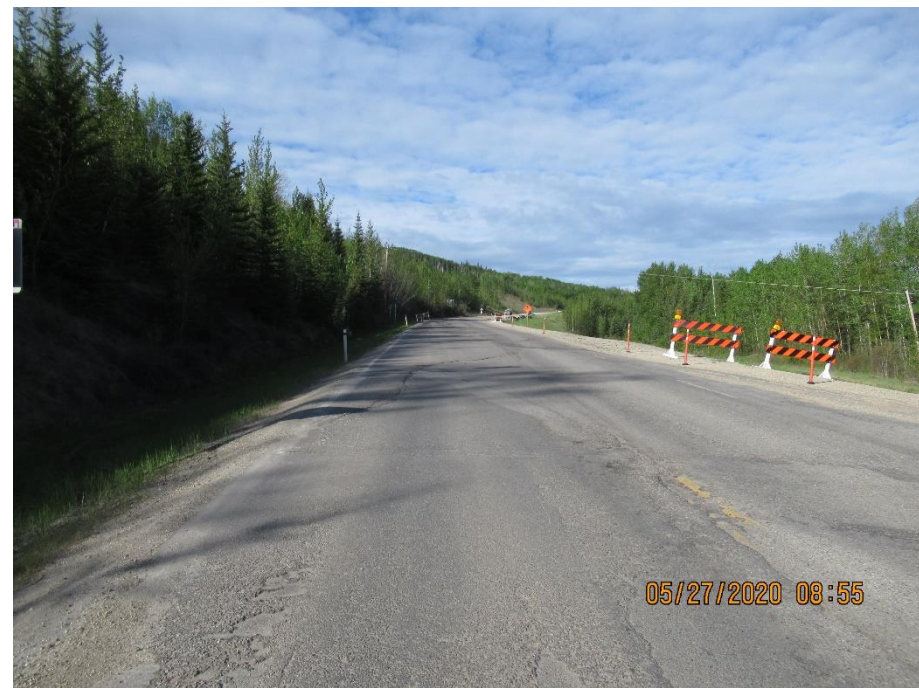
Photo 1.
Looking southwest
towards the east
portion of the
Lower Valley
Landslide (Site 2).

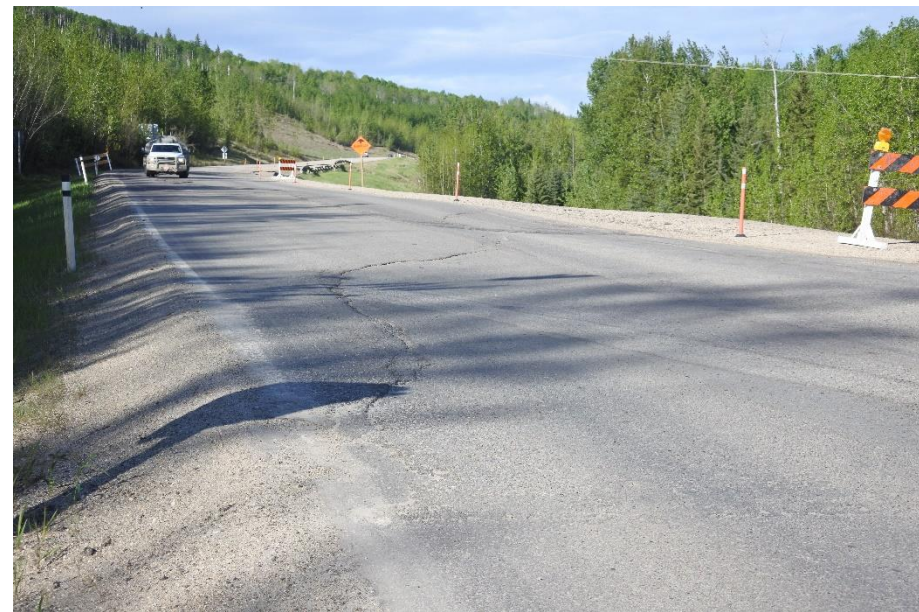
Photo 2.
Looking southwest
towards the east
portion of Lower
Valley Landslide
(Site 2).

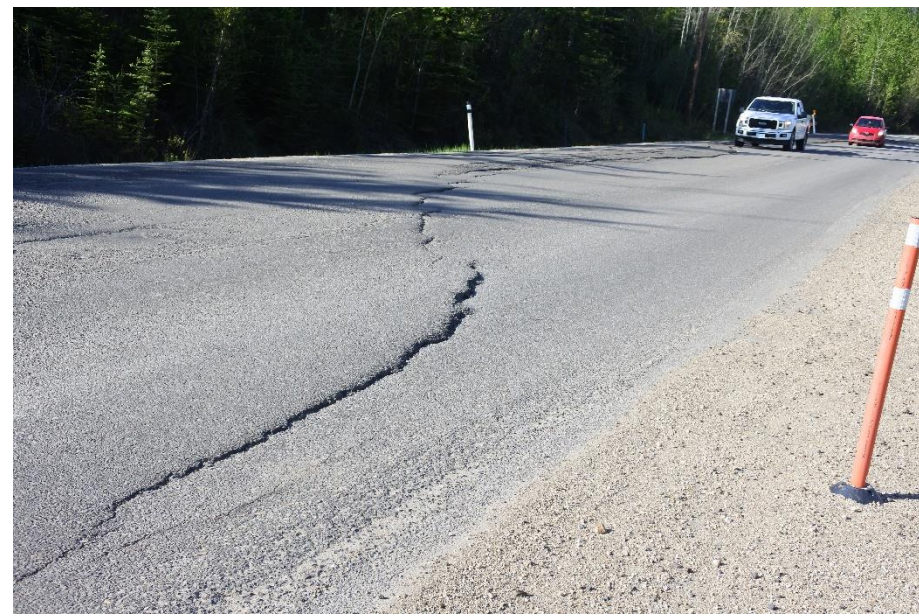
Photo 3.
Looking southwest along Hwy 666 at east portion Lower Valley Landslide (Site 2). The drops along the scarp in the ACP in this section in the roadway surface were about 70 mm.

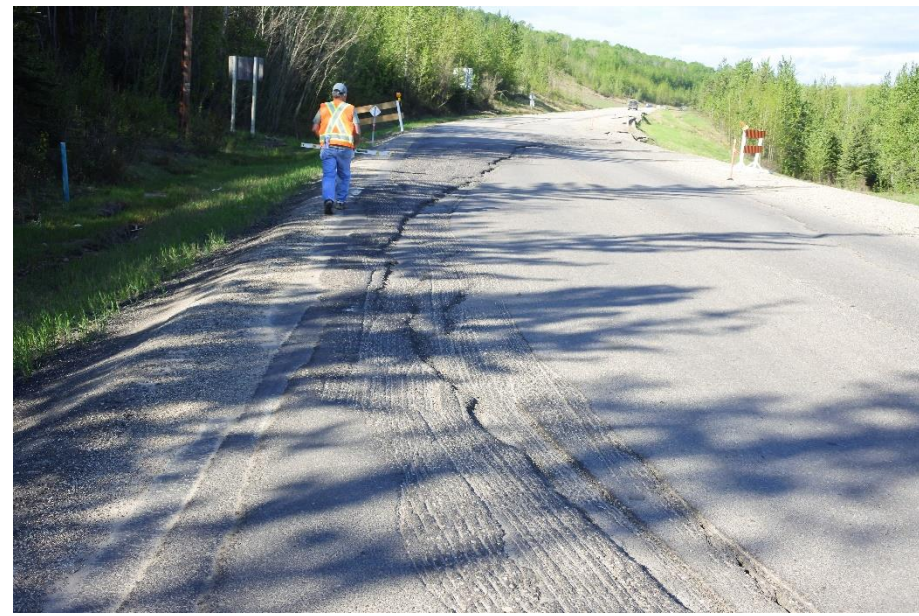
Photo 4.
Looking southwest along Hwy 666 at middle portion Lower Valley Landslide (Site 2). The drop along the scarp in the ACP in this section in the roadway surface was up to about 80 mm.

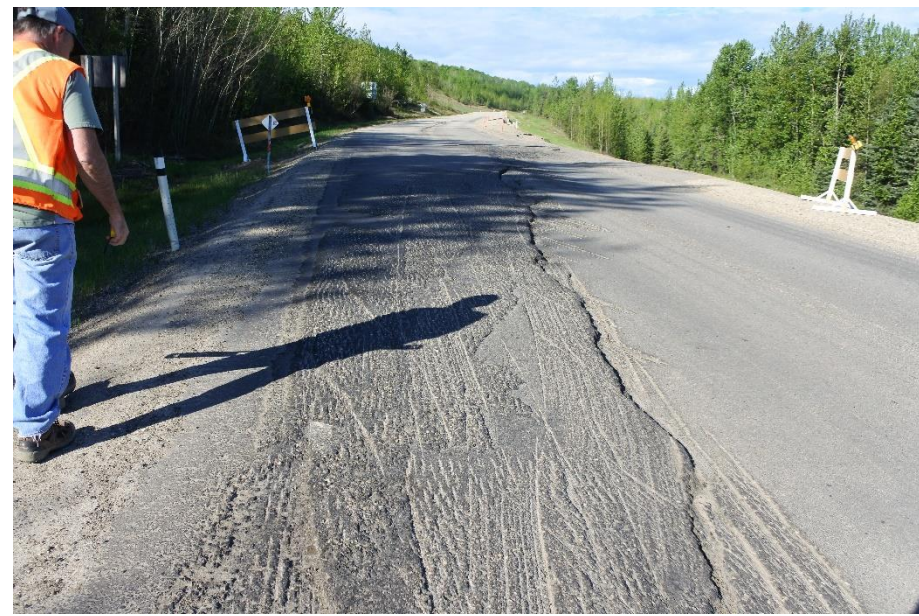
Photo 5.
Looking southwest along Hwy 666 near the middle of the Lower Valley Landslide (Site 2). The scarp had asphalt placed and then milled in fall 2019.

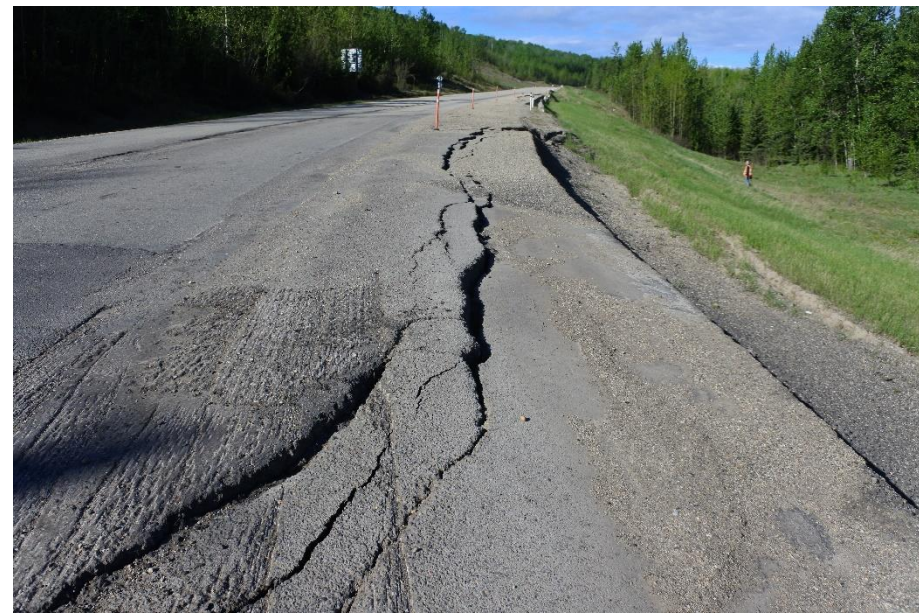
Photo 6.
Looking southwest along WBL near middle of the Lower Valley Landslide (Site 2). The scarp has a 90 mm drop in the WBL shoulder.

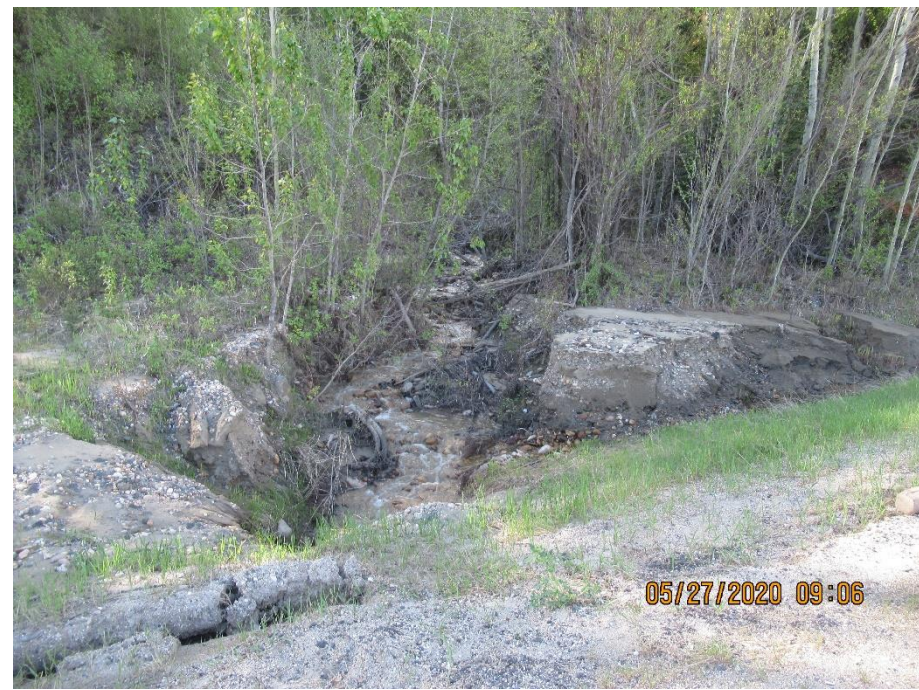
Photo 7.
Looking southeast at erosion that has formed in sediment that had accumulating at the 600 mm diameter SWSP inlet, possibly due to the culvert being temporarily frozen.

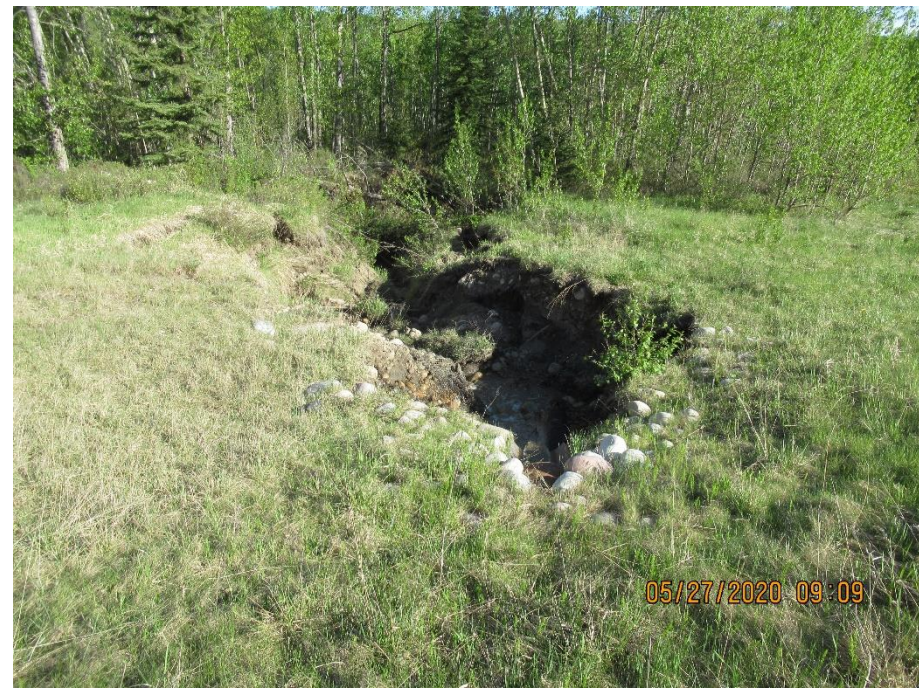
Photo 8.
Looking northwest at erosion gully at 600 mm diameter SWSP outlet.

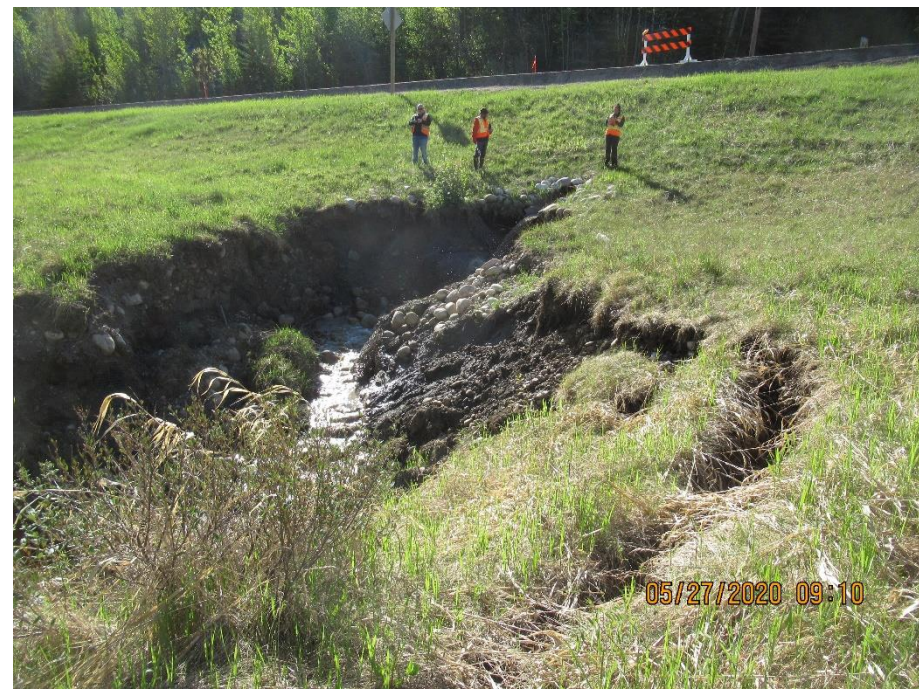
Photo 9.
Looking southeast
at erosion gully at
600 mm diameter
SWSP outlet.

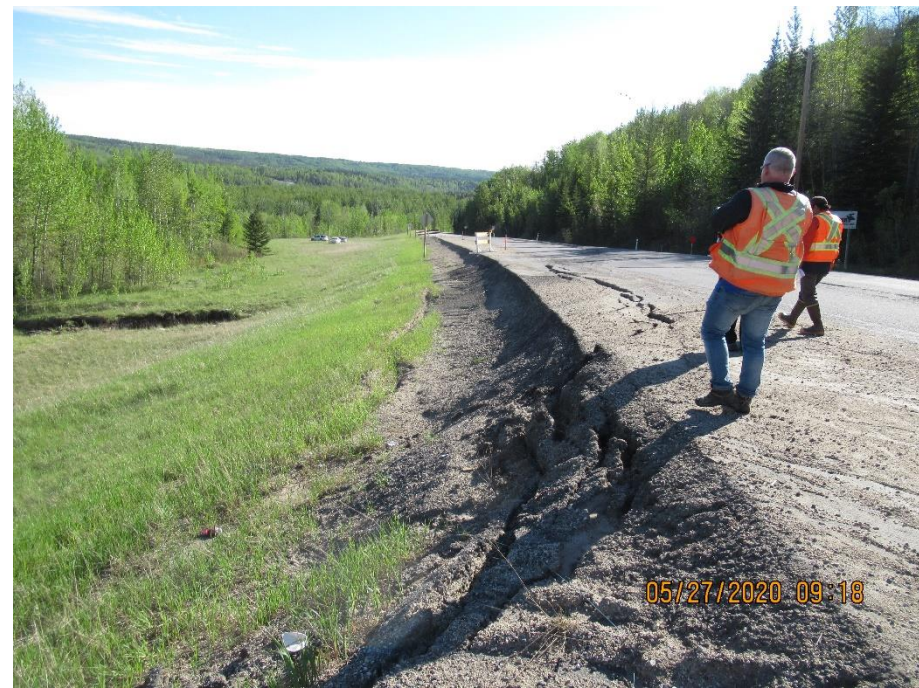
Photo 10.
Looking east at
overly steep drop
off from several
layers of ACP
patching near the
east portion of the
Lower Valley
Landslide (Site 2).

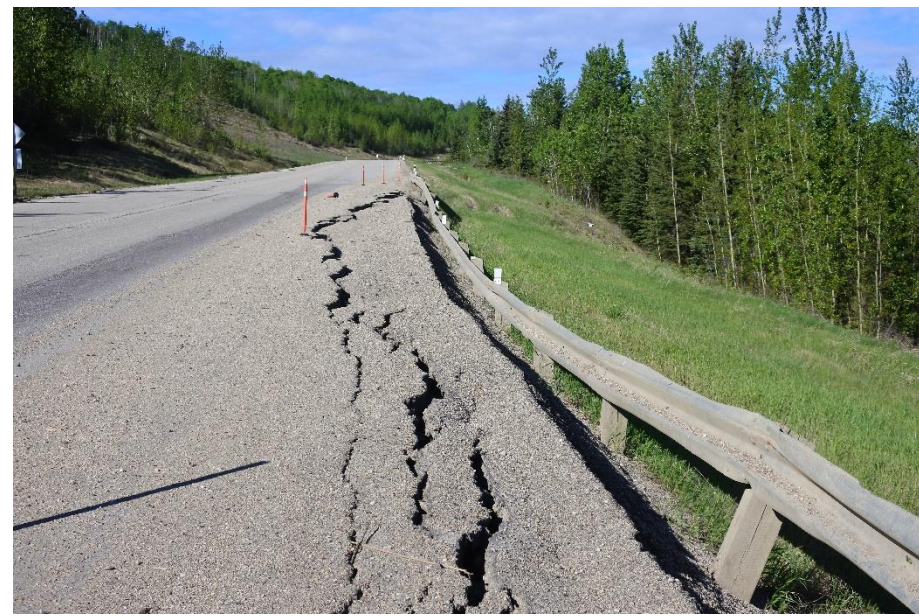
Photo 11.
Looking southwest
along WBL at the
west extent of
Lower Valley
Landslide (Site 2).
The crack is open
to 80 mm and
drops 90 mm.

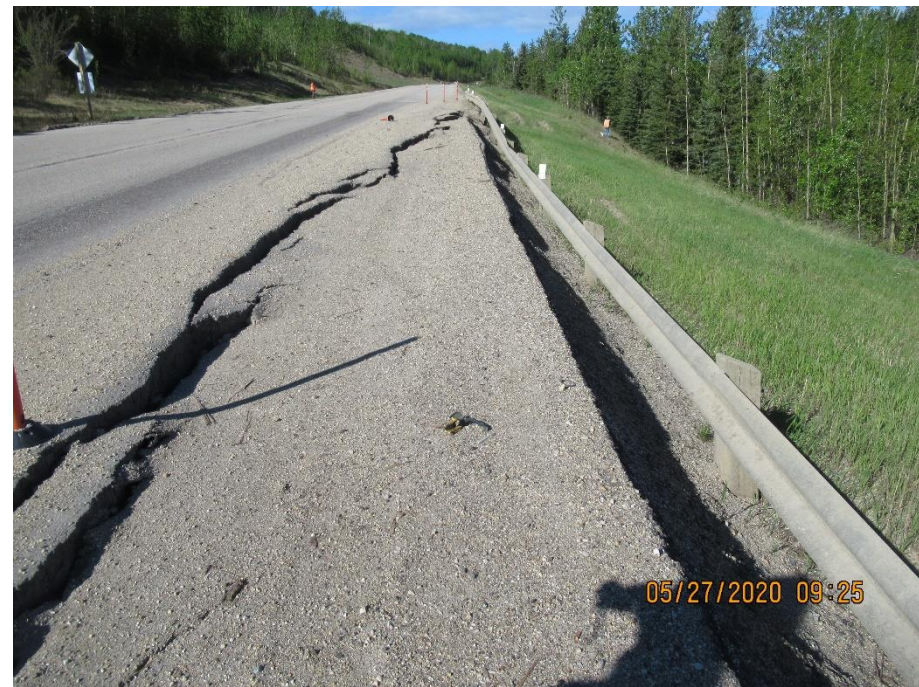
Photo 12.
Looking southwest
along WBL at the
west extent of
Lower Valley
Landslide (Site 2).
The crack is open
to 80 mm and
drops 90 mm.

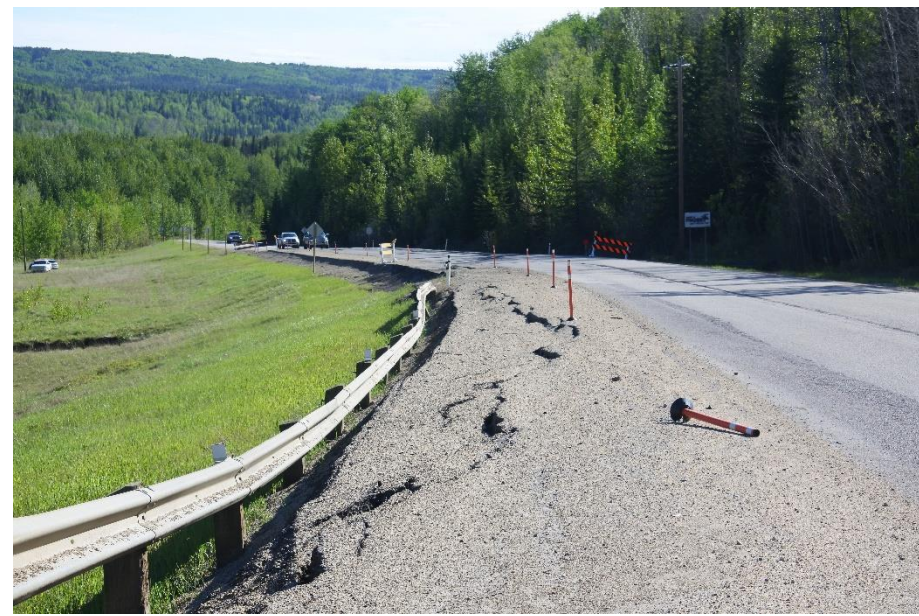
Photo 13.
Looking northeast
along WBL at the
west extent of the
Lower Valley
Landslide (Site 2).

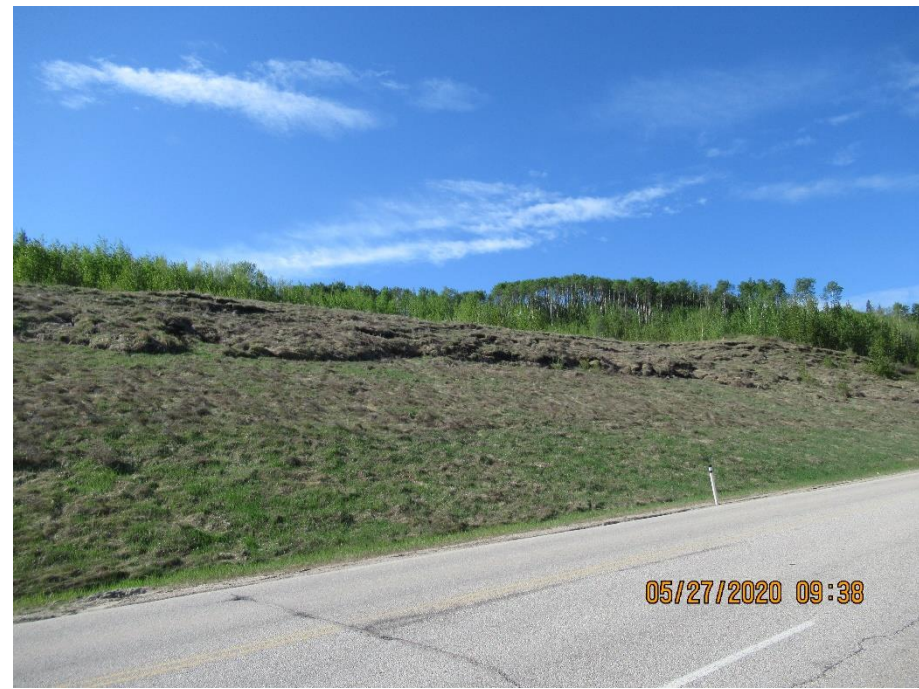
Photo 14.
Looking southwest
from the WBL
shoulder at the
slide in the
backslope in the
eastern portion off
the Mid-Valley/" Old
Major" Landslide
(Site 1).

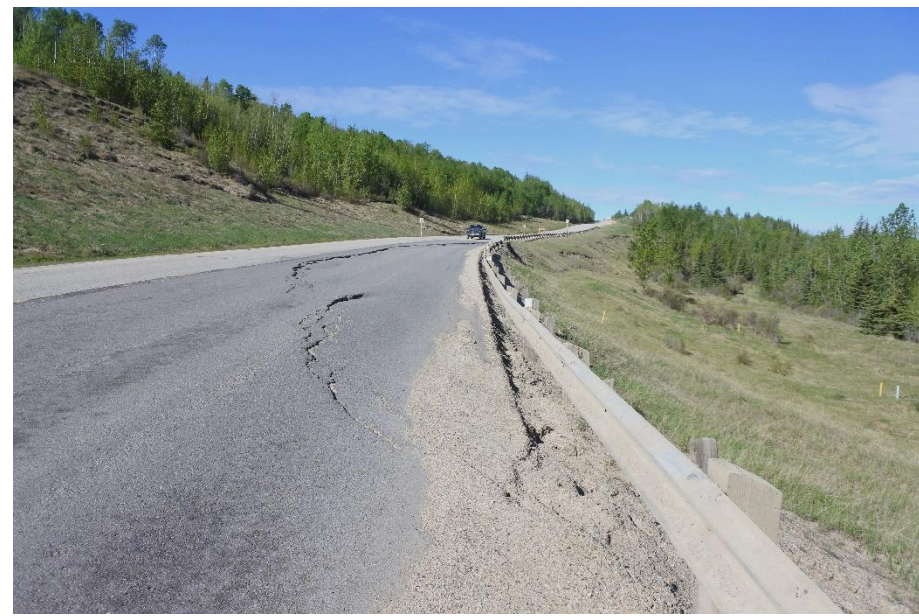
Photo 15.
Looking west at the
ACP patch in outer
WBL at Mid-
Valley/" Old Major"
Landslide (Site 1).
