**ALBERTA TRANSPORTATION
GEOHAZARD ASSESSMENT PROGRAM
PEACE REGION–GRANDE PRAIRIE
2020 INSPECTION**

Site Number	Location	Name	Hwy	km
GP16	Hwy 666:02 S. of Grande Prairie (Wapiti River Valley Slides)	Mid-Valley/Old Major (Site 1)	666:02	34+773
		Lower Valley (Site 2)		34+837
		Valley Top (Site 3)		34+250
Legal Description (Site 1)		UTM Co-ordinates (Site 1)		
NE¼ 15-070-06 W6M		11U E 383370		N 6103058

Date	PF	CF	Total
Previous Inspection:	30-Aug-2019	13	6	78 (Site 1)
		14	6	84 (Site 2)
		14	5	70 (Site 3)
Current Inspection:	27-May-2020	14	6	84 (Site 1)
		15	7	105 (Site 2)
		14	5	70 (Site 3)
Road AADT:	2680	Year:	2019	
Inspected by:	Ed Szmata, TRANS Dwayne Loewen, TRANS Rishi Adhikari, TRANS		Nicole Wilder, Thurber Don Proudfoot, Thurber	
Report Attachments:	<input checked="" type="checkbox"/> Photographs <input checked="" type="checkbox"/> Plans <input checked="" type="checkbox"/> Maintenance Items

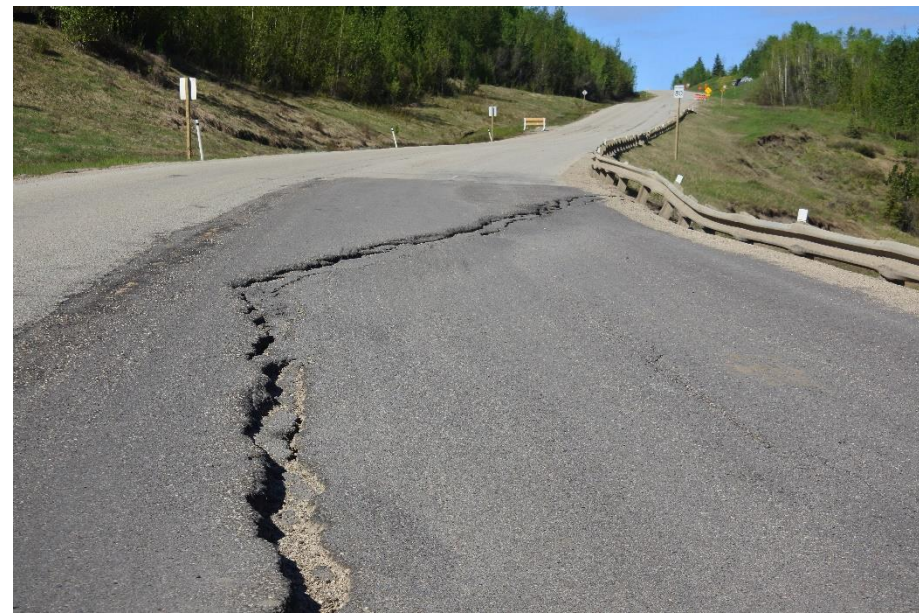
Photo 16.
Looking west at the
ACP patch in outer
WBL at Mid-
Valley/" Old Major"
Landslide (Site 1).
There is a 70 mm
drop along the
scarp in the ACP
and it is open to
100 mm.

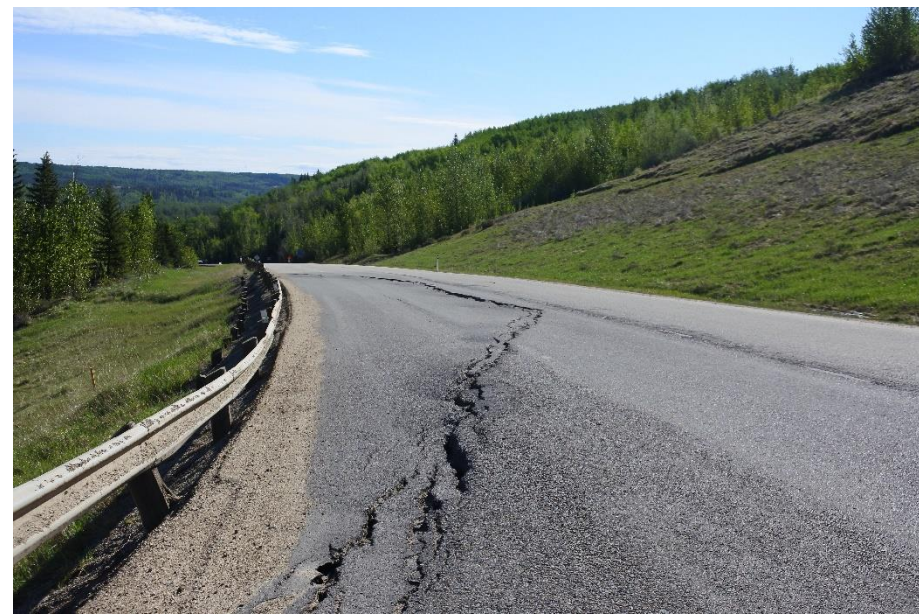
Photo 17.
Looking northeast at backscarp in the WBL at Mid-Valley/" Old Major" Landslide (Site 1). The scarp crack is now 100 m wide with a 70 mm drop in the ACP.

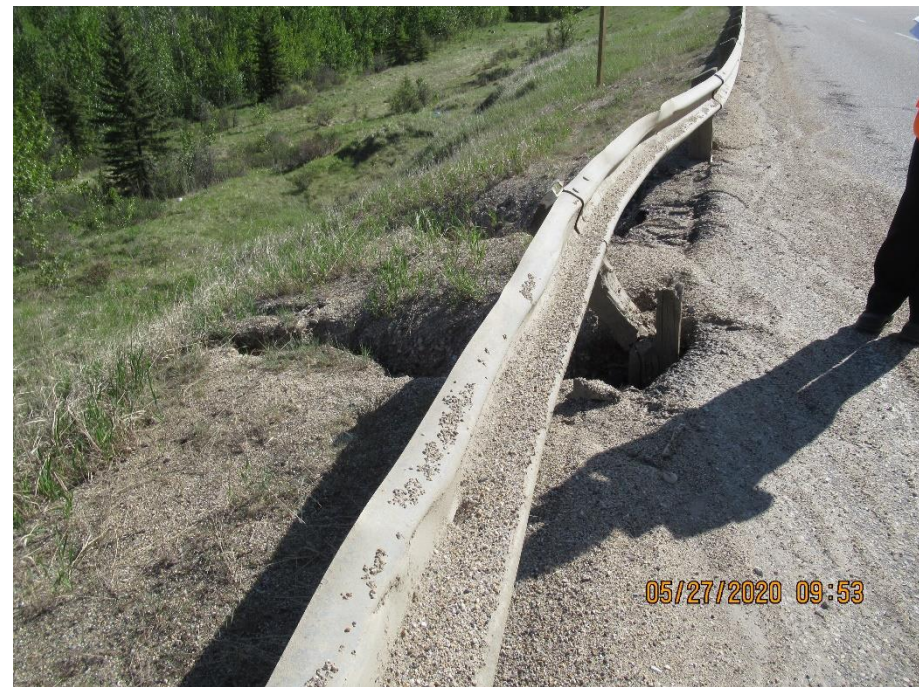
Photo 18.
Looking northeast at where guardrail is damaged, and erosion is occurring around the posts and below them.

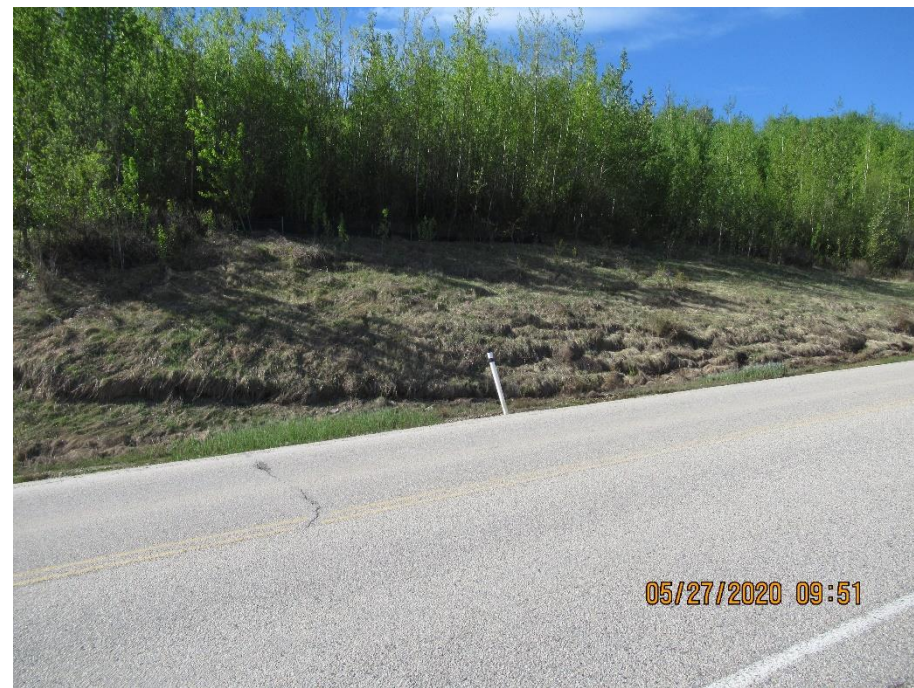
Photo 19.
Looking southwest at part of the backslope toe showing recent movement near the Mid-Valley Landslide / "Old Major" (Site 1).

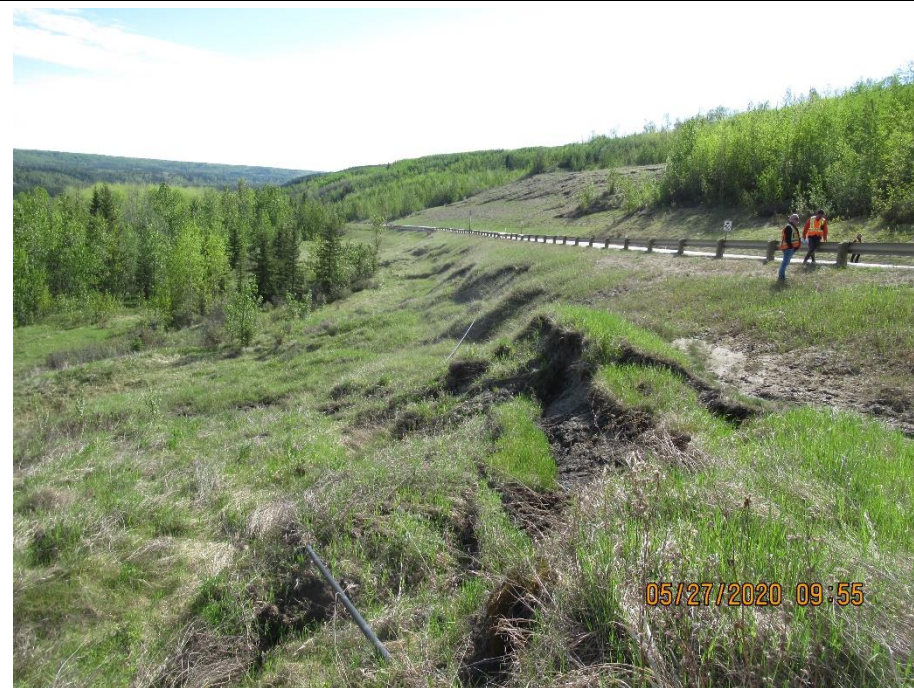
Photo 20.
Looking northeast at graben below the highway at the Mid-Valley Landslide / "Old Major" (Site 1) at scarp below the highway and exposed telecommunication cable.

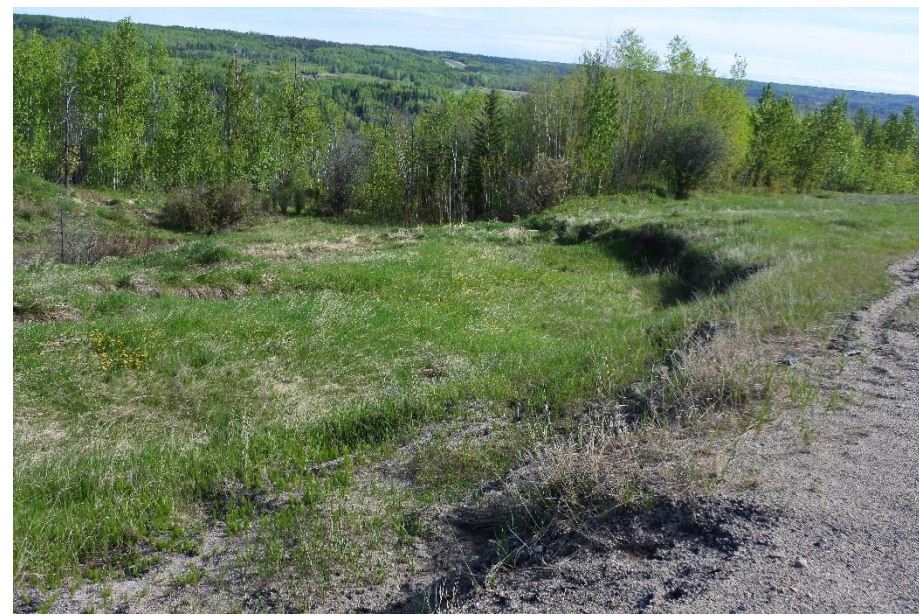
Photo 21.
Looking northeast from the shoulder of the WBL at the scarp extending into the brush at the Valley Top Landslide (Site 3).

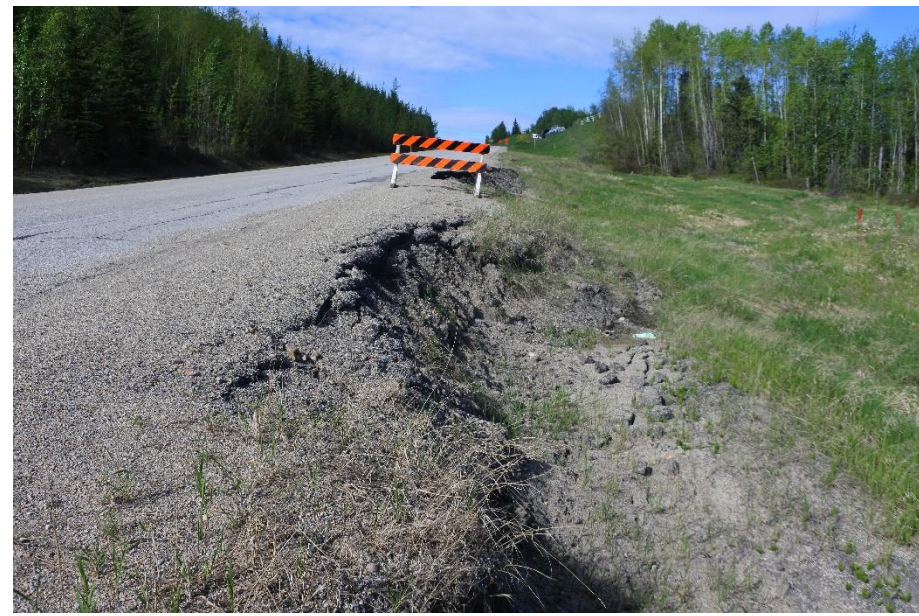
Photo 22.
Looking west along backscarp of Valley Top Landslide (Site 3). Backscarp drop in embankment side slope now about 1.6 m

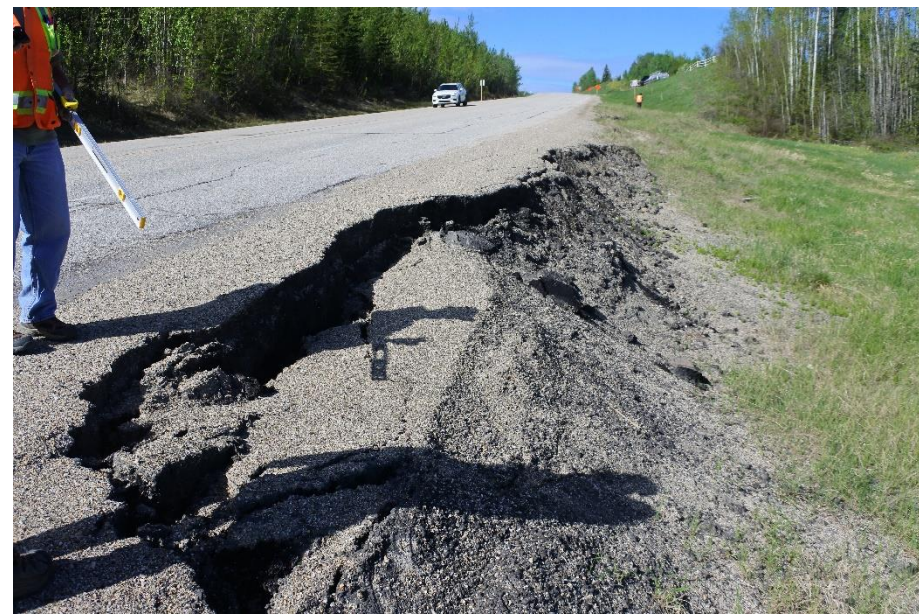
Photo 23.
Looking west along backscarp in the west section of the Valley Top Landslide (Site 3). Site was patched in June 2019. Cracks extend past the white line in the WBL and the asphalt has dropped 400 mm.

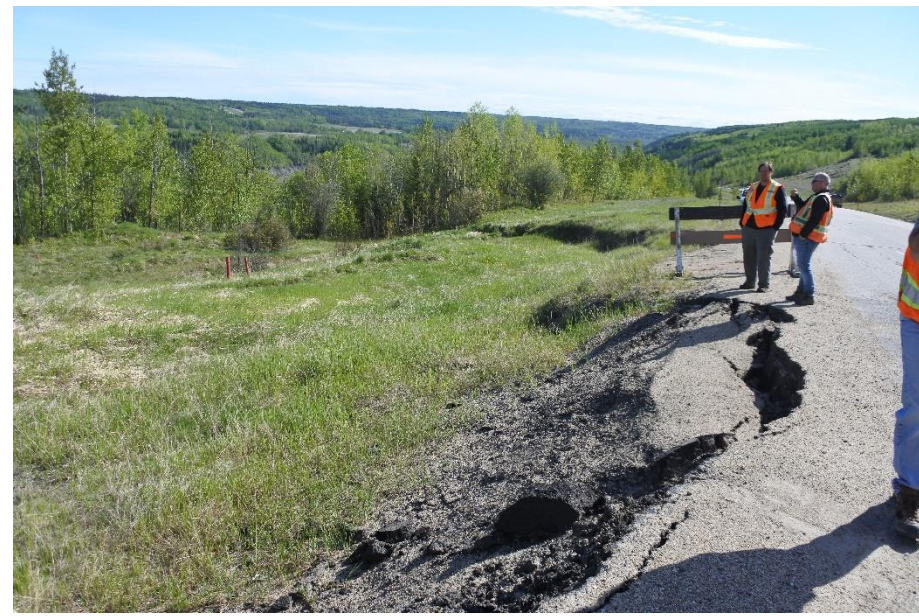
Photo 24.
Looking northeast along backscarp near the middle of the Valley Top Landslide (Site 3).

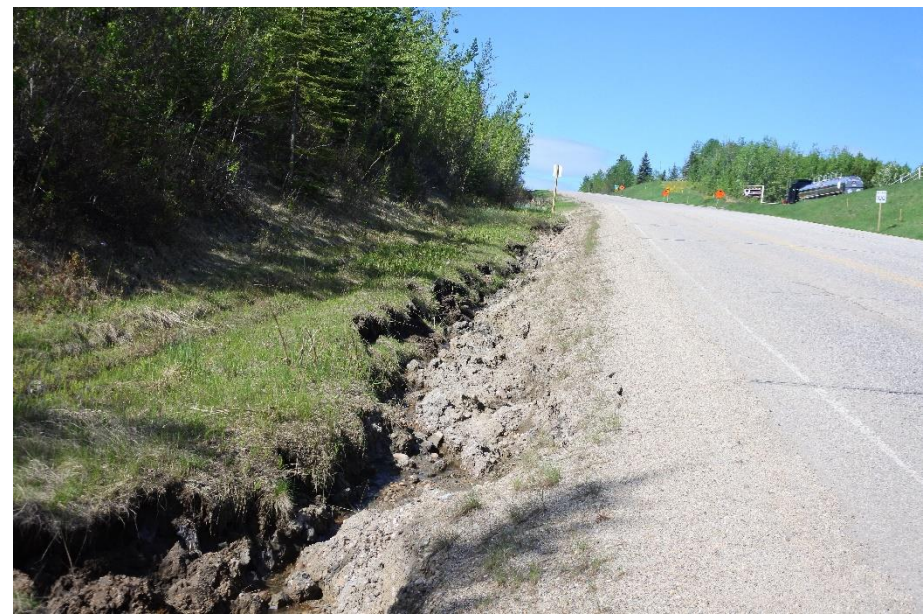
Photo 25.
Looking west at erosion in south ditch near the Valley Top Landslide (Site 3).

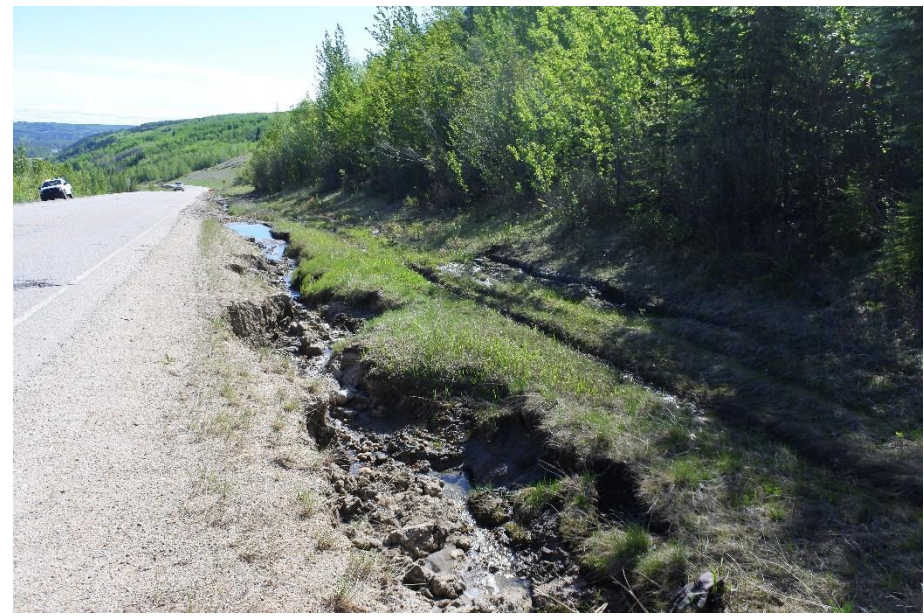
Photo 26.
Looking northeast at ditch erosion along the south ditch near the Valley Top Landslide (Site 3).
