SITE NUMBER AND NAME: GP016 2 km West of Hwy 40 and Hwy 666 Junction		HIGHWAY & KM: 666:02, 34.837	PREVIOUS INSPECTION DATE: May 27, 2020	INSPECTION DATE: July 20, 2021
LEGAL DESCRIPTION: NE 15-70-06-W5M	NAD 83 COORDINATES: UTM Northing Easting 11 6103361 383748		RISK ASSESSMENT: Lower (2): PF: 13 CF: 7 TOTAL: 91 Middle (1): PF: 11 CF: 5 TOTAL: 55 Upper (3): PF: 11 CF: 4 TOTAL: 44	
AVERAGE ANNUAL DAILY TRAFFIC (AADT): 2740 (west) & 2740 (east) (Reference No. 28690 & 70000759)			CONTRACT MAINTENANCE AREA (CMA): 504

PRIMARY SITE ISSUE: Three landslide features are affecting the embankment of Hwy 666:02 along the south slope of the Wapiti River Valley. The entire south slope of Wapiti River valley is a landslide zone with varying rates of movement.

GP016 Wapiti River Valley Slide – Lower Slide (Site 2)

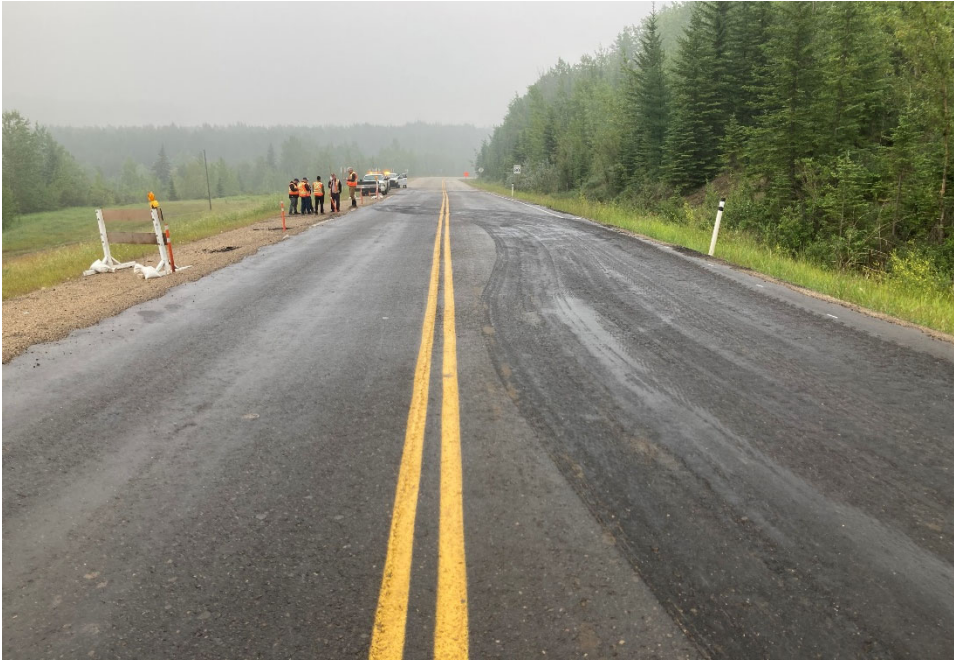
- Pavement paved fall 2020 and milled in spring this year. Movements started to occur soon after paving.
- The passing lane is decommissioned. The pavement has only been raised on two lanes with two lifts of pavement, pavement is 0.2 to 0.25 m thick where raised above old pavement. The former passing lane is blocked with wooden barricades and orange delineators.

Photo 1 The asphalt surface was milled in spring 2021 to remove a ridge in the eastbound and westbound lane, caused by settlement. Photo taken July 20, 2021 facing east.

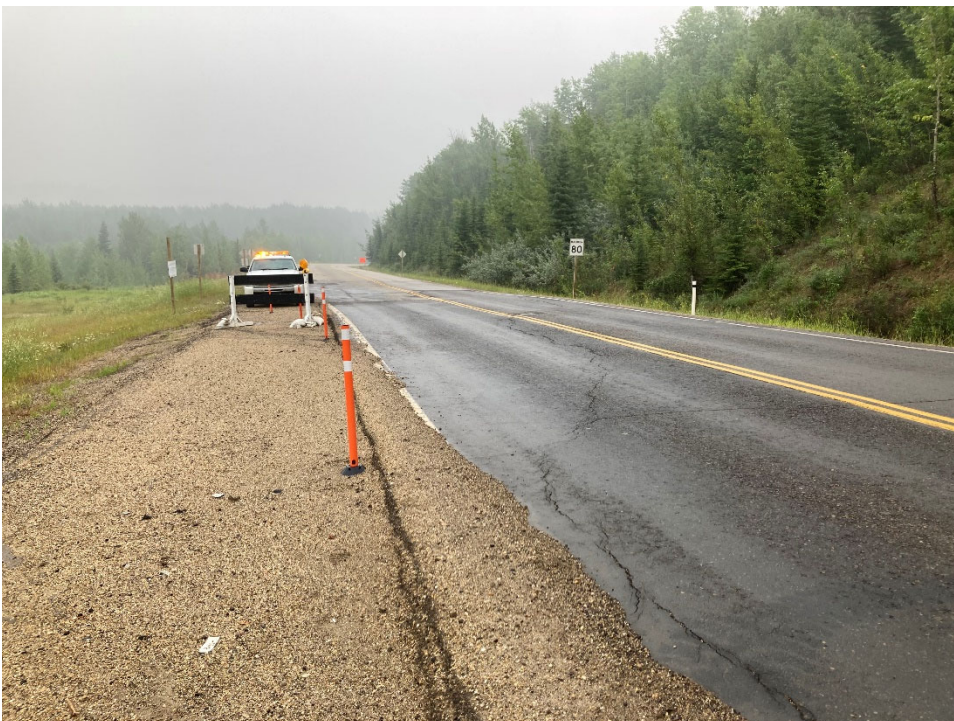
Photo 2 Asphalt cracking observed near the east extent of the lower slide, running diagonally across the highway. Photo taken July 20, 2021 facing east.

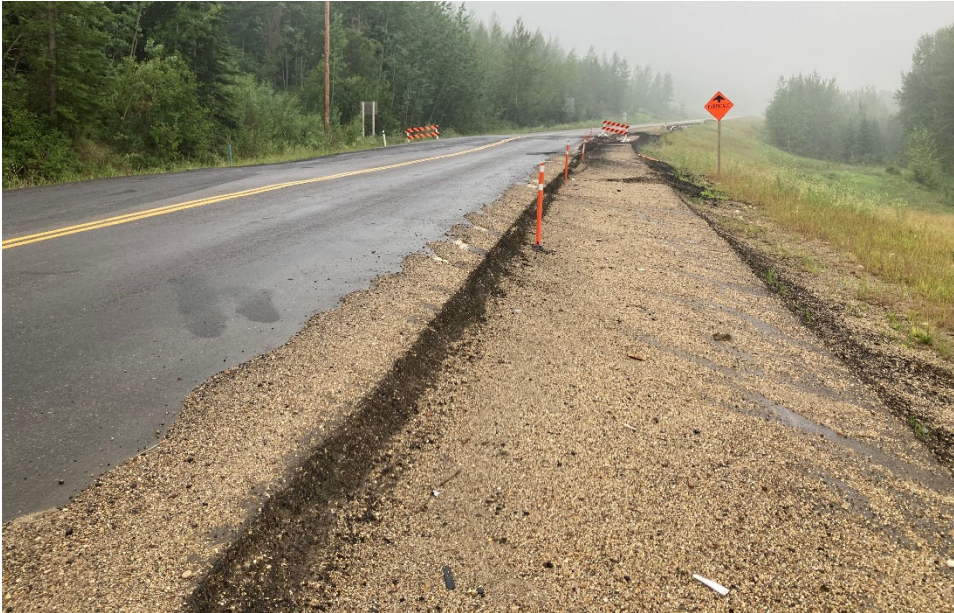
Photo 3 Edge of the recent asphalt patches after the highway was realigned approximately 8 ft (2.4 m) upslope (south). The height of the new asphalt is approximately 0.2 m to 0.3 m above the previous road surface. Photo taken July 20, 2021 facing west.

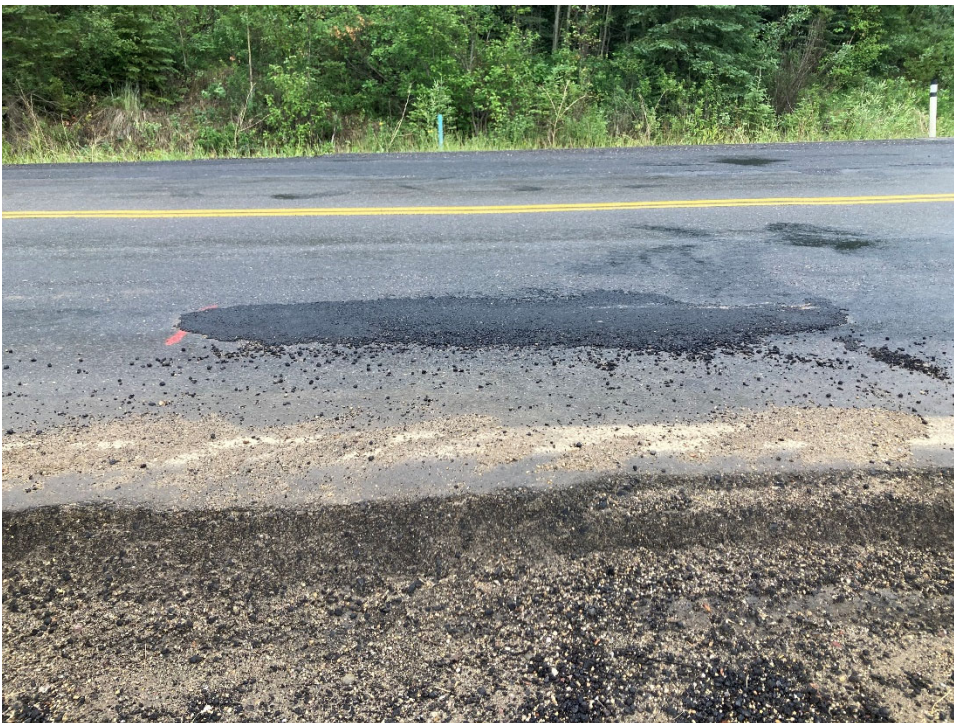
<ul style="list-style-type: none"> - WP087, a void opened through the pavement where landslide deformations created a void or widened a crack at depth that the pavement started to deflect into (a “pothole” or “sinkhole”) 	
<ul style="list-style-type: none"> - WP088 pavement looks like it is 1.5 m thick at edge of pavement 	
<ul style="list-style-type: none"> - 9 cm of vertical movement in latest paved surface near upper (west) barricade. Recent milling done at this location to improve smoothness of surfacing has deflected by 1 to 2 cm since milling. Recent cracks in unmilled pavement are 0.5 cm wide. 	
<u>Middle Slide (Site 1)</u>	
<ul style="list-style-type: none"> - Patched spring 2020. Approximately 2 m of pavement total at edge of pavement 	
<ul style="list-style-type: none"> - Asphalt settled up to 4 cm across backscarp since then, cracking extends through climbing and passing lanes to centreline, cracking approximately 1 cm wide

Photo 4 A recent patch at WP 0087 completed in the north (westbound) lane in spring 2021 after cracking and a sinkhole (void under pavement) was observed by the Maintenance Contract Inspector (MCI). Photo taken July 20, 2021 facing south.

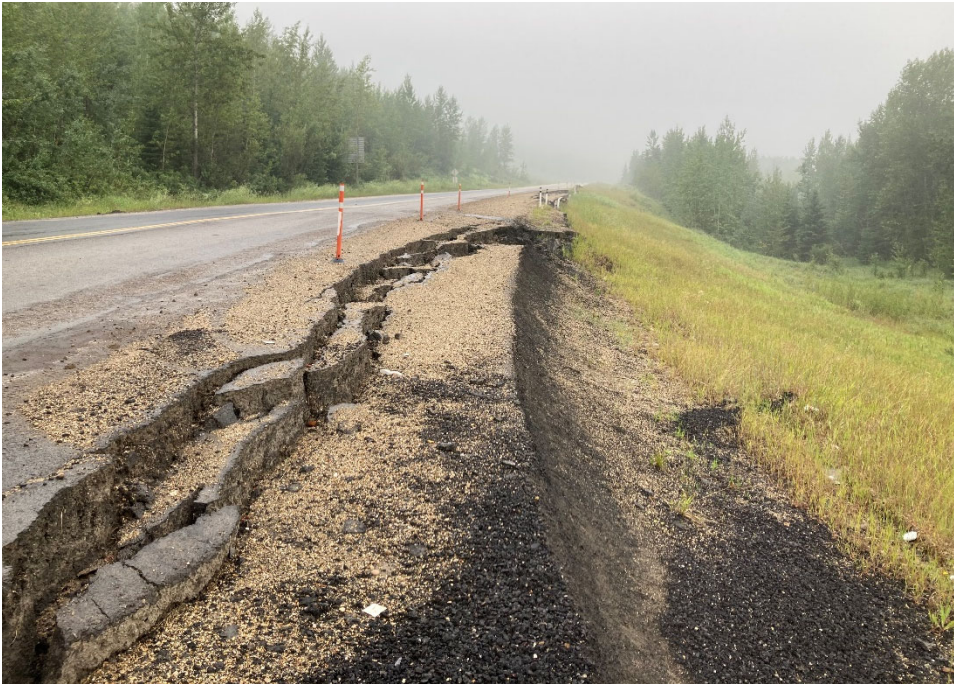
Photo 5 Existing asphalt on the north (westbound) shoulder is breaking away from the highway. Photo taken July 20, 2021 facing west.

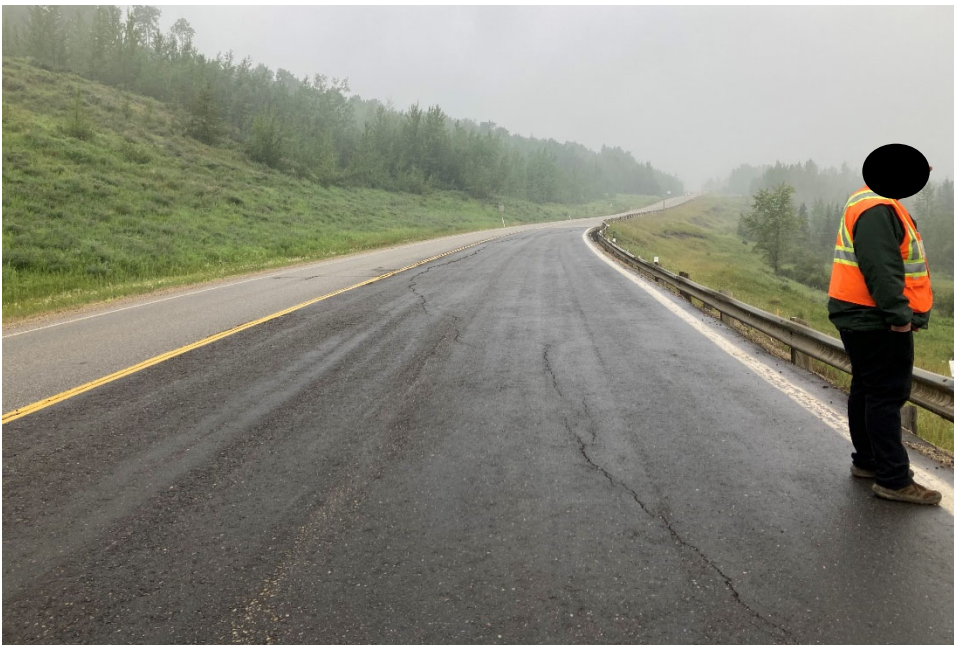
Photo 6 Asphalt cracking observed in the north (westbound) lane of Hwy 666, after the westbound lane was patched in 2020. Photo taken July 20, 2021 facing west.

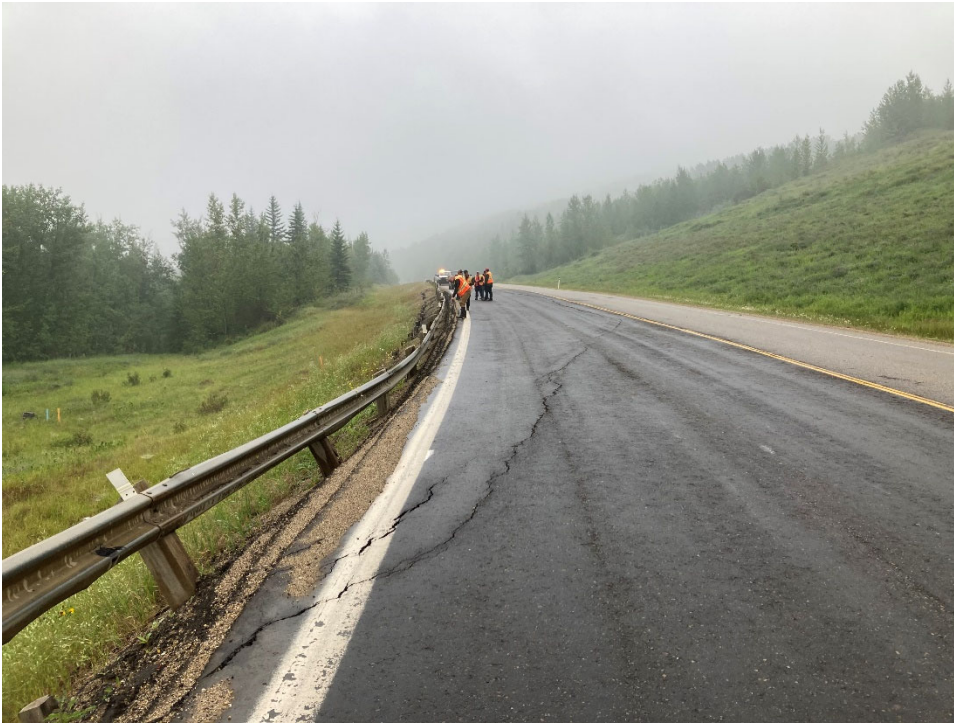
Photo 7 Asphalt cracking observed in the north (westbound) lane of Hwy 666, just east of the asphalt cracking shown in Photo 1. Photo taken July 20, 2021 facing east.

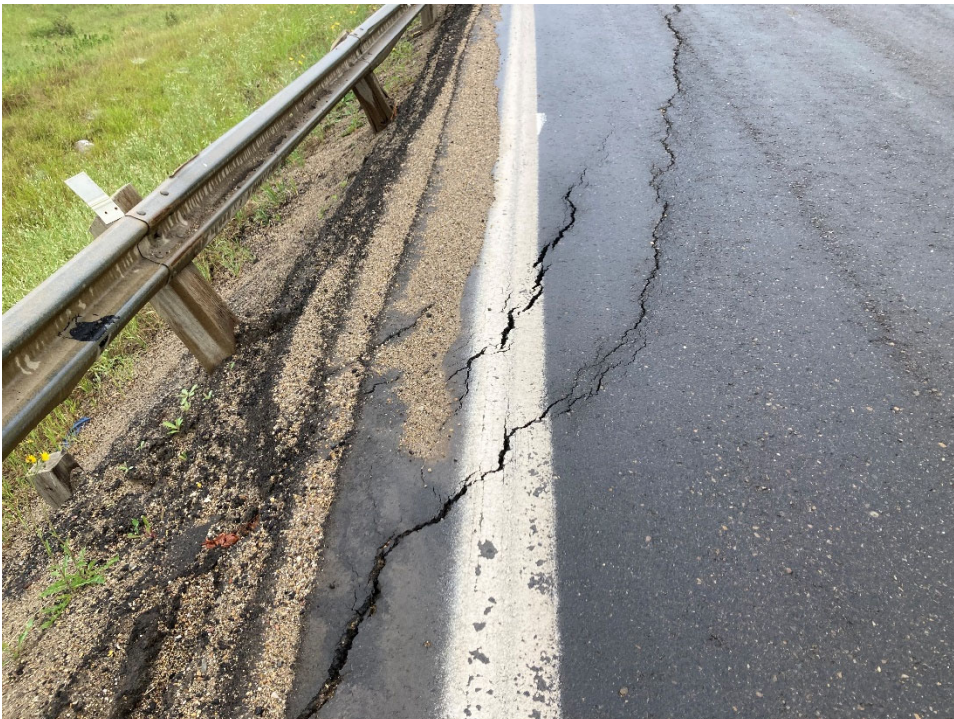
Photo 8 A close-up photo of the asphalt cracking observed near the west extent of the asphalt patch (shown in Photo 8). Photo taken July 20, 2021 facing east.

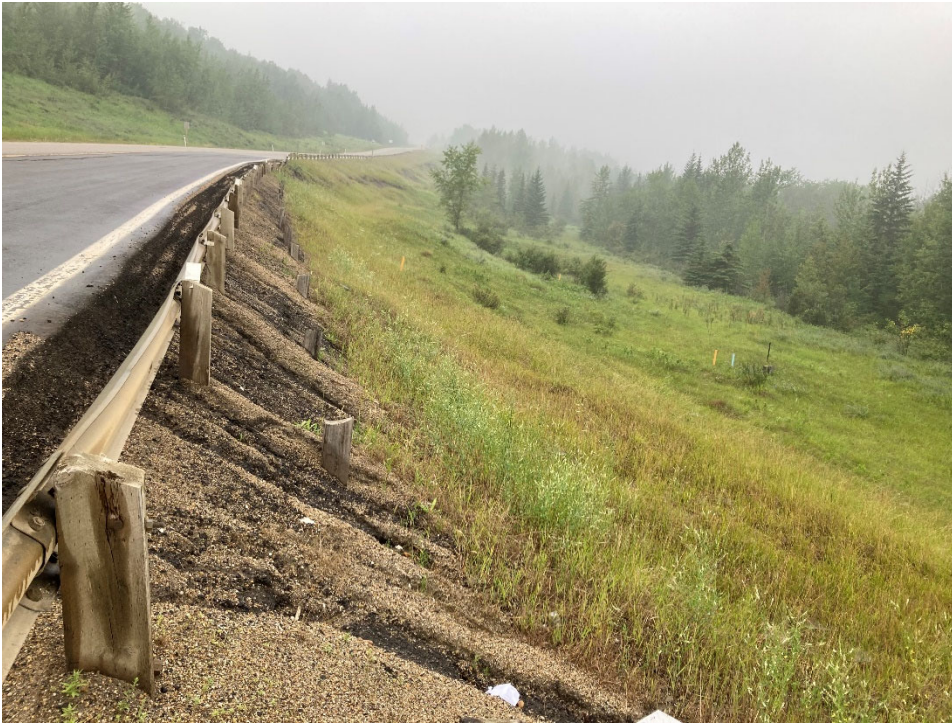
<ul style="list-style-type: none"> - WP089, top of guardrail is at elevation of pavement (second row of old guardrail posts about 1.5 m horizontal below existing edge of pavement 	
<ul style="list-style-type: none"> - Backslope where the road was realigned to the south (i.e., into the slope) has some failures. 	
<ul style="list-style-type: none"> - Very steep and high sharp shoulders at edge of pavement 	
<ul style="list-style-type: none"> - AT will close passing lane, and add more wooden barricades, delineators, sharp shoulder signs and no-passing signs to discourage aggressive driving. 	
<u>Upper Slide (Site 3)</u>	
<ul style="list-style-type: none"> - Backscarp of sliding extends into shoulder 	
<ul style="list-style-type: none"> - Wooden barricades in place to keep drivers away from the shoulder 	
<ul style="list-style-type: none"> - 0.5 to 1.0 m drop off at edge of pavement 	
<u>Other work</u>

Photo 9 North (downslope) edge of the highway, showing the location of the new and existing guardrail (WP 0089). Photo taken July 20, 2021 facing west.

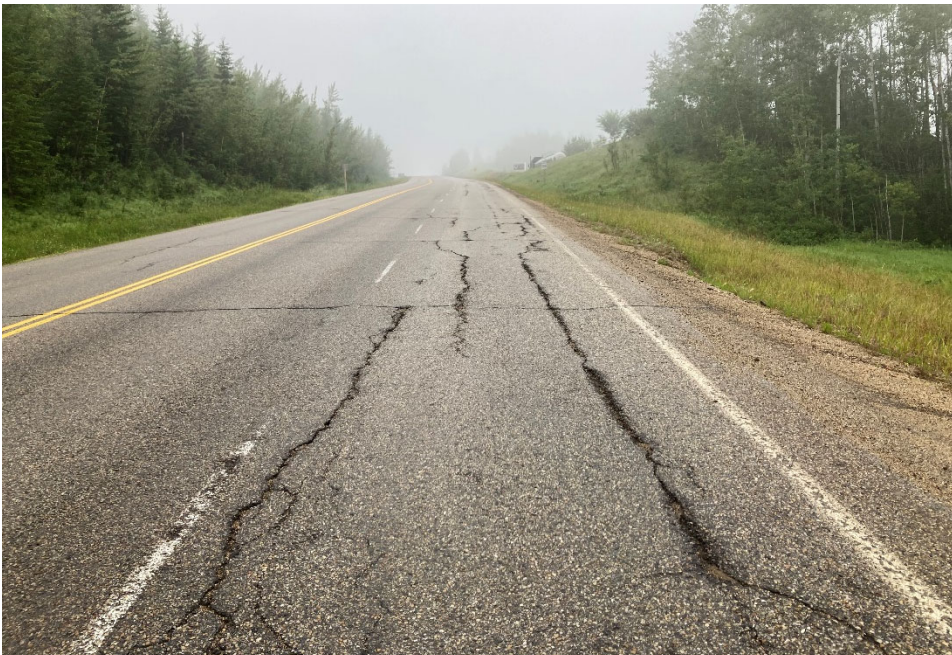
Photo 10 Longitudinal asphalt cracking observed in the north (westbound) travel lane. Photo taken July 20, 2021 facing west.

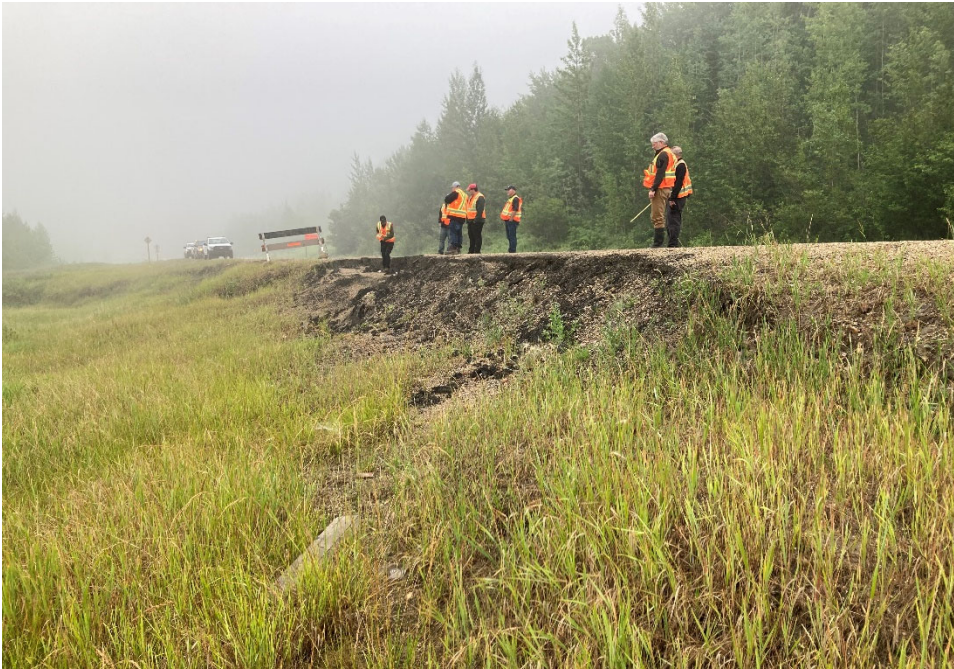
Photo 11 The thickness of the asphalt at the upper slide was estimated to be approximately 1.5 m. Photo taken July 20, 2021 facing southeast.

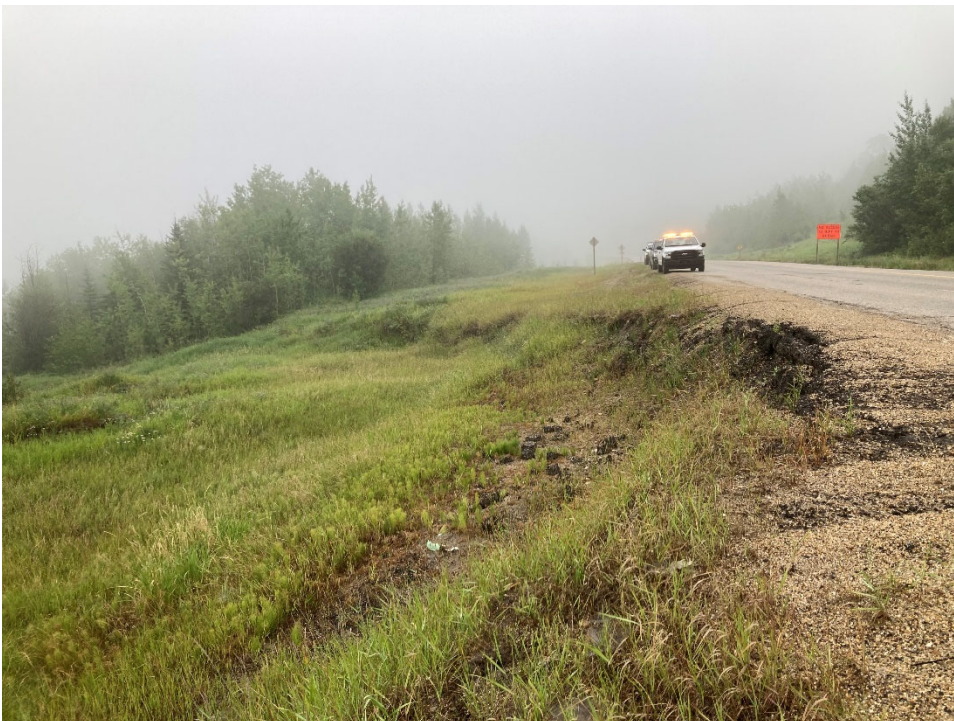
Photo 12 The left flank of the upper slide. Photo taken July 20, 2021 facing northeast.

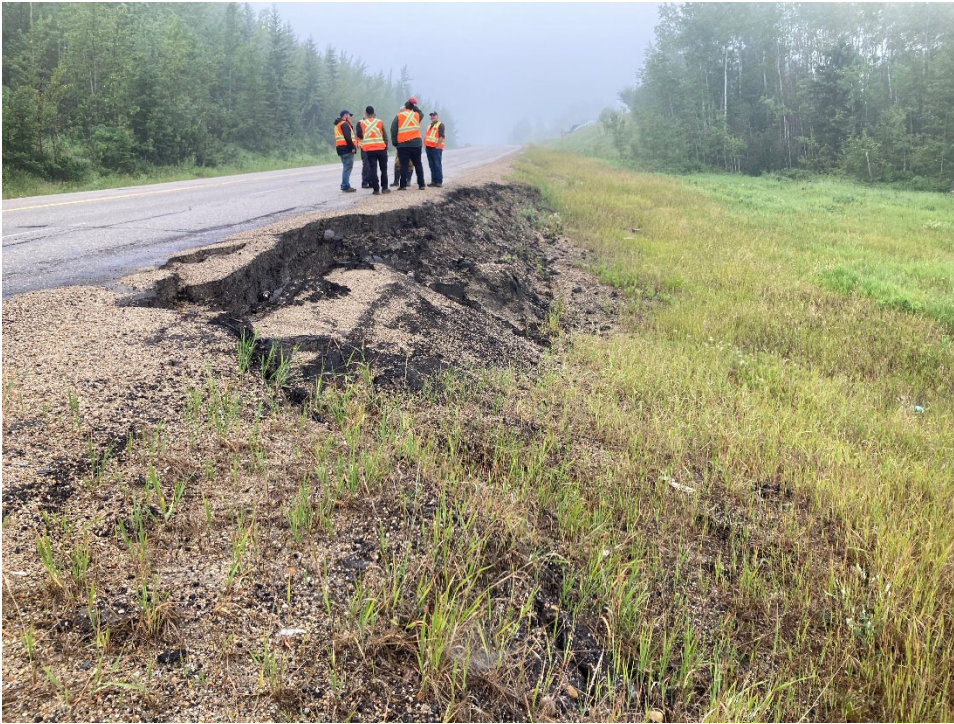
Photo 13 **The asphalt of the north (westbound) shoulder is failing. Photo taken July 20, 2021 facing west.**
