July 15, 2025

CON0022166 Peace Region (Grande Prairie District – South) GRMP Instrumentation Monitoring Site GP016; H666:02, km 34.837 Slide 2 km West of Hwy 40 and Hwy 666 Junction Section C – 2025 Spring Readings

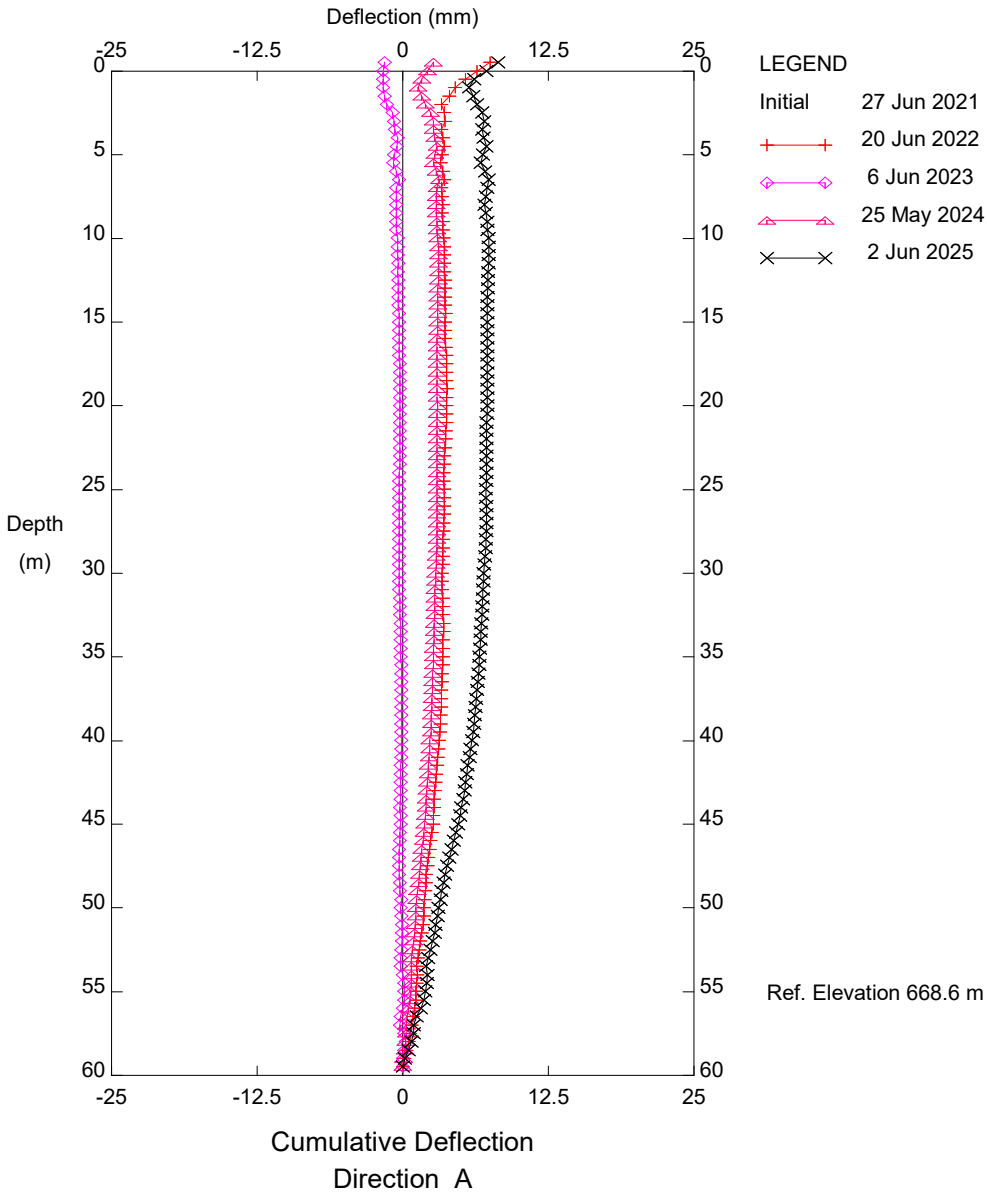
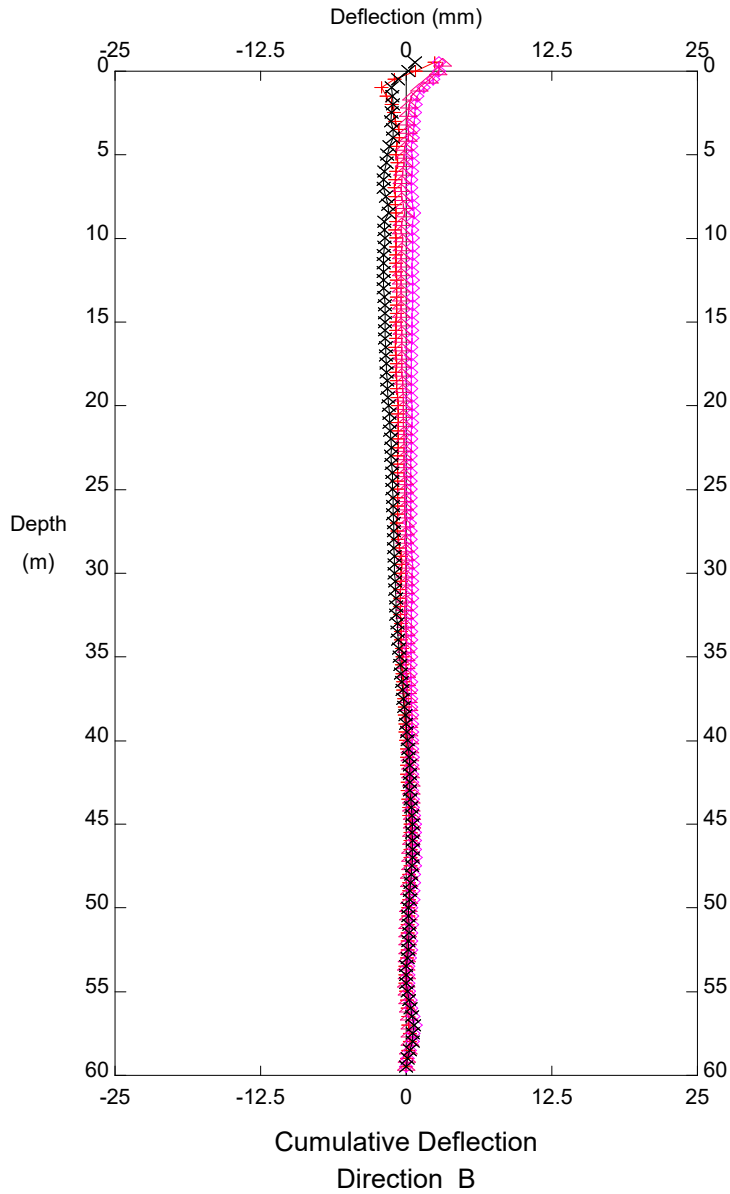
GP016; H666:02 Slide 2 km West of Hwy 40, Inclinator SI-1
Alberta Transportation

- For SI-1, the data is relatively noisy and the readings after 2021 do not line up well with the previous consultants' readings. To improve our ability to interpret the data, we have re-initialized this instrument to the June 2021 readings. Only the re-initialized plots are included in Appendix I.
- For SI-2, the previous consultant was copying the bottom eight readings (4 m) for each subsequent reading instead of using the data obtained in the field. Without this correction, there is a "kick-out" at the base of the instrument when compared to the previous readings. With the replacement readings, KCB's readings are relatively consistent with the previous readings. However, to improve our ability to interpret the data, we have re-initialized this instrument to the June 2021 readings. Only the re-initialized plots are included in Appendix I.

In general, the data for SI-1 and SI-2 is noisy and difficult to interpret. Based on the absolute plots for these instruments, they have several kinks and tilts up to 1.0 m.

No defined zones of discernible movement have been recorded in SI-1 and SI-2 since installation. These instruments are installed at the valley crest of Site 1, upslope (south) of the highway.

Depending on long-term plans for the site, TEC could consider replacing SI-13, since it was the last active SI at highway surface, and either removing or replacing SI-01 and SI-02, since the data recorded in these instruments is noisy and difficult to interpret. Alternatively, TEC could adopt change-detection or remote-sensing type monitoring, including Light Detection and Ranging (LiDAR), Interferometric Synthetic Aperture Radar (InSAR), or low-cost differential Global Positioning System (GPS) if the risk of equipment loss or damage is acceptable. Such an assessment would help provide a wider perspective assessment on where movements are occurring across the whole slope and may offer some opportunities to assess the influence of toe-of-slope movements and associated time-lag effects to when the slope movements affect the highway surface.

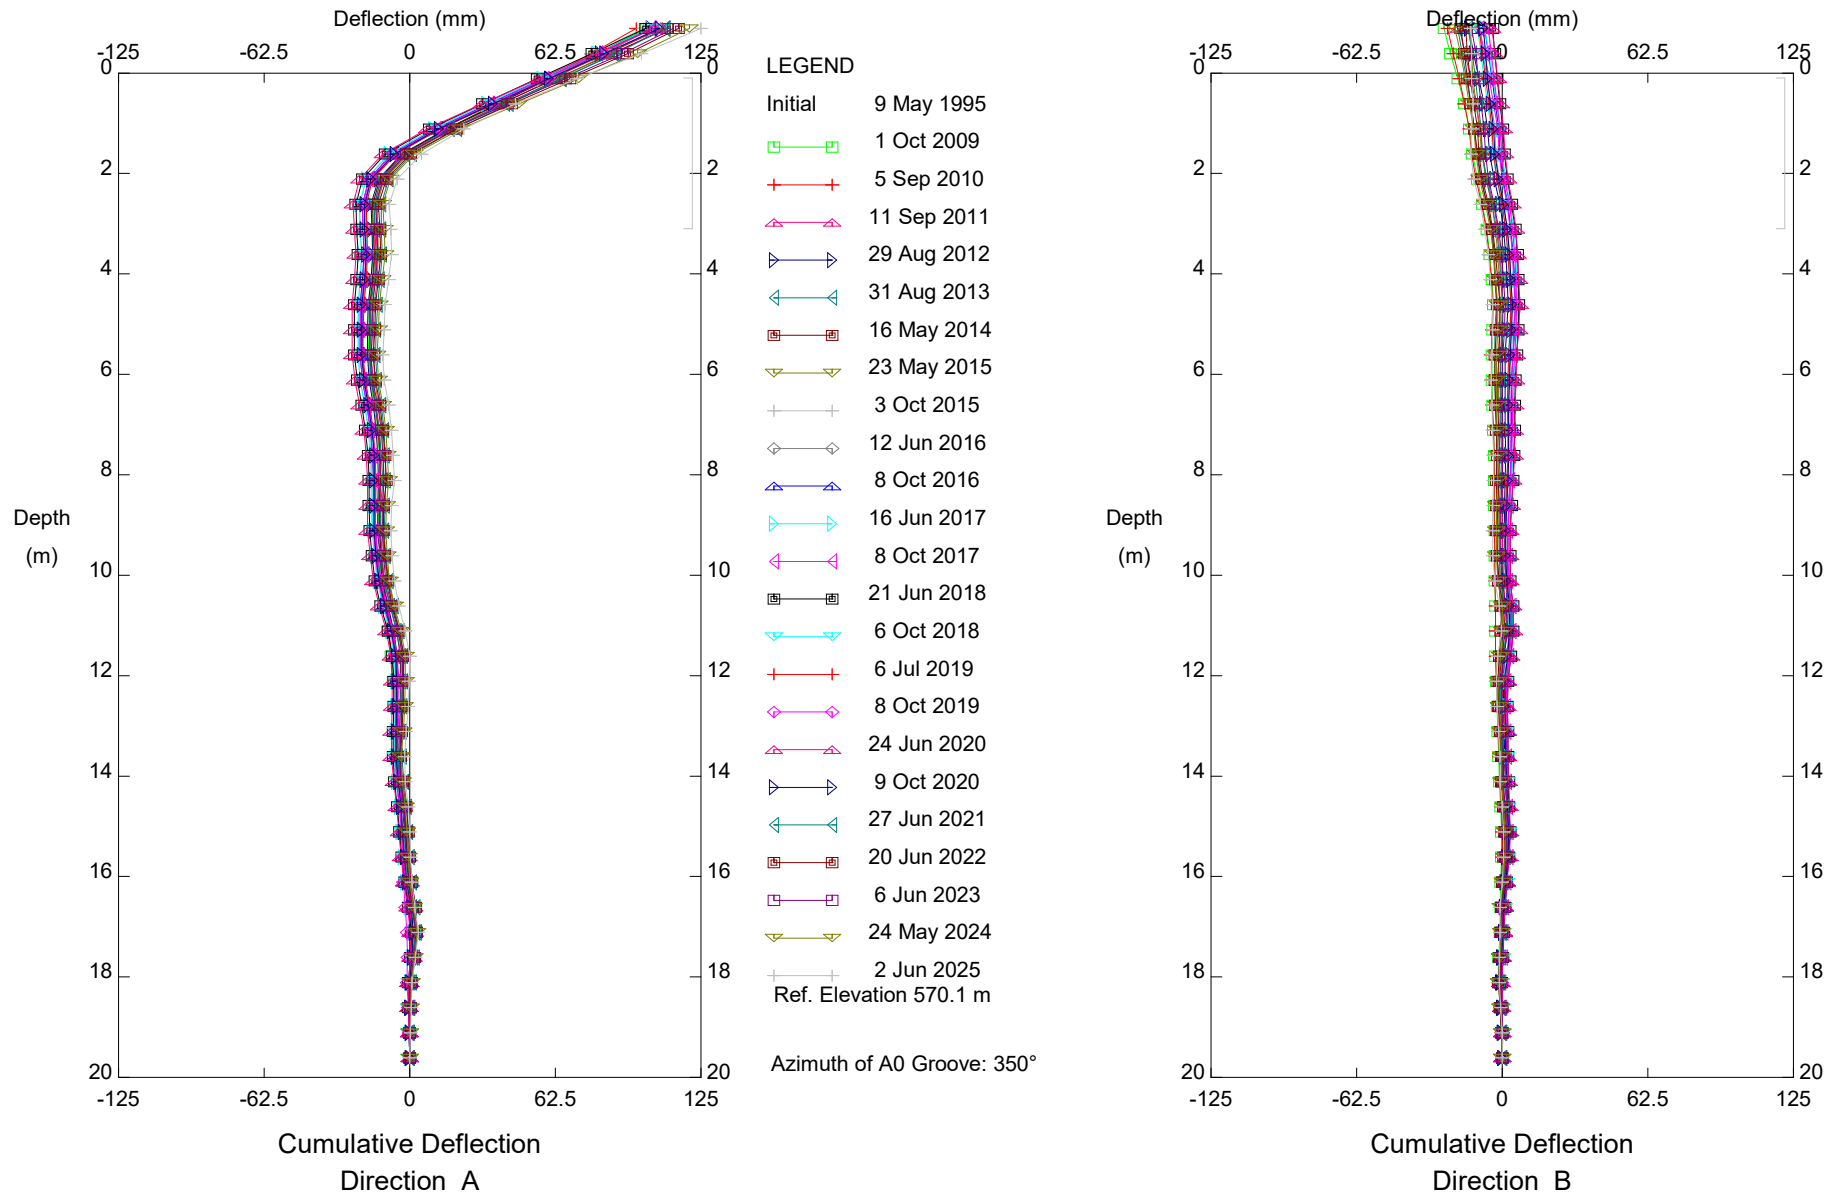
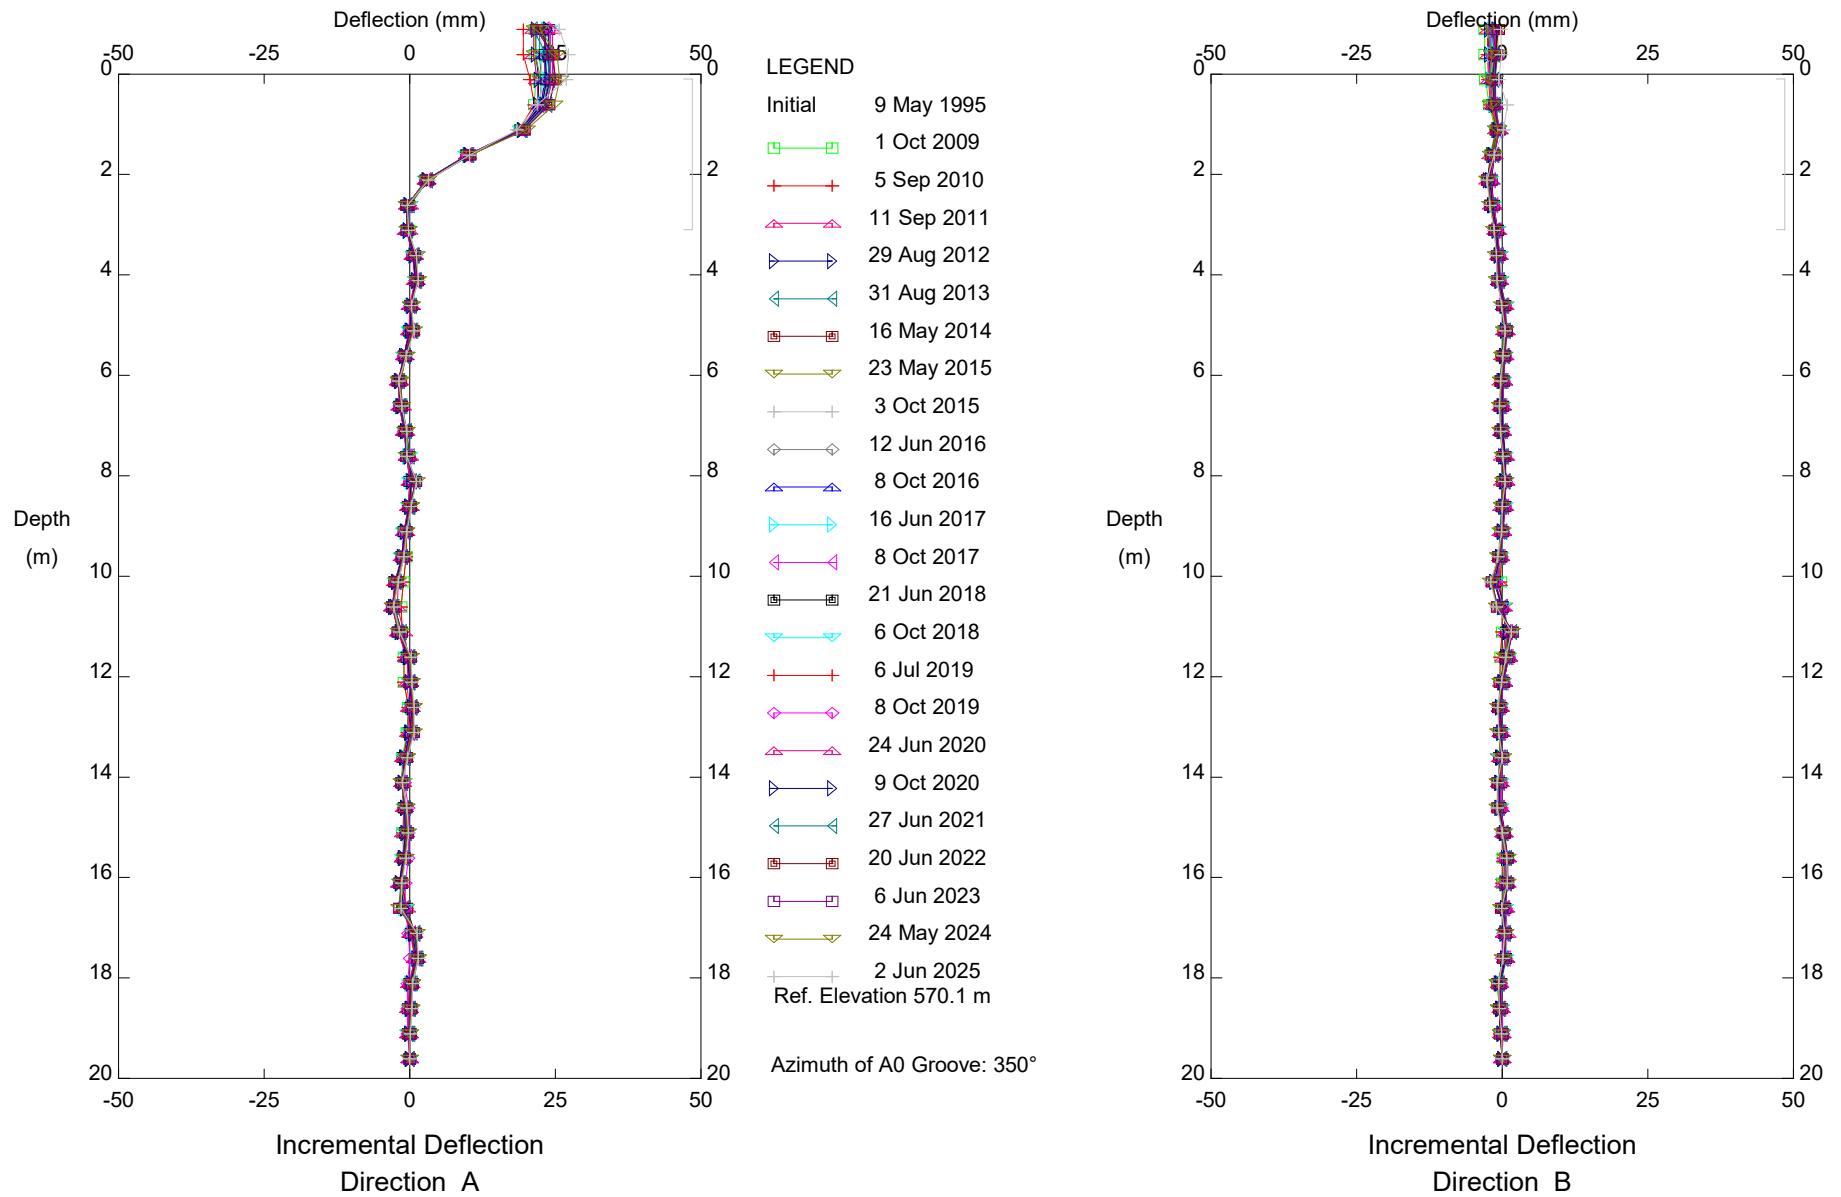
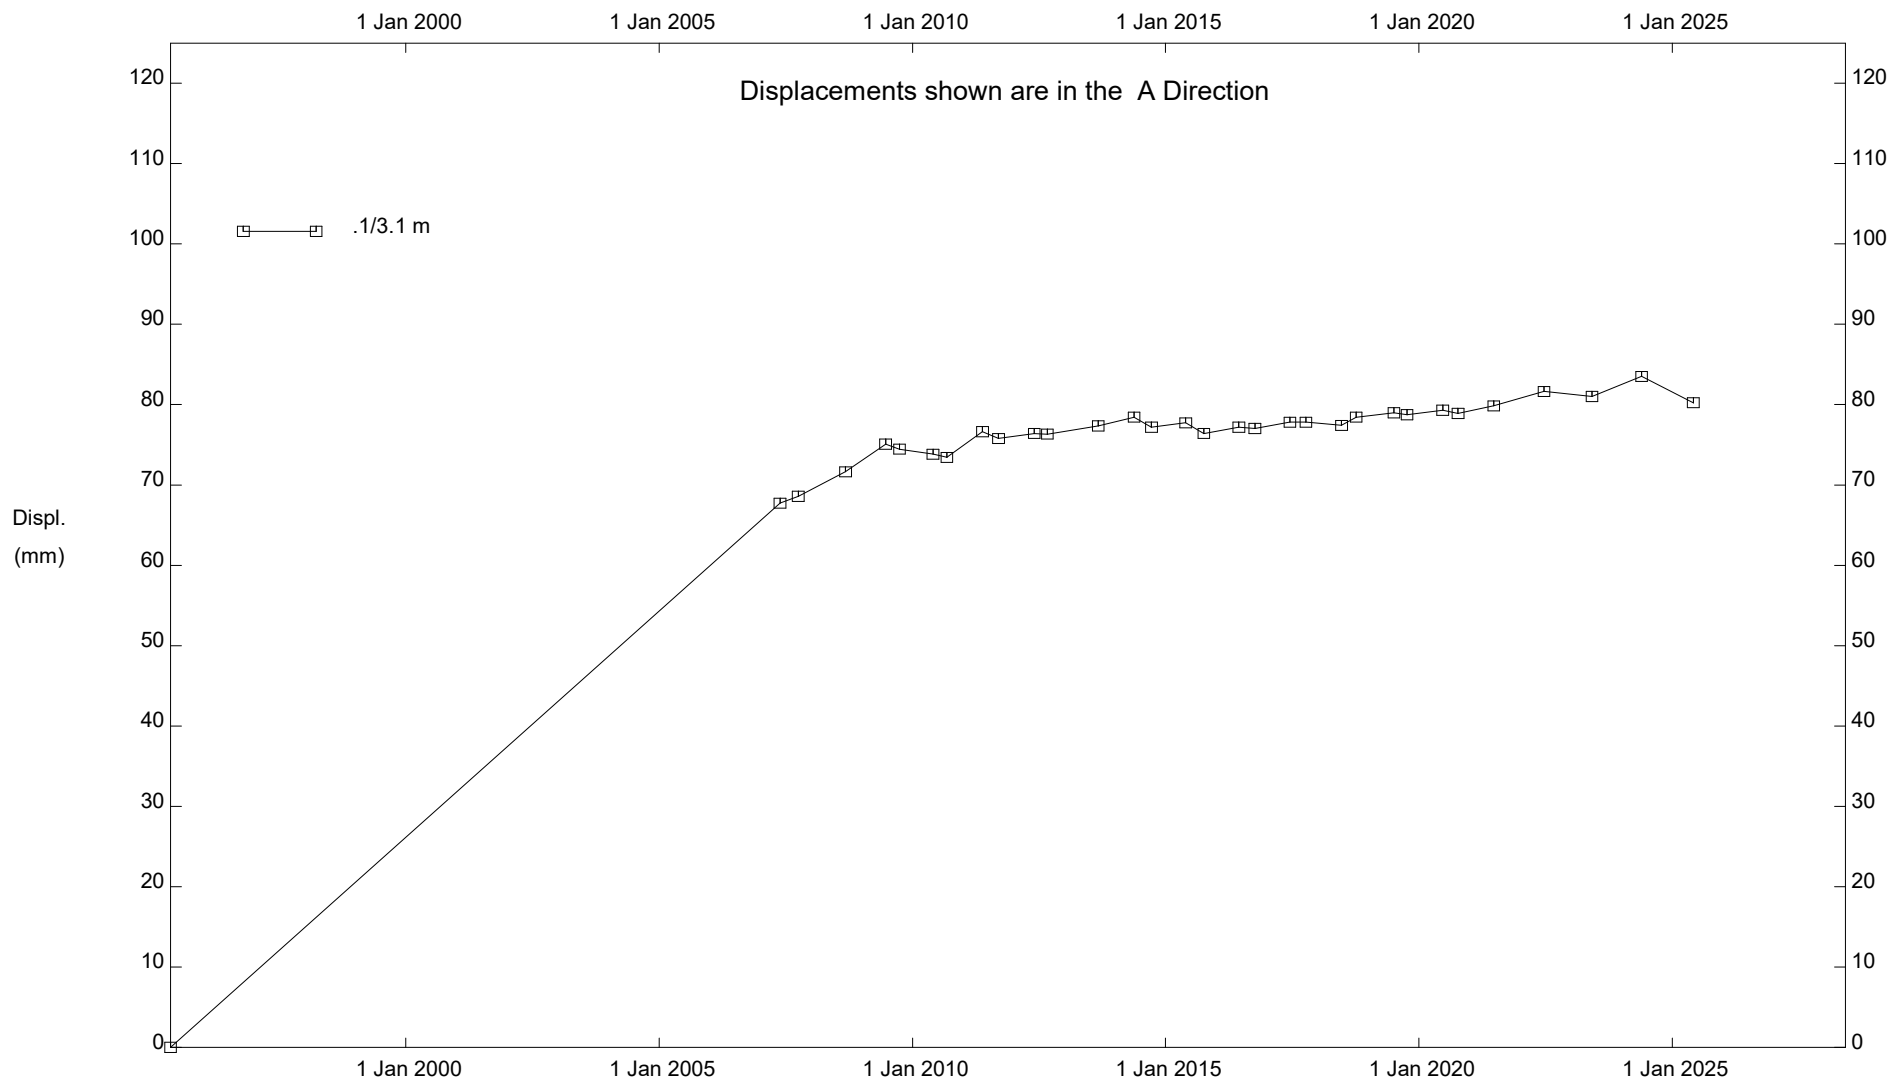
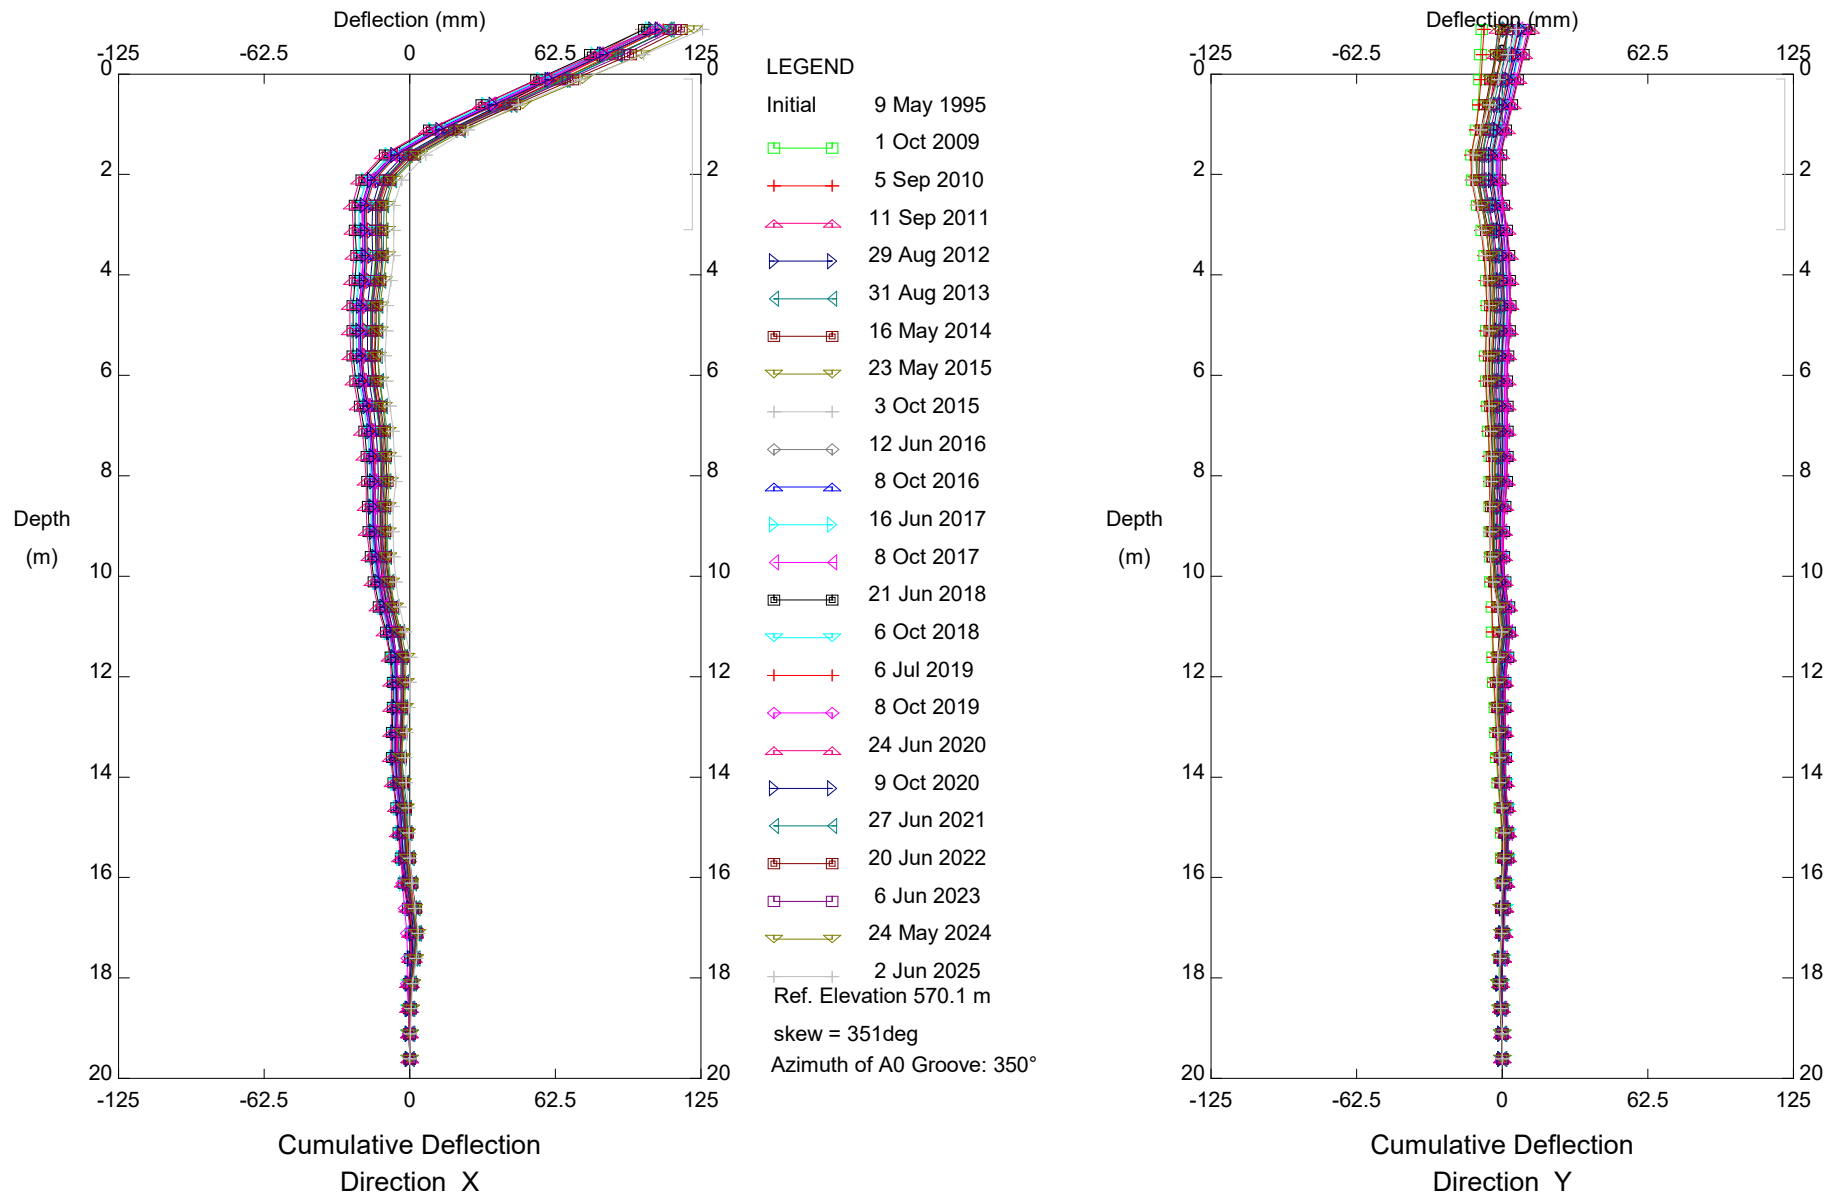
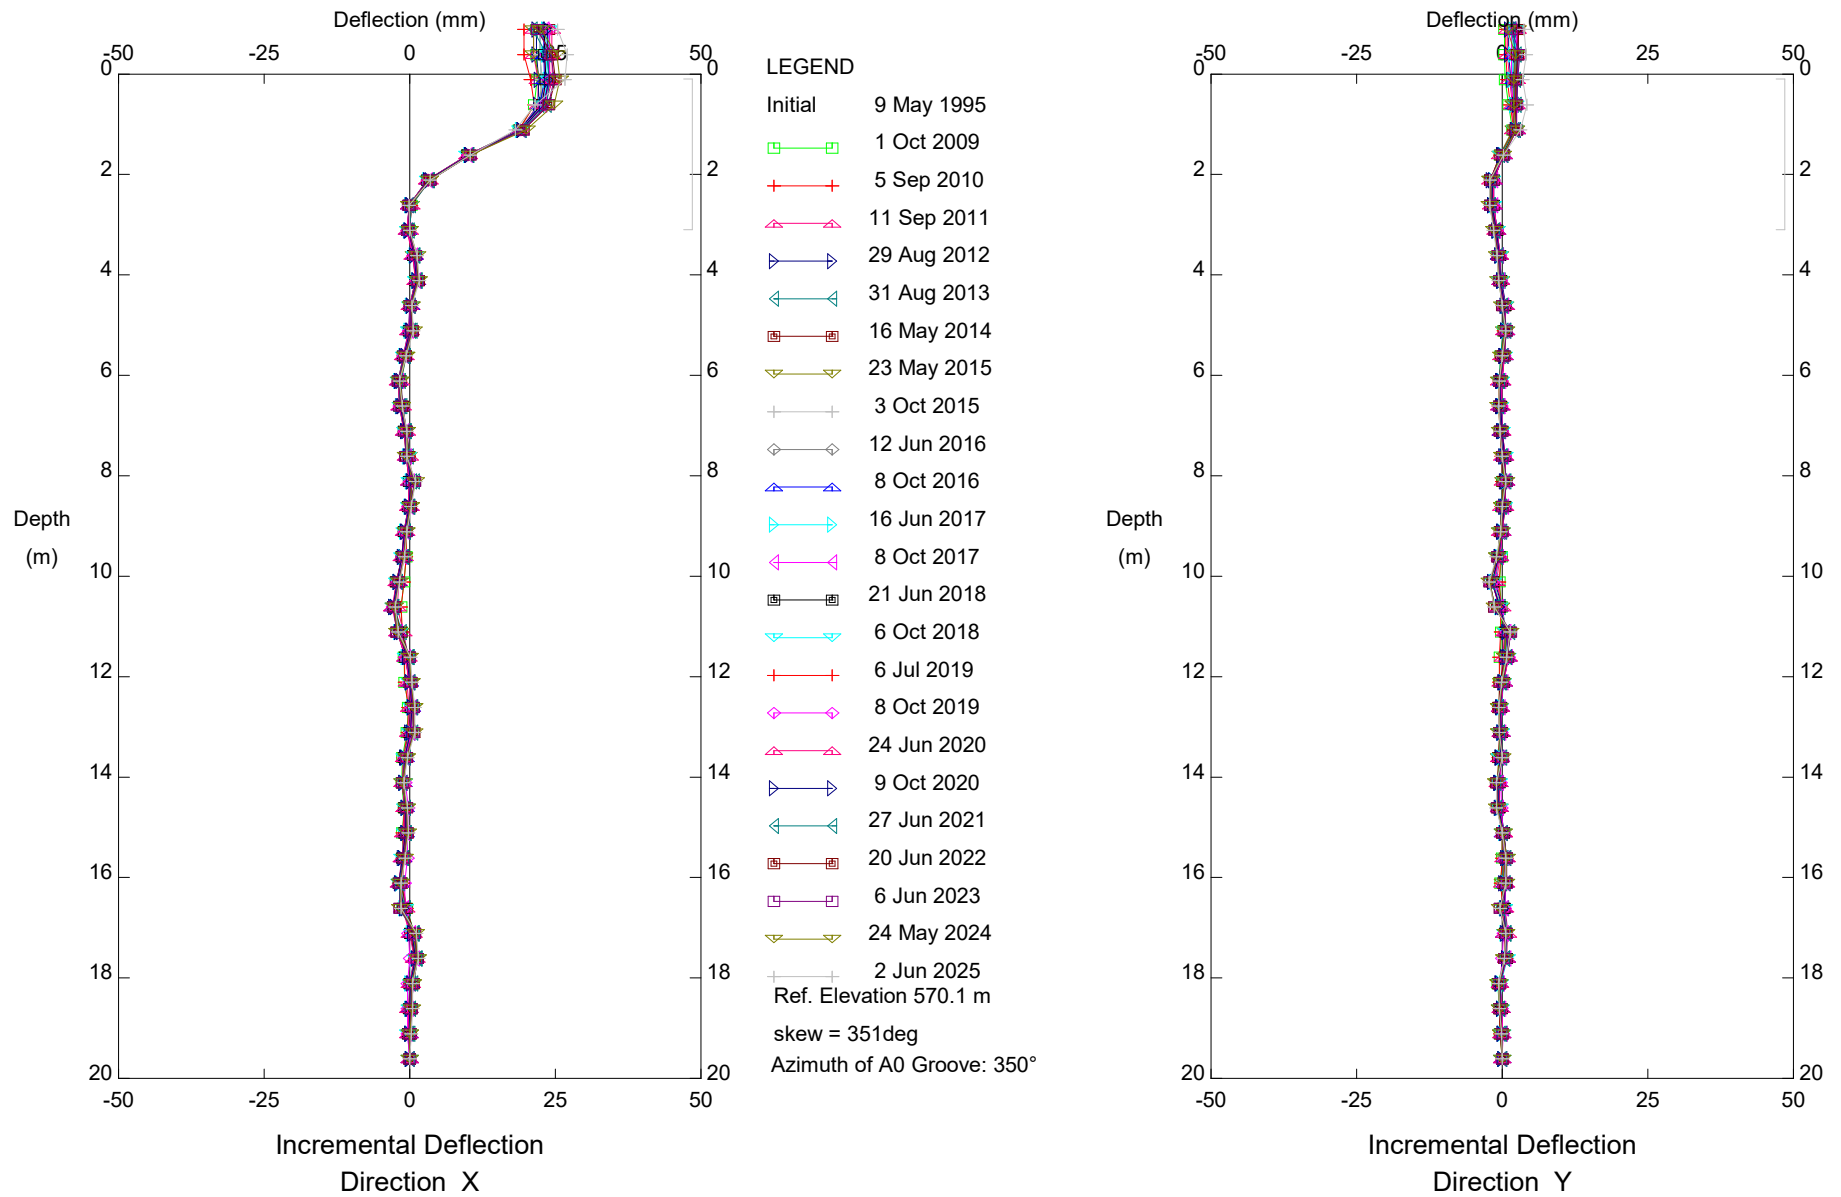
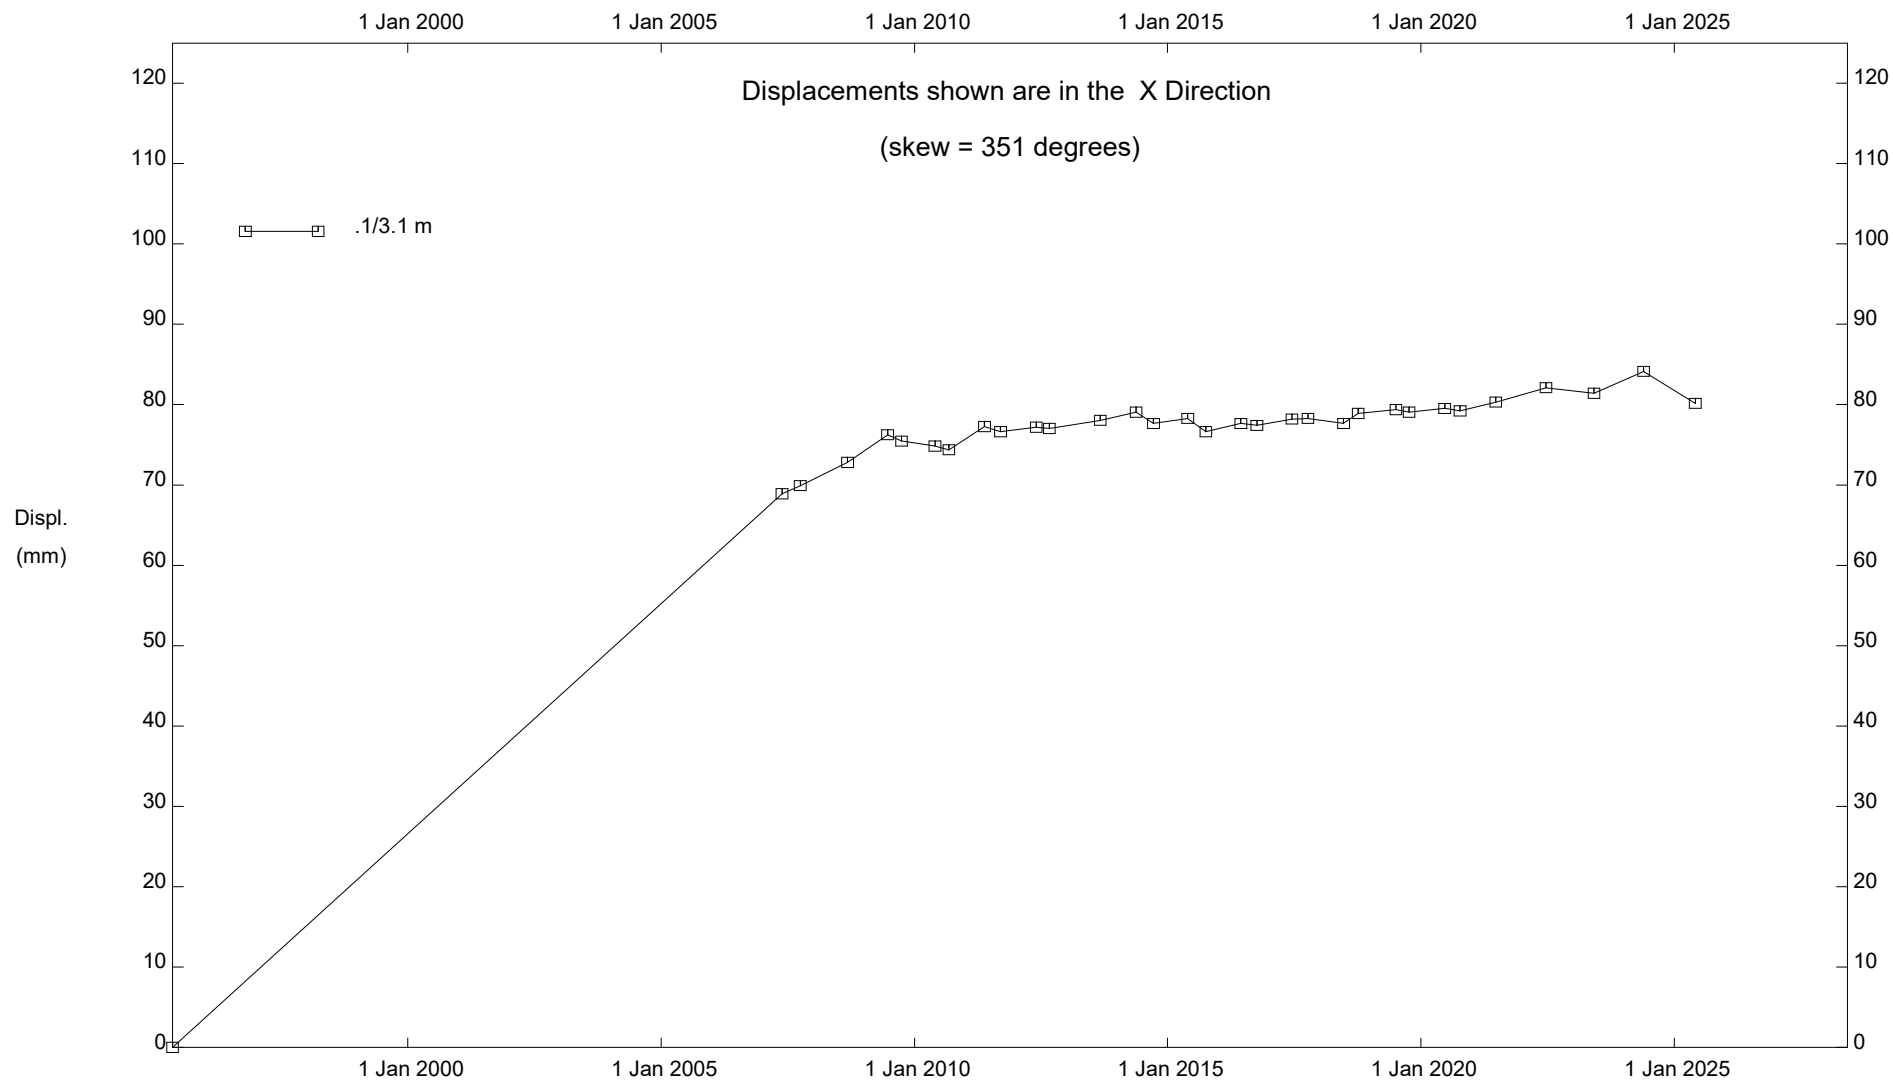
GP016; H666:02 Slide 2 km West of Hwy 40, Inclinator SI-41

In SI-41, which is installed upslope (south) of the highway at Site 2, distributed movement is being recorded from ground surface to an approximate depth of 2.1 m below ground surface (elevation 570 m to 568 m).

Since June 2009, the rate of movement recorded in SI-41 has been slow (less than 4 mm/year). The pavement distress previously observed at Site 2 does not appear to have been reflected in the data obtained from SI-41, which is installed upslope (south) of the highway.
