**CON0022166 Peace Region
(Grande Prairie - South) GRMP**

GP055; Hwy 674:02, km 15.150

Call-Out Report

October 2022

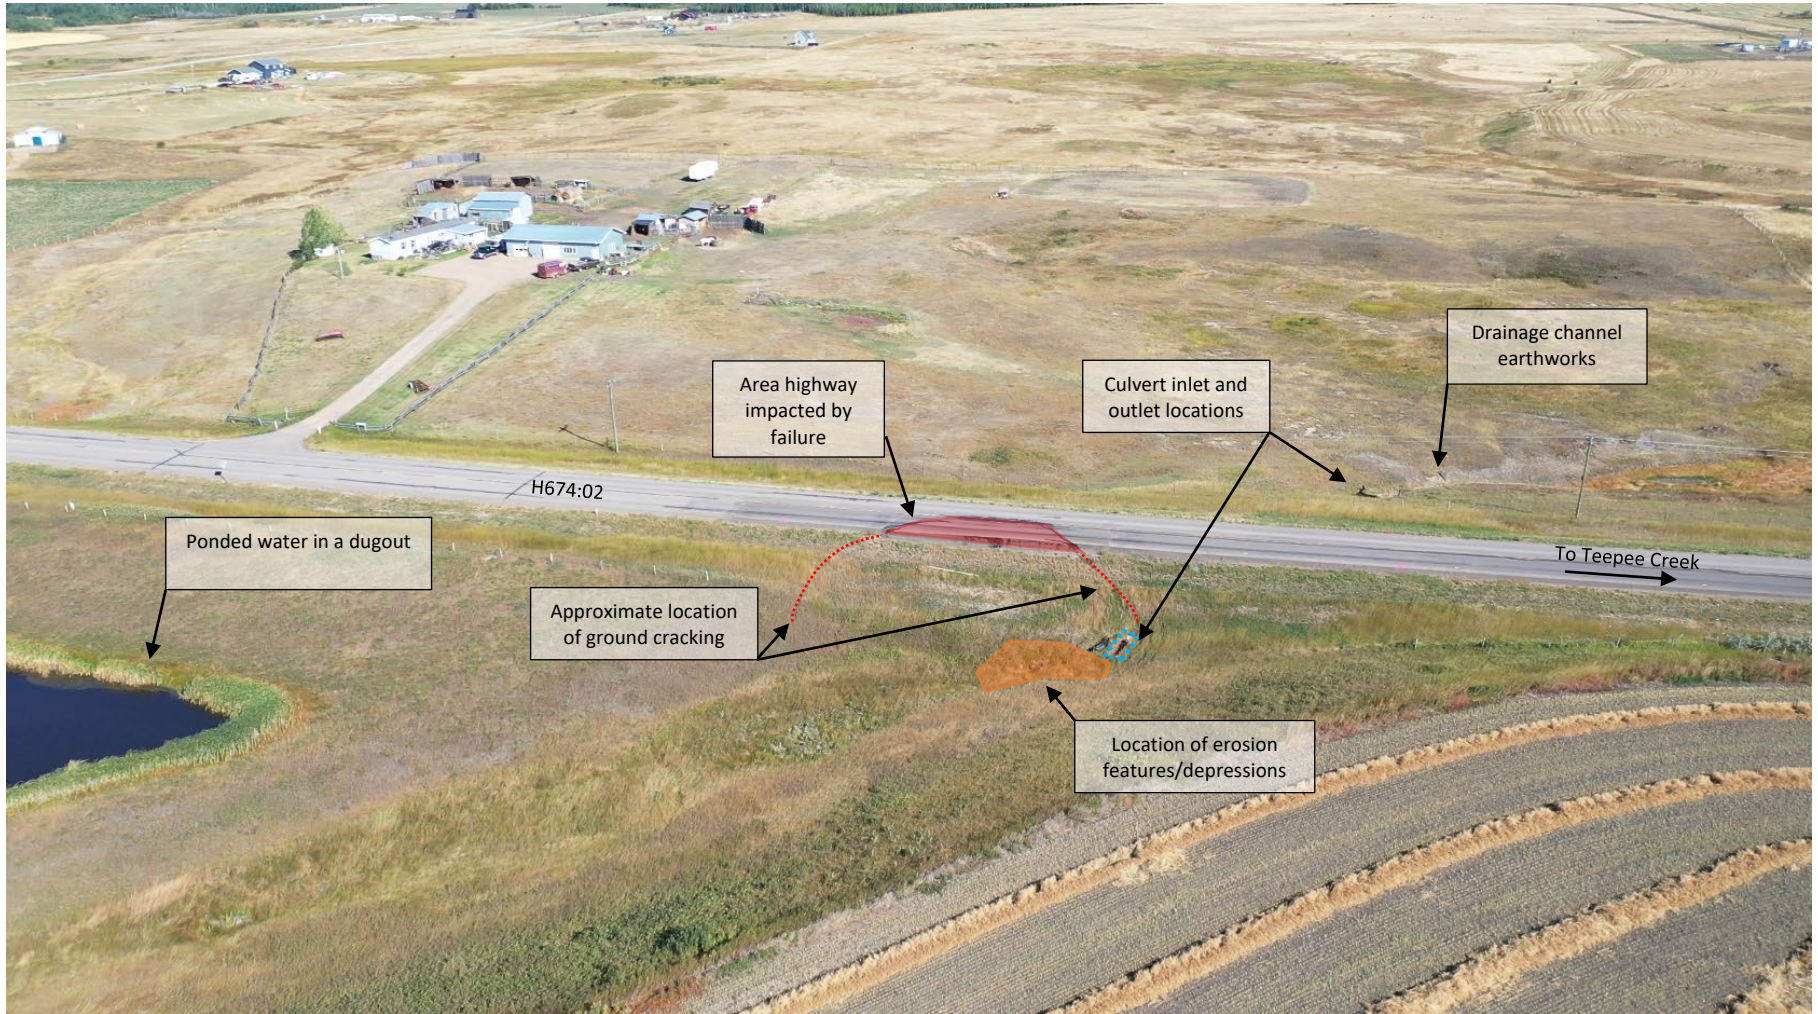
- The embankment slide was present through the east bound lane of the highway (south side) with its backscarp extending just past the centre line of the highway and extended approximately 7 m parallel with the highway (Photo 6). AT said that the backscarp used to extend to centreline but was now creeping past centreline into the westbound lane. Pavement cracking and differential settlement up to 75 mm within the slide area was evident. Width of cracking within the asphalt was up to approximately 30 mm.

Photo 1 Oblique aerial drone photo of the site, indicating the main site features. Highway impacted by embankment slope failure is indicated by the red highlighted area. Photo taken August 31, 2022, facing northwest.

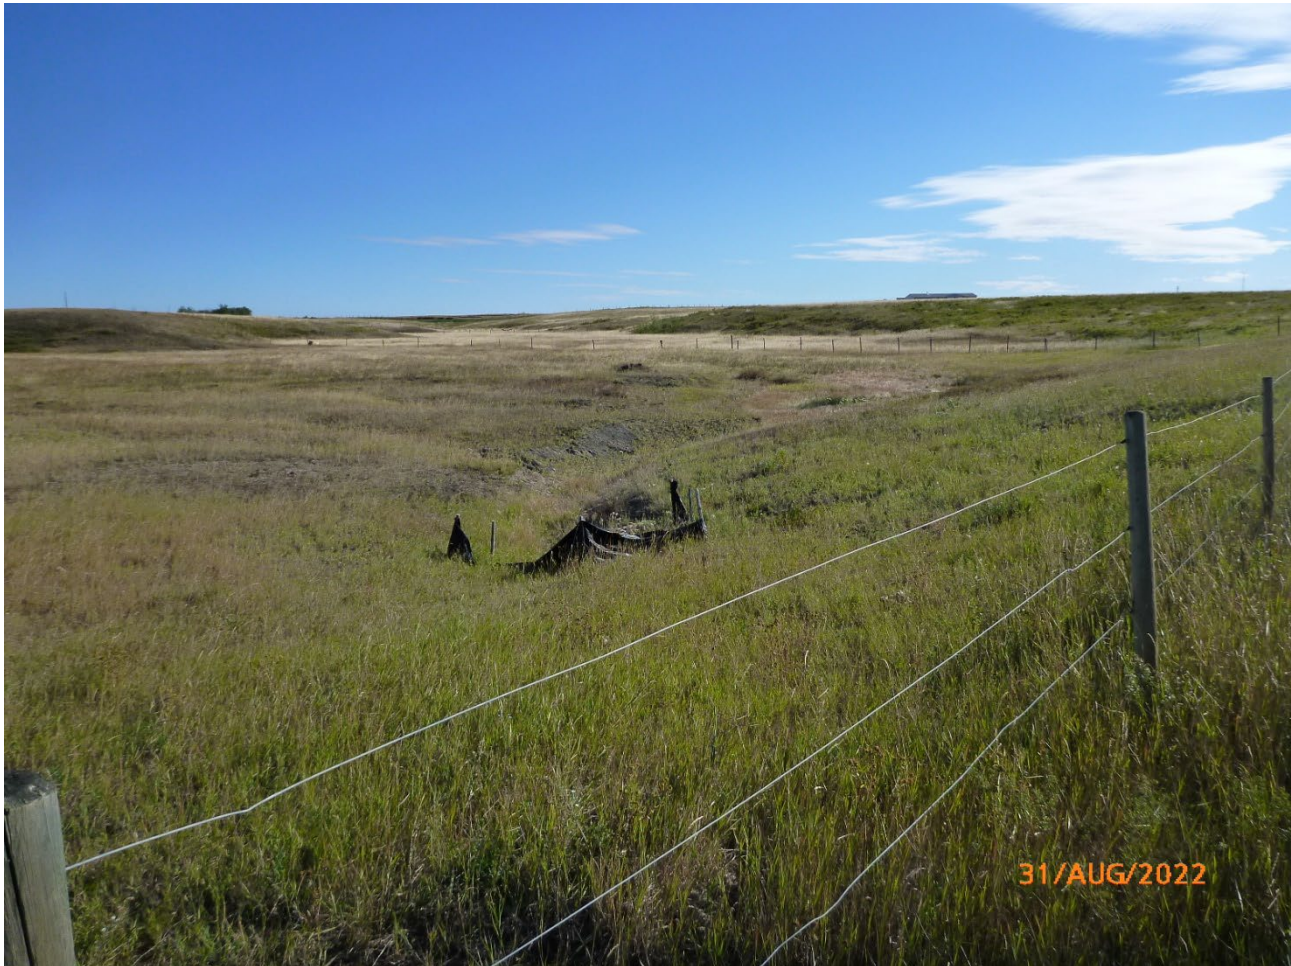
- KCB did not obtain permission from the landowner(s) to access property next to the highway right of way which impacted KCB's ability to inspect the culvert inlet present approximately 15 m from the highway right-of-way (ROW) boundary, approximately 30 m east of the centre of the embankment slide (Photo 2).

Photo 2 Culvert inlet north of highway and earthworks to direct flow into inlet of smooth-wall steel culvert. Photo taken August 31, 2022, facing northeast.

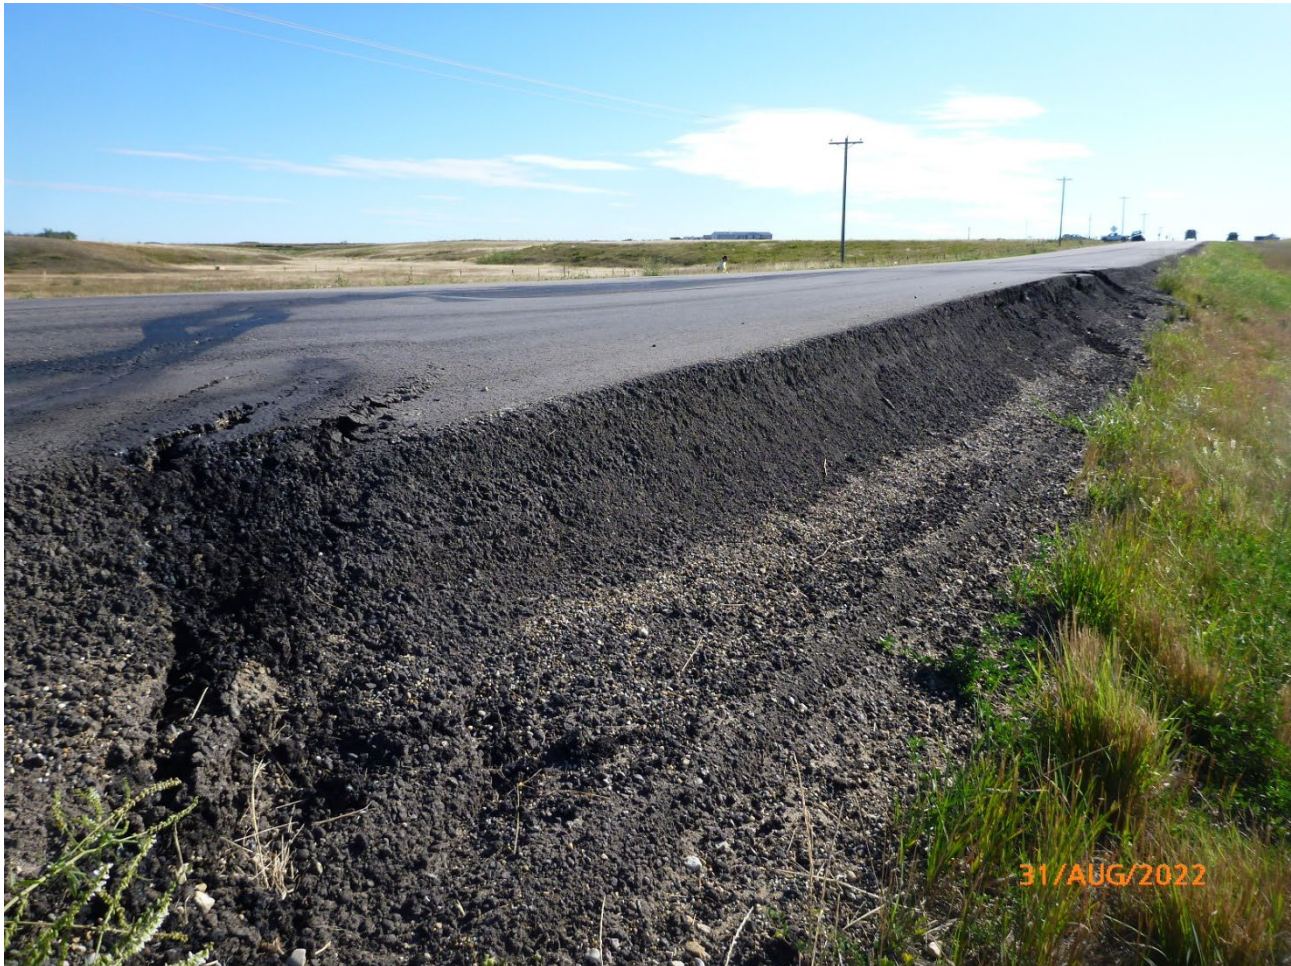
- Asphalt patching was evident extending approximately 70 m east of the slide and 20 m west of the slide backscarp. Asphalt thickness at the slide location had a measured thickness of approximately 1.0 m (Photos 3 and 4).

- The thickness of asphalt and AT's reports of routine maintenance and patching indicate that the embankment failure has been moving steadily since 2018.

Photo 3 **Thickness of asphalt upwards of 1.0 m at western edge of impacted eastbound lane of the highway. Photo taken August 31, 2022, facing northeast.**

- AT should continue with their plans to patch this section of highway this fall.
- The MCI should continue to monitor the site for further pavement or slope cracking after the pavement patch.
- The existing traffic accommodation measures should be maintained. If the severity of settlement and slope movement increases, additional speed reduction or more frequent patching from could be implemented to reduce the risk to local traffic while a repair is being designed.

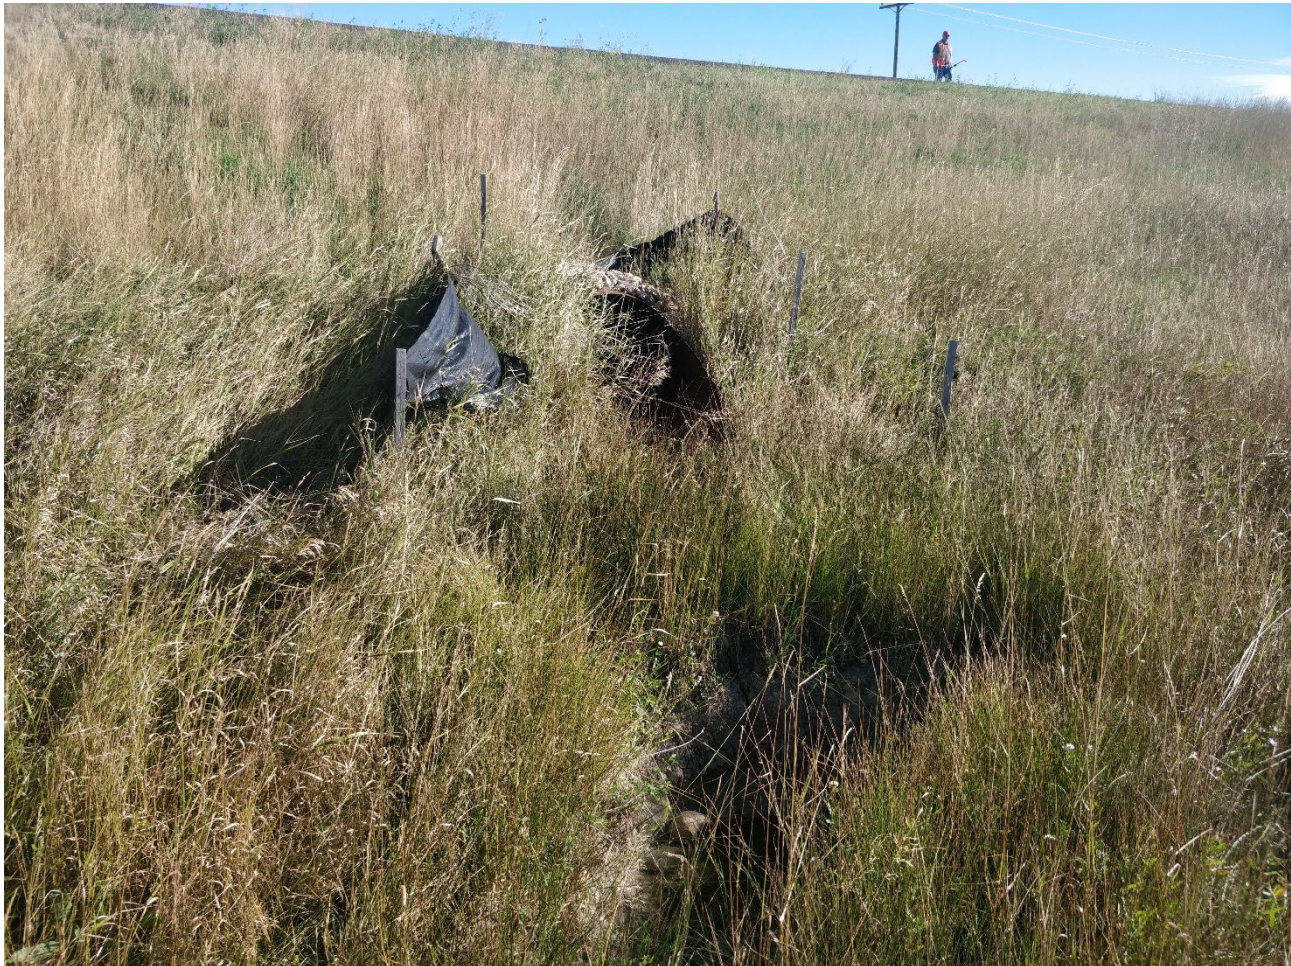
- A smooth-wall, 0.9 m diameter steel culvert outlet is present approximately 12 m downslope of the south embankment and 12 m east of the centre of the slide (Photo 4). The culvert is located up the east abutment of the embankment and appears to have been installed after the embankment was constructed.

Photo 4 Smooth-wall steel pipe culvert outlet on south embankment, note erosion below point of discharge. Photo taken August 31, 2022, facing northeast.

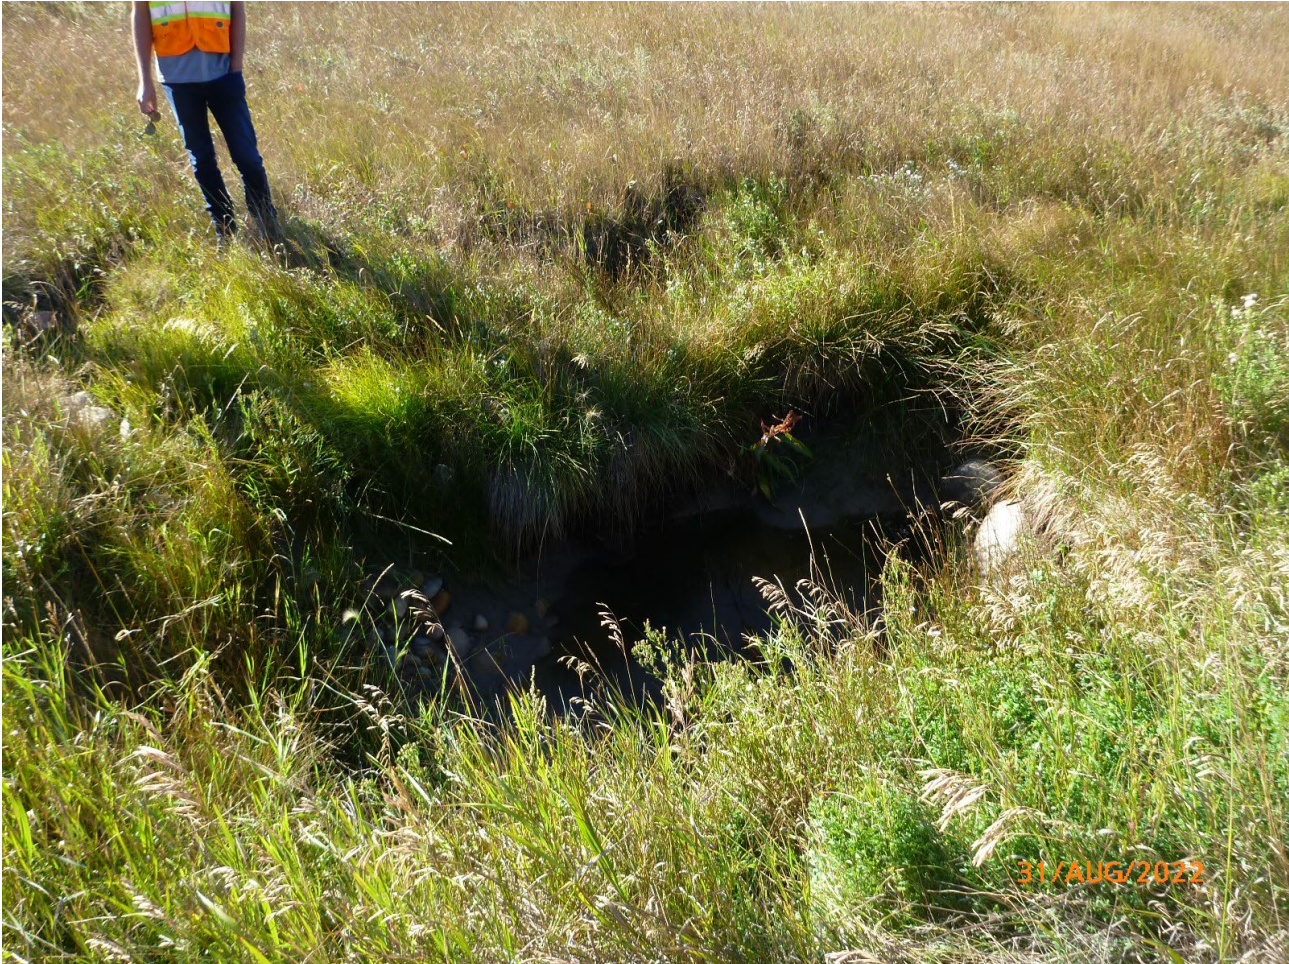
- Several relatively large erosional features, possibly sinkholes, were observed downslope of the culvert outlet. Water was present in the some of these depressions, the largest of which were at least 2 m across and over 1 m deep (Photo 5). Depths of the depressions were not directly measured to limit risk while approaching the edges which were significantly undermined.

- Riprap at the toe (lowest point) of the south embankment slope suggests the potential presence of a decommissioned culvert that may be present within the road embankment (Photo 5). The riprap appears to be located where a culvert would be expected.

- Evidence of a decommissioned culvert present under the highway needs to be reviewed further to confirm its impact on any future construction work to repair the embankment.

Photo 5 Large depression approximately 5 m away from culvert outlet at toe of south embankment slope. Note eroded rip rap within depression possibly from decommissioned culvert not visible during inspection. Photo taken August 31, 2022, facing southwest

- Drilling a mid-slope borehole will require a temporary bench to be excavated to provide drill rig access. While an excavator is constructing the temporary bench, a shallow test pit could be excavated at the possible location of an old culvert that appears to have been located at the valley bottom.

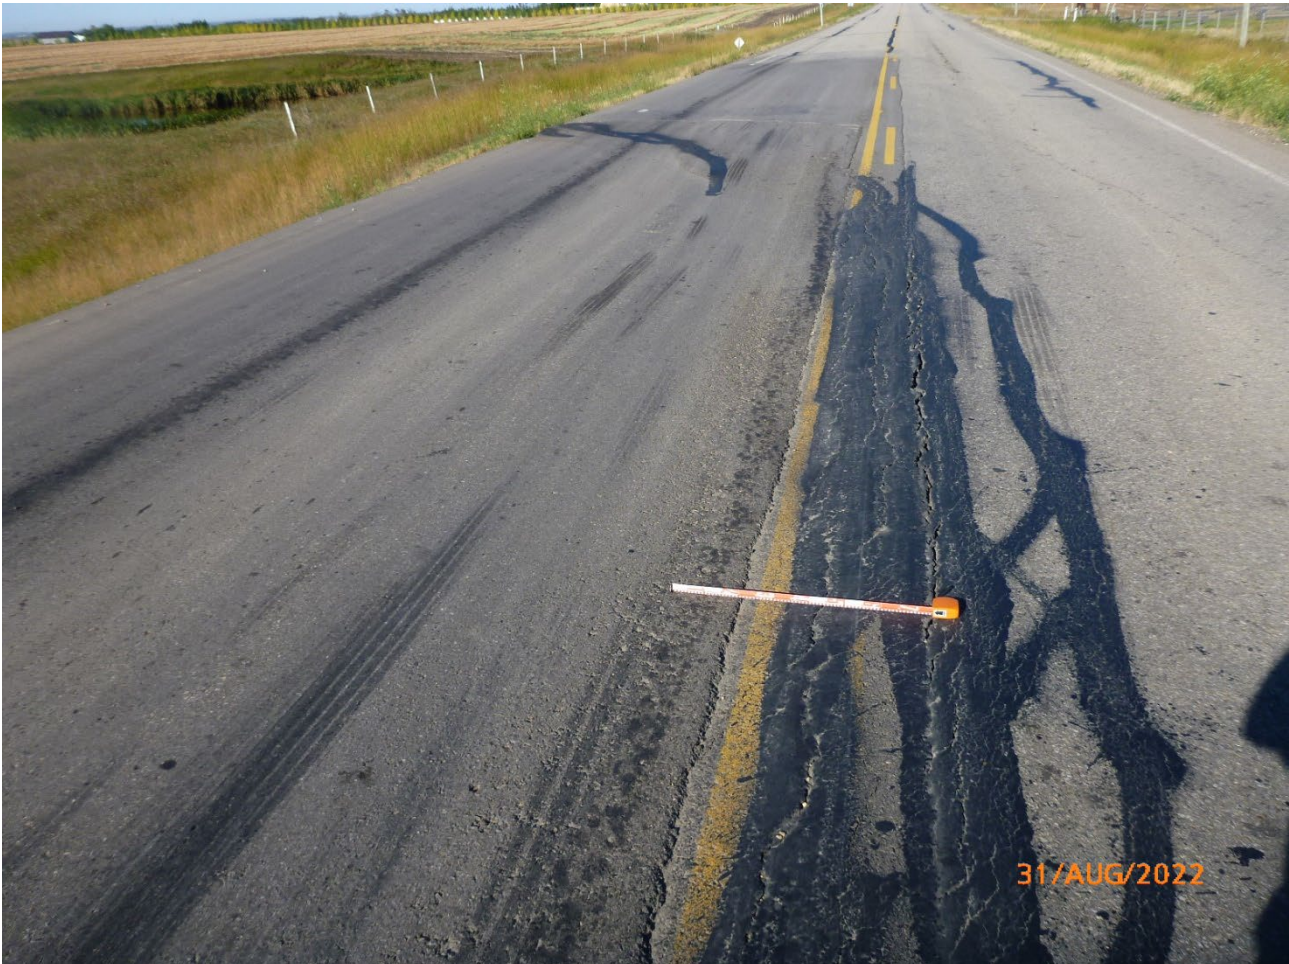
- The MCI's and HMC's observation that the failure surface is extending further past centreline than it has before indicates the embankment failure is retrogressing.

Photo 6 **Extent of settlement and cracking observed in east bound lane of highway. Photo taken August 31, 2022, facing west.**

- A design should be prepared for repair of the embankment. We anticipate that the repair would include excavating the south embankment slope, installing a gravel shear key and foundation drainage (either perforated pipe laid out on the foundation or in drainage trenches excavated into the foundation), and reconstruction of the south embankment slope with compacted gravel reinforced with geogrid. The asphalt surface would be reinstated using the asphalt thickness design previously used for the 2018 overlay. The design work should include a drilling investigation with instruments installed as well as an

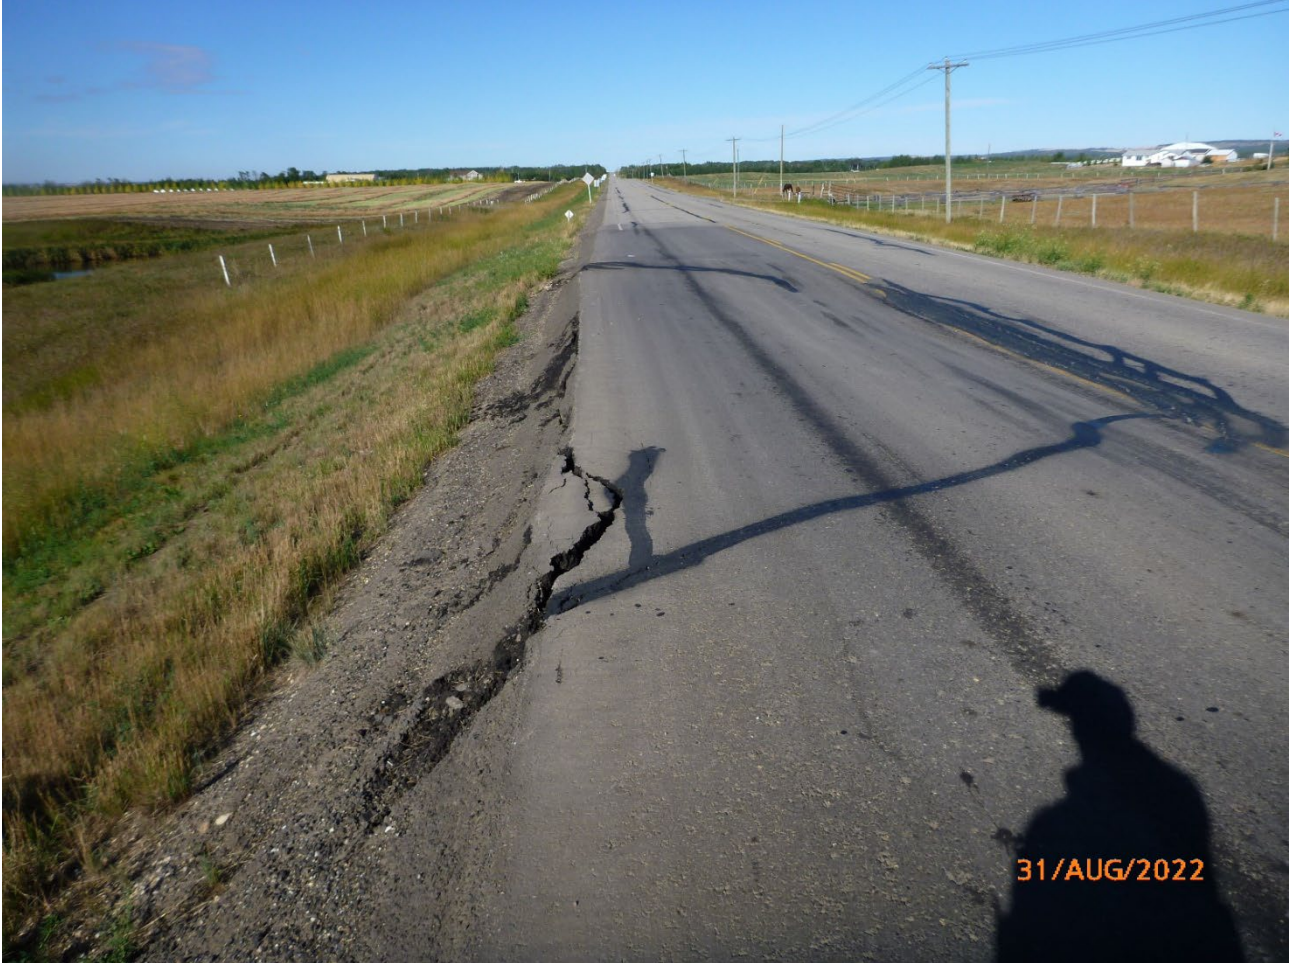
- The backscarp formed a crescent shape through the asphalt which widened to approximately 15 m at the highway shoulder.
- An approximately 1 m long segment of asphalt along the eastern edge of the backscarp within asphalt has separated from the highway with cracks open to a width of approximately 100 mm (Photo 7).

Photo 7 **Cracking and separation of asphalt segment at shoulder of eastbound lane. Note that cracking is extending north past centreline. Photo taken August 31, 2022, facing west.**

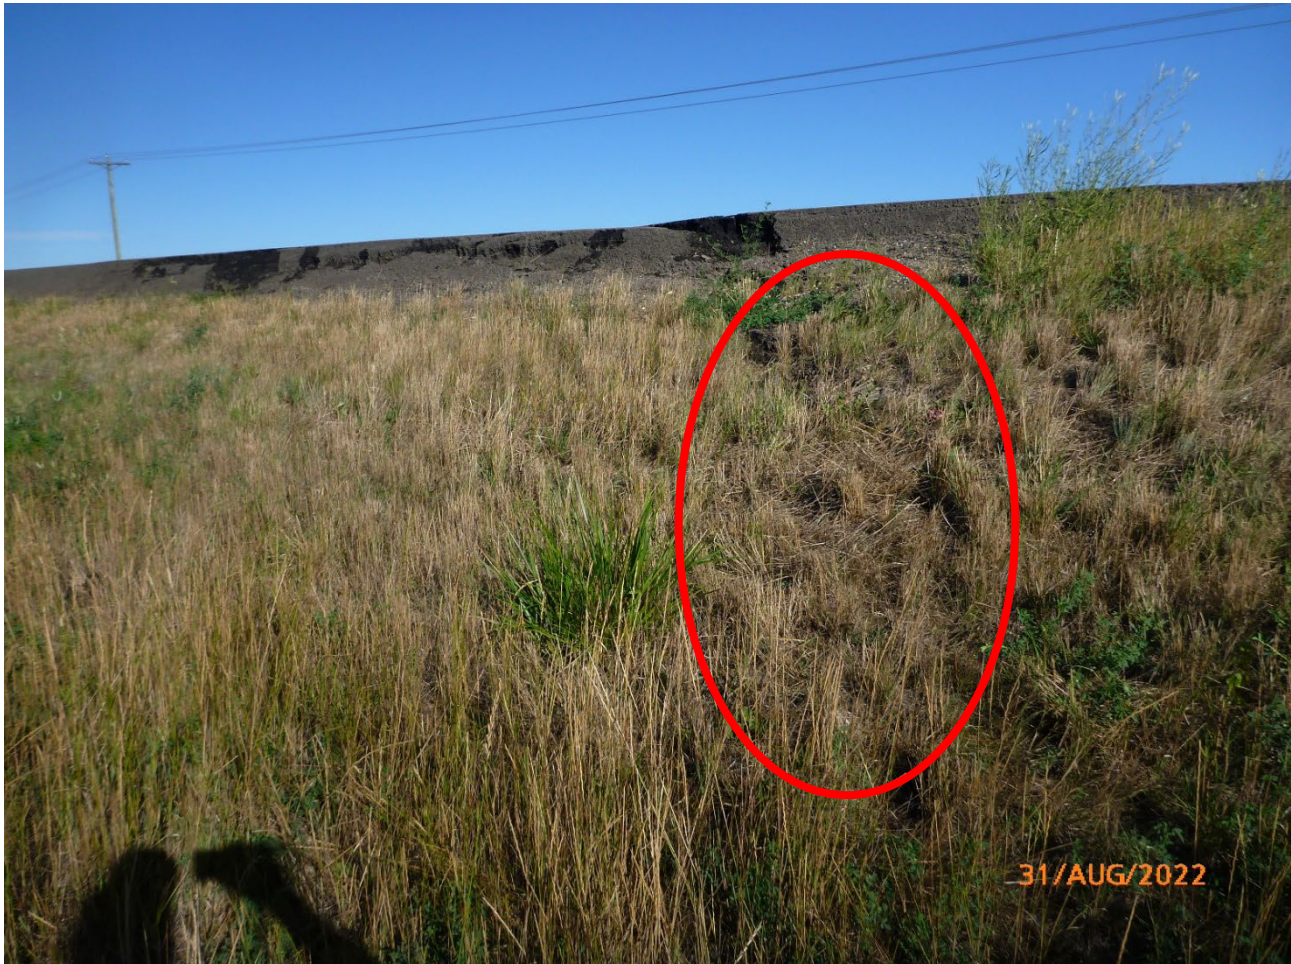
- Cracking of the embankment fill, open approximately 50 mm, extended approximately 12 m down the south embankment and ended on the eastern side above the outlet of a culvert (Photo 8). The cracking on the western flank of the slide zone on the embankment slope extended beyond shoulder ditch of the highway and terminated at the western slope of the gully (Photo 9).

Photo 8 Red circle indicates cracking observed at east side of south embankment slope.
Photo taken August 31, 2022, facing north.

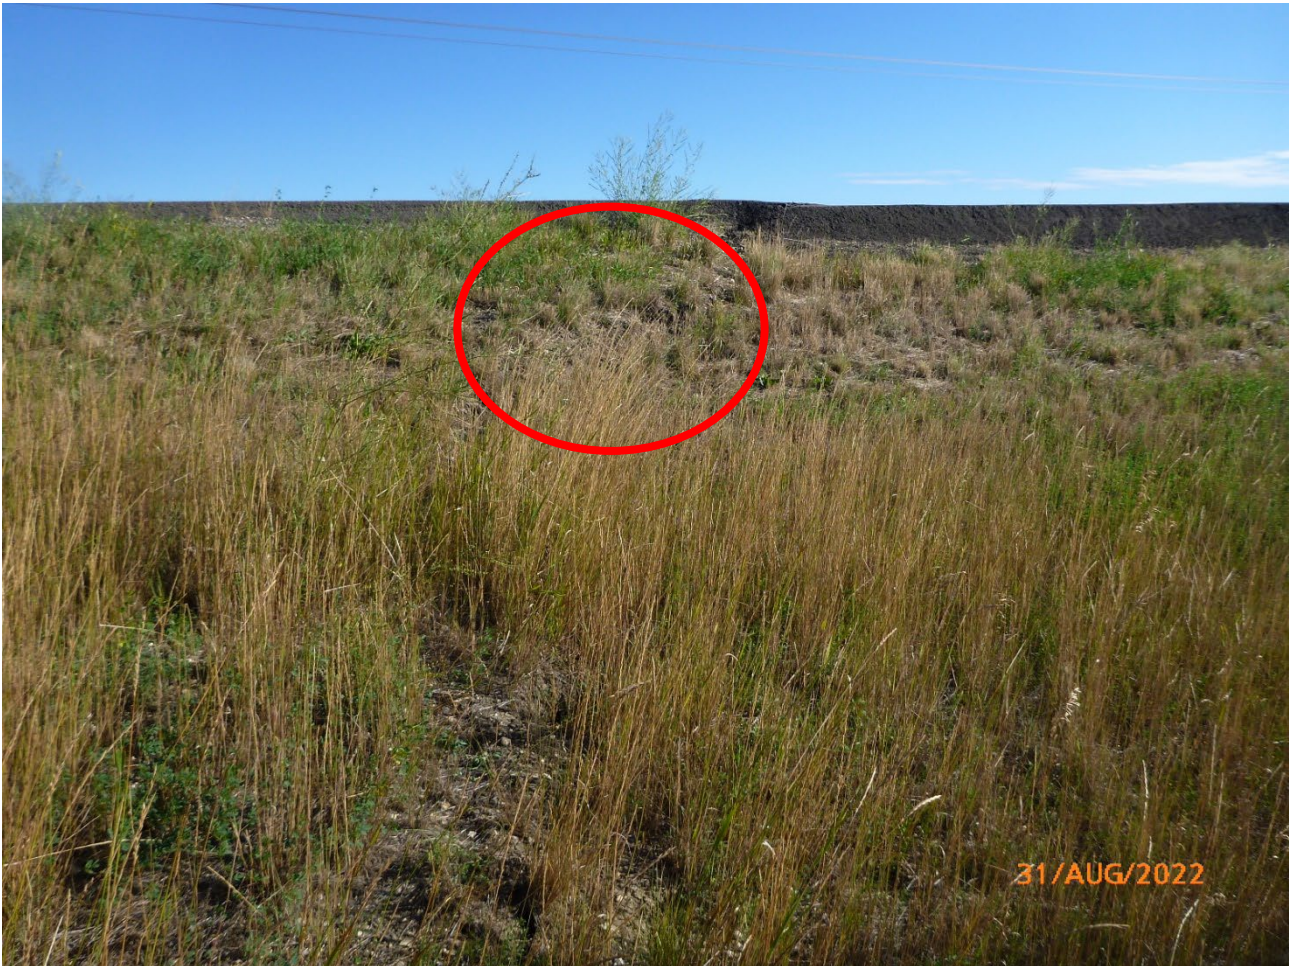
Photo 9 Red circle indicates cracking observed at west side of south embankment. Photo taken August 31, 2022, facing north.
