<b>SITE NUMBER AND NAME:</b> <b>GP055 Hwy 674 Embankment</b> <b>Slide North of Sexsmith</b>	<b>HIGHWAY &amp; KM:</b> 674:02, 15.150	<b>PREVIOUS INSPECTION DATE:</b> June 11, 2024	<b>INSPECTION DATE:</b> <b>June 3, 2025</b>
<b>LEGAL DESCRIPTION:</b> SW-03-74-04-W6M NW 34-73-04-W6M	<b>NAD 83 COORDINATES:</b> UTM    Northing    Easting 11       6137500    403034	<b>RISK ASSESSMENT:</b>  PF: 2    CF: 5    TOTAL: 10	
<b>AVERAGE ANNUAL DAILY TRAFFIC (AADT):</b> 1,220 (east) & 590 (west) (Reference No. 29750 and 30730, 2024)		<b>CONTRACT MAINTENANCE AREA (CMA):</b> 504

**SITE INSPECTION FORM**

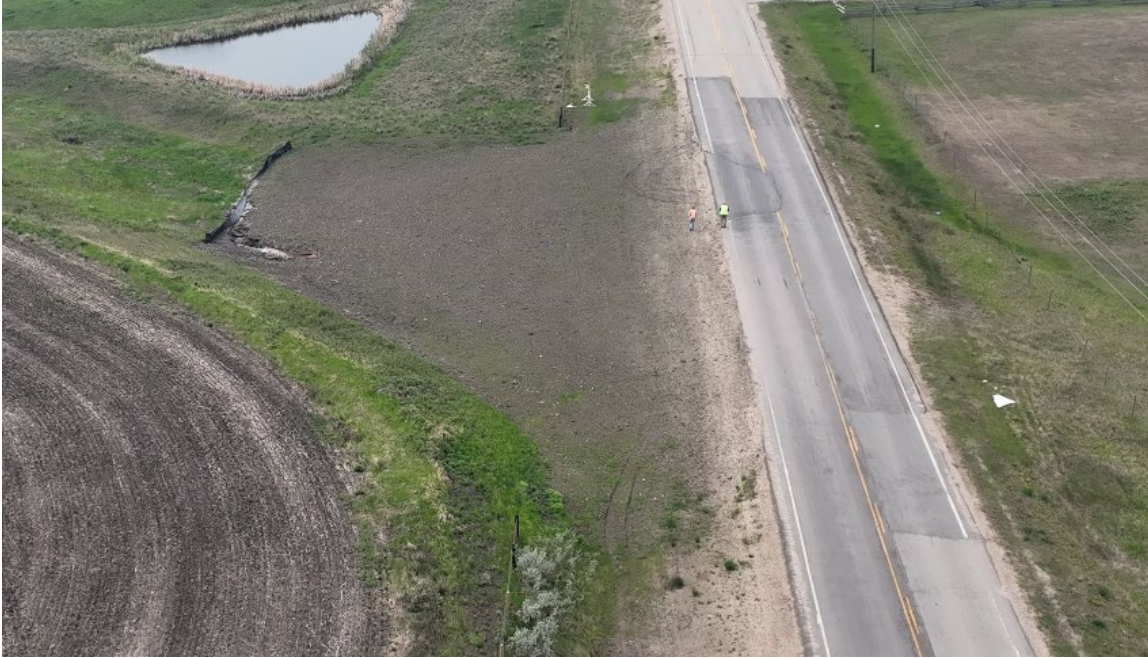
- Photo 1** Overview of toe berm constructed in 2024 to repair embankment slide on south side of Hwy 674:02. Note pavement distress and erosion downstream of culvert outlets shown in Photos 3 through 7. UAV photo taken June 3, 2025, facing west.

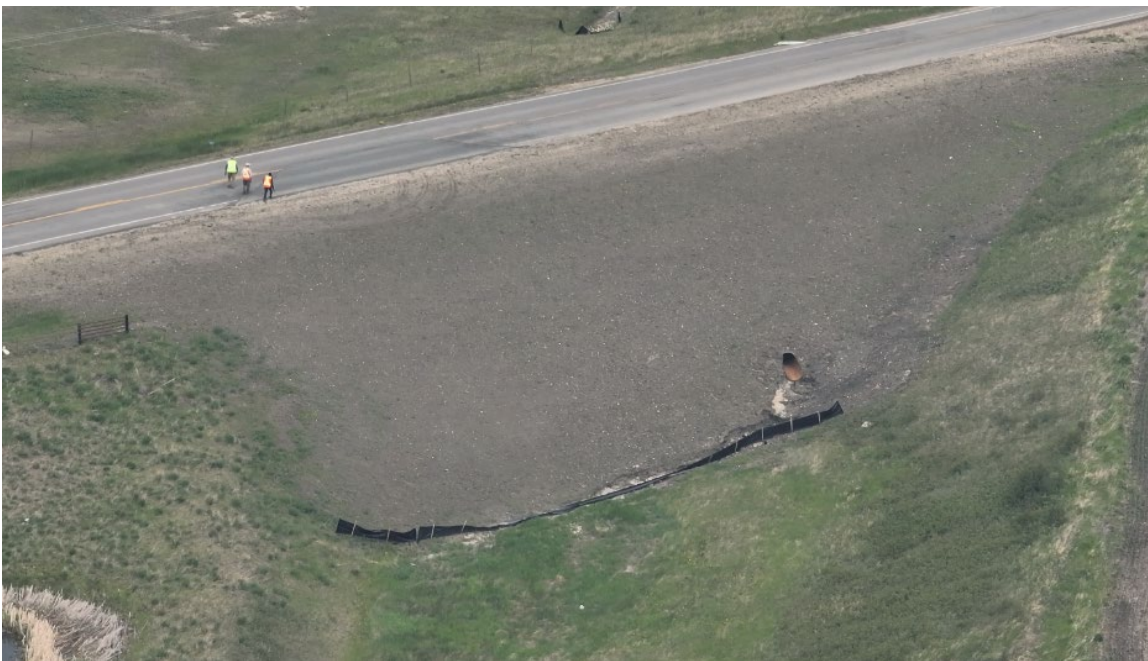
- Photo 2** Overview of toe berm constructed in 2024 to repair embankment slide on south side of Hwy 674:02. UAV photo taken June 3, 2025, facing northeast.

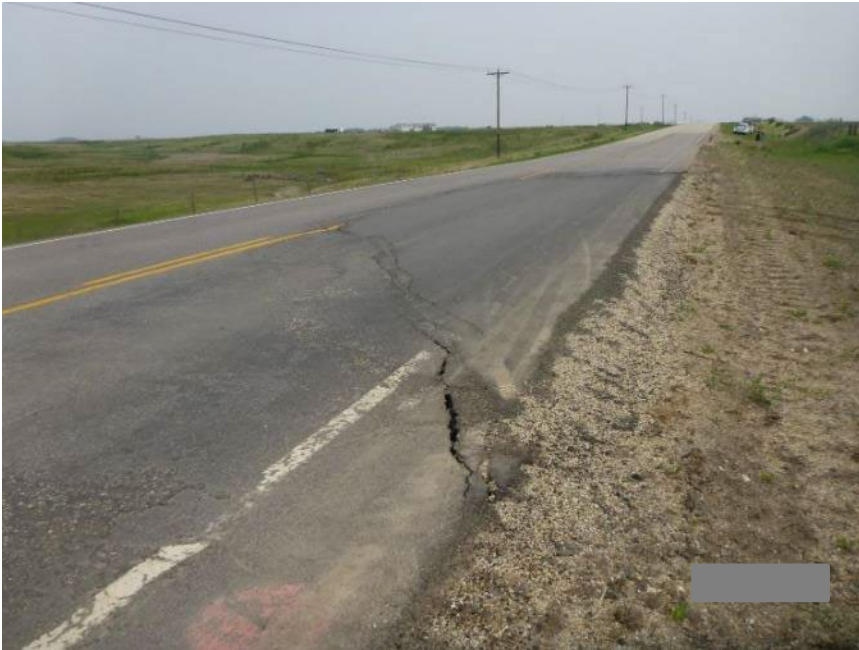
<p>Since the site was repaired in 2024:</p> <ul style="list-style-type: none"> <li>Some cracking and settlement (up to approximately 30 mm and 10 mm, respectively) observed in the eastbound lane (Photos 3 to 4). The contractor who repaired the site in 2024 mentioned to KCB that most of the observed pavement distress occurred shortly after paving in the fall of 2024, and there has been very little subsequent deterioration of the pavement surface since.</li> <li>Besides pavement distress noted above, there were no other visual indications of slope or toe berm movement observed at the time of the 2025 inspection. The toe berm/flattened slope was in good condition (Photos 5 and 6).</li> <li>Vegetation coverage on the flattened slope is poor (Photos 5 and 6). Vegetation appears to be mainly weeds, and dead seed was observed on the bare ground surface.</li> <li>An erosion channel has formed downstream of the smooth-walled steel pipe culvert outlet (Photos 7 to 8). The erosion channel is approximately 10 m long, 0.5 m to 1.0 m deep, and up to 2.0 m wide at top of channel.</li> </ul>

**Photo 3**      **Cracking and settlement in eastbound lane of Hwy 674:02 through pavement patch placed in October 2024. Photo taken June 3, 2025, facing northeast.**

<p><u>Maintenance/Repair/Monitoring Recommendations:</u></p> <ul style="list-style-type: none"> <li>Complete warranty inspection in fall 2025.</li> <li>Warranty work should include reseeding the site.</li> <li>Pavement patched in October 2024, immediately after construction was completed, and should be patched again now that movements have slowed.</li> <li>Erosion channel downstream of the culvert outlet should be repaired (e.g., regraded then armoured with riprap) to prevent further erosion. Estimated cost: \$10,000 to \$15,000.</li> <li>This site should continue to be inspected by the Maintenance Contract Inspector (MCI) and inspected at least once during the next contract cycle as part of the GP South GRMP Section B inspections. If the repairs continue to perform well, TEC could consider removing the site from the list of active GRMP sites and excluding it from the GP South GRMP Section B inspections. If site conditions were to deteriorate, the site could always be returned to the list of active GRMP sites and inspected again as part of a Section B inspection or Section D call-out inspection.</li> <li>Repair design accounted for high / artesian porewater pressures at the site based on site observations and recorded piezometer data. However, TEC could consider having the piezometers read at this site at least once more during the next contract cycle, as part of the GP South GRMP Section C readings, to confirm pore pressures are not increasing below the highway embankment and toe berm and flows are being conveyed to the downstream toe.</li> </ul>

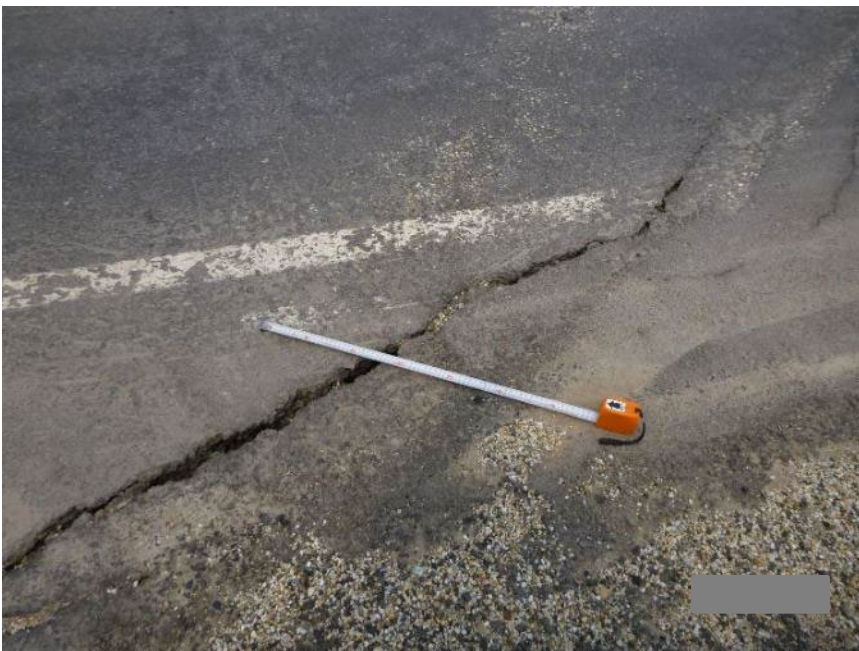
**Photo 4**      **Cracking in eastbound lane of Hwy 674:02 through pavement patch placed in October 2024. Photo taken June 3, 2025.**

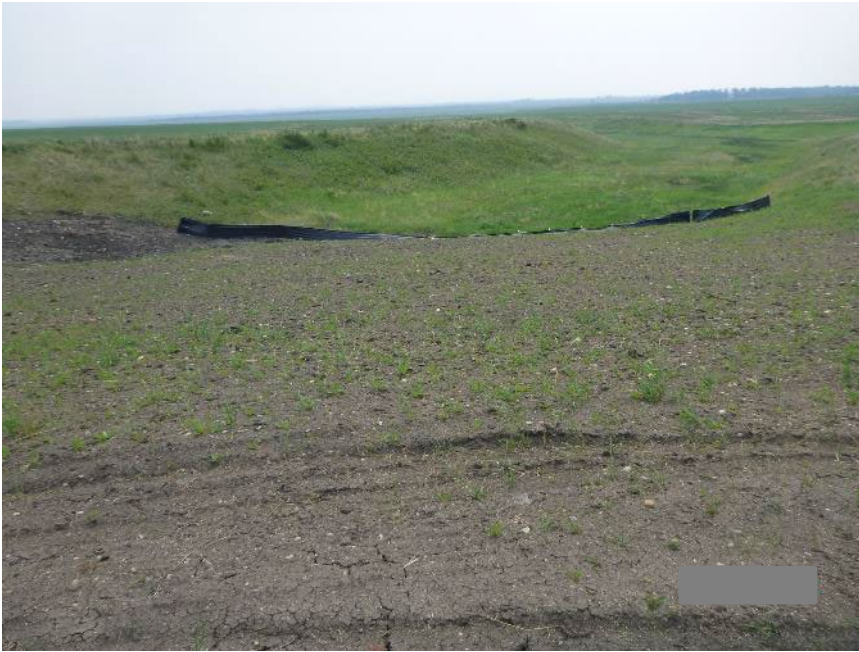
**Photo 5** Slope of toe berm constructed in 2024 on south side of Hwy 674:02. Note poor vegetation cover. Photo taken June 3, 2025, facing south.

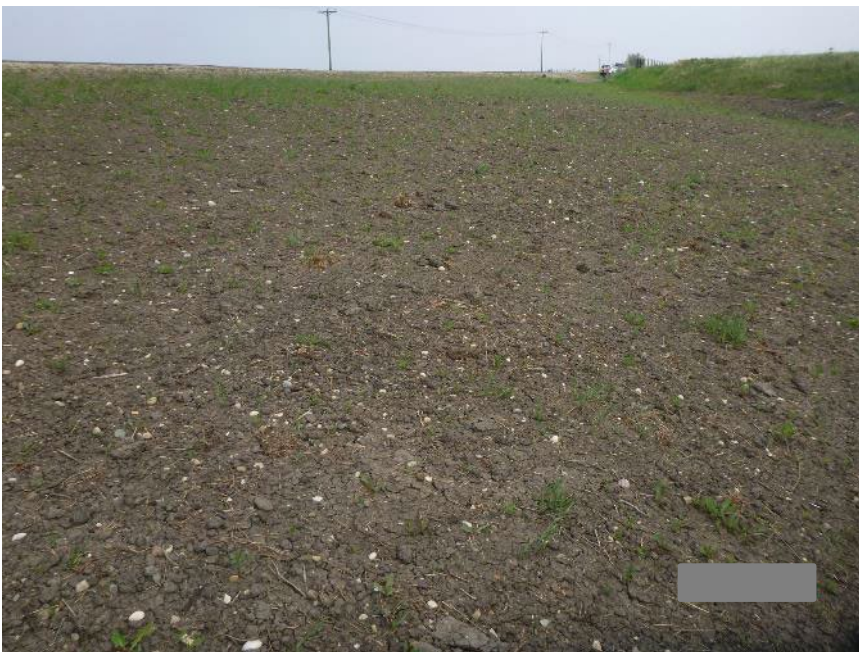
**Photo 6** Slope of toe berm constructed in 2024 on south side of Hwy 674:02. Note poor vegetation cover. Photo taken June 3, 2025, facing northeast.

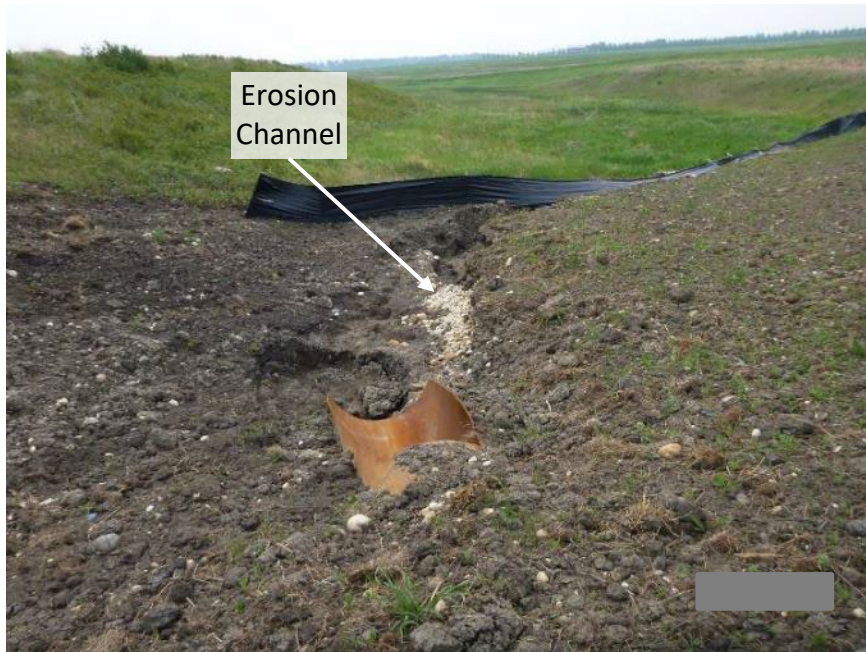
**Photo 7** Erosion channel downstream of culvert outlet extended in 2024. Photo taken June 3, 2025, facing southwest.

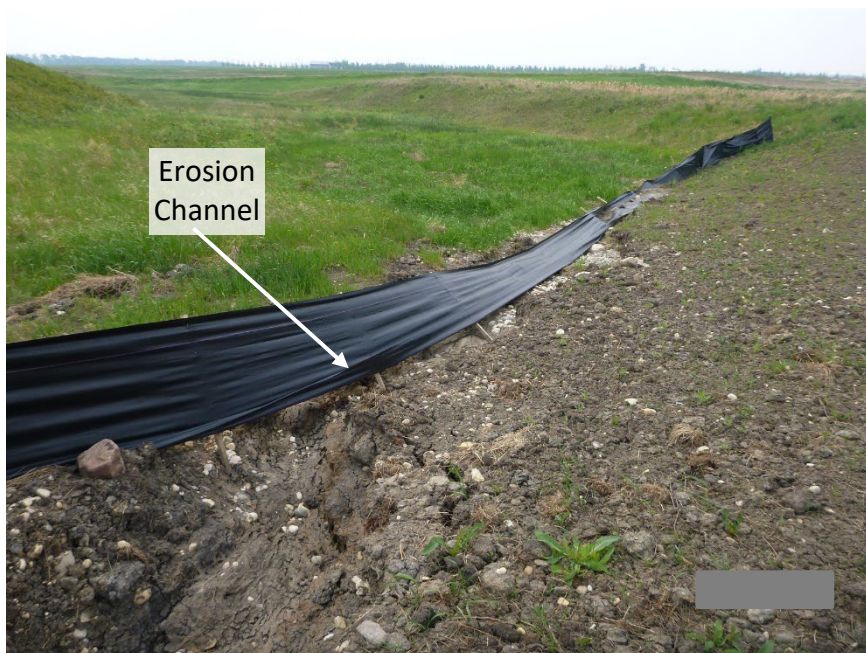
**Photo 8** Erosion channel downstream of culvert outlet extended in 2024. Note silt fence being undermined by erosion. Photo taken June 3, 2025, facing southwest.
