**PEACE REGION – GRANDE PRAIRIE
GEOHAZARD RISK ASSESSMENT
SITE INSPECTION FORM**

SITE NUMBER GP-New-II	SITE NAME Bear River Bridge-Slide (at a bridge headslope at ditch end)	HIGHWAY & KM Hwy 724:04 (4 km south of LaPlaze)	PREVIOUS INSPECTION DATE <i>New Site</i> <i>no inspection previous</i>	INSPECTION DATE May 28, 2014
LEGAL DESCRIPTION -W6M	NAD 83 COORDINATES N 5,536,028 E 119,154	RISK ASSESSMENT PF: n/a CF: n/a TOTAL: n/a		
		CURRENT 2012 RISK ASSESSMENT PF: 14 CF: 7 TOTAL: 98

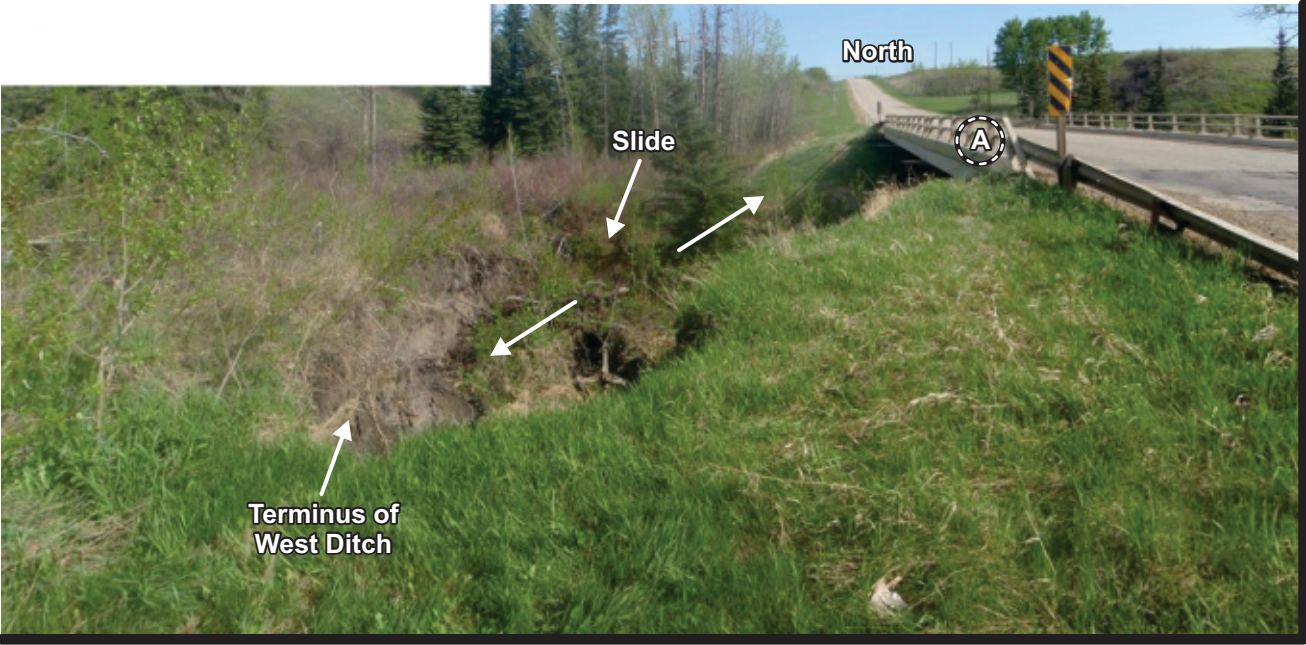
Photo 1

- Slide encroached to roadway with only 0.3 m limited setback space at (A) at bridge approach
- A +5 m scarp steepening at bottom of (A)

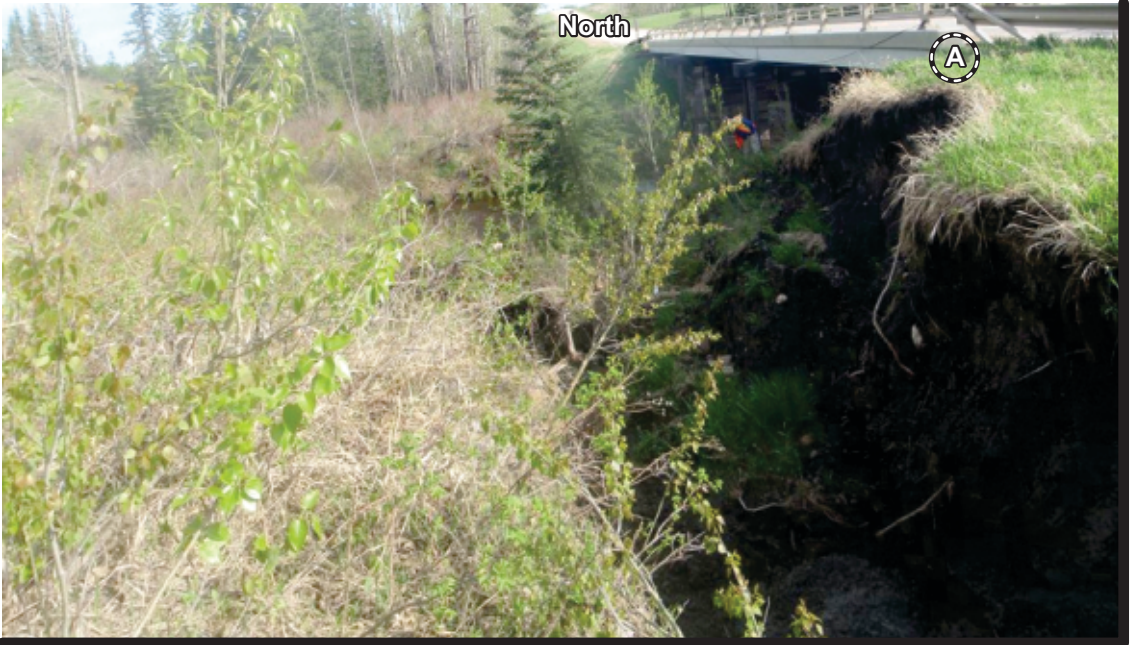
Photo 1a
Another view of head of slide

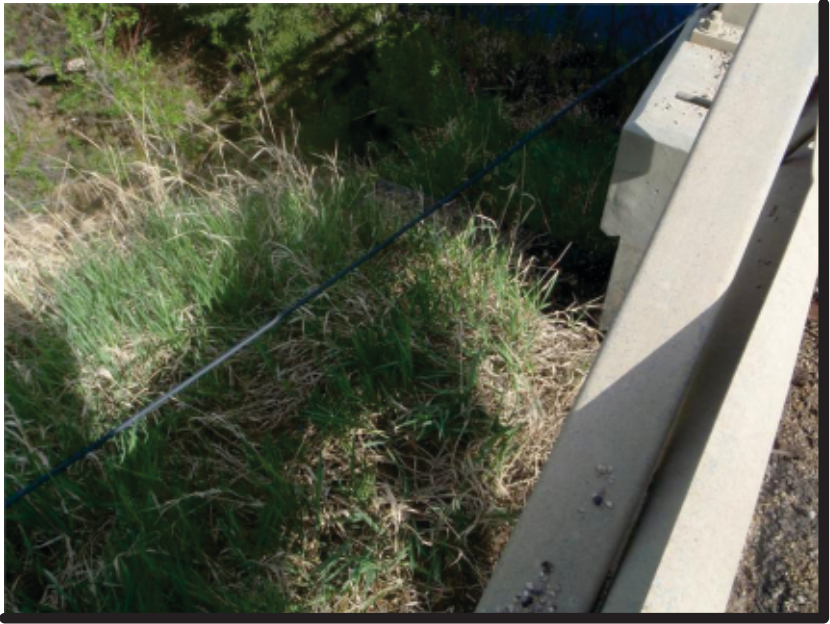
Photo 1b
Close up of limited setback space (A) to roadway

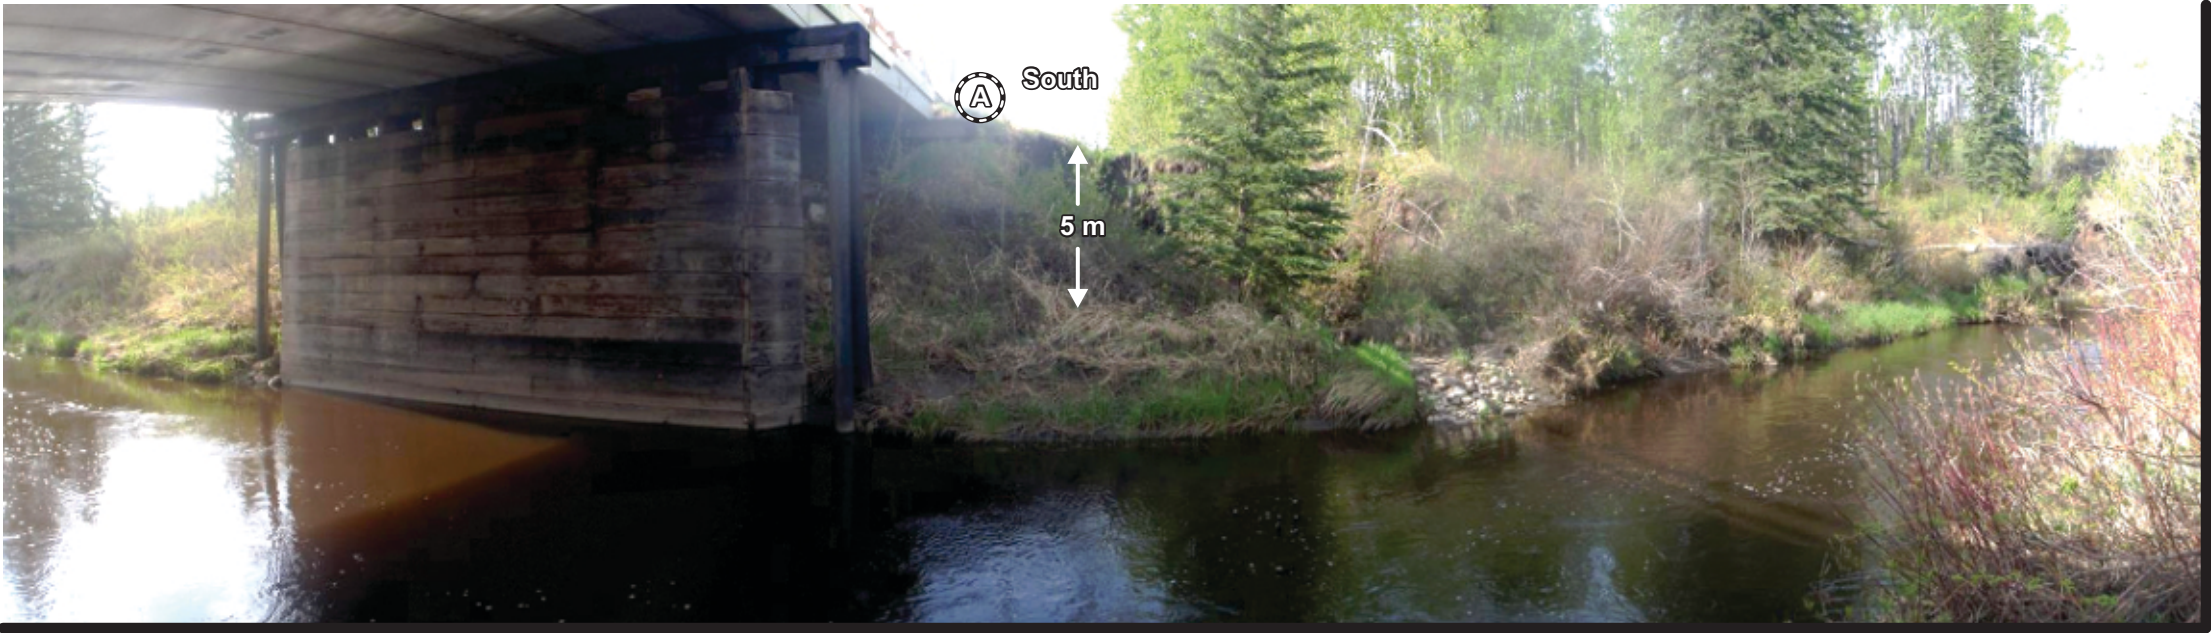
Photo 2

- Slide at SW corner of crossing
- Slide may affect the headslope

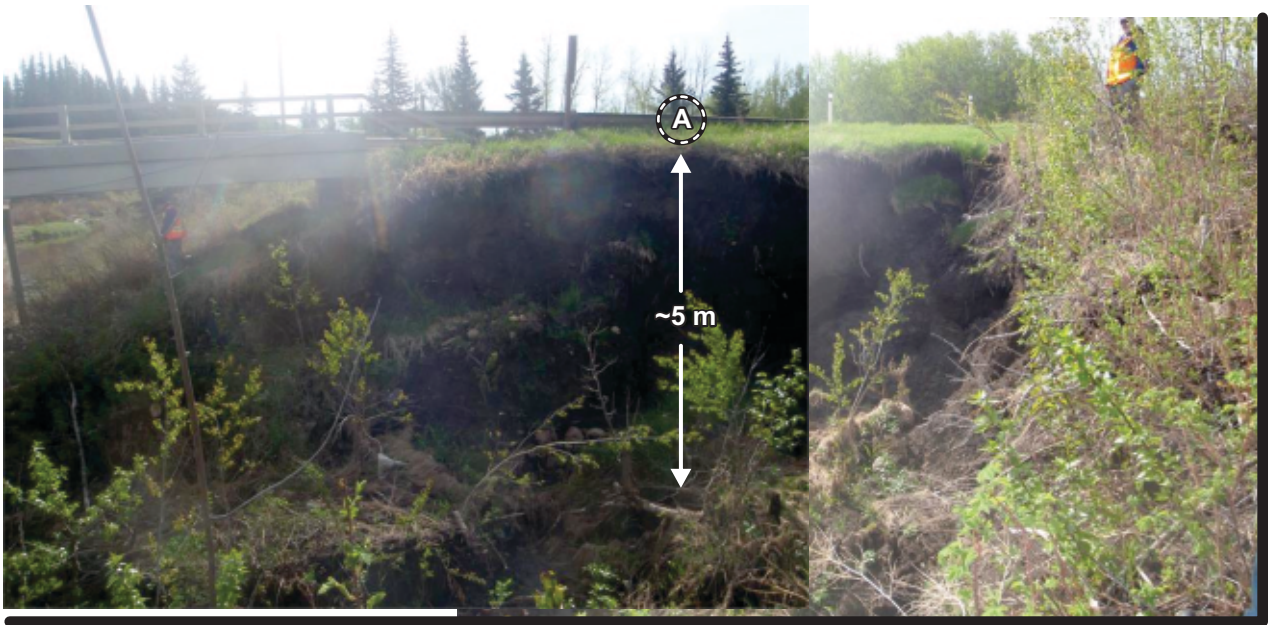
Photo 2a

- A scarp steepening along side slope at bridge approach
- Limited (0.3 m to 0.5 m) setback space at top (A)

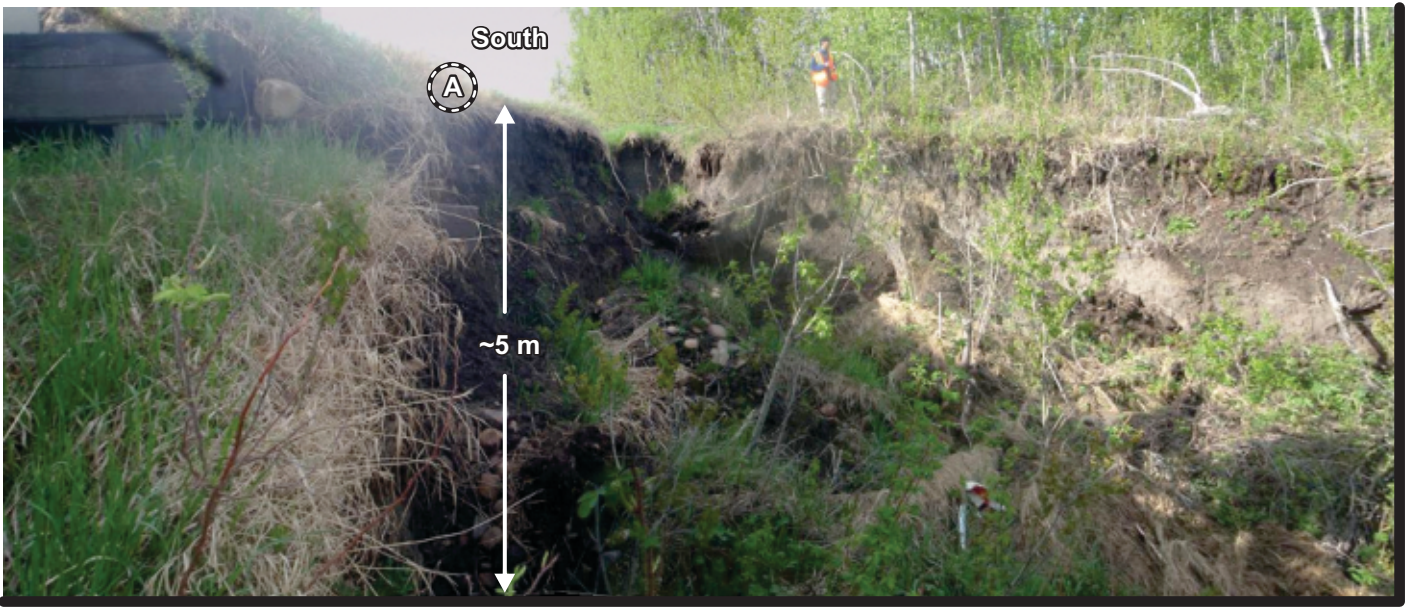
Photo 2b

A scarp steepening along side slope at bridge approach

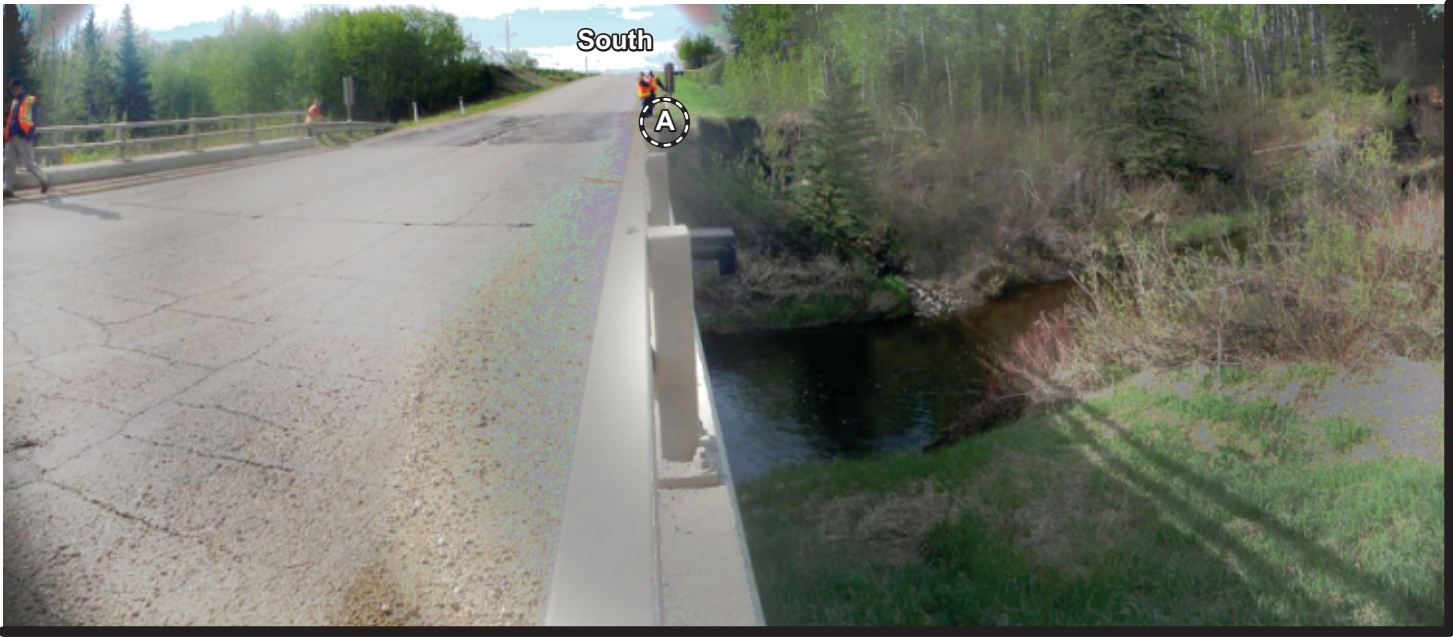
Photo 3
Slide at elbow of bridge SW headslope and biting into south approach at location (A)

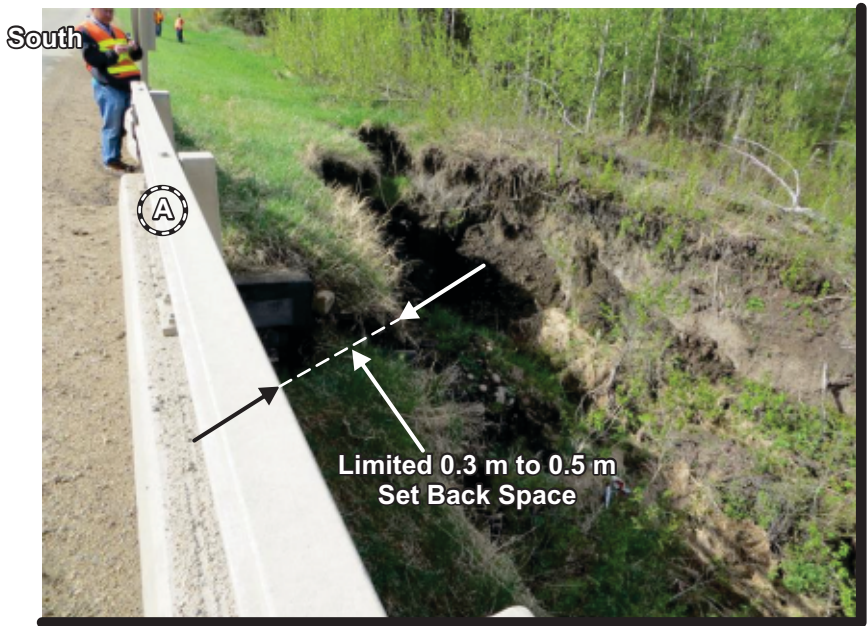
Photo 3a

- Close up of limited setback space at SW Slide
- A +5 m vertical scarp just below the limited setback

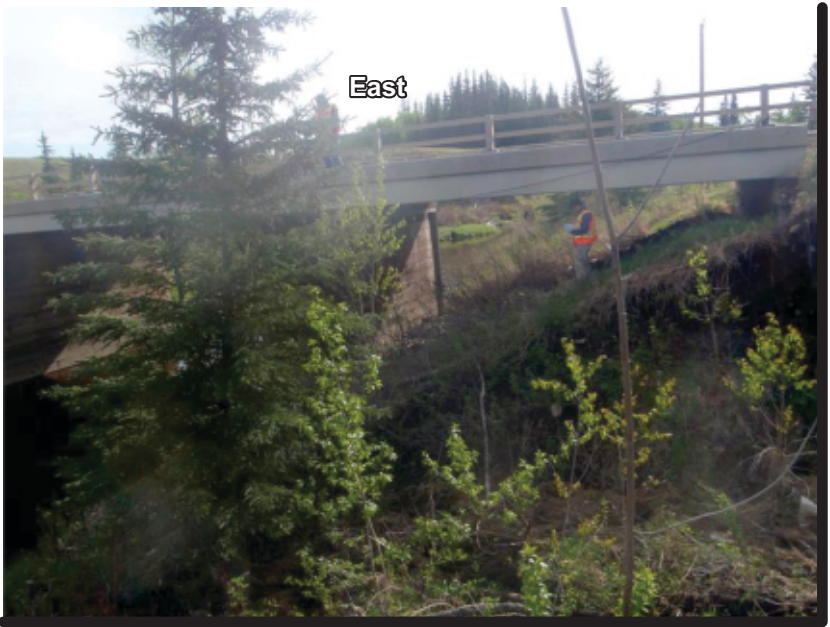
Photo 3b
Another view of bridge SW headslope

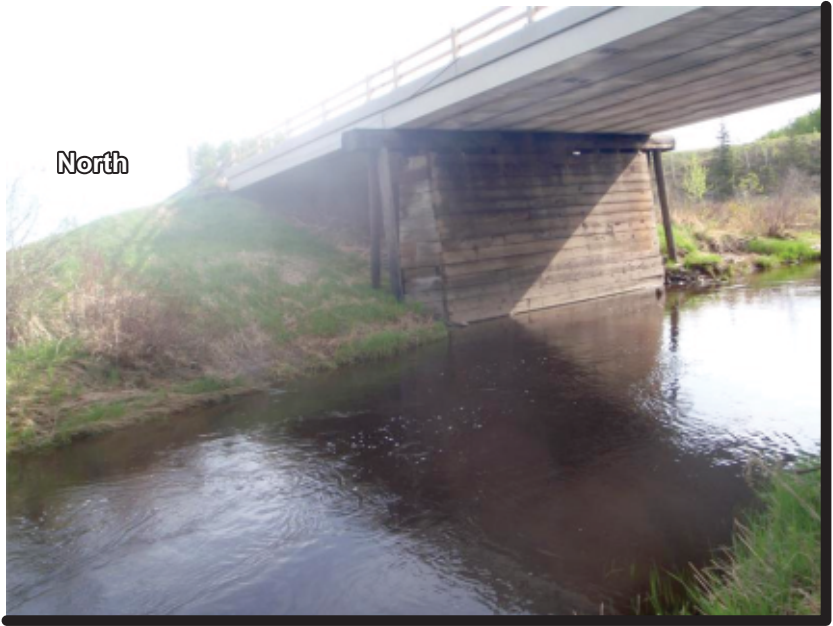
Photo 3c
Opposite headslope (NW) in good condition

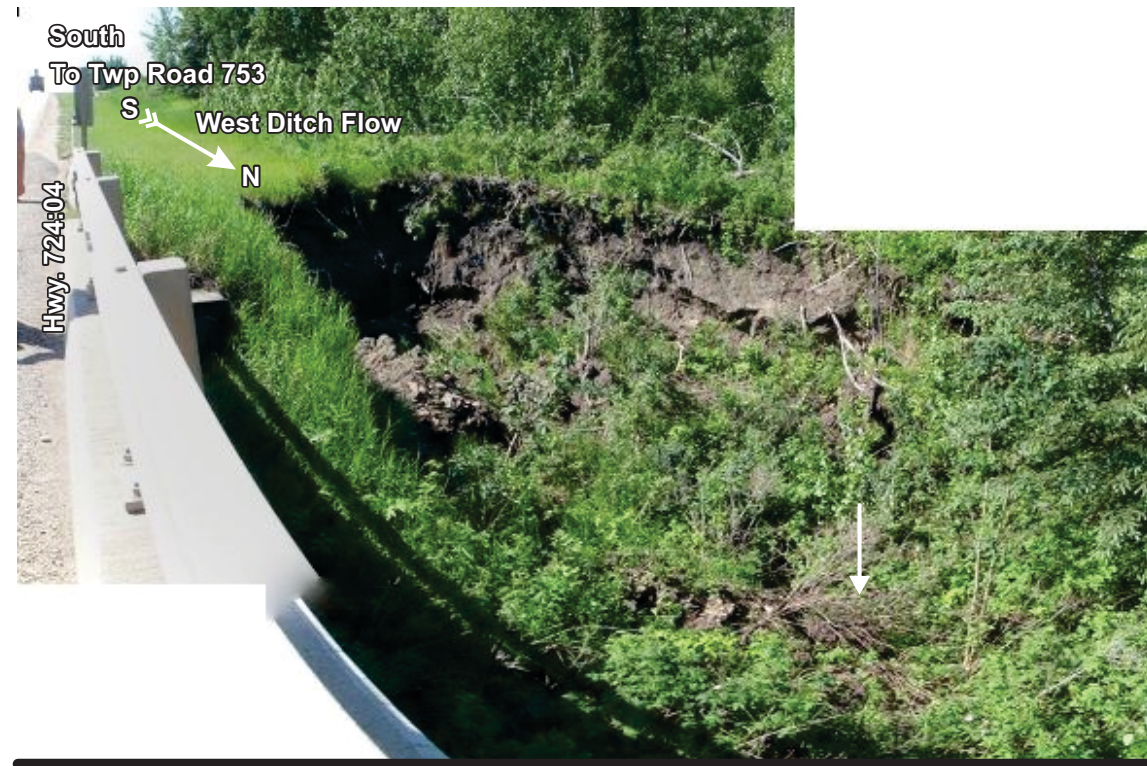
**Photo I**

Looking south at valley slope at top portion of slide failure at outfall of west ditch
Upper part of slide failure (looking from west side of bridge deck)

- Hwy 724:04 runs north - south with a west side ditch carrying runoff south to north to outfall down the river bank slope to cause slope failure (just beside the bridge south headslope)
- Increase in amount of runoff in west ditch (to outfall down the river bank slope) (south to north) was caused by
 - (i) Additional Hwy ditch flow (catchment area to south of Twp Road 753) was invoked from installation (recent 2012) of a twin culvert connecting west ditch at south upgrade end (at junction with Twp Road 753 as its new approach culverts) to flow to river slopes
 - (ii) Additional ditch flow from Twp Road 753 invoked from a recent (2012) opening up of a centreline culvert to channel the (east-west) flows into the Hwy to flow towards the river bank slope (bridge) via the west ditch (south to north)

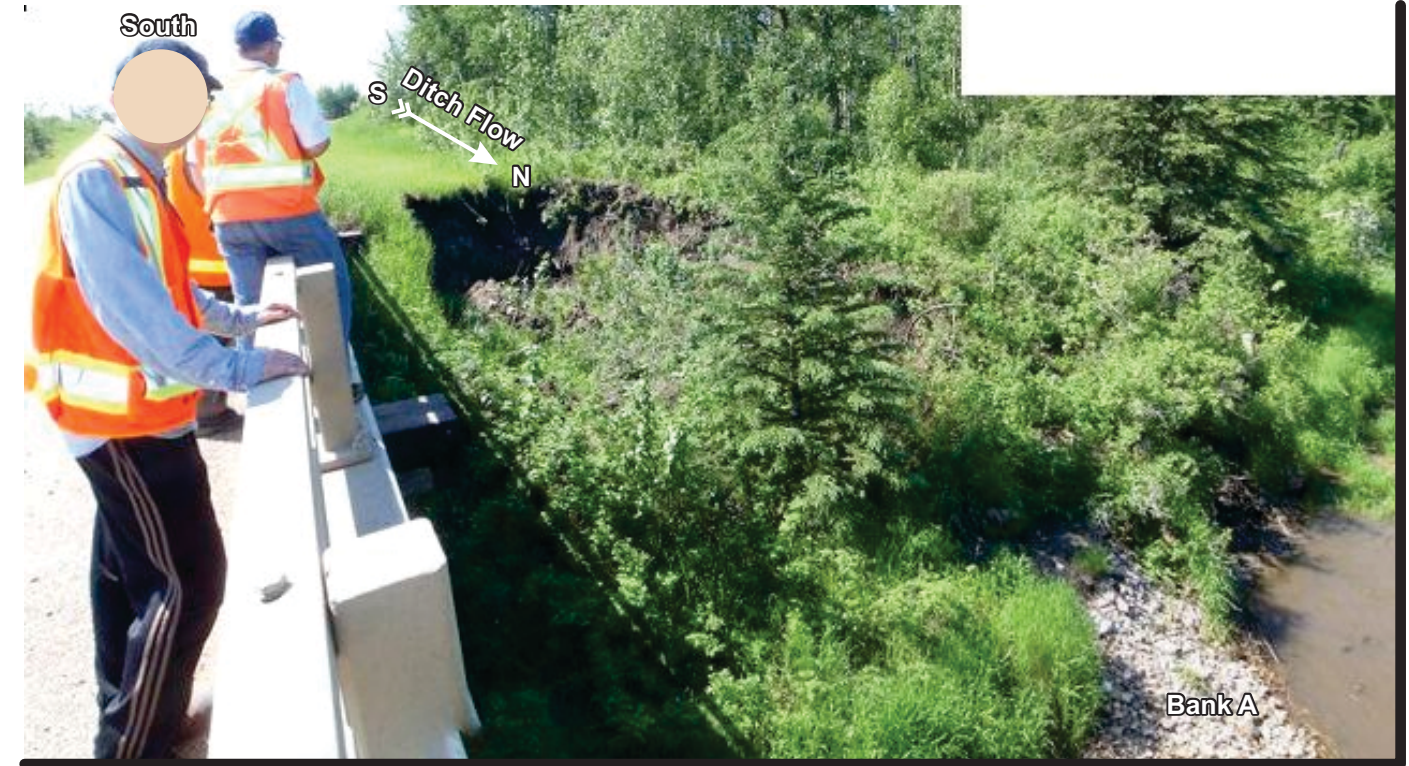
**Photo Ia**

Looking north at slide failure at outfall of west ditch - another view

- Lower part of slide failure and river bank

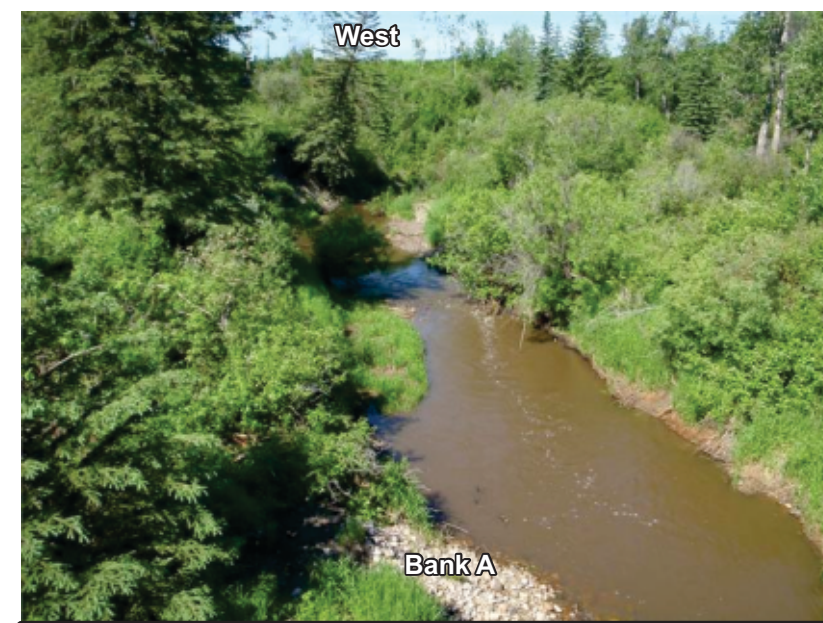
**Photo Ib**

Looking west - river channel at toe of slide

- Bank slope well vegetated and looked stable

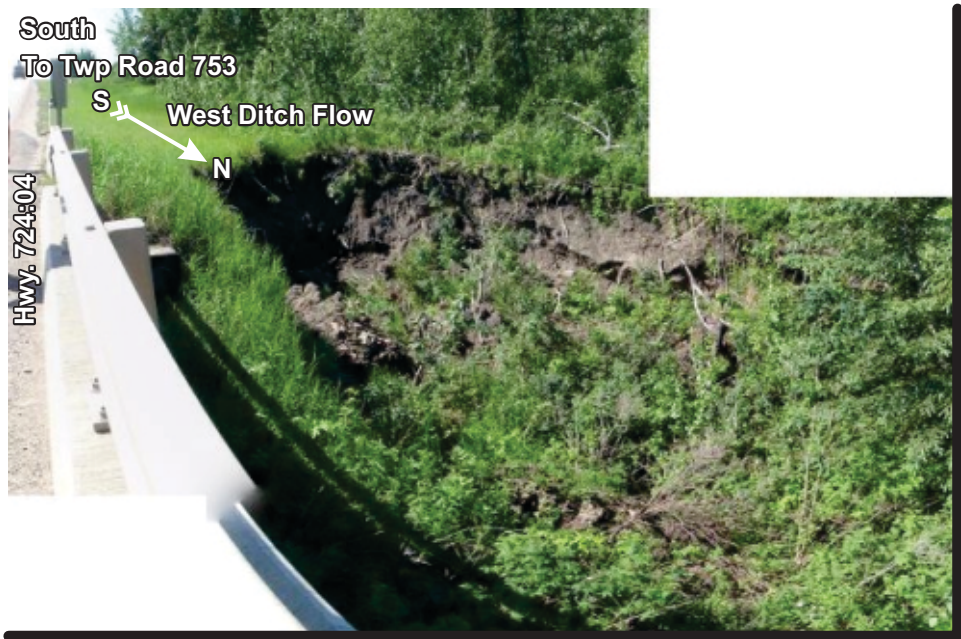
Photo II

Looking south at failure area

- Ditch waters (south to north) runoff to outfall down the valley slope to cause sliding
- Ditch waters sources from catchment areas from Twp Road 753(east-west) and Hwy 724:04 lands south of Twp 753 junction
- Twin culvert(s) at Twp 753 approach was recently (2012) installed for 1 year

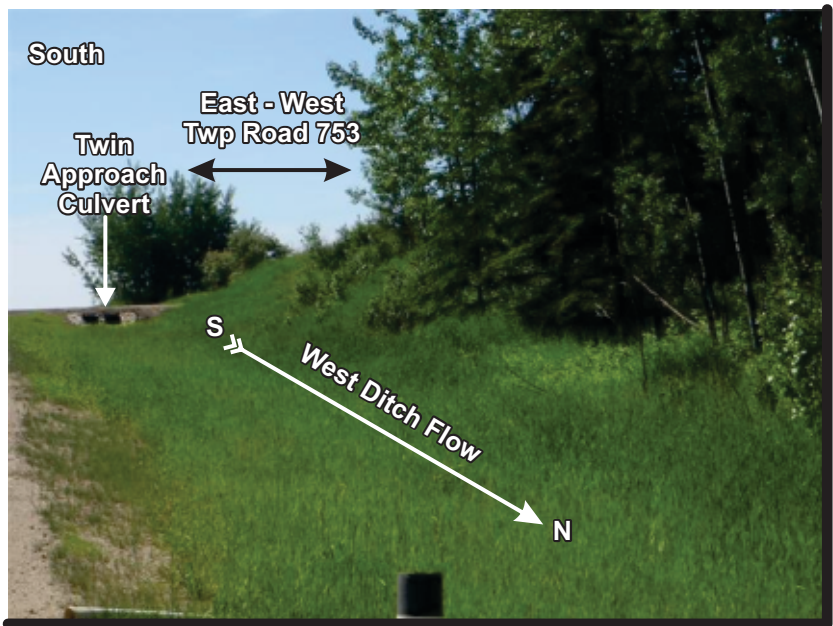
Photo IIb

Looking south at failure area

- Ditch waters (south to north) runoff to outfall down the valley slope to cause sliding
- Ditch waters sources from catchment areas from Twp Road 753(east-west) and Hwy 724:04 lands south of Twp 753 junction
- Twin culvert(s) at Twp 753 approach was recently (2012) installed for 1 year

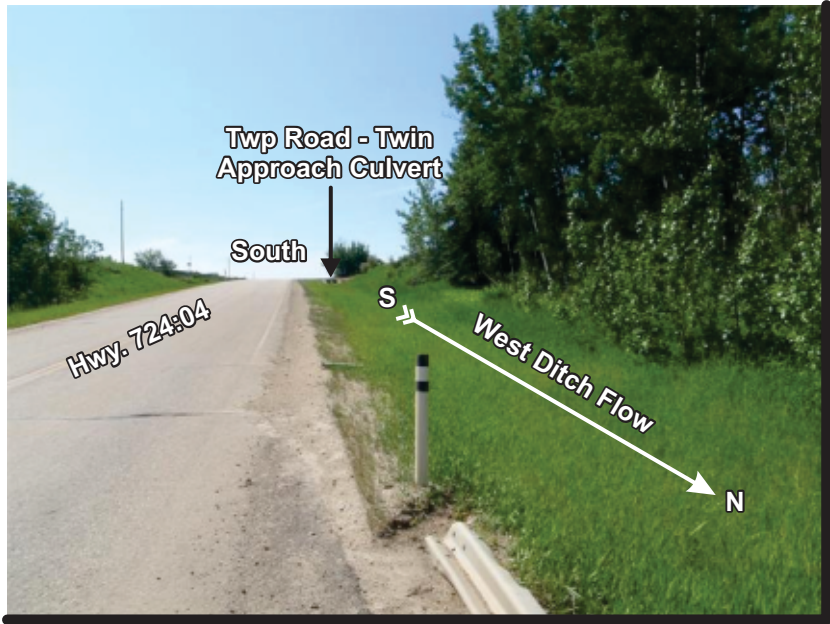
Photo IIa

Looking south at failure area

- Ditch waters (south to north) draining down the valley slope to cause sliding
- Ditch waters sources from catchment areas from Twp Road 753(east-west) and Hwy 724:04 lands south of Twp 753 junction
- Twin culvert(s) at Twp 753 approach was recently (2012) installed

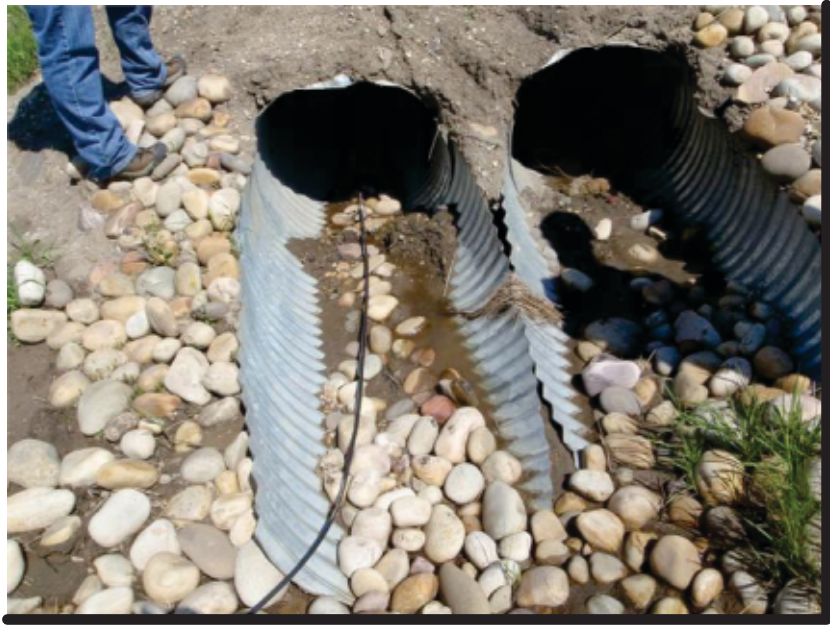
Photo IIc

Twin Culvert located at approach to Twp Road 753

- Two 600 mm CSP (twin culverts)

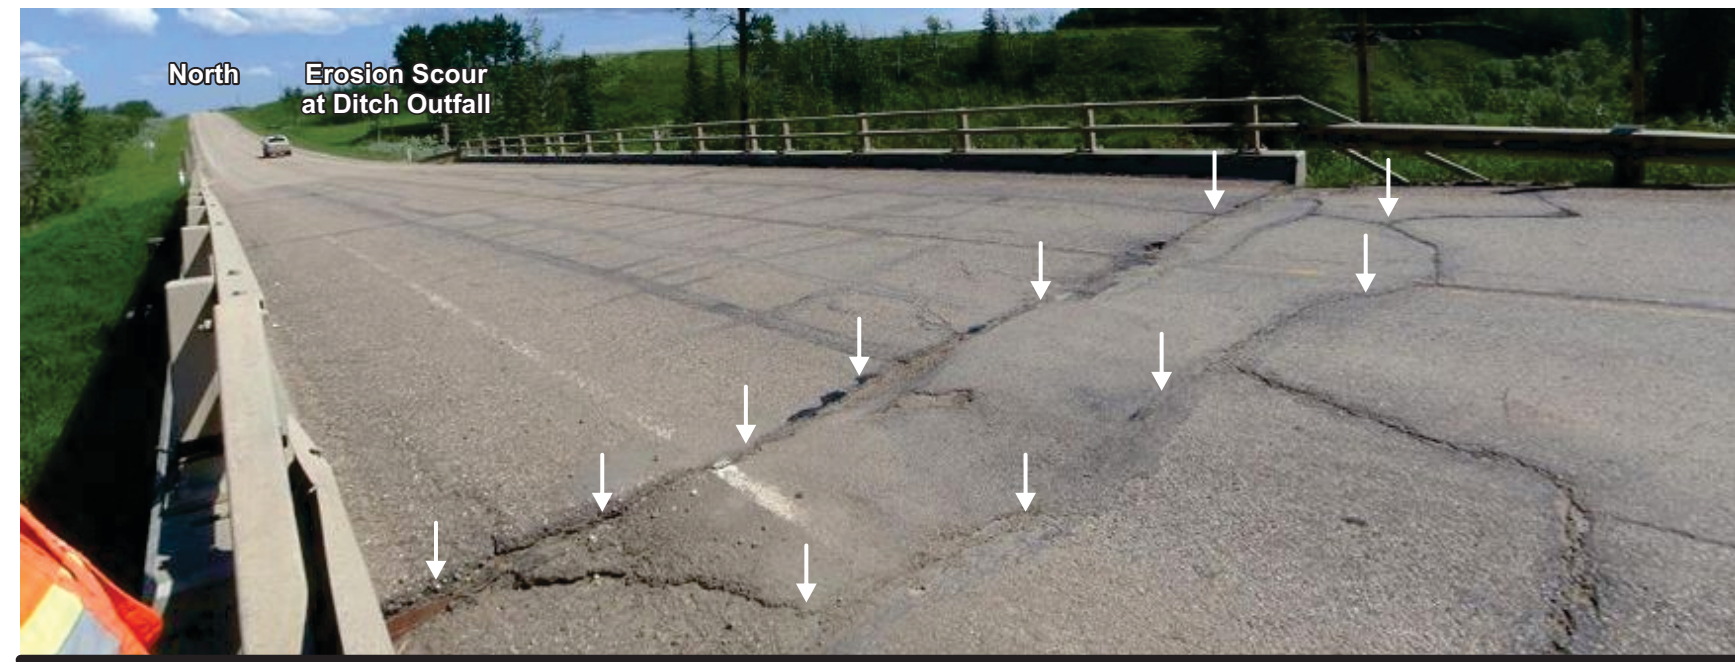
Photo III

Looking north at south approach slab area at south headslope abutment
 • Cracking and minor sag at south approach to bridge deck

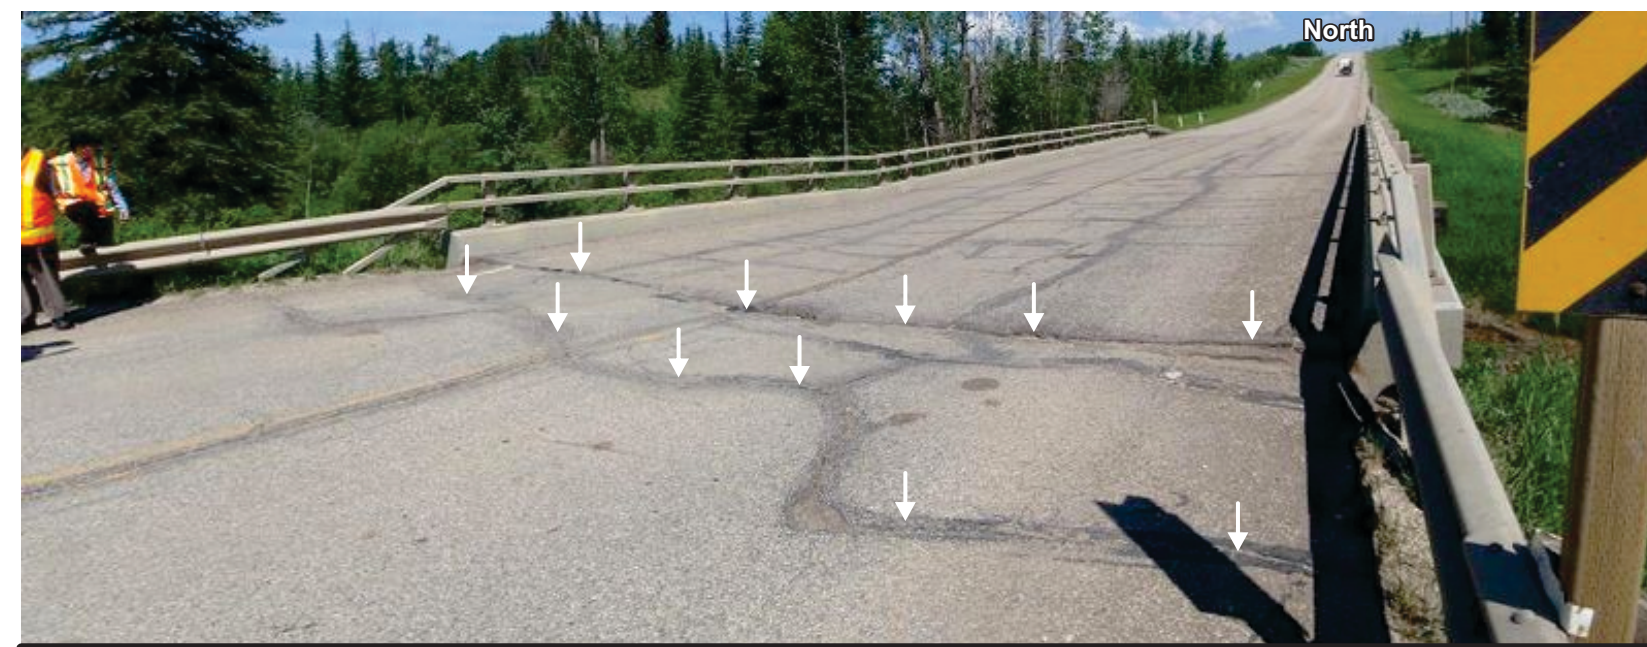
Photo IIIa

Looking north at south approach slab area at south headslope abutment
 • Cracking and minor sag at south approach to bridge deck

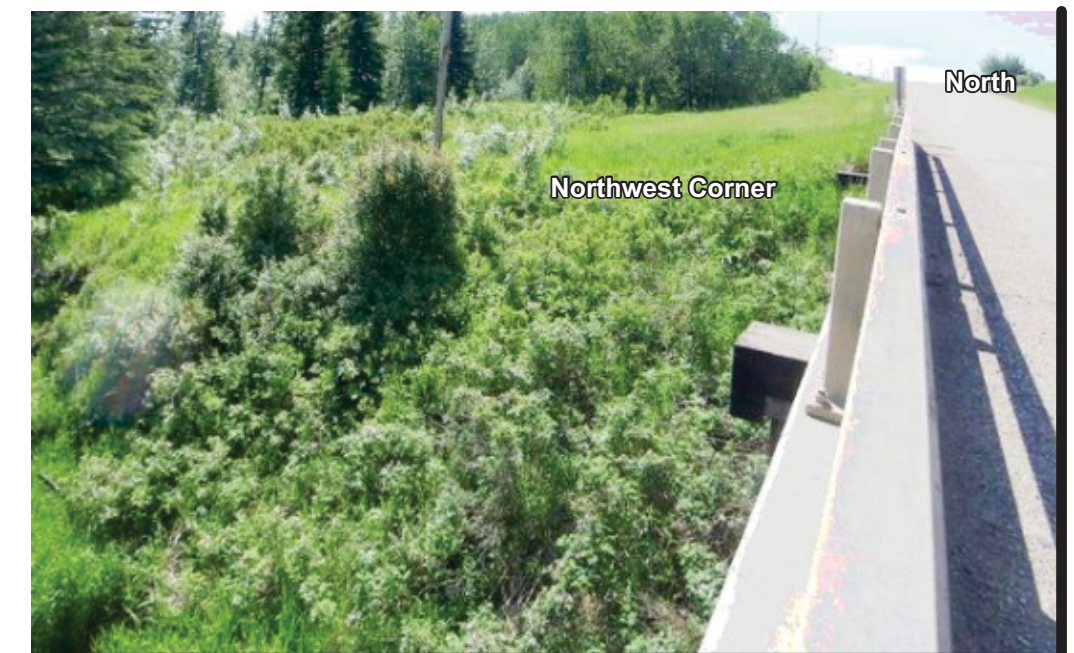
Photo IIIb

Looking north at opposite valley bank slope
 • Opposite slope well vegetated and in good condition

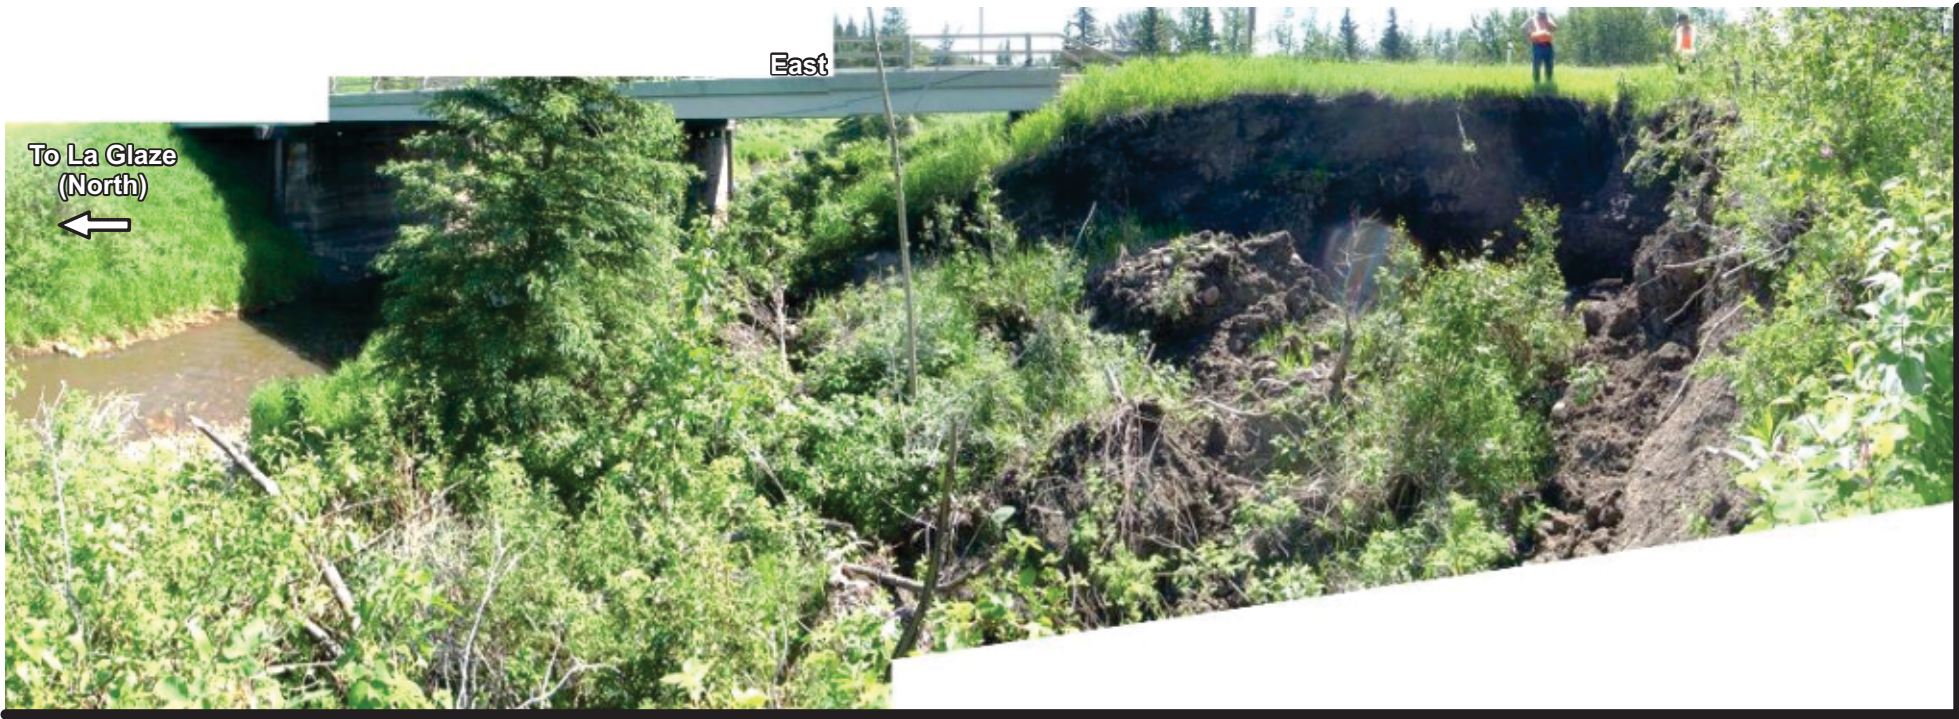
Photo IV
Looking east - another view of slide

- Width of slide at about 30-35m
- Height of slide (valley slope) at about 7-10m

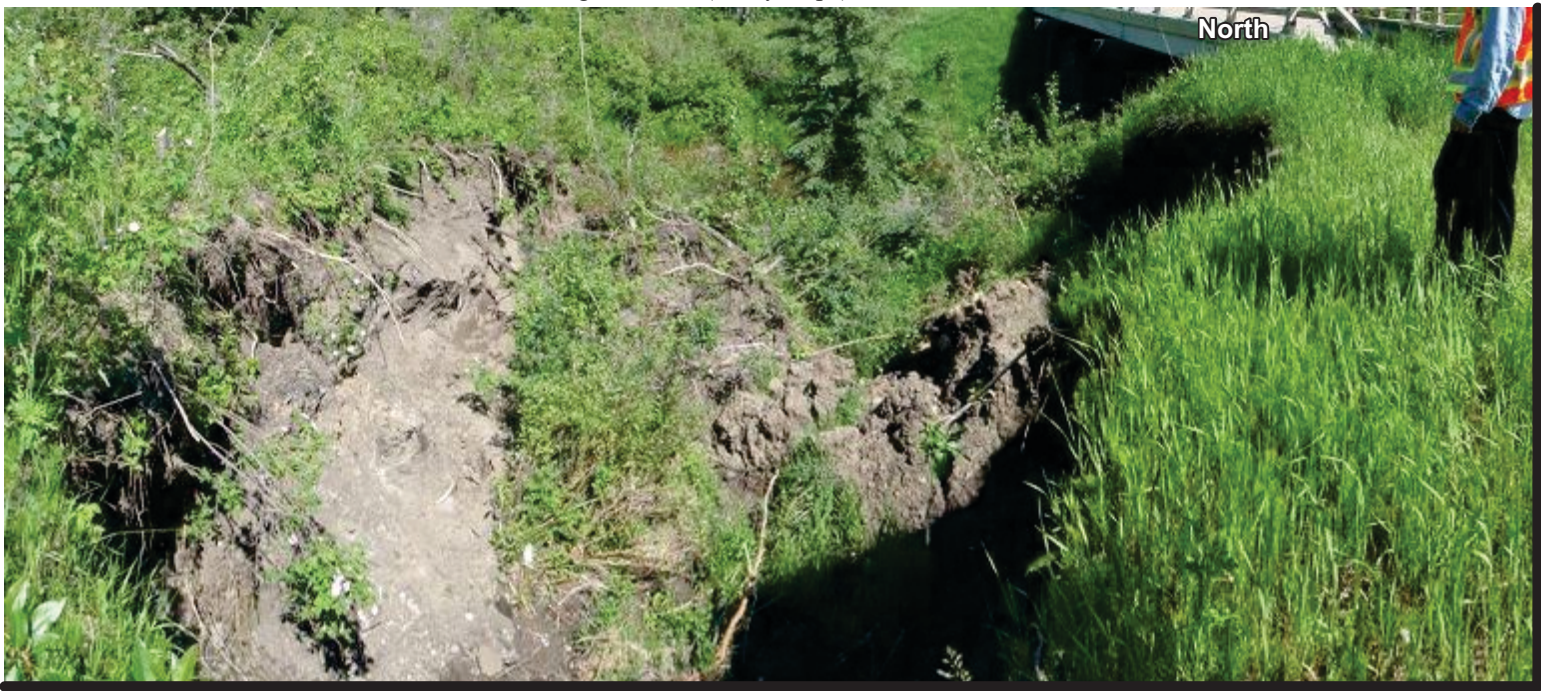
Photo IVa
Looking north - down the head of slide

- Powdery soil of weak strength and easily erodible
