**ALBERTA TRANSPORTATION
GEOHAZARD ASSESSMENT PROGRAM
PEACE REGION–GRANDE PRAIRIE
2016 INSPECTION REPORT**

Site Number	Location	Name	Hwy	km
GP039-2	Bear River Bridge	Embankment Slide and Erosion (4 km's S. of LaGlace)	724:04	21.191
Legal Description		UTM Co-ordinates		
SE¼33-073-08 W6M		11U E 363440	N 6137137

**PEACE REGION (GRANDE PRAIRIE) 2016
GP39-2: HWY 724:04 km 21.191 EMBANKMENT SLIDE
AND EROSION (4 km SOUTH OF LA GLACE)**

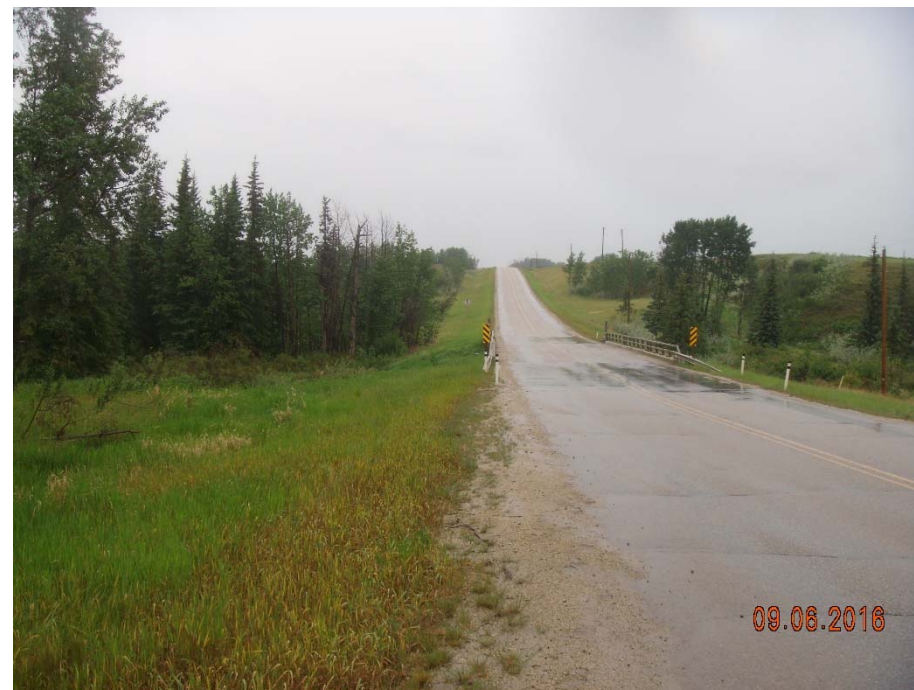
Photo 1.
Looking north from
the SBL shoulder of
Hwy 724:04 at
about 10 m north of
the intersection
with Township
Road (TWP RD)
735.

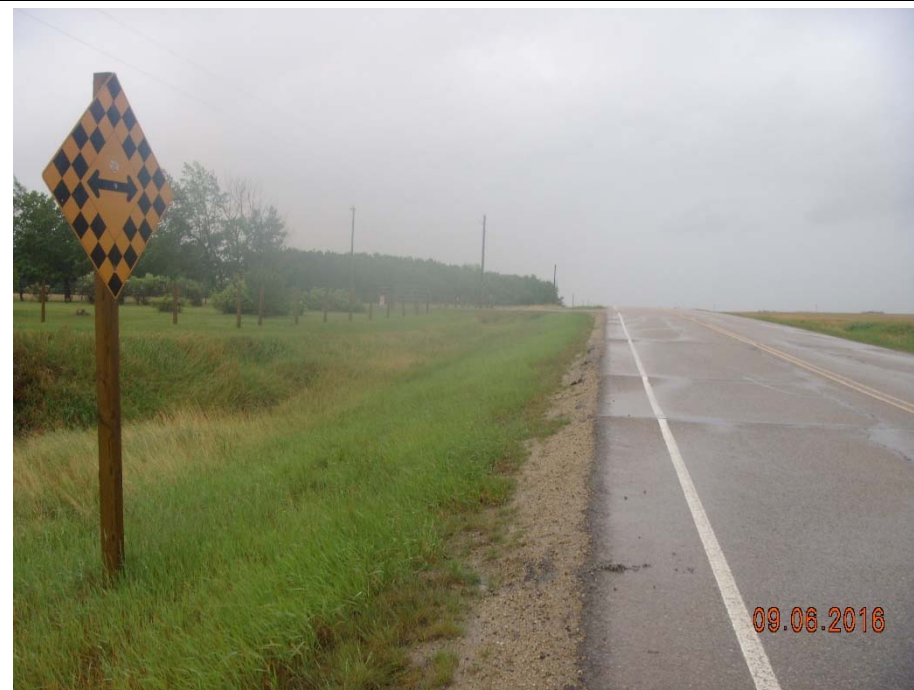
Photo 2.
Looking south
along the NBL
shoulder of Hwy
724:04 on the east
side of the TWP RD
735 intersection.

Armor/line the ditch bottoms near the crest of the Bear River south valley slope and build a ditch block in the NBL ditch at the east side of the intersection between Hwy 724:04 and TWP RD 735.	\$200,000 to \$300,000
---	------------------------

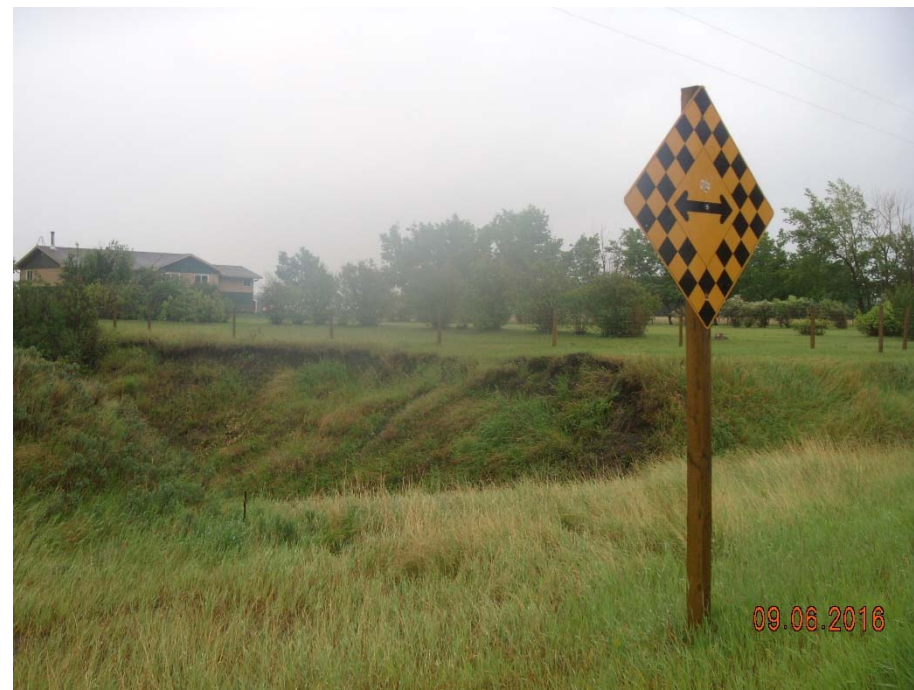
Photo 3.

Looking southeast from east side of the intersection of TWP RD 735 and Hwy 724:04 towards the erosion at the south wouth valeely slope of the Bear River. The backscarp is about 3 m m from the fencline of the privately owned land. No significant change since 2014.

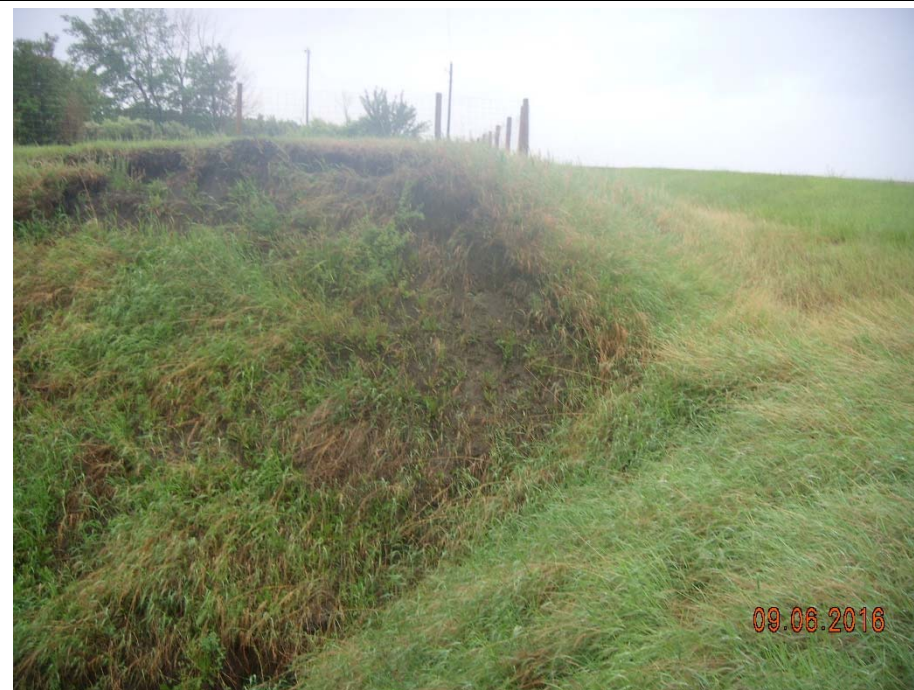
Photo 4.

Looking south from about 20 m east of the intersection between Hwy724:04 and TWP RD 735 towards the at erosion at the top of bank near the NBL ditch outflow channel.

Erosion protection and a ditch block are recommended on the NBL ditch near the crest of the Bear River Valley south slope on the east side of the TWP RD 735 to prevent further erosion at this location.

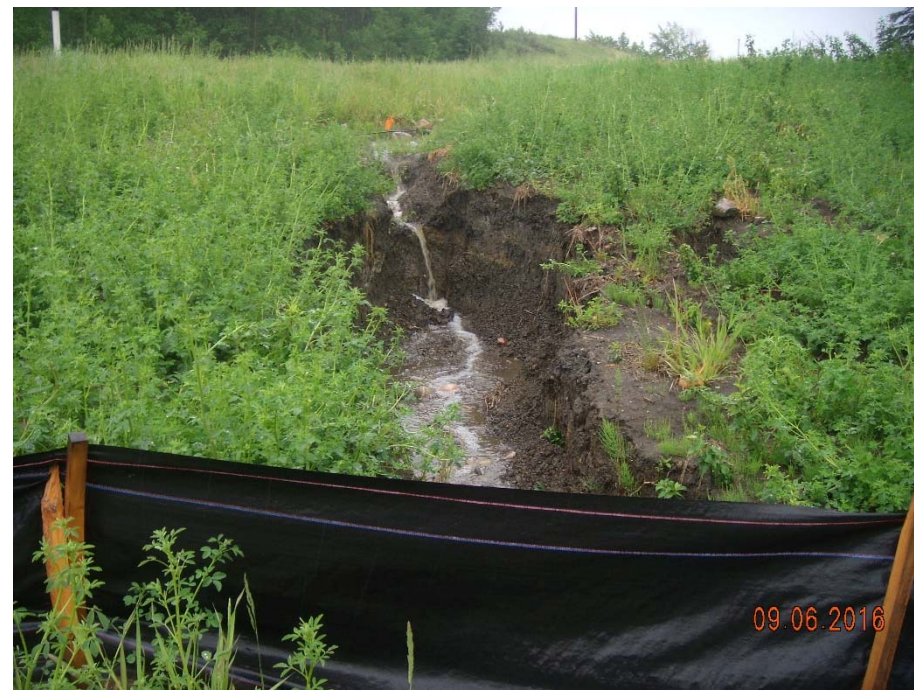
Photo 5.
Looking southeast from about 5 m south and 5 m west of the Bear River Bridge south abutment towards the erosion forming at interface between the NBL ditch and the south crest of the Bear River valley slope.

Erosion protection is required on the south bridge abutment headslope to protect the roadway embankment and bridge structure.

At both locations erosion protection at ditch bottom could consist of gabion mattresses.

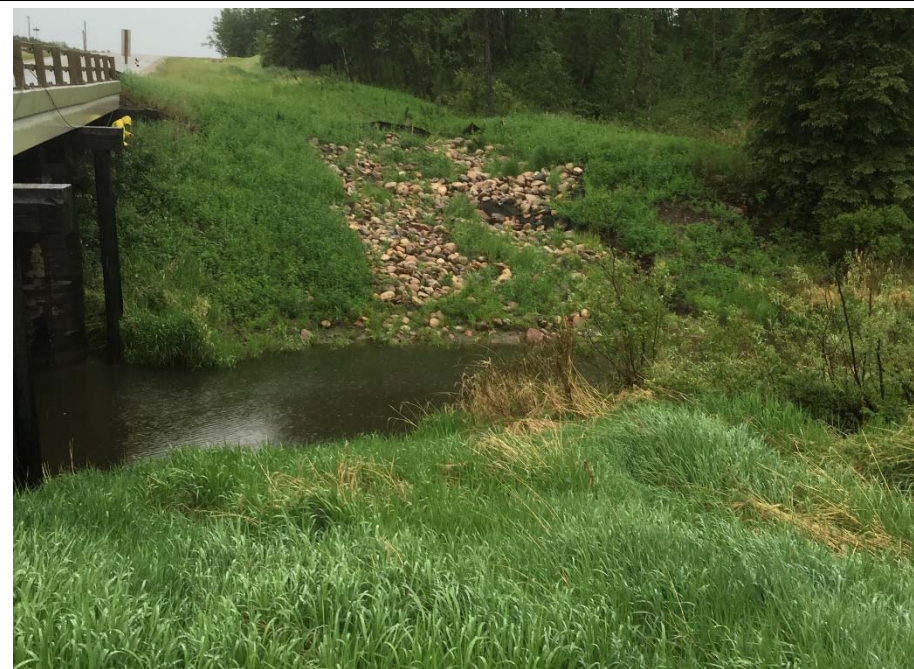
Photo 6.
Looking south from about 5m west of the Bear River Bridge north abutment towards the rip rap placed as part of the erosion repair on the south abutment northwest headslope.
