SITE NUMBER AND NAME: GP039-1 South of LaGlance Erosion Sites		HIGHWAY & KM: 724:04, 21.191	PREVIOUS INSPECTION DATE: June 9, 2016	INSPECTION DATE: July 20, 2021
LEGAL DESCRIPTION: SE 33-73-08-W6M	NAD 83 COORDINATES: UTM Northing Easting 11 6137021 363442		RISK ASSESSMENT: GP039-I PF: 13 CF: 2 TOTAL: 26 GP039-II PF: 10 CF: 3 TOTAL: 30	
AVERAGE ANNUAL DAILY TRAFFIC (AADT): 950 (north) & 1280 (south) (Reference No. 27750)			CONTRACT MAINTENANCE AREA (CMA): 504

PROJECT	GRANDE PRAIRIE SOUTH REGION GEOHAZARD RISK MANAGEMENT PROGRAM	
TITLE	Site Plan GP039-I South of La Glace Erosion Sites Hwy 724:04, km 13.349	
SCALE	PROJECT No. A05116A01	FIG No. 1

GP039-I South of La Glace Erosion Sites

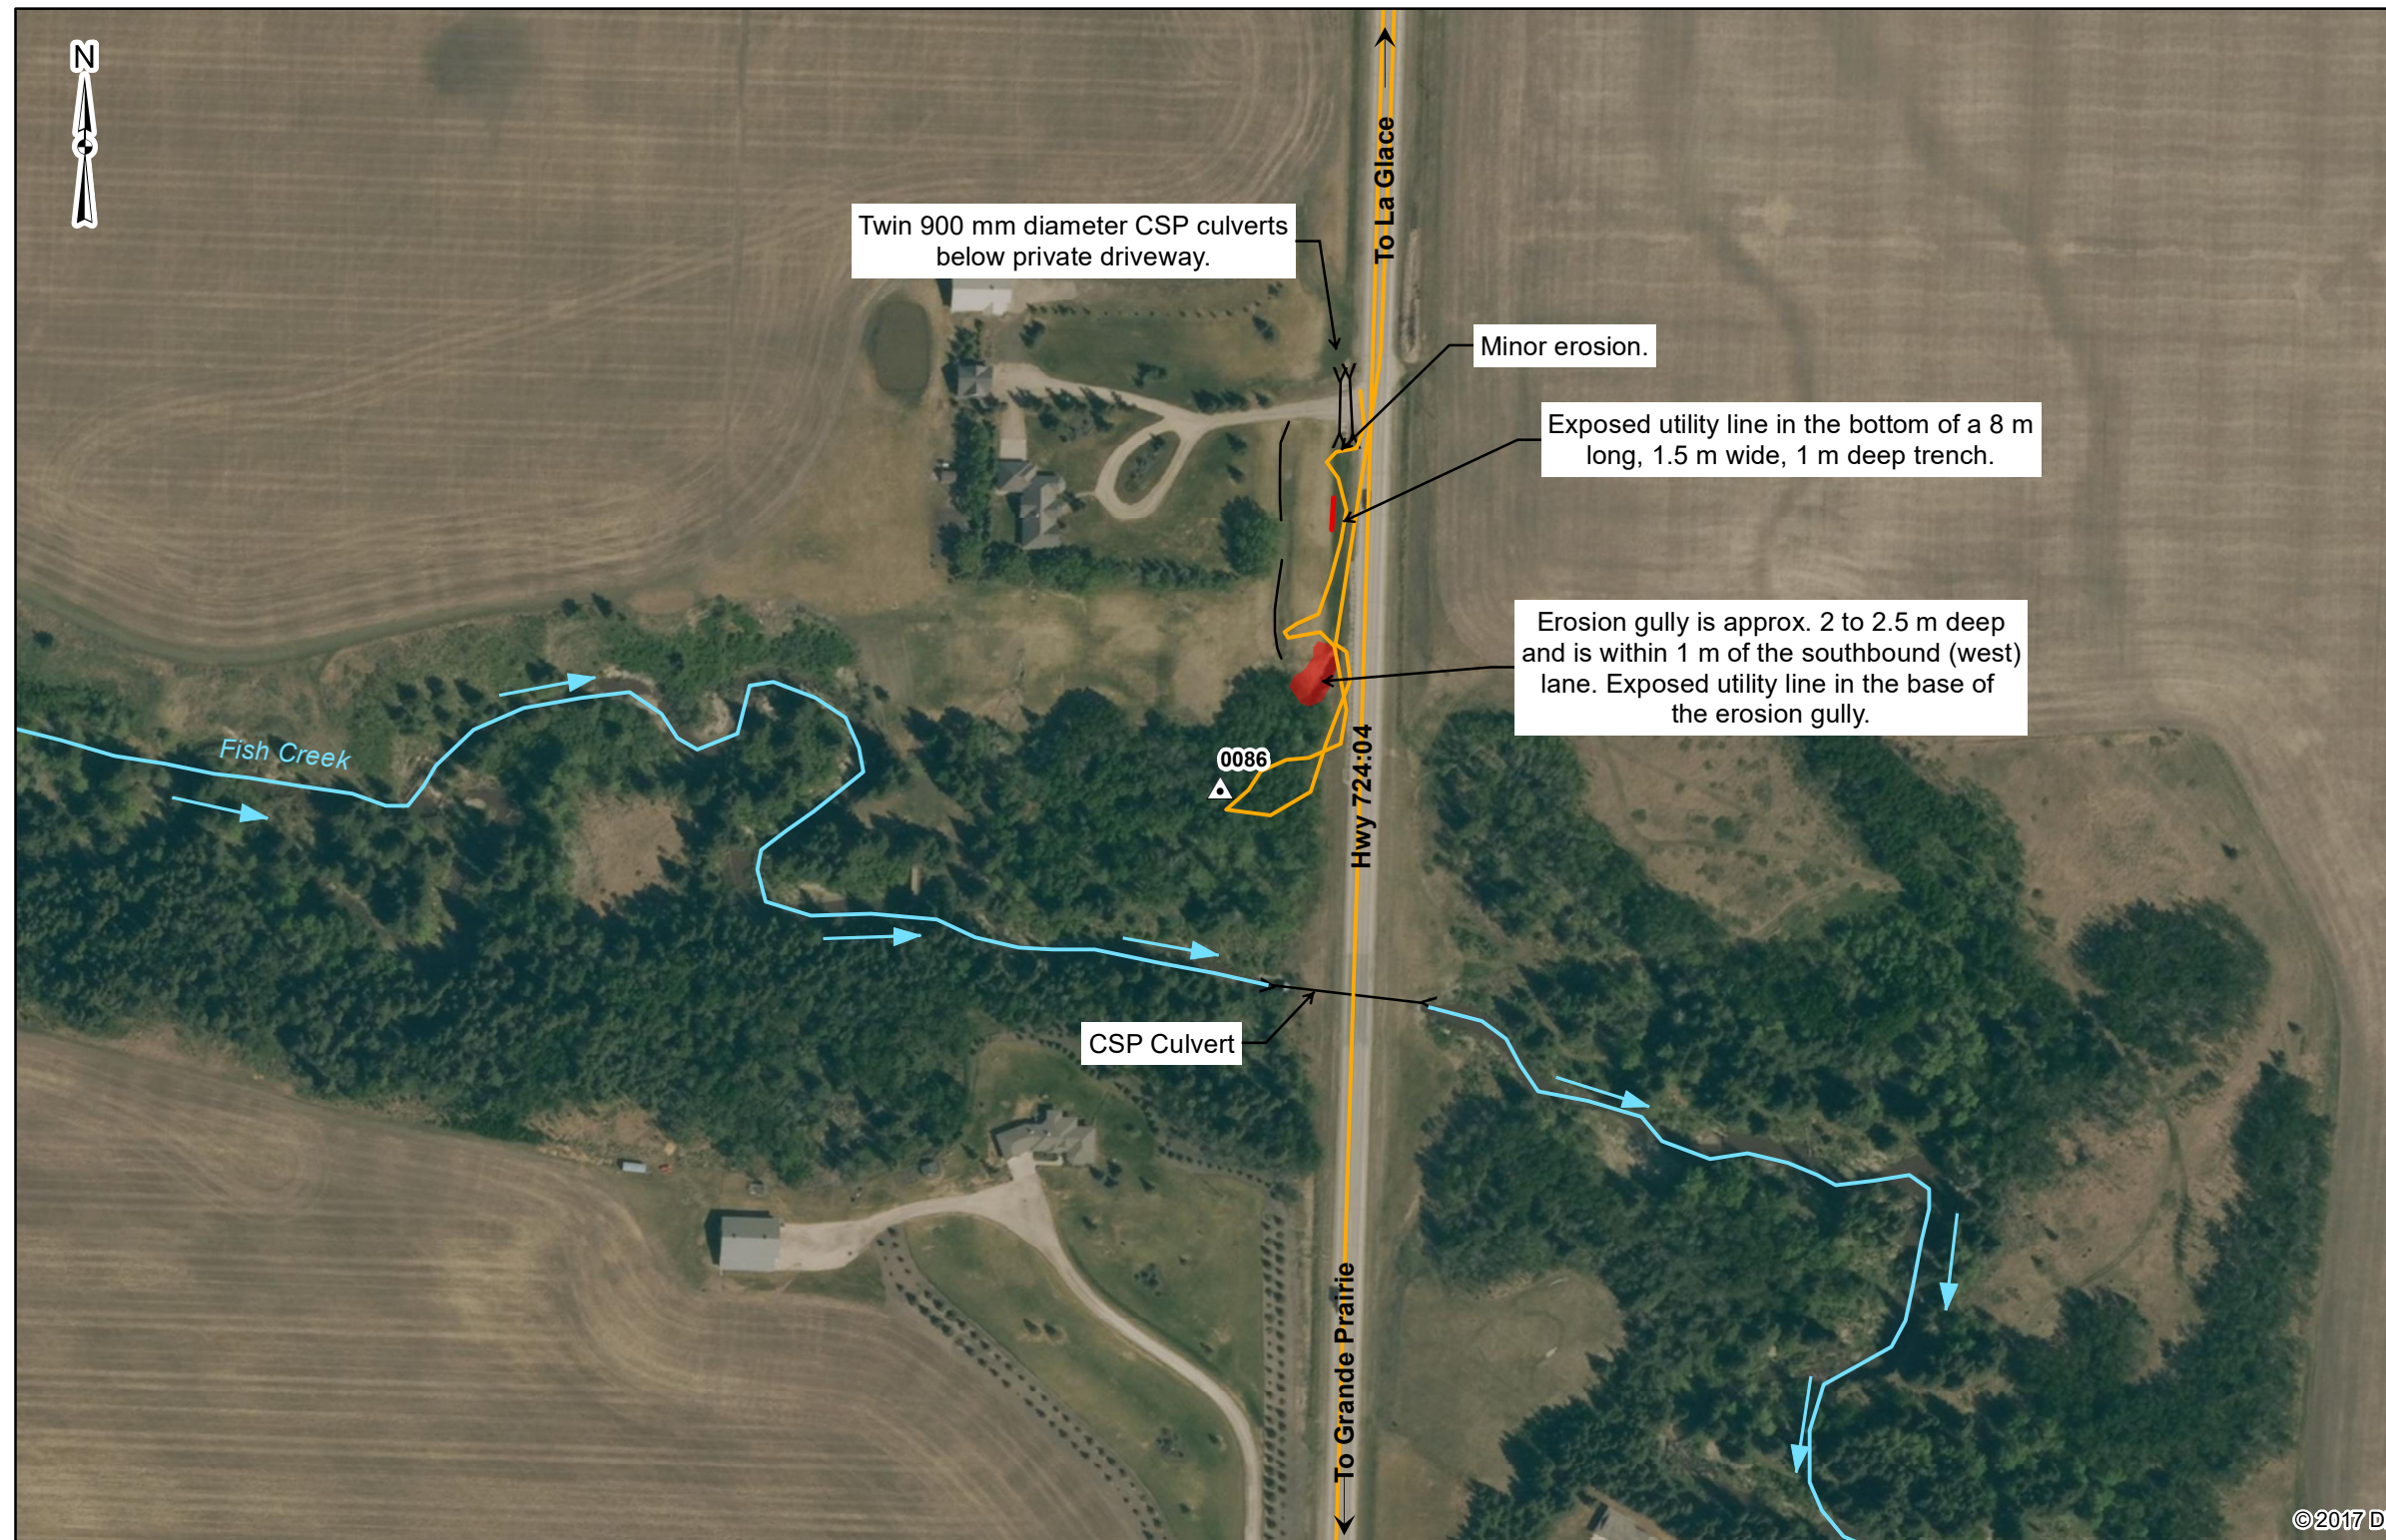
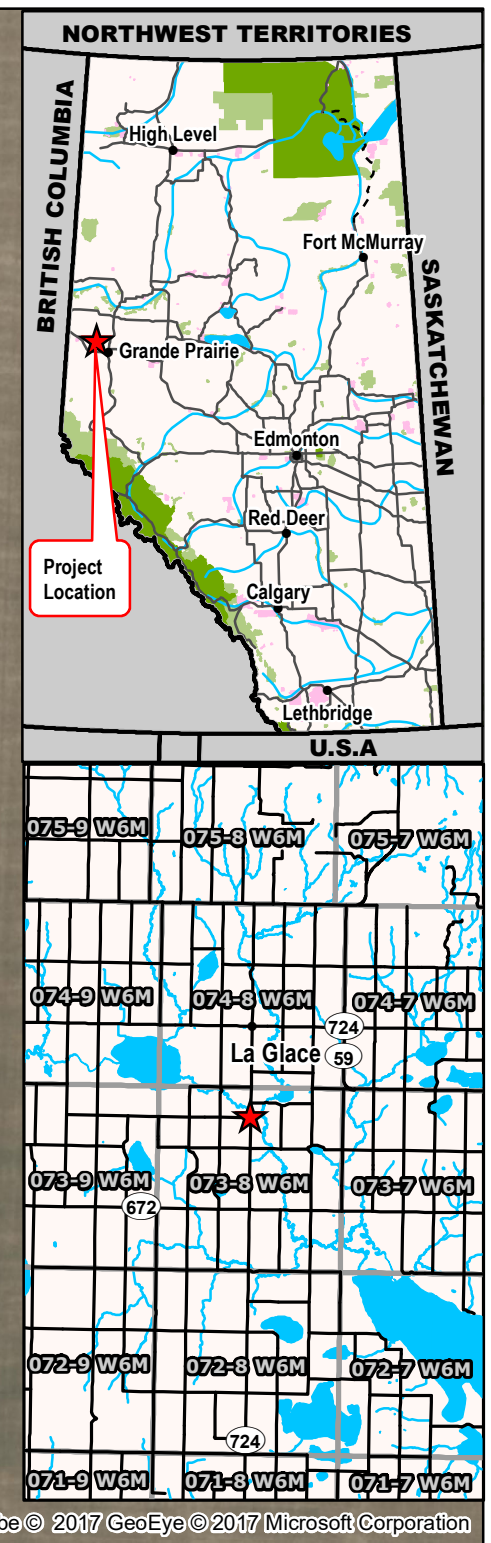
PRIMARY SITE ISSUE: GP039-I: An erosion gully has formed at the crest of the Fish Creek north valley slope along the SBL ditch and is retrogressing into the limits of the privately owned land at No.730028 Hwy 724:04. Minor erosion has occurred at the outlets of twin CSP culverts below a private driveway and in two locations in the ditch bottom between the approach and crest of the creek valley. GP039-II: an erosion gully has formed in the ditch north of the bridge. Some erosion during a highwater event occurred near the double timber bridge headwalls. The erosion gully is not affecting the approach fill or head wall(s). APPROXIMATE DIMENSIONS: The erosion gully is about 10 m long, approximately 10 m wide crest-to-crest, approximately 2 to 2.5 m deep, v-shaped to approximately 0.5 m wide at the base, with 0.5 to 1H:1V side slopes. Base of gully is sloped at approximately 20%. DATE OF ANY REMEDIAL ACTION: None. Ditch was re-routed in 2012/2013 from its former location further upslope to its current location

COMMENTS
<u>GP039-I (ditch erosion at Colquhoun Creek)</u>
<ul style="list-style-type: none"> - There is large catchment draining to the erosion gully with a gently sloped ditch extending to the north.
<ul style="list-style-type: none"> - Twin 0.9 m diameter CSP culverts under driveway
<ul style="list-style-type: none"> - Erosion at base of ditch in two locations exposes an orange jacket utility line.
<ul style="list-style-type: none"> - Edge of erosion scarp is approximately 1.5 m from guardrail posts. Guardrail protects road users from hazard of erosion in ditch.
<ul style="list-style-type: none"> - Landowner is mowing grass in ditch, ditch is very well maintained
<ul style="list-style-type: none"> - Valley bottom downslope of gully has a deposit of eroded material in a channel that drains towards Fish Creek (WP0086). Channel is 4 m wide with 1:1 slide slopes approximately 3 m high that are failing. However, the valley bottom is has irregular topography and various fallen trees and pockets of understory vegetation between the erosion and the creek (approximately 30 to 50 m) that appears to impede the transport of eroded material towards the creek.

<ul style="list-style-type: none"> - Possible solutions include: Fill gully with clean gravel and riprap armour the reconstructed ditch bottom, extend a riprap pad a few meters into the trees to transition to the valley bottom (might have to cut down a few poplars in the fall); or storm drain drop inlet, with a buried pipe discharging into an energy dissipation apron or structure (gabions or pre-cast concrete). The HMC will do the repairs so the riprap armoured channel would be more appropriate. A check trench with compacted clay should be placed around the existing utility cables to limit subsurface seepage along the cable. The cables would need to be relocated before construction starts, and routed to a location where they are not damaged by construction of repairs.
<ul style="list-style-type: none"> - Repairs should limit damage to the vegetation in the ditch, if practical and economic. The use of rig mats for truck access would limit damage. Another alternative would be to take apart of the guardrail and rout trucks right to the erosion gully, with some use of rig mats where safe. A single lane closure would likely be required for any repair option or access configuration.

<ul style="list-style-type: none"> - AT requests proposal for hydrotech study, sketch drawings, quantities, memo to support HMC repair. Repairs should be conducted in the fall of 2021.
<u>GP039-II (bridge abutment erosion)</u>
<ul style="list-style-type: none"> - Gully is about 2 to 2.5 m deep, up to about 4 m wide
<ul style="list-style-type: none"> - Erosion gully is outside of clear zone for most of it, but within 4 m at upper end of erosion
<ul style="list-style-type: none"> - Short-length, small catchment
<ul style="list-style-type: none"> - Minor erosion at edge of bridge wingwall, AT says highwater caused erosion near the toe of the wingwall in the past
<ul style="list-style-type: none"> - South abutment of bridge has double creosote timber headslope walls
<p>This report is an instrument of service of Klohn Crippen Berger (KCB). The report has been prepared for the exclusive use of Alberta Transportation (Client) for the specific application to the Central Region Geohazard Risk Management Program (Contract No. CON0022166) and it may not be relied upon by any other party without KCB's written consent.</p> <p>KCB has prepared this report in a manner consistent with the level of care, skill and diligence ordinarily provided by members of the same profession for projects of a similar nature at the time and place the services were rendered. KCB makes no warranty, express or implied.</p> <p>Use of or reliance upon this instrument of service by the Client is subject to the following conditions:</p>

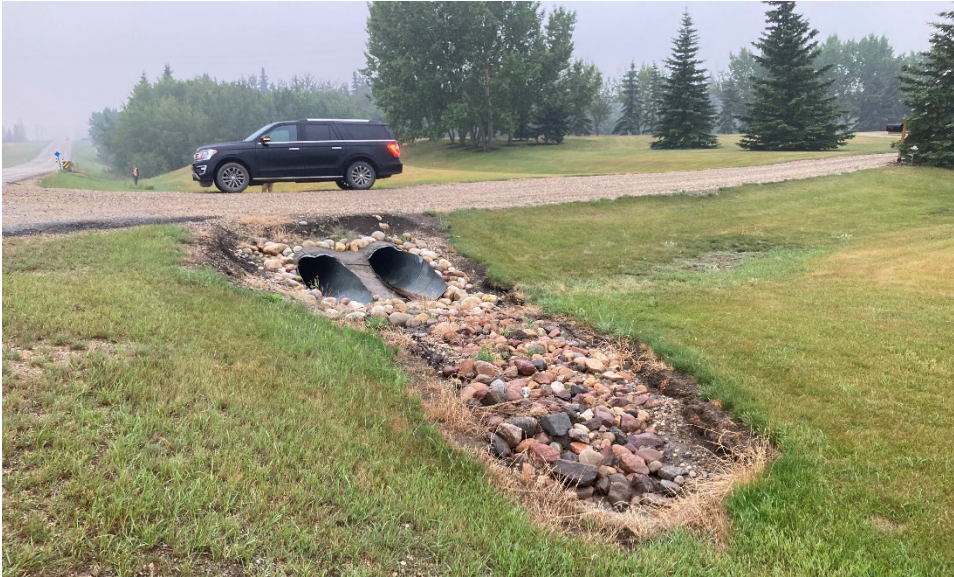
Photo 1 Inlet of the twin 800 mm diameter CSP culverts and riprap apron. Photo taken July 20, 2021 facing south.

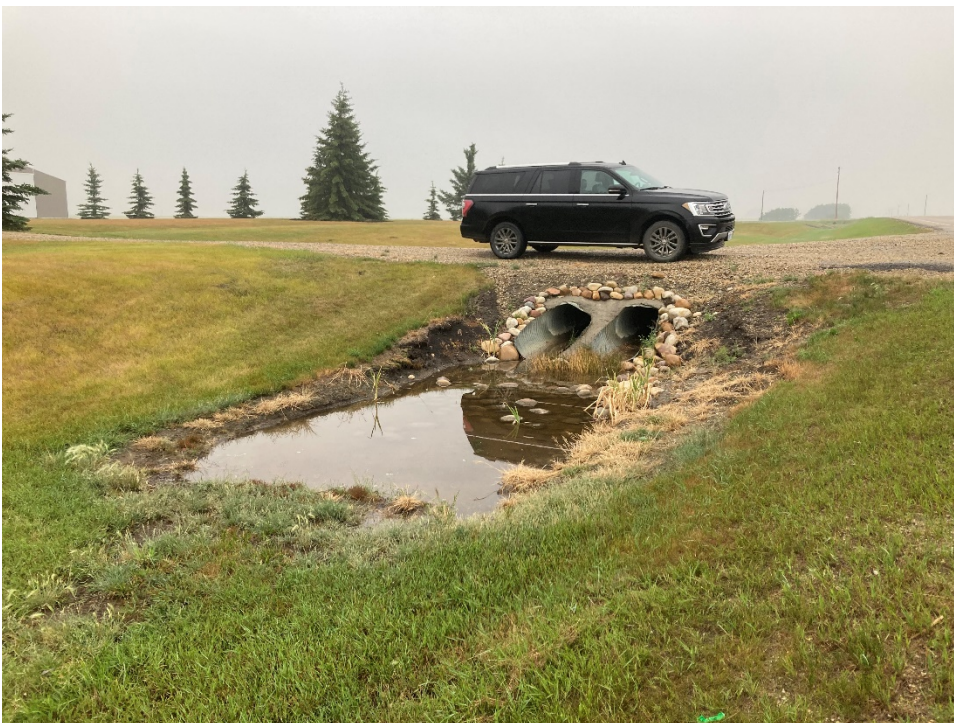
Photo 2 Outlet of the twin 800 mm diameter CSP culverts. Water has ponded in the riprap apron. Photo taken July 20, 2021 facing north.

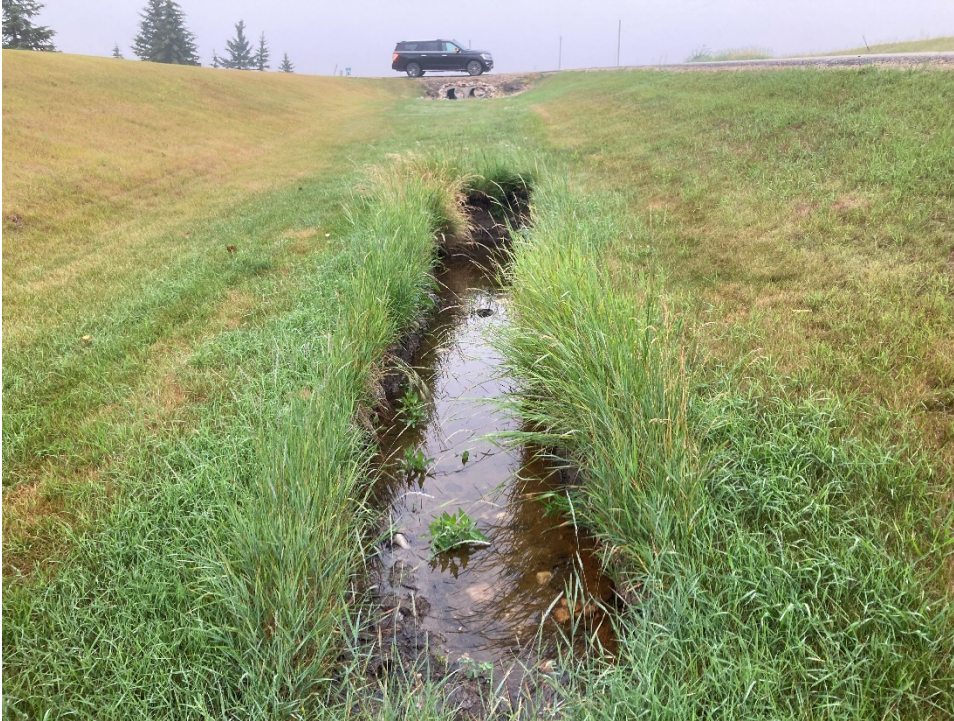
Photo 3 Left-over depression from hydro-vacing to expose the underground utility line. The depression is approximately 8 m long, 1 m wide, and 1 m deep. Photo taken July 20, 2021 facing north.

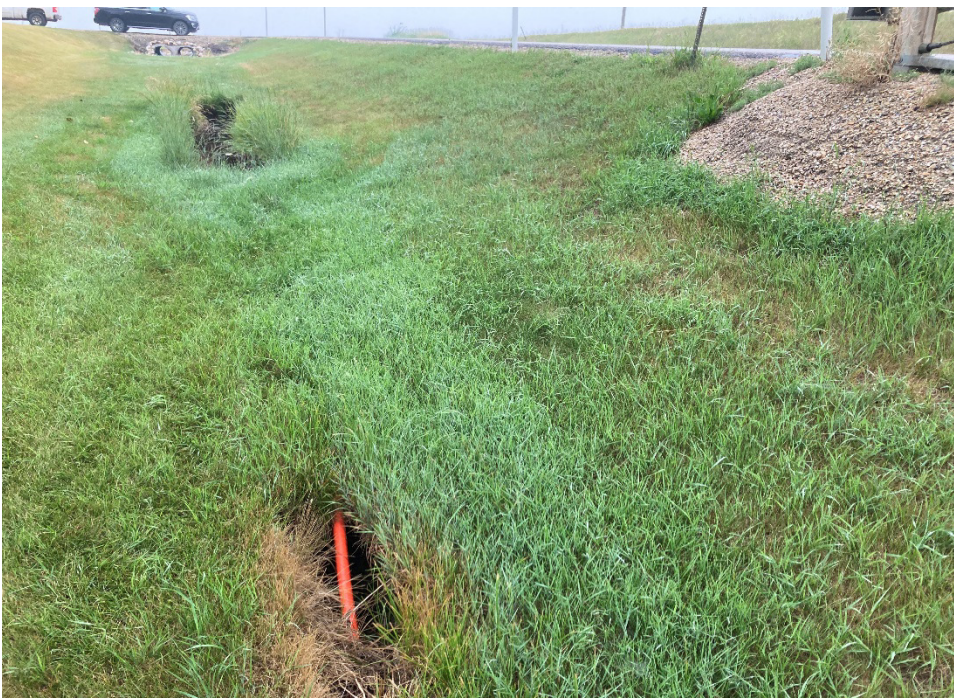
Photo 4 Exposed utility line in the west (southbound) ditch. The utility line is still exposed from hydro-vacing. Photo taken July 20, 2021 facing north.

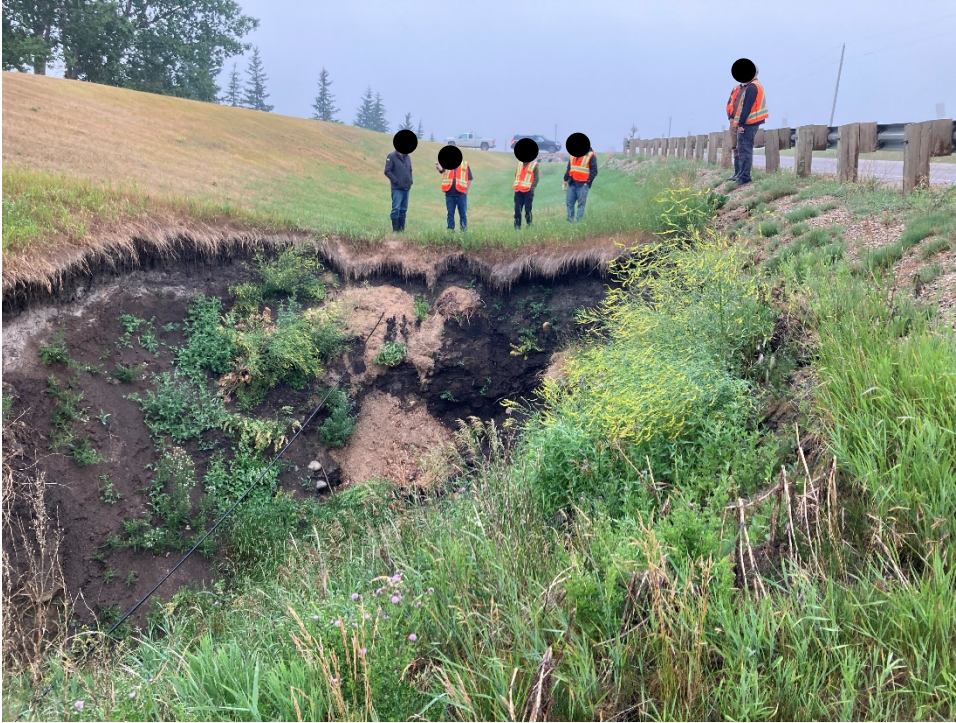
ITEM	CONDITION EXISTS		DESCRIPTION AND LOCATION	NOTICABLE CHANGE FROM LAST INSPECTION	
	YES	NO		YES	NO
Pavement Distress		X			
Slope Movement		X			
Erosion	X		Large erosion gully at south extent of the site, approx. 2 m from edge of pavement of southbound lane. Two black utility lines and one larger-diameter orange line visible in erosion gully. AT last looked at this site in 2016 and the erosion has gotten much worse.	X	
Seepage	X		Landowner says that after heavy rain or runoff, water is seen seeping out into the gully along the orange jacket buried utility line.		X
Culvert Distress

Photo 5 Erosion gully at the south extent of the site. The erosion gully is much larger than during the 2016 inspection and is approximately 5 m to 6 m deep and 8 m wide. Photo taken July 20, 2021 facing north.

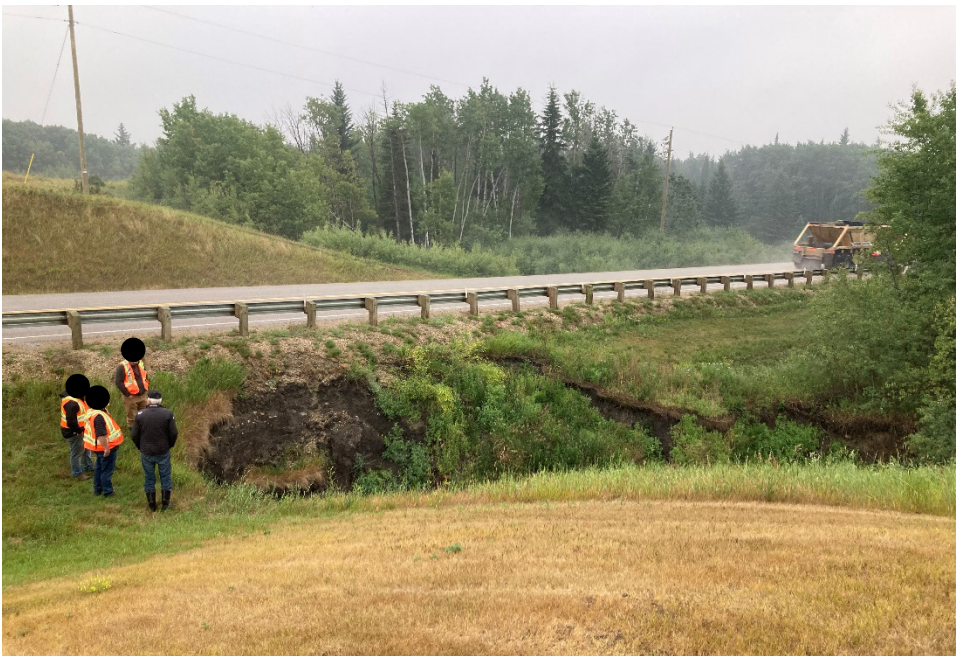
Photo 6 The erosion gully is retrogressing towards the west (southbound) lane and is less than 2 m from the edge of pavement. Photo taken July 20, 2021 facing southeast.

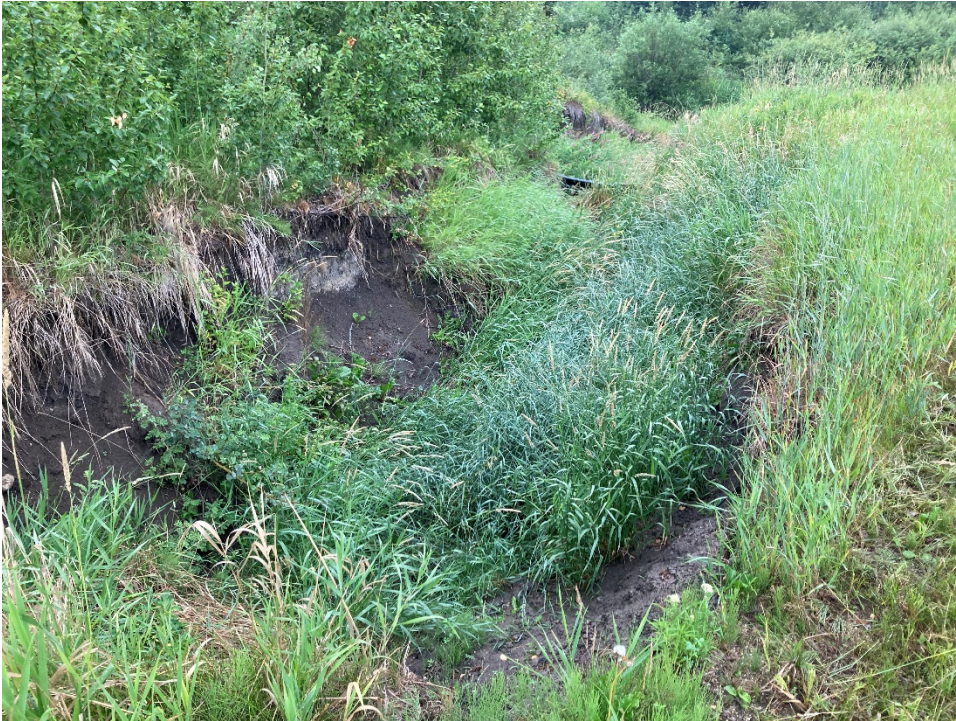
Photo 7 Erosion gully in the west (southbound) ditch of the S039-II site. Photo taken July 20, 2021 facing north.

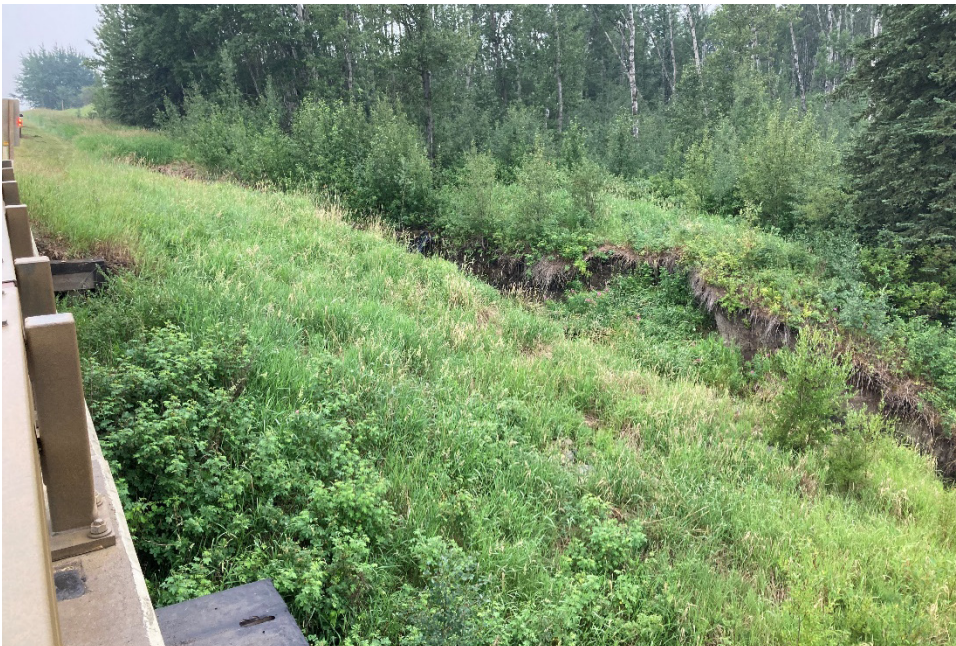
Photo 8 Erosion gully viewed from the south abutment of the bridge crossing Colquhoun Creek. Photo taken July 20, 2021 facing southwest.

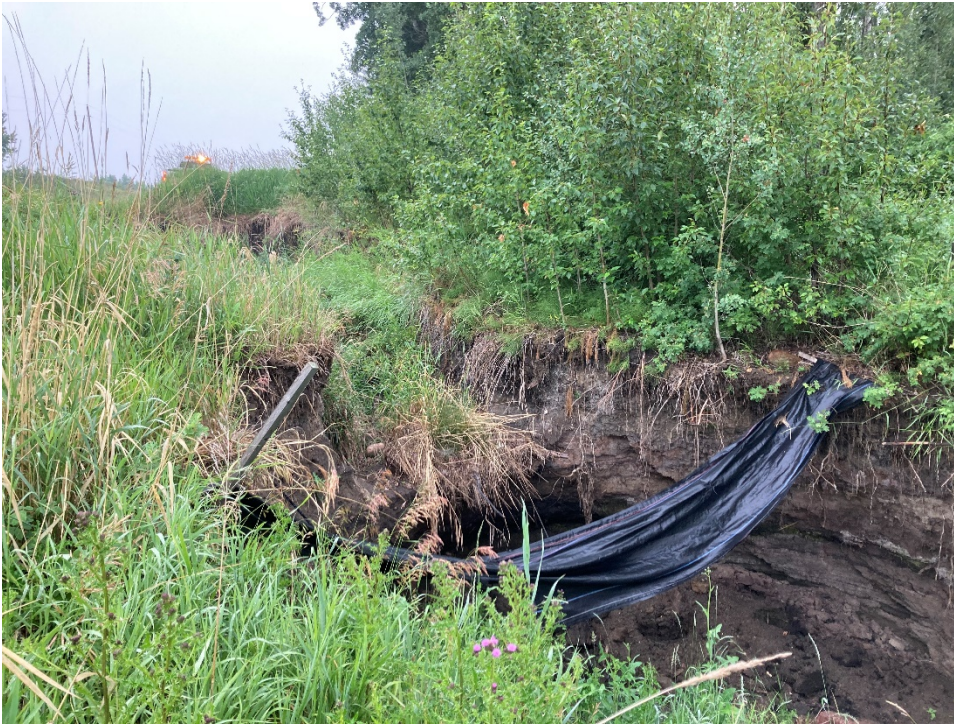
Photo 9 The silt fencing near the north extent of the erosion gully has been undermined. Photo taken July 21, 2021 facing south.

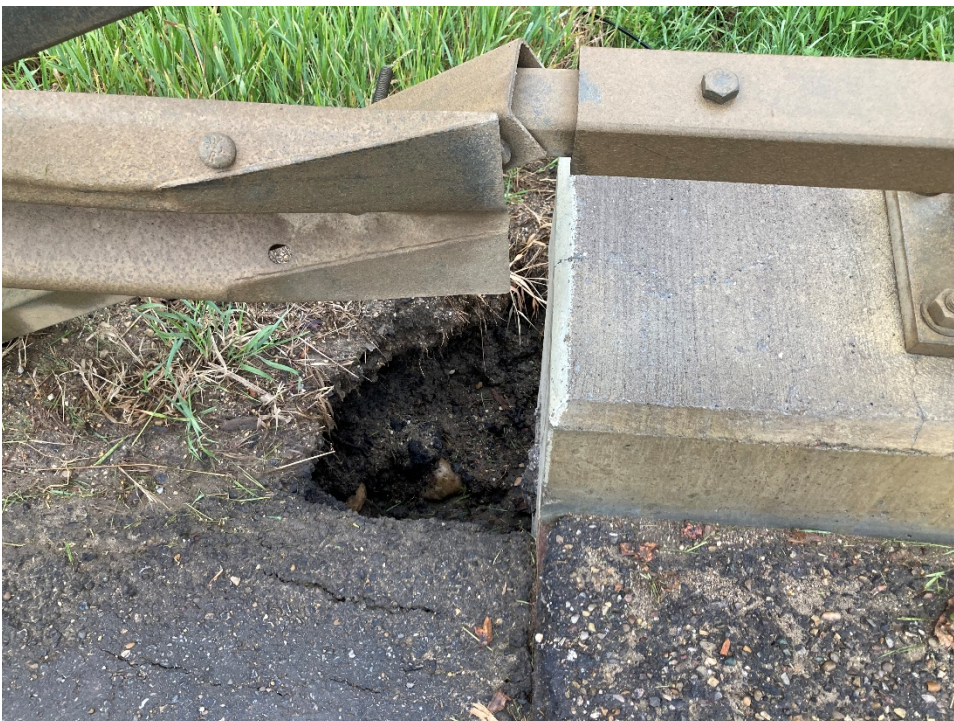
Photo 10 Erosion at the southwest corner (west side of the south abutment) of the bridge crossing Colquhoun Creek. Photo taken July 20, 2021 facing west,
