**PEACE REGION
(GRANDE PRAIRIE DISTRICT – SOUTH) GRMP**

SITE INSPECTION FORM

SITE NUMBER AND NAME: GP039-I and -II South of LaGlance Erosion Sites		HIGHWAY & KM: 724:04, 13.349 and 21.191	PREVIOUS INSPECTION DATE: July 20, 2021	INSPECTION DATE: June 11, 2024
LEGAL DESCRIPTION: SE 04-73-08-W6M SE 33-73-08-W6M	NAD 83 COORDINATES: UTM Northing Easting 11 6129293 363209 11 6137021 363442		RISK ASSESSMENT: GP039-I PF: 2 CF: 1 TOTAL: 2 GP039-II PF: 10 CF: 8 TOTAL: 80	
AVERAGE ANNUAL DAILY TRAFFIC (AADT): 1,200 (north) & 1,330 (south) (Reference No. 27750, 2023)			CONTRACT MAINTENANCE AREA (CMA): 504

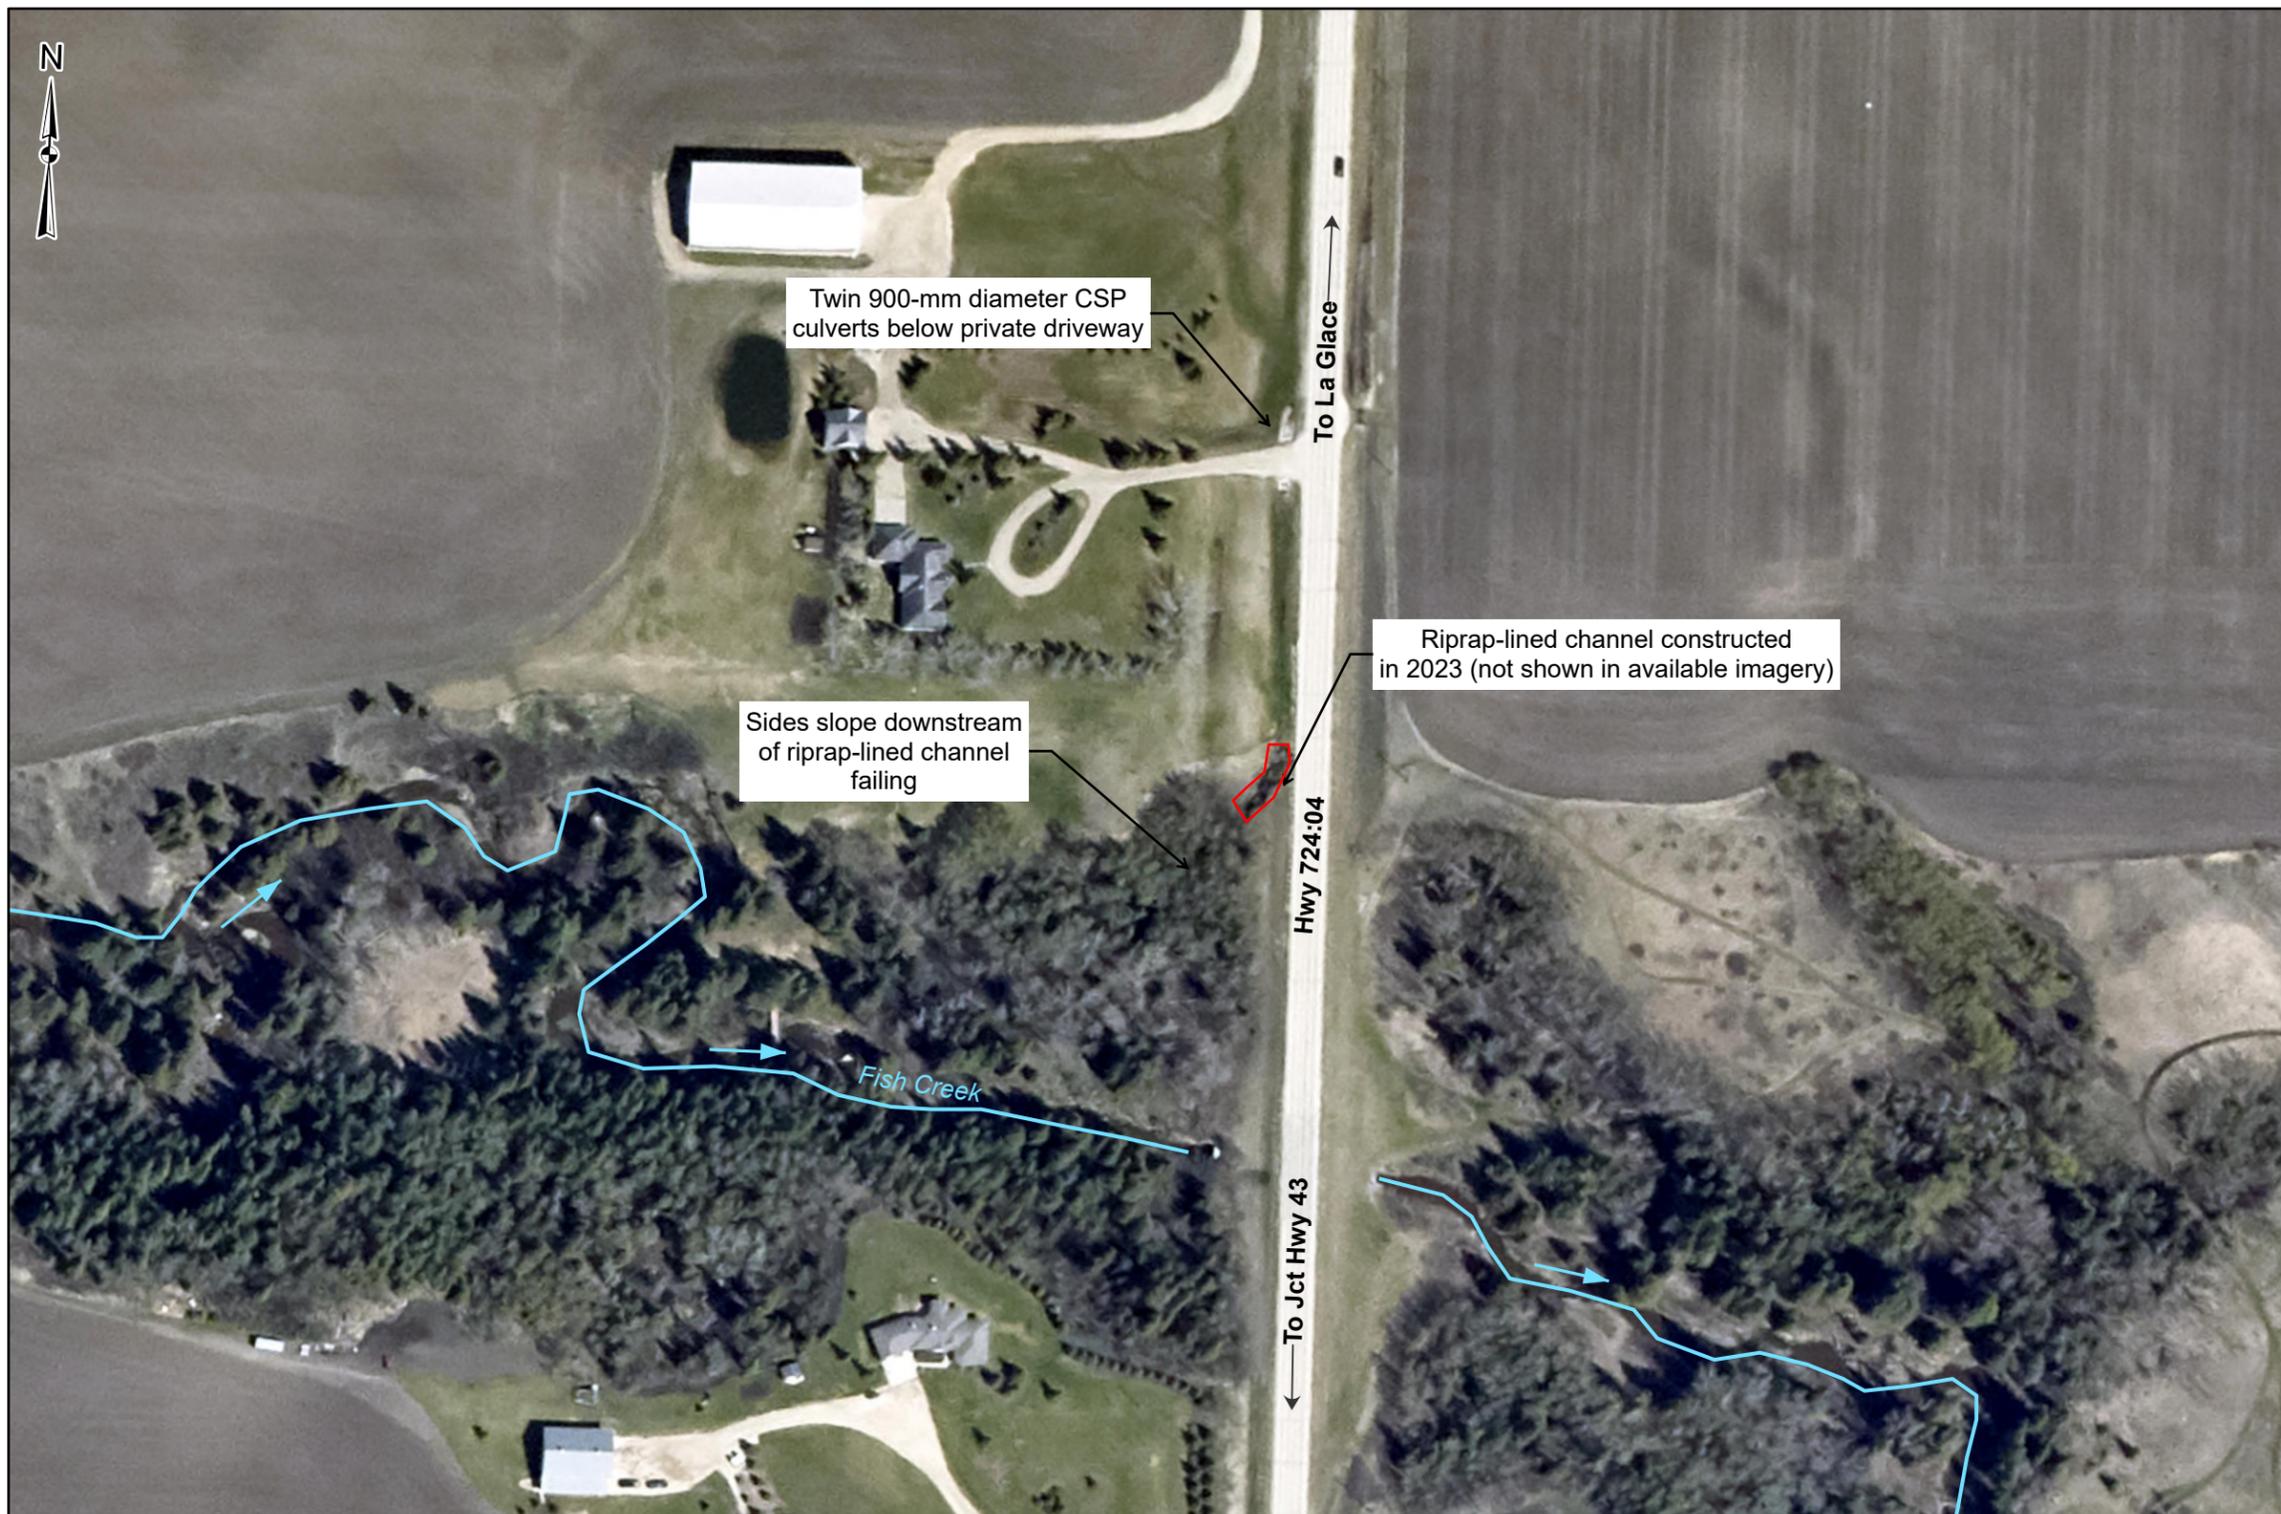
SCALE: 1:2,000 PROJECT No. A05116A01 FIG No. 1

TITLE: Site Plan
 GP039-I South of La Glace Erosion Sites
 Hwy 724:04, km 13.349

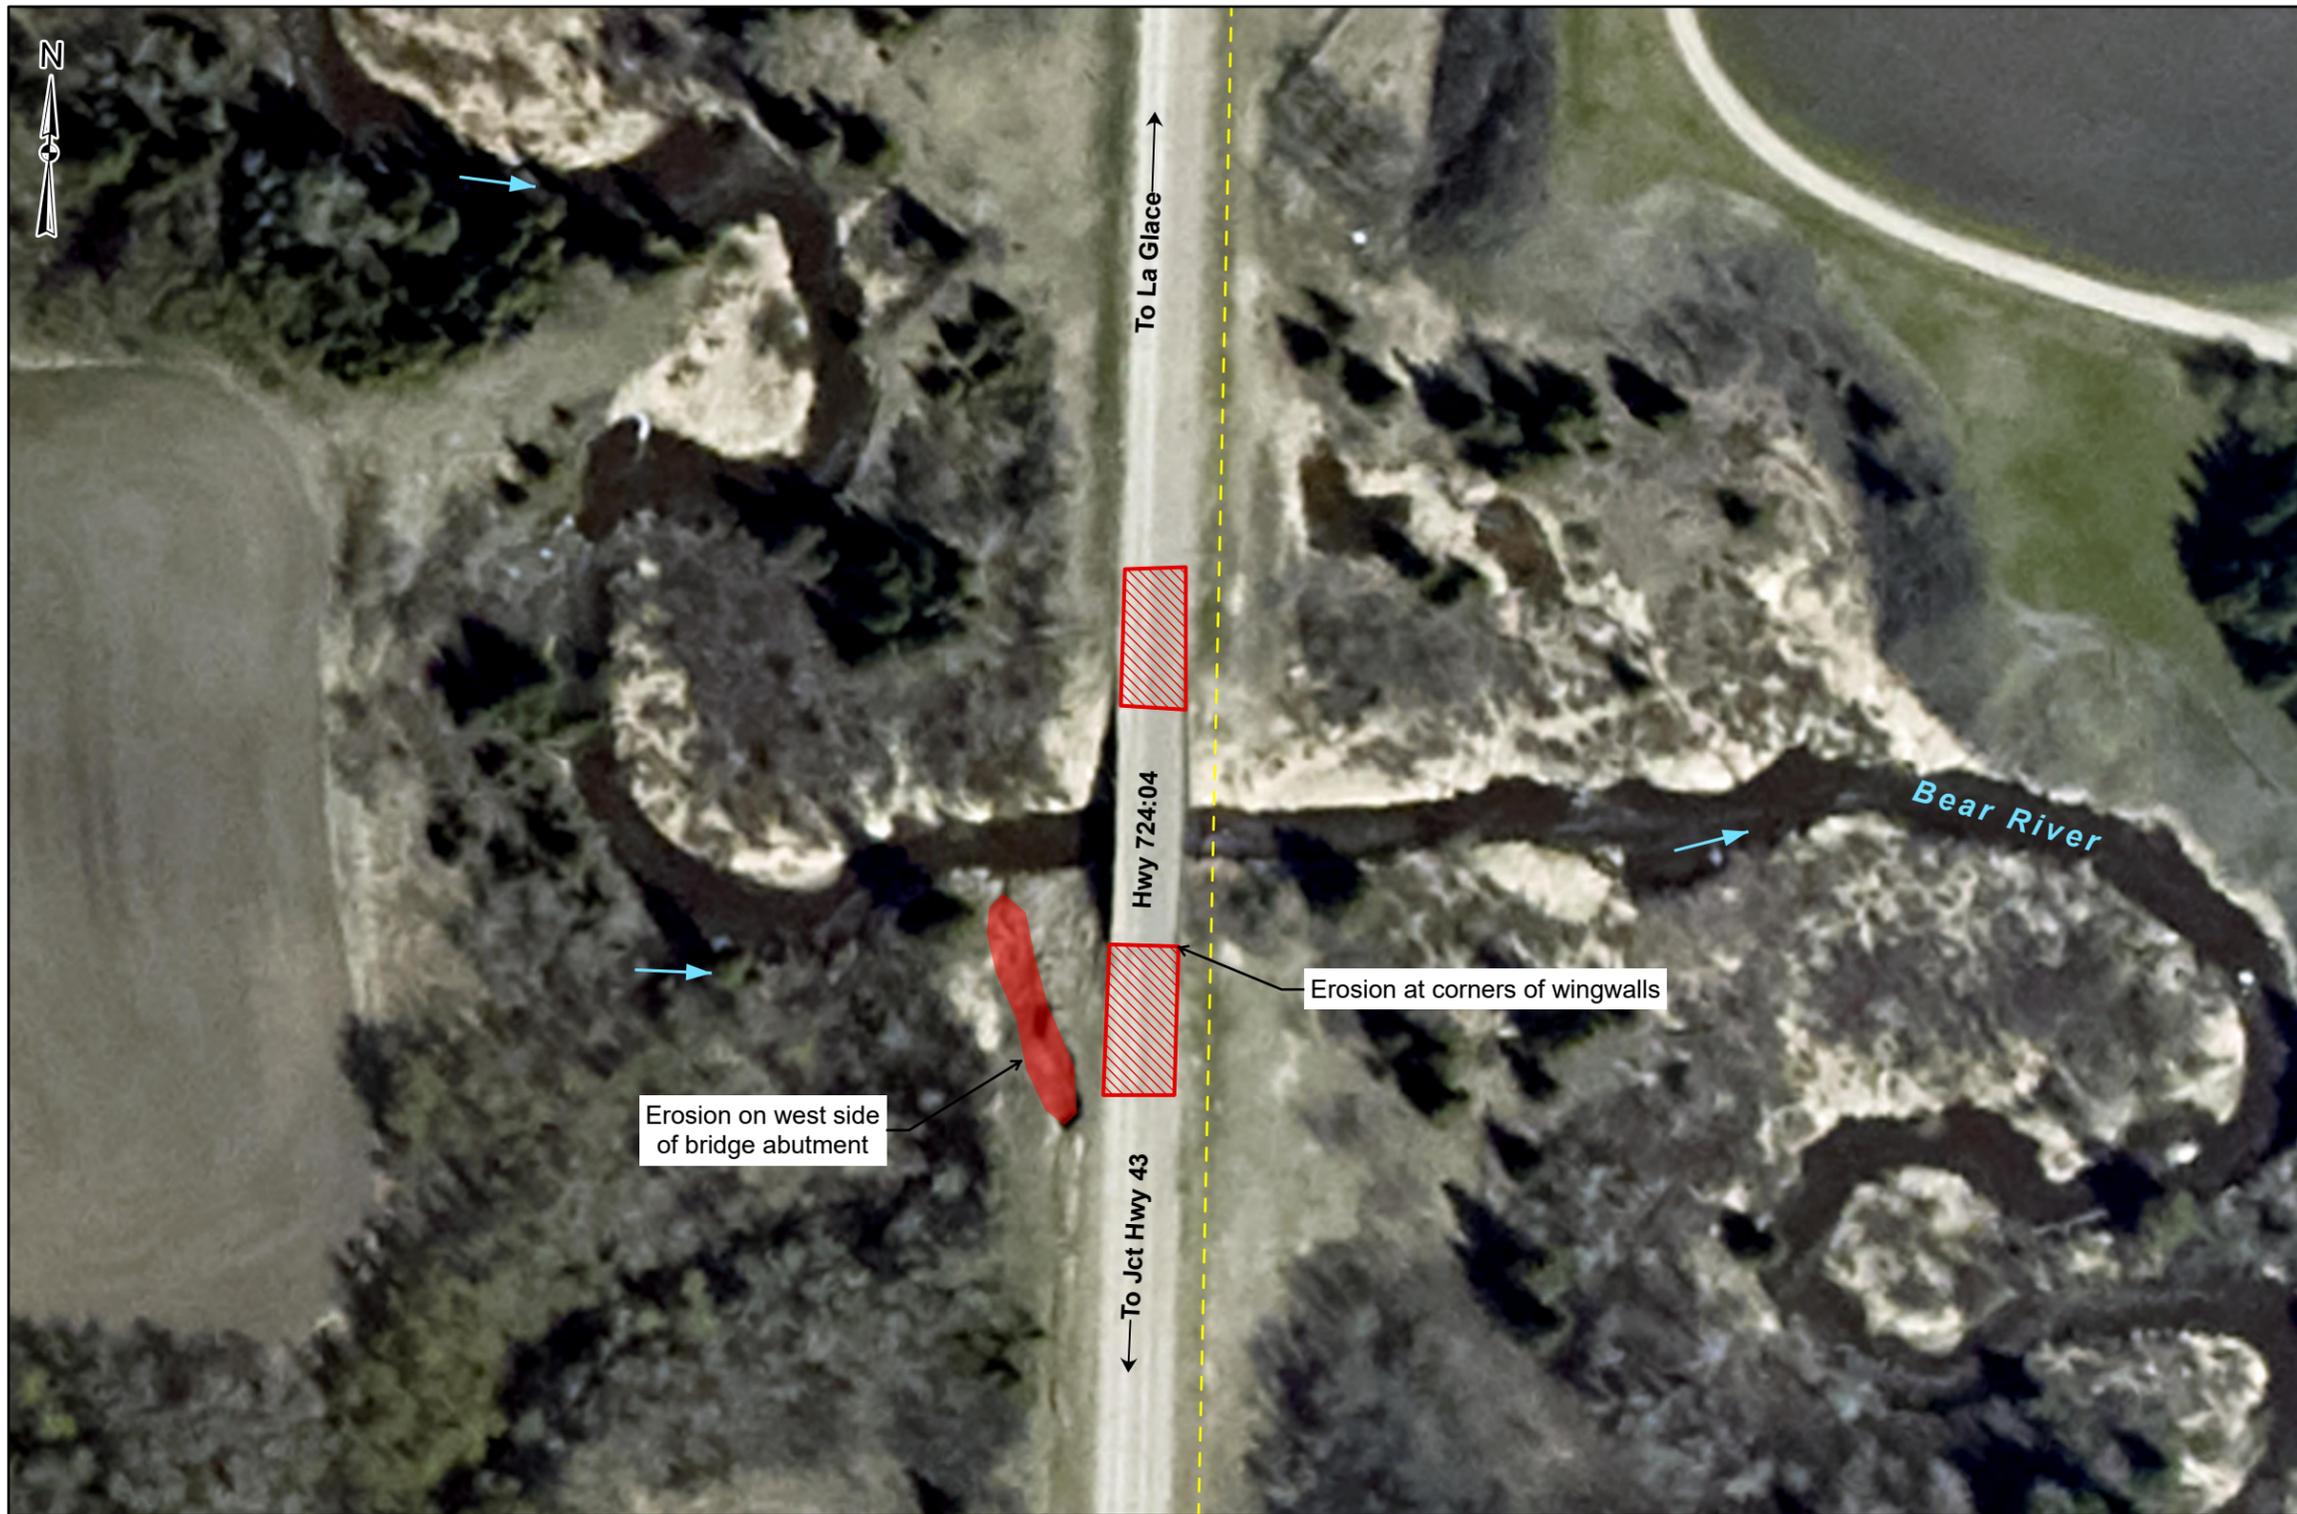
SCALE 1:1,000 PROJECT No. A05116A01 FIG No. 1

TITLE
 Site Plan
 GP039-II South of La Glace Erosion Sites
 Hwy 724:04, km 21.191

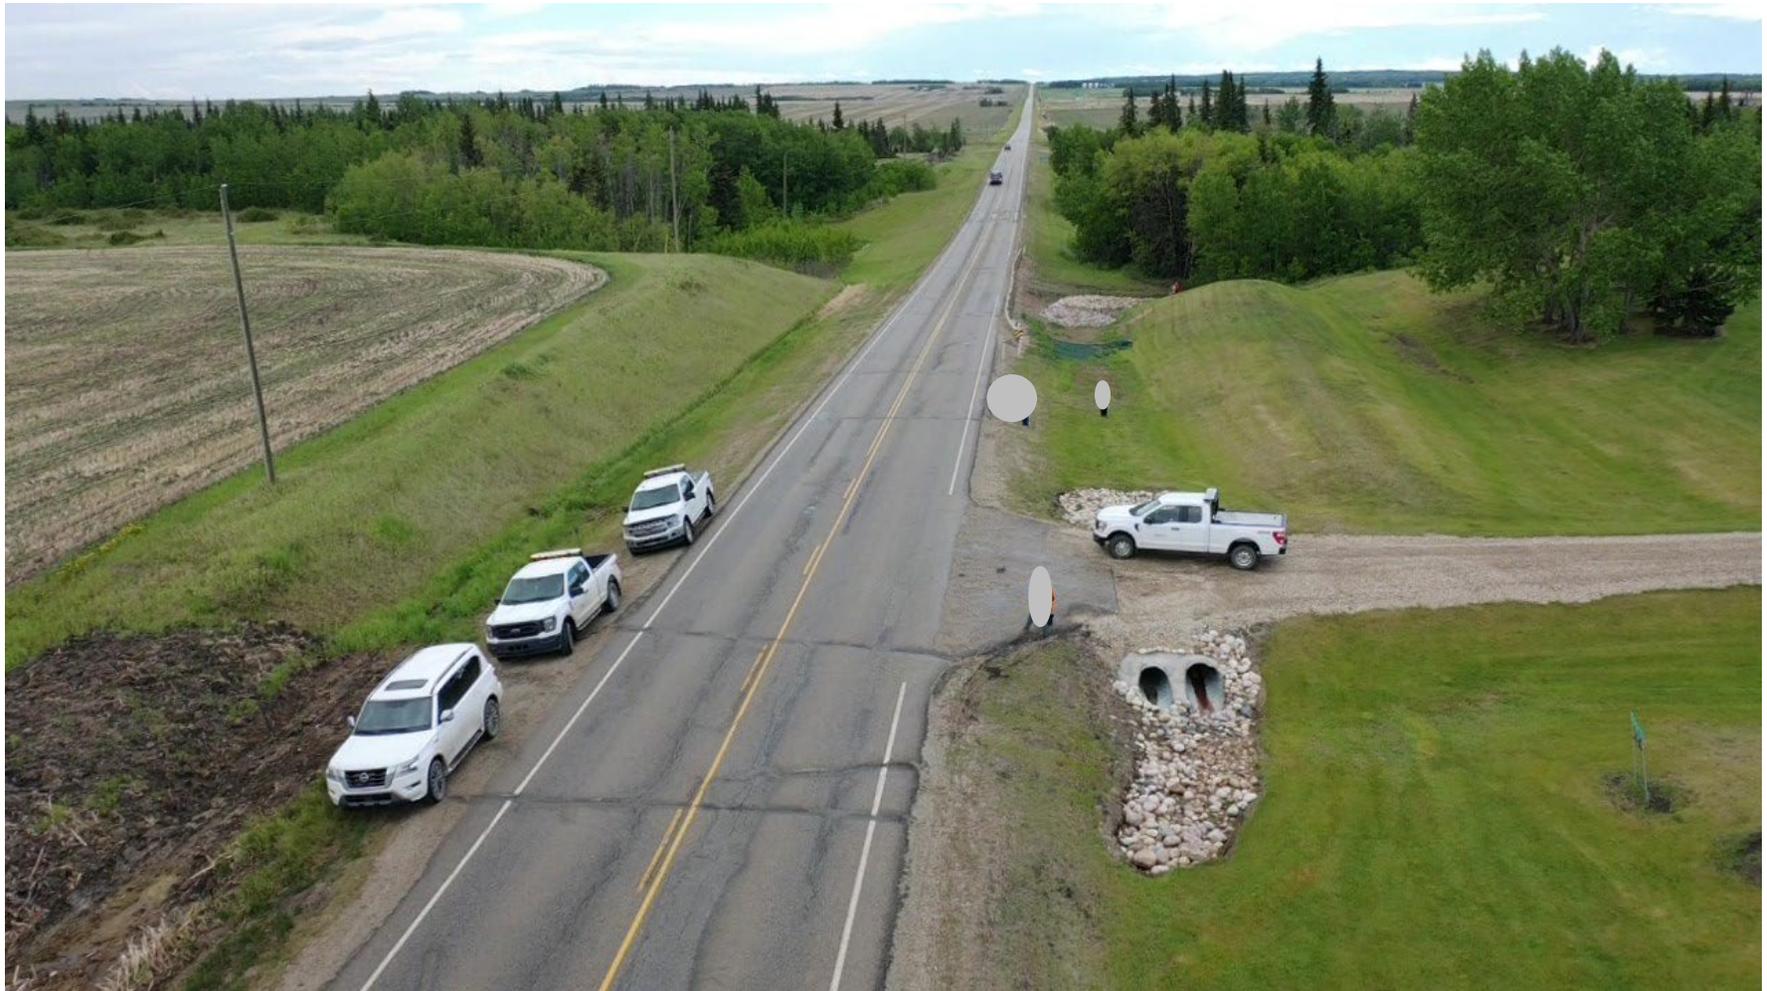
Photo 1 Overview of GP039-I site on Hwy 724:04. Photo taken with Unmanned Aerial Vehicle (UAV) June 11, 2024, facing south.

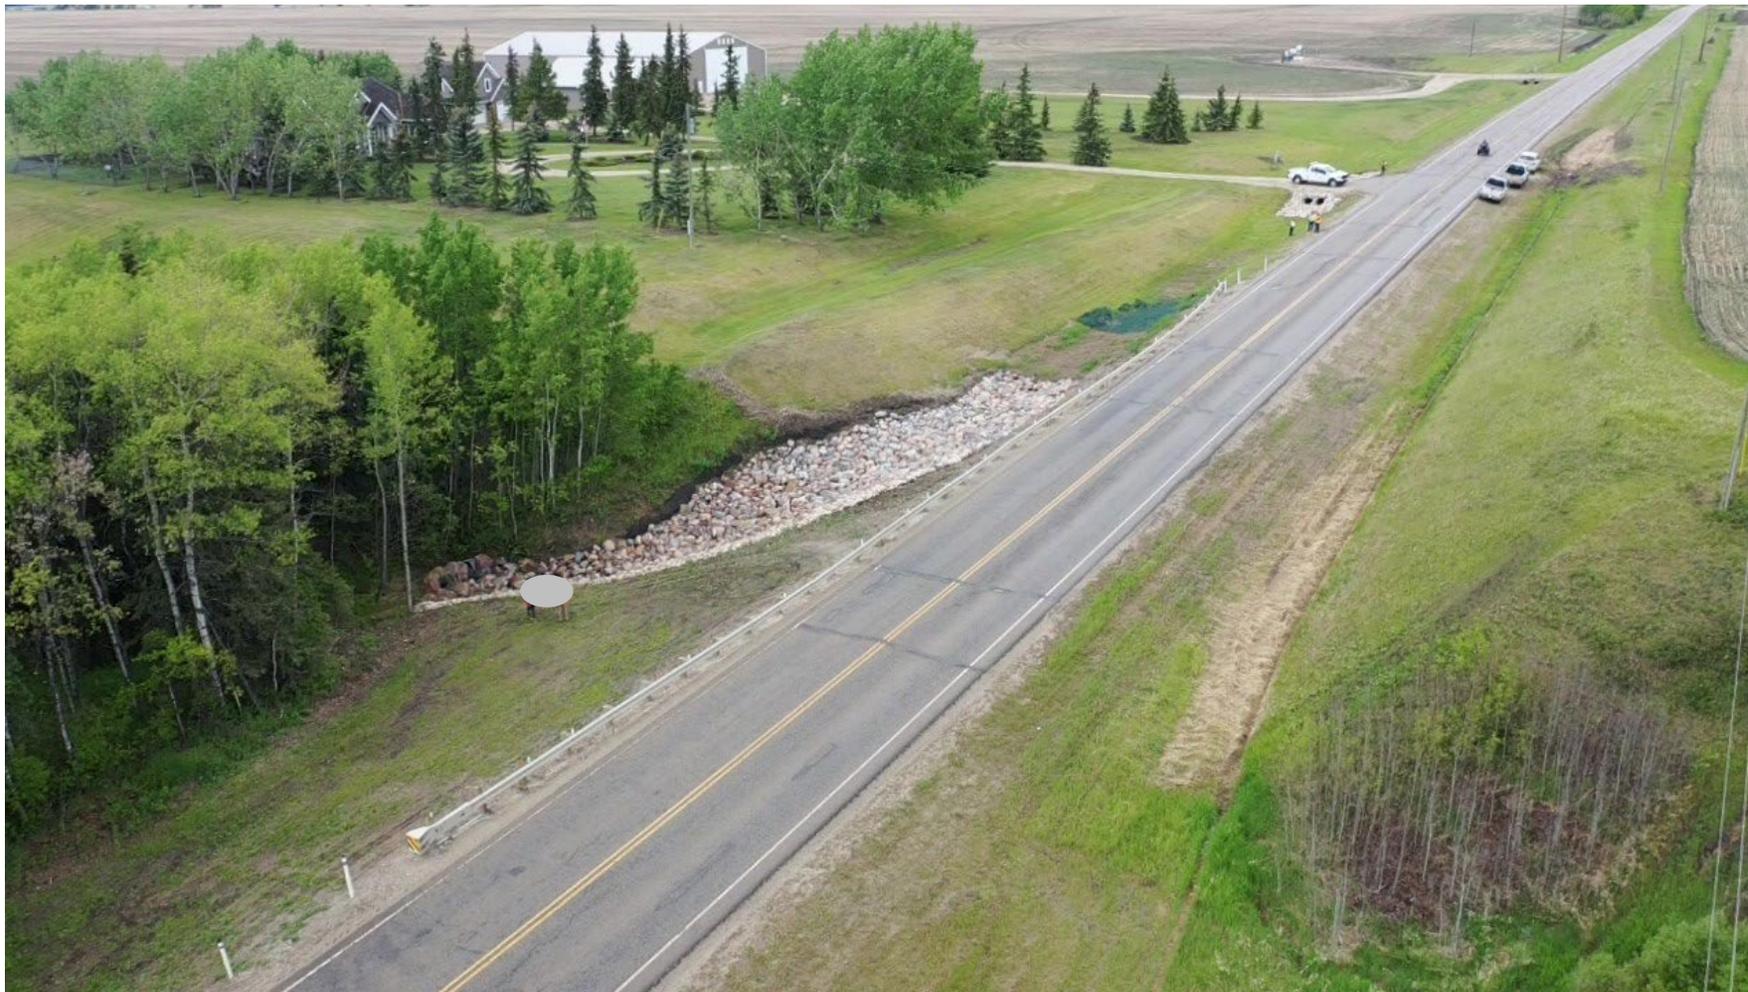
Photo 2 Overview of GP039-I site on Hwy 724:04. Photo taken with UAV June 11, 2024, facing northwest.

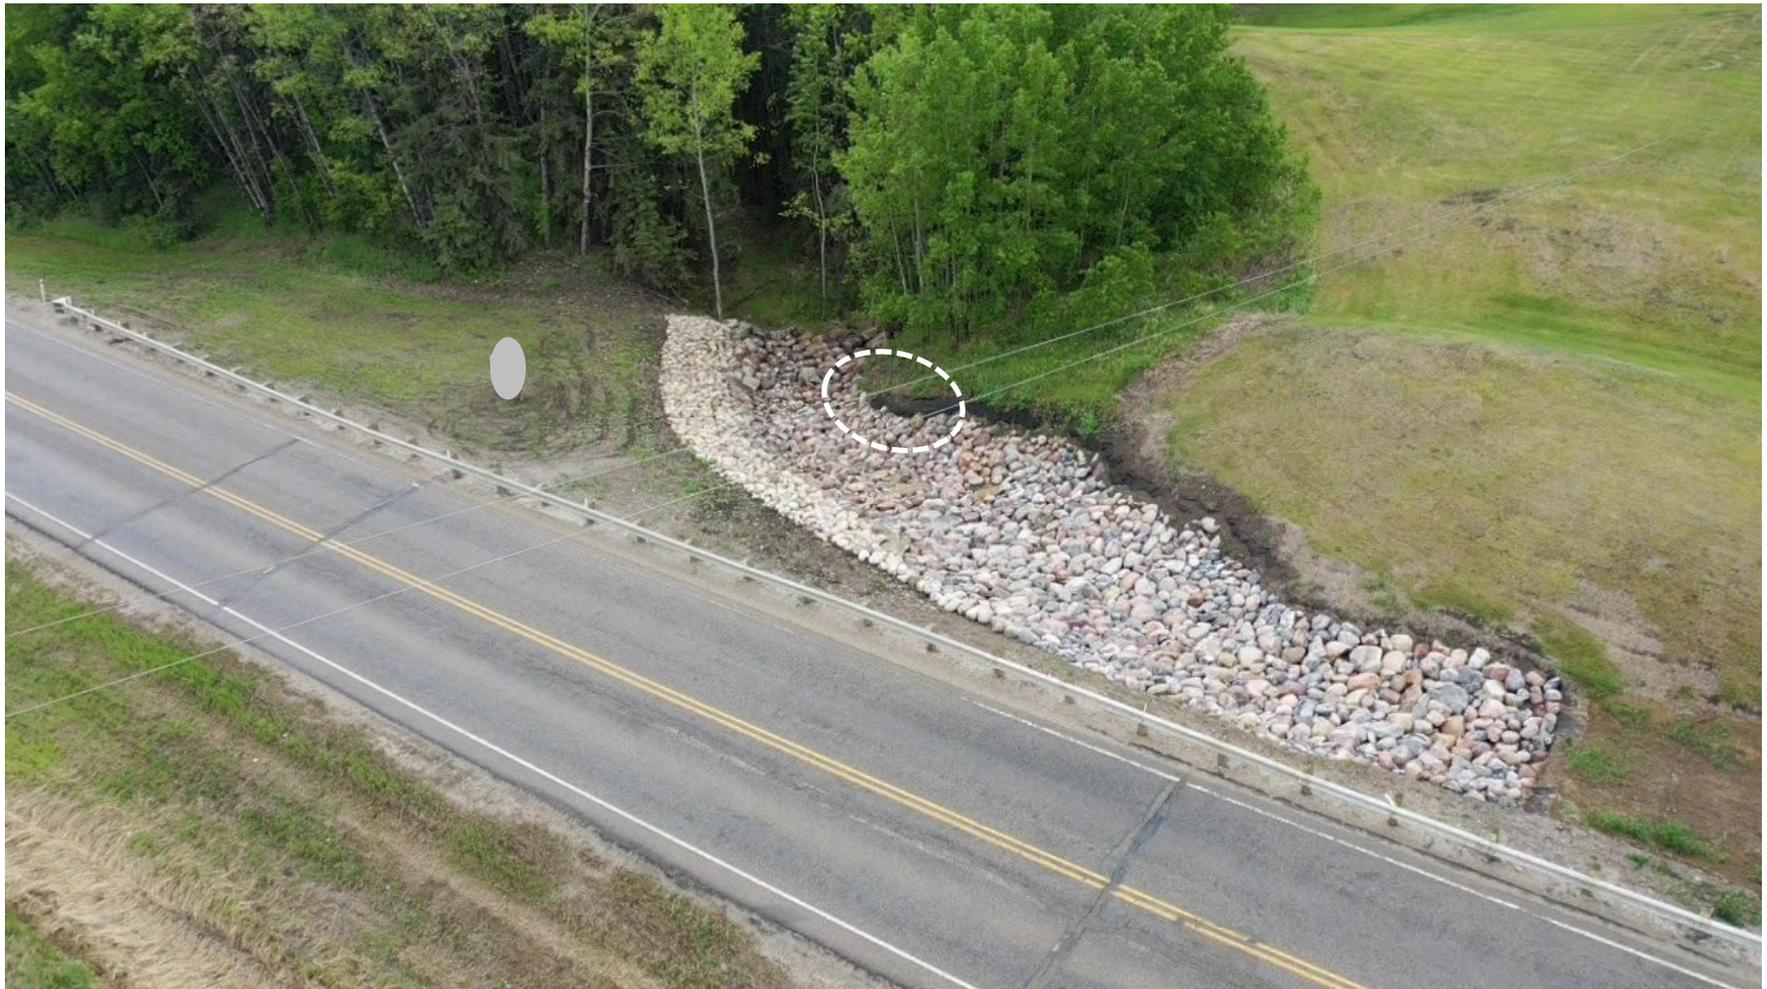
ITEM	CONDITION EXISTS		DESCRIPTION AND LOCATION	NOTICABLE CHANGE FROM LAST INSPECTION	
	YES	NO		YES	NO
Pavement Distress	X		Some cracking in pavement surface at both sites, which appear unrelated to erosion feature (Photos 3, 11, and 16).		X
Slope Movement	X		Side slopes of channel downstream of riprap-lined channel at GP039-I are failing (Photo 4).		X
Erosion	X		GP039-I: some rill erosion where there is little to no vegetation re-establishment. GP039-II: erosion gully on west side of highway and south bridge abutment (Photos 13 and 14). Just south of bridge gully is approximately 4 m to 6 m from edge of pavement. Erosion also observed along corners of wingwalls (Photo 17).	X	
Seepage	X		None observed at time of 2024 inspection, but landowner has previously said water would seepage out into gully at GP039-I after heavy rainfall or runoff events.		X

- Since post construction inspection completed in June 2023, some additional riprap placed along riprap-lined channel to increase freeboard (still a little low on inside bend but should be above water for most flows and soil is covered with geotextile, Photos 3 and 5), an erosion feature in west highway ditch repaired (Photo 8), inlet of CSP culvert repaired and more riprap placed in apron (Photo 10), and guardrail replaced (Photos 3 and 10).

Photo 3 Riprap-lined channel constructed in 2023 in former erosion gully. Note riprap a little low on inside corner (circled in white). Photo taken with UAV June 11, 2024, facing southwest.

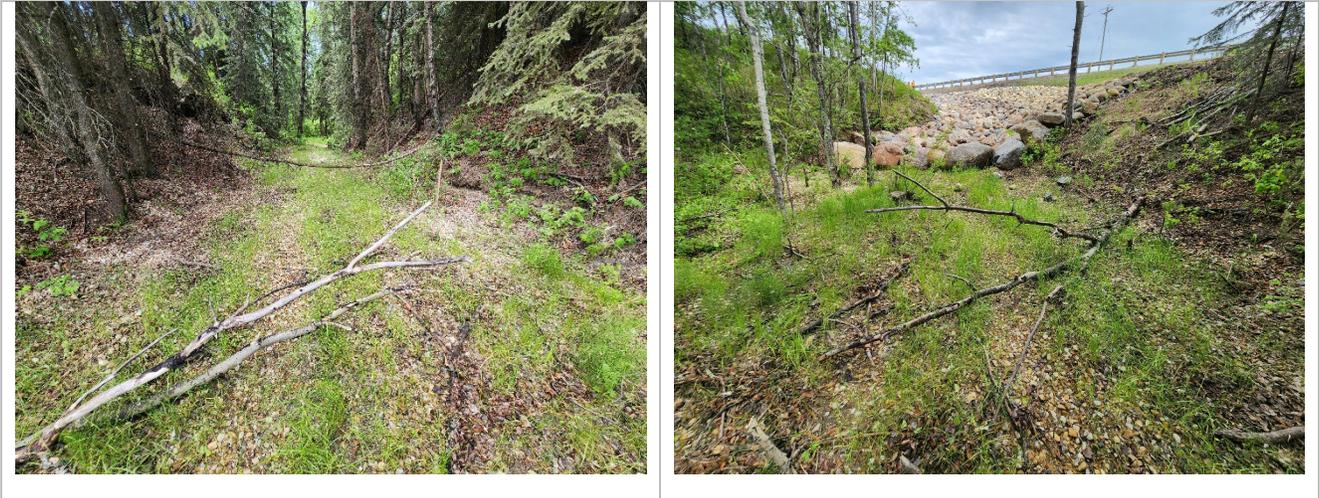
Photo 4 Channel downstream of riprap-lined channel and apron. Photo taken June 11, 2024, facing northeast.

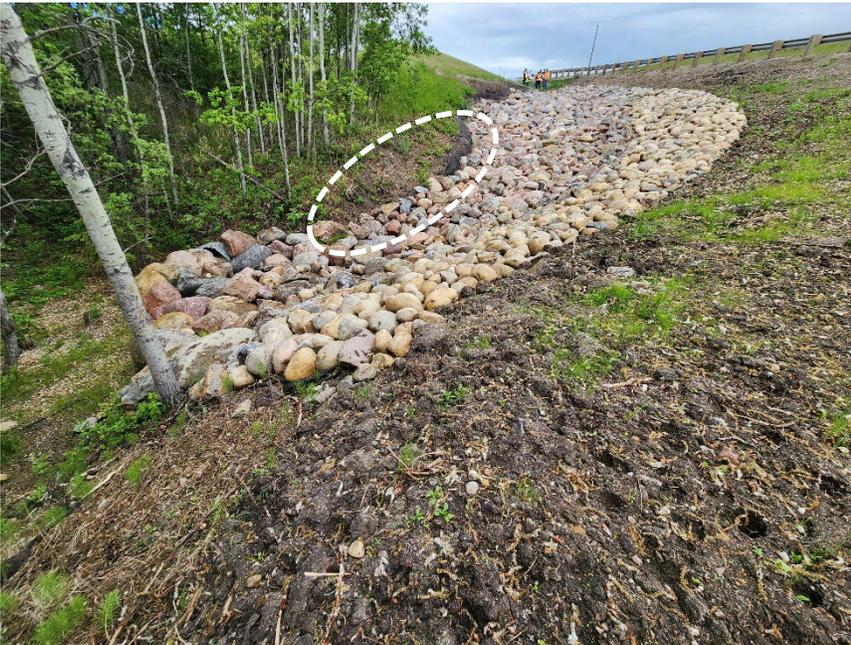
Photo 5 End of riprap-lined channel. Note riprap a little low on inside corner (circled in white). Photo taken June 11, 2024, facing northeast.

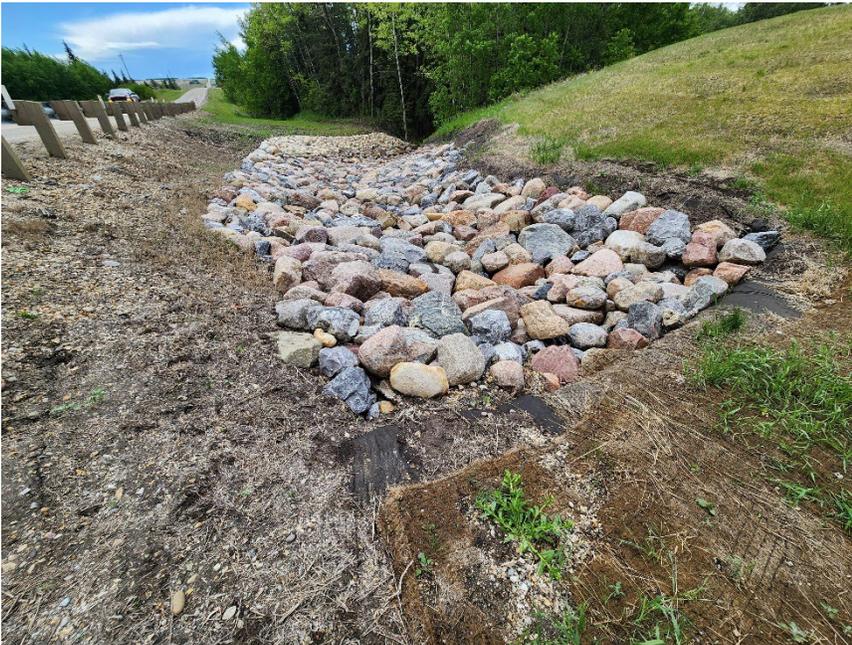
Photo 6 Start of riprap-lined channel. Photo taken June 11, 2024, facing southwest.

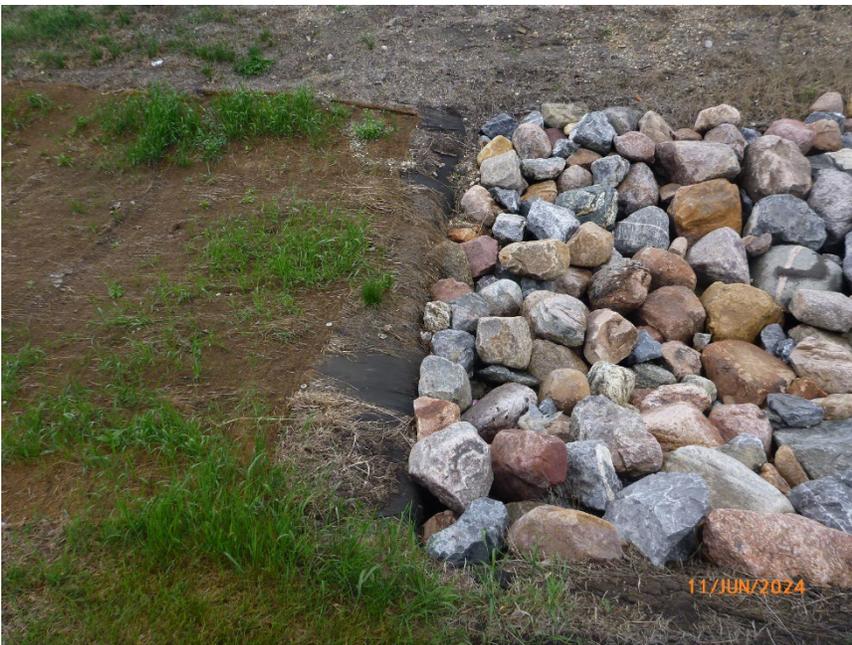
Photo 7 Transition between unarmoured ditch and riprap-lined channel. and Photo taken June 11, 2024, facing east.

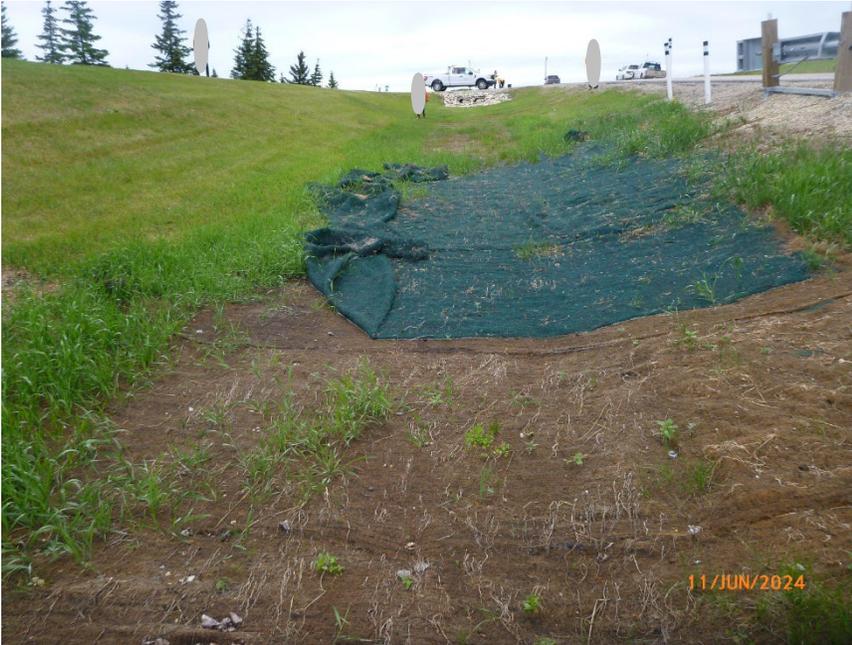
Photo 8 Unarmoured ditch on west side of Hwy 724:04. Note turf reinforcement mat (TRM) (green product) and rolled erosion control product (RECP) (brown product) placed in ditch. TRM place over erosion feature repaired after 2023 post-construction inspection and is pulled up. Photo taken June 11, 2024, facing north.

- GP039-I:
 - Turf reinforcement mat (TRM) placed over erosion feature repaired in west highway ditch is pulled up and should be re-anchored or replaced (Photo 8).

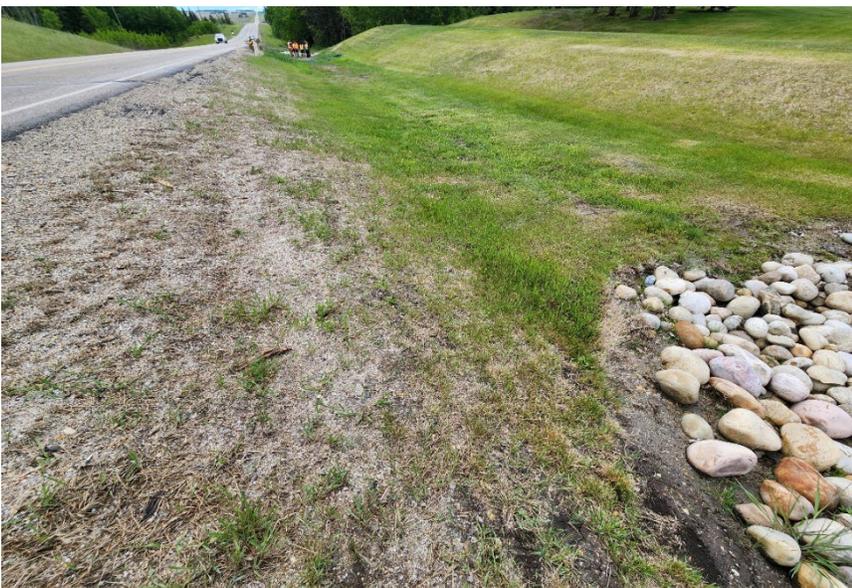
Photo 9 Unarmoured ditch on west side of Hwy 724:04. Photo taken June 11, 2024, facing southwest.

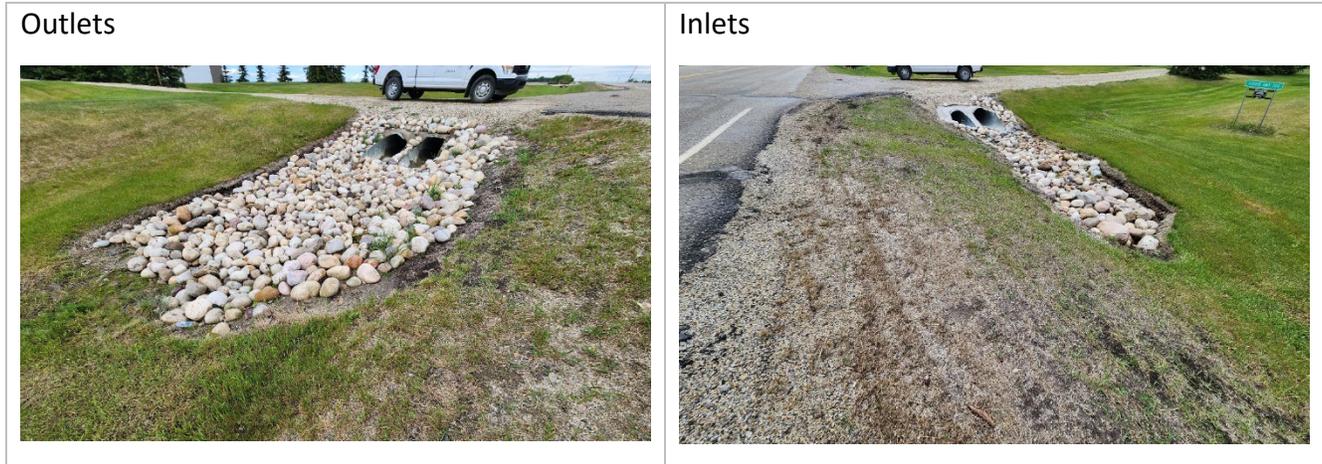
Photo 10 Twin 800 mm diameter CSP culverts and riprap apron. Photos taken June 11, 2024, facing northwest (outlet) and southwest (inlet), respectively.

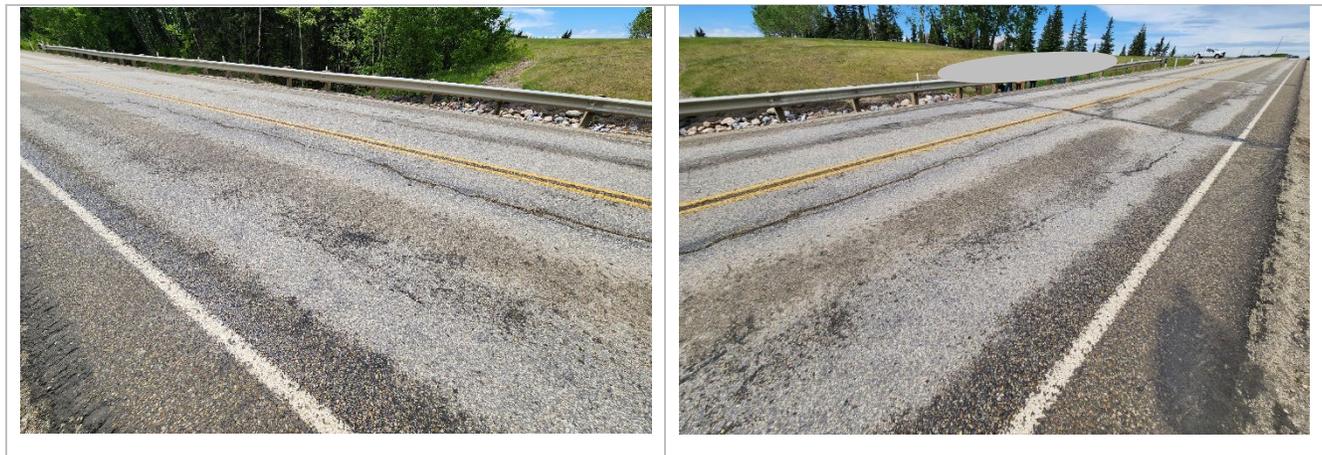
Photo 11 Pavement surface of Hwy 724:04. Some cracking above the previously repaired erosion gully. Photos taken June 11, 2024, facing southwest and northwest, respectively.

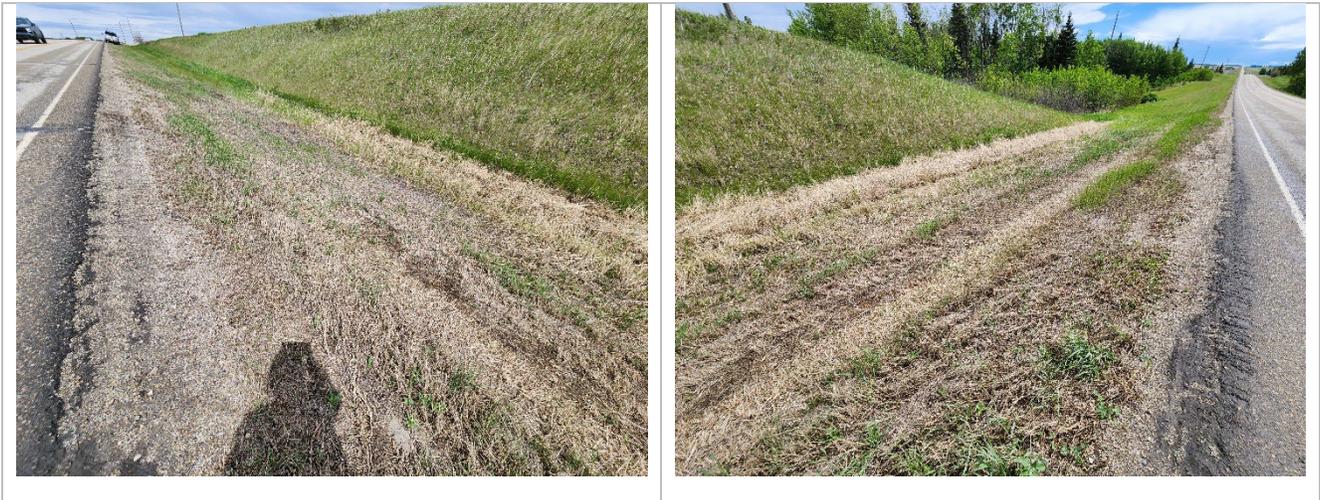
Photo 12 West side of Hwy 724:04. Photos taken June 11, 2024, facing northeast and southeast, respectively.

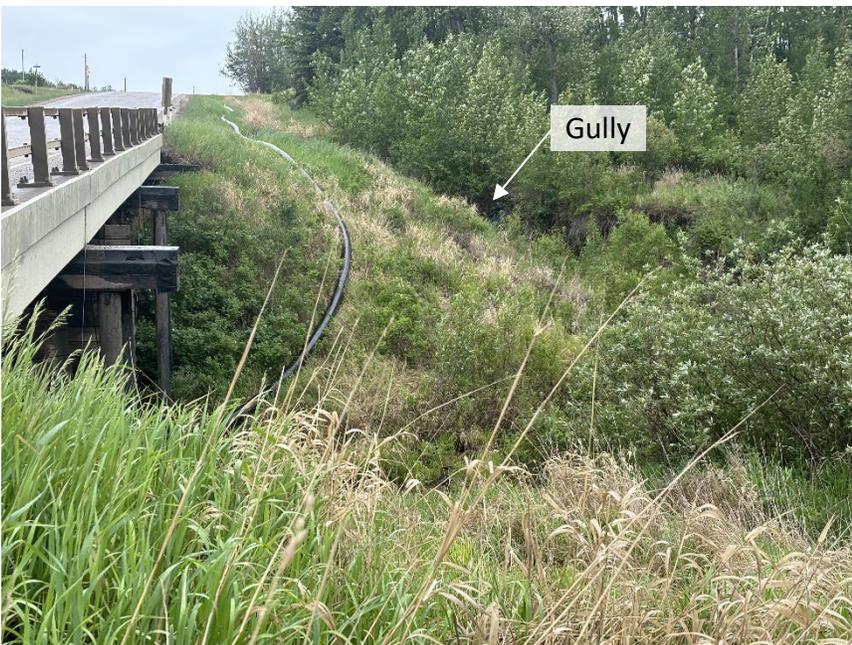
Photo 13 West side of Hwy 724:04 and bridge at GP039-II site. Note erosion gully (see next photo). Photo taken June 11, 2024, facing south from north abutment of bridge.

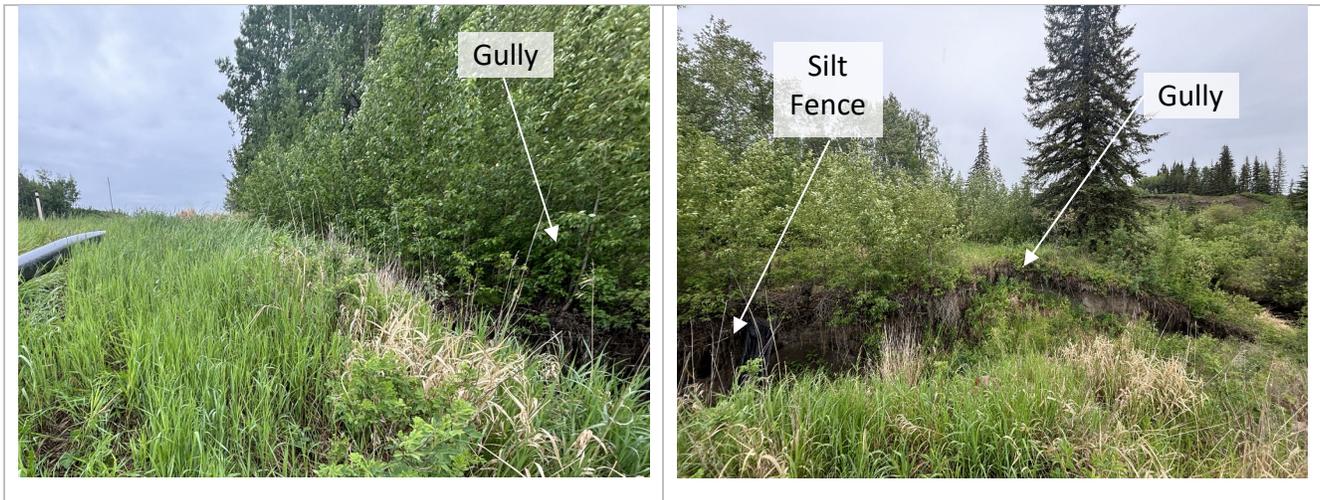
Photo 14 Erosion gully on west side of Hwy 724:04 at GP039-II site. Note silt fence is undermined. Photos taken June 11, 2024, facing south and west, respectively.

- TEC’s Maintenance Contract Inspection (MCI) should continue to inspect the site regularly until vegetation is re-established.
- GP039-II:
 - Erosion gully is close to highway in some locations and is a potential roadside hazard to motorists who go off the highway and will eventually begin to impact pavement surface and possibly the bridge. The erosion gully should be repaired. Possible repair options could include establishing a ditch where erosion has occurred and armouring the ditch with riprap. Estimated cost: \$50,000 to \$150,000.

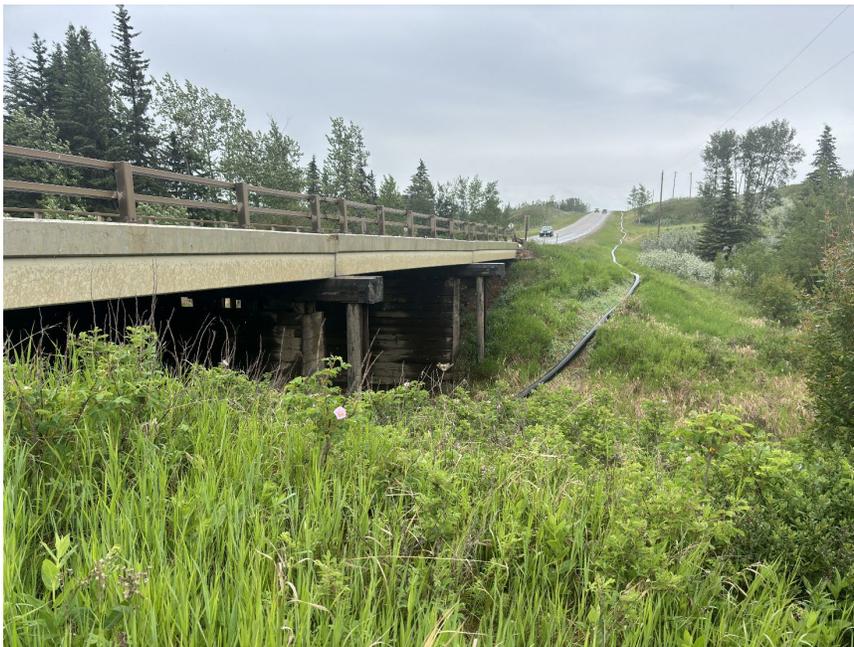
Photo 15 East side of Hwy 724:04 and bridge at GP039-II site. Photo taken June 11, 2024, facing north from south abutment of bridge.

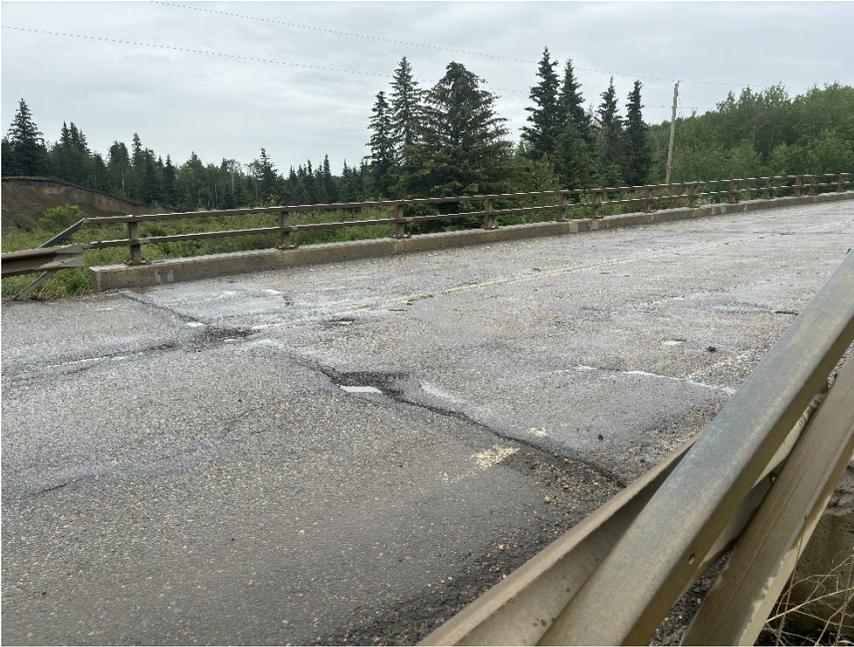
Photo 16 Cracking and dip in pavement surface of Hwy 724:04 at south abutment of bridge at GP039-II site. Photo taken June 11, 2024, facing southeast.

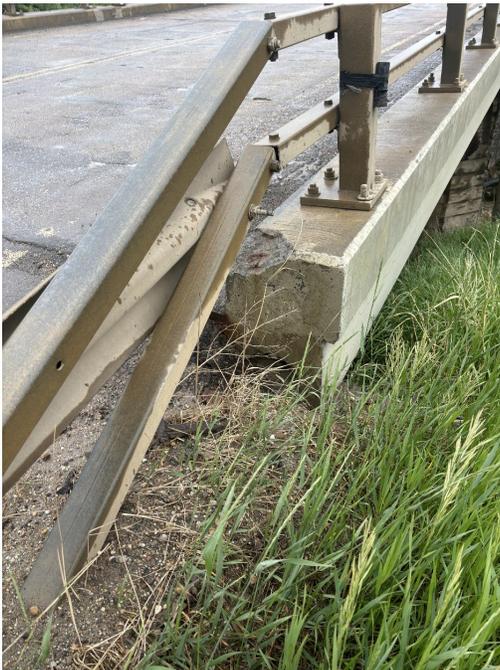
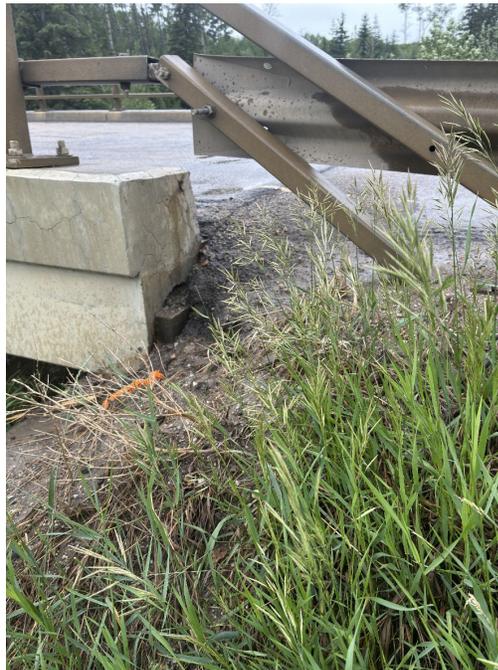
Photo 17 Erosion at northwest and northeast bridge wingwalls. Photos taken June 11, 2024, facing southeast and southwest, respectively.
