SITE INSPECTION FORM

SITE NUMBER AND NAME: GP048 Kleskun Creek Erosion		HIGHWAY & KM: 733:02, 14.506	PREVIOUS INSPECTION DATE: May 28, 2020	INSPECTION DATE: June 16, 2022
LEGAL DESCRIPTION: SE 33-73-03-W6M	NAD 83 COORDINATES: UTM Northing Easting 11 6135882 412217		RISK ASSESSMENT: PF: 8 CF: 6 TOTAL: 48	
AVERAGE ANNUAL DAILY TRAFFIC (AADT): 890 (north) & 880 (south) (Reference No. 30730, 2021)			CONTRACT MAINTENANCE AREA (CMA): 504

PEACE REGION
(GRANDE PRAIRIE DISTRICT – SOUTH) GRMP
SITE INSPECTION FORM

PROJECT	PEACE REGION (GRANDE PRAIRIE DISTRICT-SOUTH) GEOHAZARD RISK MANAGEMENT PROGRAM	
TITLE	Site Plan GP048 - Kleskun Creek Erosion Hwy 733:02, km 14.506	
SCALE	1:1,250	PROJECT No. A05116A01
		FIG No. 1

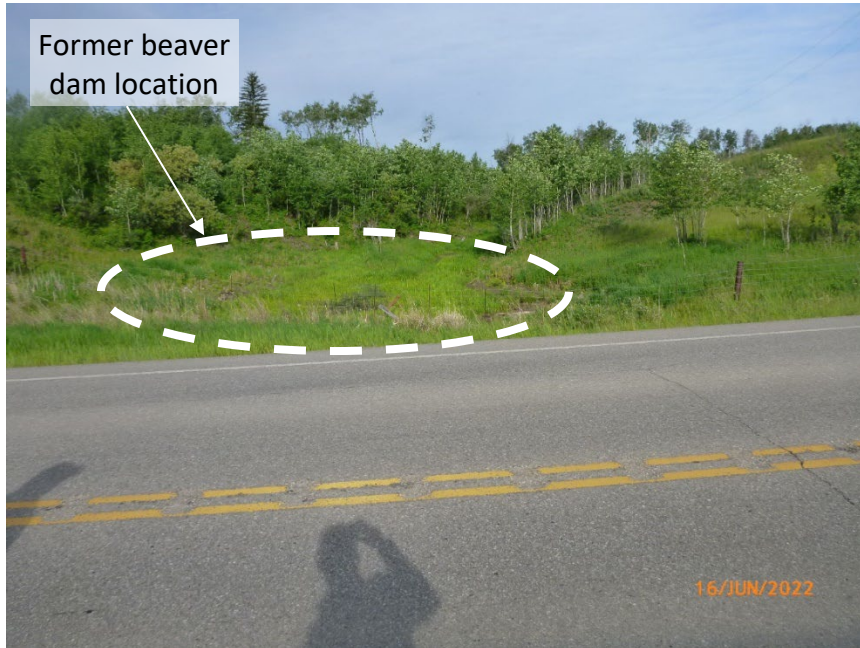
Photo 1 Former beaver dam location on west side of Hwy 733:02 (circled in white). Photo taken June 16, 2022, facing west.

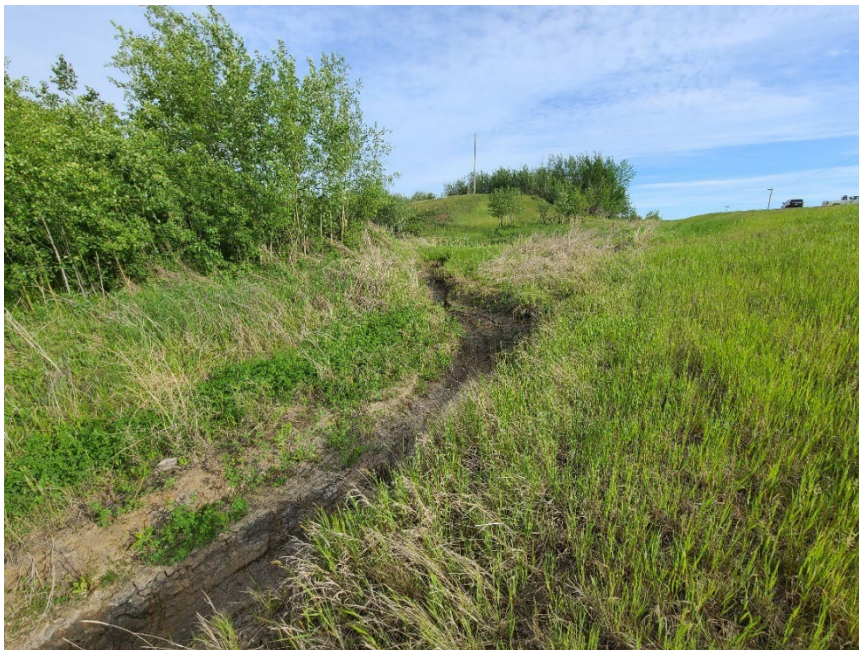
The gullying in the west highway ditch upstream/above the formerly riprap-lined channel appears to have failed because the flow rates were too high for the rolled erosion control product placed in the ditch. The flow rate in the west highway ditch was increased because the centreline culvert was blocked and decommissioned, diverting all flow down the west highway ditch. Also, removal of the beaver dam eliminated any flood attenuation offered by the beaver pond.

Photo 2 Channel approximately 0.3 m to 0.5 m deep, 1.0 m wide eroded into west ditch of Hwy 733:02. Photo taken June 16, 2022, facing northwest.

- Repair the ditch and reconstruct the riprap-lined channel. Assess peak flow rates for design flood event (return period to be selected in discussion with AT). New channel should be designed with check trenches installed below the non-woven geotextile to reduce the potential for erosion happening underneath the non-woven geotextile, which will not be uniformly pressed into the subgrade by the weight of the riprap. Estimated cost: between \$150,000 to \$250,000 depending on design.

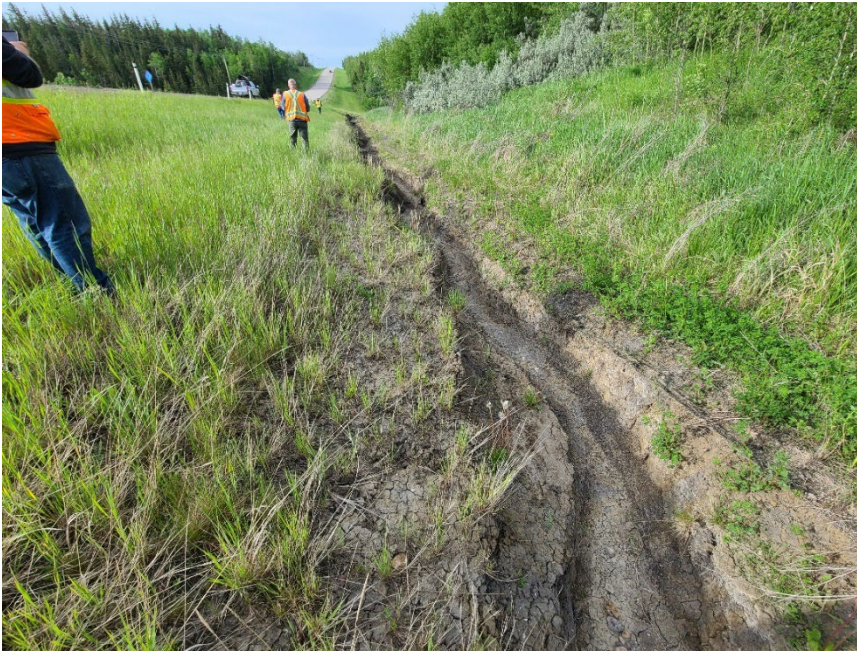
Photo 3 Channel approximately 0.3 to 0.5 m deep, 1.0 m wide eroded into west ditch of Hwy 733:02. Photo taken June 16, 2022, facing south.

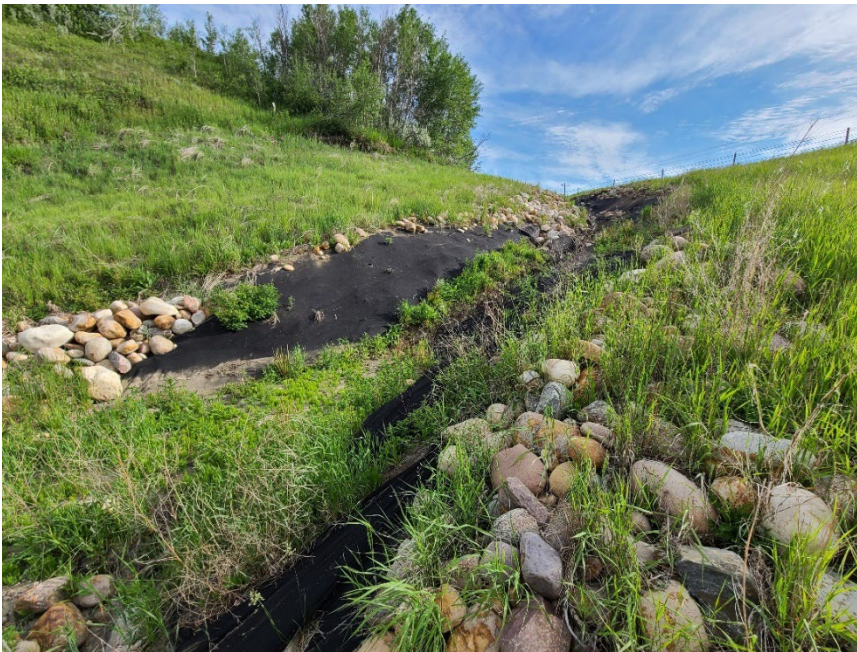
Almost all riprap from the previously riprap-lined portion of the ditch channel has been displaced and deposited in a pile near the bottom of the ditch channel exposing the underlying geotextile, which is damaged. The riprap appears to have failed because of the riprap being undersized. The non-woven geotextile also appears to have been undermined, which could have been initiated by lower flows passing below the non-woven geotextile causing erosion of the subgrade.

Photo 4 Almost all riprap from previously riprap-lined portion of ditch channel displaced. Note underlying geotechnical is damaged and undermined. Photo taken June 16, 2022, facing northeast looking up northwest embankment abutment.

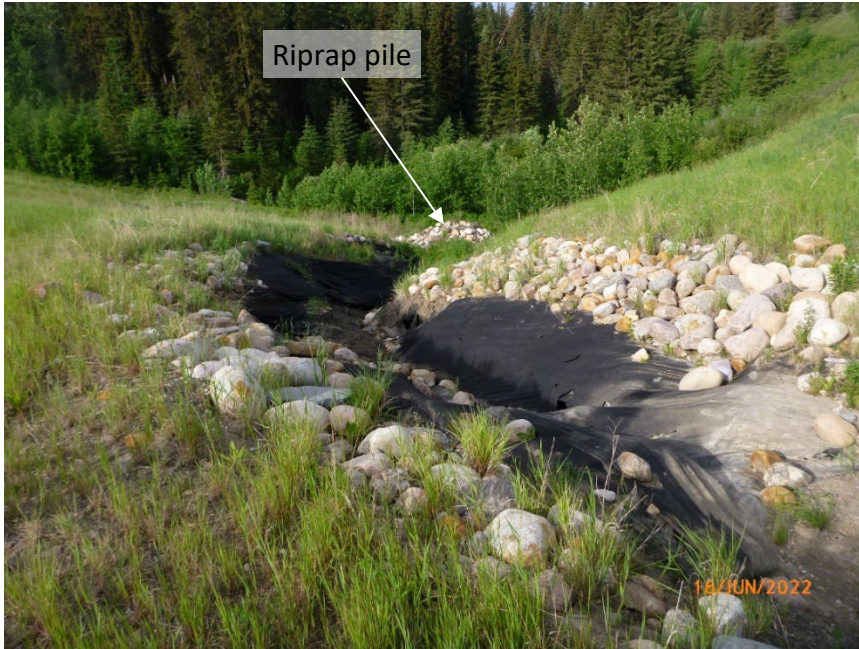
Photo 5 Displaced riprap deposited in pile near bottom of ditch channel. Note underlying geotechnical is damaged and undermined. Photo taken June 16, 2022, facing southwest.

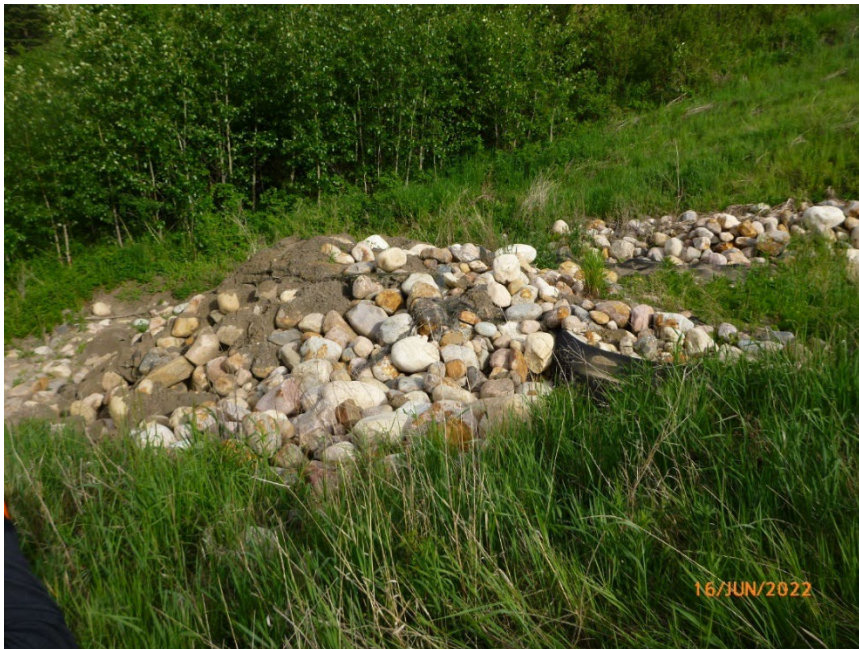
Photo 6 Displaced riprap deposited in pile near bottom of ditch channel. Photo taken June 16, 2022, facing northwest.

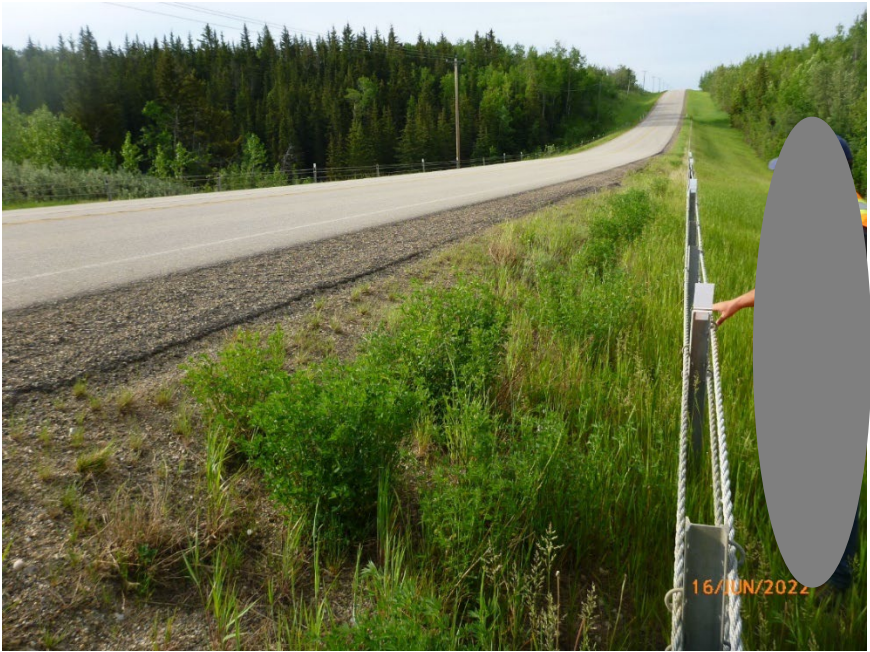
COMMENTS
Kleskun Creek is a tributary of the Smoky River, and a mapped D watercourse with no restricted activity period (RAP). There is no fish occurrence information for the creek.
The high-tension-cable barrier is located too far downslope from the highway and may not redirect motorist back onto highway.

Photo 7 **Pavement surface of Hwy 733:02. Note guardrail located downslope from pavement edge. Photo taken June 16, 2022, facing southeast.**
