SITE INSPECTION FORM

SITE NUMBER AND NAME: GP052 Puskwaskau River Slide		HIGHWAY & KM: 736:02, 27.011	PREVIOUS INSPECTION DATE: July 19, 2021 Section B October 22, 2024 Warranty	INSPECTION DATE: June 3, 2025
LEGAL DESCRIPTION: NE/SE 26-74-01-W6M	NAD 83 COORDINATES: UTM Northing Easting 11 6144232 434495		RISK ASSESSMENT: Slide: PF: 1 CF: 4 TOTAL: 4 Erosion: PF: 1 CF: 10 TOTAL: 10	
AVERAGE ANNUAL DAILY TRAFFIC (AADT): 90 (north) & 80 (south) (Reference No. 30760, 2024)			CONTRACT MAINTENANCE AREA (CMA): 504

PROJECT	PEACE REGION (GRANDE PRAIRIE DISTRICT-SOUTH) GEOHAZARD RISK MANAGEMENT PROGRAM		
TITLE	Site Plan GP052 - Puskwaskau River Slide Hwy 736:02, km 27.001		
SCALE	PROJECT No.	FIG No.	
1:2,000	A05116A01	1

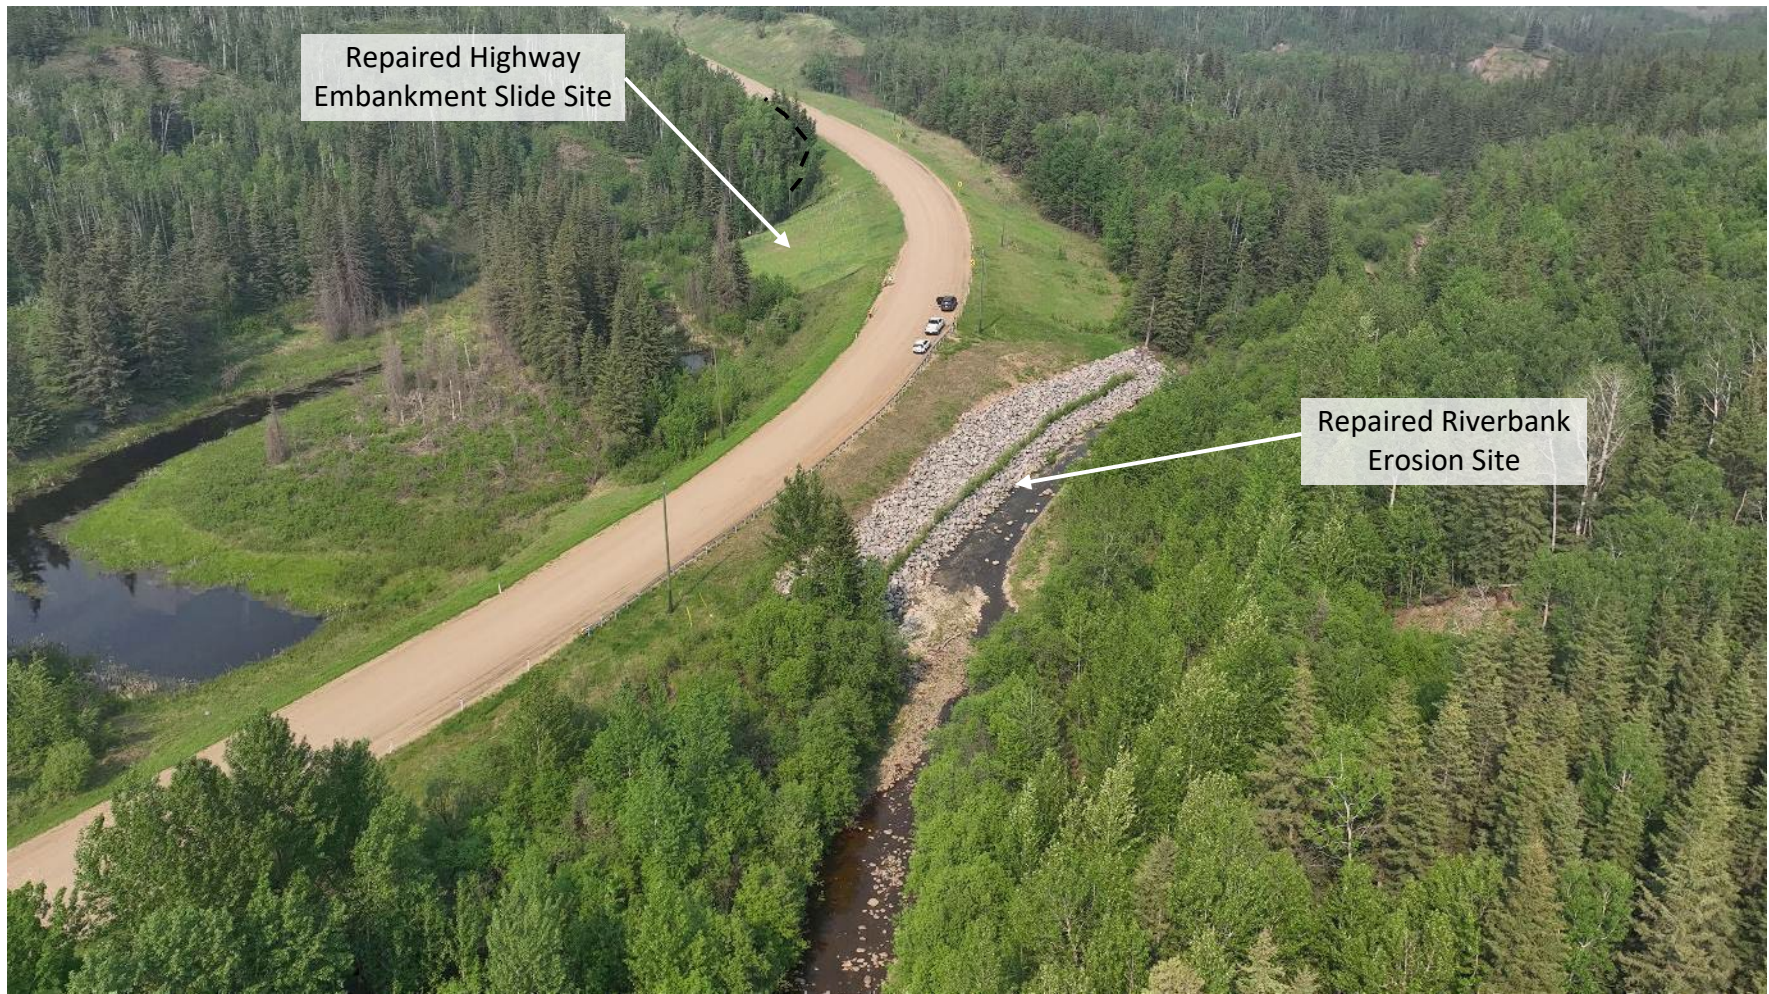
- No visual indications of slope movement were observed at the time of the 2025 inspection (Photos 1 through 4). Revegetation of the slope is well underway.
- Wetland area (oxbow lake) at the toe of the highway embankment.

- No visual indications of continuing erosion or slope movement were observed at the time of the 2025 inspection (Photos 1, and 5 to 7). Growth of willows within the brush layer and live staking on the south riverbank have been successful.
- Puskwaskau River (Class C watercourse) at the toe of the highway embankment.

Photo 1 Overview of GP052 site, showing repaired highway embankment slide and riverbank erosion sites. UAV photo taken June 3, 2025, facing northeast.

- This site should continue to be inspected by the Maintenance Contract Inspector (MCI). However, based on the performance of the repairs, so far, TEC could consider removing the site from the list of active GRMP sites and excluding it from the GP South GRMP Section B inspections. If site conditions were to deteriorate, the site could always be returned to the list of active GRMP sites and/or inspected again as part of a Section B inspection or Section D call-out inspection.

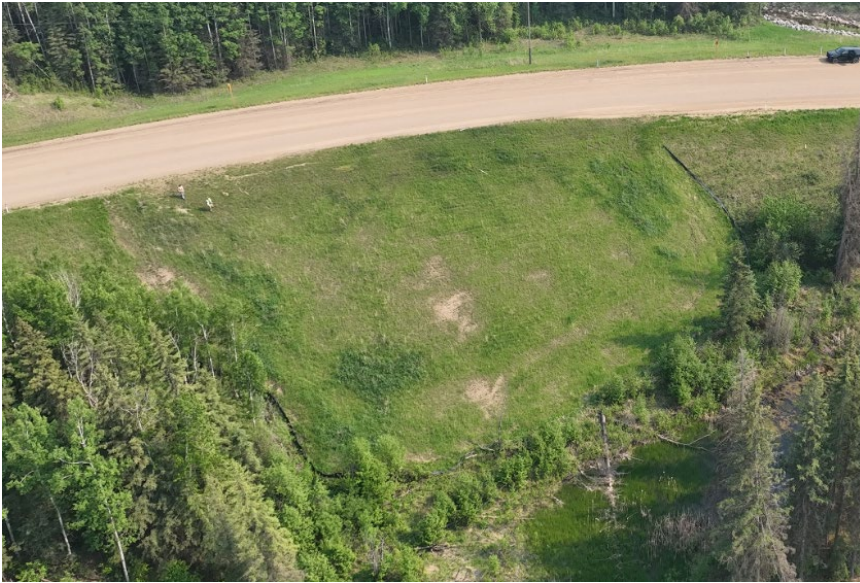
Photo 2 **Repaired highway embankment slide on northwest side of Hwy 736:02. UAV photo taken June 3, 2025, facing east.**

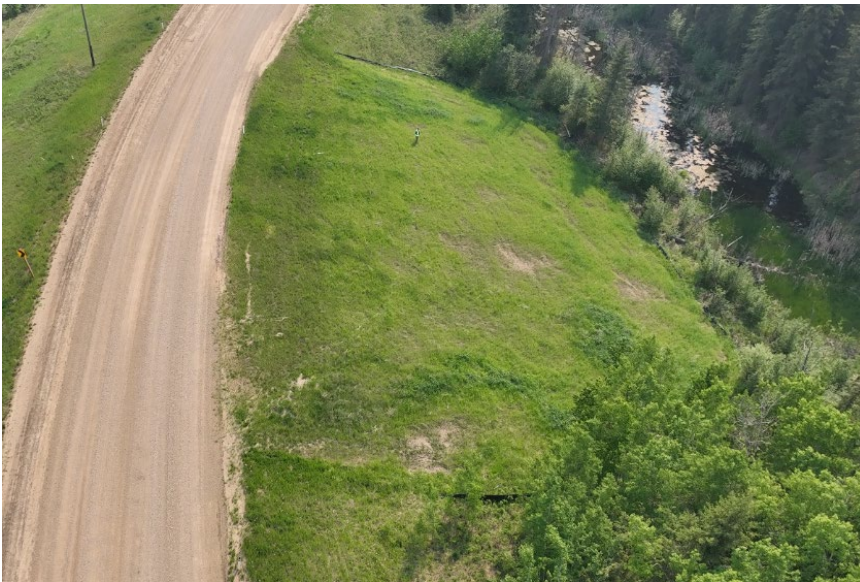
Photo 3 **Repaired highway embankment slide on northwest side of Hwy 736:02. UAV photo taken June 3, 2025, facing southwest.**

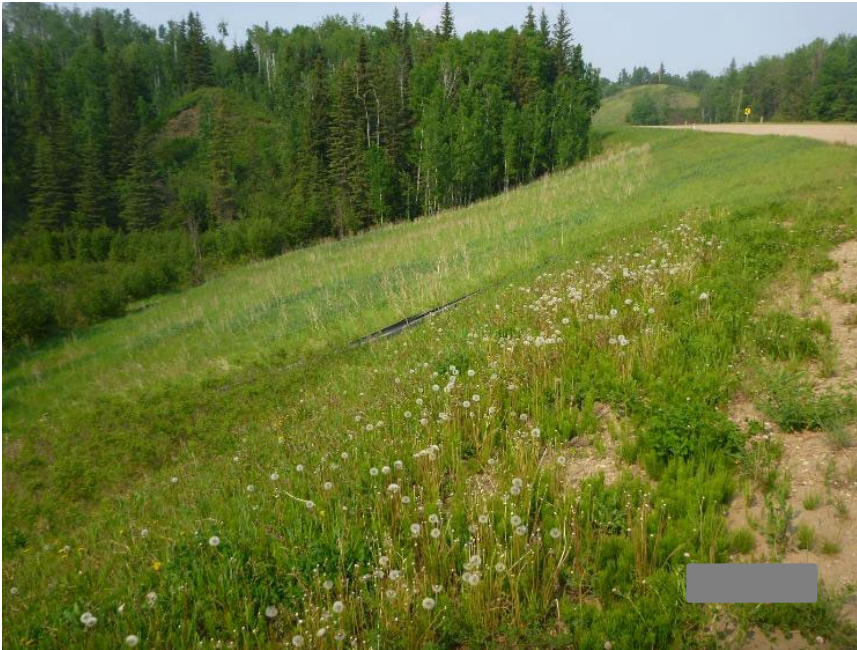
Photo 4 **Repaired highway embankment slide on northwest side of Hwy 736:02. UAV photo taken June 3, 2025, facing northeast.**

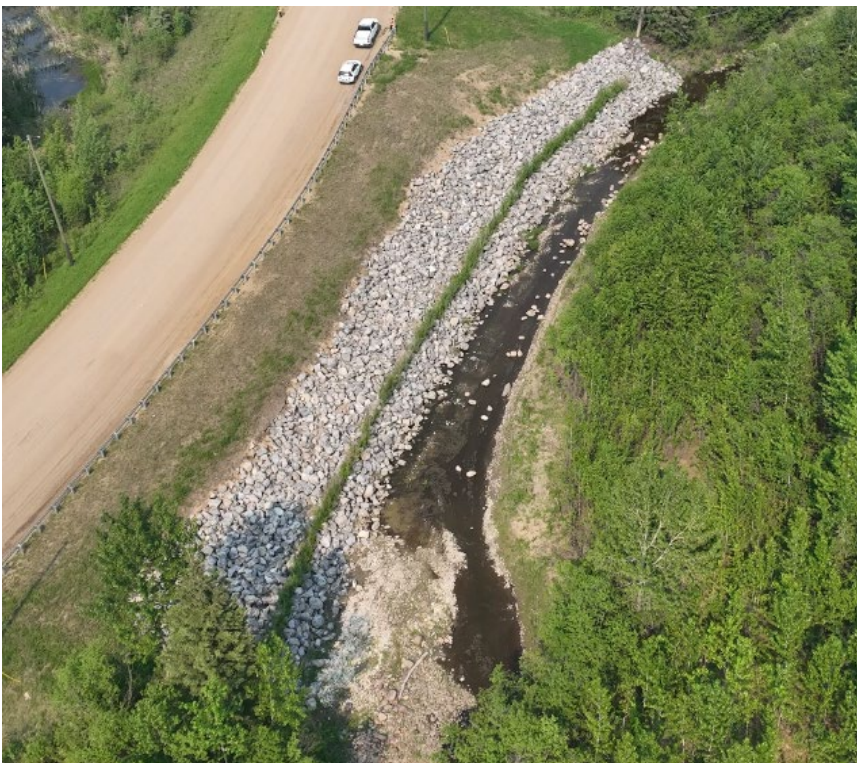
Photo 5 **Repaired riverbank erosion on southeast side of Hwy 736:02. Note row of live staking in riprap. UAV photo taken June 3, 2025, facing northeast.**

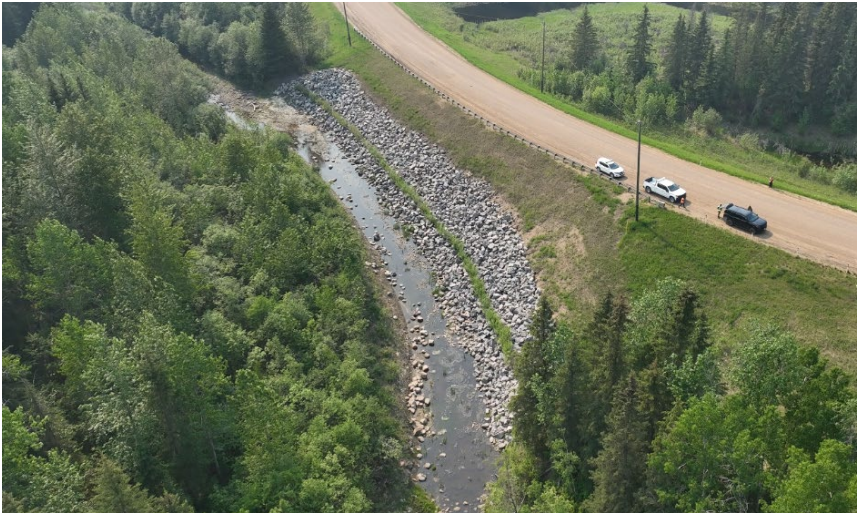
Photo 6 **Repaired riverbank erosion on southeast side of Hwy 736:02. UAV taken June 3, 2025, facing southwest.**

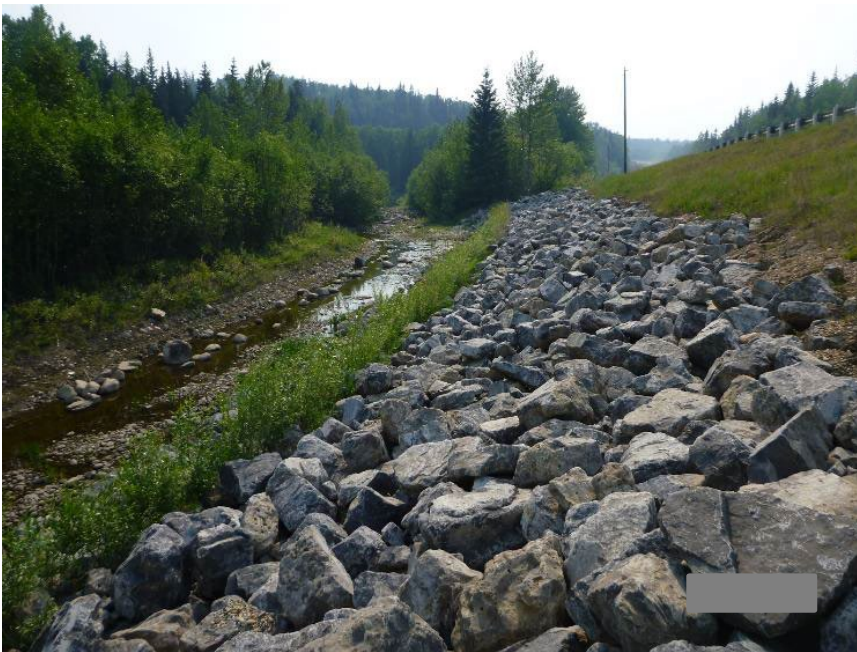
Photo 7 **Repaired riverbank erosion on southeast side of Hwy 736:02. Note row of live staking in riprap. Photo taken June 3, 2025, facing southwest.**
