File: 15-85-38

**PEACE REGION (SWAN HILLS AREA) GEOHAZARD ASSESSMENT
Hwy 2A:54 GUNN'S CREEK SLIDE (SH15)
2006 ANNUAL INSPECTION REPORT**

ANNUAL GEOHAZARD ASSESSMENT
UPDATED SITE PLAN

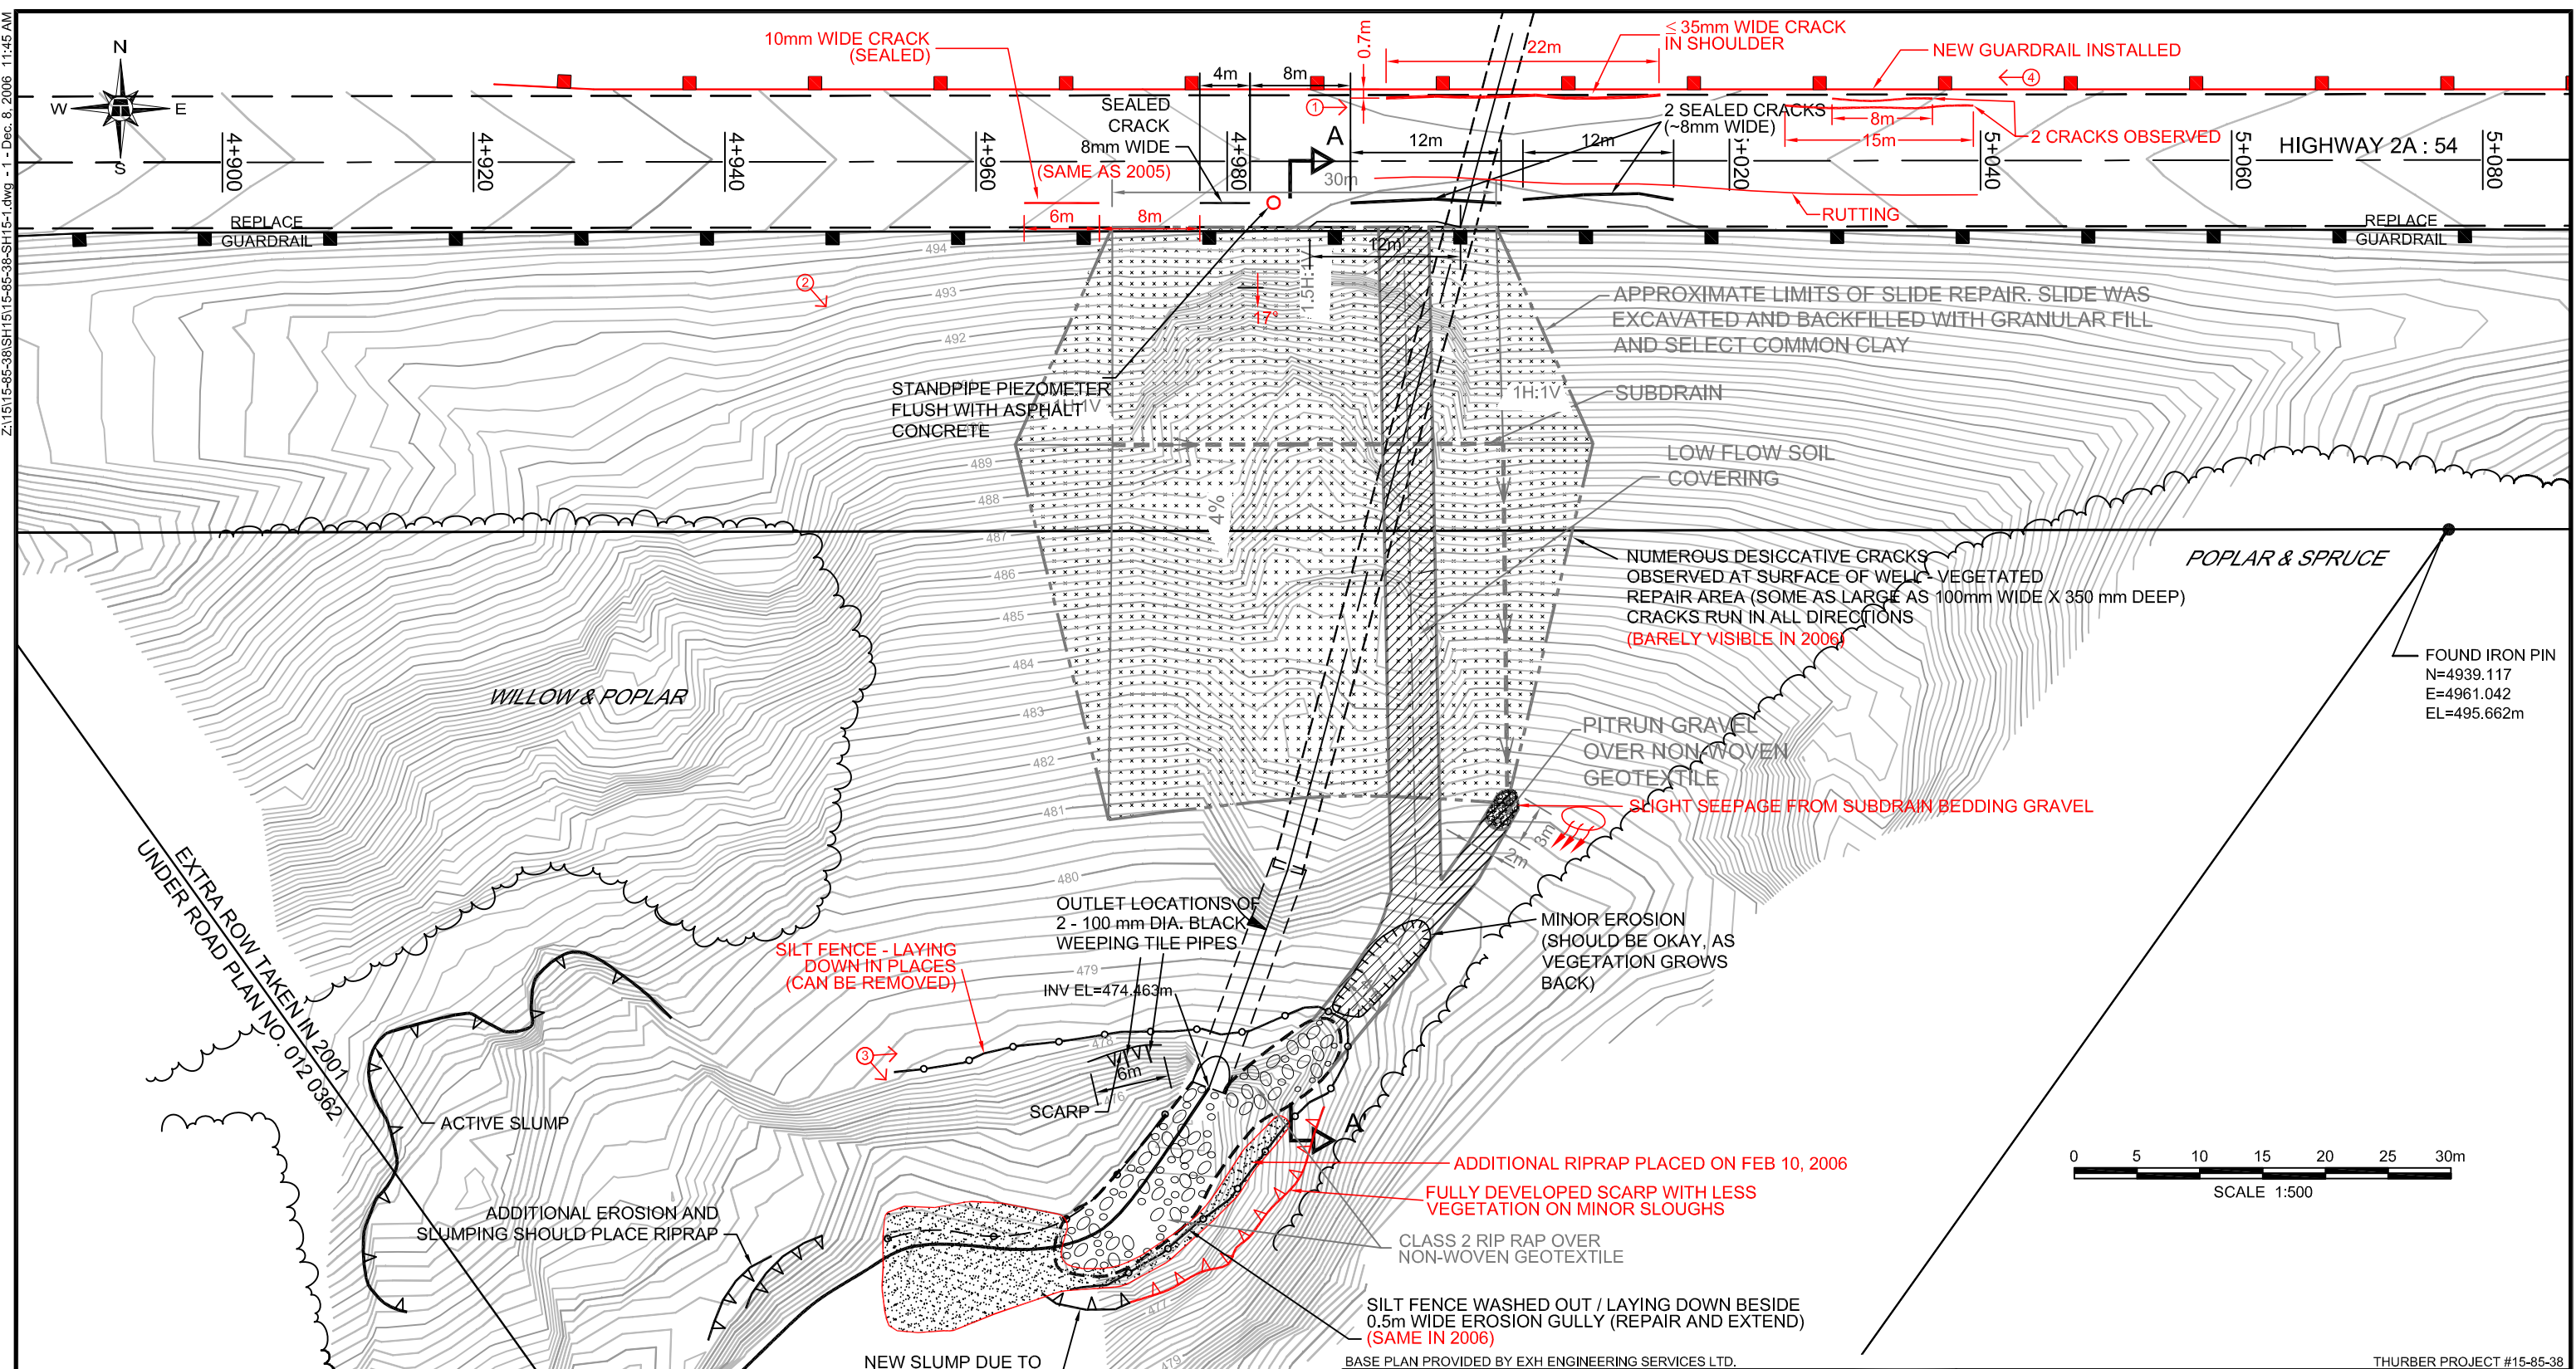
ENGINEER:	GSB/BHM	DRAWN:	HH	APPROVED:	
DATE:	JUNE 2006	SCALE:	1:500	DRAWING No.	15-85-38-SH15-1

In addition to the cracks observed in previous years along the edge of the highway shoulder another 6 m long sealed crack about 10 mm wide was observed at the west end of the slide area, as shown on Figure 15-85-38-SH15-1. These longitudinal cracks run parallel to the shoulder line, but do not appear to be slide related. The crack located along the north edge of the pavement had widened up to about 35 mm at few spots and increased up to 22 m in length. Two new cracks measuring 8 m and 15 m have emerged close to the north guardrail. Some rutting was observed in the eastbound lane. The guardrail on the north side of the highway has been replaced with a new one.

On the surface of the repaired slide area on the sideslope south of the highway, the numerous cracks observed over previous years running in all directions were barely visible this year. This cracking was attributed to desiccation in the surficial high plastic clay used to cover the slope as part of the repairs, which is further being dried out from the root system of the thick alfalfa growth and the underlying gravel drainage layer.

No water was emanating from the subdrain outlet, but the area around the pipe outlet was wet from rain/seepage. Most of the silt fences were lying down or were buried under the riprap armour. In the channel downstream of the toe of the former slide, the erosion and small slumps that were observed in 2003 to 2005 in general did not appear to have changed significantly. The scarps on the east slope of the culvert outlet now appear to be well connected, have minor slumps and had less vegetation cover.

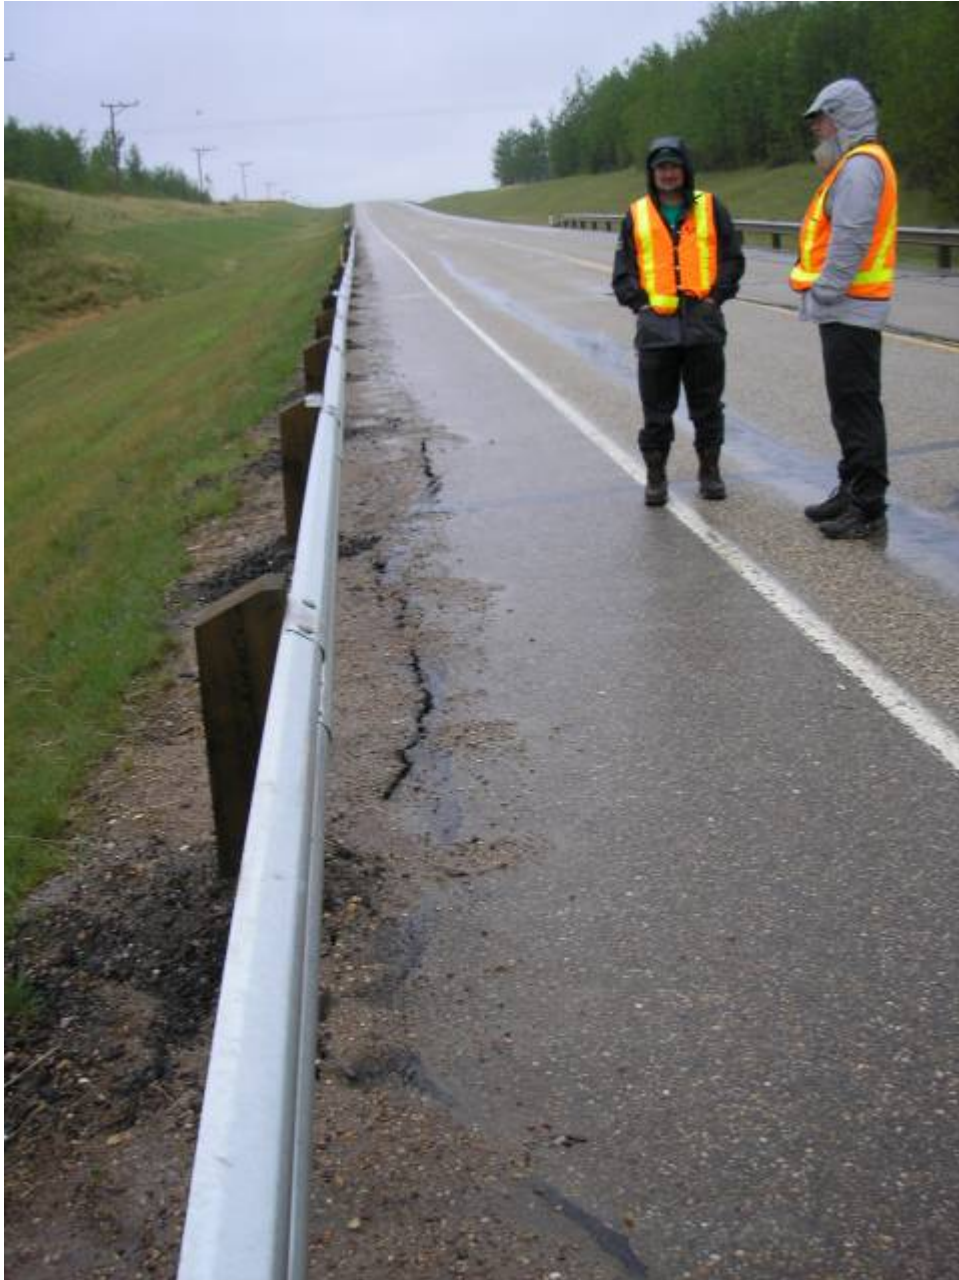
The cracks developed along the north edge of the highway warrant extra attention. It is not known at this stage if this condition was created by excess surface infiltration into the area, or if there is potential movements occurring north of the highway

Photo 1 - Looking east along north guardrail, May 25, 2006.

The top of the highway should be regularly inspected by the MCI to determine if the cracks along the north edge of the highway become more prominent, which would be a signal of the first indications of a potential slide that extends to the north. These cracks should be sealed to prevent any ingress of water into the pavement.

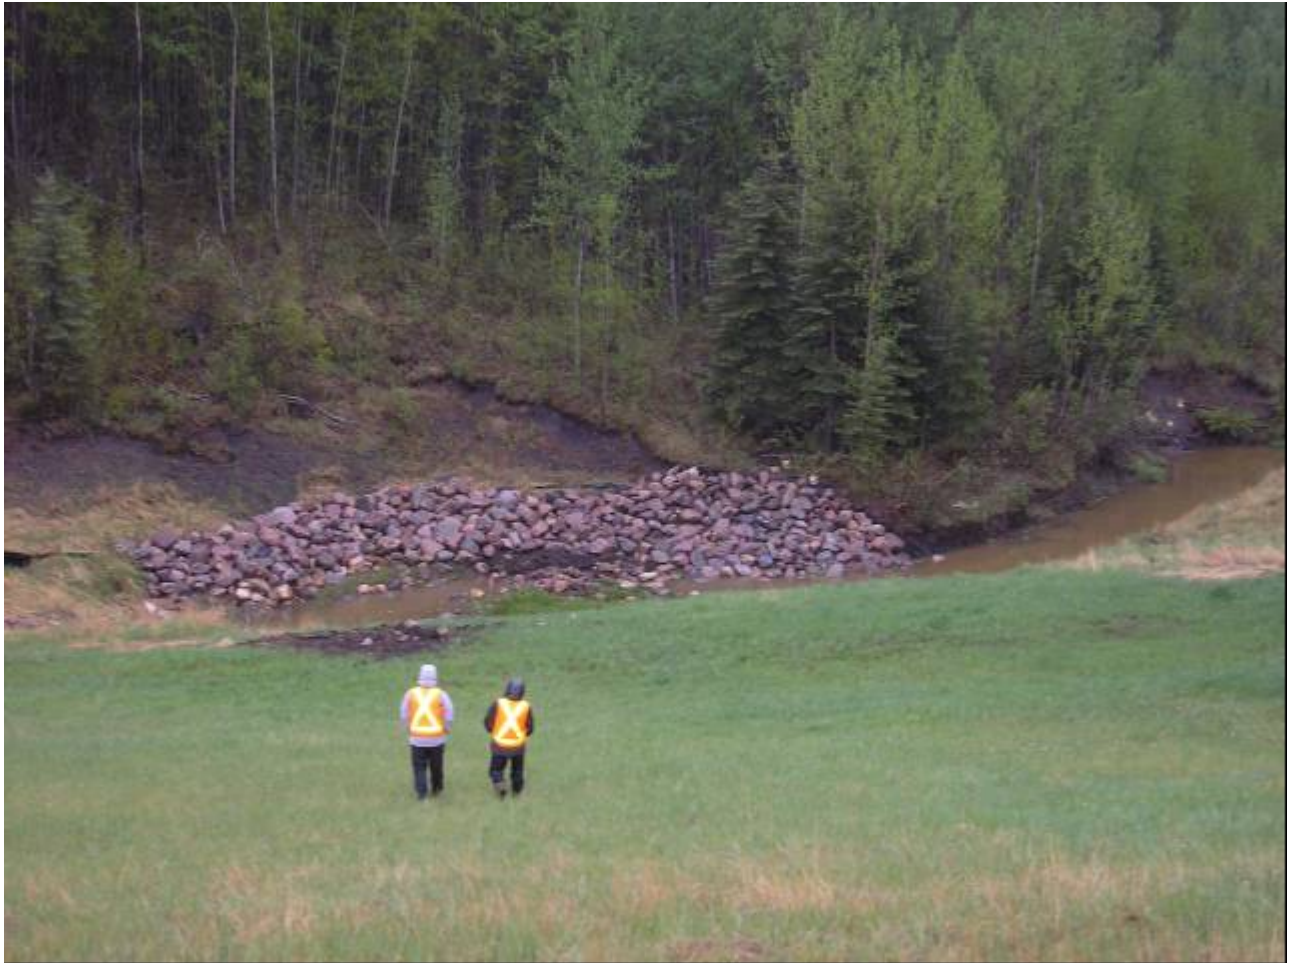
The higher than usual spring melt runoff in 2003 that caused the erosion and associated slumping along the channel downstream of the culvert outlet still exists. A few minor slumps were observed along the east slope of the culvert outlet and additional riprap has been laid to prevent toe erosion of the east slope.

Photo 2 - Southeast view of the additional Class2 riprap at culvert outlet,
May 25, 2006.

It is recommended that the silt fence along the east and north side of the culvert outlet and riprap channel be removed. The silt fence west of the outlet can be taken down, as it no longer is required as this area is well vegetated. The recommended additional armoring of the channel downstream was undertaken this year. The valley slope in the slumped areas near the culvert outlet should be seeded.

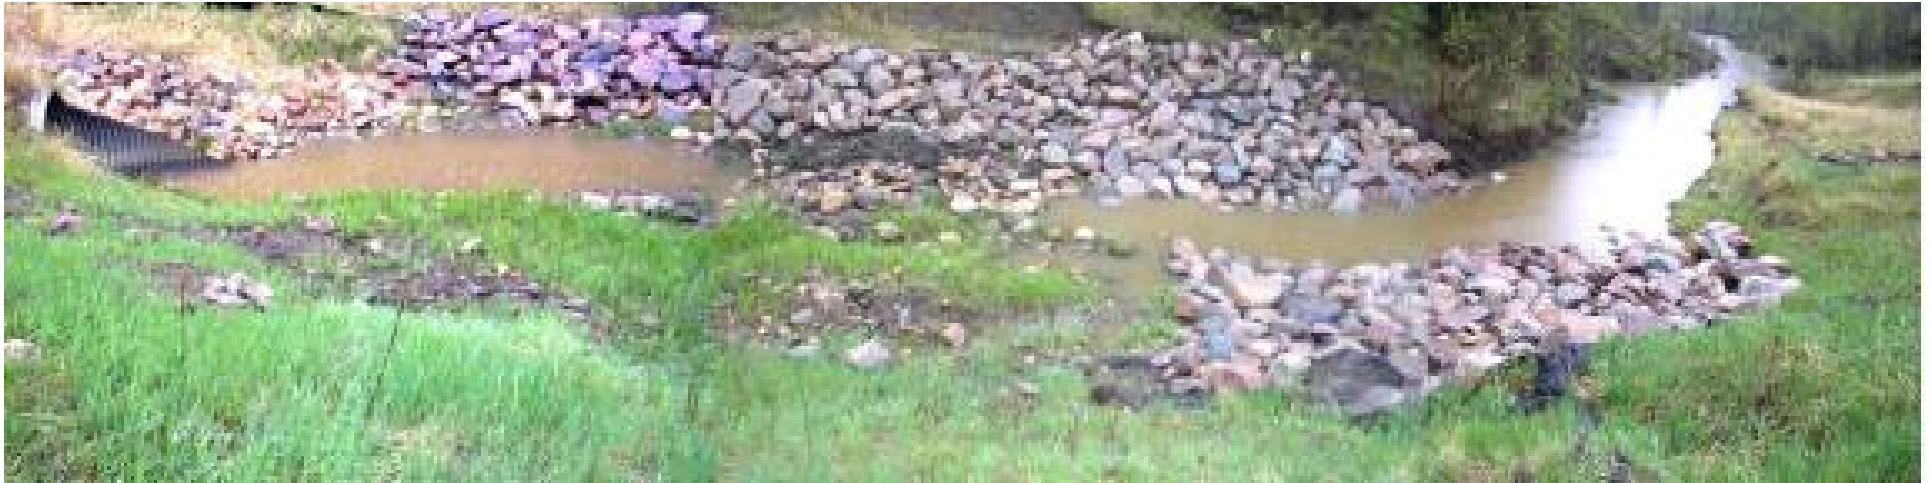
The areas identified last year where riprap replenishment was required along the edges of the creek channel were armored with Class 2 riprap on February 10, 2006 at an approximate cost of \$ 49,000.

Photo 3 - Panoramic view of the culvert outlet and the Class 2 armour, May 25, 2006.
