**PEACE REGION (SWAN HILLS AREA) GEOHAZARD ASSESSMENT
HWY 2A:54 GUNN'S CREEK SLIDE (SH 15)
2007 ANNUAL INSPECTION REPORT**

**ANNUAL GEOHAZARD ASSESSMENT
UPDATED SITE PLAN**

Highway 2A:54 West of Gunn's Creek HIGH PRAIRIE, AB

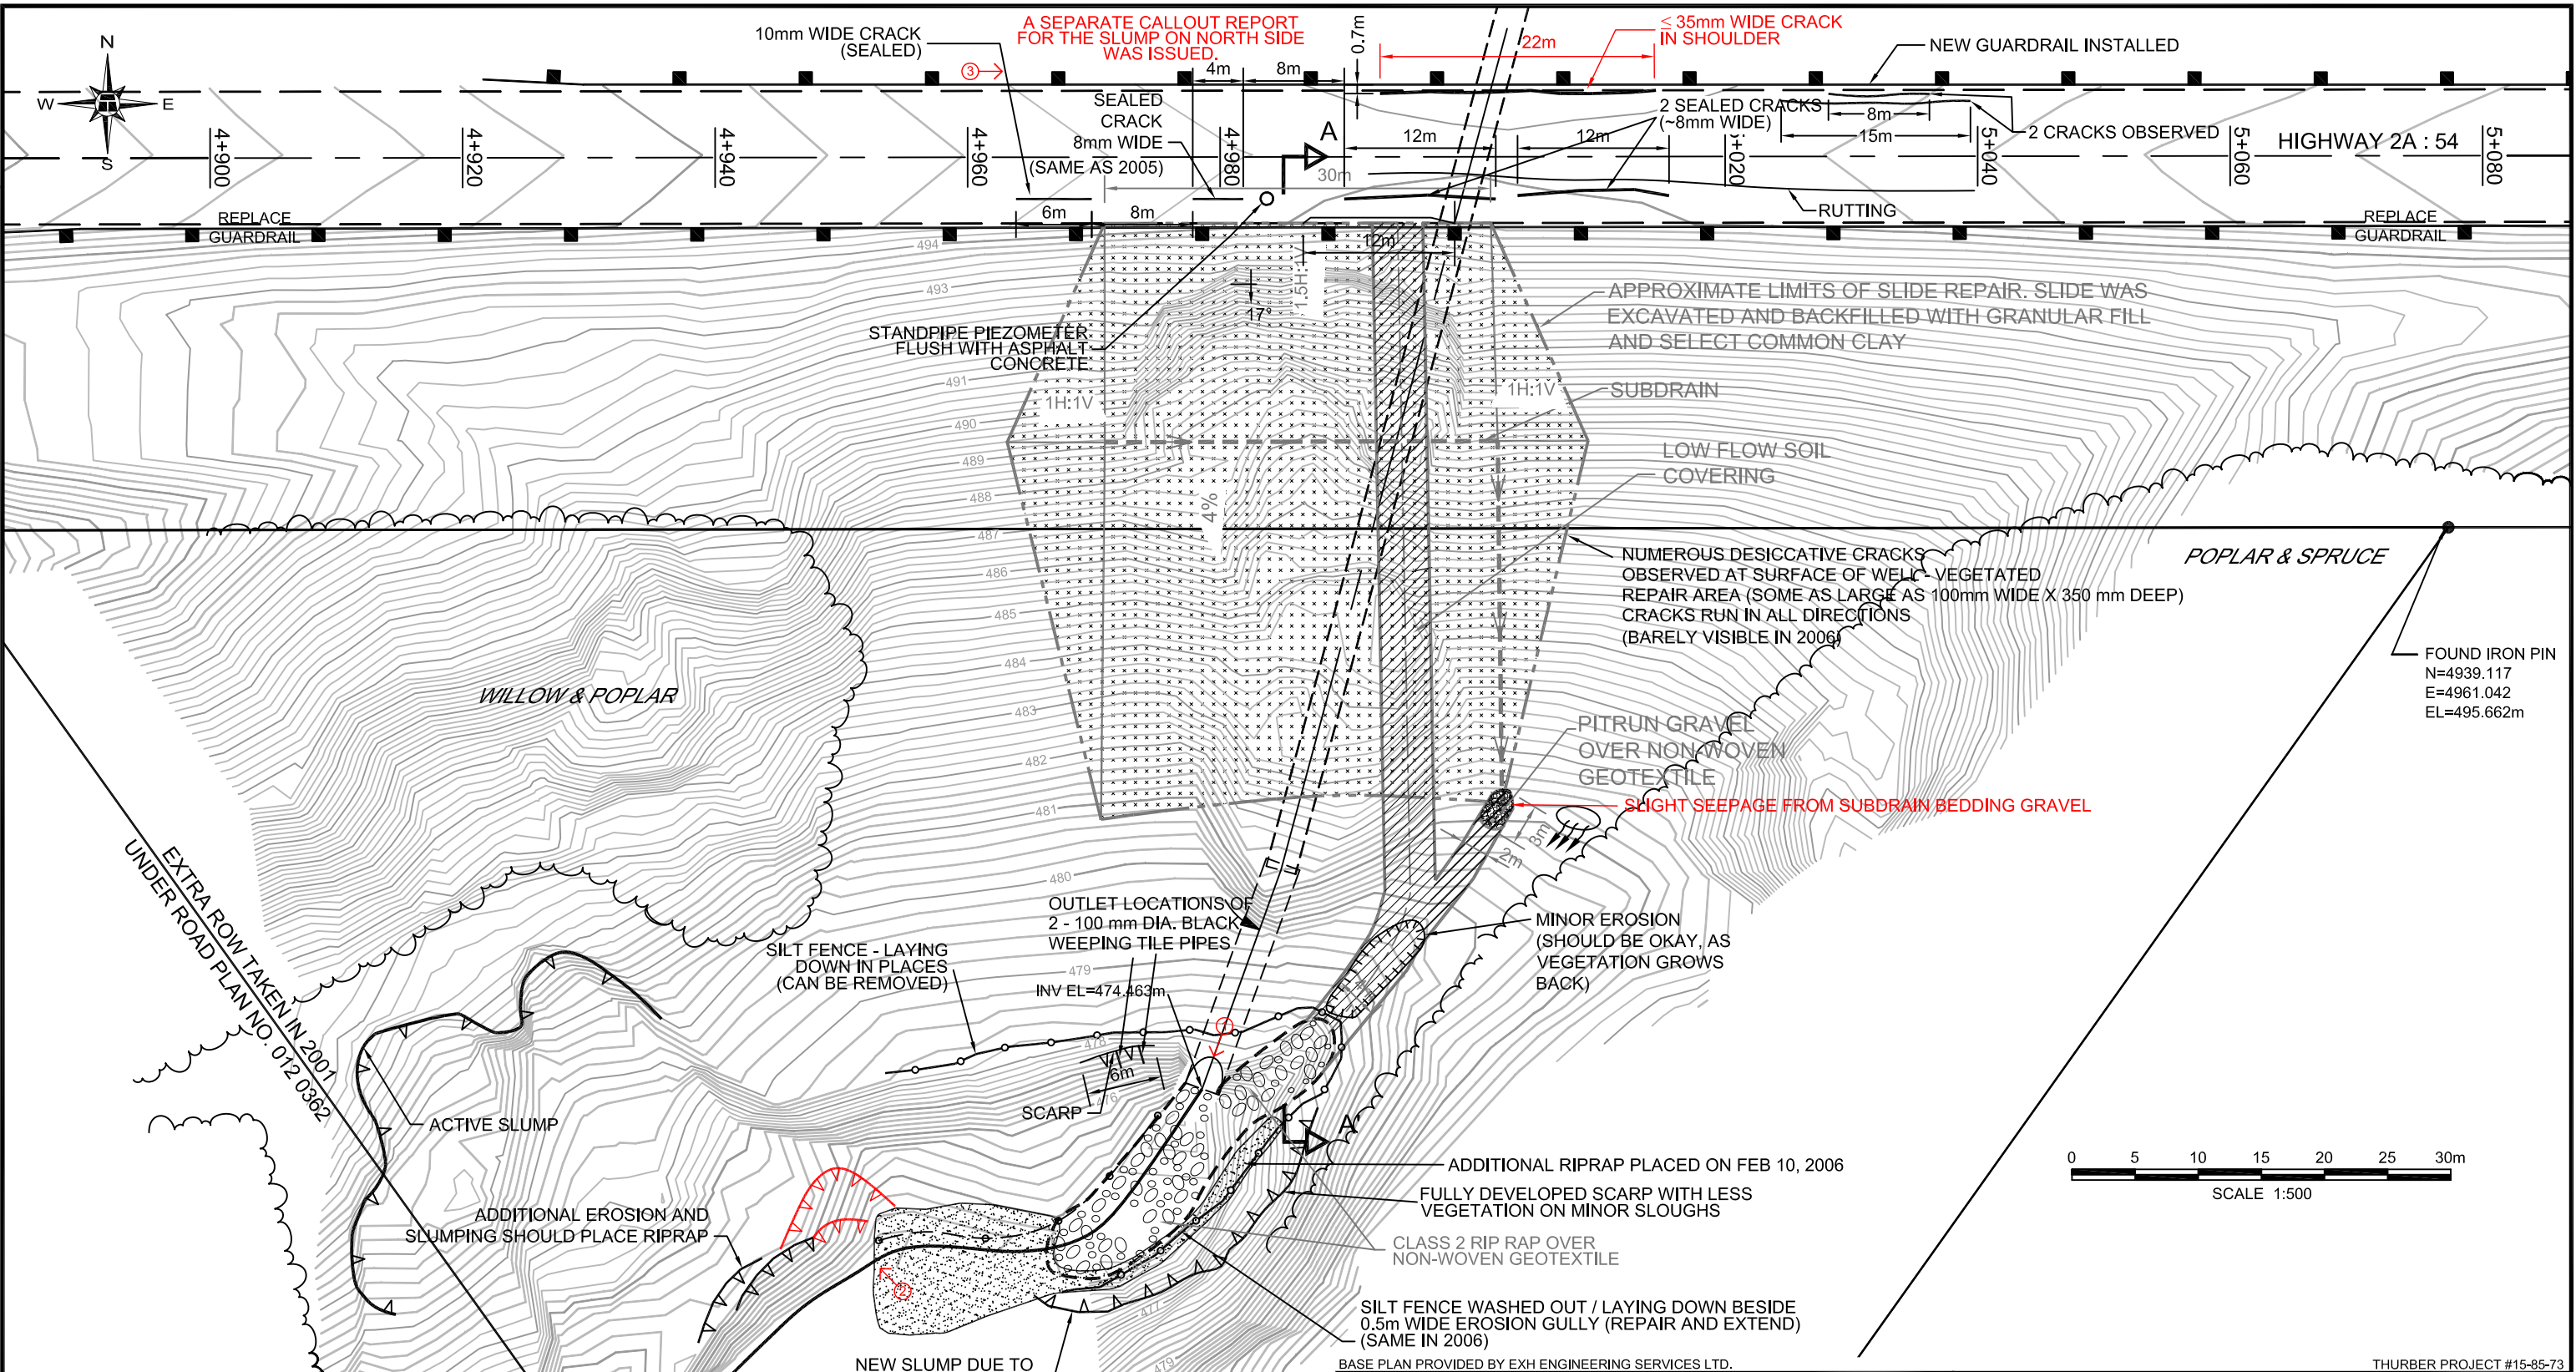
ENGINEER: GSB	DRAWN: HH	APPROVED:
DATE: JUNE 2006	SCALE: 1:500	DRAWING No. 15-85-73-SH15-1

The changes in condition since last year are shown on the attached site sketch plan and discussed below. Selected photographs taken during the visit are also attached. A slump measuring about 40 m by 20 m occurred on the north side slope of the highway. A separate call out report was issued for this slump.

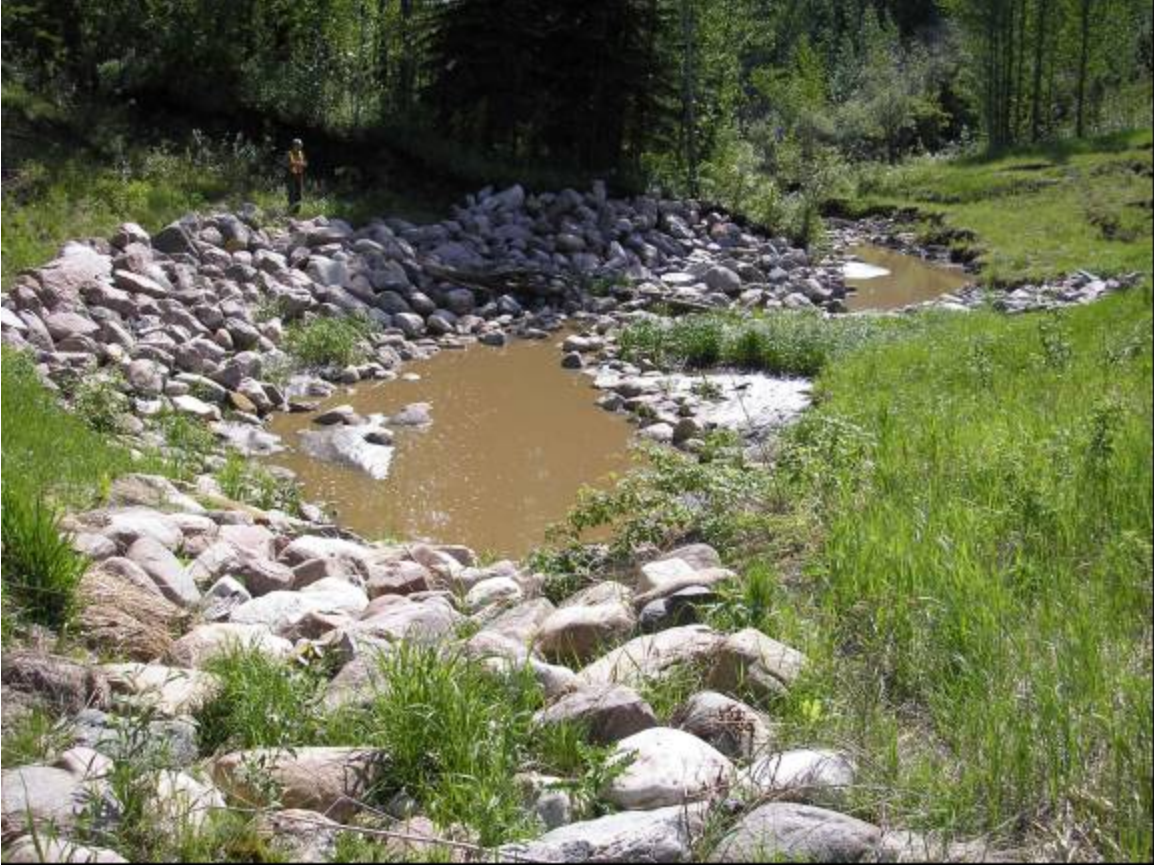
The south sideslope and outlet area of the creek was in generally good condition. Slow seepage was noted emanating from the bedding gravel under the subdrain pipe outlet. The riprap that was added at the outlet of the culvert appeared to be performing well. There was additional slumping in the natural creek banks further downstream of the riprap section.

Photo 1 - Looking south along culvert outlet riprap, June 13, 2007.

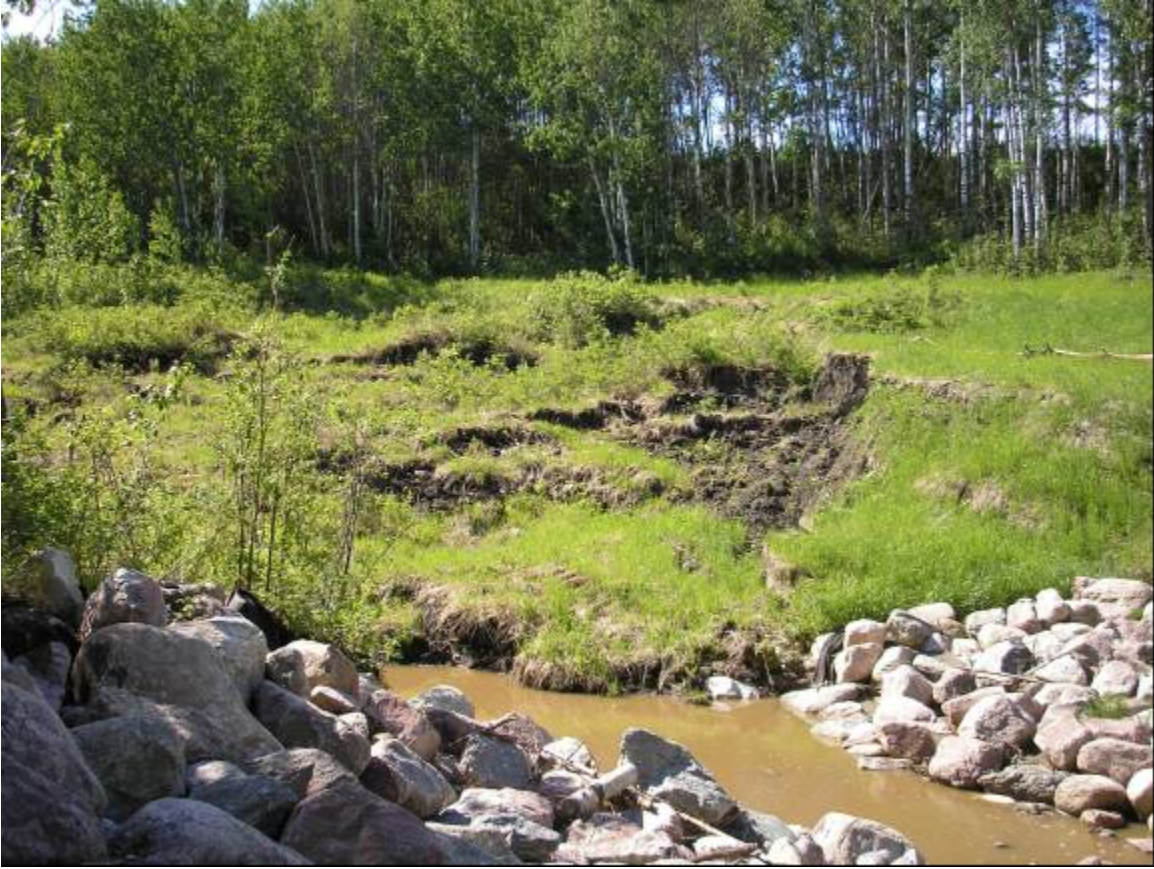
Photo 2 - Southwest view of the slumping at culvert outlet, June 13, 2007.

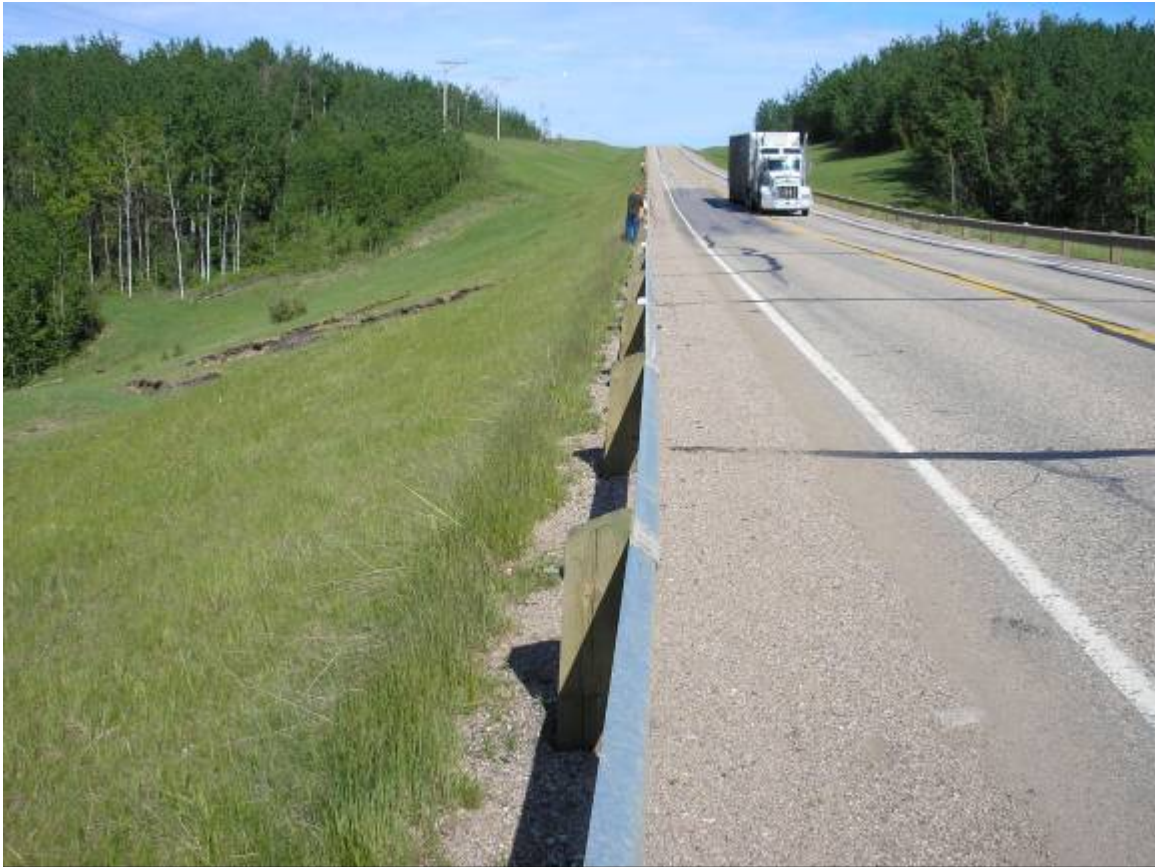
Photo 3 – East view along north guardrail, June 13, 2007.
